DISCOVERY ELEMENTARY SCHOOL

A. EXISTING BUILDING INVENTORY

D. EXISTING DEFICIENCIES

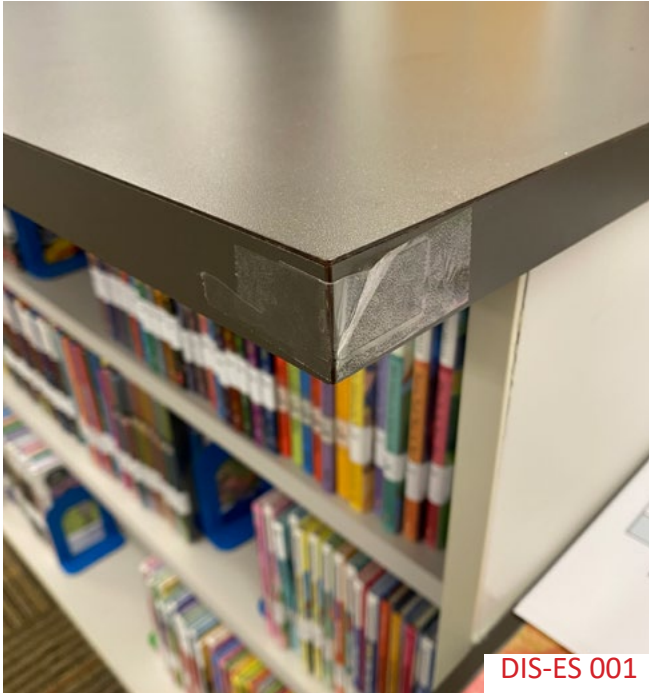
DIS-ES 001

The original casework of the building is low quality and damages easily. The laminate is peeling on the counters .

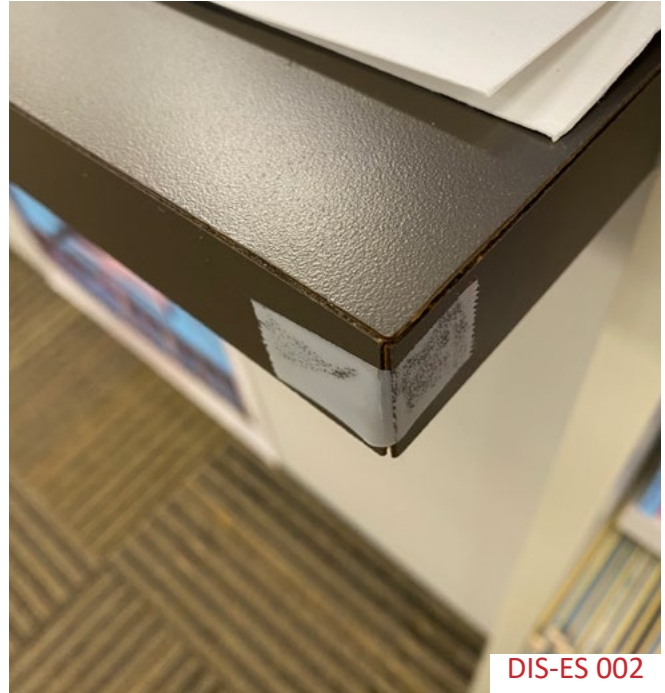
DIS-ES 002

Replacement should be considered; damage is especially apparent in library islands.

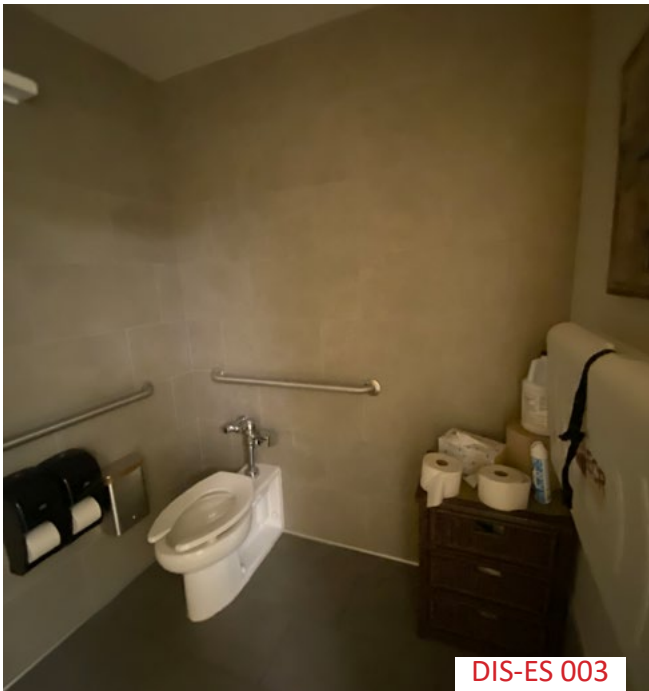
DIS-ES 003

Another concern is the lack of storage in restrooms.

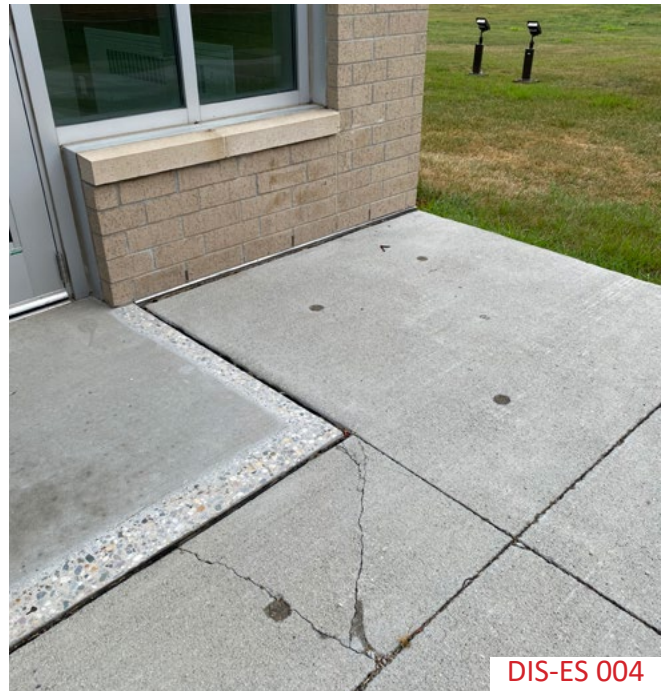
DIS-ES 004

There are several concerns with the site. The slab is sagging and sinking around the stoop at Door 7 (004, 005). There is also a wind issue at Door 7 due to the building's layout and orientation. Other concerns with the site include the lack of parking and the lack of an irrigation system.

The slab is sagging and sinking around the stoop at door 7.

Description	Item Number	Takeoff Qty	Total Cost/Unit	Critical	5 yrs Deferred Maint	10 yrs Deferred Maint	Educational Adequacy	Synergistic with other needs	Total Cost
Exterior Upgrades									
Replace the slab at door 7 since it is sagging and sinking	25	500 SF	\$17.56 /SF	\$8,780					\$8,780
Add 8 additional parking stalls to the parking lot since it is not large enough	26	2,000 SF	\$14.84 /SF				\$29,680		\$29,680
Replace the roof when it nears the end of its useable lifetime	27	75,387 SF	\$31.46 /SF			\$2,371,675			\$2,371,675
Change the door swing of door 7 to fix the wind issue due to the building's layout and orientation	28	1 Ea.	\$3,561.29 /Ea.	\$3,561					\$3,561
Exterior Upgrades Subtotal		92,118 SF	\$26.20 /SF						\$2,413,696
Electrical Upgrades									
Replace lighting in the cafeteria area since the suspended can lights are now obsolete and parts cannot be obtained for repairs	29	3,000 SF	\$7.32 /SF			\$21,960			\$21,960

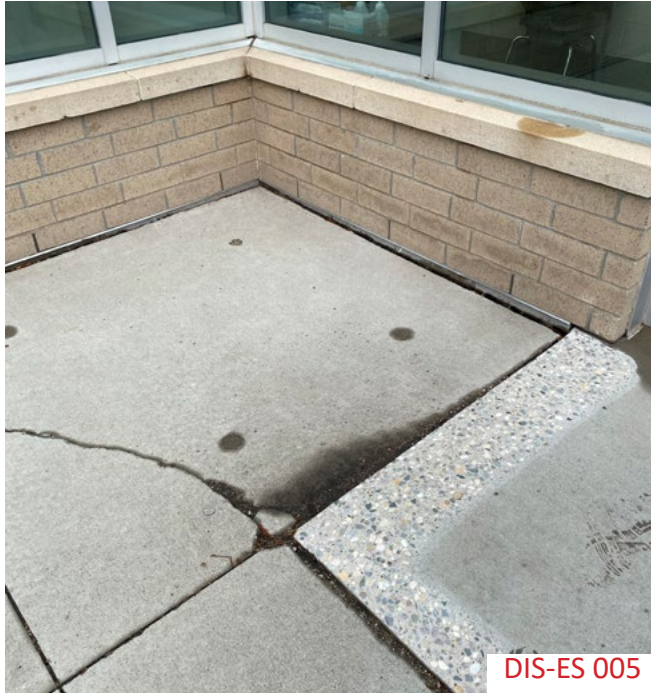
DIS-ES 005

The slab is sagging and sinking around the stoop at door 7.

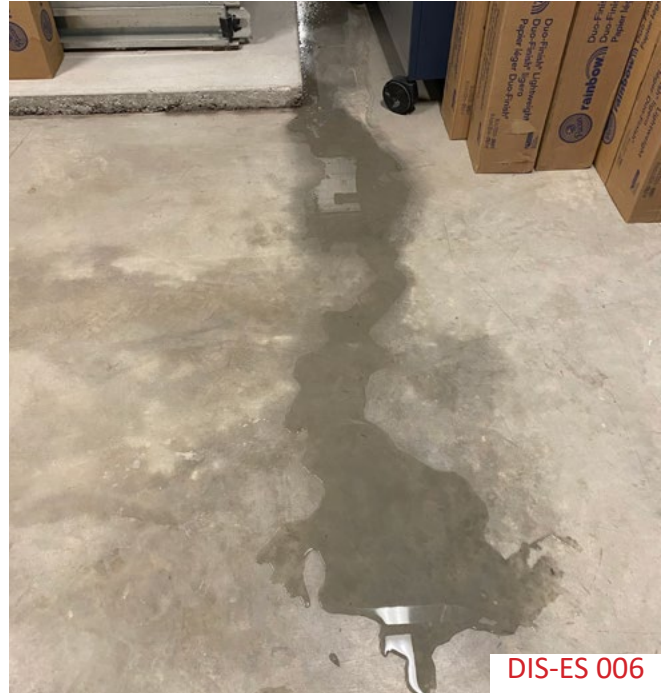
DIS-ES 006

Water is leaking and pooling in the 2nd floor mechanical room (006) which is resulting in ceiling leaks into the music and band rooms below (007, 008). There are also several ceiling tiles throughout the school that have water damage (009, 010, 011).

Water is leaking and pooling in the 2nd floor mechanical room.

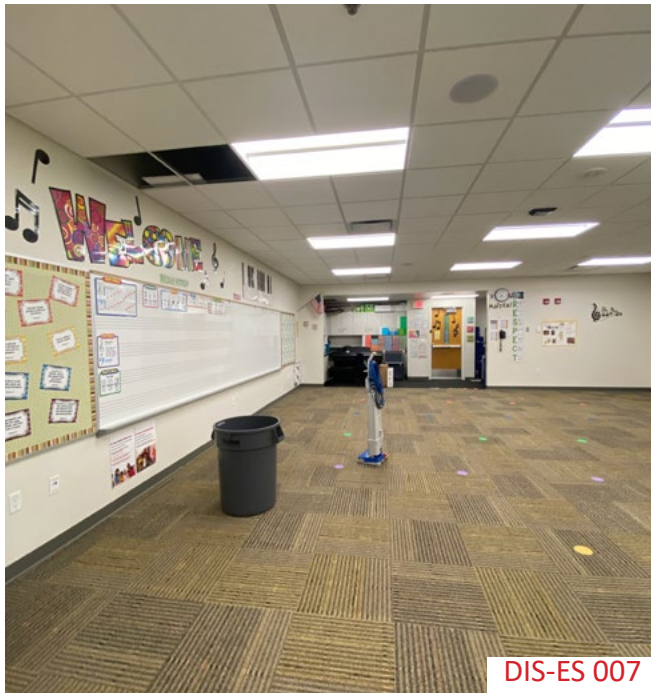
DIS-ES 007

Water is leaking and pooling in the 2nd floor mechanical room which is resulting in ceiling leaks into the music and band rooms below.

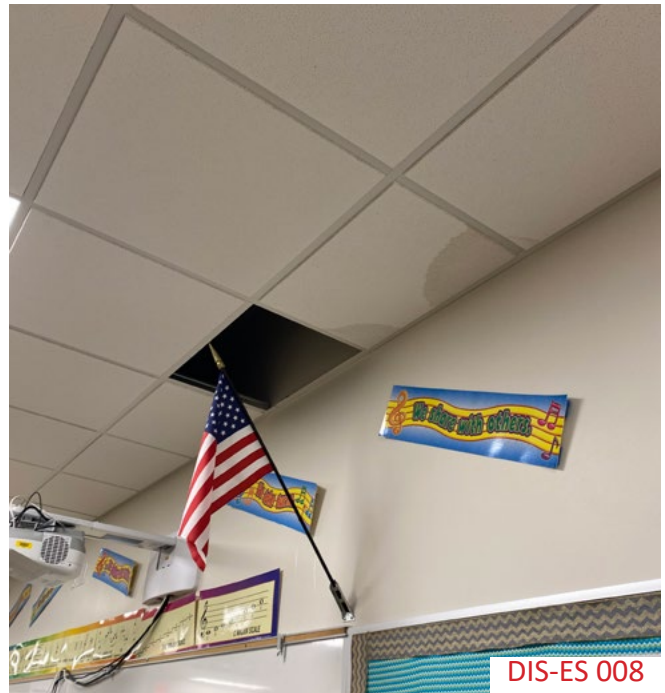
DIS-ES 008

Water is leaking and pooling in the 2nd floor mechanical room which is resulting in ceiling leaks into the music and band rooms below.

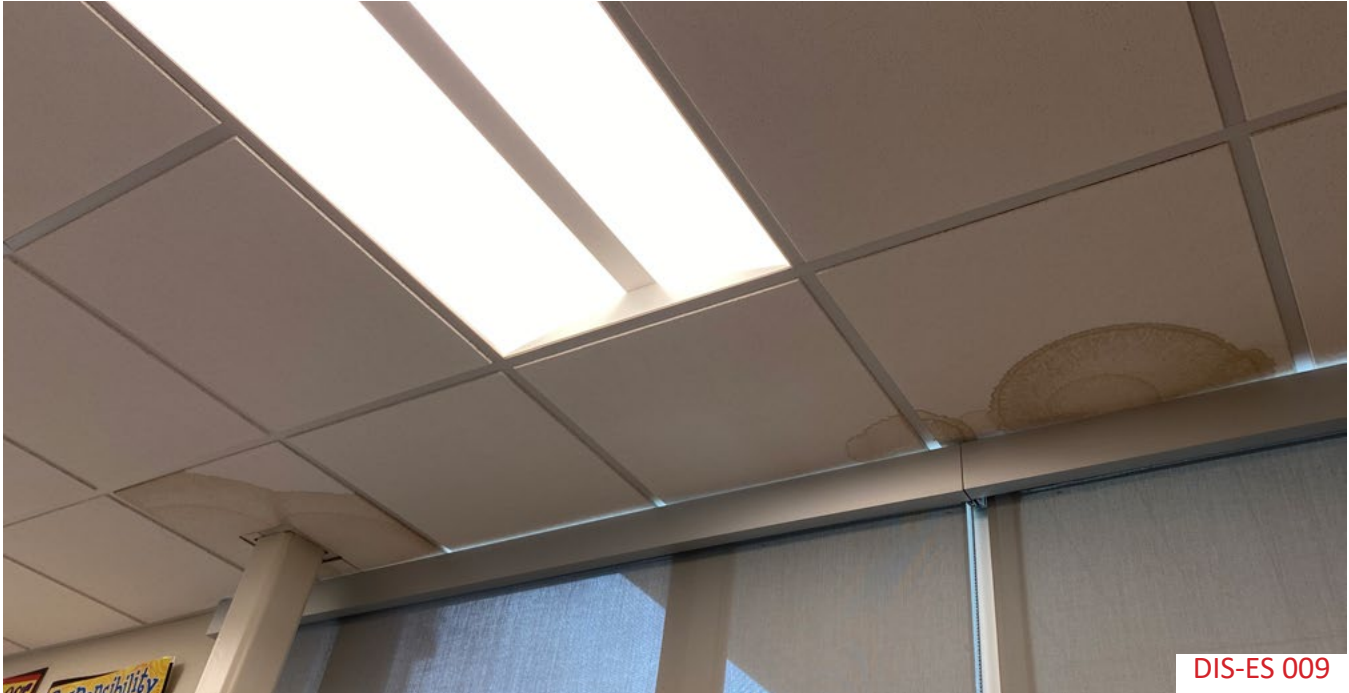
There are also several ceiling tiles throughout the school that have water damage.

Replace hardware on the doors at the entrance of each wing/pod with latches, so they be locked.	23	12 Ea.	\$651.32 /Ea.		\$7,816				\$7,816
Replace the water damaged ceiling tiles throughout the school	24	2,394 SF	\$9.54 /SF		\$22,827				\$22,827
Interior Upgrades Subtotal		92,118 SF	\$12.32 /SF						\$1,134,816

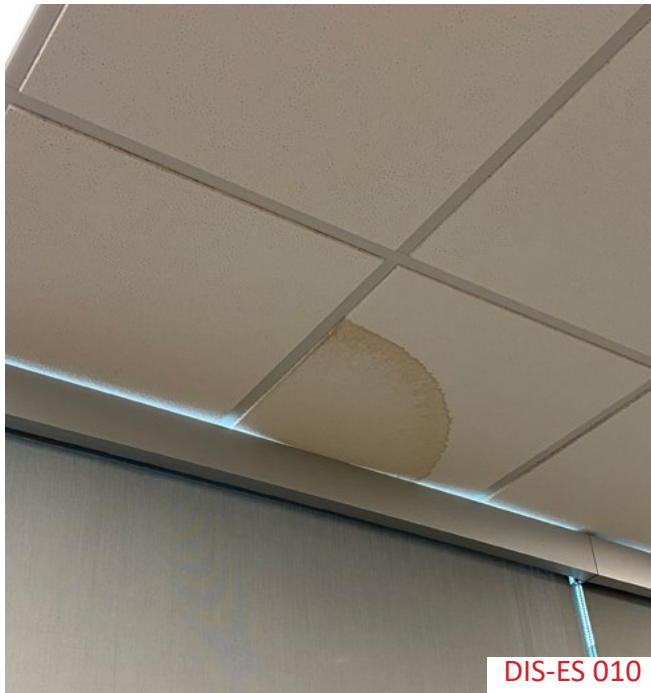
There are also several ceiling tiles throughout the school that have water damage.

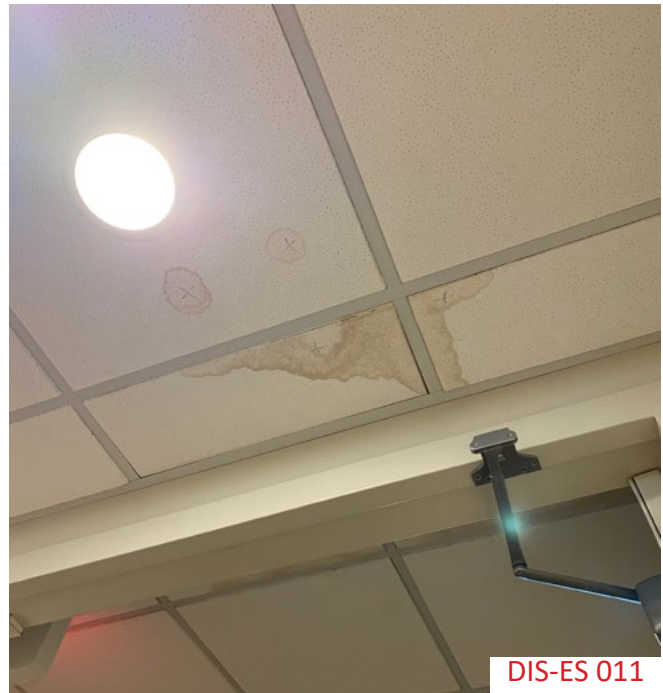
There are also several ceiling tiles throughout the school that have water damage.

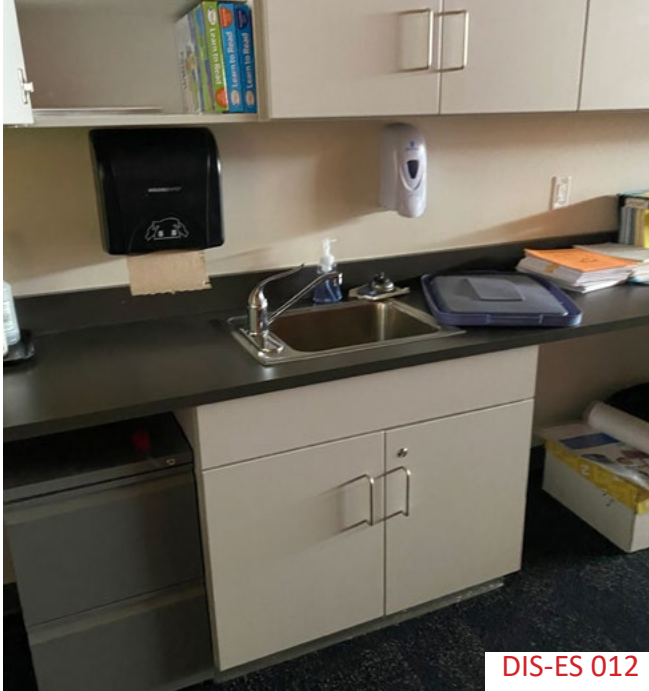
DIS-ES 012

- Sinks in commons areas are not accessible (012).
- Fire alarm systems should have permanently installed audible alarms (013).

Sinks in commons areas are not accessible.

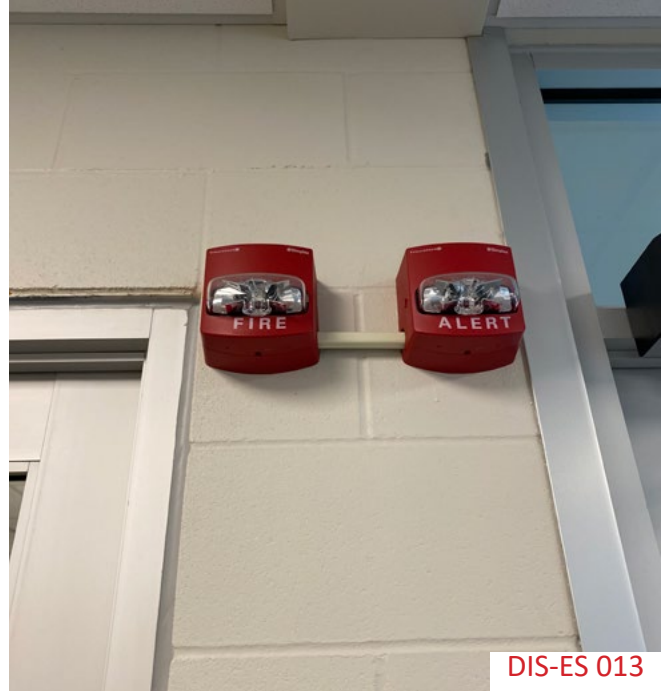
DIS-ES 013

Fire alarm systems should have permanently installed audible alarms.

Upgrade the fire alarm system to a voice-capable system as is currently required by the North Dakota Building Code	30	92,118 SF	\$5.32 /SF		\$490,068				\$490,068
Electrical Upgrades Subtotal		92,118 SF	\$5.56 /SF						\$512,028
Mechanical Upgrades									
During the walkthrough the boiler room was very warm. Add a transfer fan to circulate air between the boiler room and adjacent receiving room to mitigate this.	31	1 Ea.	\$12,367.24 /Ea.		\$12,367				\$12,367
Mechanical Upgrades Subtotal		92,118 SF	\$0.13 /SF						\$12,367
Total Capital Maintenance		92,118 SF	\$44.21 /SF	\$51,031	\$533,078	\$3,459,118	\$29,680		\$4,072,907
Total Construction Cost		111,640 SF	\$104.77 /SF	\$158,790	\$533,078	\$3,459,118	\$7,545,031		\$11,696,017
