# KELLY ELEMENTARY SCHOOL

## A. EXISTING BUILDING INVENTORY

## D. EXISTING DEFICIENCIES

## INTERIOR AND EXTERIOR EXISTING DEFICIENCIES PHOTOS

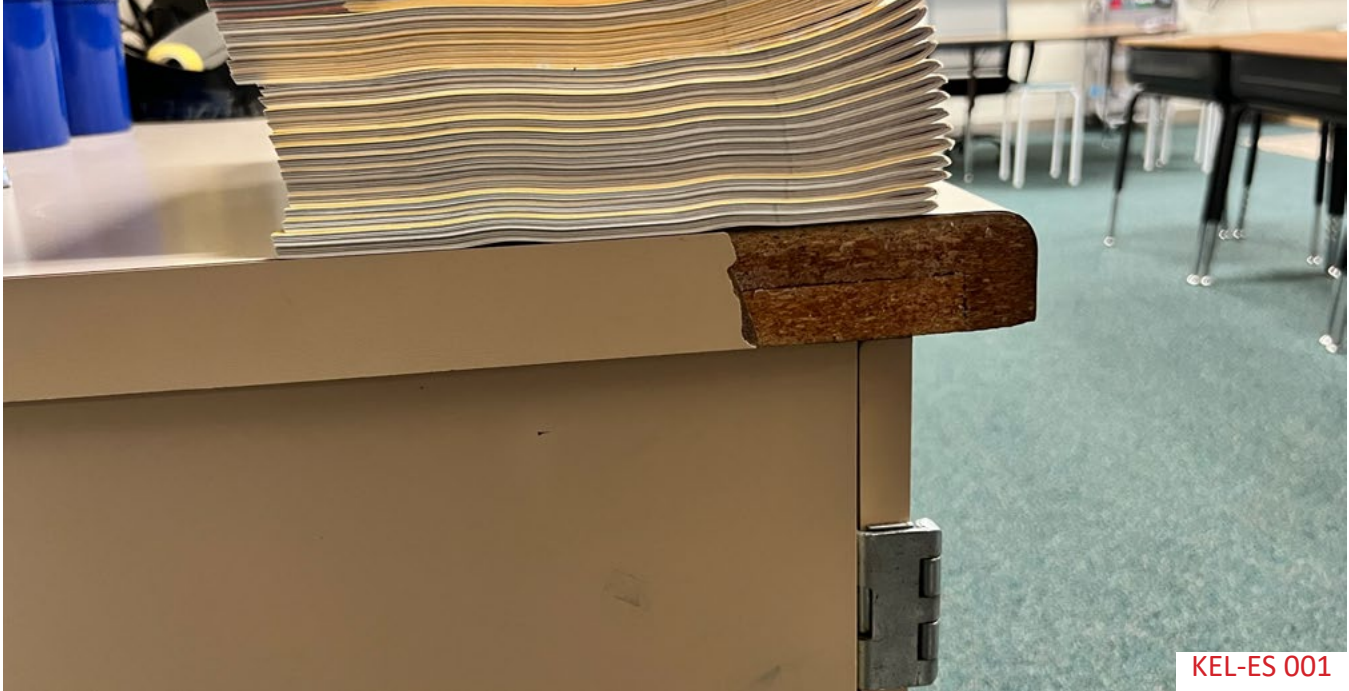
Kelly Elementary School's original portion was completed in 1966. Additions were made in 1973, 1982, and 1989. In 2004 a remodel was done, and the building was reroofed in 2010. Another remodel is currently taking place. There are areas in both the exterior and interior of the building where signs of wear and tear are present. Certain finishes, hardware, and appliances in the building are outdated and/or damaged (001). There are accessibility issues throughout the school.

Certain finishes, hardware, and appliances in the building are outdated and/or damaged.

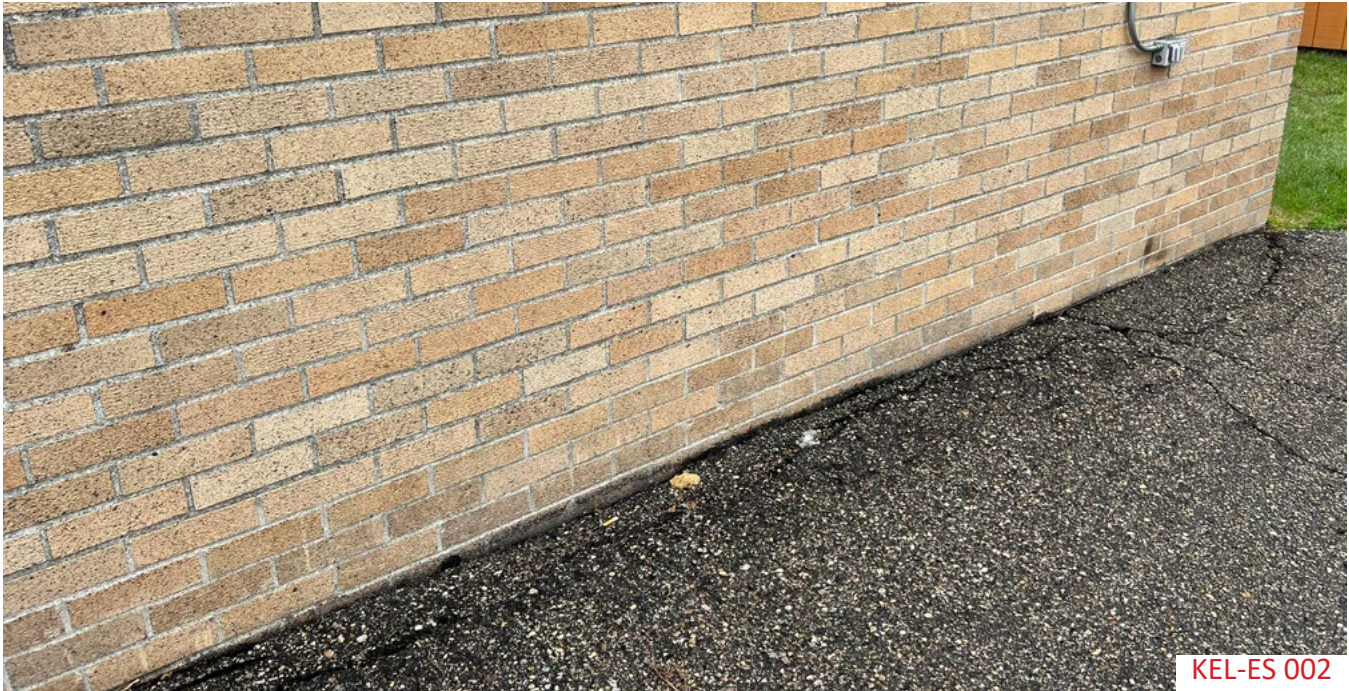
The exterior sidewalks, curbs, and pavement show some cracking. Asphalt is pushed up against the building, burying weep holes (002). The playground was recently redone and meets accessibility requirements.

Asphalt is pushed up against the building burying weep holes.

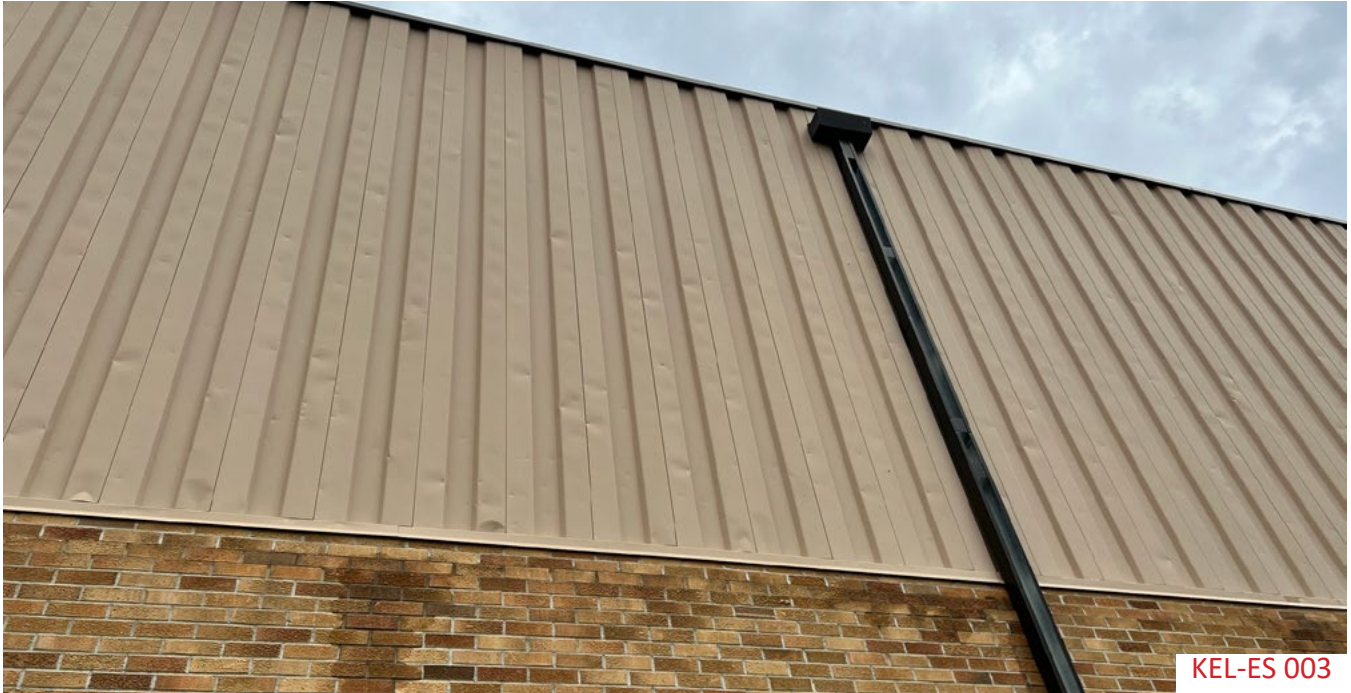
KEL-ES 003

Metal paneling around the gym has numerous dents from balls hitting it (003). Wood paneling and pressed panels are in overall good condition.

Metal paneling around the gym has numerous dents from balls hitting it.

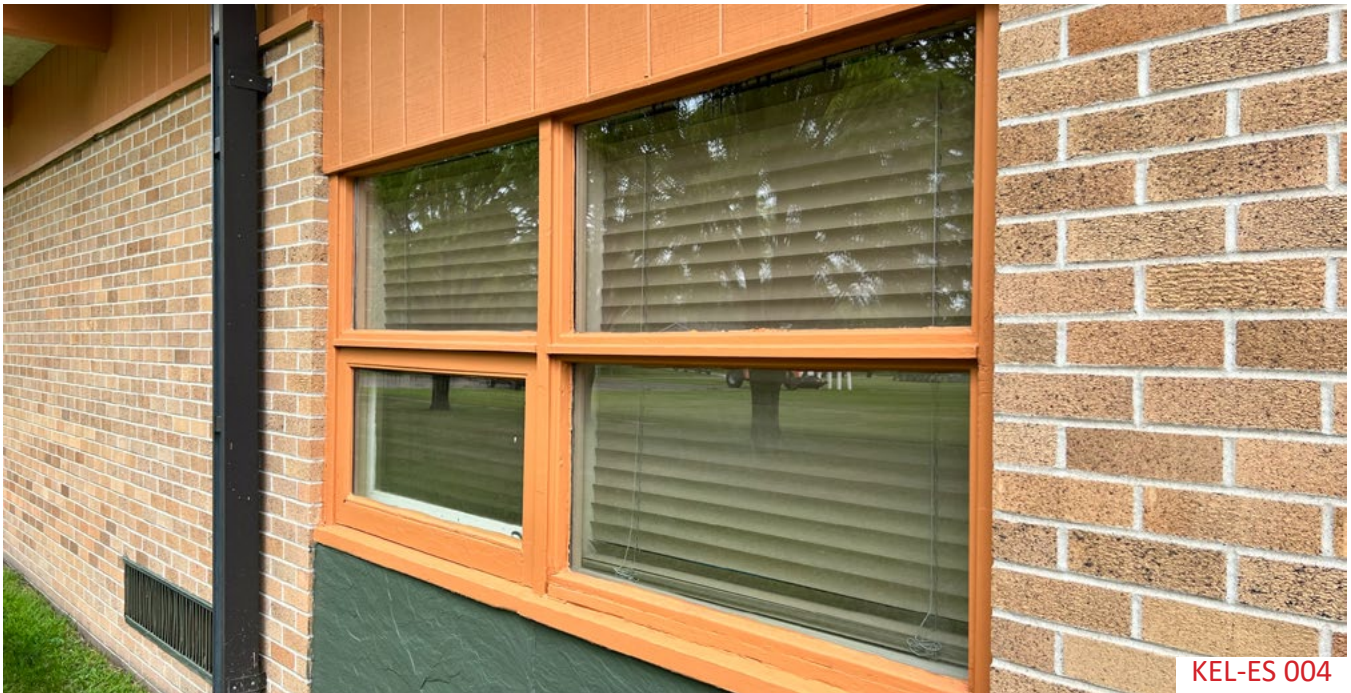
KEL-ES 004

Door openings within the school are in good condition. The east side of the school received new windows in the summer of 2022. Other windows are aged, and caulking is deteriorating (004, 005).

Other windows are aged, and caulking is deteriorating.

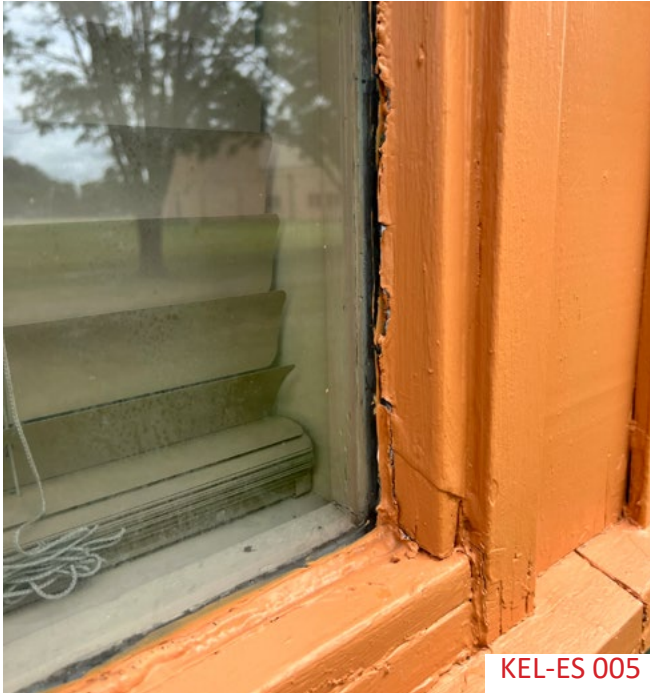
**KEL-ES 005**

Other windows are aged, and caulking is deteriorating.

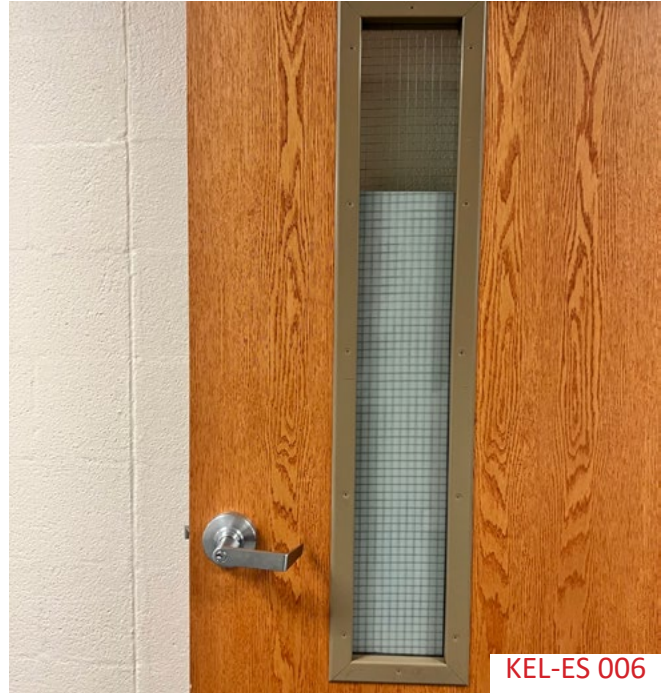
**KEL-ES 006**

- The building is not sprinklered.
- Traditional wire glass throughout the building is no longer to code as an acceptable type of safety glass. (006)
- Restrooms in classrooms are not accessible. (007)

Traditional wire glass throughout the building is no longer to code as an acceptable type of safety glass.

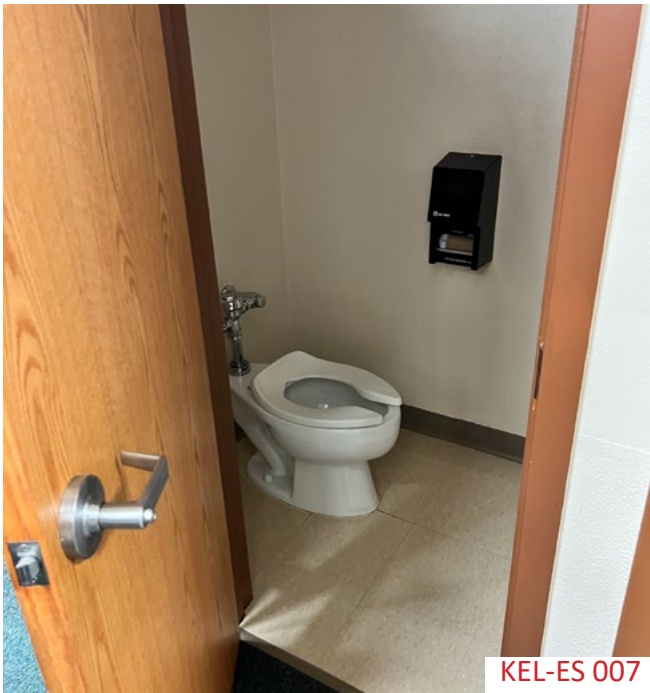
**KEL-ES 007**

Restrooms in classrooms are not accessible.

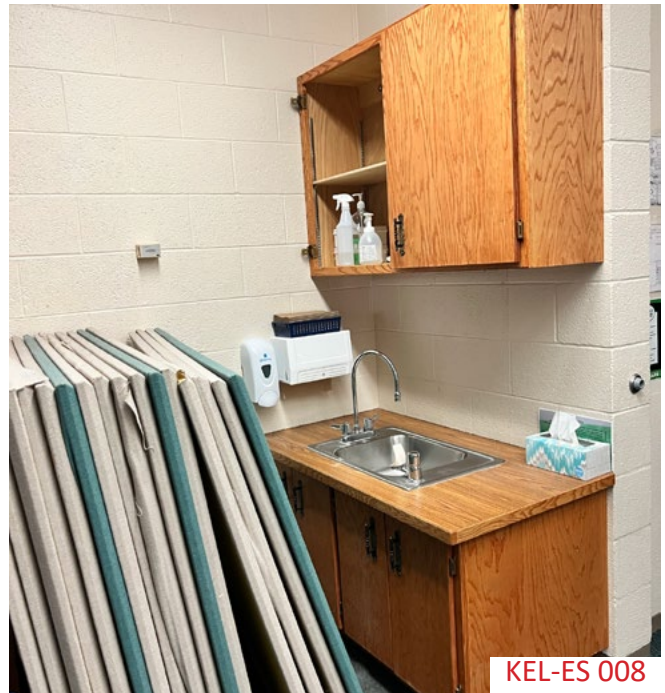
**KEL-ES 008**

- Sinks in classrooms are not accessible. (008)
- Pipes throughout the building under sinks are not protected. (009)
- Drinking fountains throughout the building do not meet the required ratio of wheelchair accessible fountains to standing person accessible fountains. (010, 011)

Sinks in classrooms are not accessible.

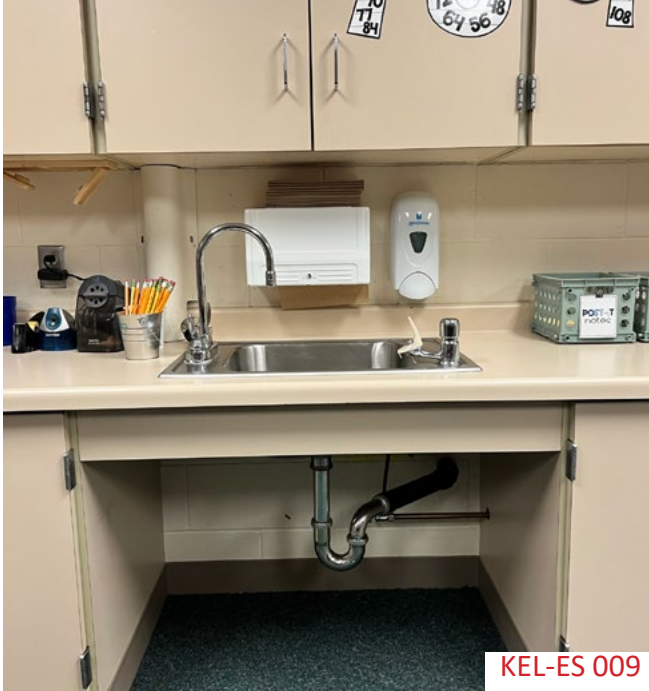
KEL-ES 009

Pipes throughout the building under sinks are not protected.

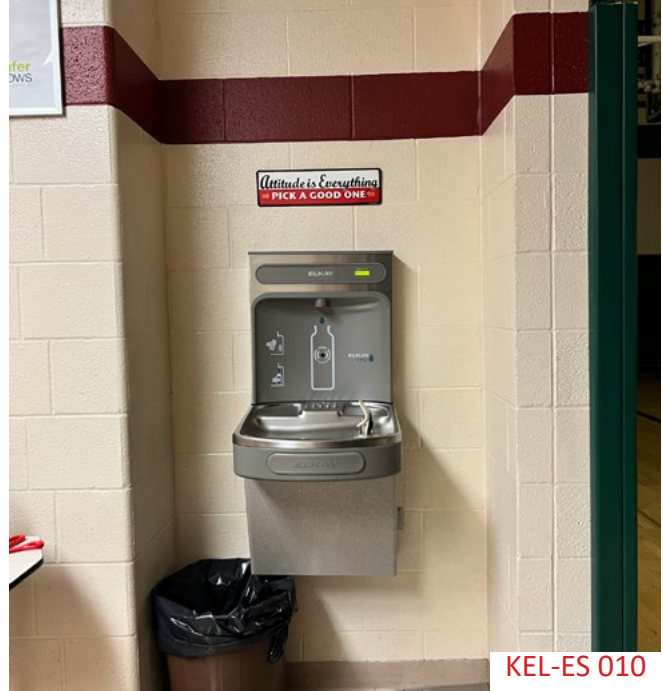
KEL-ES 010

Drinking fountains throughout the building do not meet the required ratio of wheelchair accessible fountains to standing person accessible fountains.

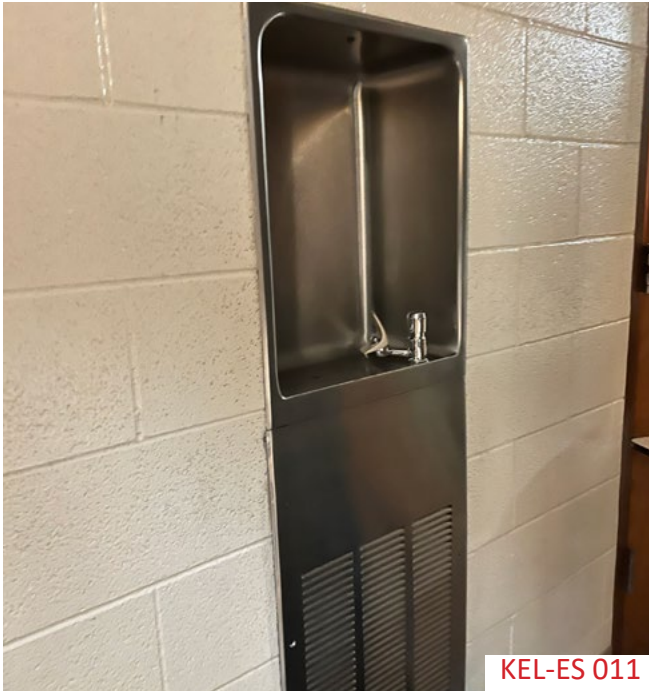
KEL-ES 011

Drinking fountains throughout the building do not meet the required ratio of wheelchair accessible fountains to standing person accessible fountains.

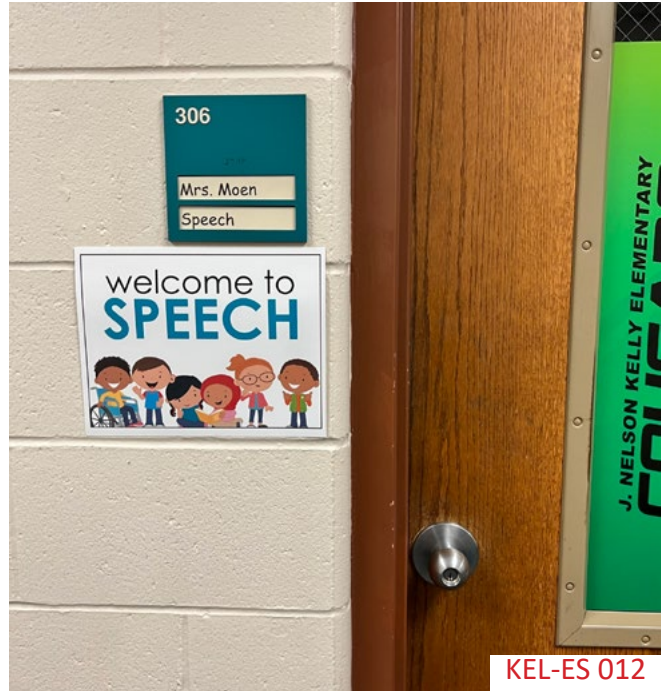
KEL-ES 012

- Many doors throughout the building have hardware that is not accessible. (012)
- Faculty restroom and gym office restrooms are not accessible. (013, 014)

Many doors throughout the building have hardware that is not accessible.

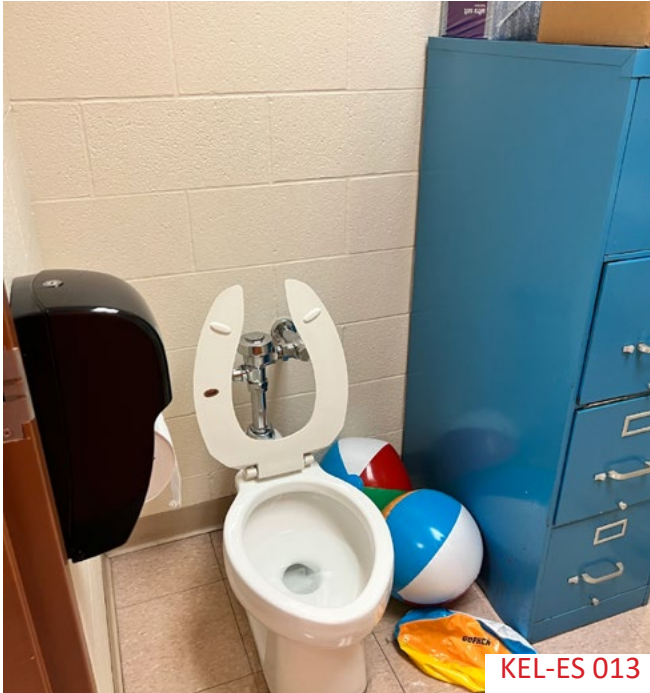
**KEL-ES 013**

Faculty restroom and gym office restrooms are not accessible.

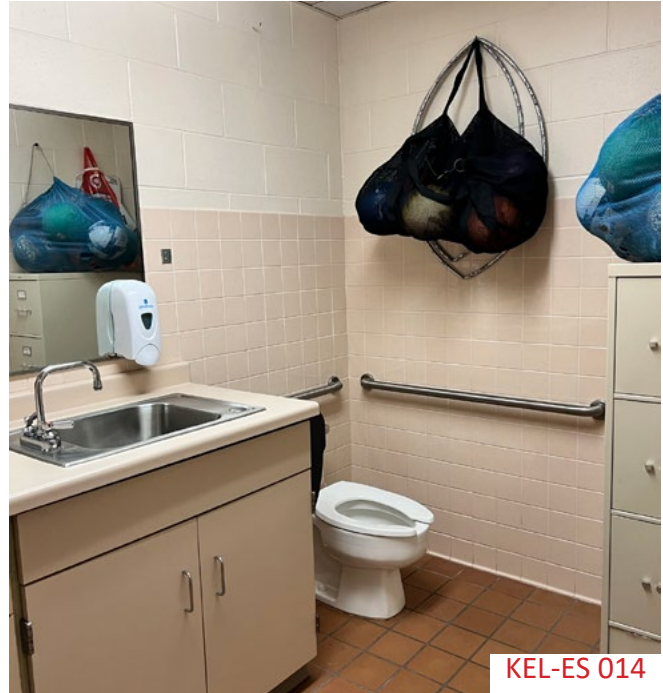
**KEL-ES 014**

Faculty restroom and gym office restrooms are not accessible.

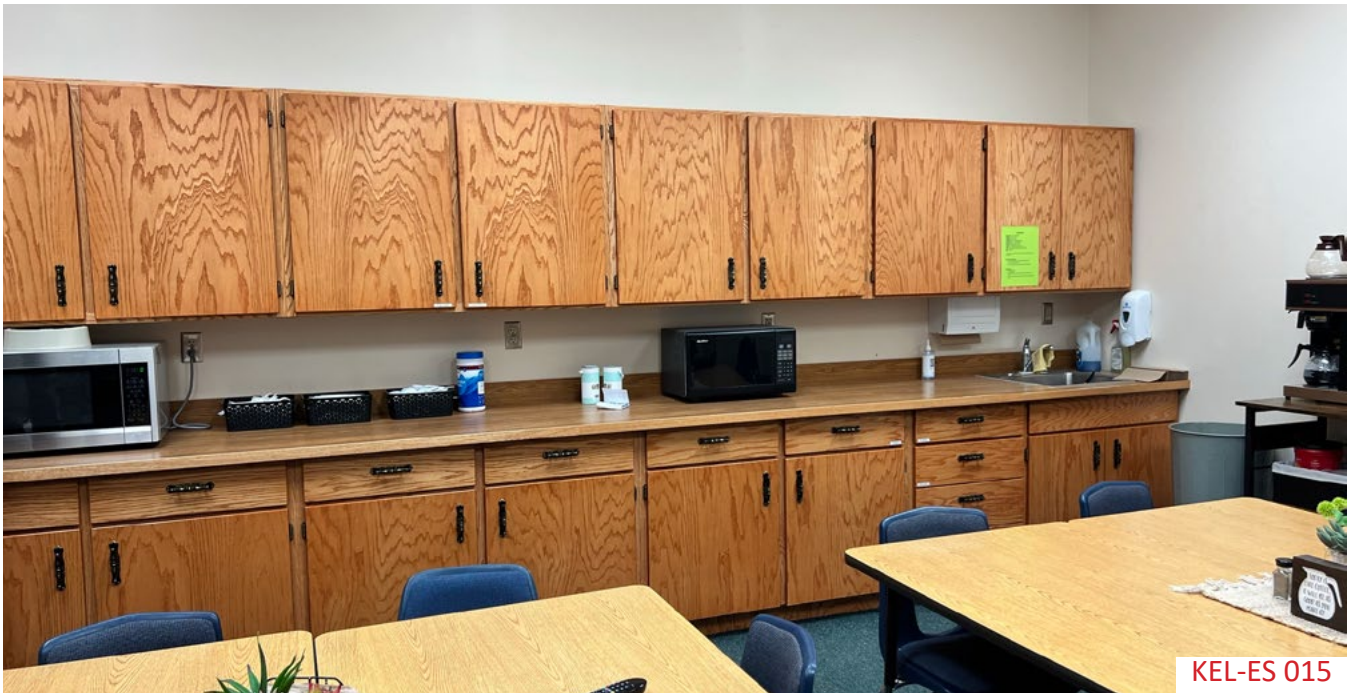
**KEL-ES 015**

- Sinks in library workroom and faculty lounge are not accessible. (015)
- Interior windows in the library computer lab do not have required tempered glass for safety.

Sinks in library workroom and faculty lounge are not accessible.

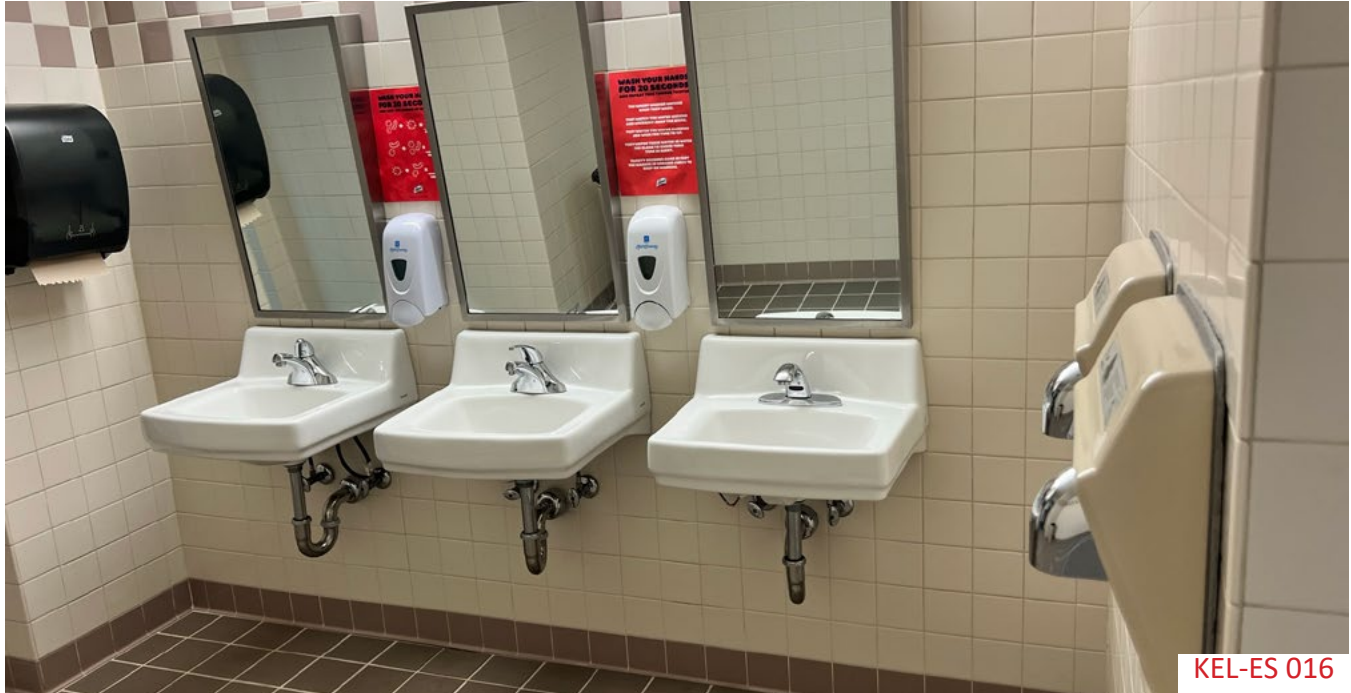
All public restrooms are not accessible.

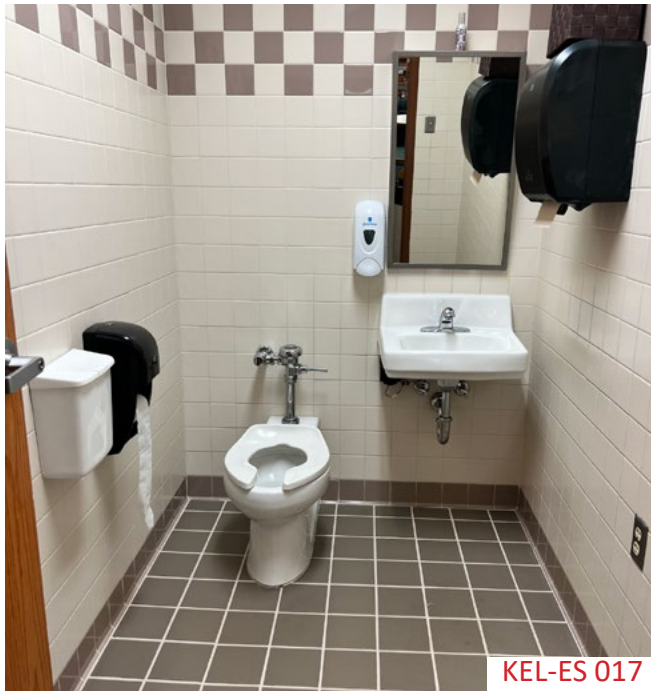
All public restrooms are not accessible.

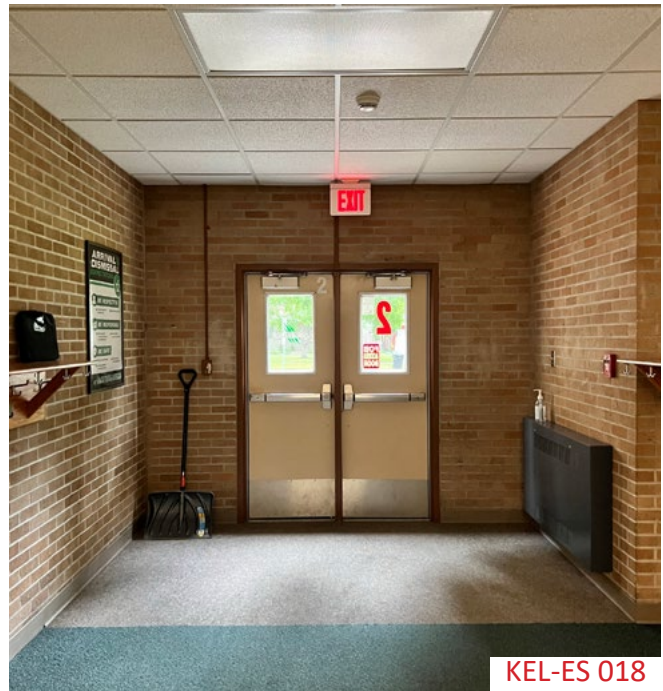
- All public restrooms are not accessible. (016, 017)
- The mop sink in the custodial room requires a splash guard.
- Door 2 entrance is not wide enough for entry clearance. (018)

Door 2 entrance is not wide enough for entry clearance.
