# LAKE AGASSIZ ELEMENTARY SCHOOL + HEAD START

**FACILITY ASSESSMENT** EXISTING BUILDING INVENTORY ARCHITECTURAL FINISHES  
MECH/ELEC ASSESSMENT EXISTING DEFICIENCIES COST ANALYSIS APPENDIX

## D. EXISTING DEFICIENCIES

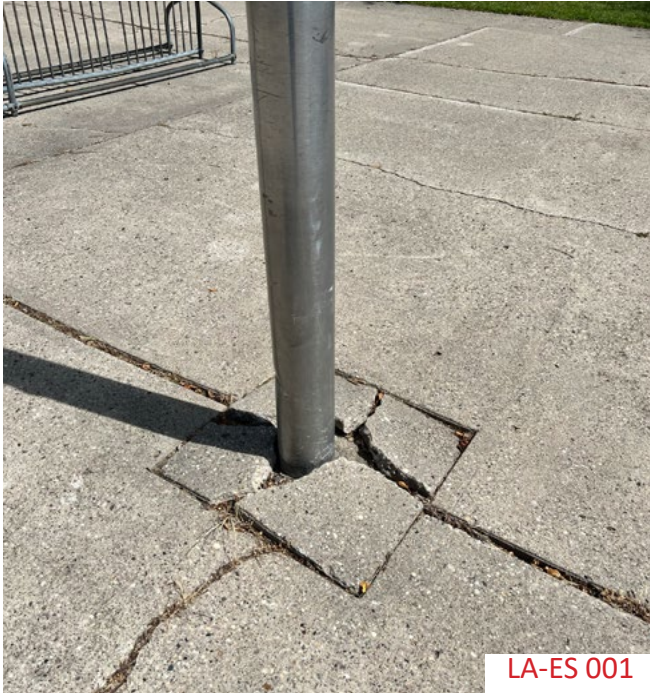
Concrete found around the building shows cracking (001). The concrete at Door 1 should be leveled out (002).

Concrete found around the building shows cracking.

<b>Interior Upgrades Subtotal</b>		<b>76,617 SF</b>	<b>\$3.74 /SF</b>						<b>\$286,442</b>
<b>Exterior Upgrades</b>									
Replace damaged concrete around the building that is cracking	30	2,000 SF	\$17.05 /SF		\$34,108				\$34,108
Remove and replace the concrete at door that is not level	31	352 SF	\$17.10 /SF		\$6,019				\$6,019

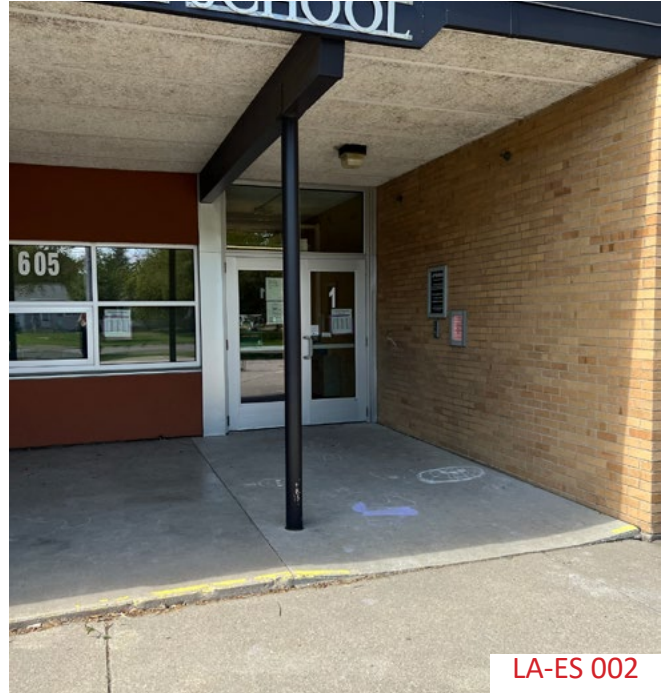
The concrete at door one should be leveled out.

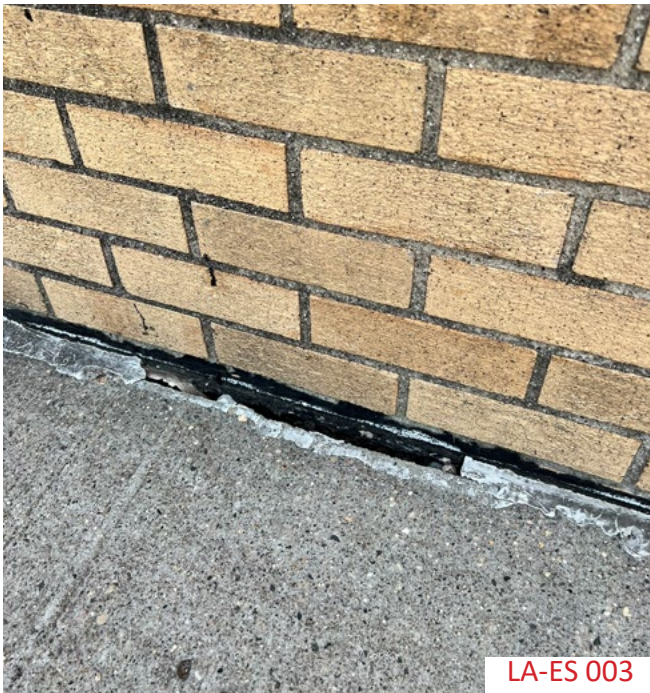
The exterior brick of the building is in overall good shape, but the mortar needs to be washed. Caulking around the base of the building could use a touch up (003). There are a few areas with damaged brick (004). Flashing at the bottom of the brick portion of the wall was caulked over, preventing proper water drainage. Water pools on the lintel and it is causing it to rust and deteriorate (005).

Caulking around the base of the building could use a touch up.

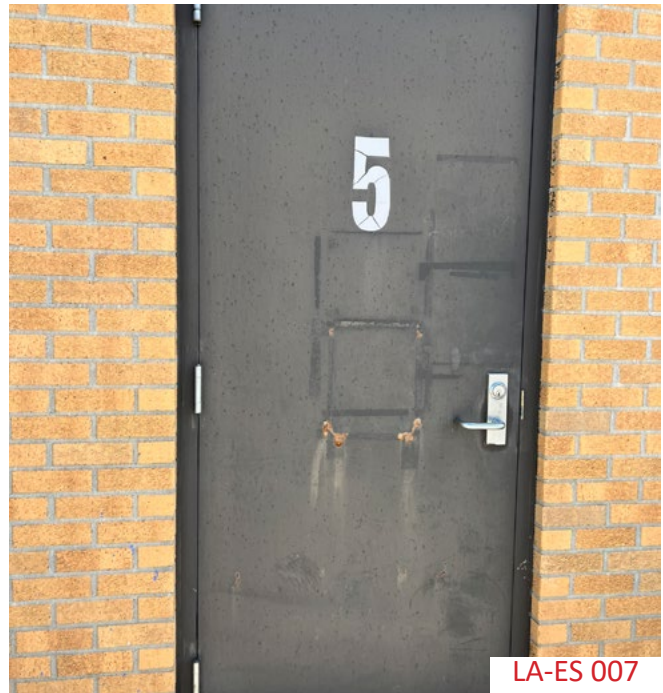
Doors and windows are in relatively good condition. The original glazing compound on windows is coming off and needs to be redone (006). West facing metal doors are aged and should be replaced (007).

West facing metal doors are aged and should be replaced.

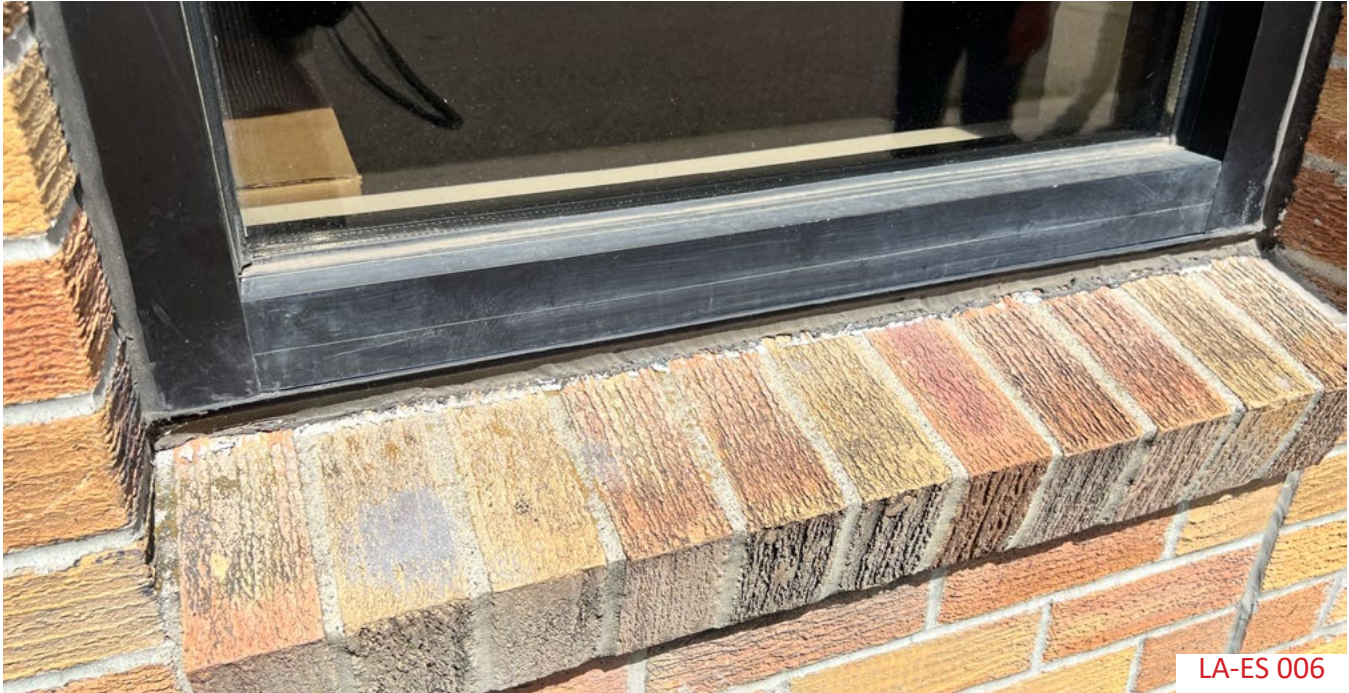
LA-ES 006

The original glazing compound on windows is coming off and needs to be redone.

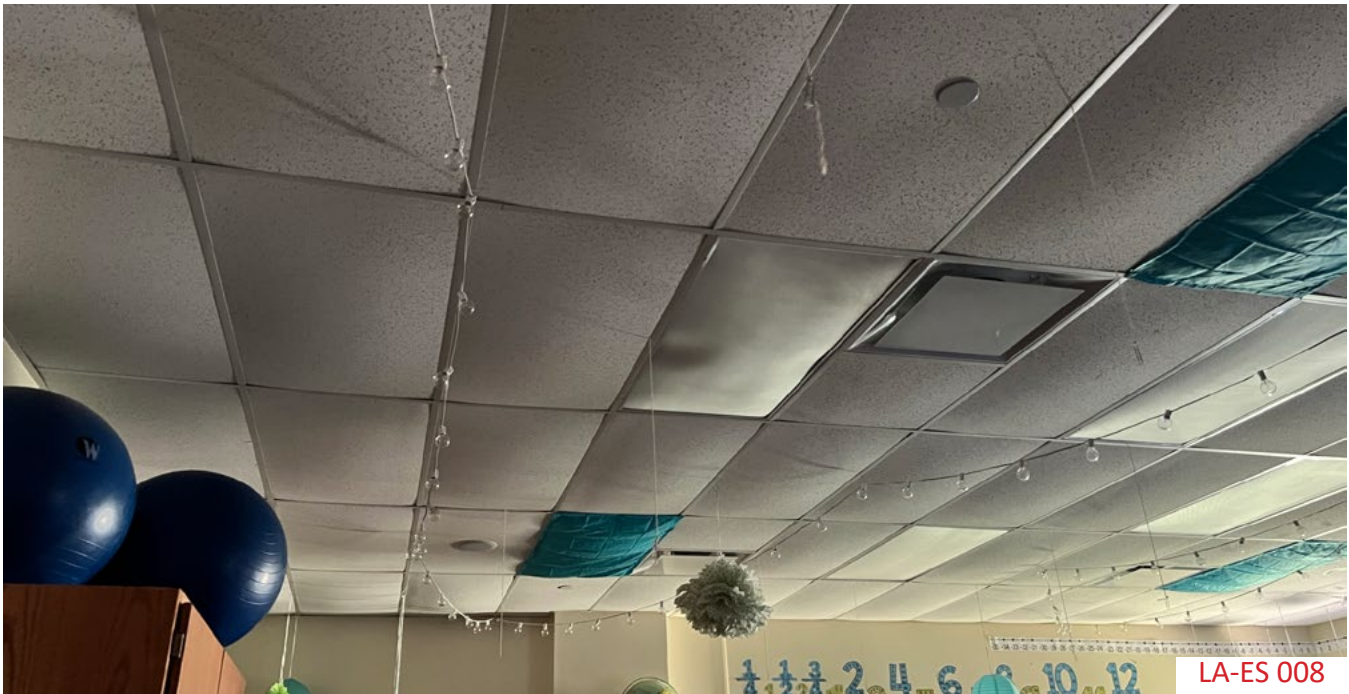
LA-ES 008

The ceilings within the school are mostly compromised of acoustical ceiling tile (ACT). Some classrooms have sagging tile due to humidity (008).

Some classrooms have sagging tile due to humidity.

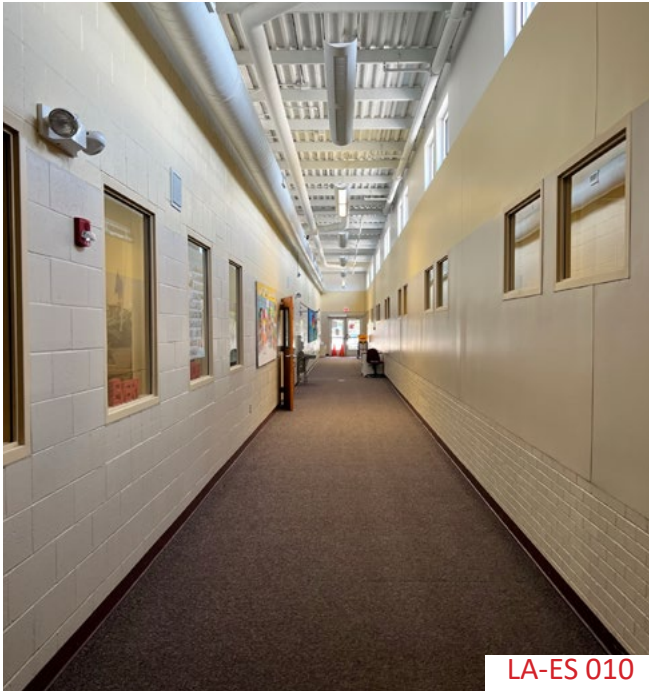
LA-ES 010

Carpet in the building is aging, but still in good condition (010).

Carpet in the building is aging but still in good condition.

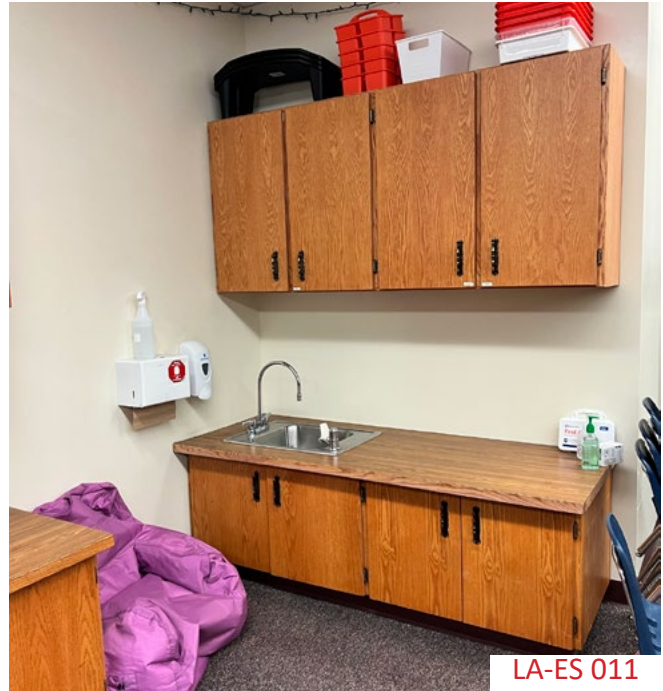
LA-ES 011

Sinks in classrooms are not accessible.

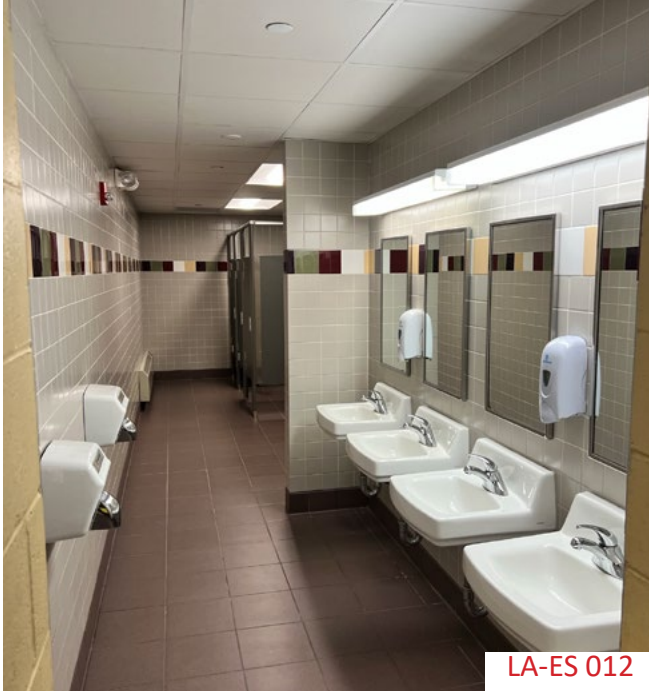
**LA-ES 012**

Sinks in restrooms are not accessible.

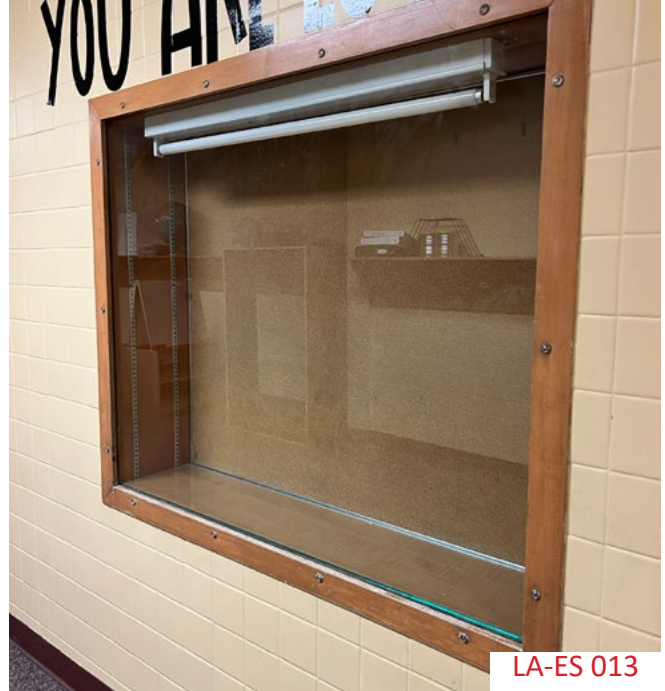
**LA-ES 013**

Display case does not have required safety glass.

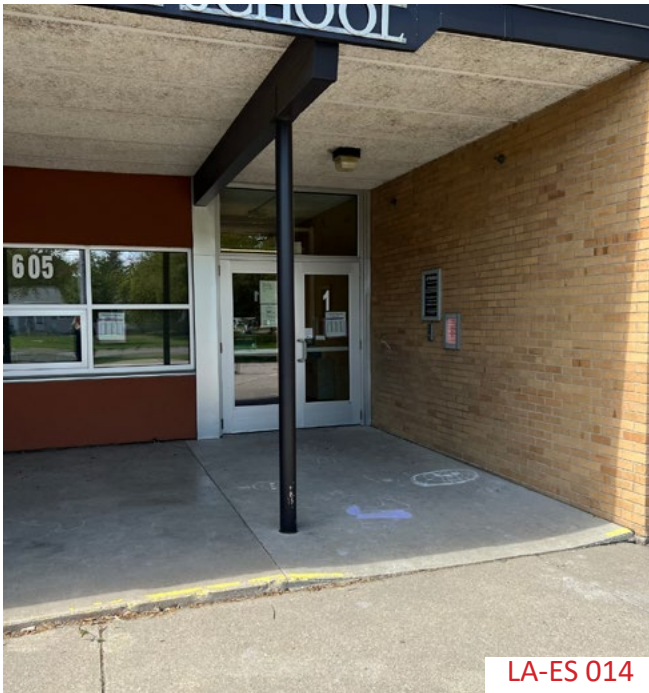
**LA-ES 014**

Doors 1,2, and 10 are not protected with an enclosed vestibule, as required by energy code.

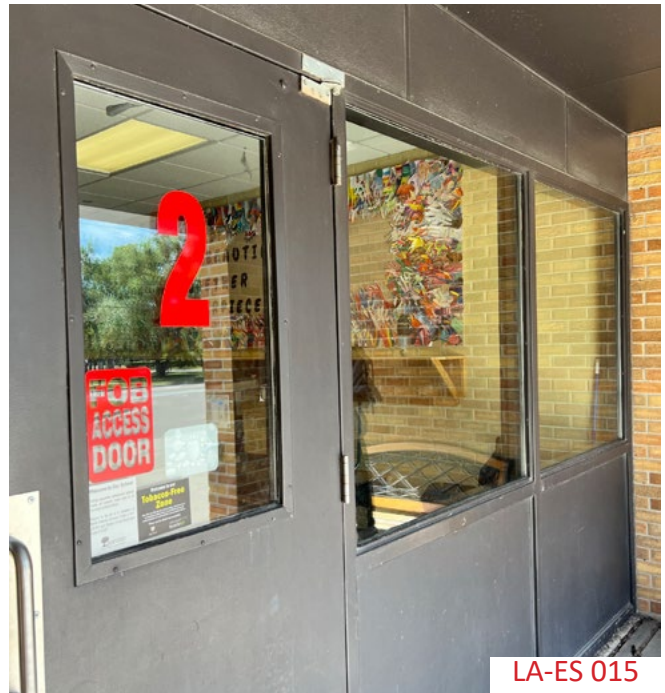
**LA-ES 015**

Doors 1,2, and 10 are not protected with an enclosed vestibule, as required by energy code.

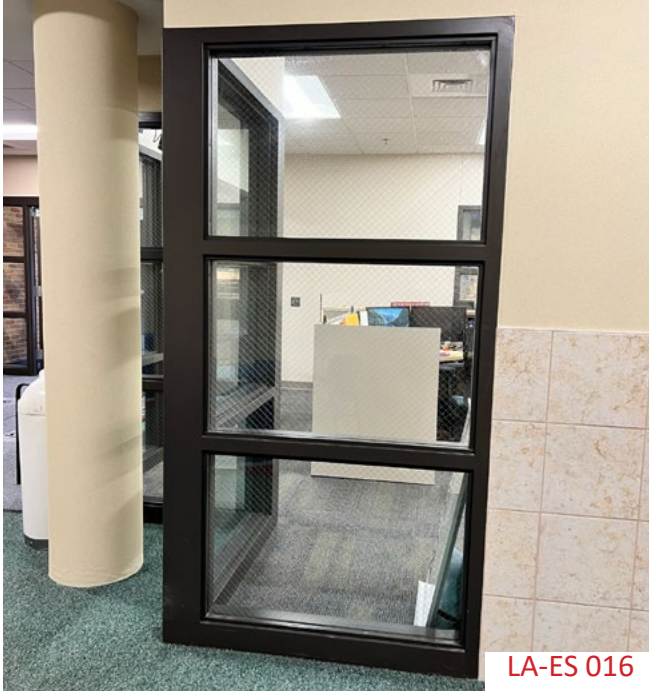
**LA-ES 016**

Traditional wire glass throughout the building is no longer to code as an acceptable type of safety glass.

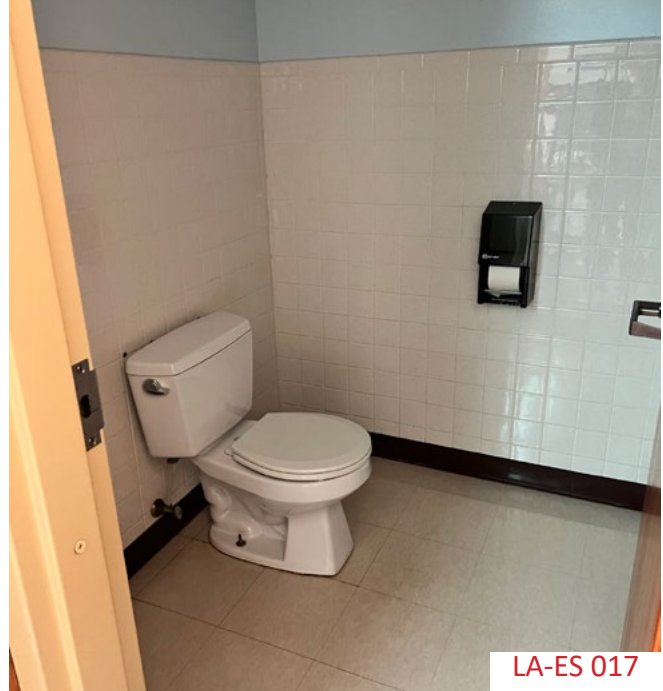
**LA-ES 017**

The restrooms near the first-grade classrooms are not accessible due to the absence of grab bars.

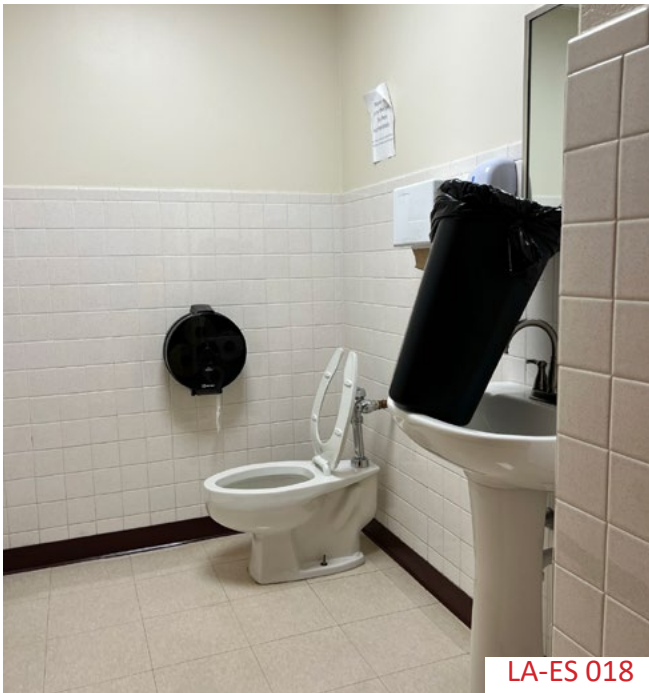
**LA-ES 018**

The restrooms near the first-grade classrooms are not accessible due to the absence of grab bars.
