# *Lewis & Clark* **LEWIS AND CLARK ELEMENTARY SCHOOL**

**FACILITY ASSESSMENT** EXISTING BUILDING INVENTORY ARCHITECTURAL FINISHES  
MECH/ELEC ASSESSMENT EXISTING DEFICIENCIES COST ANALYSIS APPENDIX

## INTERIOR AND EXTERIOR EXISTING DEFICIENCIES PHOTOS

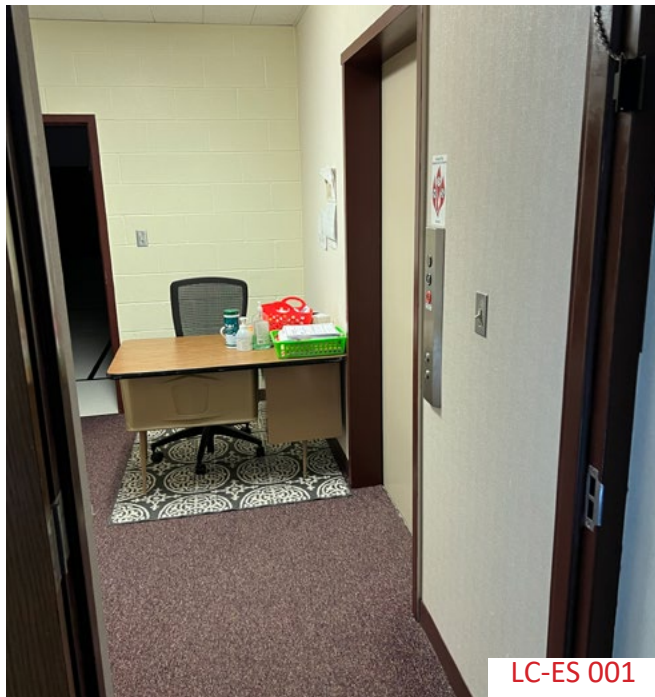
Due to the lack of space staff are working in stair and elevator landings.

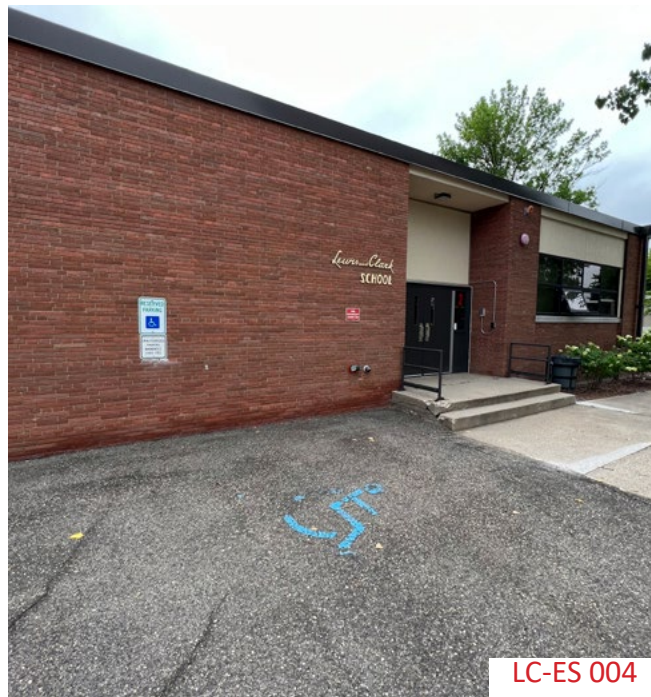
There are some site concerns with parking and accessibility. Accessible parking spots are located next to a non-accessible building entrance (004). Not all entrances are accessible, and several exterior ramps and stairs lack required railings. Water leaks into the lower-level crawl space from the exterior (005). The rim board should be painted and repaired. Boards on the platform outside of Door 7 are sagging and the platform should have a railing (006, 007).

Accessible parking spots are located next to a non-accessible building entrance.

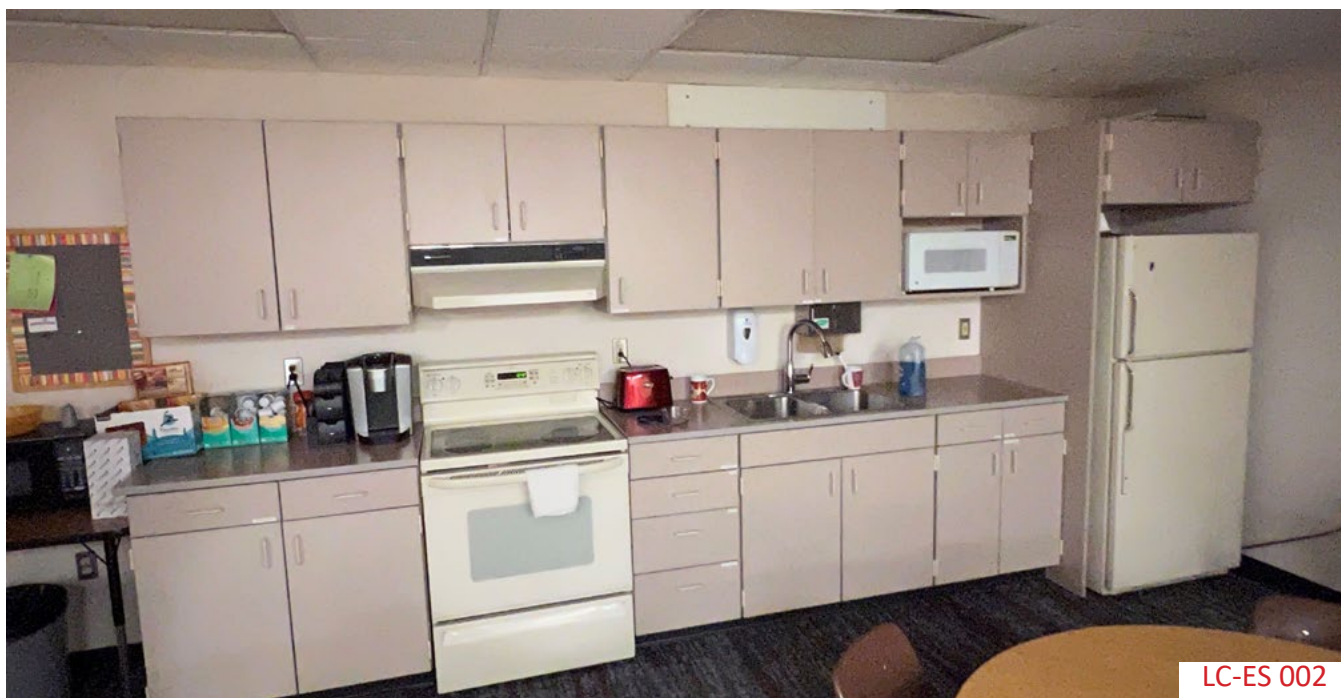
Casework and finishes throughout the school are dated and showing signs of wear.

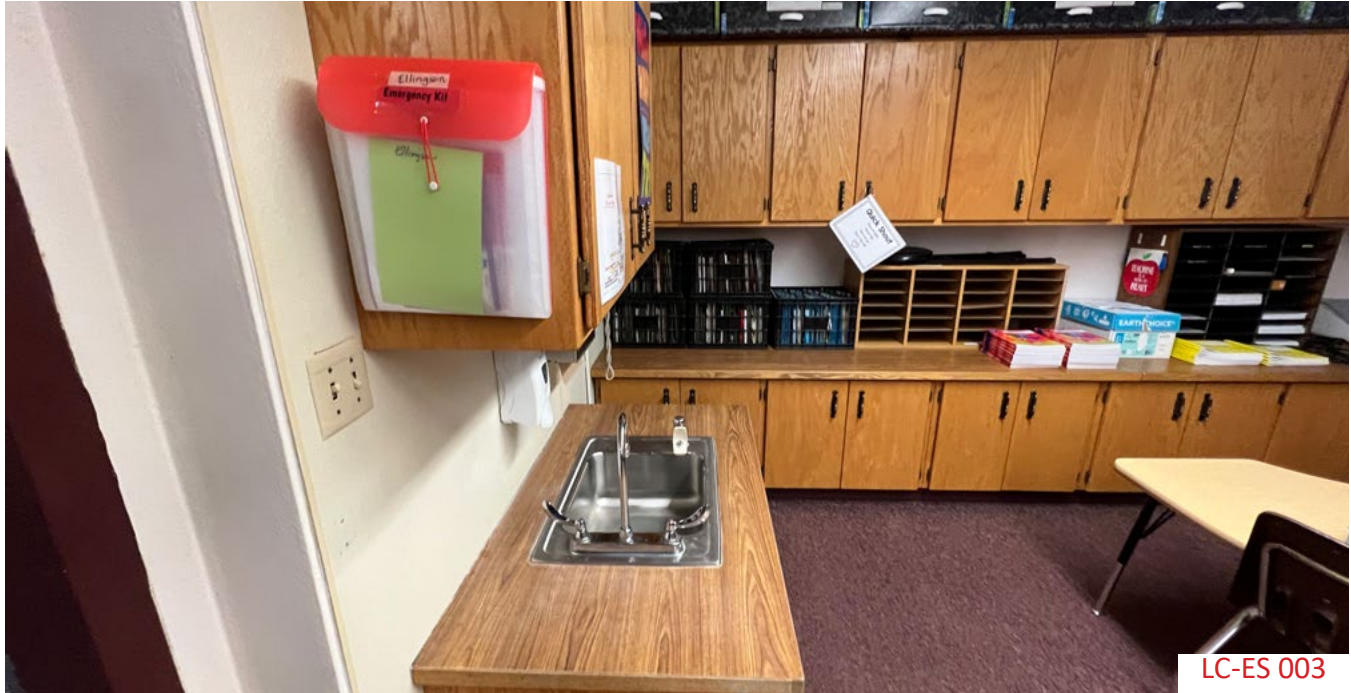
LC-ES 003

Casework and finishes throughout the school are dated and showing signs of wear.

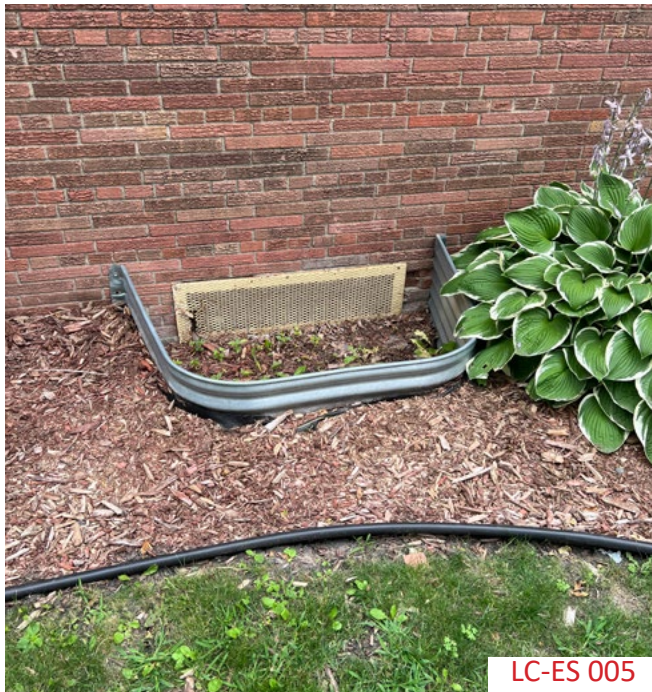
LC-ES 005

Water leaks into the lower-level crawl space from the exterior.

Install a deeper window well and free draining fill that is established below the opening to prevent water leaking into the lower-level crawl space from the exterior	46	1 Ea.	\$34,145.74 / Ea.	\$34,146					\$34,146
Paint and repair the damaged rim board	47	1 Ea.	\$7,435.25 / Ea.	\$7,435					\$7,435
Rebuild deck on the platform outside of door 7 that are sagging and add a railing	48	1 Ea.	\$24,361.84 / Ea.		\$24,362				\$24,362
Masonry tuckpointing at exterior of the building where the brick is wearing and where there are signs of moisture at the bottom	49	10,000 SF	\$18.82 / SF		\$188,222				\$188,222
Repair damage to the bottom edge of the EIFS around the perimeter	50	1 Ea.	\$3,462.24 / Ea.	\$3,462					\$3,462
Repair caulking that is worn and deteriorating	51	1 Ea.	\$8,435.65 / Ea.	\$8,436					\$8,436
Investigate and fix the roof leak in the front office.	52	1 Ea.	\$53,495.65 / Ea.	\$53,496					\$53,496

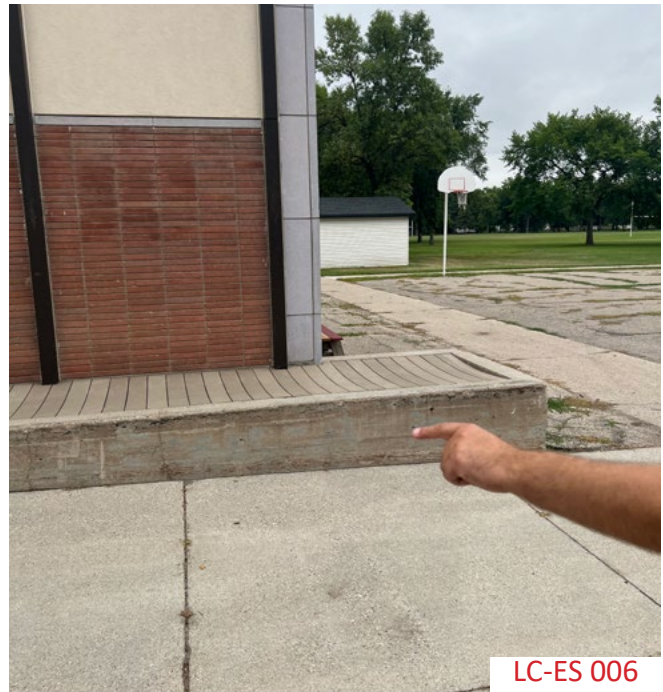
LC-ES 006

Boards on the platform outside of door 7 are sagging and the platform should have a railing.

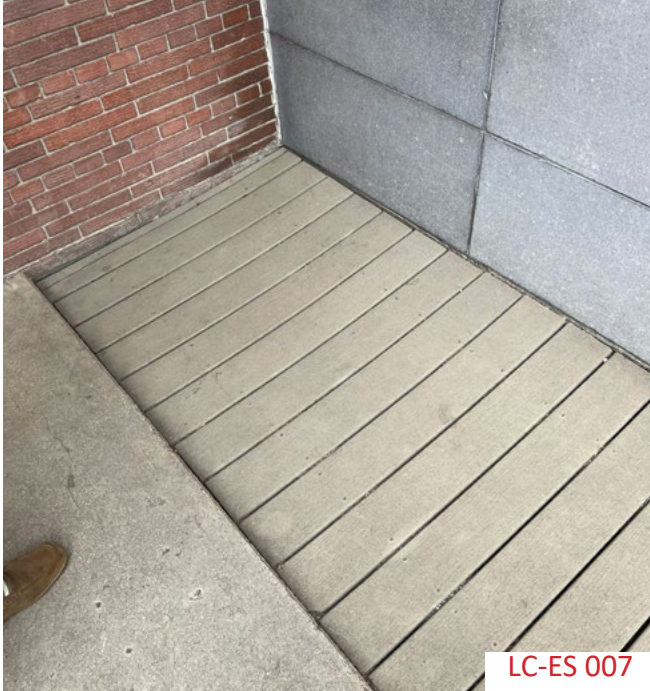
LC-ES 007

Boards on the platform outside of door 7 are sagging and the platform should have a railing.

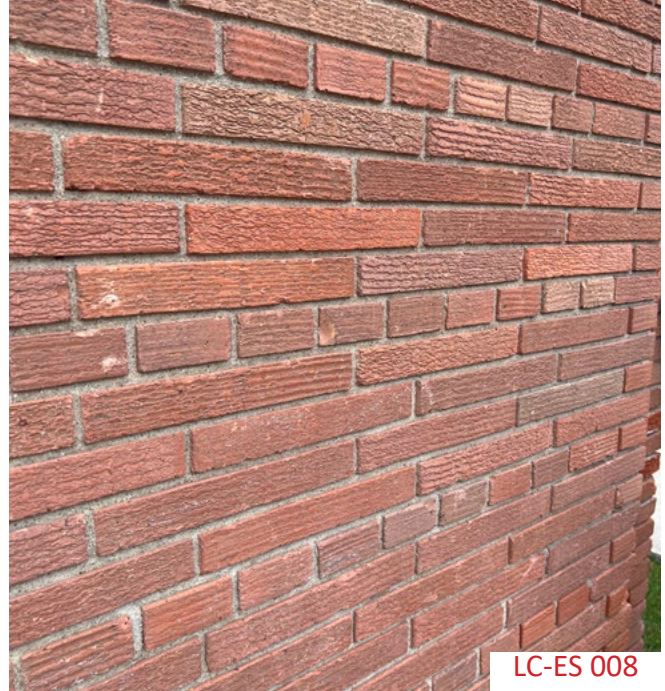
LC-ES 008

Tuckpointing is wearing.

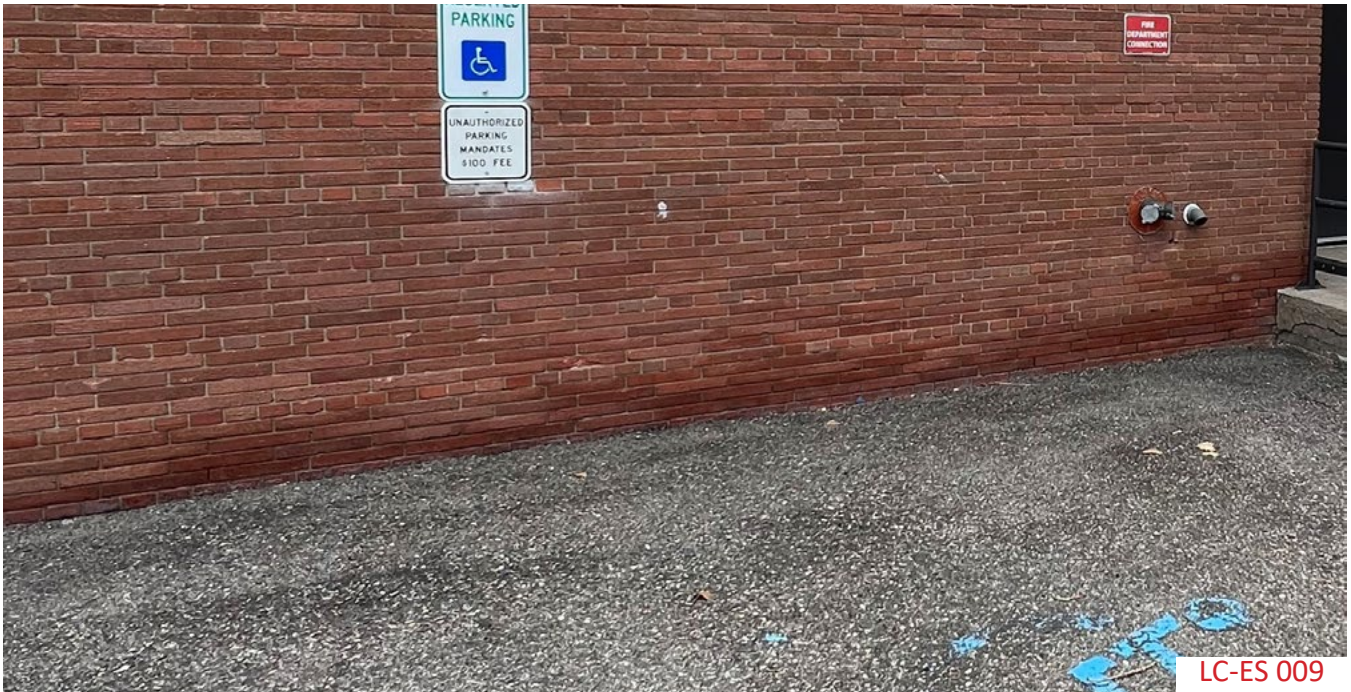
LC-ES 009

The exterior brick is in decent condition. Tuckpointing is wearing (008) and there are signs of moisture at the bottom of exterior brick walls (009).

Tuckpointing is wearing and there are signs of moisture at the bottom of exterior brick walls

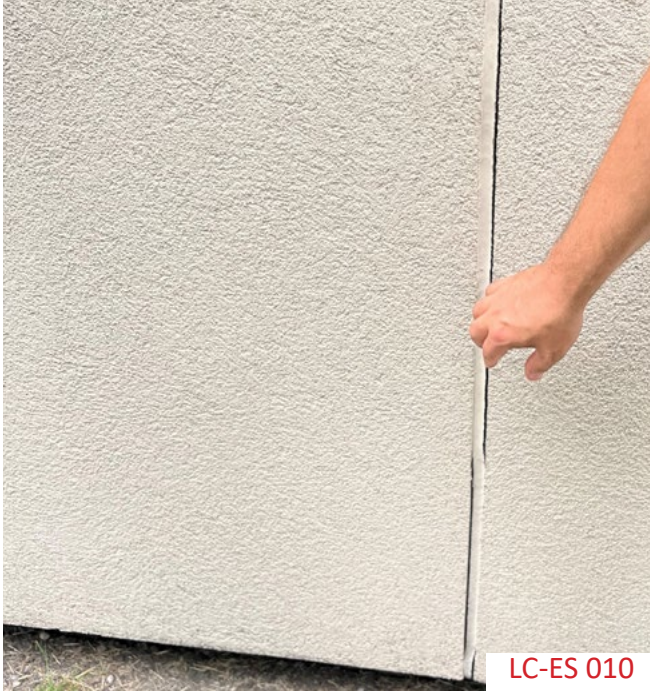
LC-ES 010

Caulking should be redone as it is worn and deteriorating.

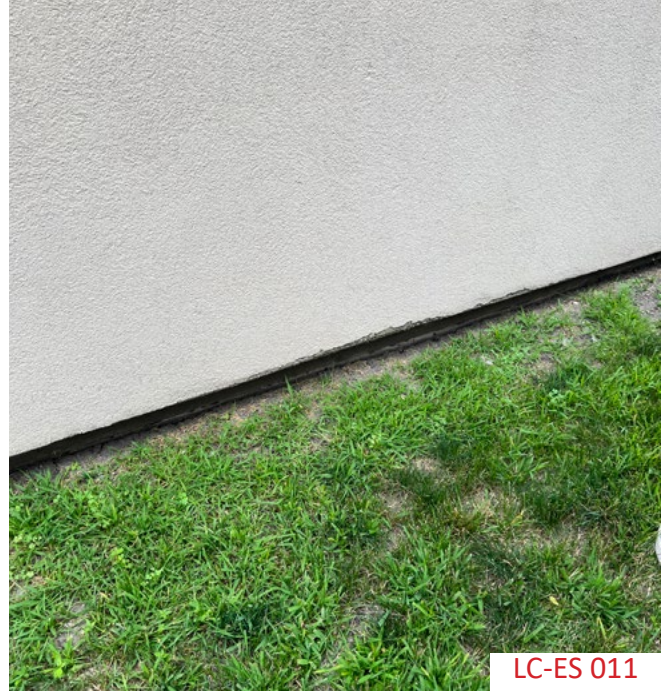
LC-ES 011

There is damage to the bottom edge of the EIFS around the perimeter.

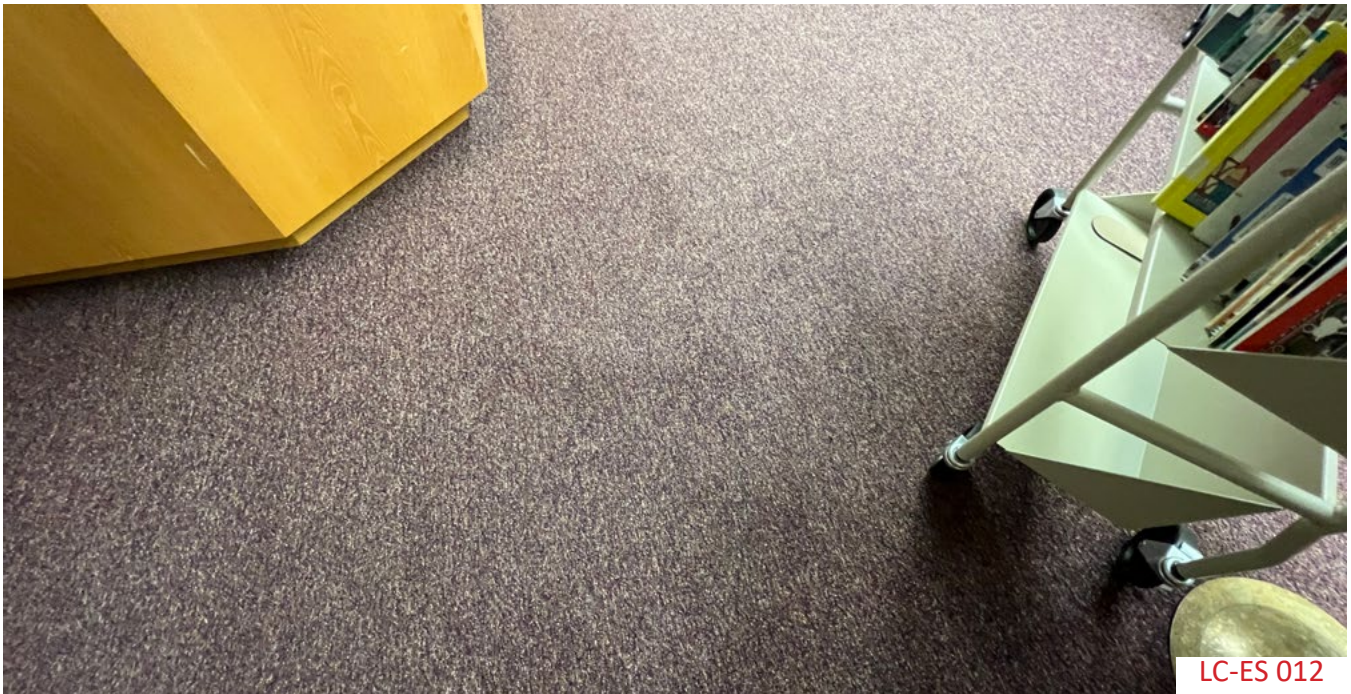
LC-ES 012

Carpet has been replaced in some spaces but overall, the flooring throughout the school is dated and showing signs of wear.

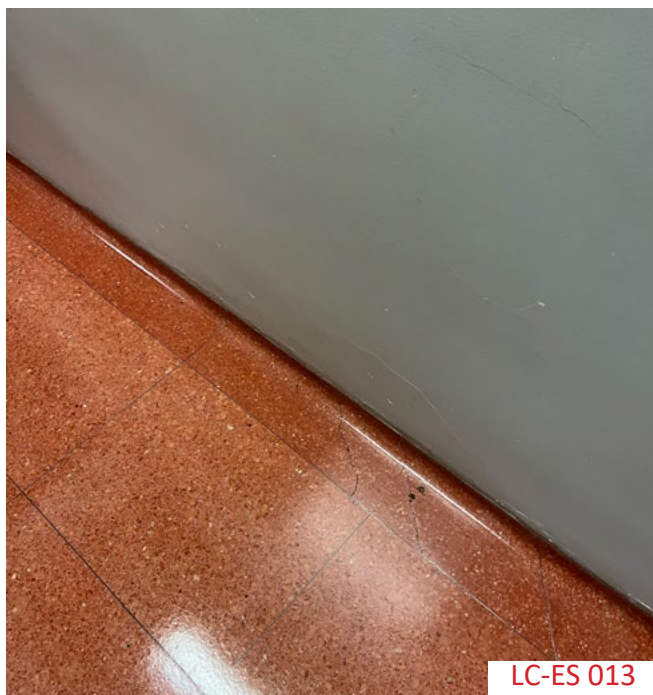
Carpet has been replaced in some spaces but overall, the flooring throughout the school is dated and showing signs of wear.

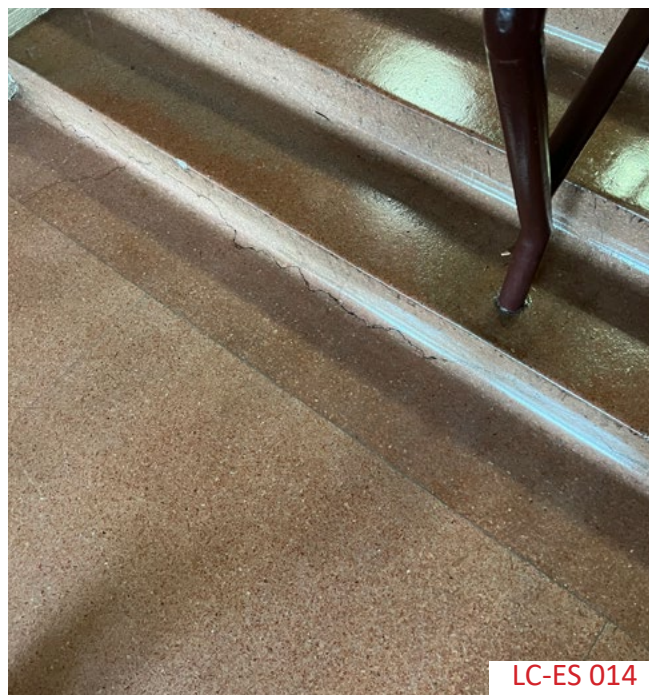
The flooring is cracked by door 1 and there are cracks in the flooring of several staircases.

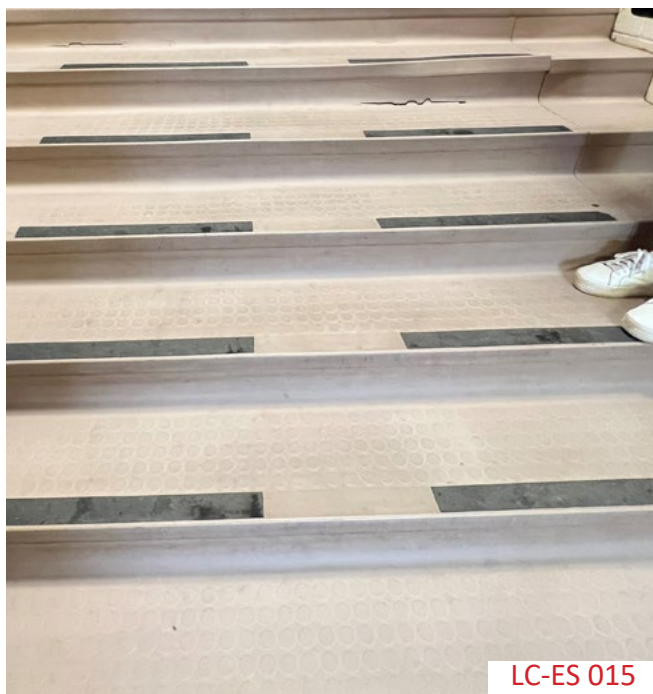
The flooring is cracked by door 1 and there are cracks in the flooring of several staircases.

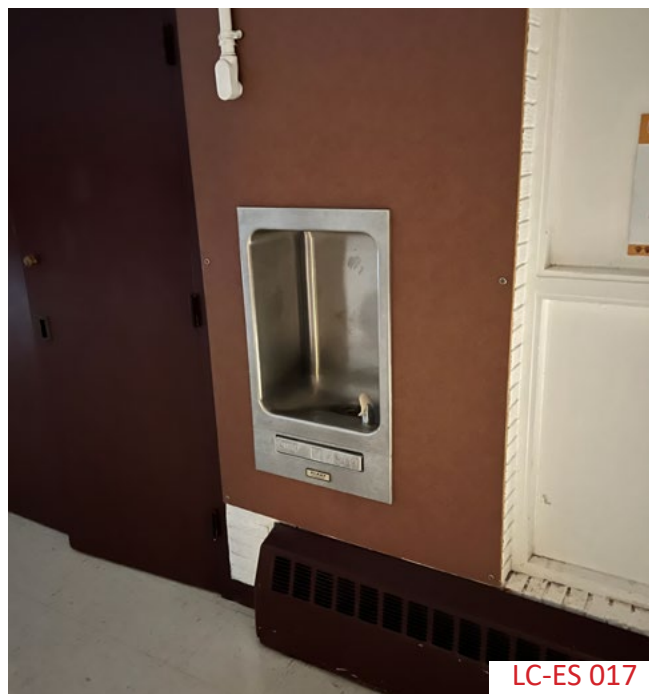
Drinking fountains throughout the building do not meet the required ratio of wheelchair accessible fountains to standing person accessible fountains

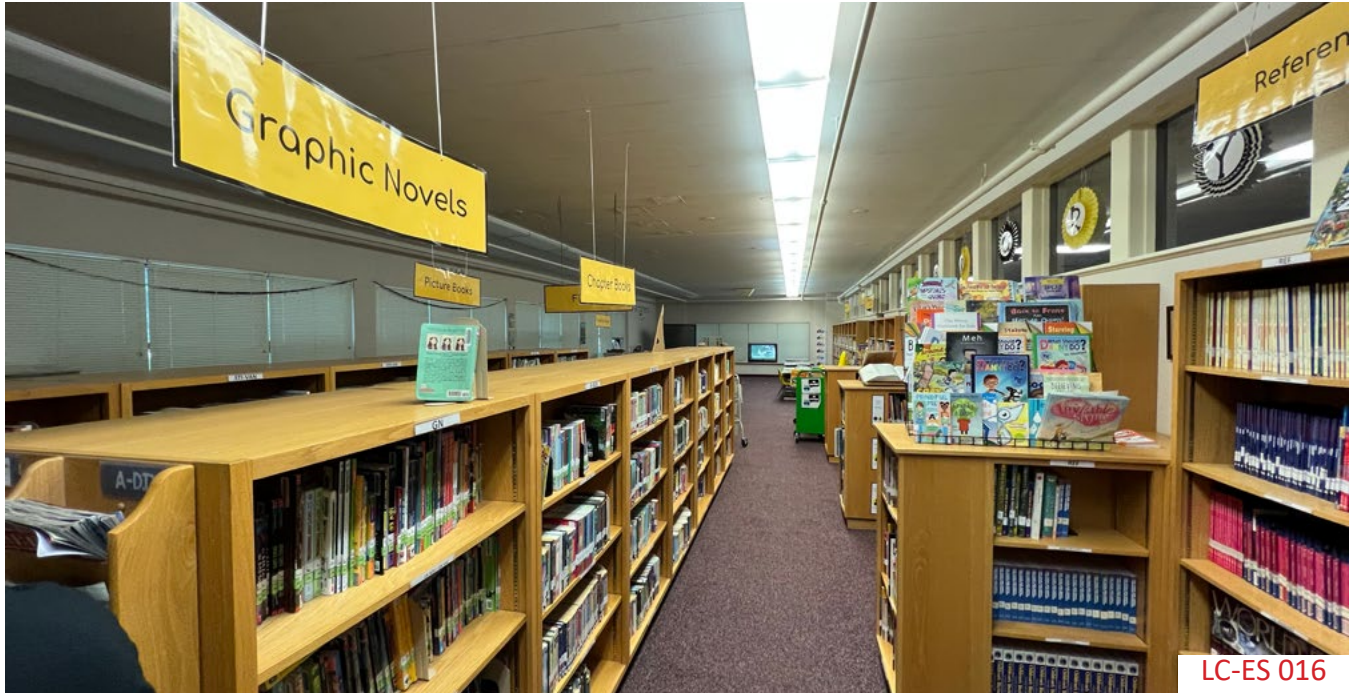
There is concern with the floor structure in the library due to the load the books place upon it.

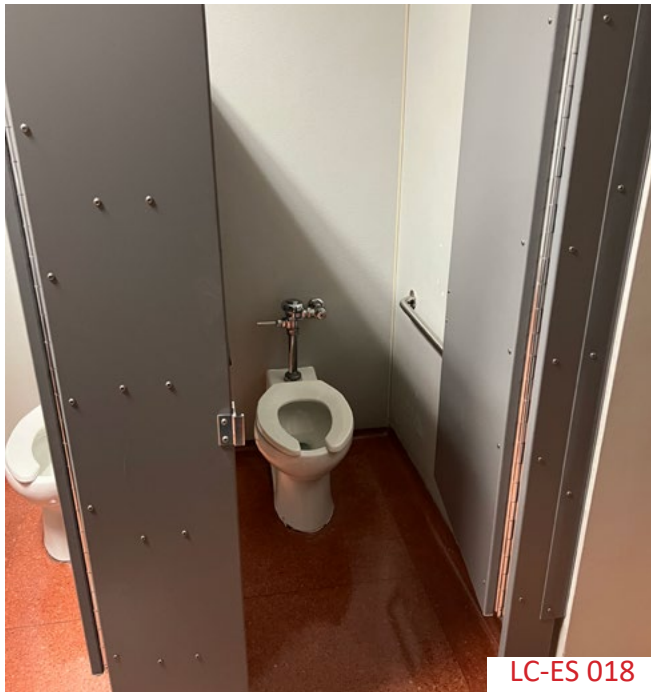
Public restrooms are not accessible

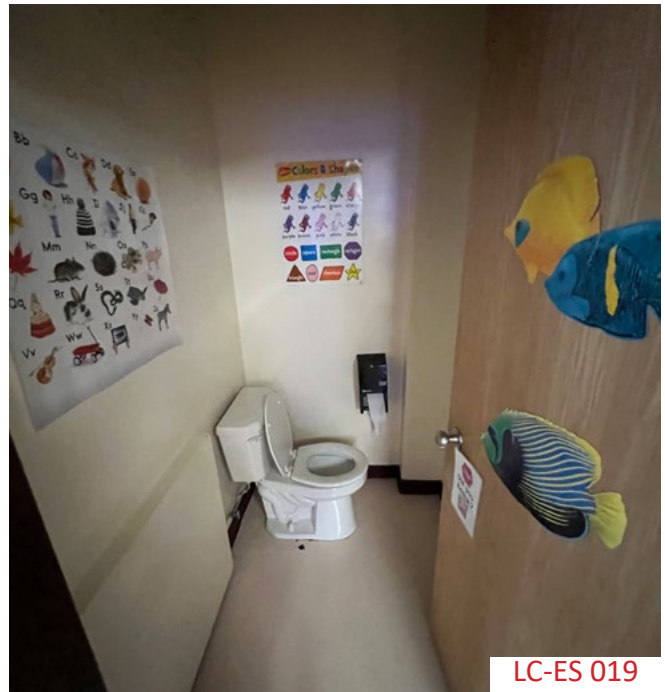
Restrooms in classrooms are not accessible

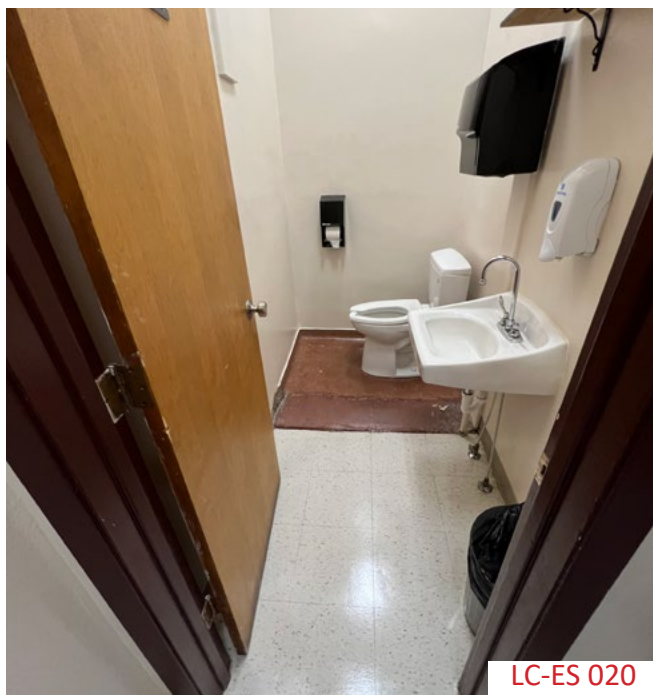
LC-ES 020

Faculty restrooms are not accessible

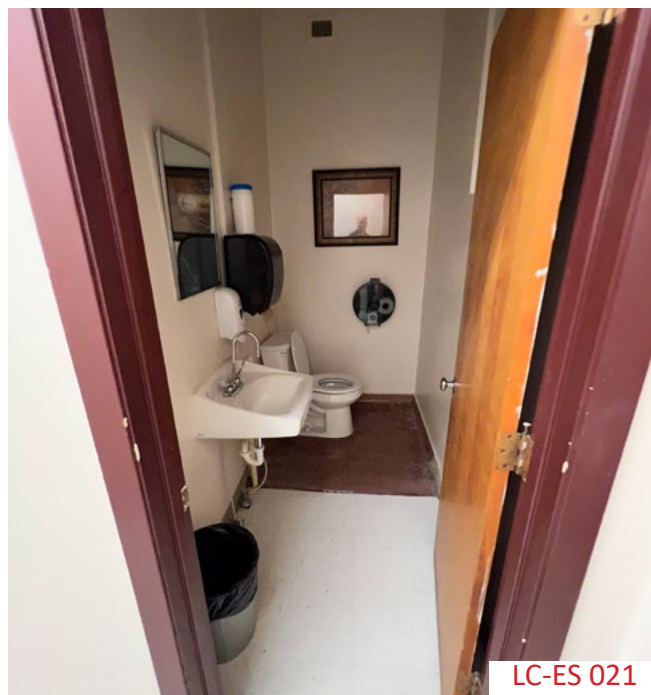
LC-ES 021

Faculty restrooms are not accessible

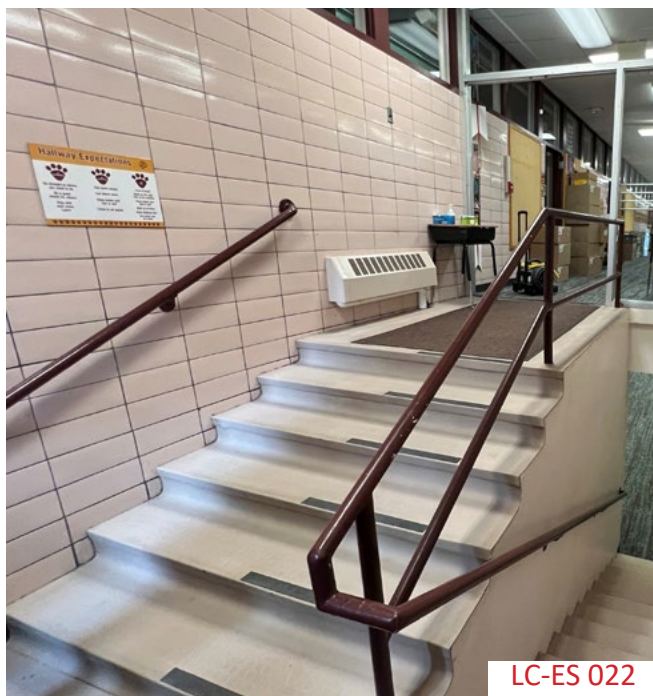
LC-ES 022

Railing on the stairs by Door 2 is lacking an accompanying guard rail and does not meet the required code

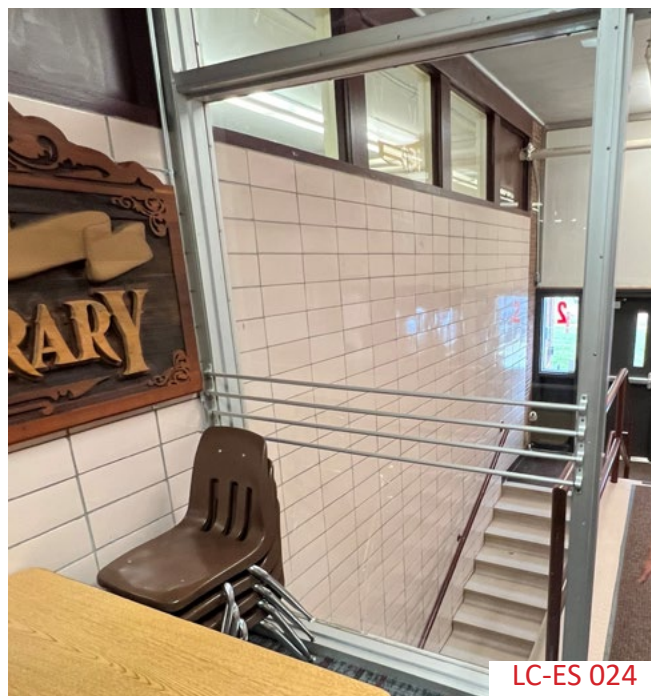
LC-ES 024

Many doors and windows throughout the school do not have fire glass, as required by code

Replace glass in window in the gym with tempered glass (frame to remain)	8	16 SF	\$74.33 / SF	\$1,189					\$1,189
Replace glass throughout with fire glass as required by code in the many doors and windows throughout the school	9	600 SF	\$74.33 / SF	\$44,598					\$44,598
Add railings to ramp outside of door 1	10	80 LF	\$414.64 / LF	\$33,171					\$33,171
Add railings on both sides to ramp outside that extends the full length of the ramp	11	100 LF	\$414.64 / LF	\$41,464					\$41,464
Upgrade door hardware with ADA hardware	12	50 Ea.	\$983.61 / Ea.	\$49,180					\$49,180
Replace casework (20lf of base, top, and upper) per classroom and sinks in classrooms are not accessible	13	10 Ea.	\$26,939.88 / Ea.	\$269,399				X	\$269,399
Change swing on doors where the door approaches fail to meet required push/pull clearances	14	10 Ea.	\$3,561.29 / Ea.	\$35,613					\$35,613
Remove and install new stairs since the doors are too close to the stair nosing	15	1 Ea.	\$148,642.96 / Ea.	\$148,643					\$148,643

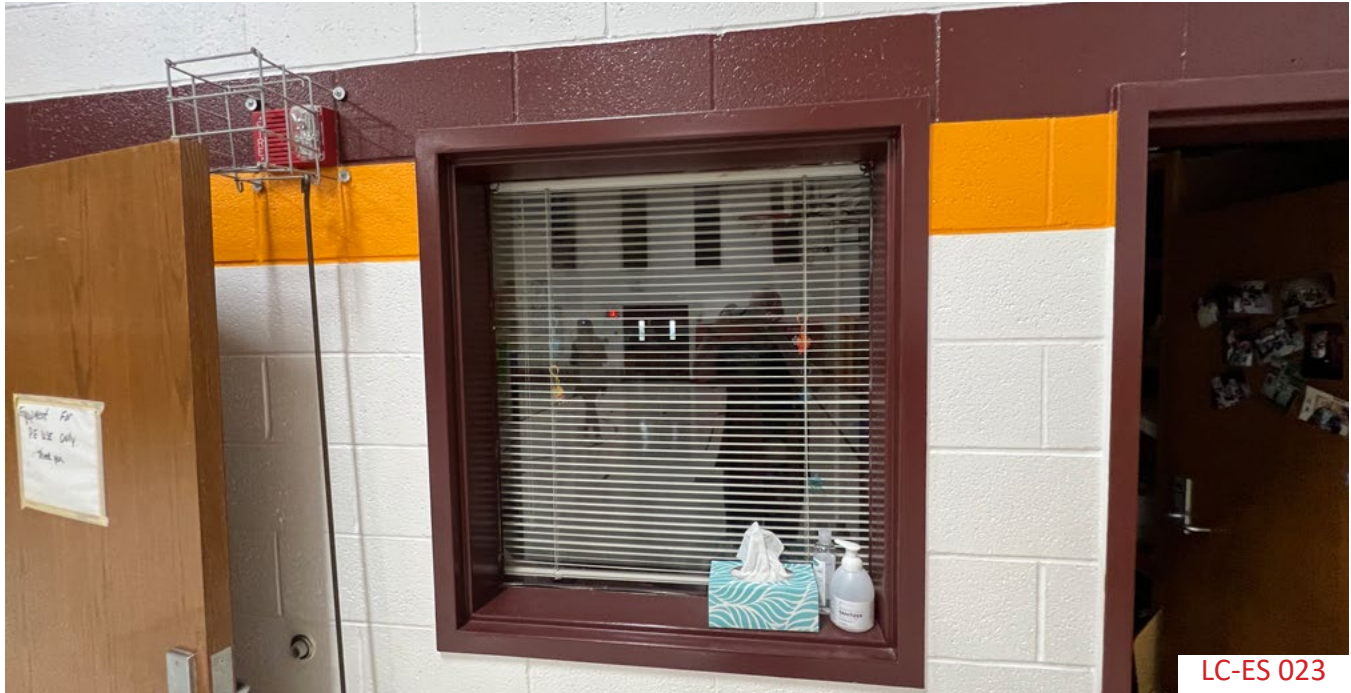
LC-ES 023

Window in the gym does not have the required safety glass

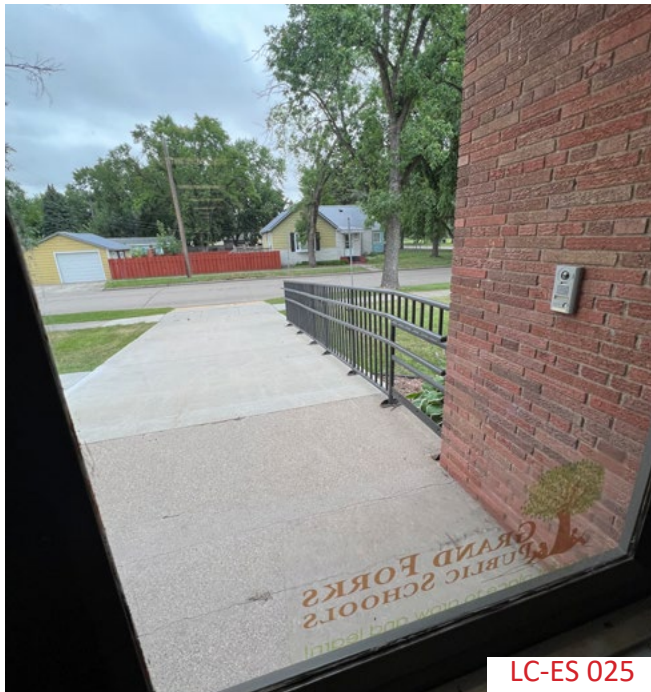
LC-ES 025

Many doors and windows throughout the school do not have fire glass, as required by code

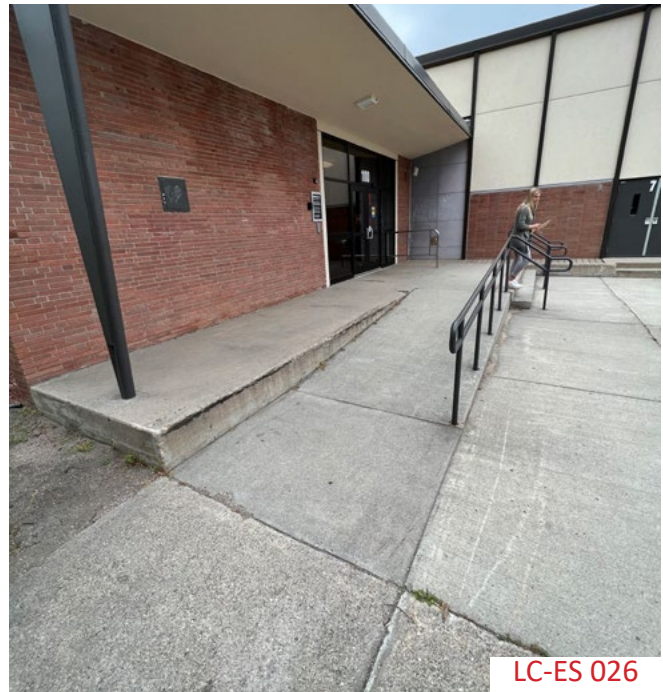
LC-ES 026

Ramp outside of Door 1 is missing a railing as required by code

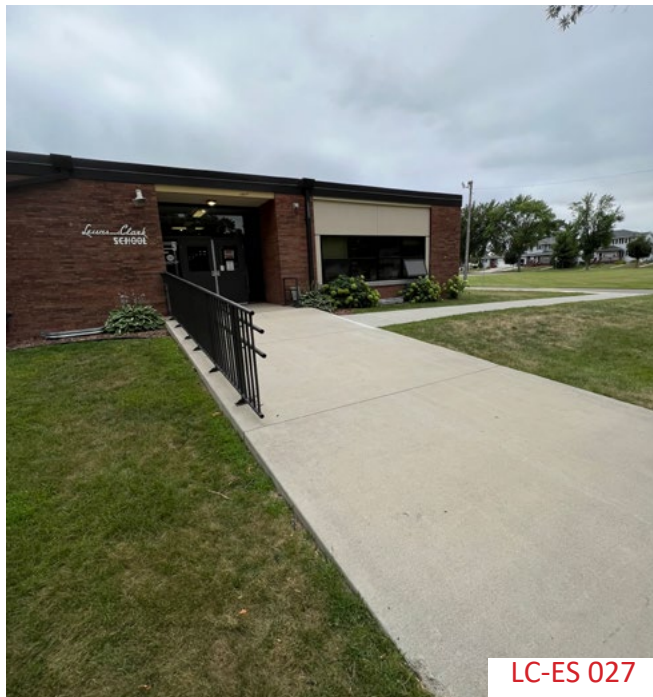
LC-ES 027

Ramp outside of Door 5 does not have a railing on both sides as required by code. The railings should extend the full length of the ramp

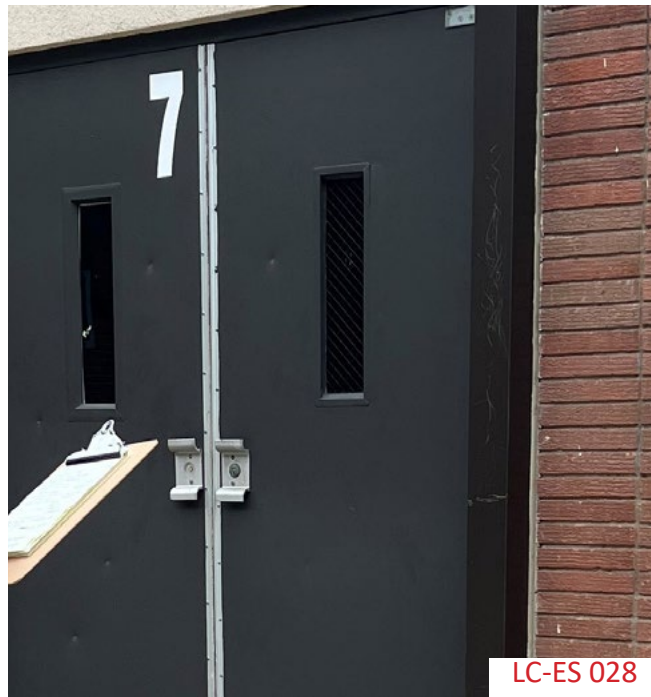
LC-ES 028

Various doors throughout the building have door hardware that is not accessible

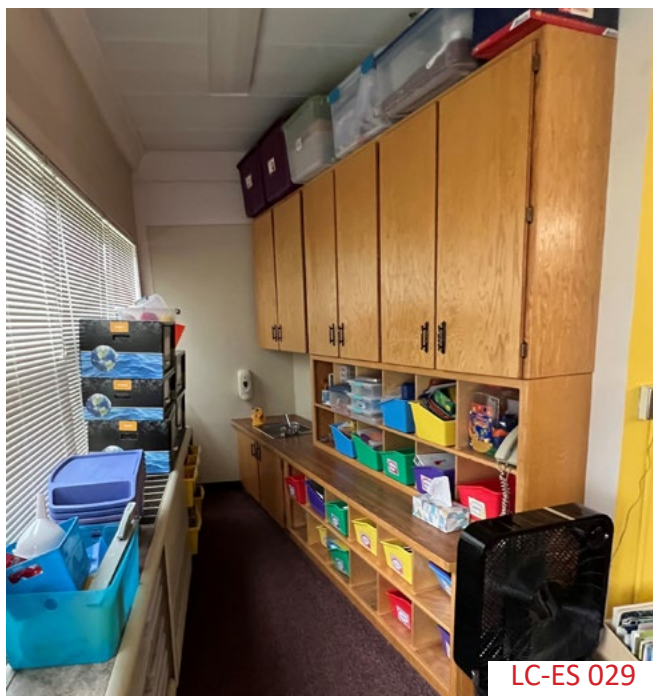
LC-ES 029

Sinks in classrooms are not accessible

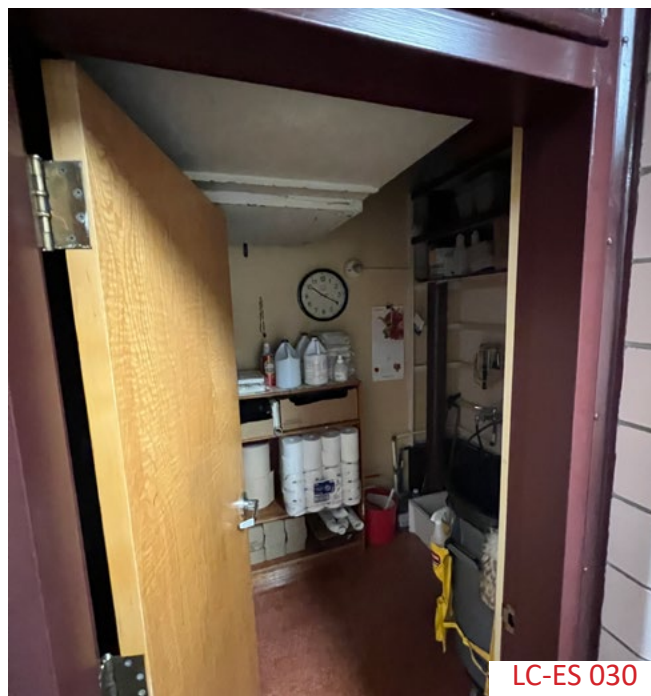
LC-ES 030

Stair landing is not large enough, causing doors to project farther into the landing than code permits

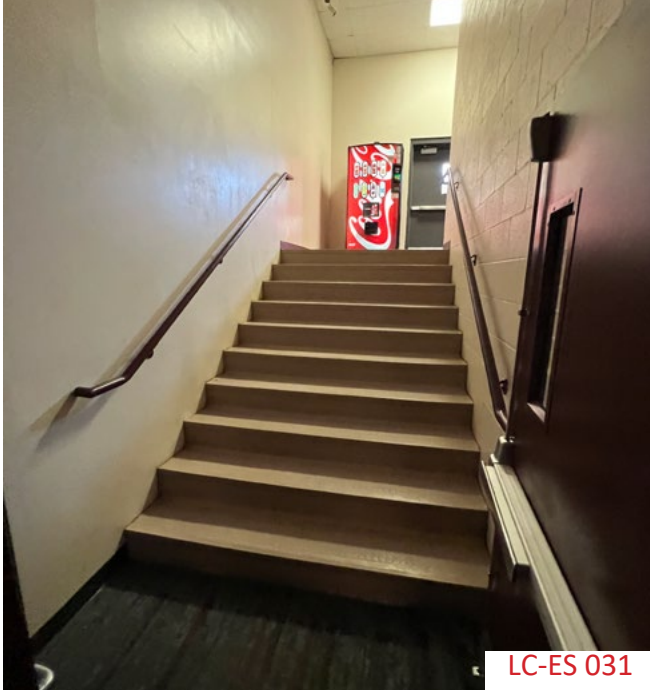
LC-ES 031

Stair landing is not large enough, causing doors to project farther into the landing than code permits.

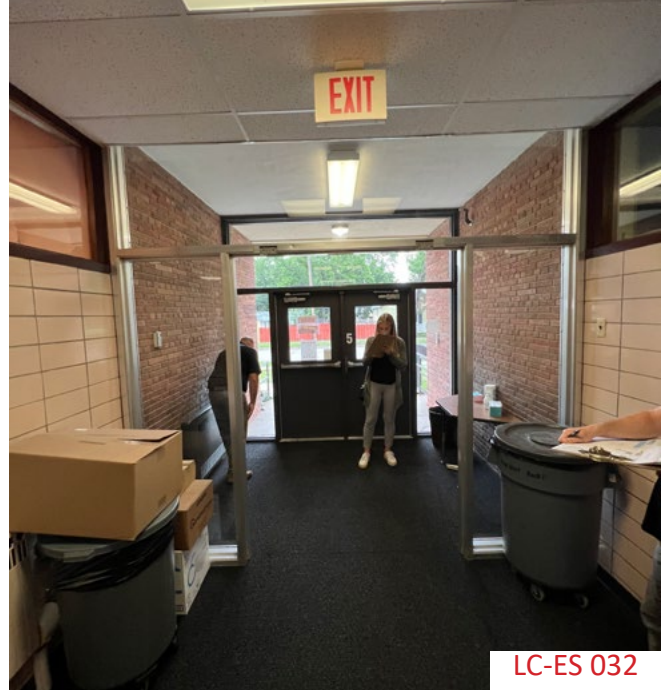
LC-ES 032

Door 5 should have a vestibule, per energy code requirements.
