PHOENIX ELEMENTARY SCHOOL
351 4th Avenue South

A. EXISTING BUILDING INVENTORY

B. ARCHITECTURAL FINISHES

D. EXISTING DEFICIENCIES

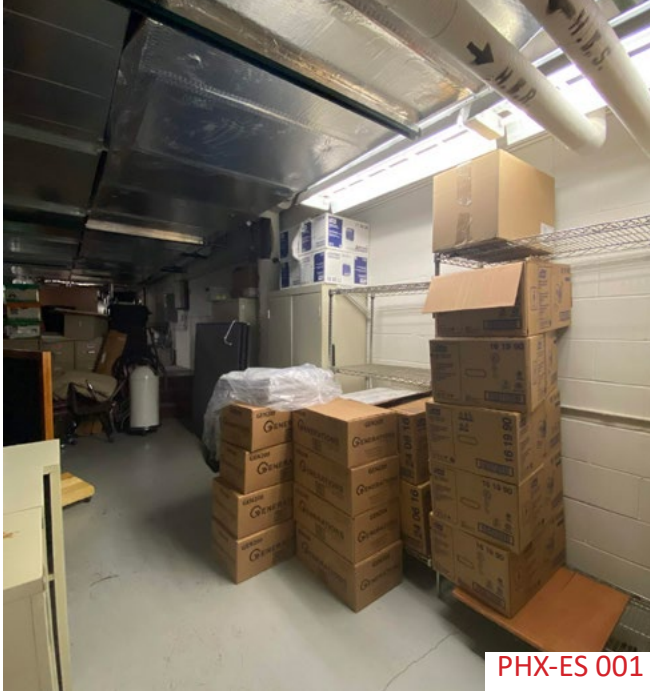
PHX-ES 001

Phoenix Elementary School opened in 1998. The school lacks adequate storage space as many of the restrooms, electrical closets, and mechanical rooms double as storage (001). Many individual learning spaces have had to move to spaces that are not optimal for learning. For example, there is a one-on-one learning space inside of an electrical closet (002) and a specialized learning space within the mechanical and janitorial area of the building (003). Overall, the building is in good condition minus a few areas of typical wear and tear.

The school, in general, lacks storage space as many of the restrooms, electrical closets, and mechanical rooms double as storage.

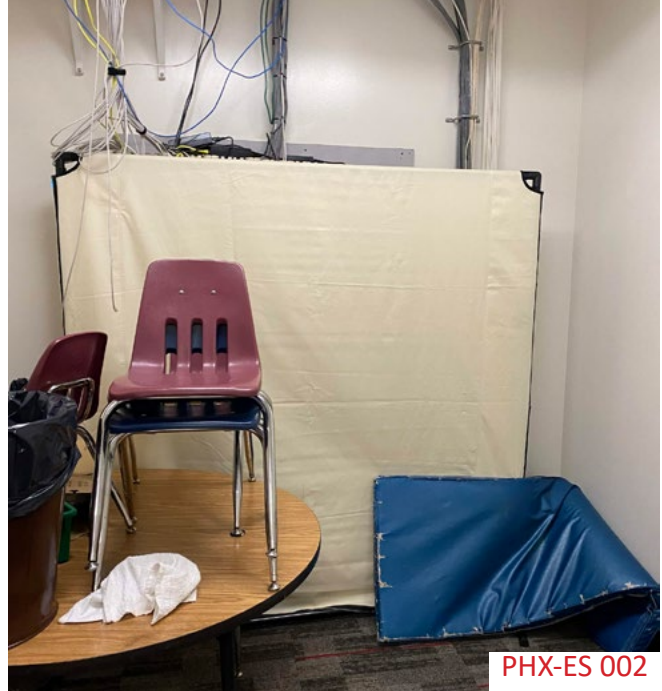
PHX-ES 002

Many individual learning spaces have had to move to spaces that are not optimal for learning. For example, there is a one-on-one learning space inside of an electrical closet.

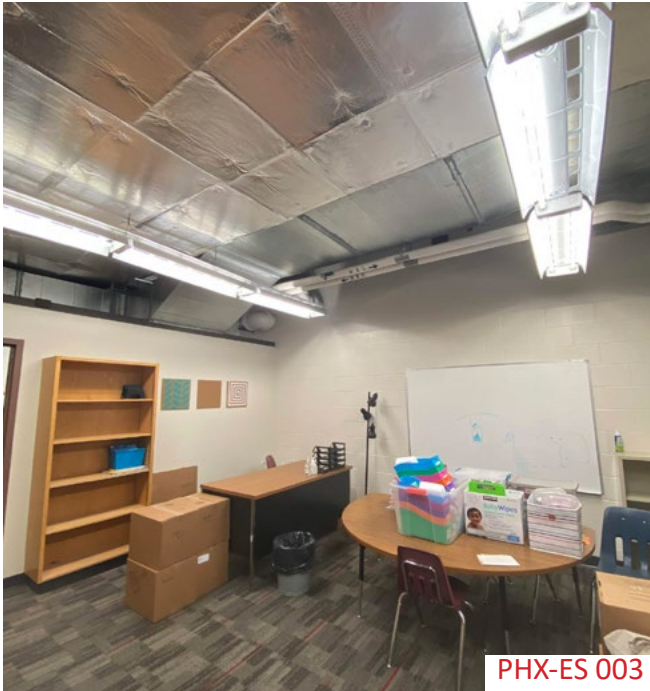
PHX-ES 003

Many individual learning spaces have had to move to spaces that are not optimal for learning. For example, there is a specialized learning space within the mechanical and janitorial area of the building.

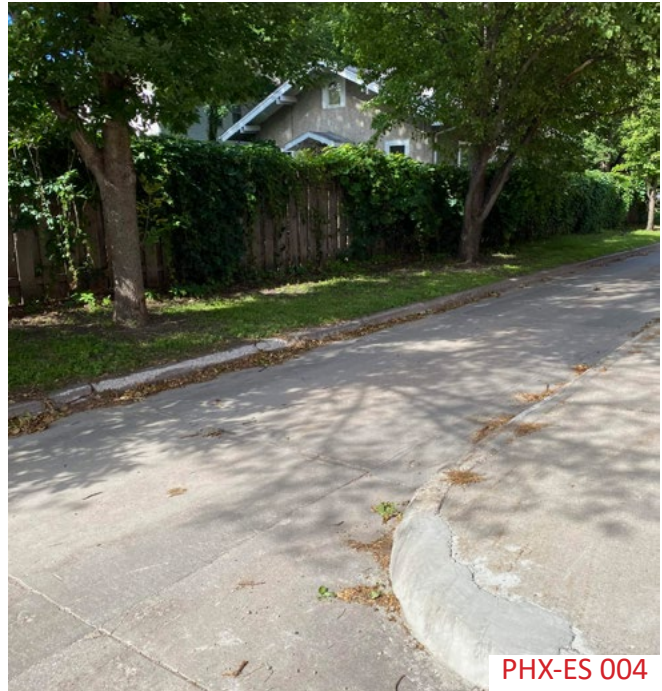
PHX-ES 004

This causes drivers to circumvent the one-way and cross over a crosswalk to connect to 5th Avenue South, creating concern for the safety of the children who utilize the crosswalk.

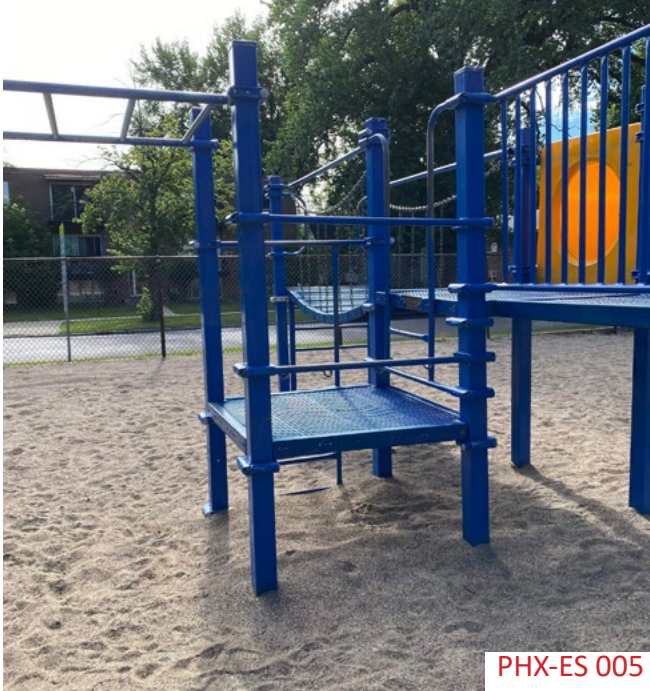
PHX-ES 005

The playground directly outside the building is outdated, broken, and inaccessible and should be replaced.

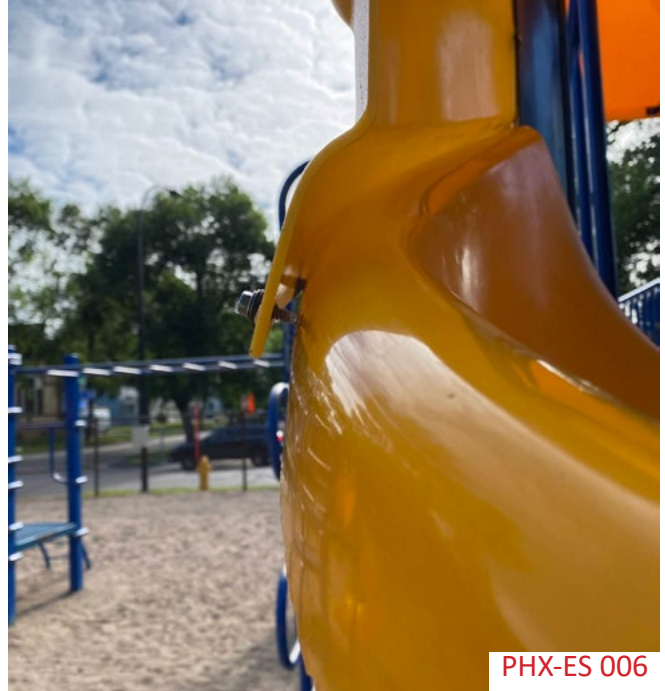
PHX-ES 006

The playground directly outside the building is outdated, broken, and inaccessible and should be replaced.

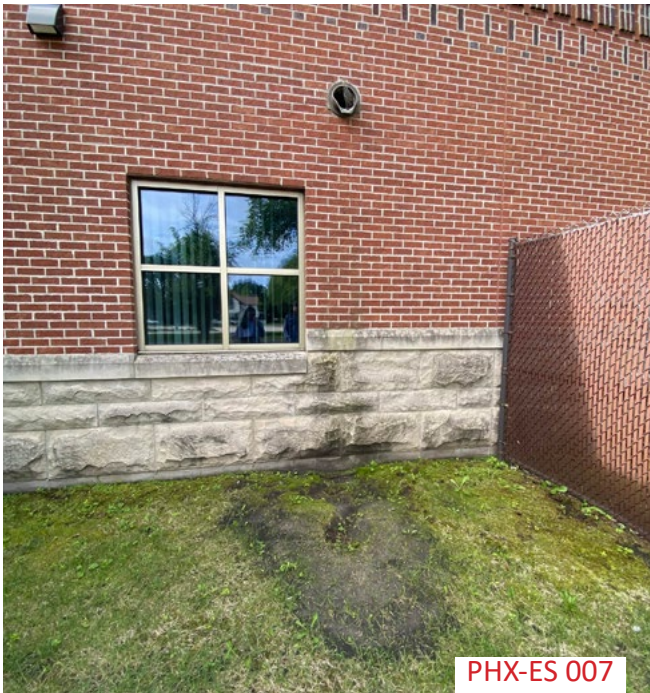
PHX-ES 007

A roof drain/overflow scupper on the north side of the building needs a concrete splash block beneath it and for the drain mesh to be repaired.

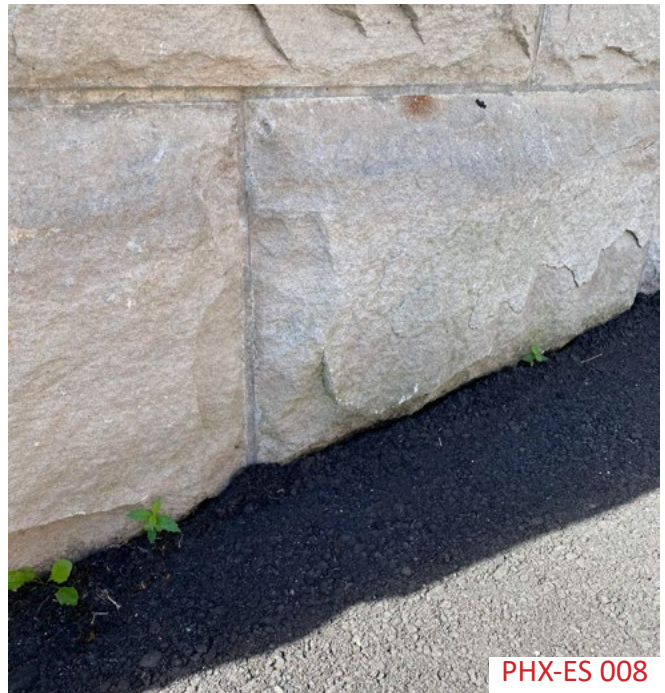
PHX-ES 008

Outside of the library where new asphalt was laid for drainage, the weepholes in the brick are potentially covered which can prevent moisture from leaving the brick.

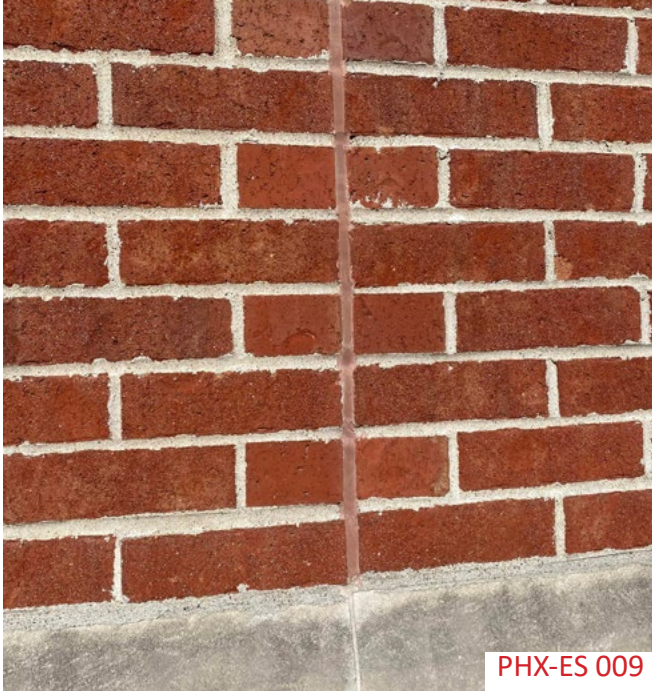
PHX-ES 009

The expansions within the brick have been well maintained, as the caulk was redone less than three years ago.

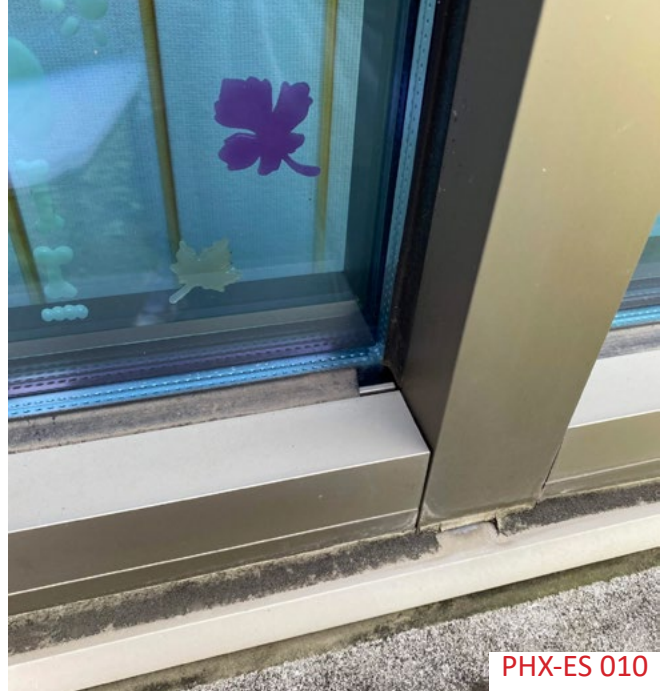
PHX-ES 010

The door openings within the school are in good condition. The caulking where the windows meet the walls is in good condition, but the sealant/gasketing within the windows is in poor shape and needs to be redone. Due to the age of the windows, the sealant/gasket has shrunk and no longer runs the entire width of the glass panels (010, 011).

Due to the age of the windows, the sealant/gasket has shrunk and no longer runs the entire width of the glass panels.

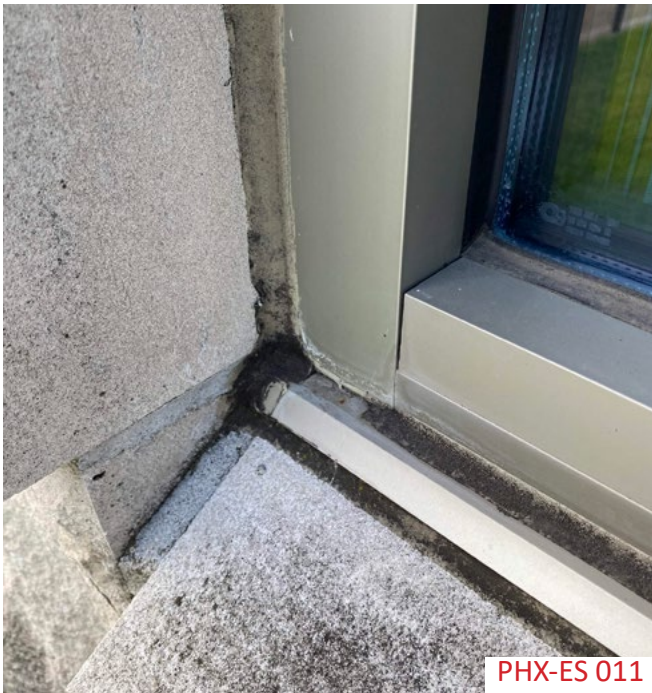
PHX-ES 011

Due to the age of the windows, the sealant/gasket has shrunk and no longer runs the entire width of the glass panels.

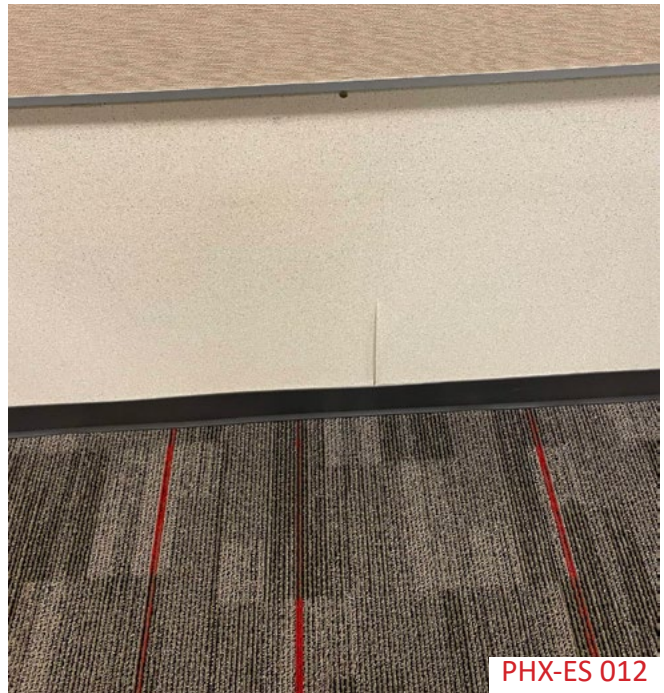
PHX-ES 012

There are several areas where the vinyl wall covering is releasing from the gypsum wall board substrate

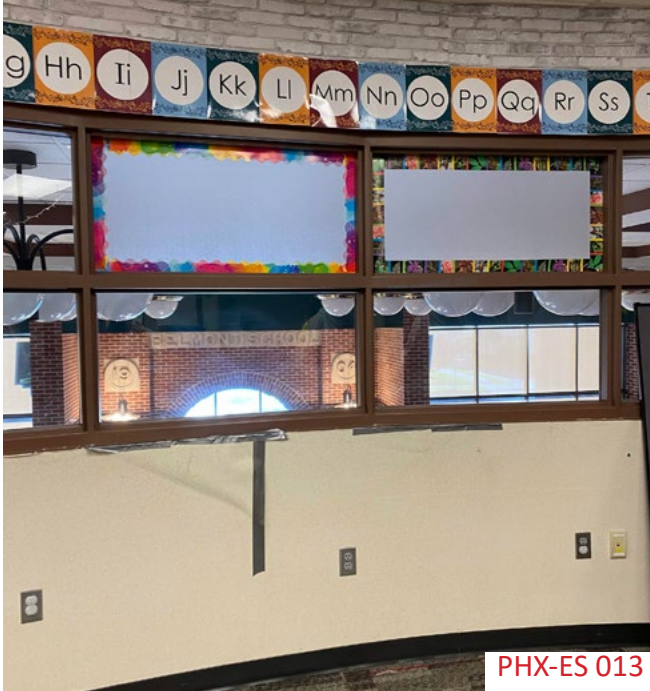
PHX-ES 013

Other areas have signs of wear and tear and could use wall and corner guards to protect from future damage

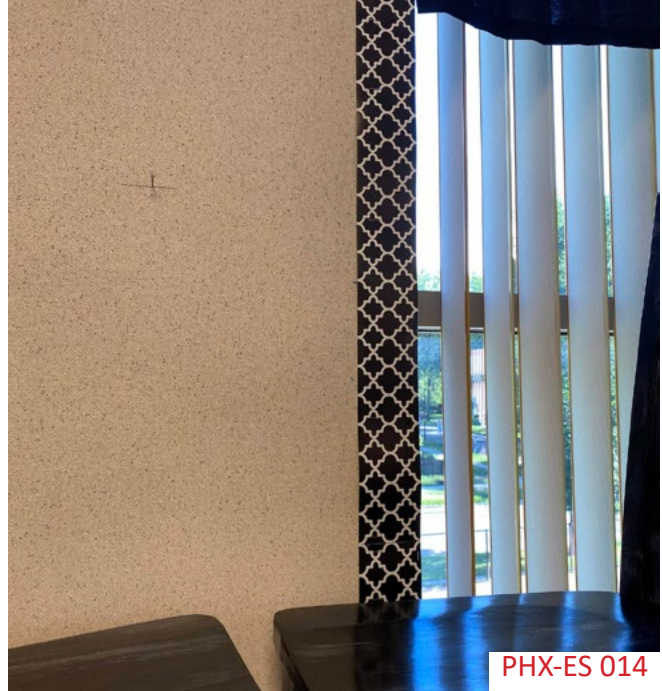
PHX-ES 014

It is recommended the vinyl wall covering be removed from the interior surface of exterior walls, as this could potentially create a double vapor barrier and trap moisture within the walls.

Remove vinyl wall coverings from the inside of exterior walls that is creating a double vapor barrier, skim coat existing sheetrock and paint.	14	7,500 SF	\$7.16 / SF	\$53,700					\$53,700
Replace south exterior ramp outside cafeteria and add guardrail (66 lf) to make accessible. (036)	15	132 SF	\$206.86 / SF	\$27,306					\$27,306
Add accessibility to playground on all sides.	16	1 LS	\$45,327.24 / LS	\$45,327				X	\$45,327
Total Code Compliance		54,066 SF	\$7.02 / SF	\$379,804	\$0	\$0	\$0		\$379,804
Security									
Secure entrance, administration office and special education relocation remodel	17	3,635 SF	\$266.94 / SF	\$970,327			\$970,327		\$970,327
Total Security		3,635 SF	\$266.94 / SF	\$0	\$0	\$0	\$970,327		\$970,327
Addition/Remodel (Educational Adequacy)									
Administration	18	466 SF	\$339.20 / SF				\$158,067		\$158,067
Art	19	SF	\$351.74 / SF				\$0		\$0
Athletics	20	SF	\$360.52 / SF				\$0		\$0

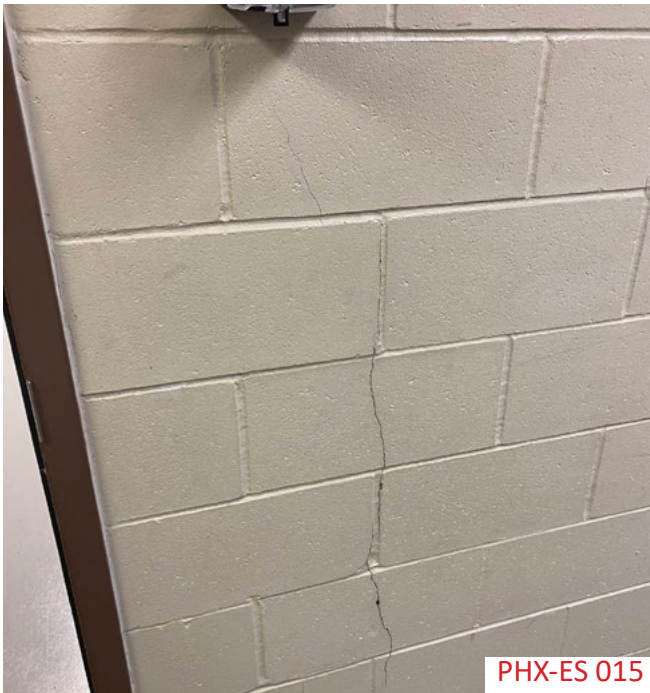
PHX-ES 015

There is cracking in a CMU wall adjacent to a steel column that can be seen from the mechanical room and the hallway.

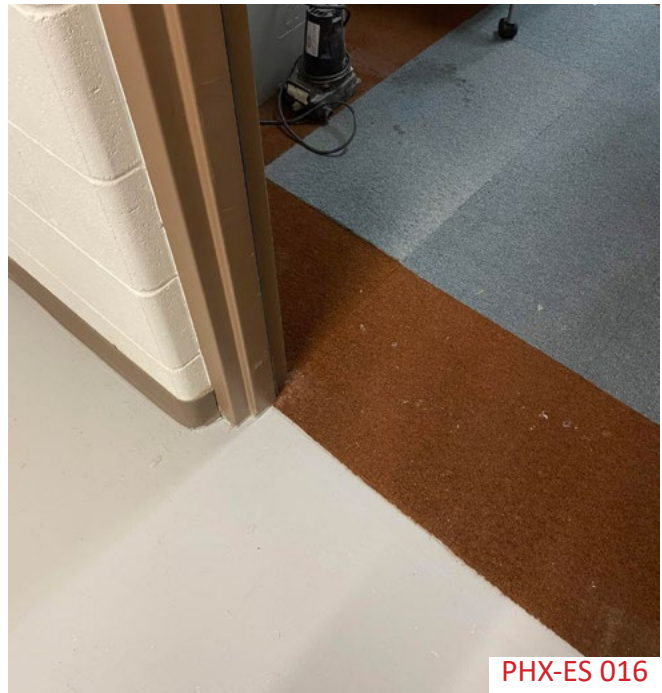
PHX-ES 016

The only area that does not have new carpet is the janitorial closet.

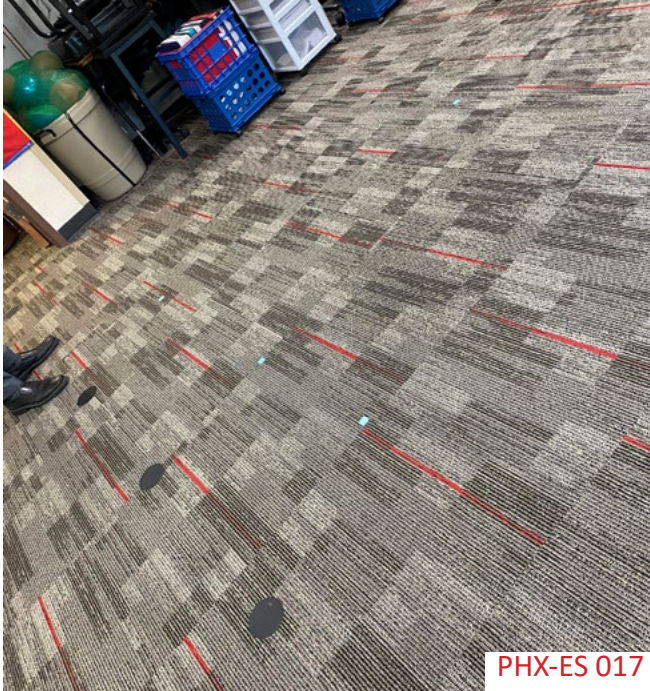
PHX-ES 017

All the classrooms have recently replaced carpet that is in good condition. The only area that does not have new carpet is the janitorial closet (016). There is an area in Room B235 where the precast concrete underneath the carpet has inconsistencies in its seams. Because of this, there is an uneven and sloped portion of the floor in the classroom (017). This could be followed in what would be perceived as the precast joint line and does not present itself as a structural deficiency.

There is an area in Room B235 where the precast concrete underneath the carpet has inconsistencies in its seams. Because of this, there is an uneven and sloped portion of the floor in the classroom.

Remove flooring, add floor fill, and install new flooring in Room B235 where the precast concrete underneath the carpet had inconsistency in its seams	39	1,008 SF	\$13.89 / SF		\$14,001				\$14,001
Interior Upgrades Subtotal		54,066 SF	\$1.64 / SF						\$88,414
Exterior Upgrades									
Repair the west curb in the drop-off alleyway that is damaged	40	1 Ea.	\$2,635.12 / Ea.		\$2,635				\$2,635
Replace the outdated playground	41	1 Ea.	\$264,142.24 / Ea.		\$264,142				\$264,142
Clean the exterior limestone	42	1 Ea.	\$10,248.24 / Ea.		\$10,248				\$10,248
Fix the drain mesh in a fire drain on the north side of the building and add a concrete splash block beneath it	43	1 Ea.	\$741.24 / Ea.	\$741					\$741
Outside of the library where new asphalt was laid for drainage, the weepholes in the brick have been covered which can prevent moisture from leaving the brick	44		/ 0						\$0
Replace the roof when it nears the end of its useable lifetime	45	35,134 SF	\$31.69 / SF	\$1,113,396					\$1,113,396

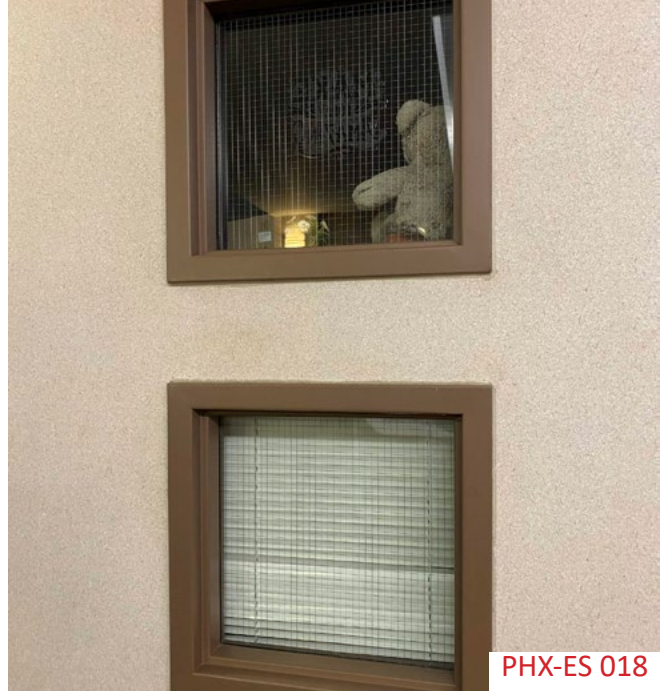
PHX-ES 018

Traditional wire glass throughout the building is no longer to code as an acceptable type of safety glass

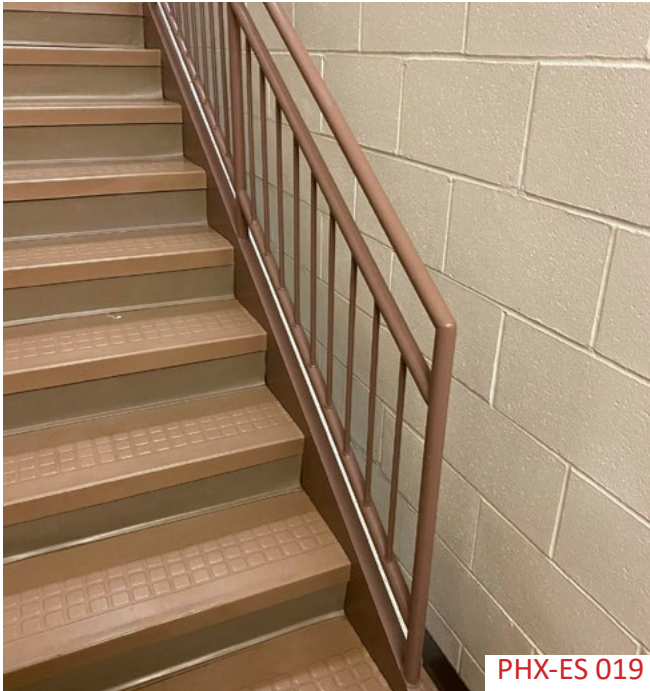
PHX-ES 019

Both stairwells are lacking a separate handrail from the guardrails and existing guardrails do not meet height requirements

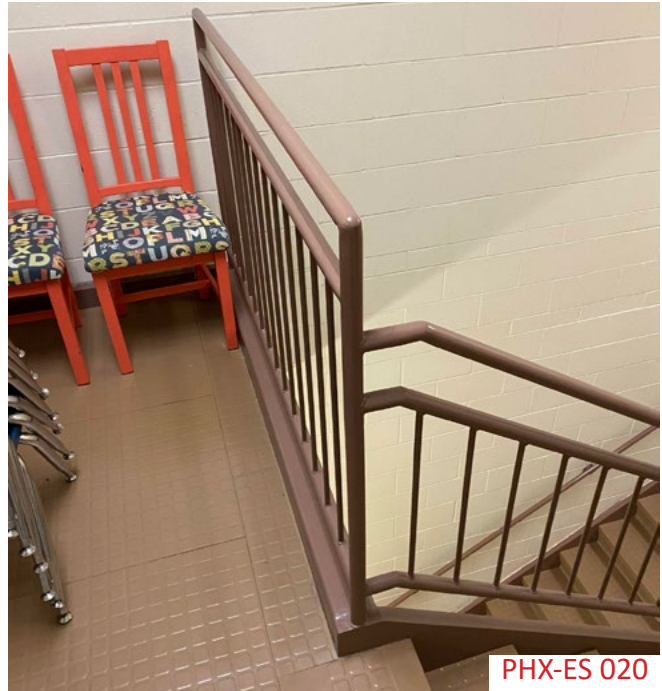
PHX-ES 020

Both stairwells are lacking a separate handrail from the guardrails and existing guardrails do not meet height requirements

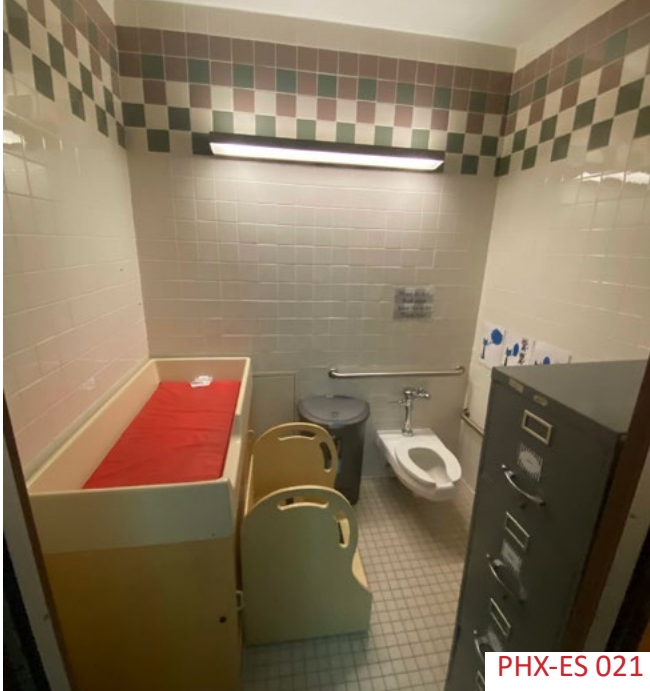
PHX-ES 021

Numerous single restrooms throughout the school are accessible, but with all the extra items stored there, are no longer accessible

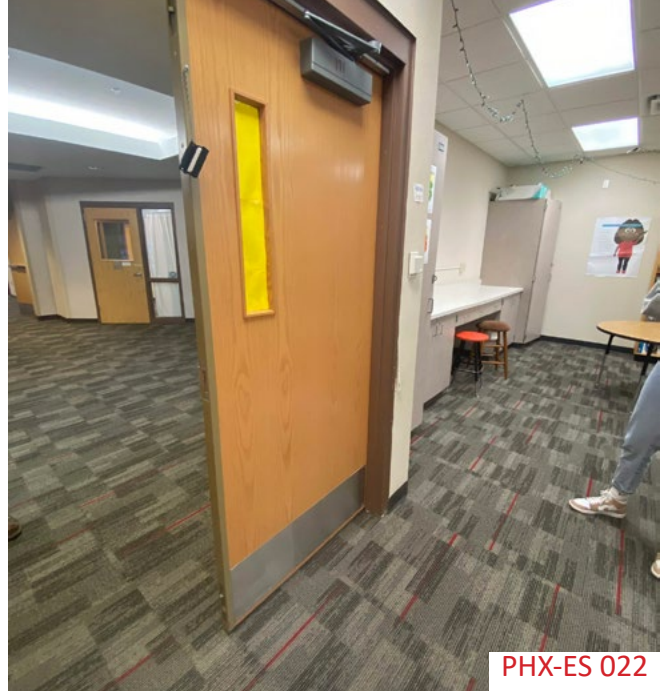
PHX-ES 022

Double doors in the Title 1 classroom (Room 171) do not have required panic hardware

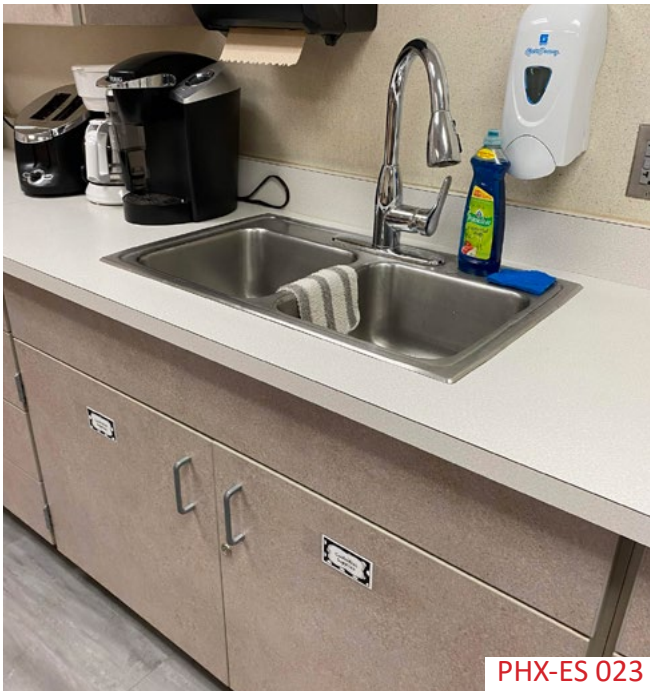
PHX-ES 023

Sinks in the staff lounge, main office, nurse's office, and library office (Rooms A136, A137, B145 and no corresponding room number) are not accessible

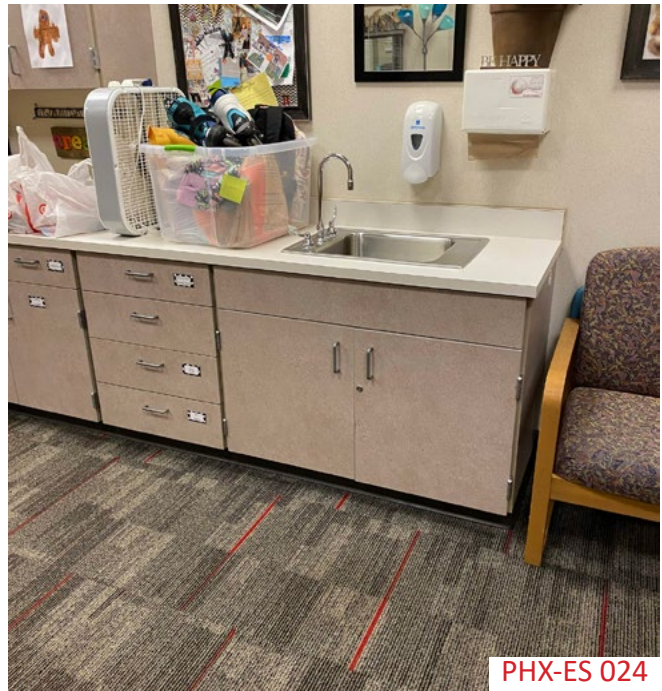
PHX-ES 024

Sinks in the staff lounge, main office, nurse's office, and library office (Rooms A136, A137, B145 and no corresponding room number) are not accessible

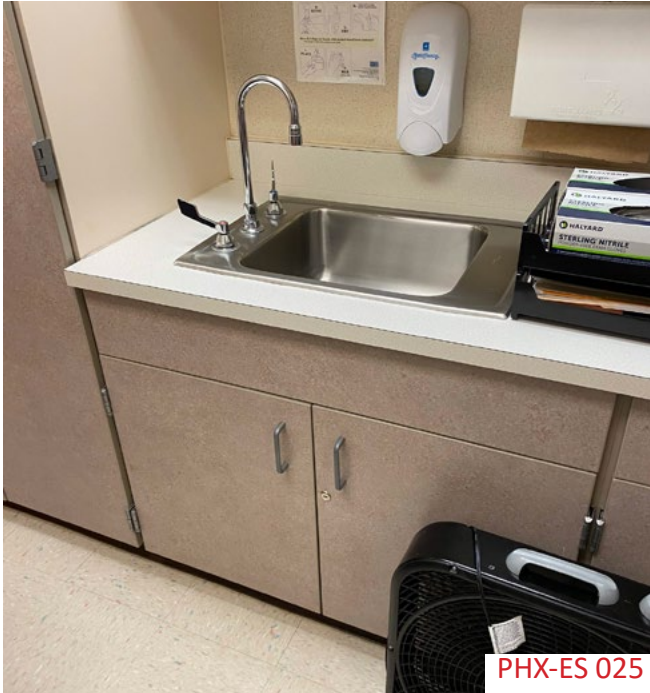
PHX-ES 025

Sinks in the staff lounge, main office, nurse's office, and library office (Rooms A136, A137, B145 and no corresponding room number) are not accessible

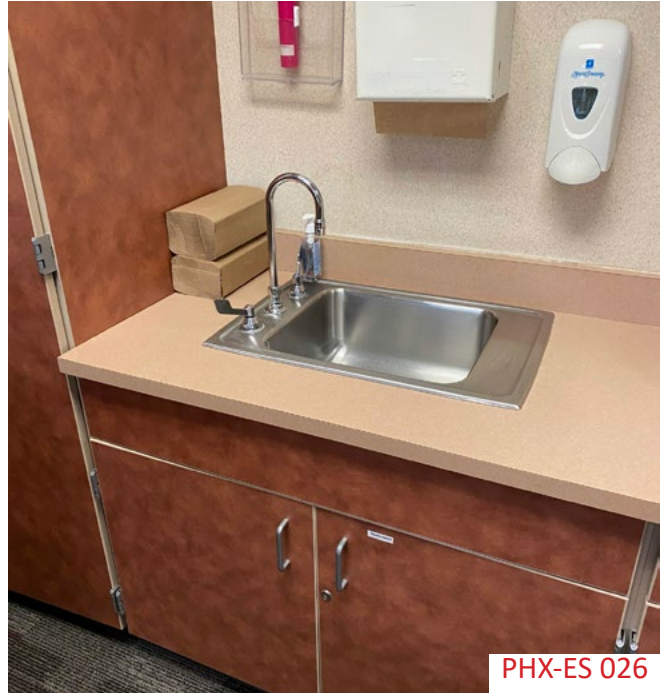
PHX-ES 026

Sinks in the staff lounge, main office, nurse's office, and library office (Rooms A136, A137, B145 and no corresponding room number) are not accessible

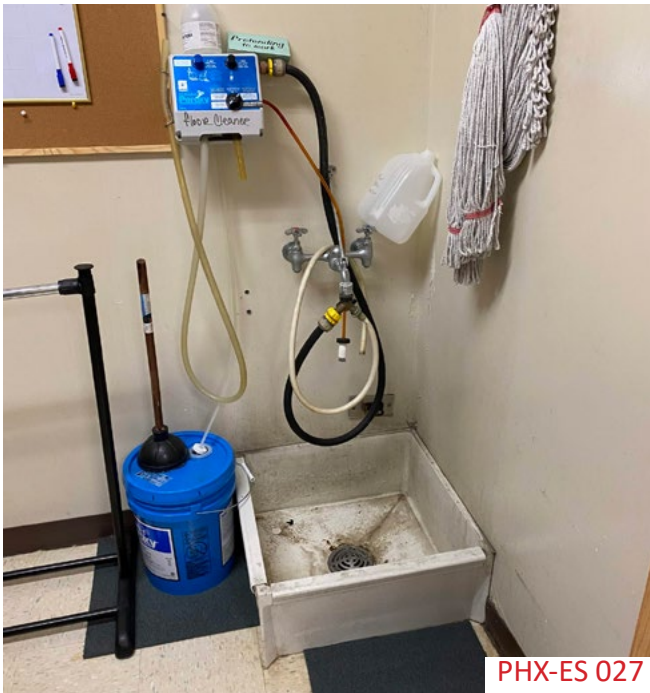
PHX-ES 027

Mop sink in the second-floor janitorial closet (Room A214) needs fiber-reinforced panels on the adjacent walls

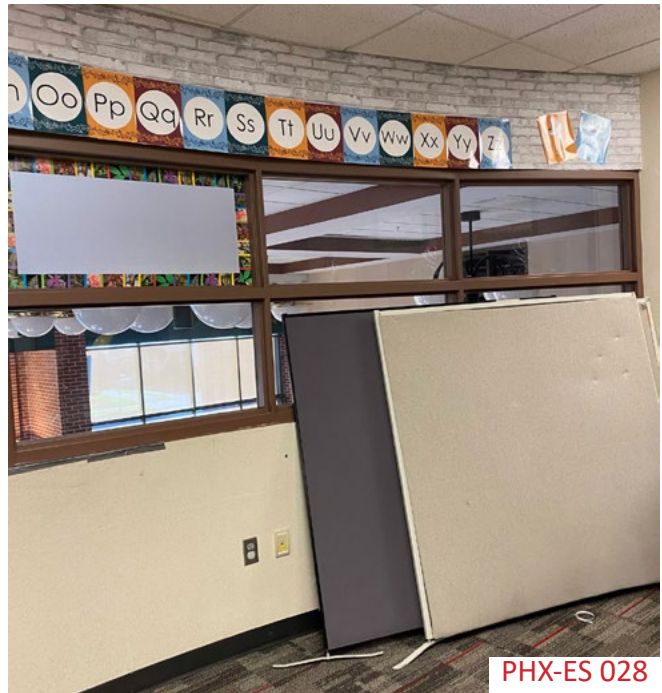
PHX-ES 028

All classrooms with interior windows facing the atrium are missing sprinklers 4"-12" from the windows for fire protection

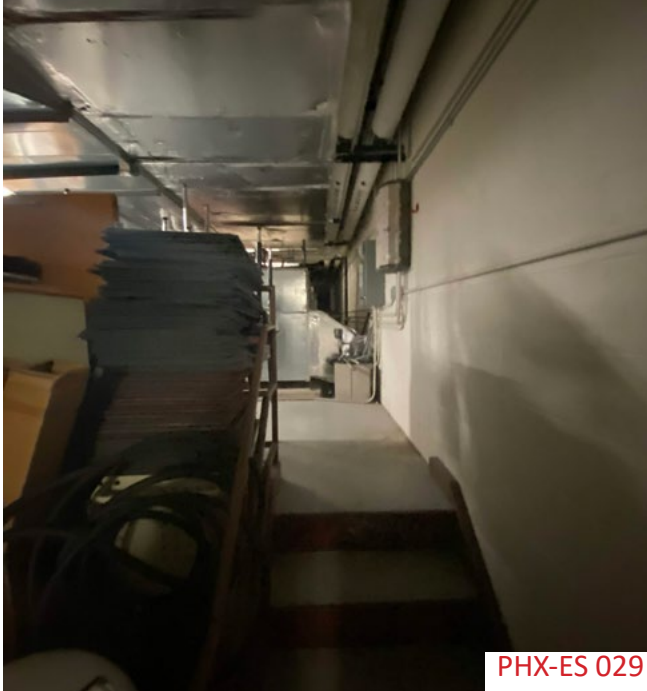
PHX-ES 029

The guardrail in the mechanical room does not meet height requirements and appropriate handrails are missing

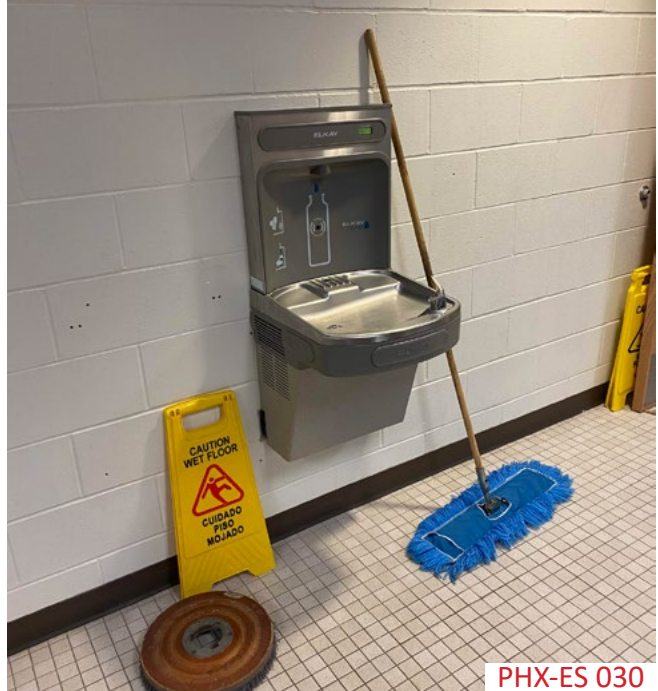
PHX-ES 030

Drinking fountains throughout the building do not meet the required ratio of wheelchair accessible fountains to standing person accessible fountains

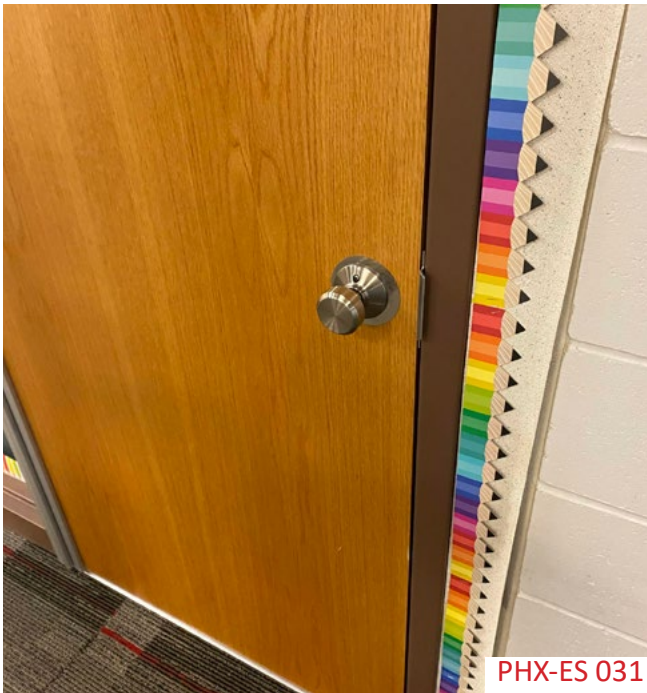
PHX-ES 031

Door hardware, on the door to the STAR room in Room 229, is not accessible

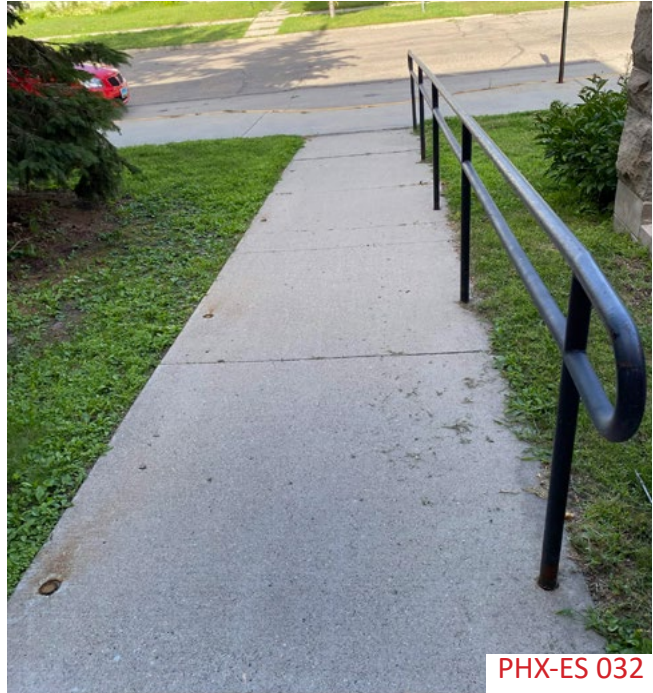
PHX-ES 032

Due to the incline of the southernmost exterior ramp outside of the cafeteria, handrails are required on both sides of the ramp

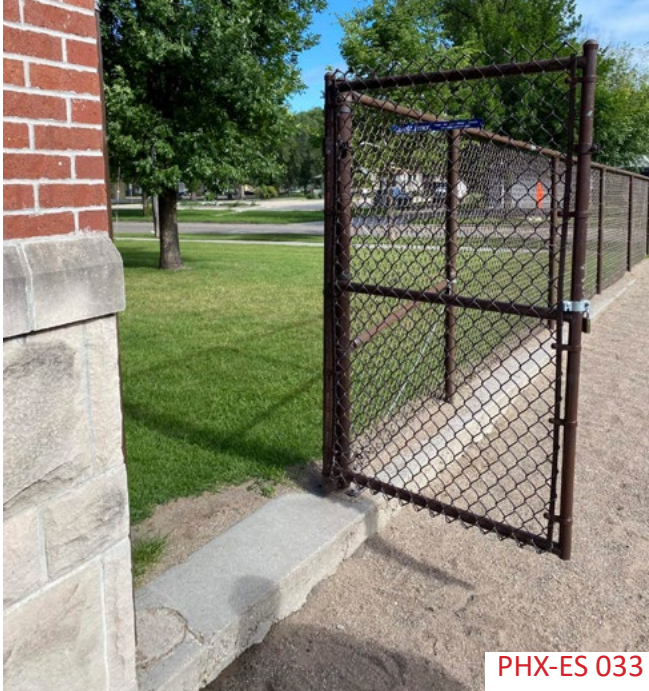
PHX-ES 033

The playground is not accessible on all sides

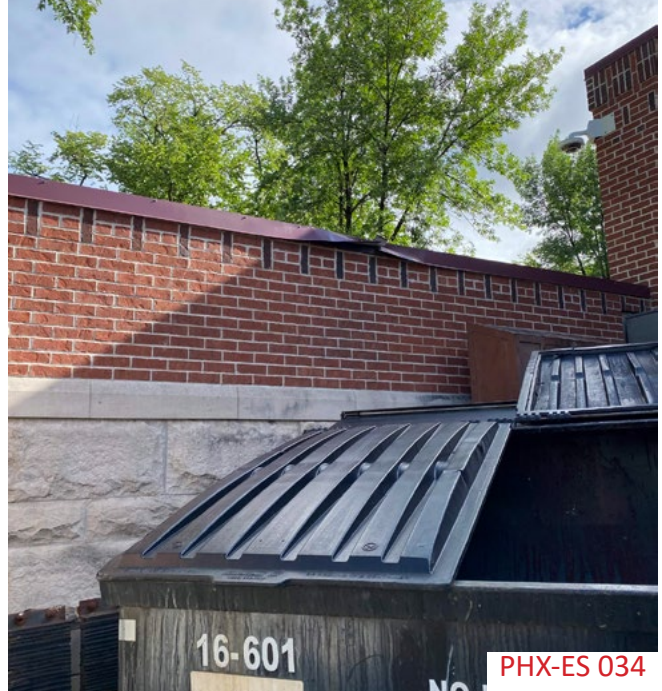
PHX-ES 034

A portion of the metal parapet cover is damaged near the loading docks on the north side of the school.

Replace caulking around windows	46	49 Ea.	\$501.42 / Ea.		\$24,570				\$24,570
Replaced the damaged metal parapet near the loading docks on the north side of the school	47	1 Ea.	\$4,124.21 / Ea.		\$4,124				\$4,124
Replace the metal caging protecting the exterior speaker that damaged	48	1 Ea.	\$2,412.24 / Ea.		\$2,412				\$2,412
Exterior Upgrades Subtotal		54,066 SF	\$26.31 / SF						\$1,422,269
Electrical Upgrades									
Add egress lighting to doors to exterior as is required by Building Code	49	54,066 SF	\$0.84 / SF	\$45,415					\$45,415
Upgrade of all interior lighting controls throughout to digital lighting management	50	54,066 SF	\$2.51 / SF		\$135,706				\$135,706
Upgrade of all exterior lighting controls throughout to digital lighting management	51	54,066 SF	\$0.25 / SF		\$13,517				\$13,517
Update the existing intercom system with a new IP system throughout entire school.	52	54,066 SF	\$3.76 / SF		\$203,288				\$203,288

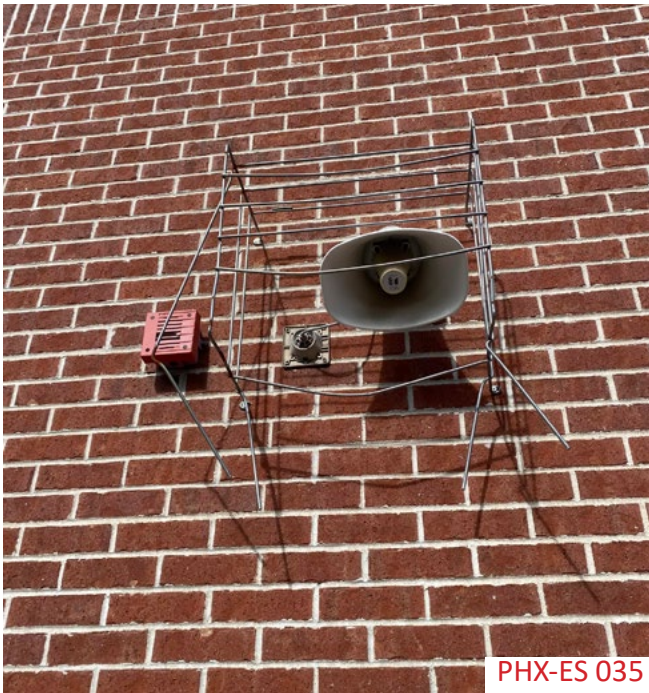
PHX-ES 035

Metal caging protecting the exterior speaker is damaged and should be replaced.
