# SCHROEDER MIDDLE SCHOOL

## FACILITY ASSESSMENT

### A. EXISTING BUILDING INVENTORY

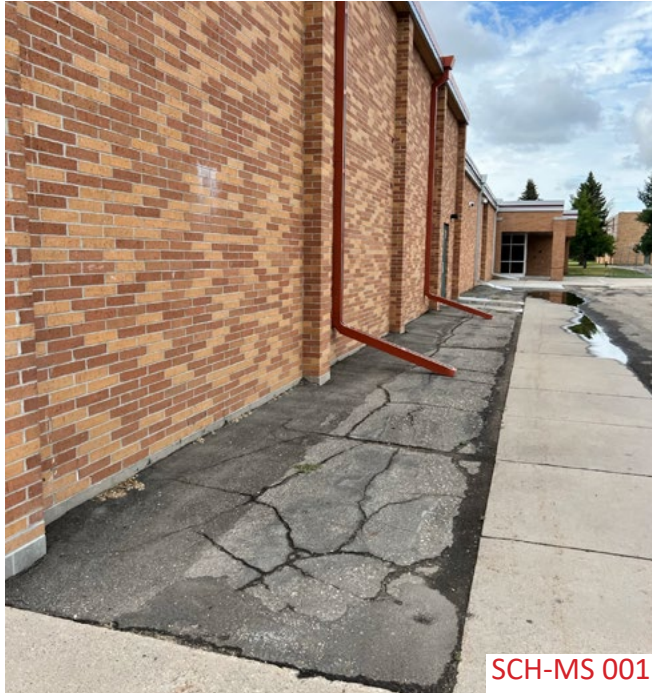
SCH-MS 001

The exterior sidewalks, curbs, and pavement are in poor condition in certain areas (001). The parking lot should be refinished. Standing water is present near entrances (002).

The exterior sidewalks, curbs, and pavement are in poor condition in certain areas.

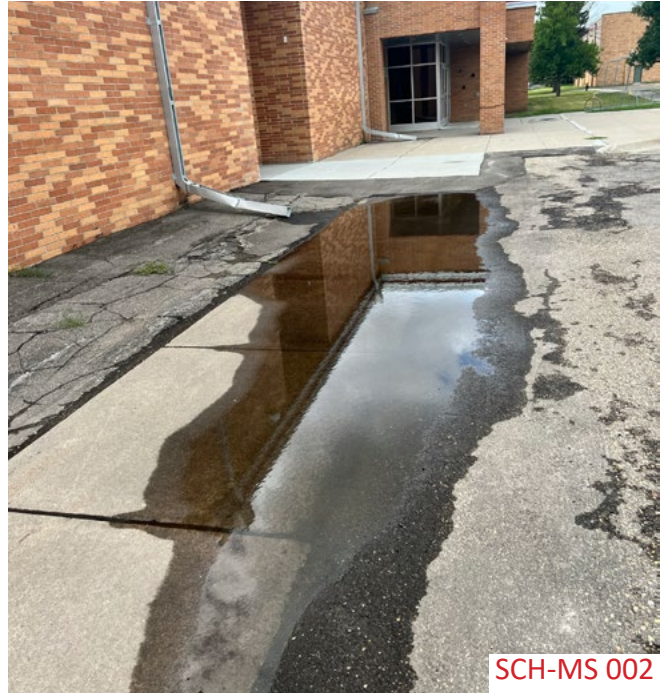
SCH-MS 002

Standing water is present near entrances.

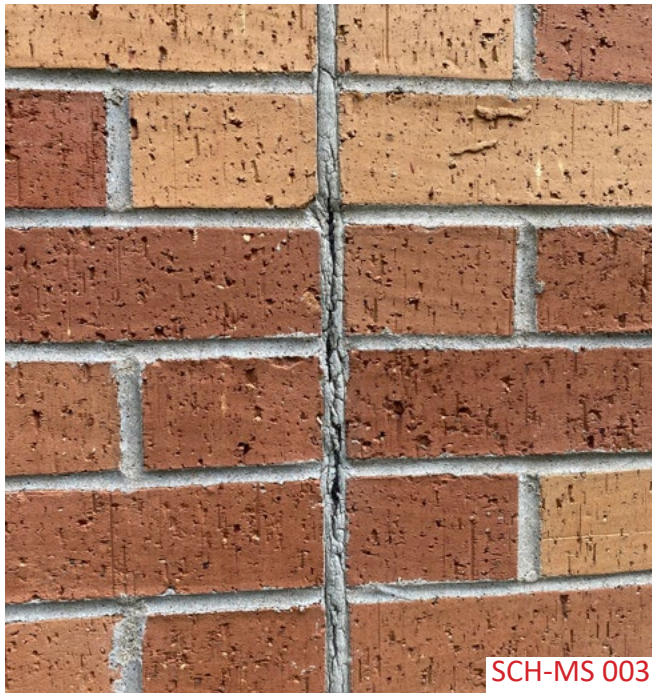
SCH-MS 003

The exterior brick is in overall good condition, but caulking is deteriorating. The caulking deterioration is most prevalent on the south side of the building (003).

The caulking deterioration is most prevalent on the south side of the building.

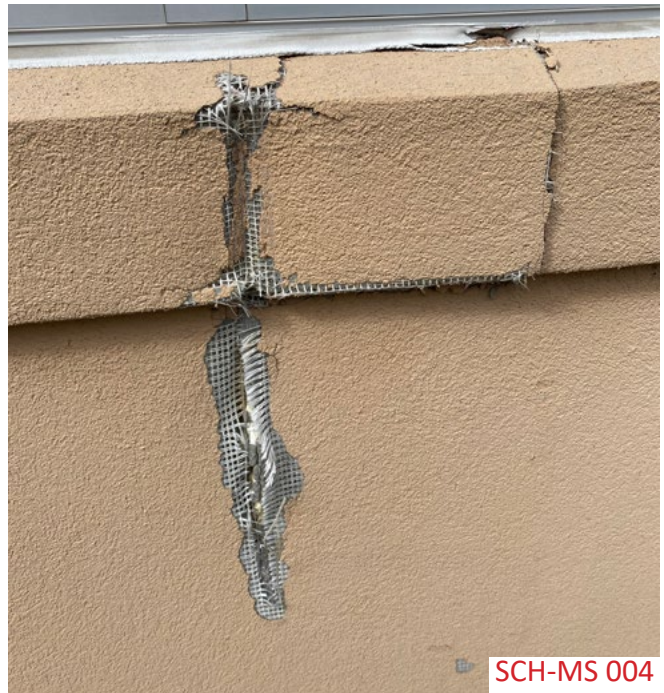
SCH-MS 004

The exterior insulation and finish system (EIFS) is in poor condition with multiple holes seen around the building (004). A canopy repair is needed outside Door 1 (005, 006).

The EIFS is in poor condition with multiple holes seen around the building.

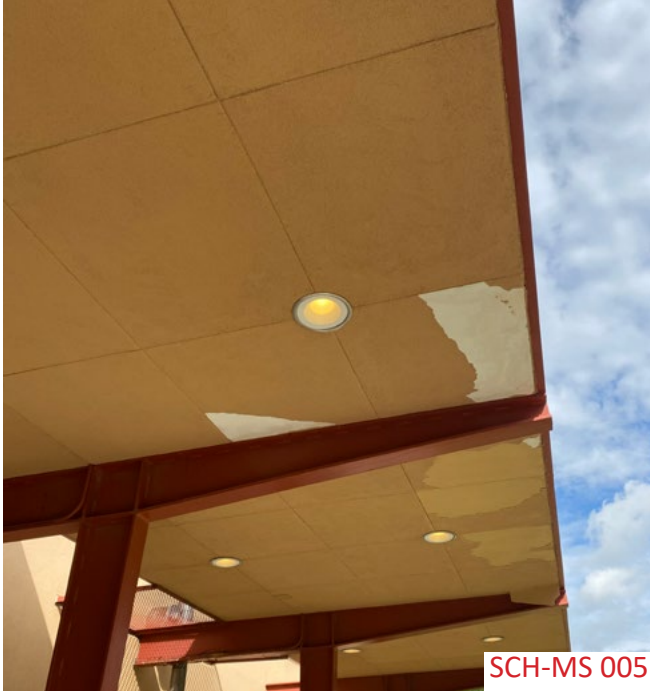
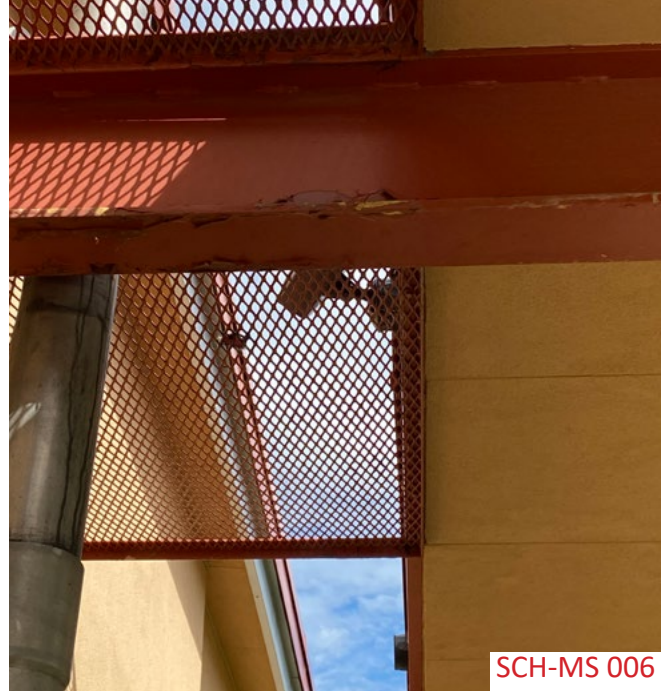
A canopy repair is needed outside door 1.

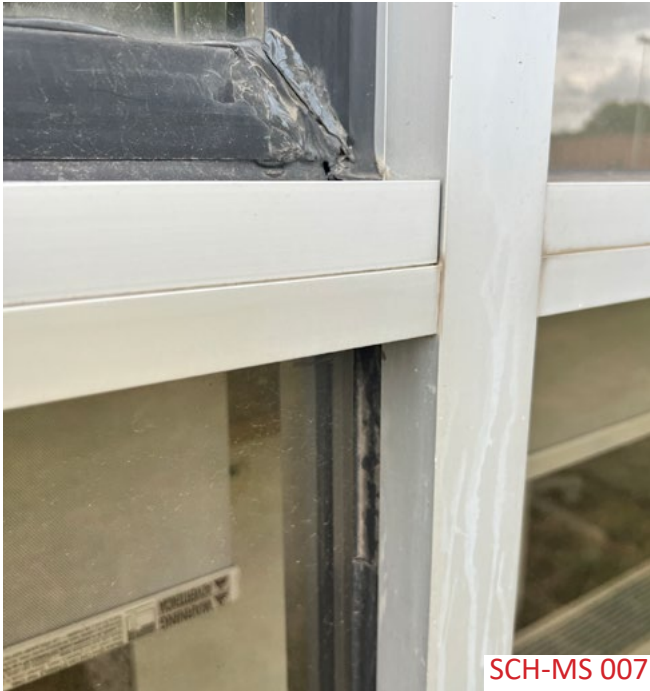
Window gaskets are deteriorating and need to be replaced.

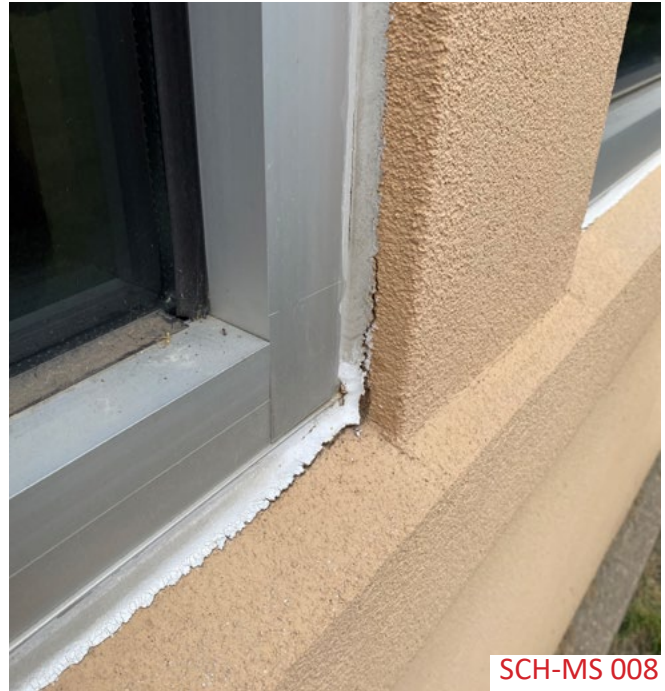
Caulking is worn and should be replaced as well.

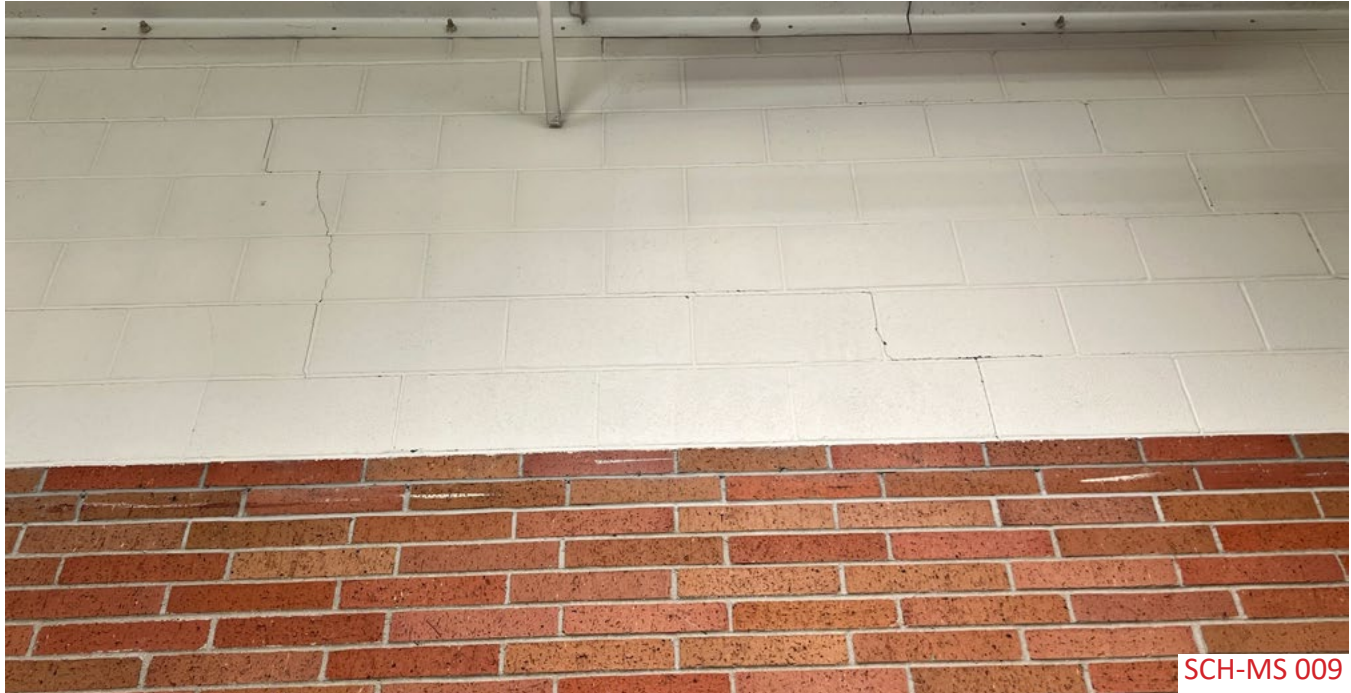
SCH-MS 009

There is some cosmetic cracking of the CMU brick throughout the school.

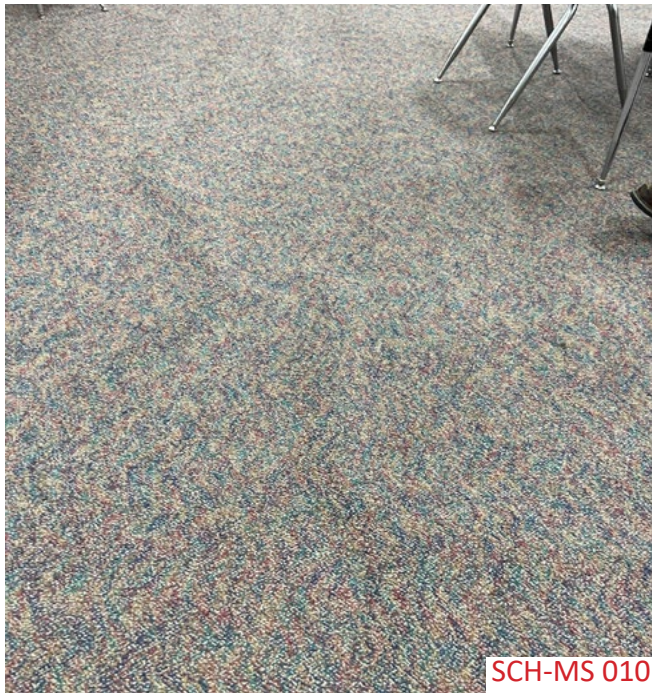
SCH-MS 010

Spaces with older carpeting have warping and the carpet is bubbling.

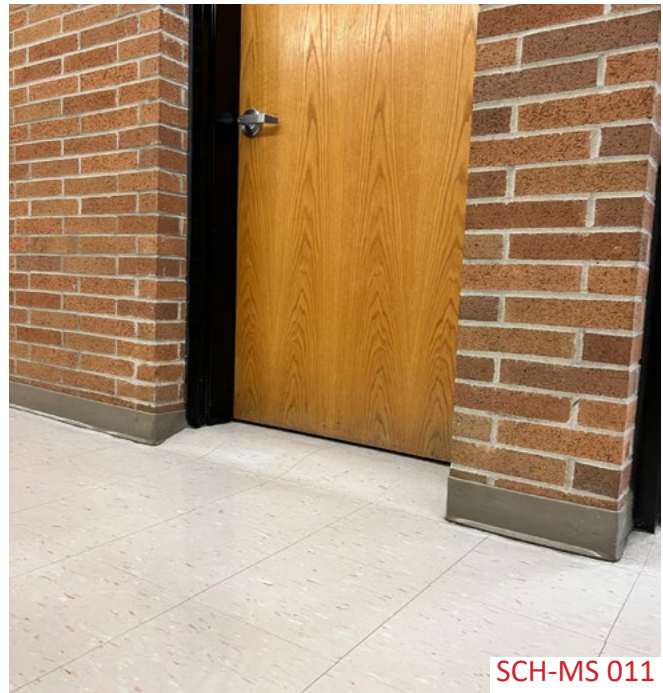
SCH-MS 011

Flooring is uneven at some spots.

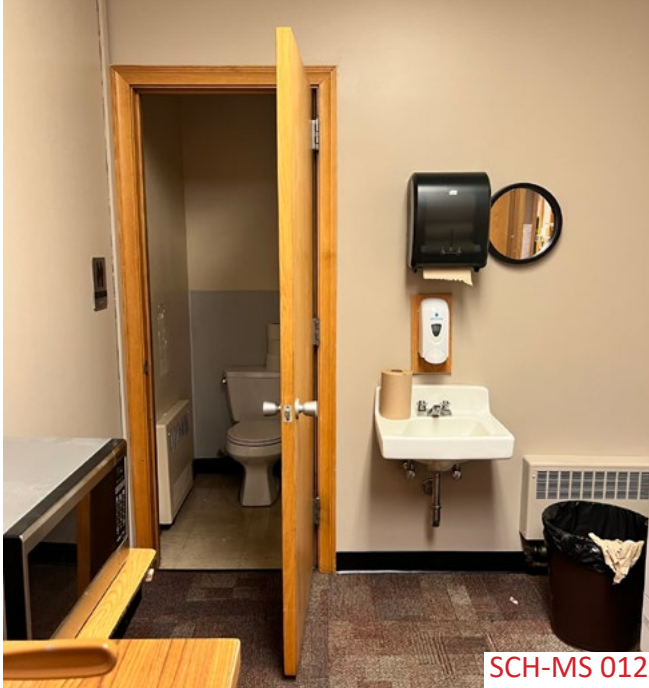
SCH-MS 012

Restrooms within classrooms are not accessible

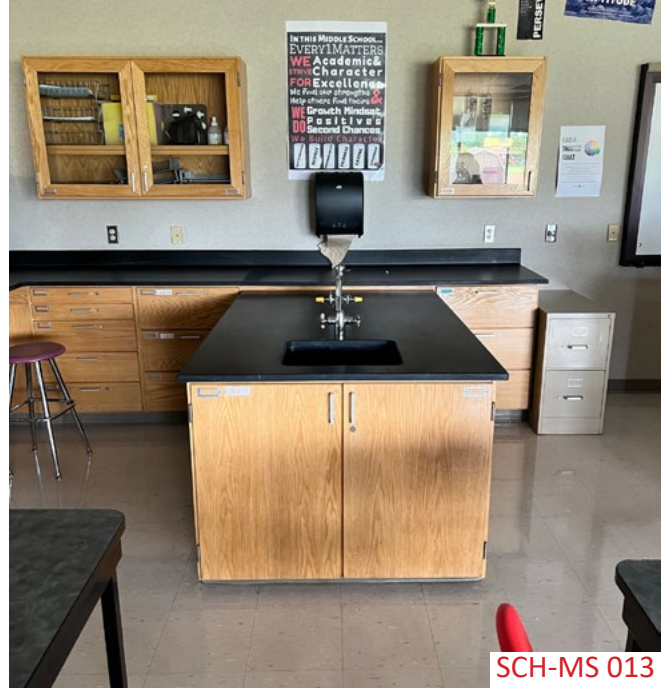
SCH-MS 013

Science labs do not have an accessible sink

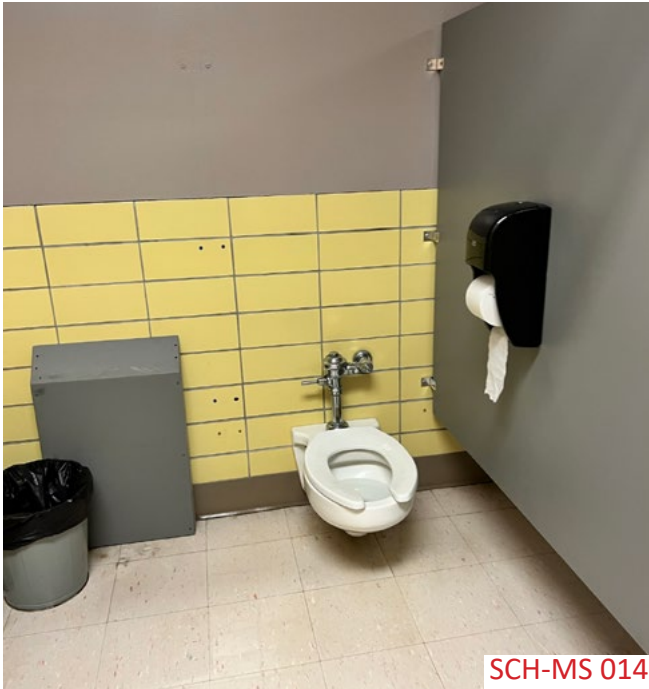
SCH-MS 014

Restrooms throughout the school are not accessible

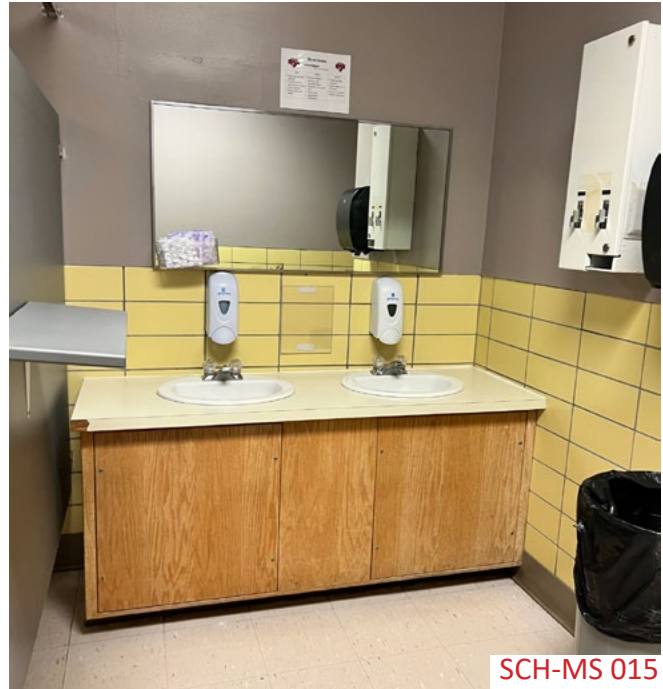
SCH-MS 015

Sinks in restrooms are not accessible

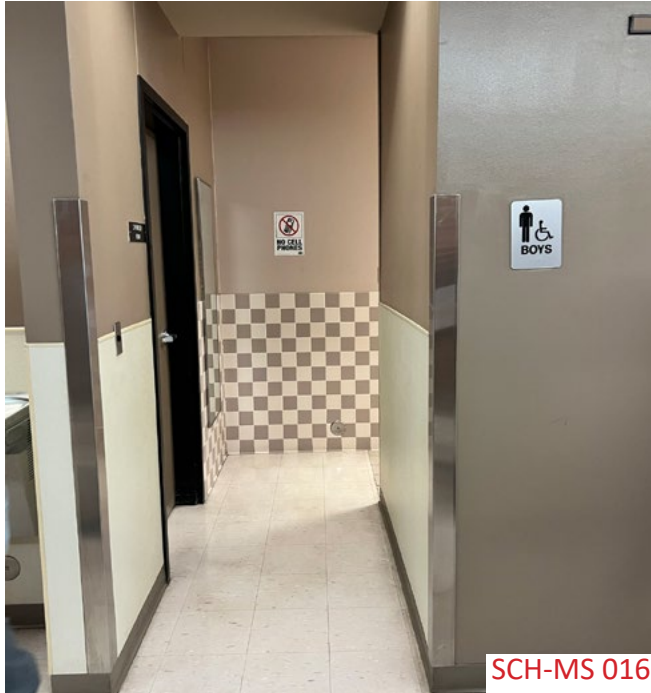
SCH-MS 016

Entries into restrooms do not have adequate clearances for accessibility

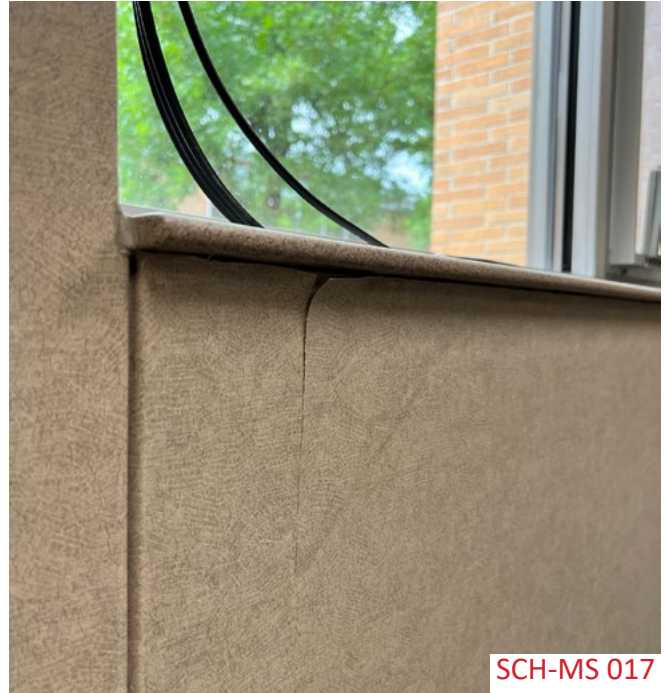
SCH-MS 017

Portions of exterior walls are covered with vinyl wall covering on the interior side, which is not to code

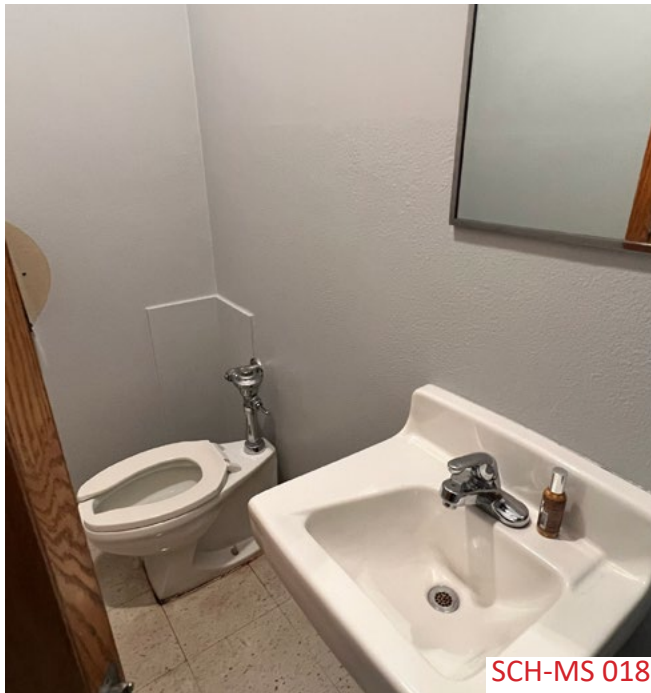
SCH-MS 018

Staff restroom is not accessible

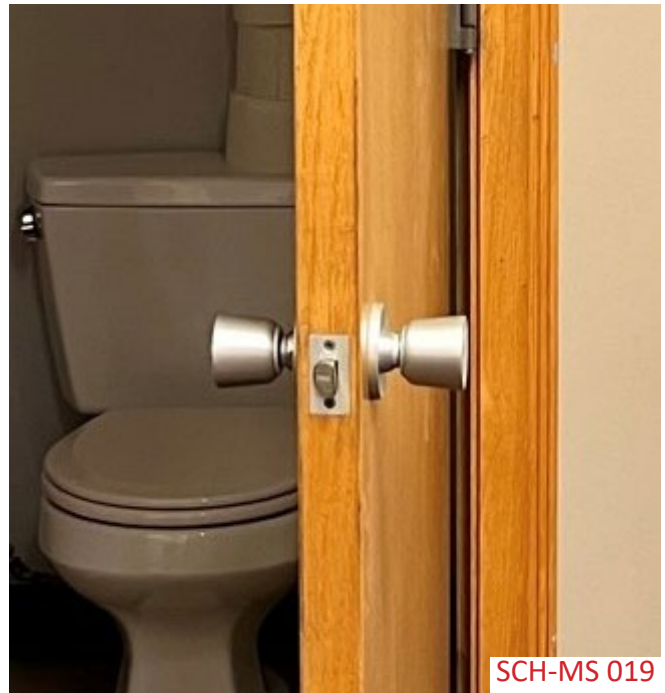
SCH-MS 019

Door hardware throughout the building is not accessible

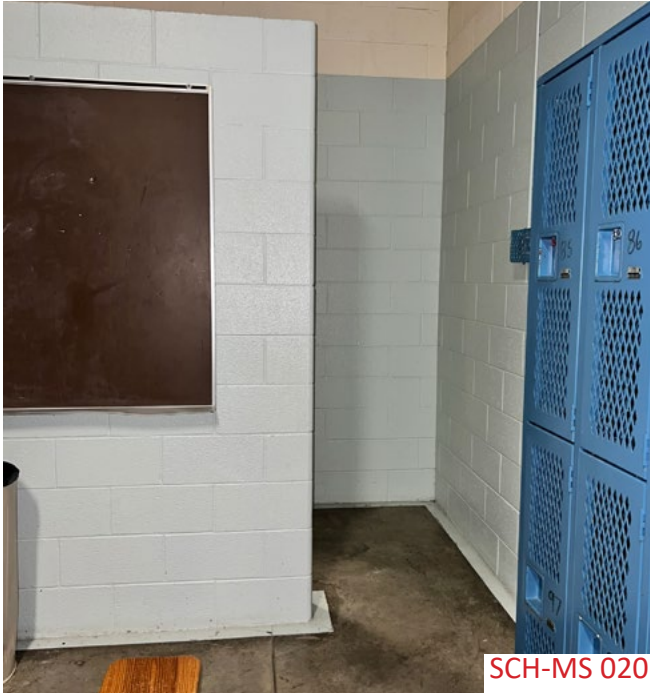
Entry into locker rooms do not have adequate clearances for accessibility

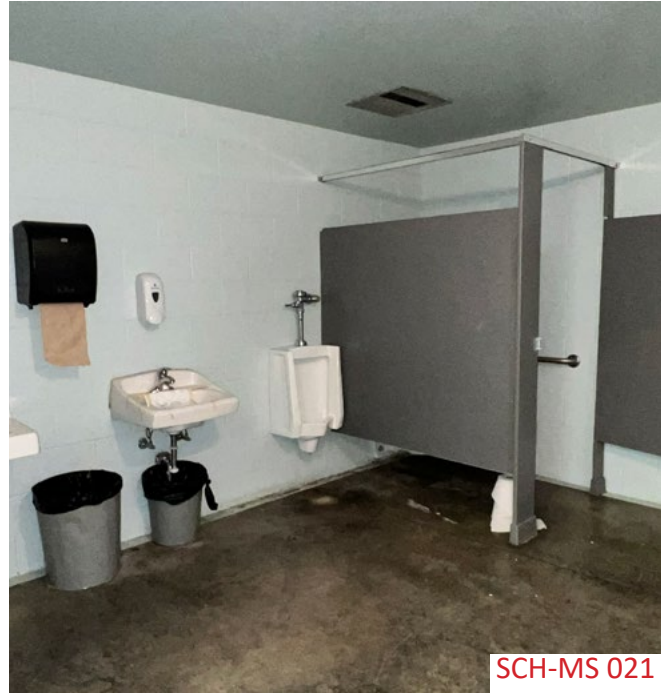
Locker room restrooms are not accessible

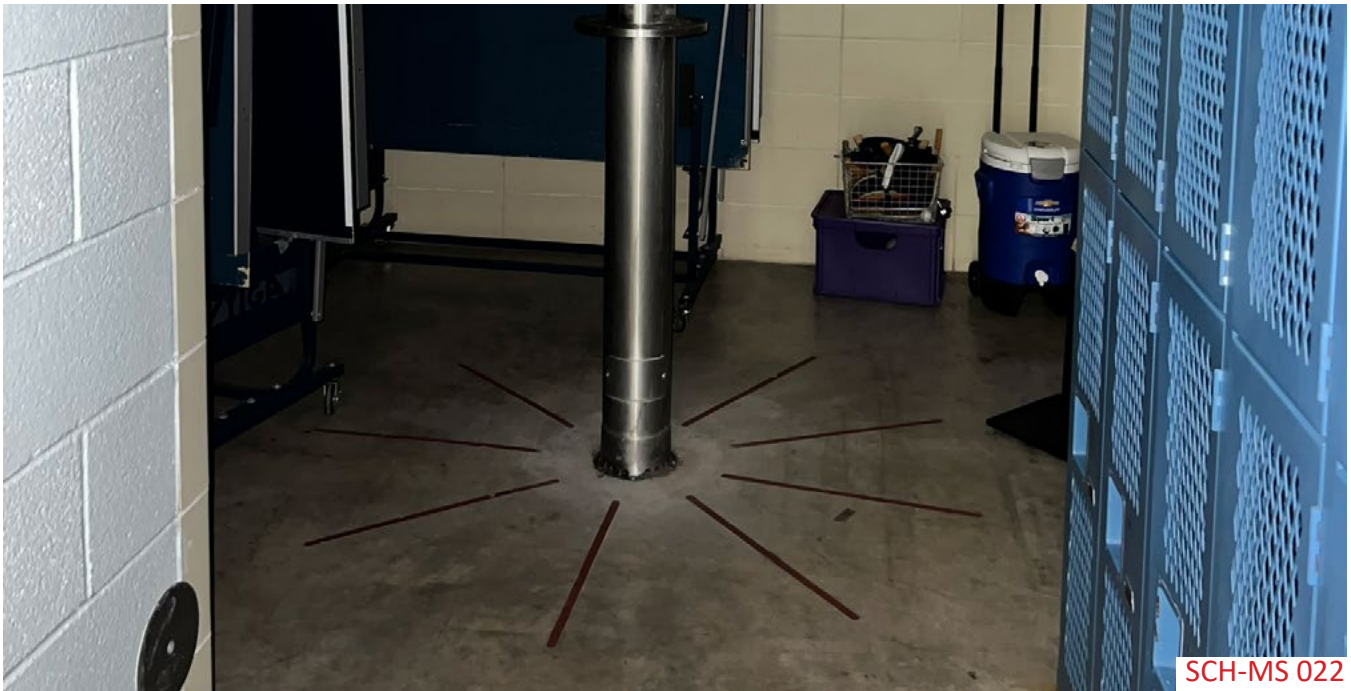
Showers in locker rooms do not have sufficient drains as required by code to prevent wastewater from one bather passing over areas occupied by other bathers.

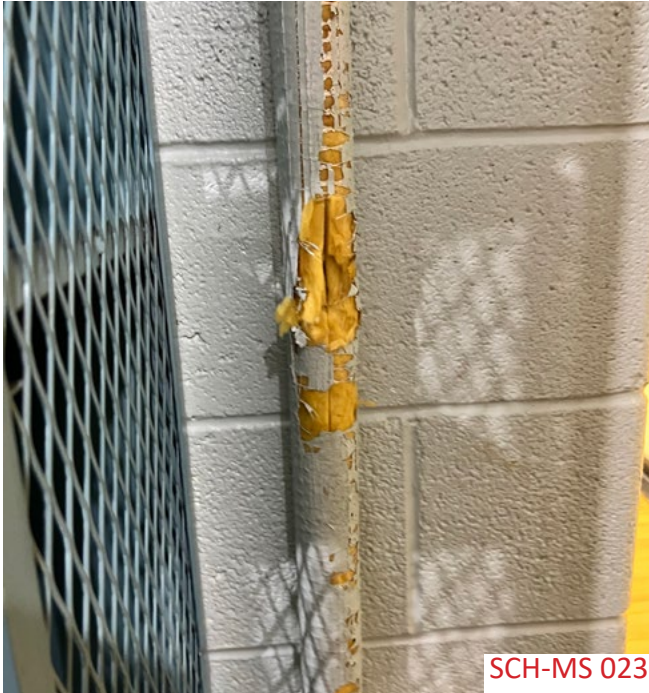
SCH-MS 023

Pipes are exposed throughout the school and should be protected

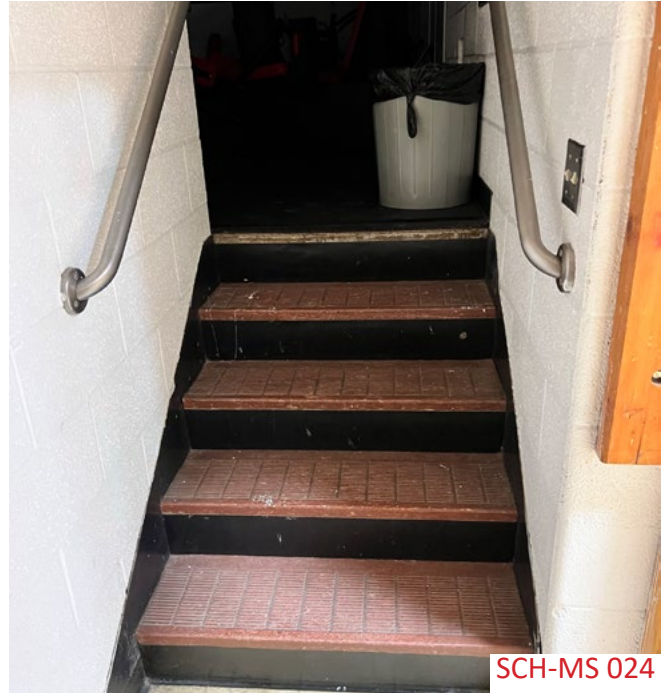
SCH-MS 024

The weight room is not accessible

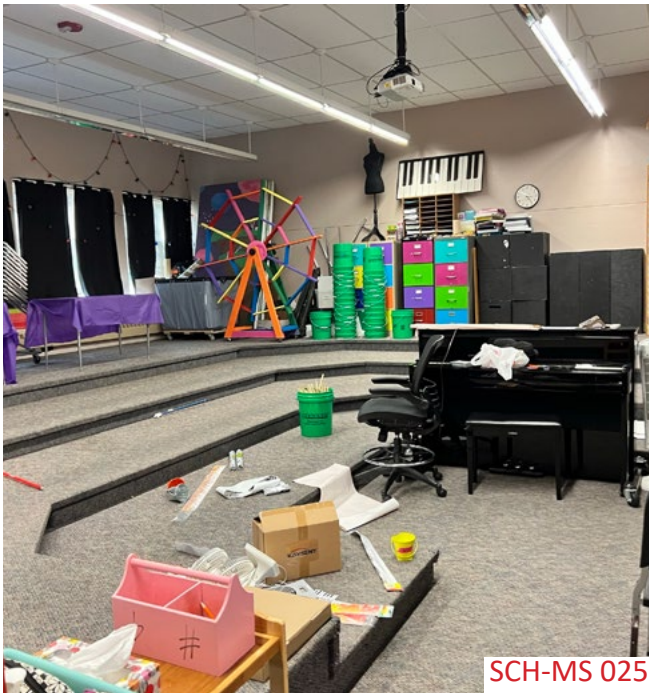
SCH-MS 025

The music room is not accessible

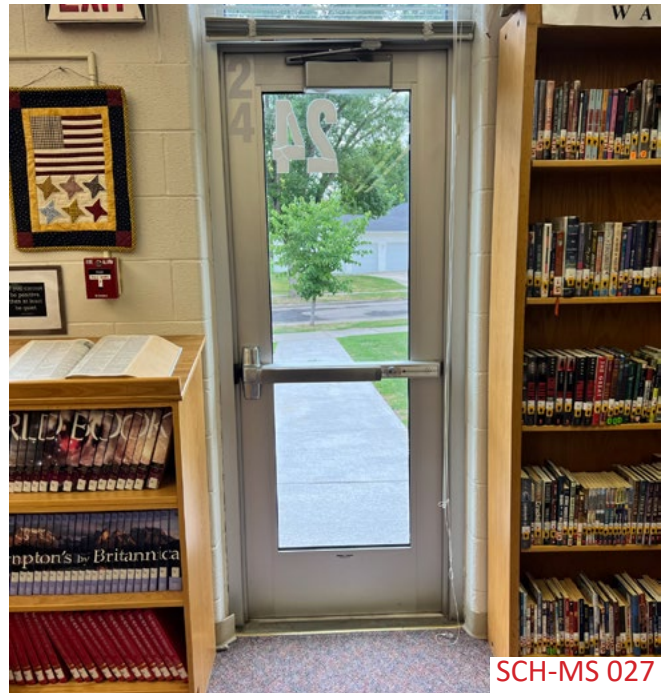
SCH-MS 027

Door 24 does not meet the clear opening width required by code

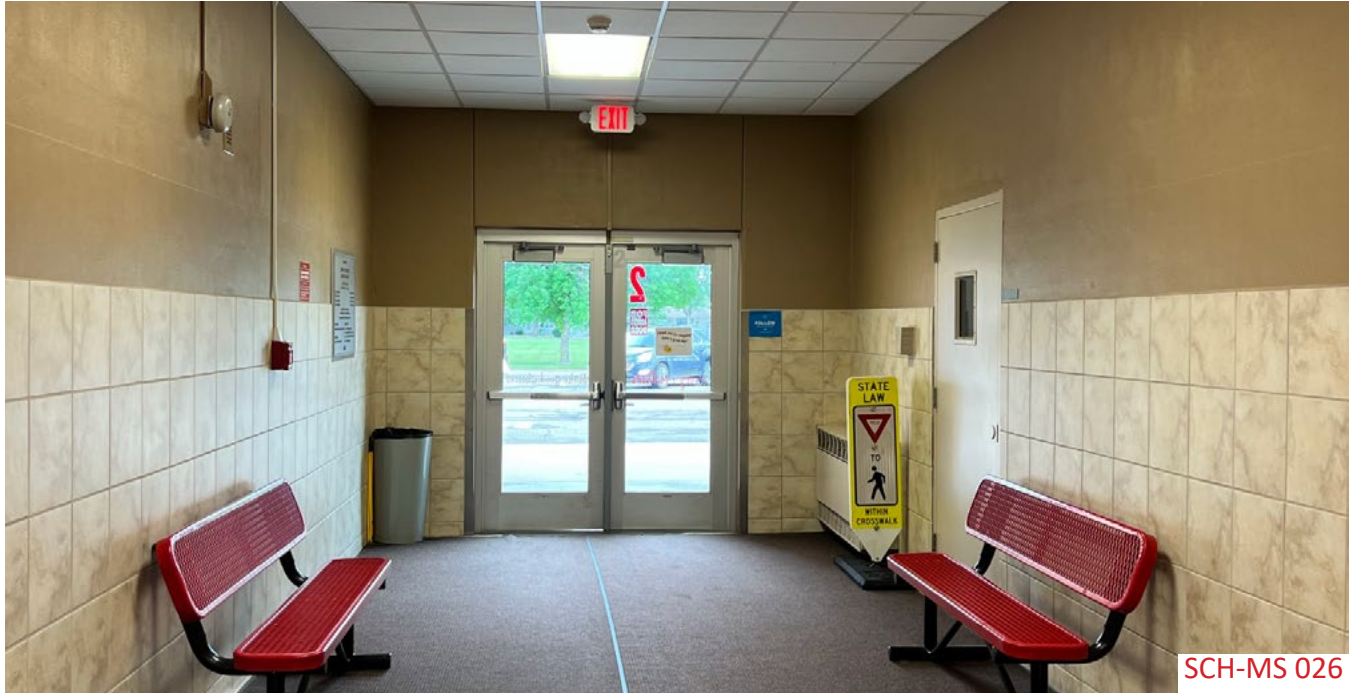
SCH-MS 026

Not all entry doors in the building are protected with an enclosed vestibule, as required by energy code

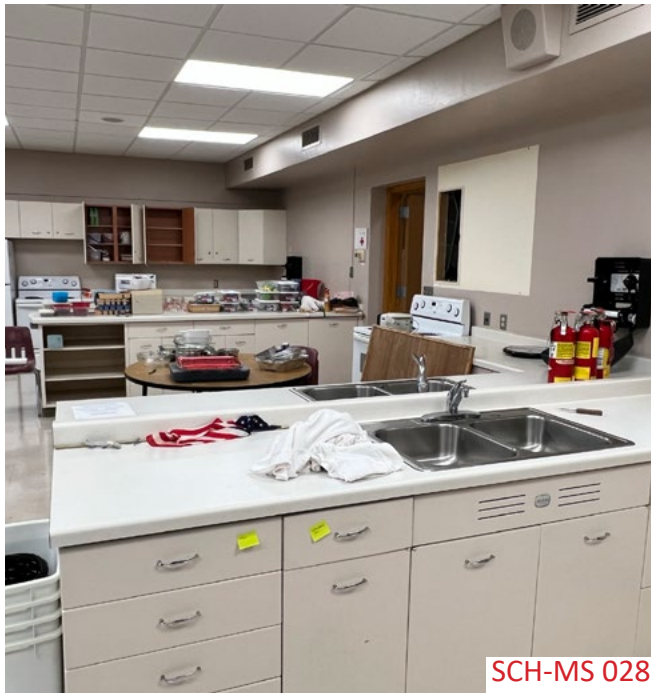
SCH-MS 028

FACS classroom is not accessible

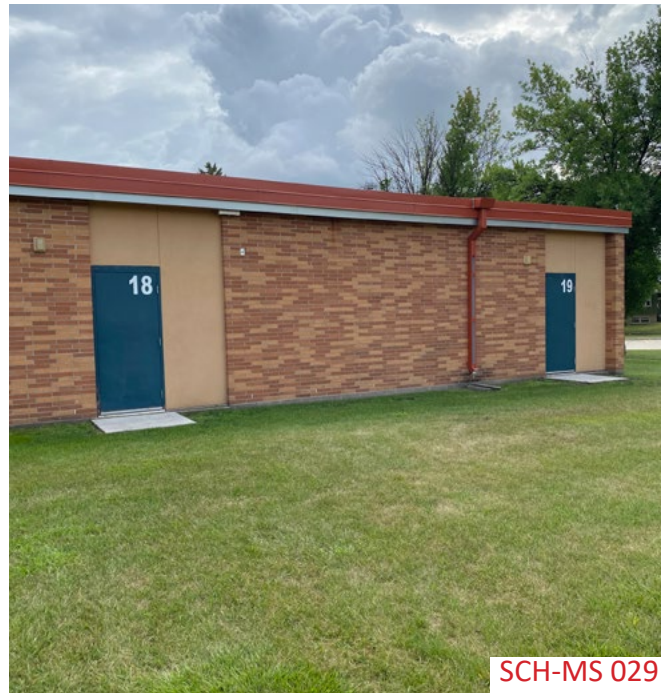
SCH-MS 029

Doors 18 and 19 do not have a direct access to a public way.

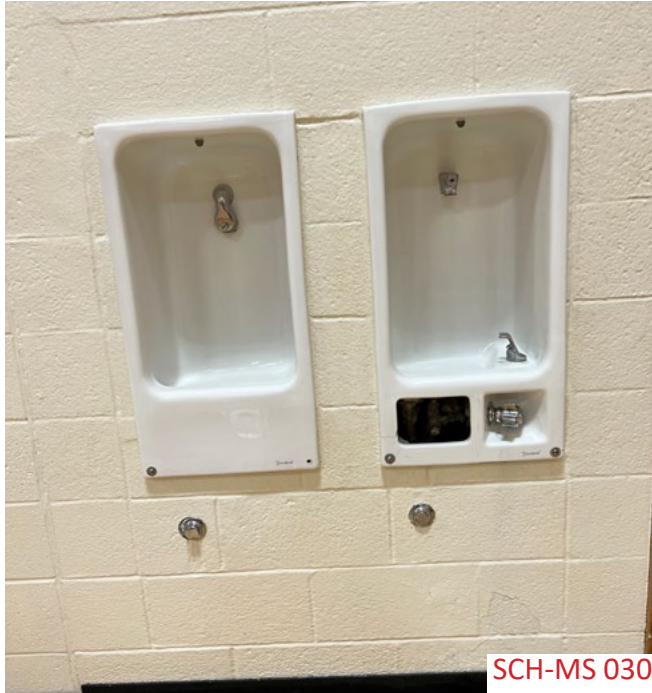
**SCH-MS 030**

Drinking fountains throughout the building do not meet the required ratio of wheelchair accessible fountains to standing person accessible fountains
