SOUTH MIDDLE SCHOOL

FACILITY ASSESSMENT

D. EXISTING DEFICIENCIES

INTERIOR AND EXTERIOR EXISTING DEFICIENCIES PHOTOS

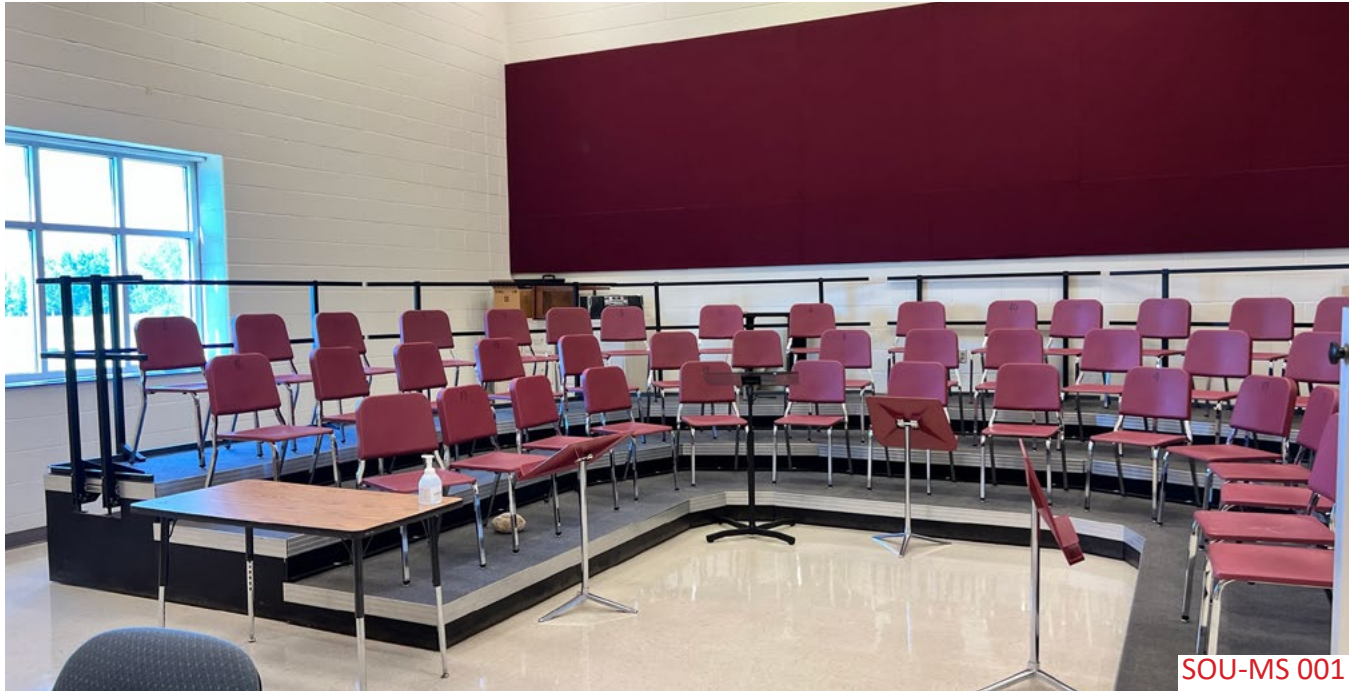
SOU-MS 001

The risers in Room 606 are not portable and should be replaced with ones that better serve the music department.

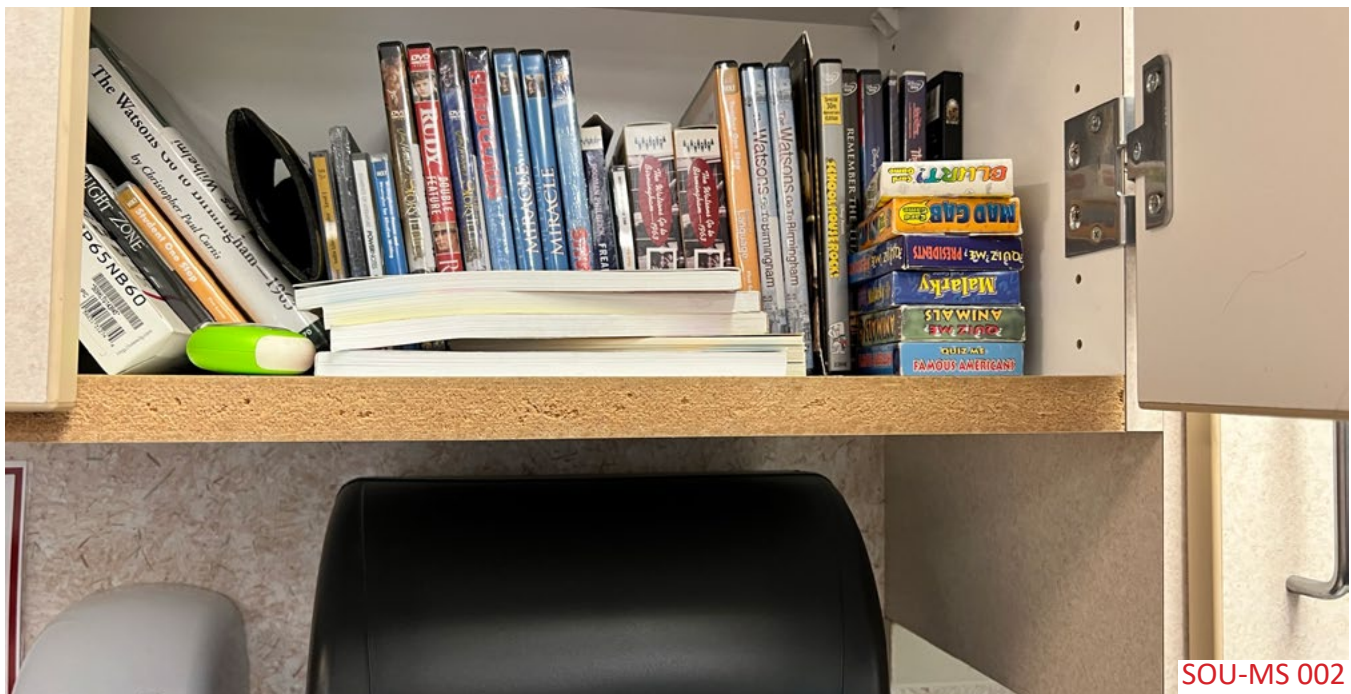
SOU-MS 002

The laminate trim on much of the casework throughout the school is peeling off and needs new adhesion.

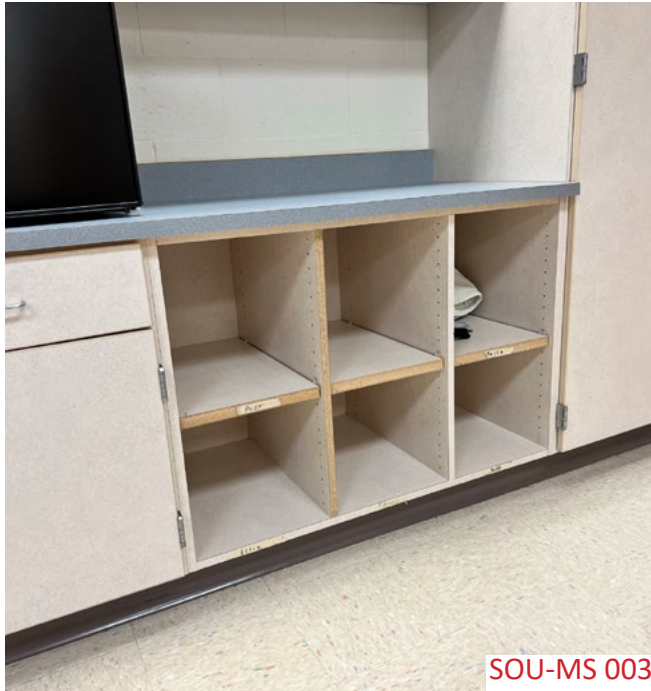
SOU-MS 003

The laminate trim on much of the casework throughout the school is peeling off and needs new adhesion.

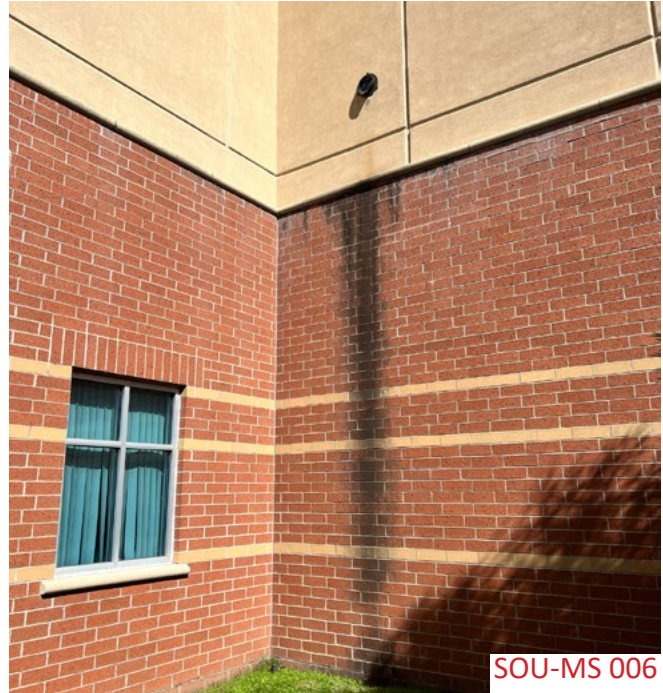
SOU-MS 006

There are exterior drains near Doors 5 and 13 that need to be cleaned so that water can properly drain out as it is currently going onto the brick and creating water spots.

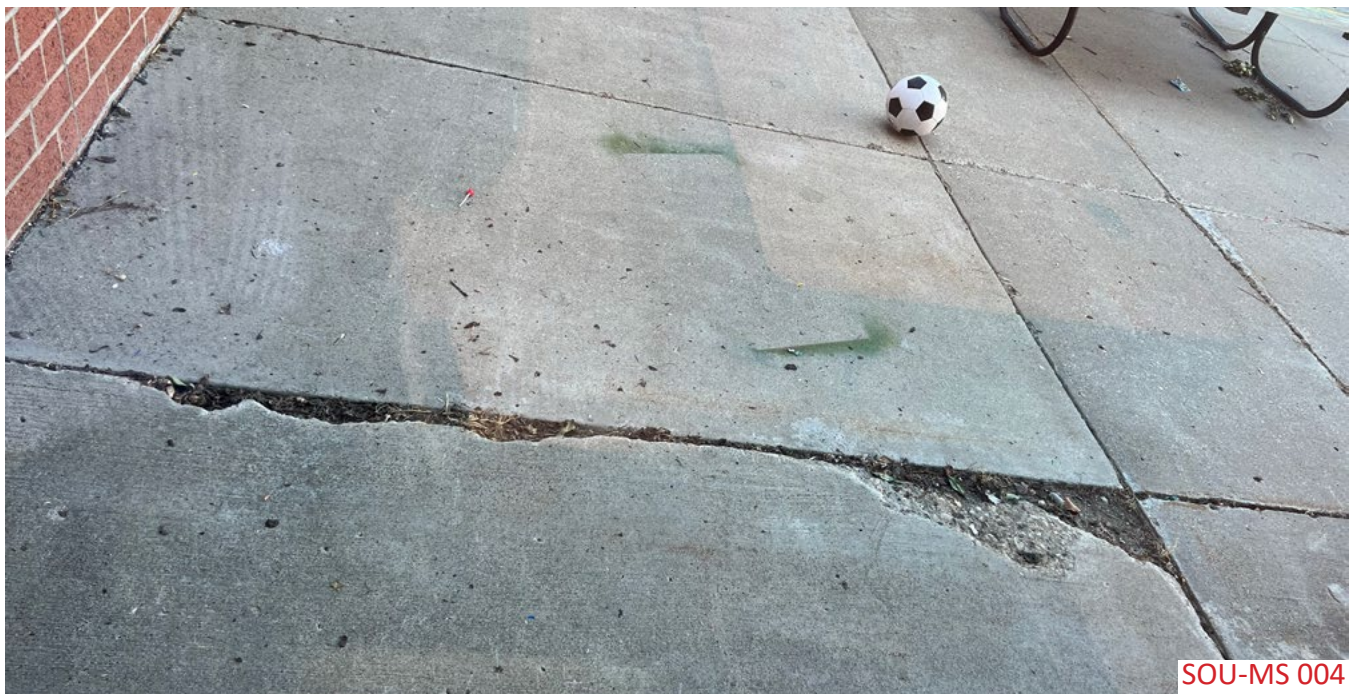
SOU-MS 004

A general patch and repair can be done for the sidewalk and asphalt on the site of the school.

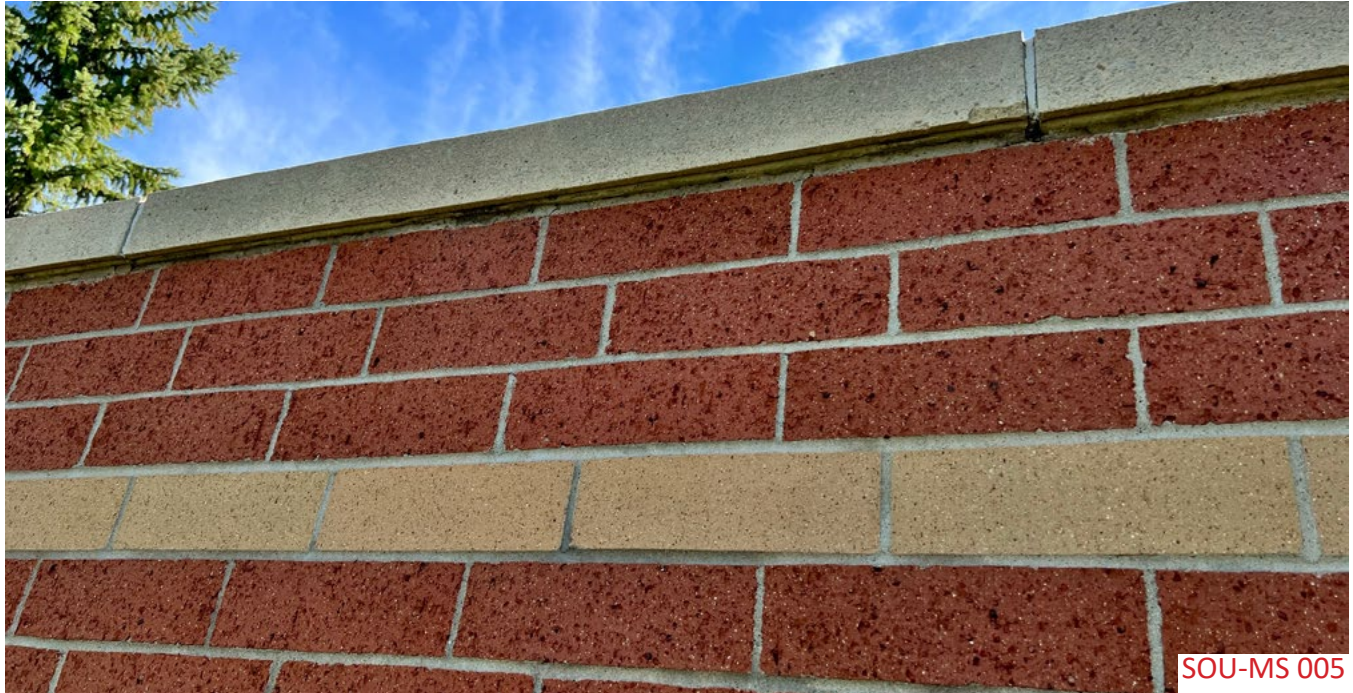
The joints for the limestone cap need to be cleaned out and resealed to prevent future water damage from happening on the brick underneath

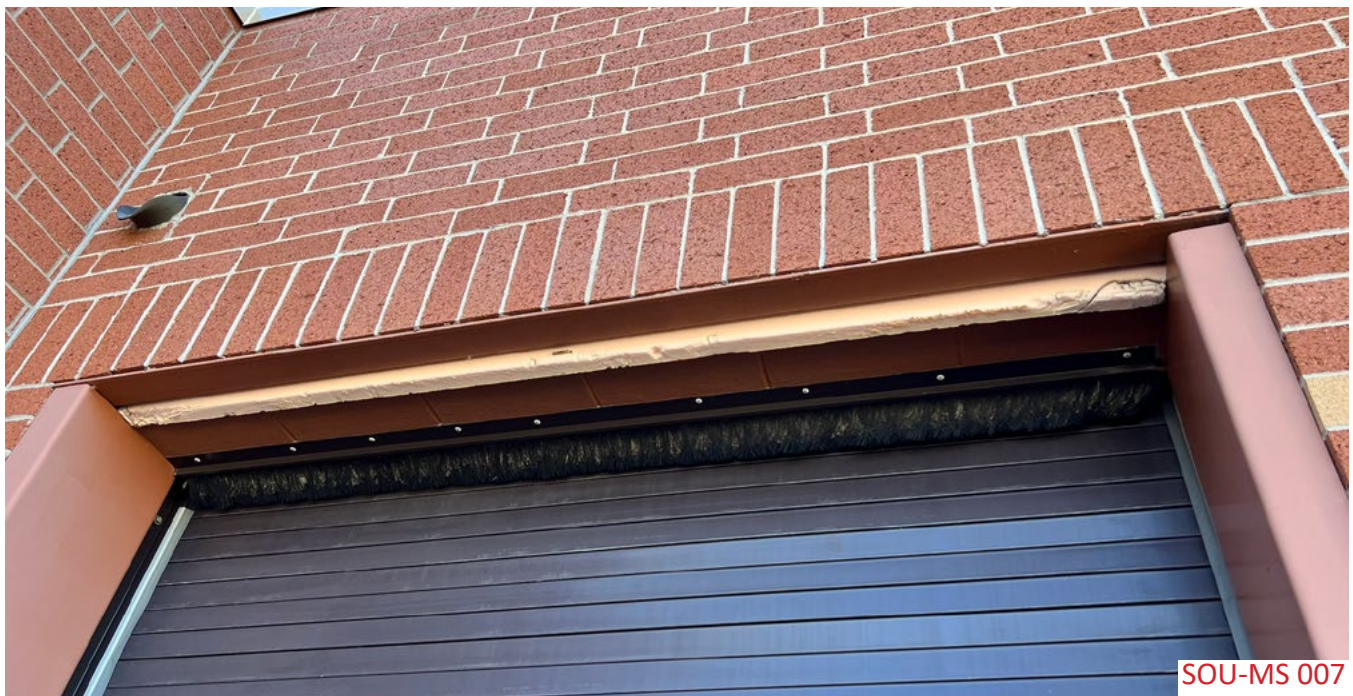
There is insulation of the brick wall exposed near Door 30 adjacent to the garage that needs a plate to be put on it to prevent future damage.

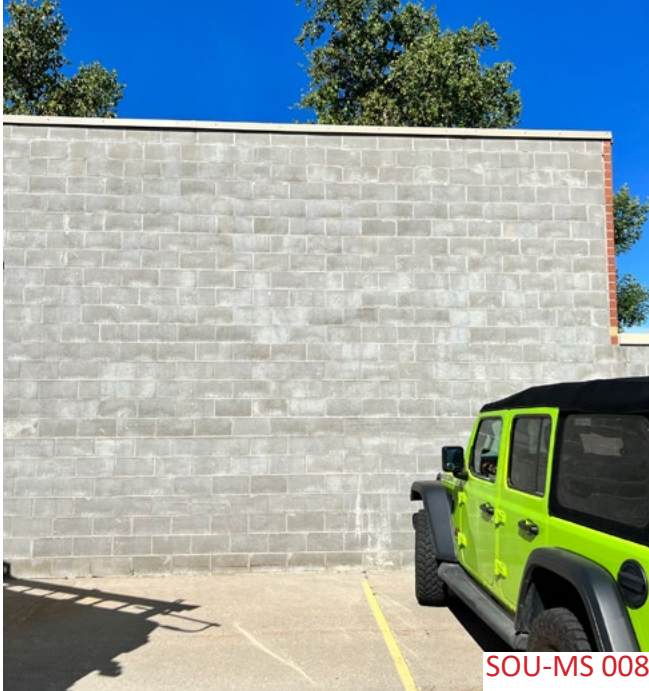
There is unpainted, exterior CMU brick near the receiving doors that should be painted to stop moisture from entering the bricks.

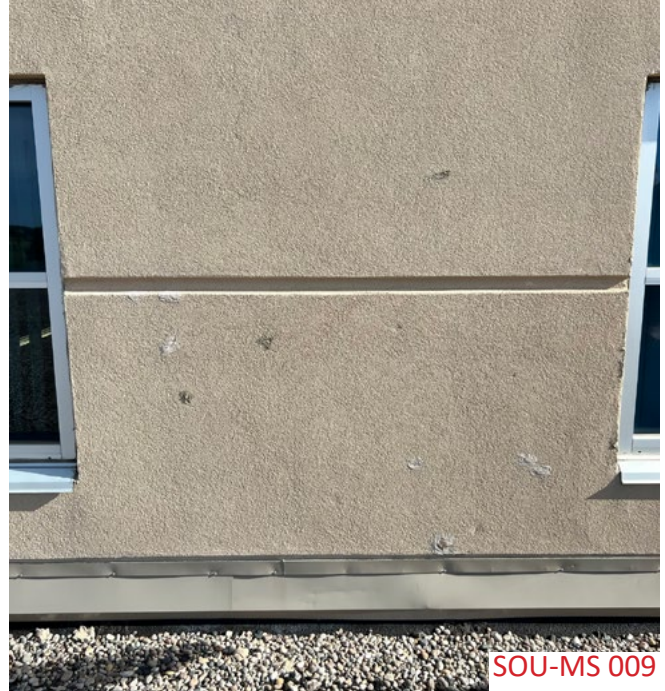
There is EIFS on the upper portions of the exterior walls that is cracking and peeling in many areas.

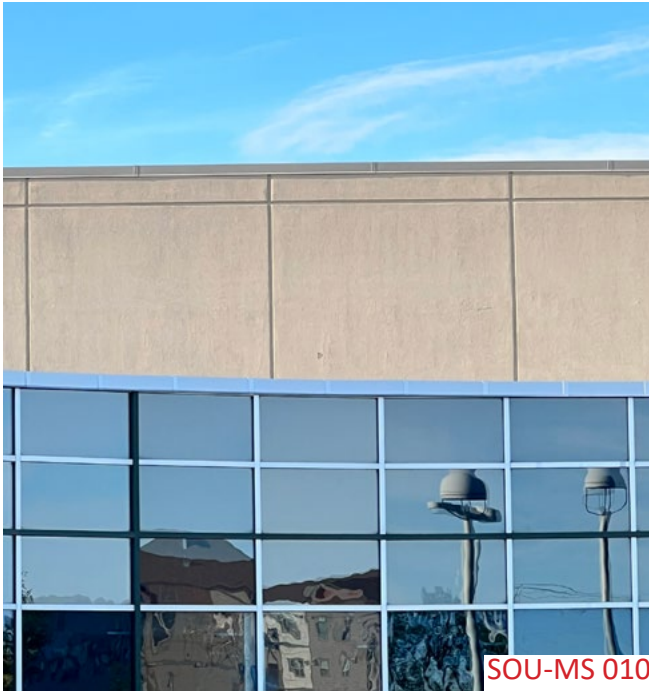
There is EIFS on the upper portions of the exterior walls that is cracking and peeling in many areas.

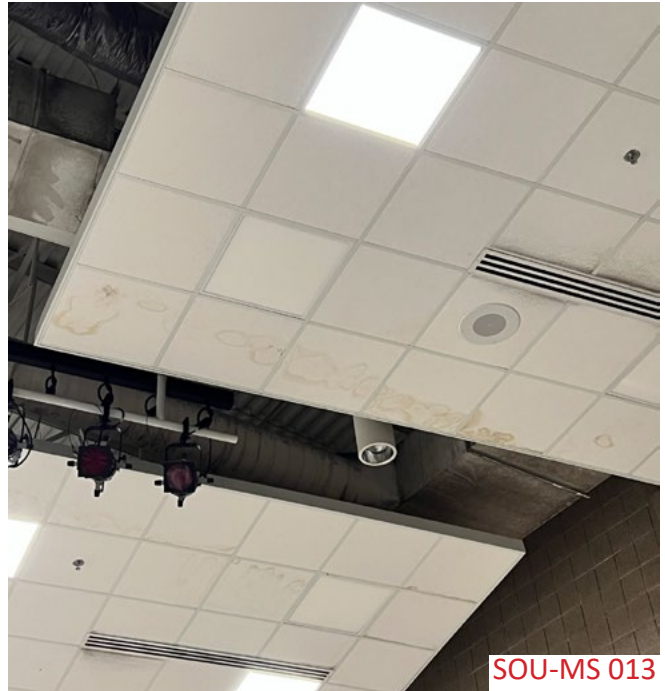
The Acoustical Ceiling Tile (ACT) is in good shape, but there is water damage in the cafeteria and replacement is advised.

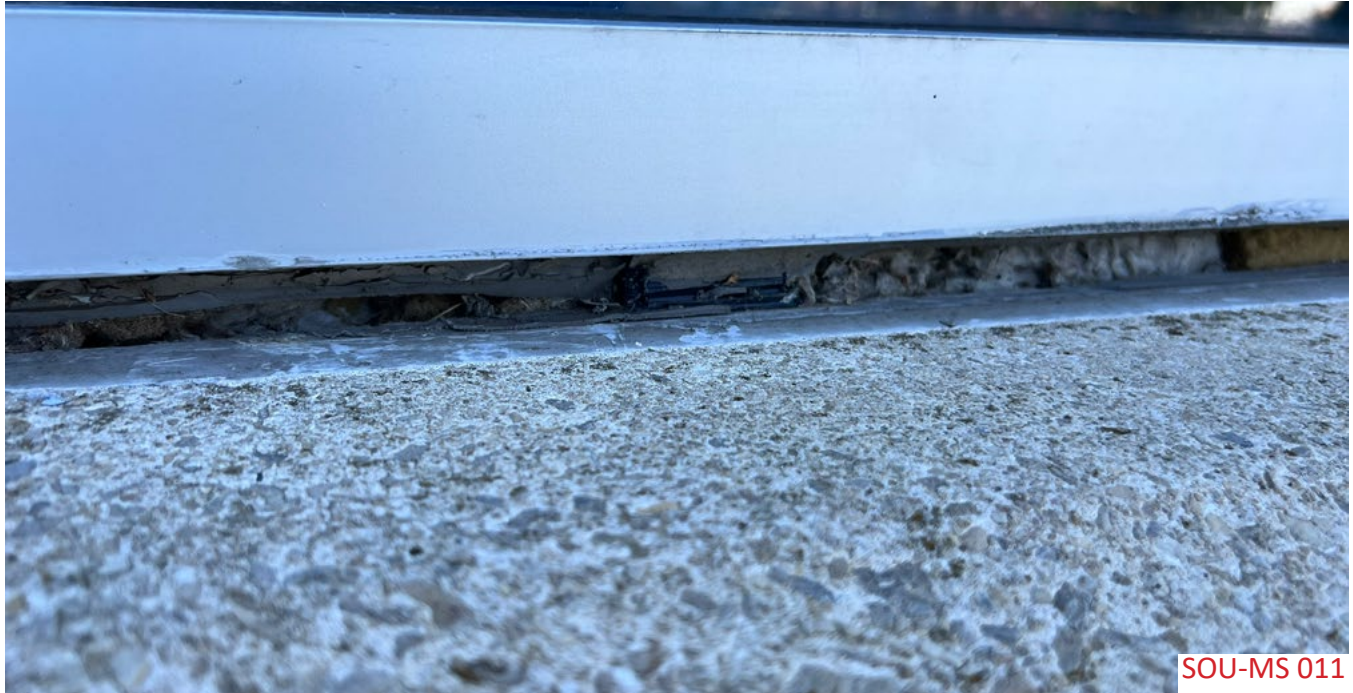
SOU-MS 011

The curved, curtain wall window in the main office does not have the proper drainage in the flashing and is poorly sealed underneath, allow cold air to enter in the winter.

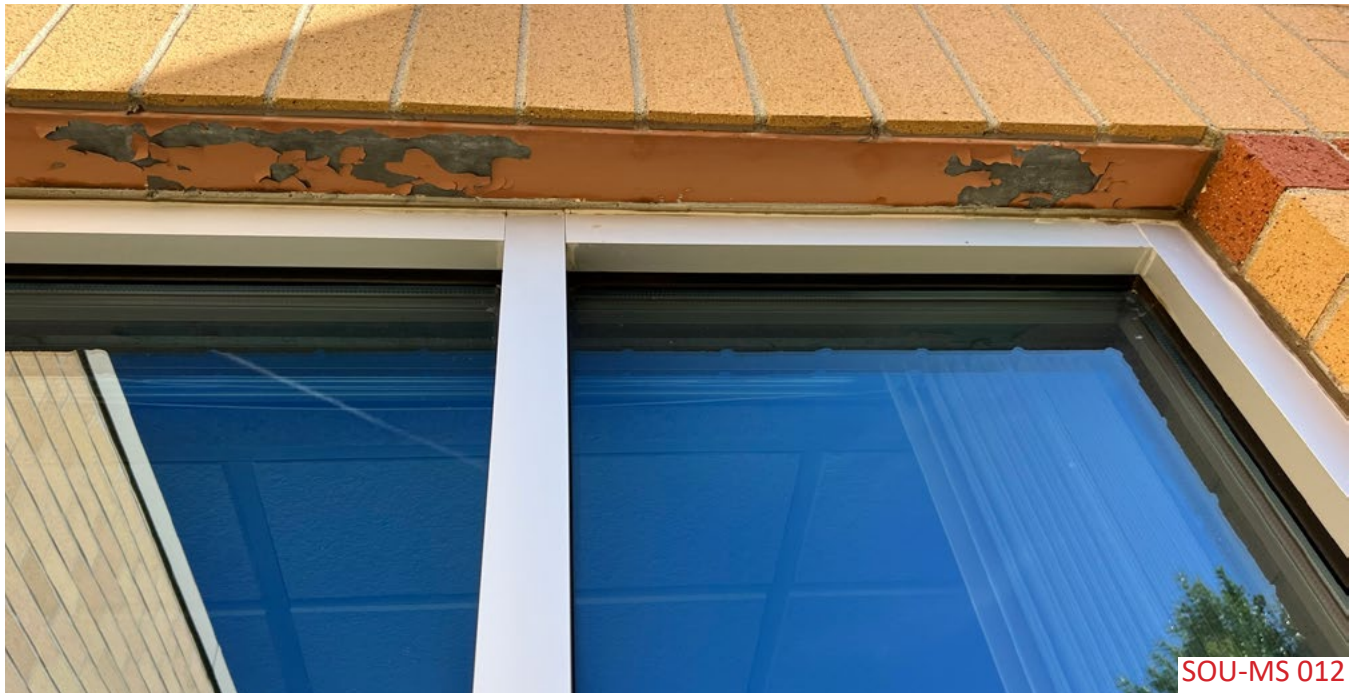
SOU-MS 012

All the metal lintels in the school need new paint as they are currently peeling and chipping.

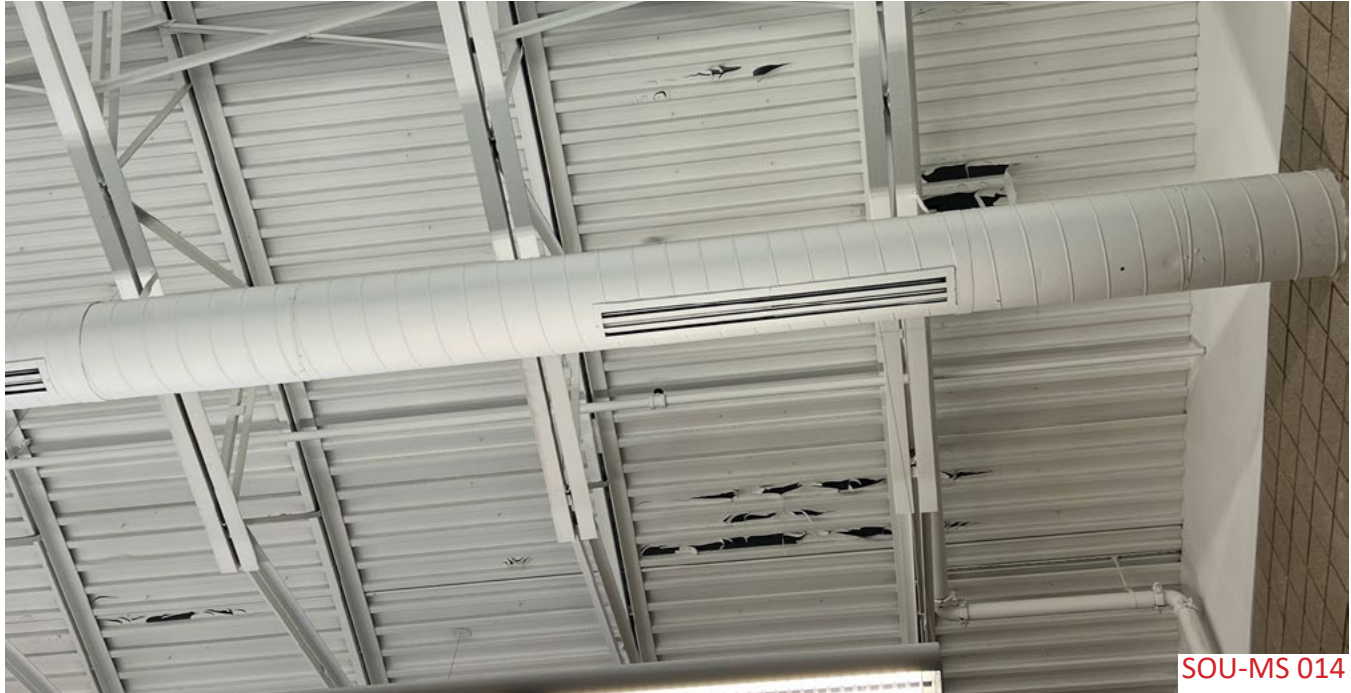
Another area of concern with ceiling is in the library where there is paint flaking from the steel deck paneling.

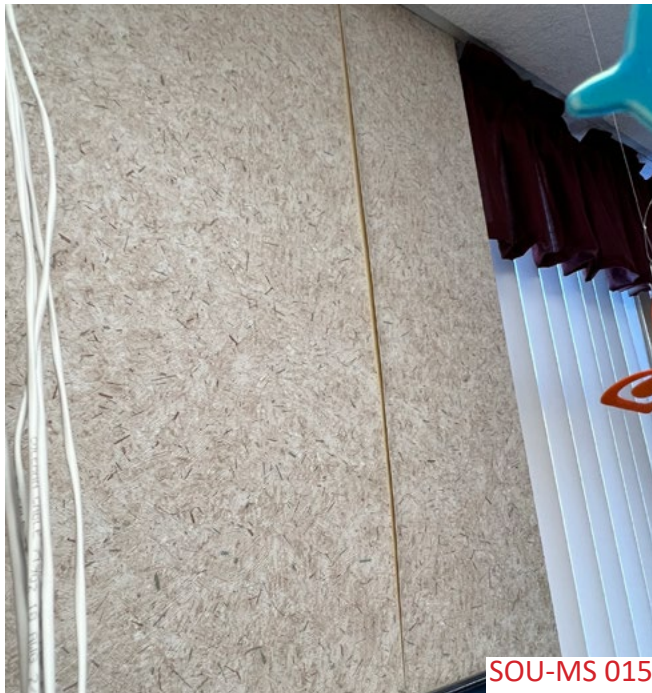
There are several areas where the vinyl wall covering is releasing from the gypsum substrate.

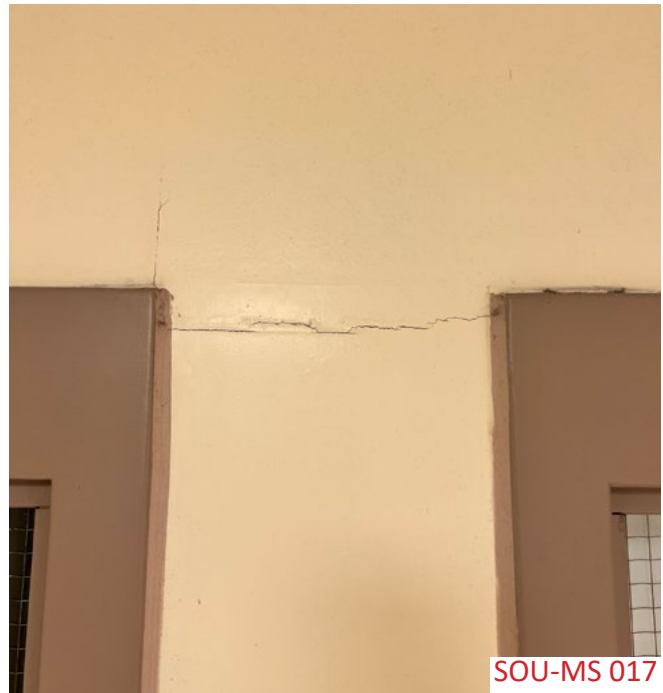
There is horizontal cracking on the dry wall between many of the interior doors.

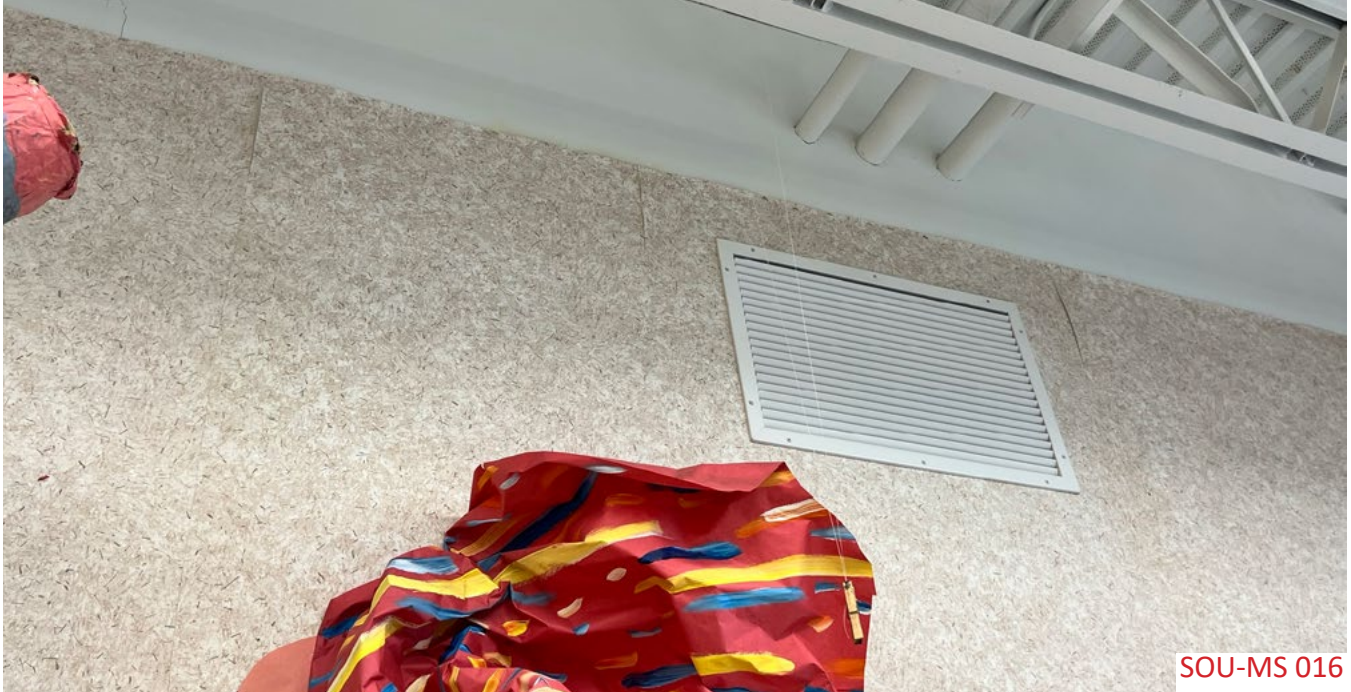
SOU-MS 016

There are several areas where the vinyl wall covering is releasing from the gypsum substrate.

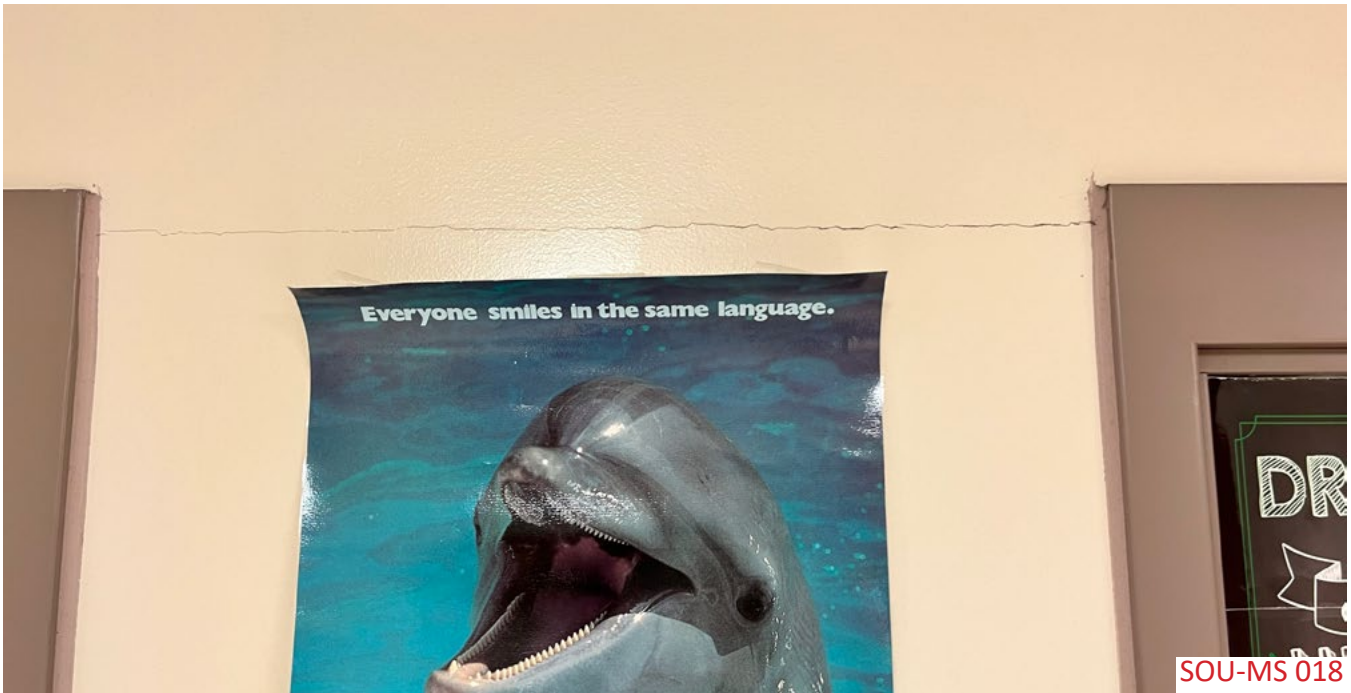
SOU-MS 018

There is horizontal cracking on the dry wall between many of the interior doors.

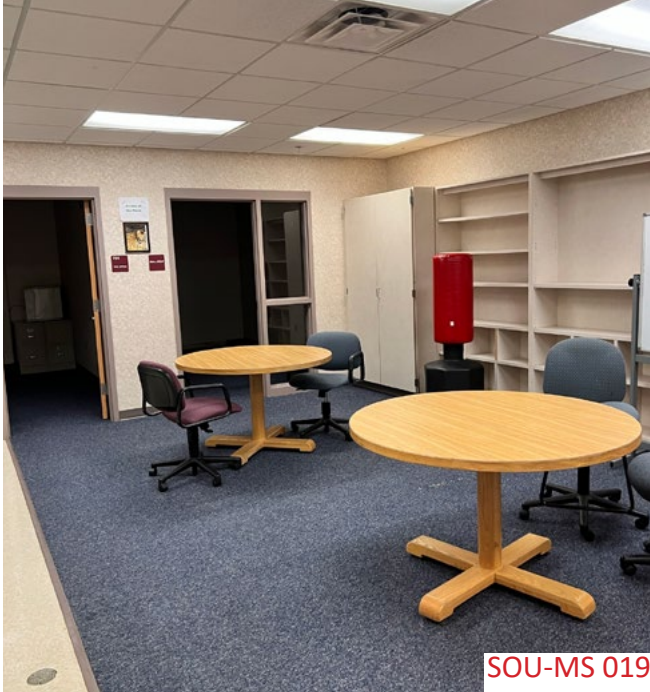
SOU-MS 019

Most of the hallways have new carpeting, but many of the classrooms still have original carpeting which is getting older and isn't in great shape

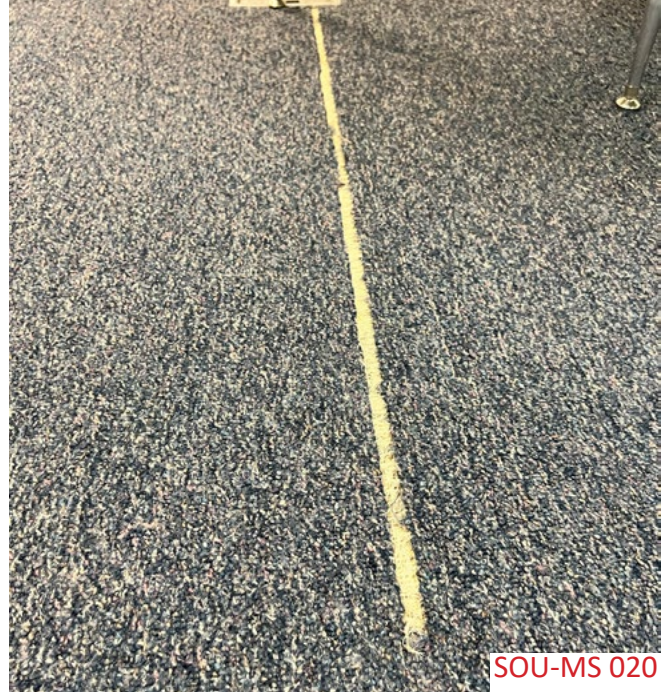
SOU-MS 020

Most of the hallways have new carpeting, but many of the classrooms still have original carpeting which is getting older and isn't in great shape

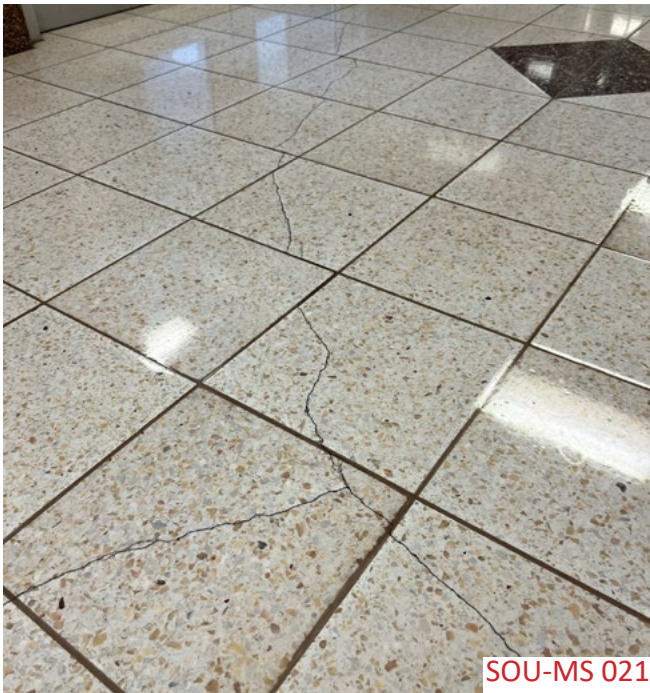
SOU-MS 021

The terrazzo tile in the hallways is beginning to crack

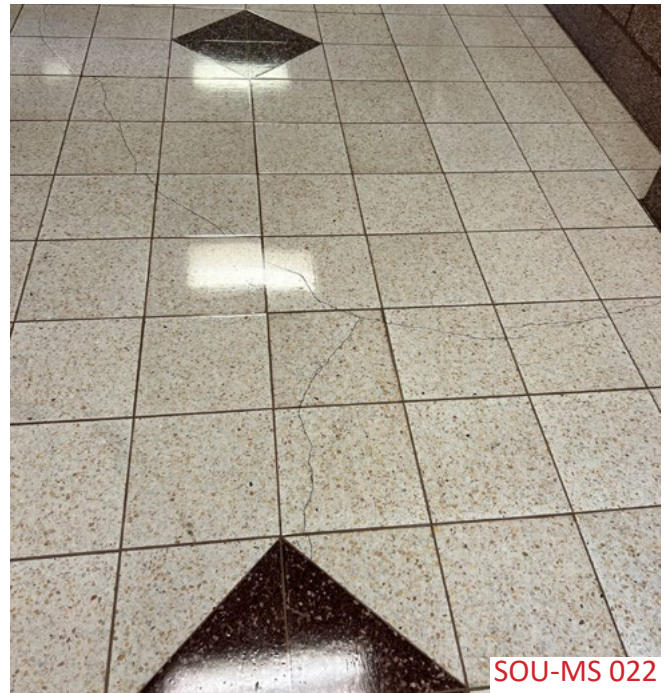
SOU-MS 022

The terrazzo tile in the hallways is beginning to crack

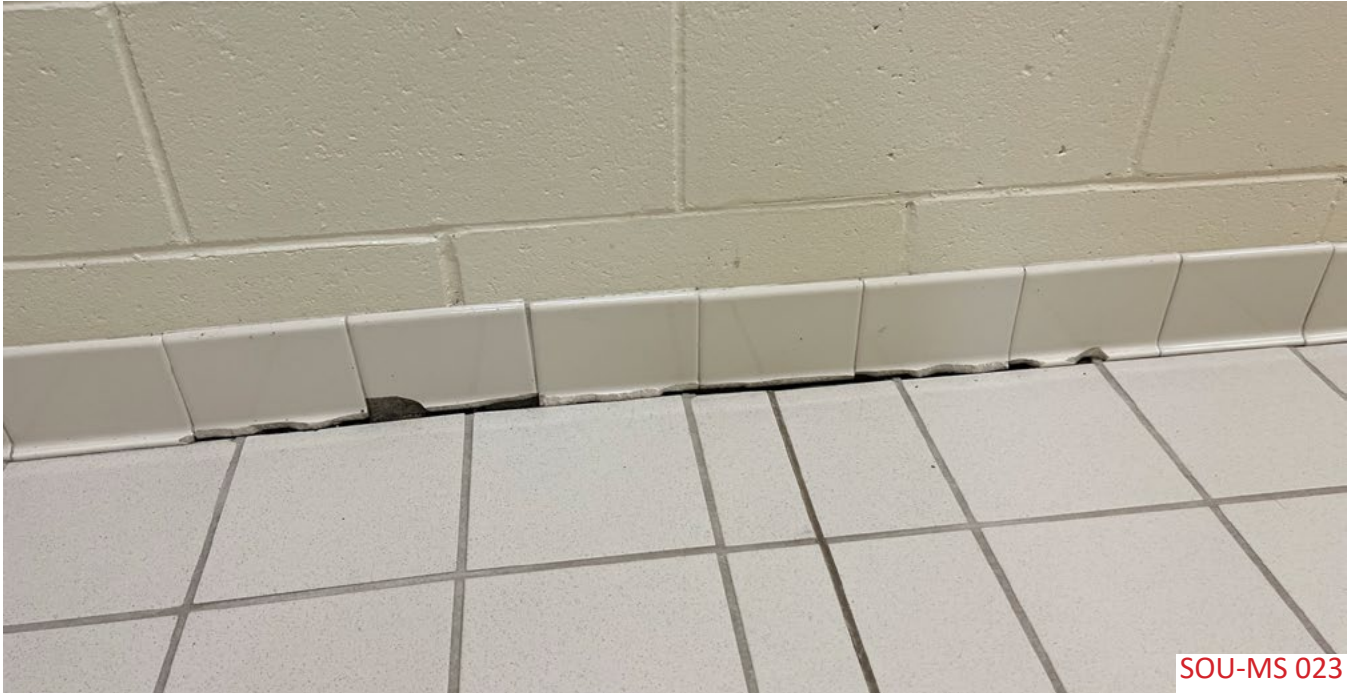
SOU-MS 023

The quarry and ceramic tiles in the kitchen and locker rooms could use general repair for problem spots, but do not have major issues.

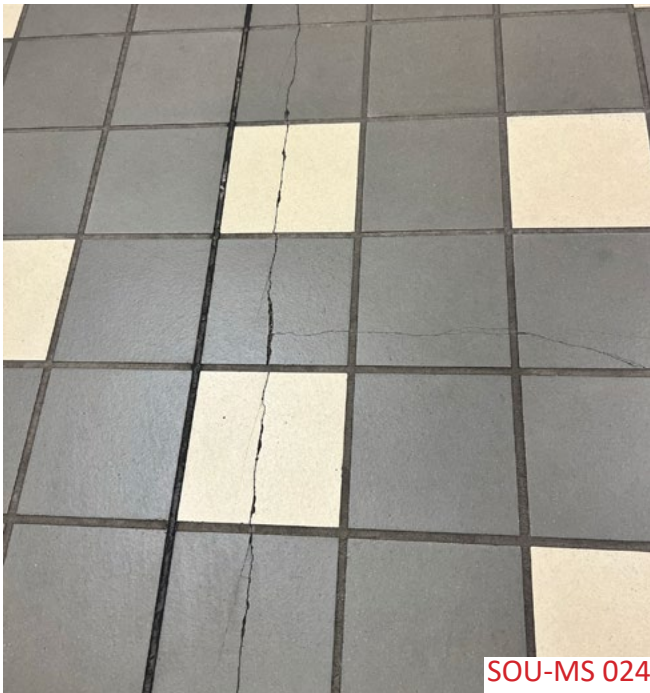
SOU-MS 024

The quarry and ceramic tiles in the kitchen and locker rooms could use general repair for problem spots, but do not have major issues

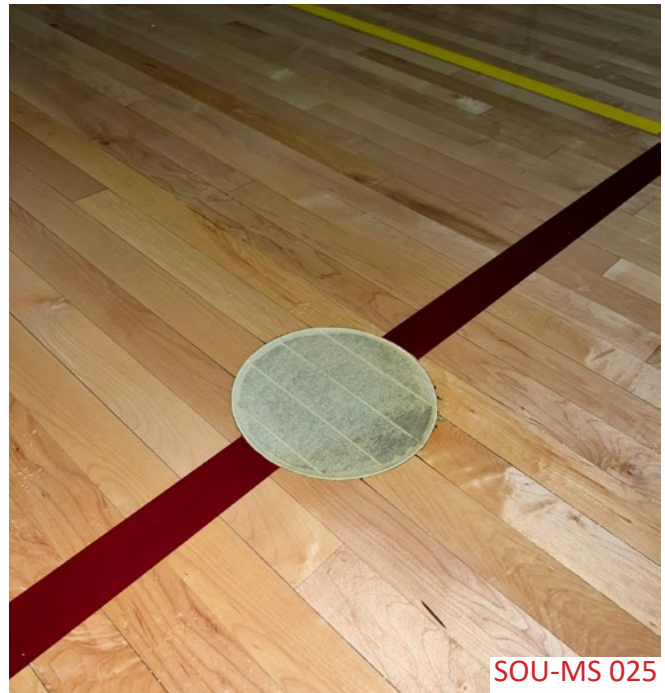
SOU-MS 025

The volleyball pole holes are not flush with the floor surrounding, which creates a tripping hazard.

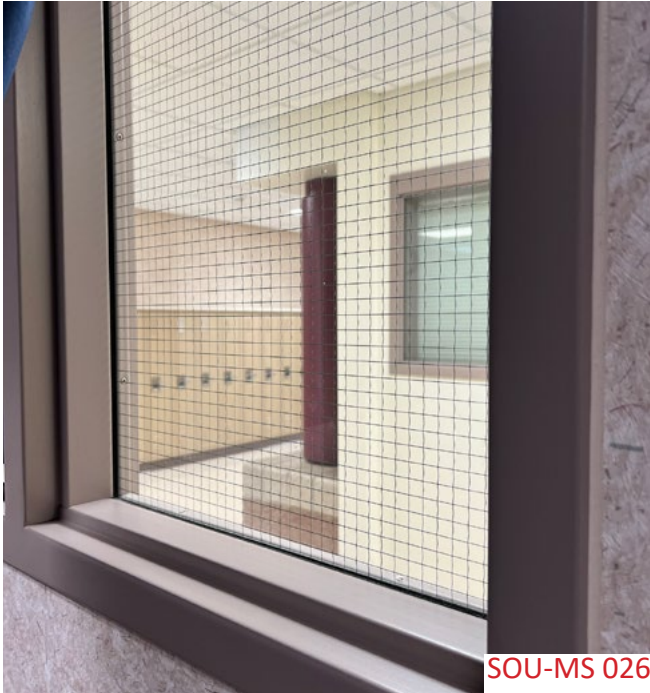
SOU-MS 026

Traditional wire glass throughout the building is no longer to code as an acceptable type of safety glass.

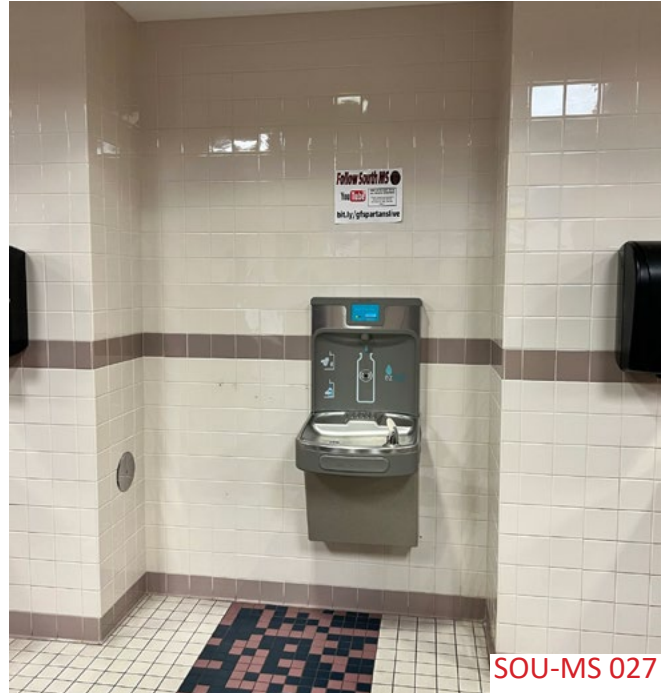
SOU-MS 027

Drinking fountains throughout the building do not meet the required ratio of wheelchair accessible fountains to standing person accessible fountains.

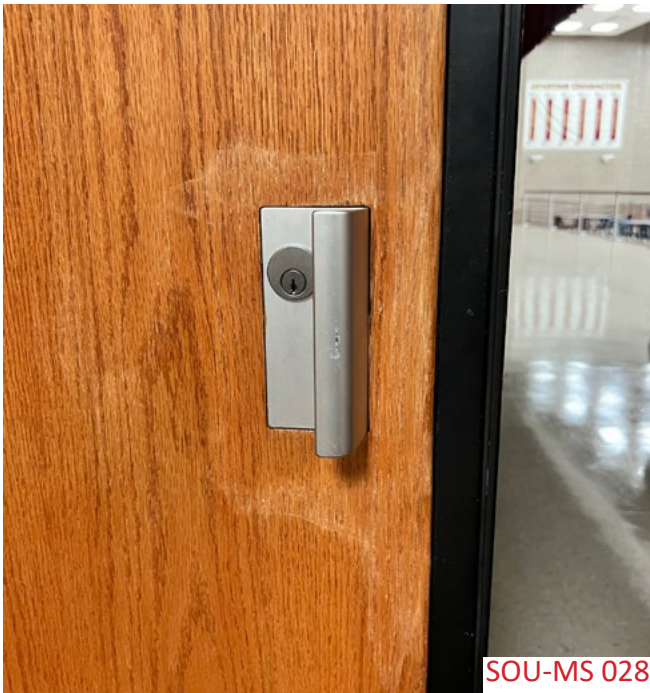
SOU-MS 028

Door 25 is not protected with an enclosed vestibule, as required by energy code.
Door hardware on doors to the stage is not accessible.

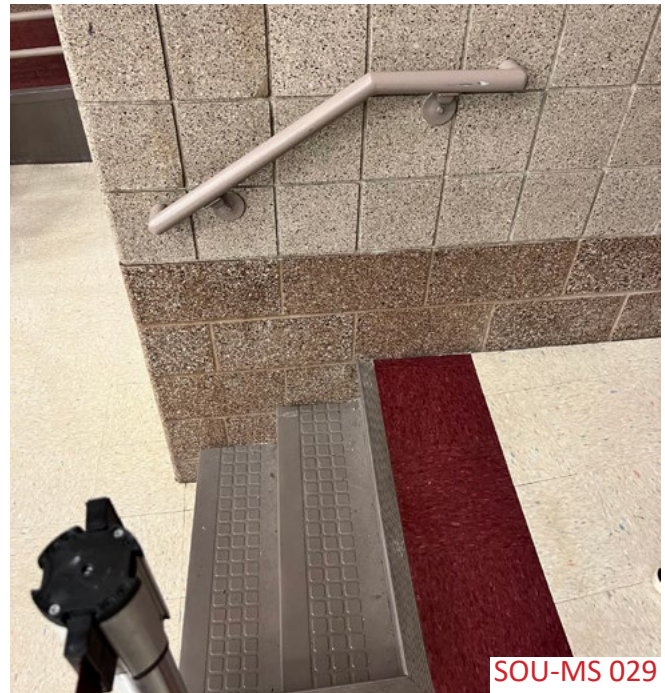
SOU-MS 029

Handrails on the stairs up to the stage do not provide the code required extensions at the top and bottom of the stairs.

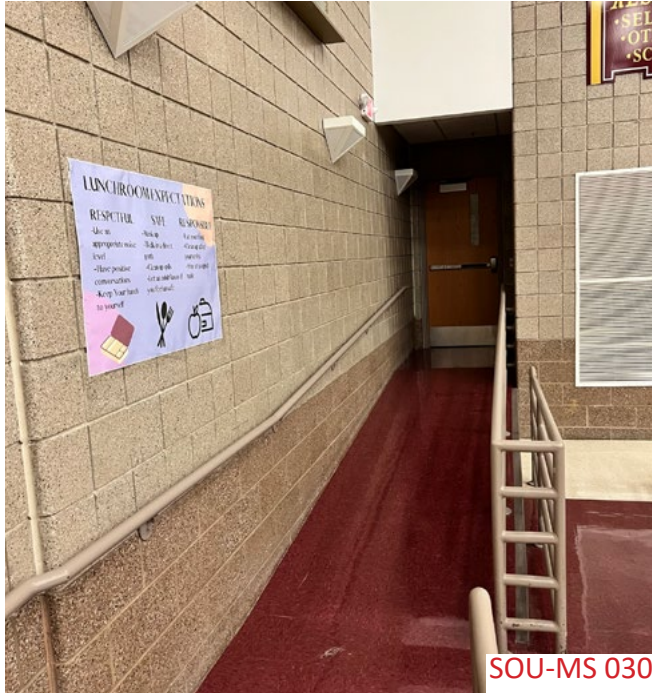
SOU-MS 030

Guardrails for ramps in the cafeteria do not meet height requirements and are lacking a separate handrail.

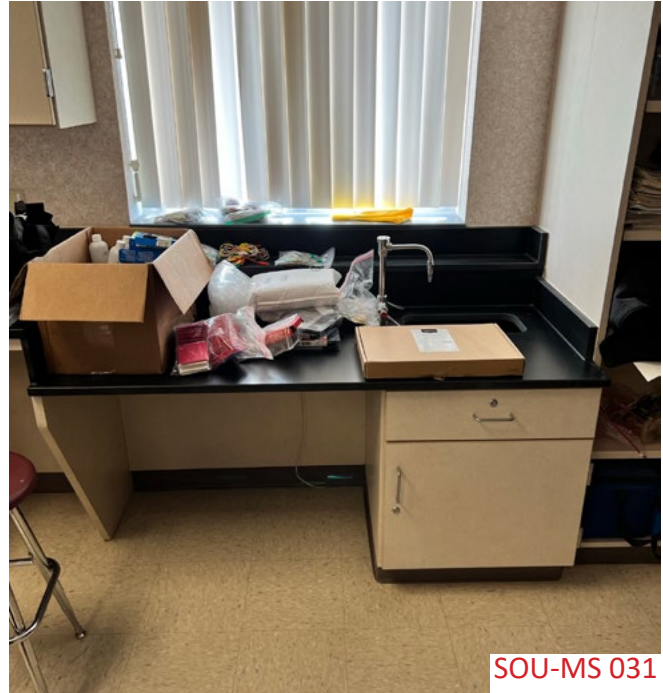
SOU-MS 031

The lower sink in the science lab is not accessible, as it exceeds reach range requirements and has no knee and toe clearance.

Create an accessible sink and workstation in the science lab	7	1 Ea.	\$7,654.74 /Ea.	\$7,655					\$7,655
Remove and replace concrete in locker rooms showers so each individual showerhead can have its own drain per code	8	2 Ea.	\$73,711.64 /Ea.	\$147,423				X	\$147,423
Remove vinyl wall coverings from the inside of exterior walls that is creating a double vapor barrier, skim coat existing sheetrock and paint	9	12,060 SF	\$7.16 /SF	\$86,350					\$86,350
Remodel the shower in the PE staff locker room to meet clearances for accessibility	10	1 Ea.	\$43,951.64 /Ea.	\$43,952					\$43,952
Total Code Compliance		130,780 SF	\$3.52 /SF	\$460,392	\$0	\$0	\$0		\$460,392
Security									
Administration Office Entry Remodel	11	952 SF	\$101.40 /SF				\$96,529		\$96,529
Total Security		952 SF	\$101.40 /SF	\$0	\$0	\$0	\$96,529		\$96,529
Addition/Remodel (Educational Adequacy)									
Administration	12	SF	\$339.20 /SF				\$0		\$0

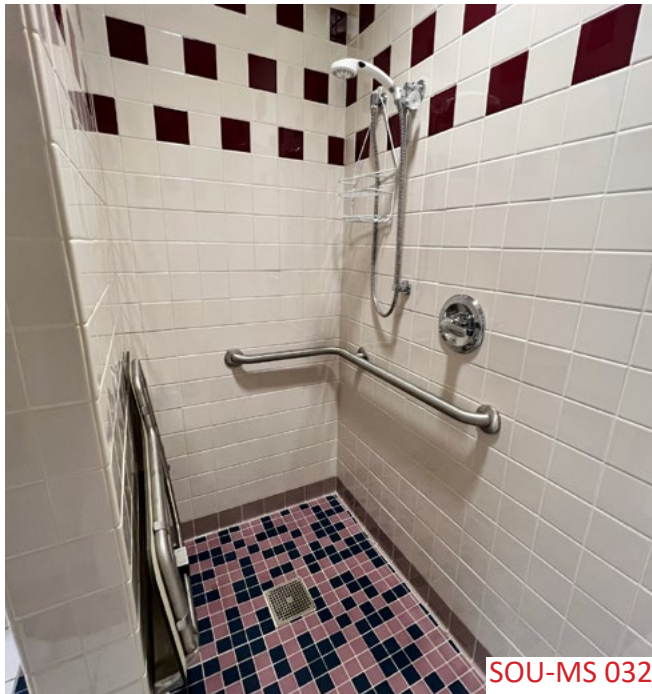
SOU-MS 032

The shower in the PE staff locker room does not have sufficient clearances for accessibility.

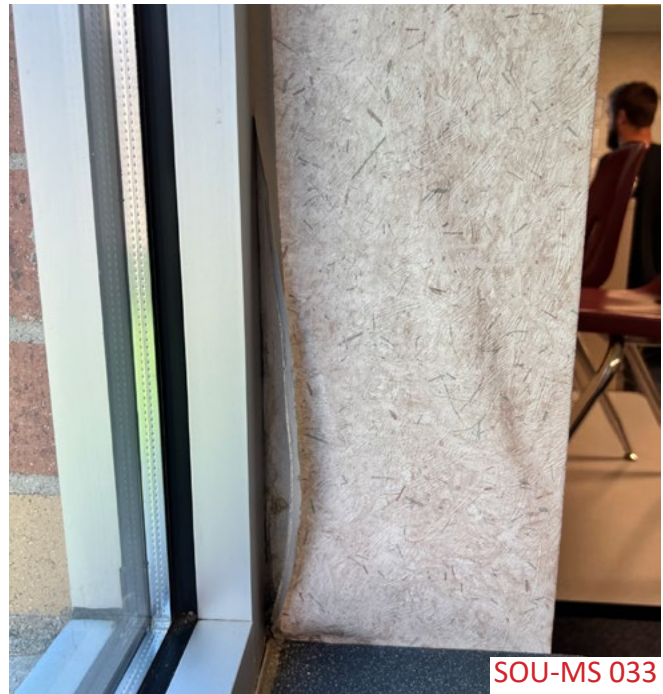
SOU-MS 033

Portions of exterior walls are covered with vinyl wall covering on the interior side, which is not to code.
