VALLEY MIDDLE SCHOOL

A. EXISTING BUILDING INVENTORY

INTERIOR AND EXTERIOR EXISTING DEFICIENCIES PHOTOS

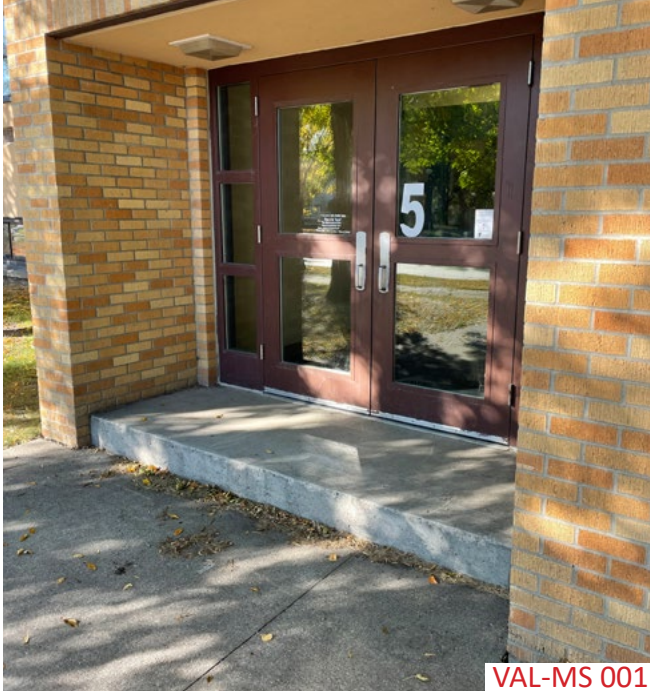
VAL-MS 001

There are accessibility issues at most exterior doors as a step up is required to enter the building.

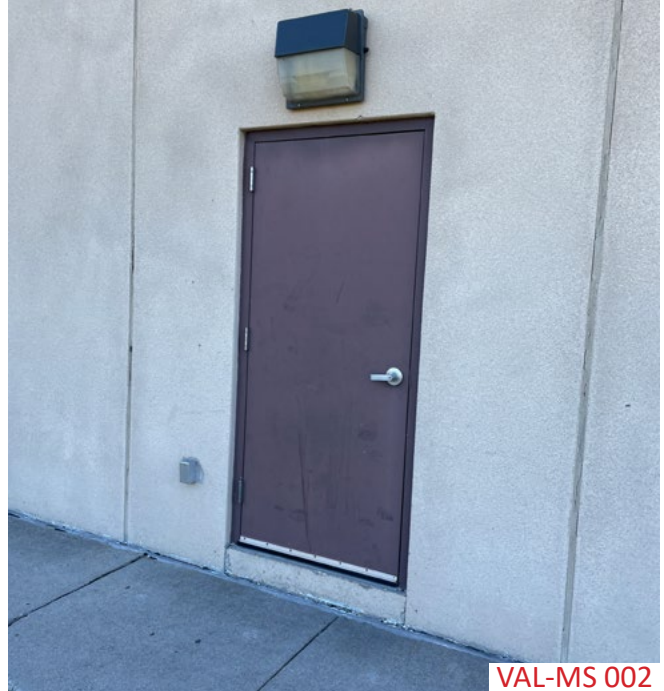
VAL-MS 002

There are accessibility issues at most exterior doors as a step up is required to enter the building.

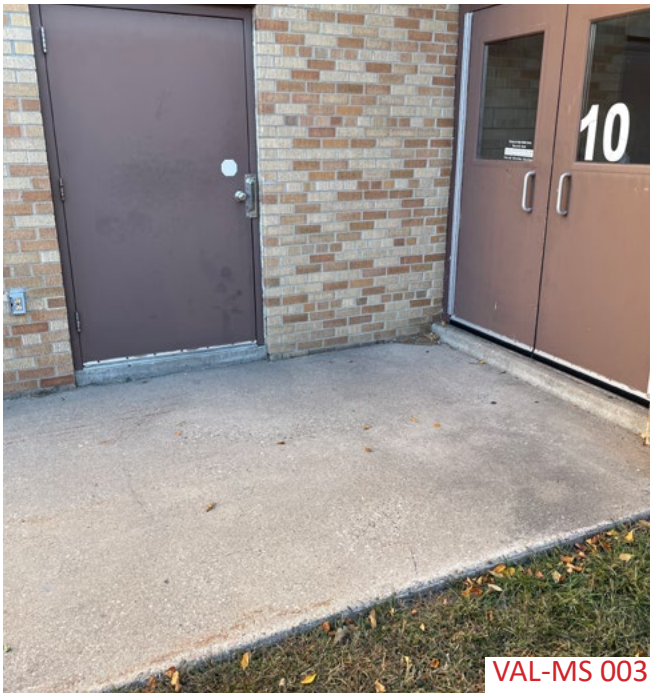
VAL-MS 003

There are accessibility issues at most exterior doors as a step up is required to enter the building.

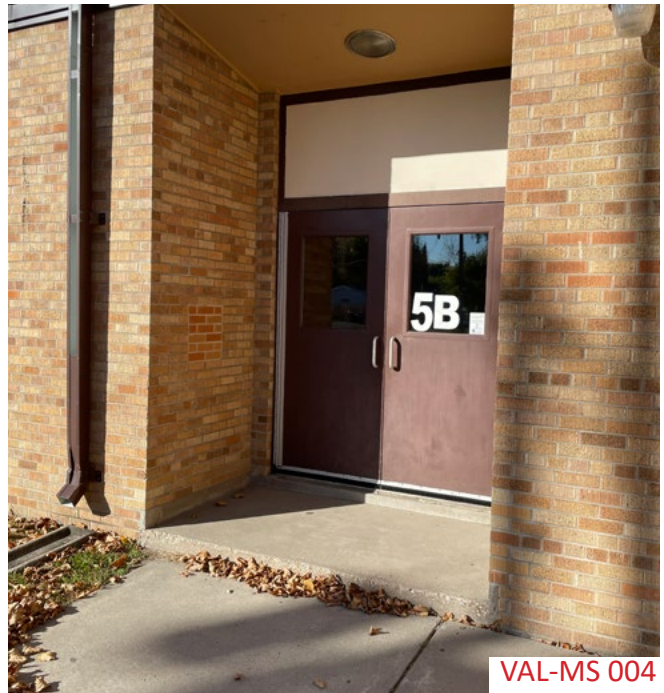
VAL-MS 004

There are accessibility issues at most exterior doors as a step up is required to enter the building.

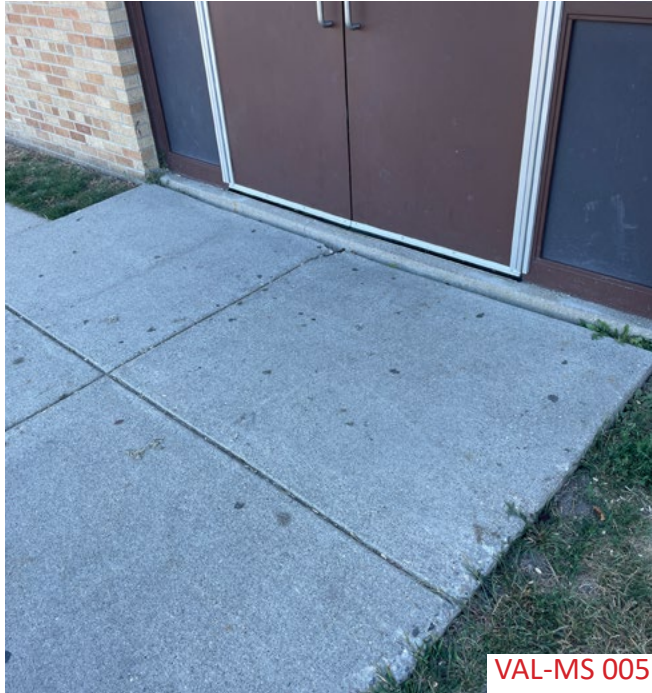
VAL-MS 005

The stoop at the exterior door in the corridor outside the library is sinking and pulling away from the door sill causing gaps at the threshold.

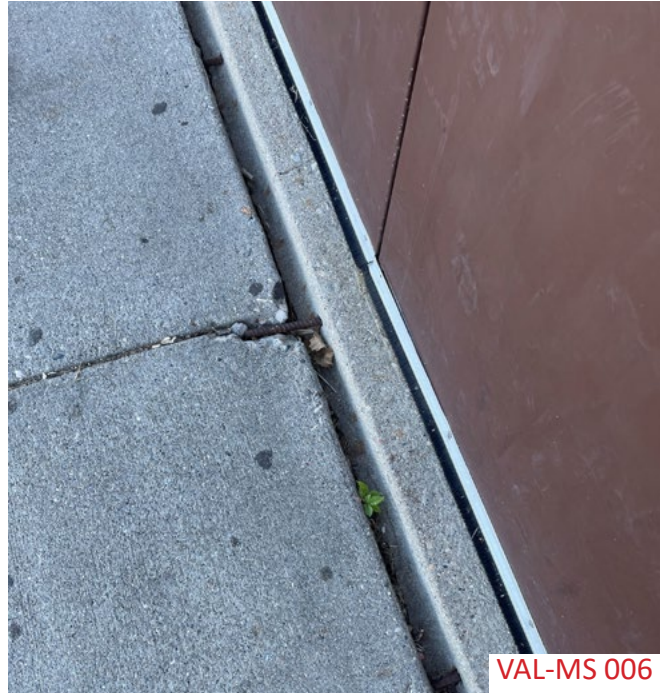
VAL-MS 006

The stoop at the exterior door in the corridor outside the library is sinking and pulling away from the door sill causing gaps at the threshold.

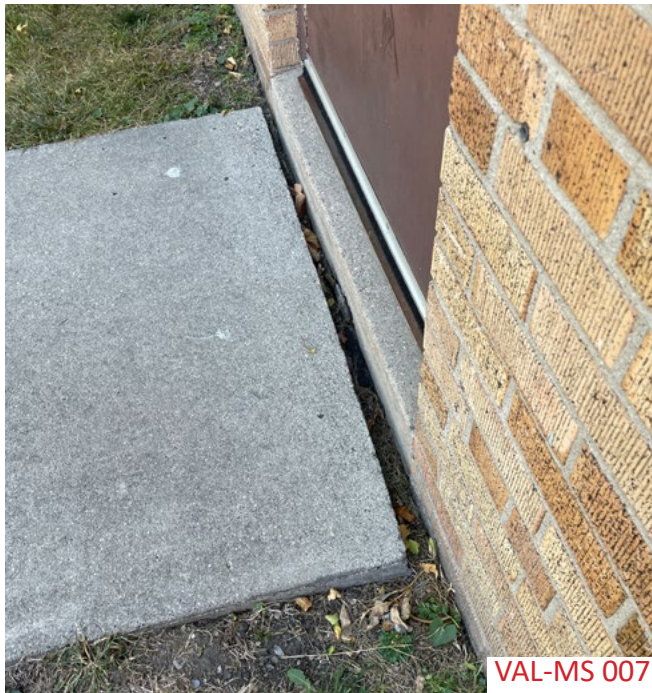
VAL-MS 007

The same issue is apparent at other doors where there isn't a proper stoop tied in.

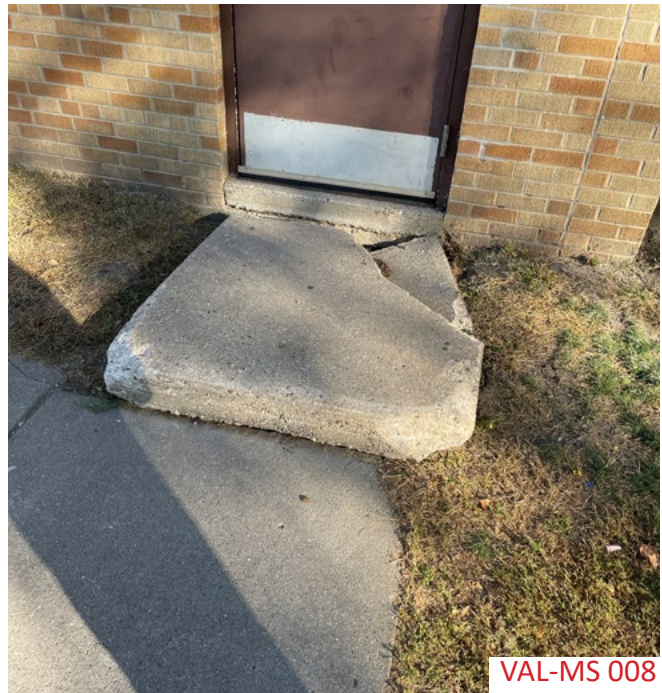
VAL-MS 008

The stoop outside the southeast door of the small gymnasium is in very bad shape and needs to be replaced.

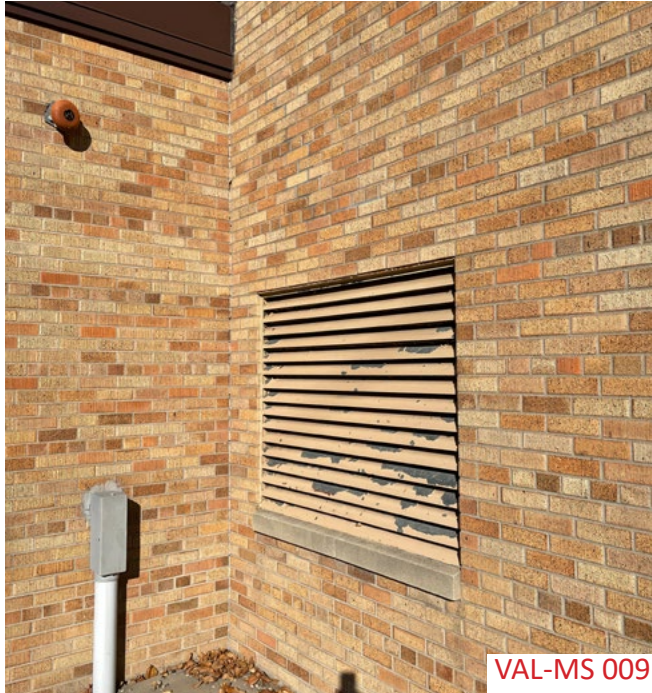
VAL-MS 009

Louvres around the exterior of the building should be repainted.

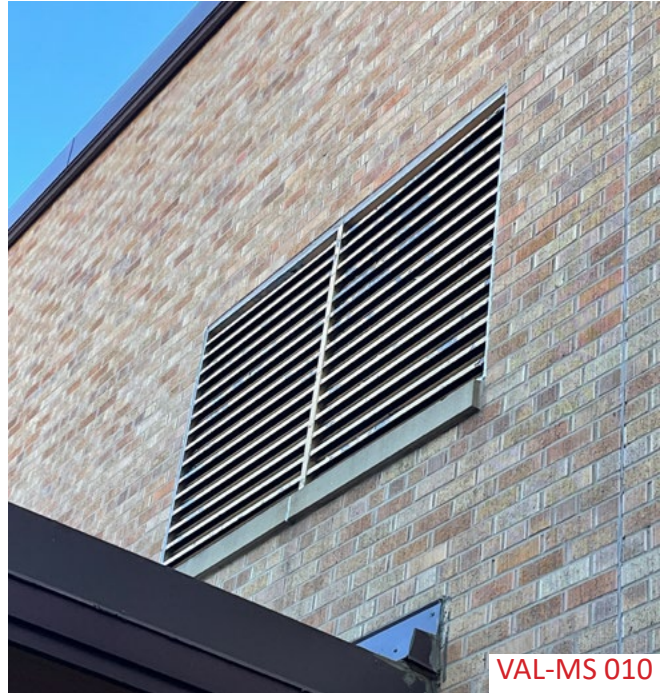
VAL-MS 010

Louvres around the exterior of the building should be repainted.

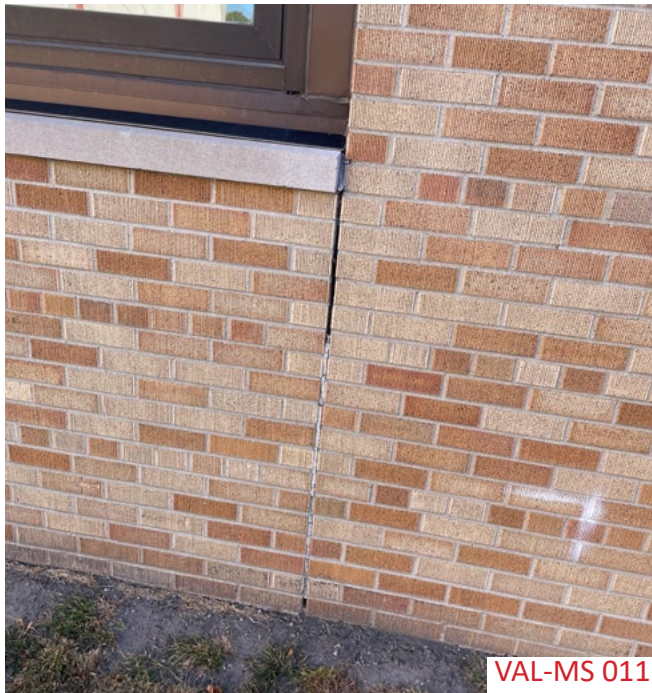
VAL-MS 011

The brick is in good condition overall, but caulking is wearing and needs attention.

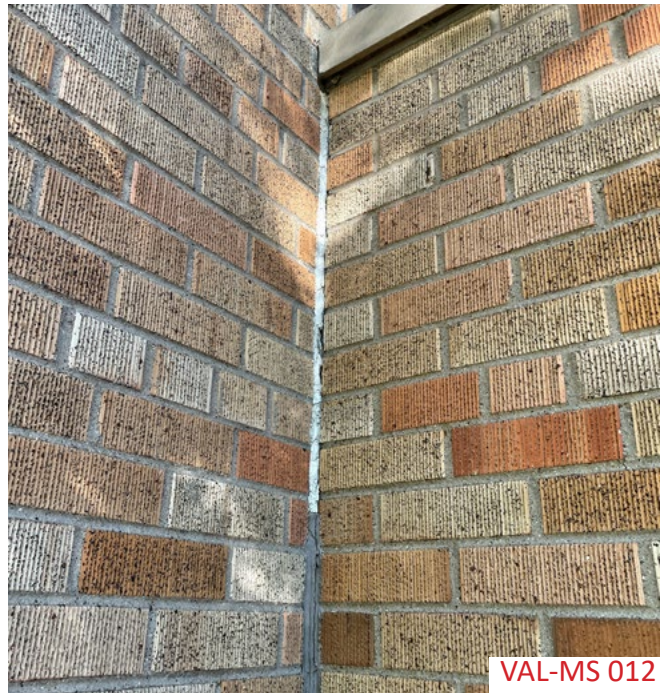
VAL-MS 012

The brick is in good condition overall, but caulking is wearing and needs attention.

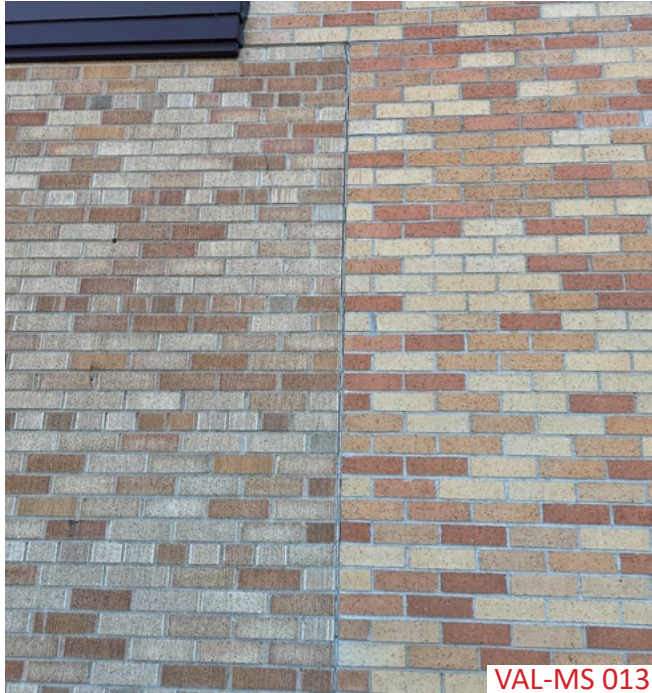
VAL-MS 013

The brick is in good condition overall, but caulking is wearing and needs attention.

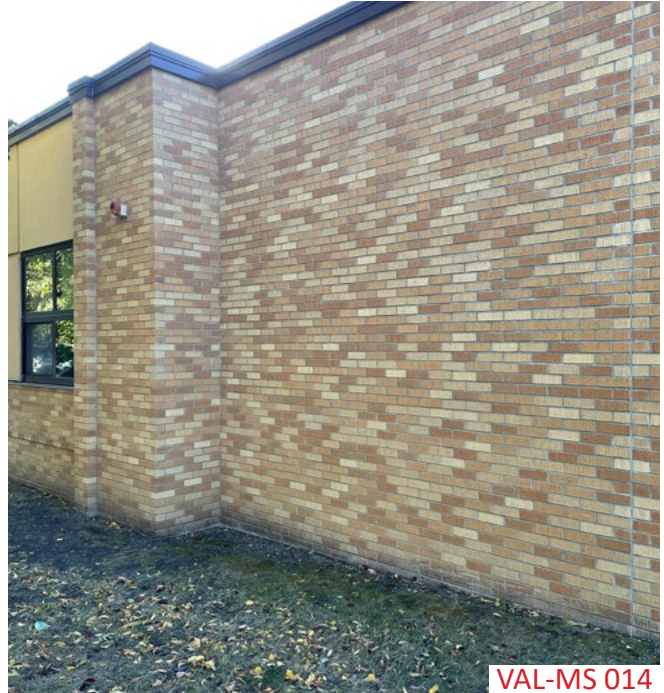
VAL-MS 014

The first few courses of brick around the building are dirty and should be cleaned.

The brick is in good condition overall, but caulking is wearing and needs attention (011, 012, 013). The first few courses of brick around the building are dirty and should be cleaned (014). A mowing strip should be installed to prevent this issue in the future.

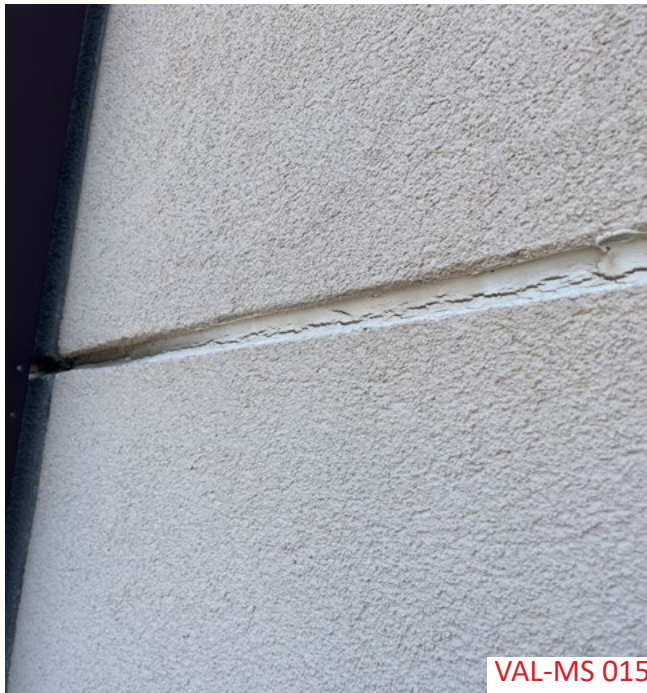
VAL-MS 015

Caulking is wearing and should be redone on EIFS walls.

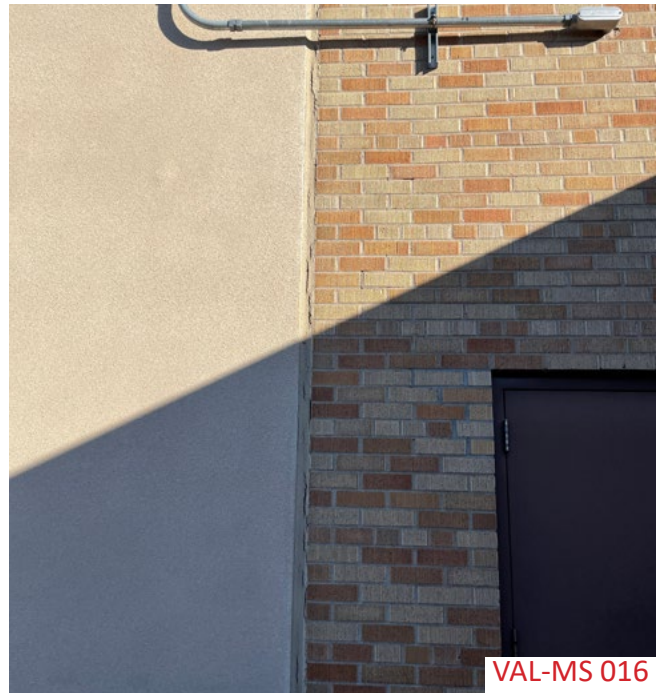
VAL-MS 016

Caulking is wearing and should be redone on EIFS walls and where the EIFS meets the brick.

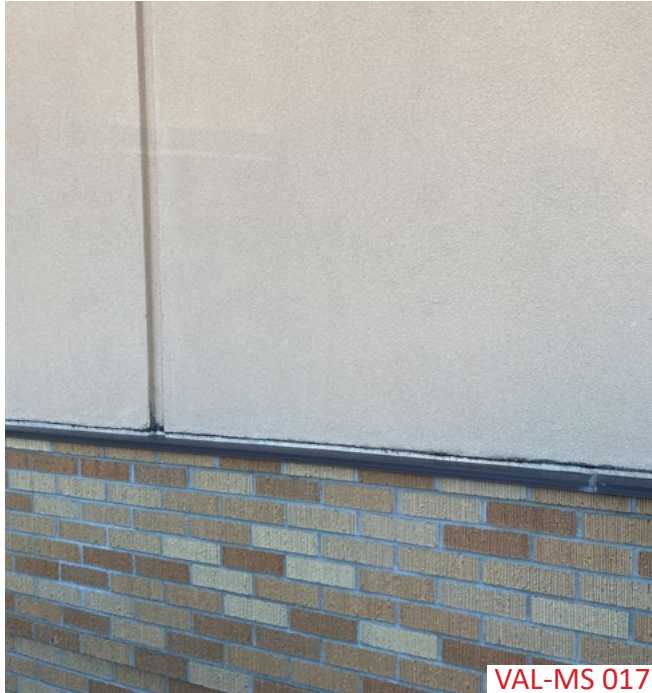
VAL-MS 017

The flashing around the bottom of the EIFS is not sufficiently running away from the wall.

Replace the flashing around the bottom of the EIFS that is not sufficiently running away from the wall	63	1 Ea.	\$76,379.74 / Ea.	\$76,380					\$76,380
Patch and refinish the damaged EIFS band beneath the windows in the north parking lot	64	1 Ea.	\$9,843.64 / Ea.	\$9,844					\$9,844
Paint the exposed trim boards around the top of the brick walls	65	1 Ea.	\$6,417.64 / Ea.	\$6,418					\$6,418
Fill the gaps in the exterior soffit	66	1 Ea.	\$16,743.74 / Ea.	\$16,744					\$16,744
Remove and replace hardboard siding with metal wall panel	67	1 Ea.	\$54,328.23 / Ea.	\$54,328					\$54,328
Exterior Upgrades Subtotal		77,911 SF	\$55.59 / SF						\$4,331,125
Electrical Upgrades									
Replace branch panels throughout building that are noted to be very old that are nearing the end of their useful life	68	77,911 SF	\$3.45 / SF	\$268,702					\$268,702
Add additional outlets throughout the school and upgrade related circuits as needed	69	77,911 SF	\$11.91 / SF	\$928,244					\$928,244

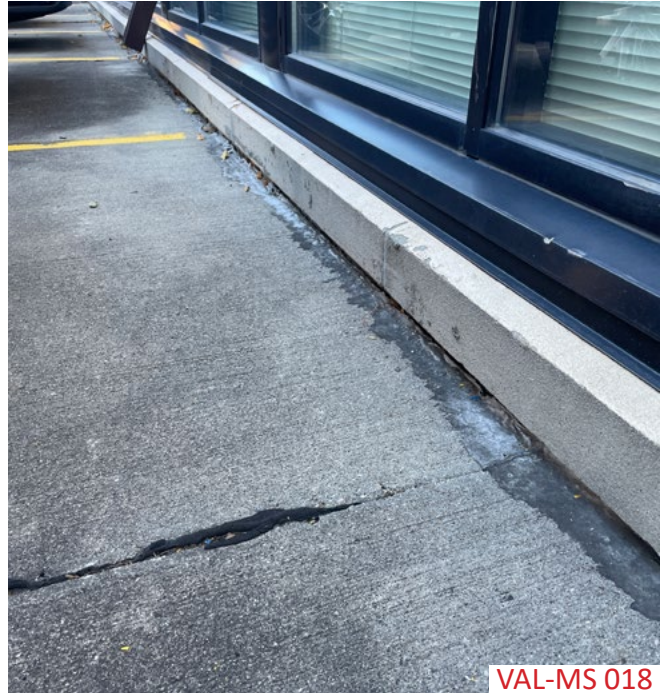
VAL-MS 018

The EIFS band beneath the windows in the north parking lot is damaged and should be refinished.

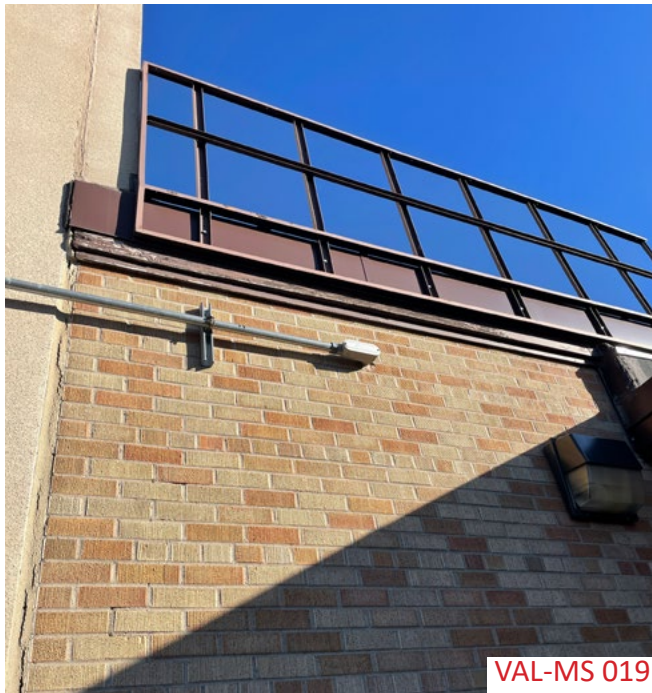
VAL-MS 019

The exposed trim board around the top of the brick walls should be repainted.

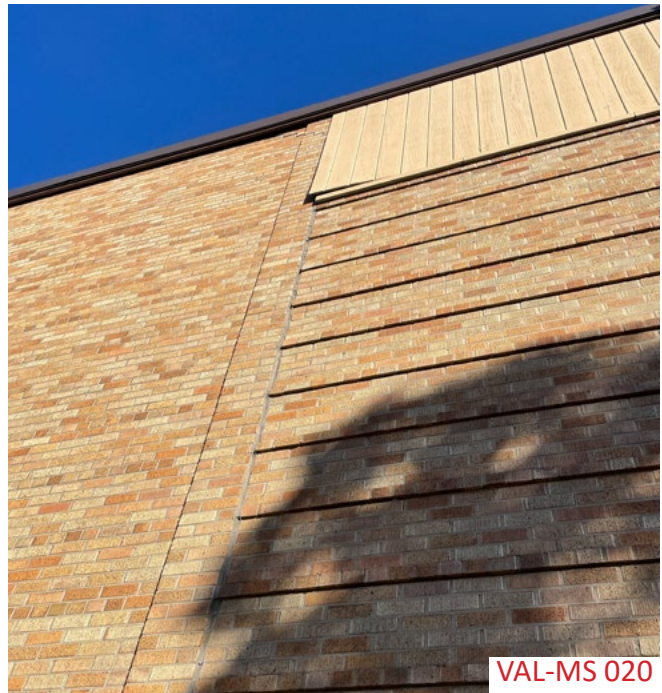
VAL-MS 020

Wood paneling above the brick at the south exterior wall of the gymnasium is pulling away and needs attention.

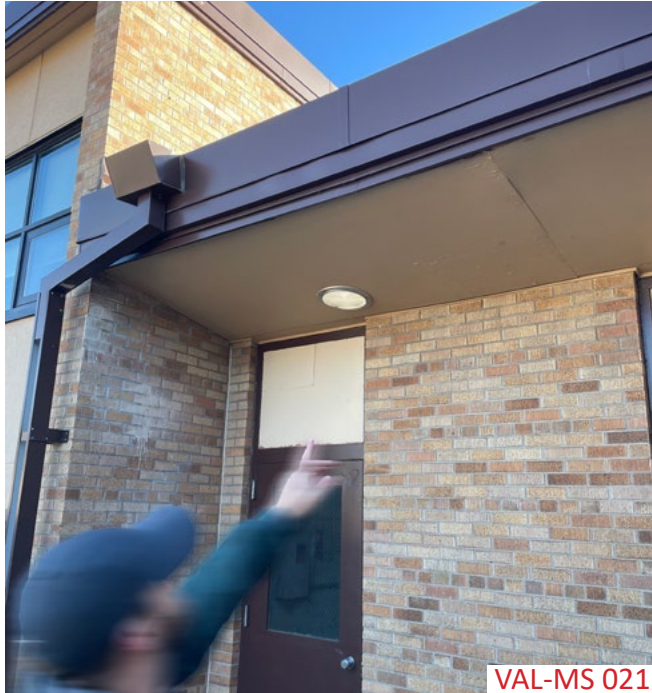
VAL-MS 021

Painted plywood around the exterior of the building is damaged and deteriorating.

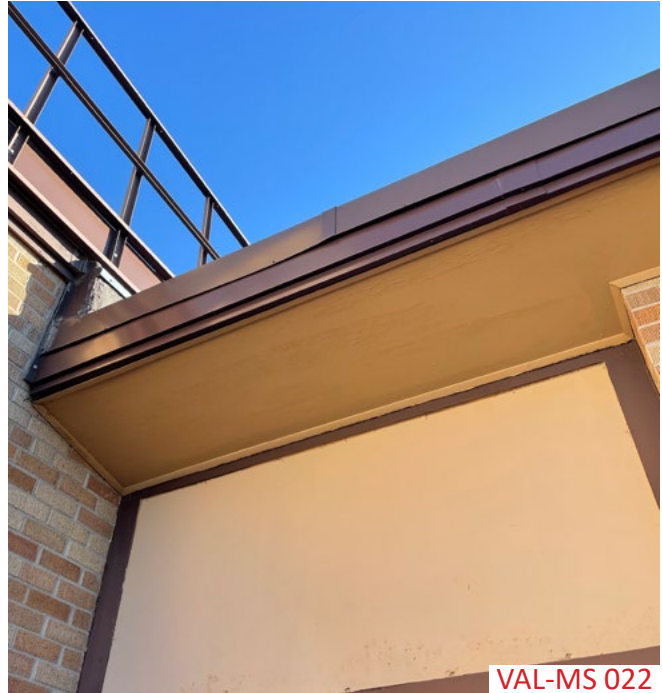
VAL-MS 022

Painted plywood around the exterior of the building is damaged and deteriorating and shows signs of water damage above the exterior door between classroom D2 and the food service building.

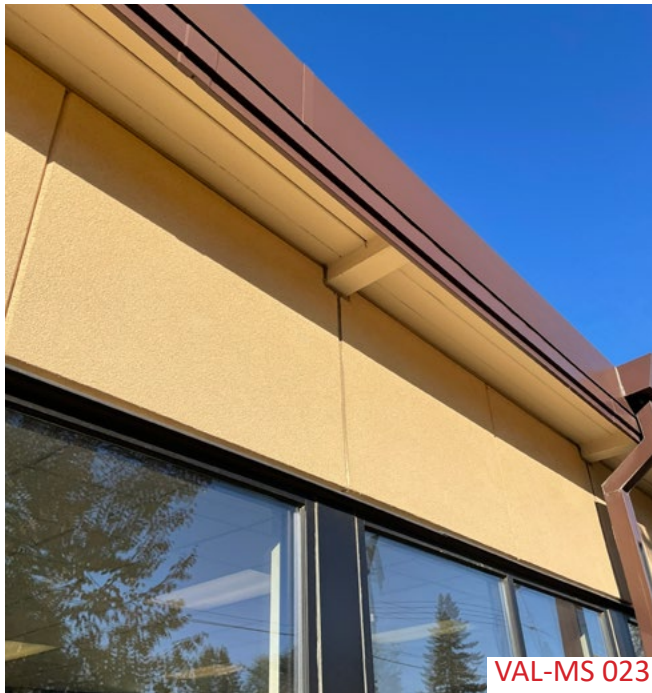
VAL-MS 023

There are gaps in the soffit that need to be addressed.

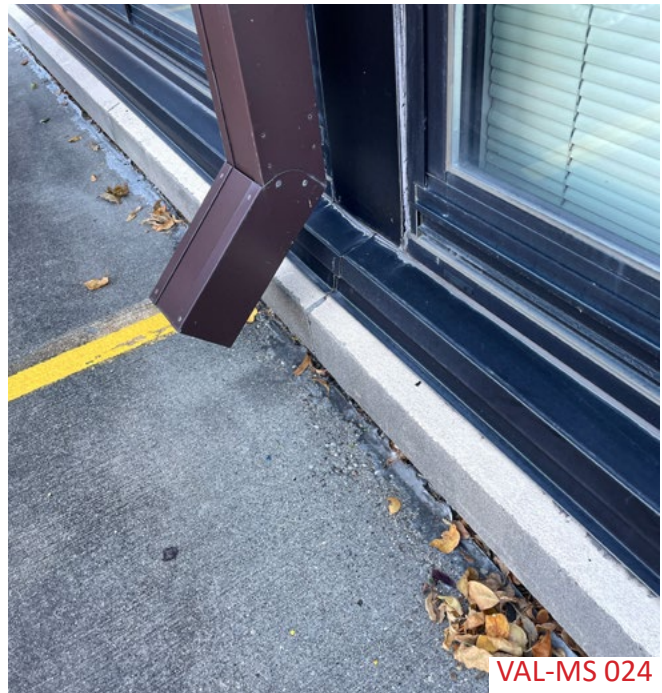
VAL-MS 024

Overall, the windows appear to be in good condition but the sealant and gasketing within the windows are in poor shape and need to be redone.

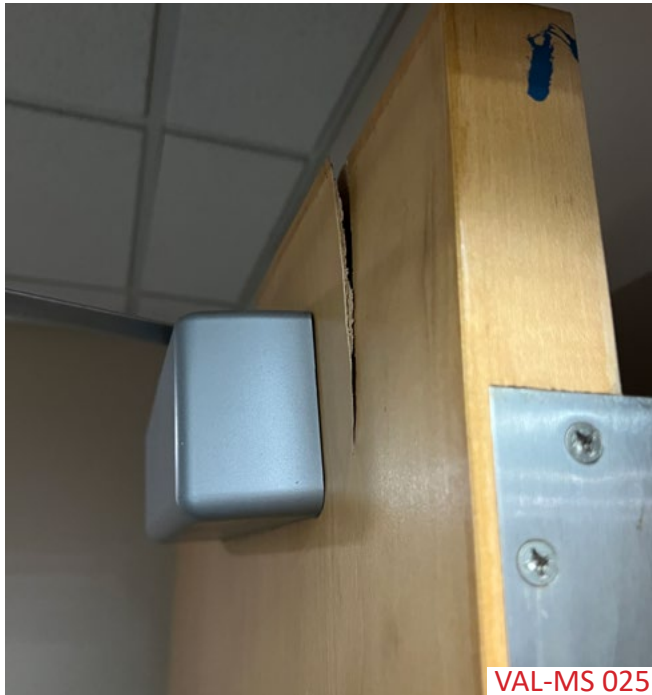
VAL-MS 025

Due to the age of the doors, visible wear and tear is shown on multiple doors.

Capital Maintenance									
Interior Upgrades									
Replace doors throughout the building that are in rough shape due to the age of the doors	50	50 Ea	\$3,780.24 /Ea		\$189,012			X	\$189,012
Replace dated ACT	51	20,000 SF	\$9.14 /SF		\$182,803			X	\$182,803
Further investigation is warranted to determine the cause of the shifting and large cracks in multiple CMU walls throughout the building	52								
Replace dated carpet throughout the school	53	25,000 SF	\$10.51 /SF		\$262,719				\$262,719
Replace old VCT, assumed to be contaminated with asbestos, replace with new flooring including abatement costs	54	5,000 SF	\$24.78 /SF		\$123,898				\$123,898
Interior Upgrades Subtotal		77,911 SF	\$9.73 / SF						\$758,433
Exterior Upgrades									
Add 62 additional parking stalls to the parking lot since it is not large enough	55	15,500 SF	\$14.84 /SF				\$230,020		\$230,020

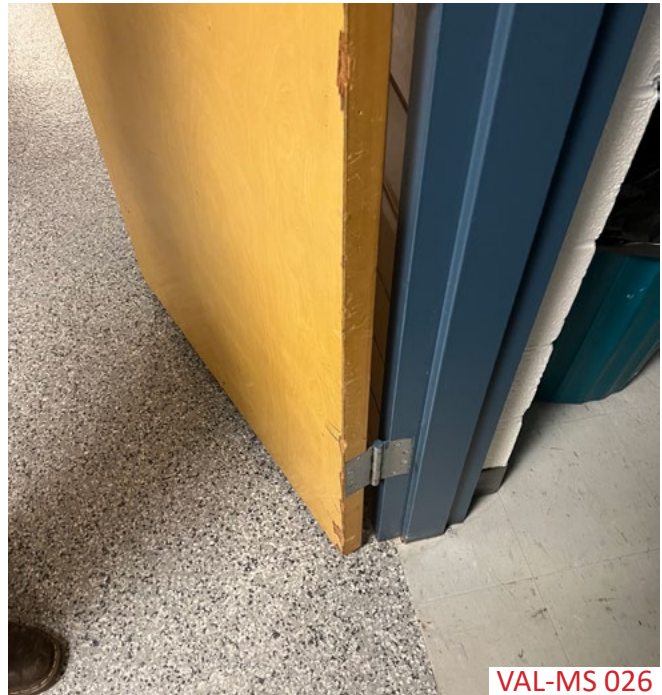
VAL-MS 026

Due to the age of the doors, visible wear and tear is shown on multiple doors.

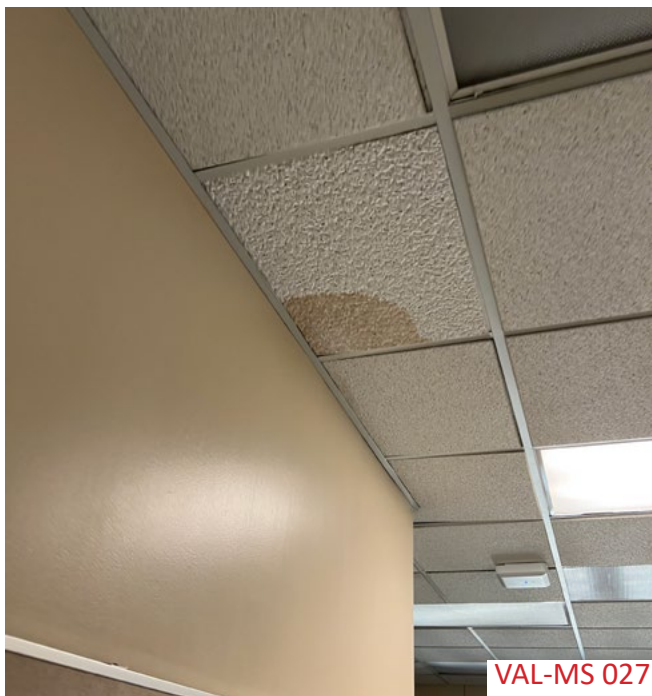
VAL-MS 027

There are some water stains throughout the building.

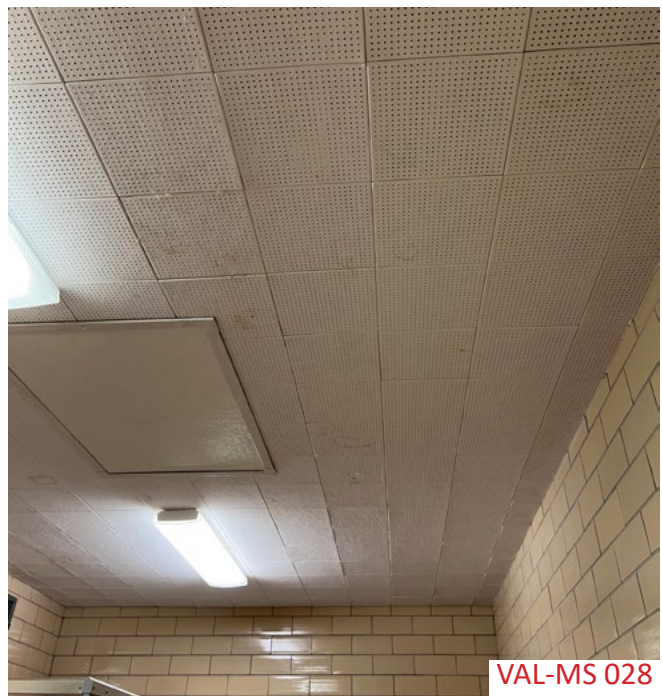
VAL-MS 028

The acoustical panels are dated and showing wear.

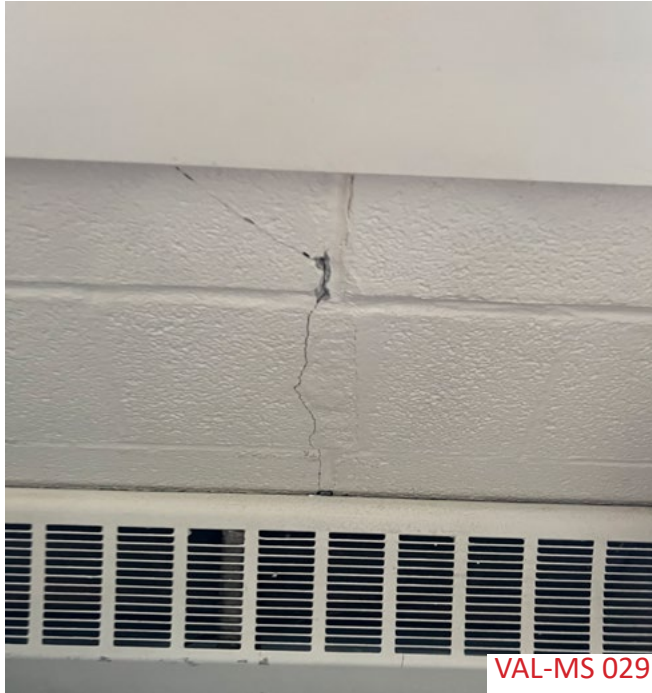
VAL-MS 029

There are notes of shifting and large cracks in multiple CMU walls throughout the building.

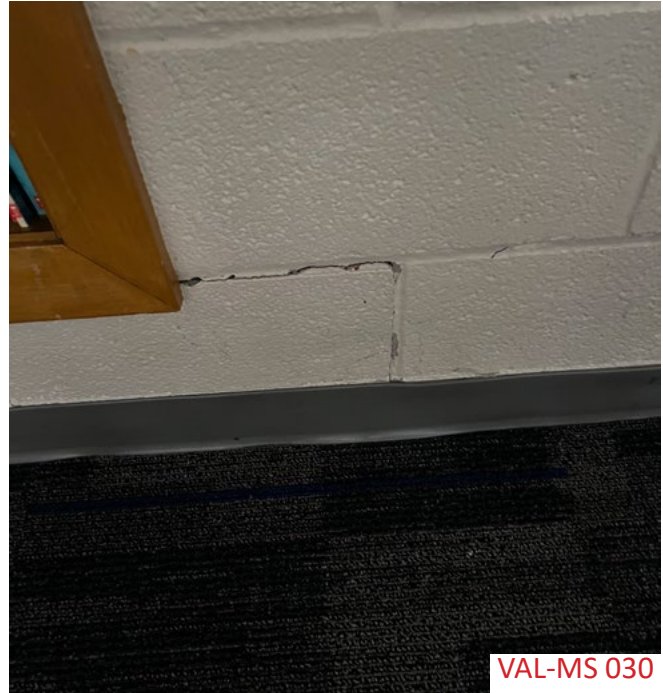
VAL-MS 030

There are notes of shifting and large cracks in multiple CMU walls throughout the building.

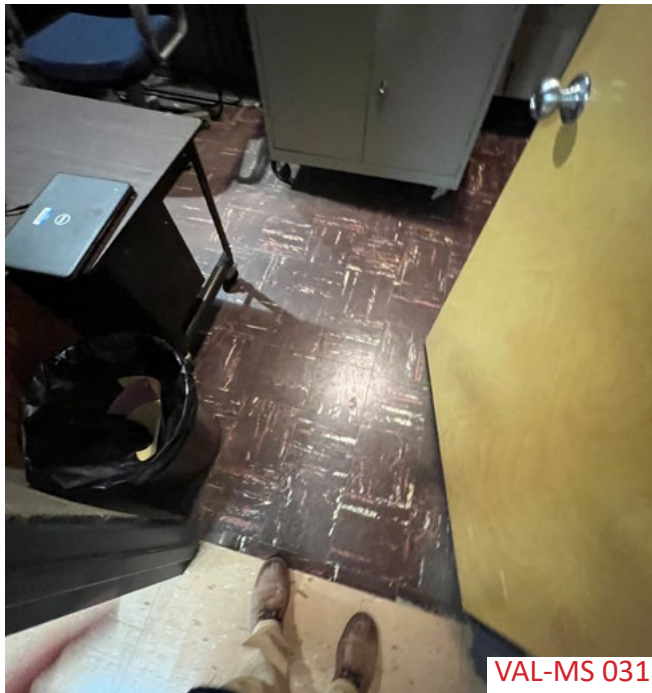
VAL-MS 031

Old tile located throughout the school should be tested for asbestos.

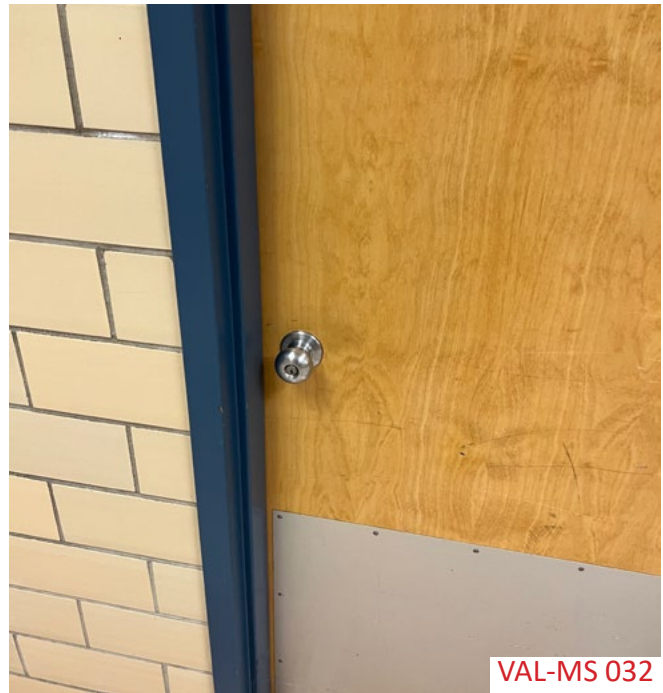
VAL-MS 032

Door hardware on various doors throughout the building is not accessible.

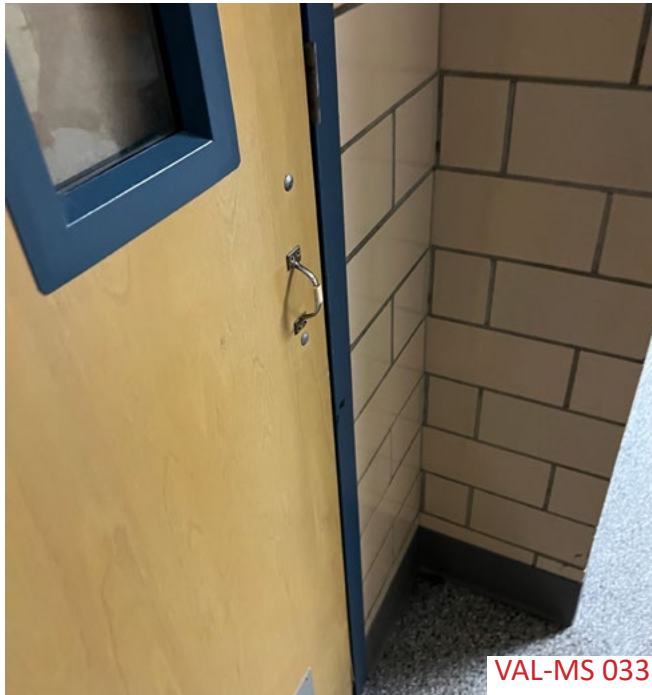
VAL-MS 033

Door hardware on various doors throughout the building is not accessible.

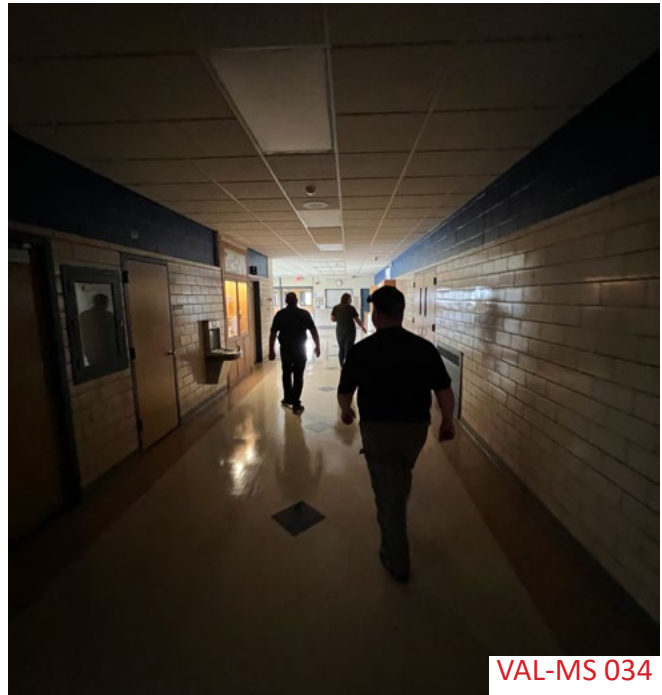
VAL-MS 034

Most of the building is non-sprinklered with the exception of several of the additions.

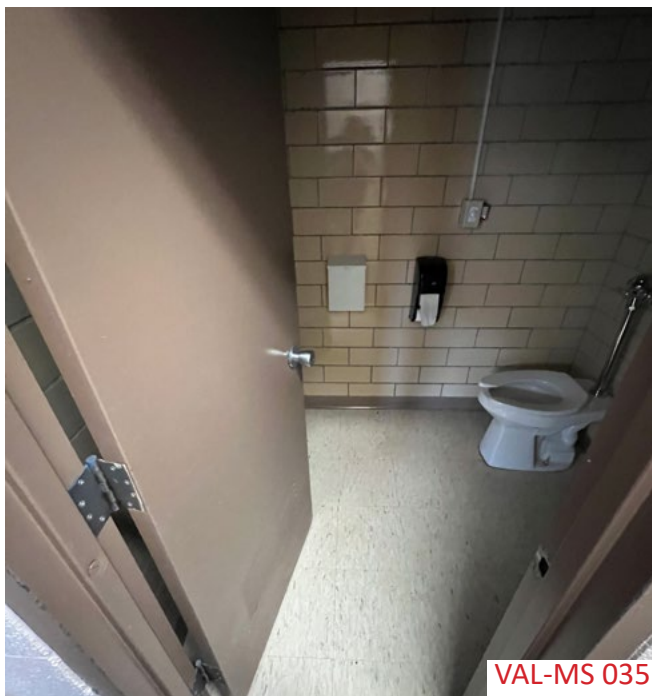
VAL-MS 035

The staff lounge restroom is not accessible.

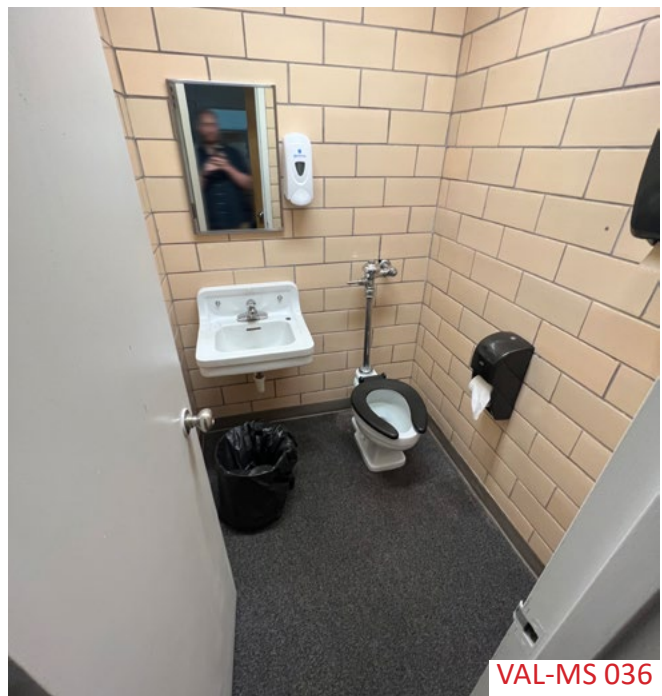
VAL-MS 036

The counseling room restroom is not accessible.

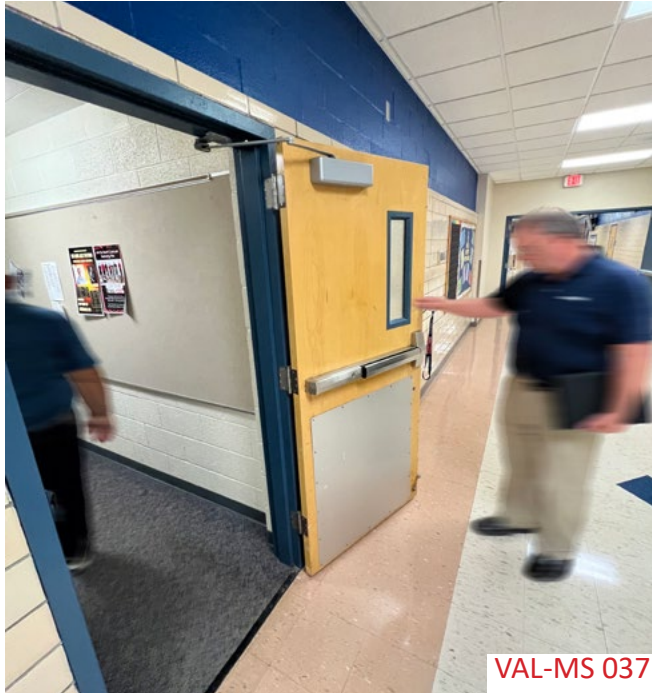
VAL-MS 037

Many interior doors are not fire rated.

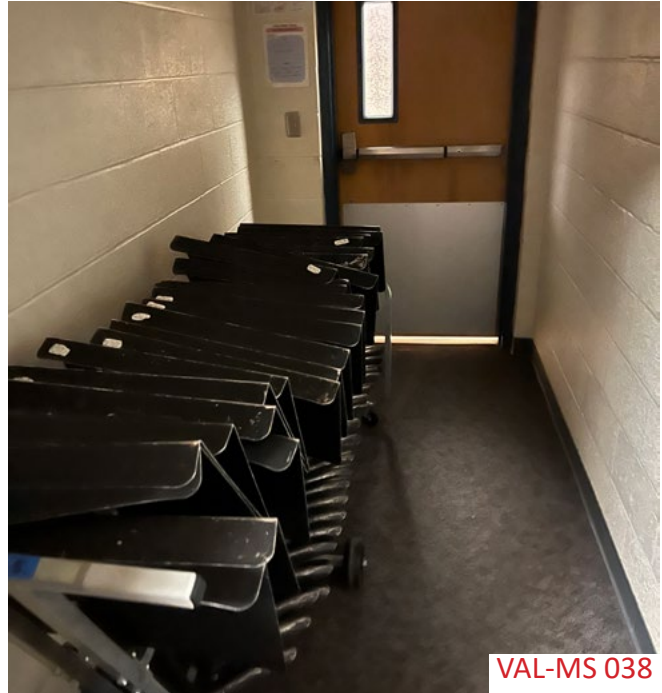
VAL-MS 038

Hallways in the music room do not meet minimum width requirements for accessibility.

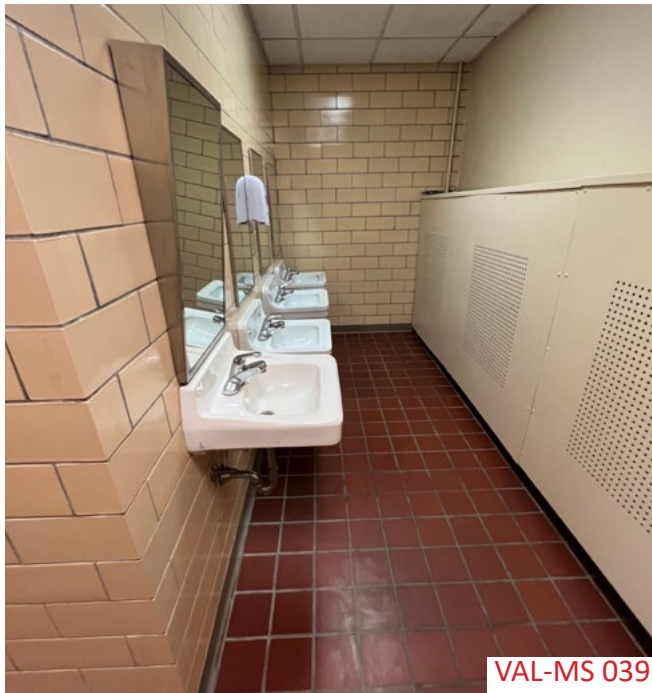
VAL-MS 039

All public restrooms in the building are not accessible.

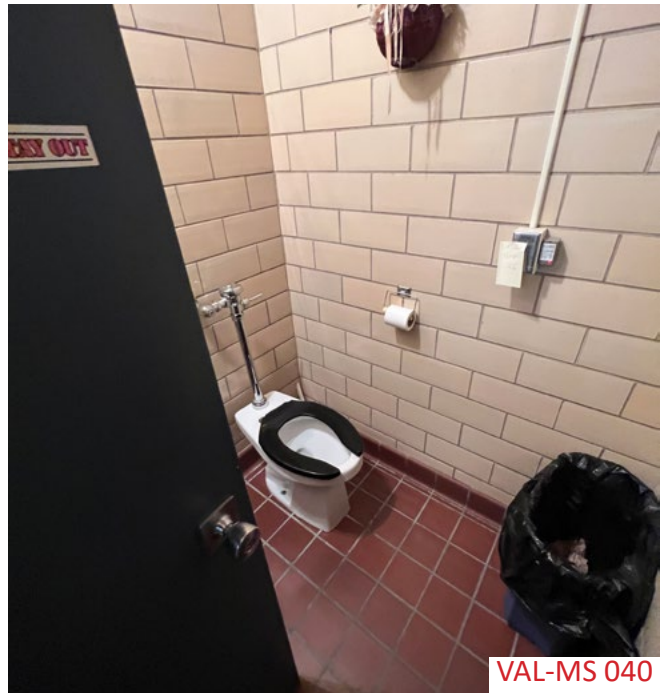
VAL-MS 040

The custodial office restroom is not accessible.

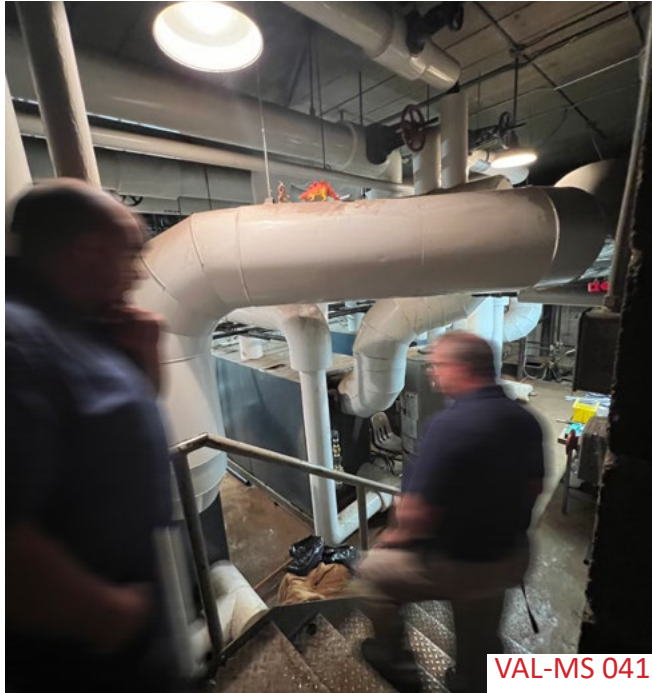
VAL-MS 041

The stairwell in the mechanical room is missing a handrail.

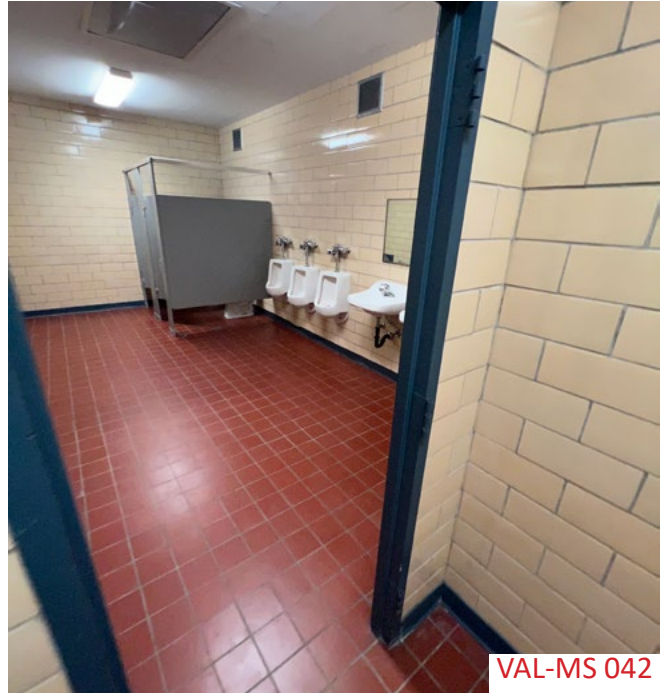
VAL-MS 042

All locker rooms are not accessible.

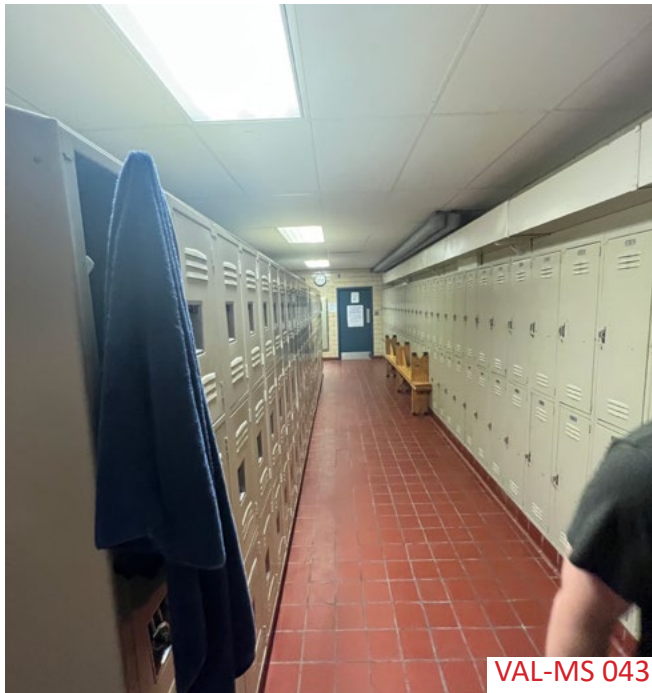
VAL-MS 043

All locker rooms are not accessible.

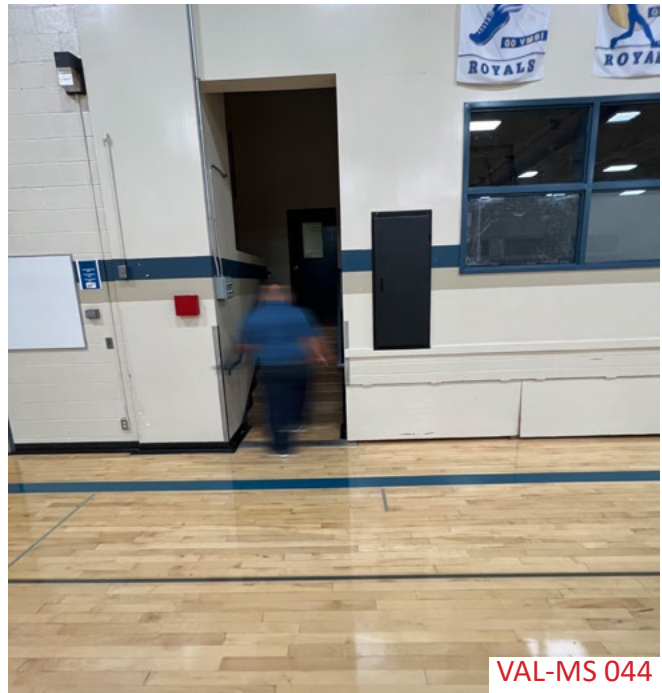
VAL-MS 044

The weight room is not accessible from the gym.

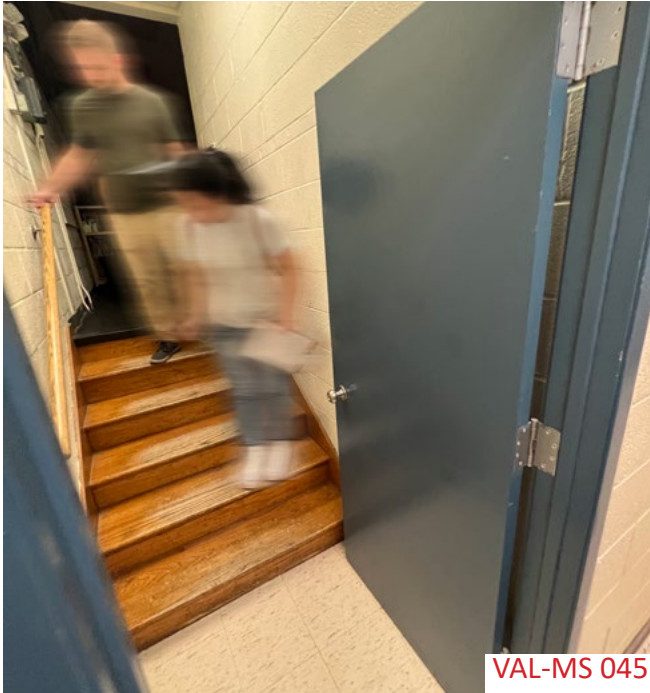
VAL-MS 045

The door into the weight room fails to meet required maneuvering clearance for accessibility and the door does not swing in the proper direction.

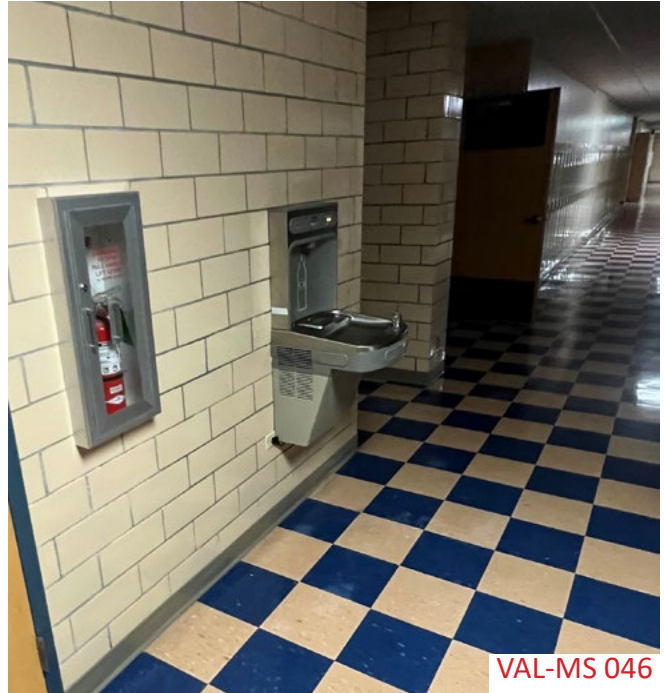
VAL-MS 046

Drinking fountains throughout the building do not meet the required ratio of wheelchair accessible fountains to standing person accessible fountains.

Add handicap accessible water fountains throughout the building	13	16 Ea	\$21,944.54 / Ea	\$351,113					\$351,113
Replace exterior and interior entrance with tempered glass at the main south entrance, the east entrance by the gym, and the west entrance by the library.	14	3 Ea	\$42,899.62 / Ea	\$128,699					\$128,699
Remove combustible material from ceilings and walls in the music area, replace with acoustical wall coverings and ACT	15	1,500 SF	\$53.84 / SF	\$80,764					\$80,764
Replace room signage that is missing brail with ADA compliant signs	16	185 Ea	\$128.26 / Ea	\$23,729					\$23,729
Replace all guardrails and handrails in public stairwells that do currently meet code (60 lf guardrail and 240 lf handrails)	17	300 LF	\$199.43 / LF	\$59,829					\$59,829
Add handrails extensions to the to and bottom of the stairs	18		/						
Add a separate handrail to the guardrail as required in the stairwell in the middle of the school	19		/
