VALLEY MIDDLE SCHOOL

A. EXISTING BUILDING INVENTORY

INTERIOR AND EXTERIOR EXISTING DEFICIENCIES PHOTOS

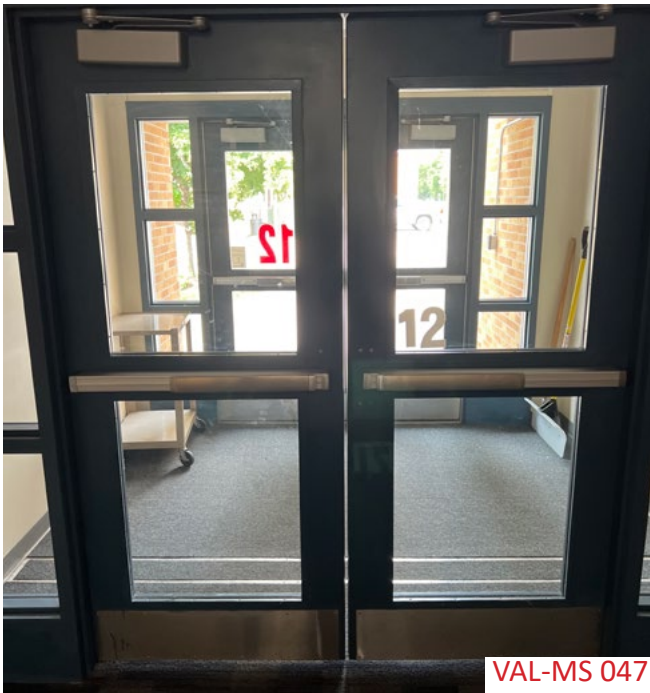
VAL-MS 047

Most entrances to the school do not have the required safety glass.

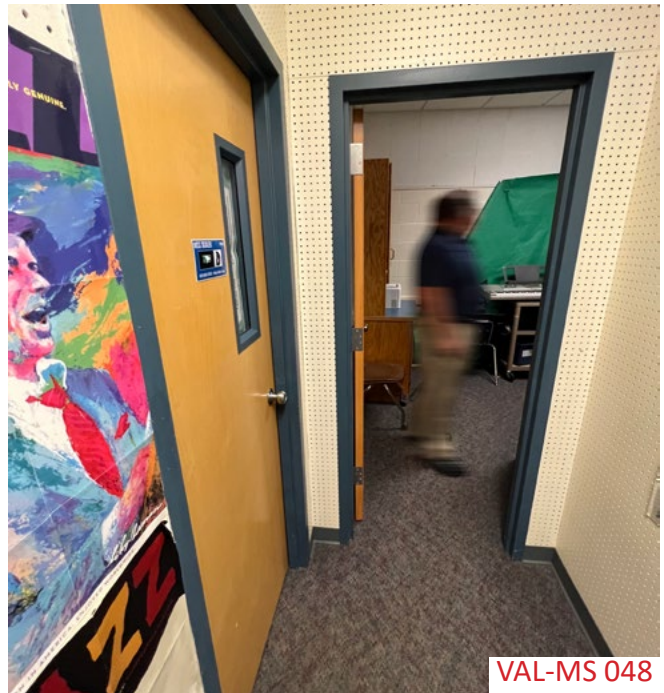
VAL-MS 048

Combustible material is found in corridors that are non-sprinklered.

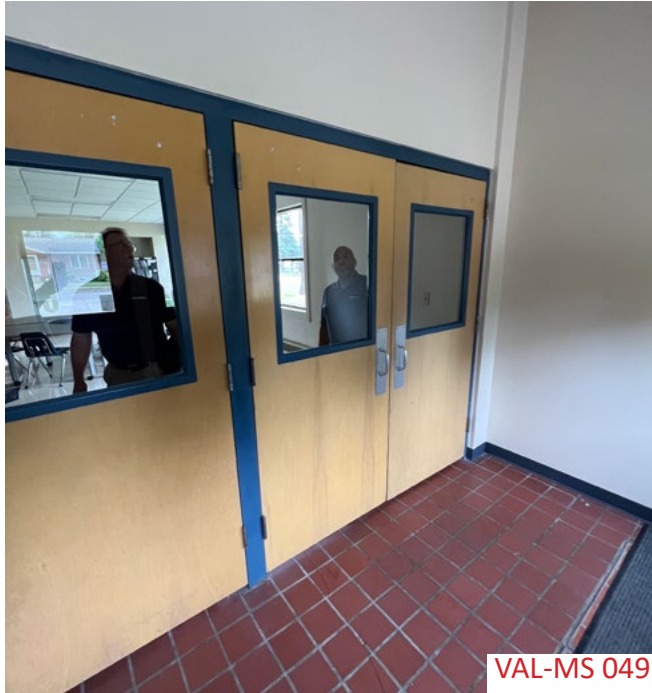
VAL-MS 049

Exit doors do not have the required safety glass.

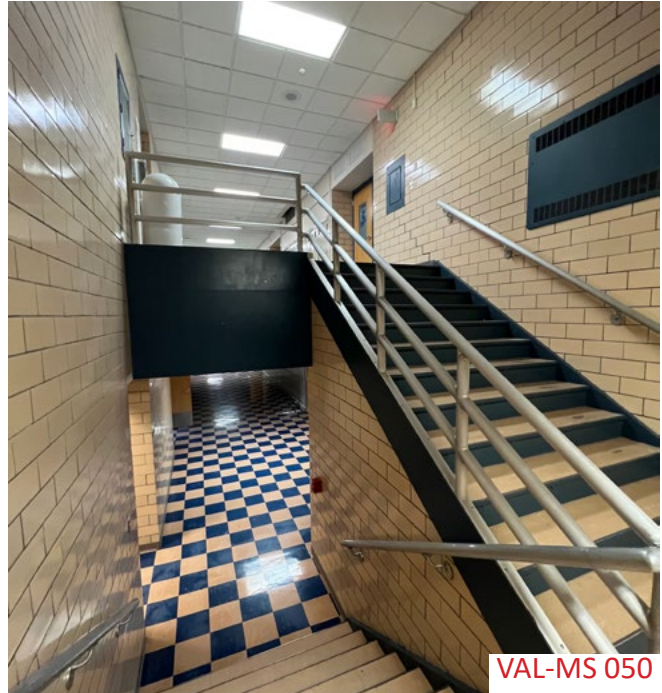
VAL-MS 050

The stairwell in the middle of the school is lacking a separate handrail from the guardrail and spaces between the railings exceed the maximum size of 4".

Replace guardrail where the spaces between railings exceed the maximum size of 4"	20		/						
Change the swing of the door to the electrical meter room	21	1 Ea	\$3,561.29 / Ea	\$3,561					\$3,561
Replace wire glass throughout the building that is no longer up to code (frame to remain)	22	3,200 SF	\$33.65 / SF	\$107,683				X	\$107,683
Protect sink plumbing in restrooms throughout the building that are exposed	23	18 Ea	\$940.48 / Ea	\$16,929				X	\$16,929
Replace casework (20lf of base, top, and upper per classroom) and sinks in 40 classrooms that are not accessible	24	40 Ea	\$26,939.88 / Ea	\$1,077,595					\$1,077,595
Create a second exit in computer room 3	25	1 Ea	\$3,508.52 / Ea	\$3,509					\$3,509
Create a second exit in the art room	26	1 Ea	\$3,508.53 / Ea	\$3,509					\$3,509
Create a second exit in room B-5	27	1 Ea	\$3,508.52 / Ea	\$3,509					\$3,509
Create an ADA workstation at the desk in the main office	28	1 Ea	\$7,855.41 / Ea	\$7,855					\$7,855

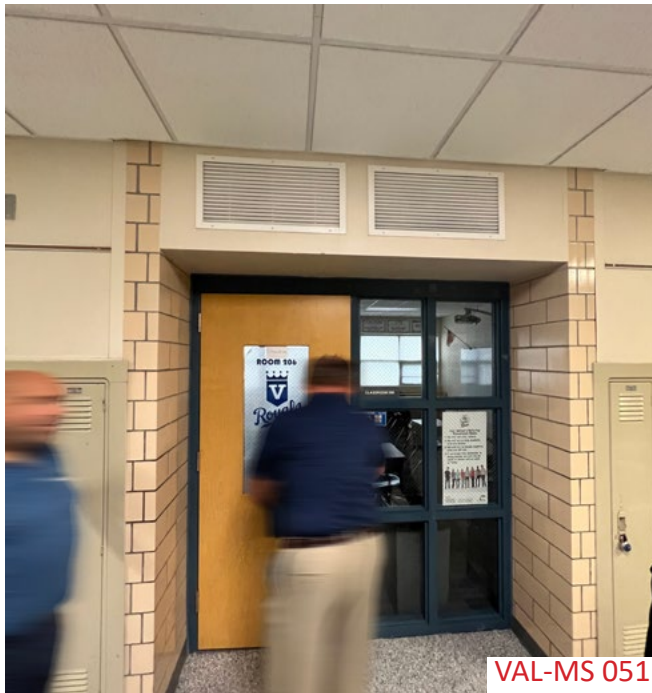
VAL-MS 051

Wire glass is seen throughout the building.

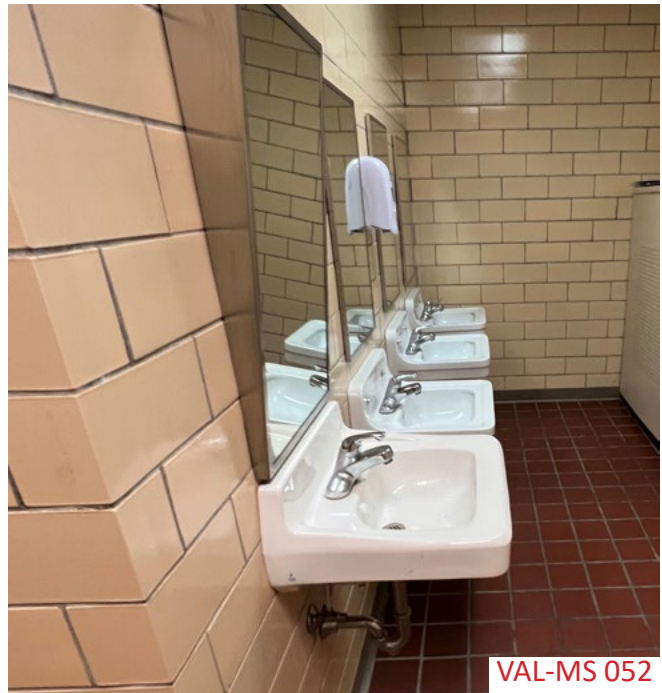
VAL-MS 052

Pipes throughout the building are exposed and should be protected.

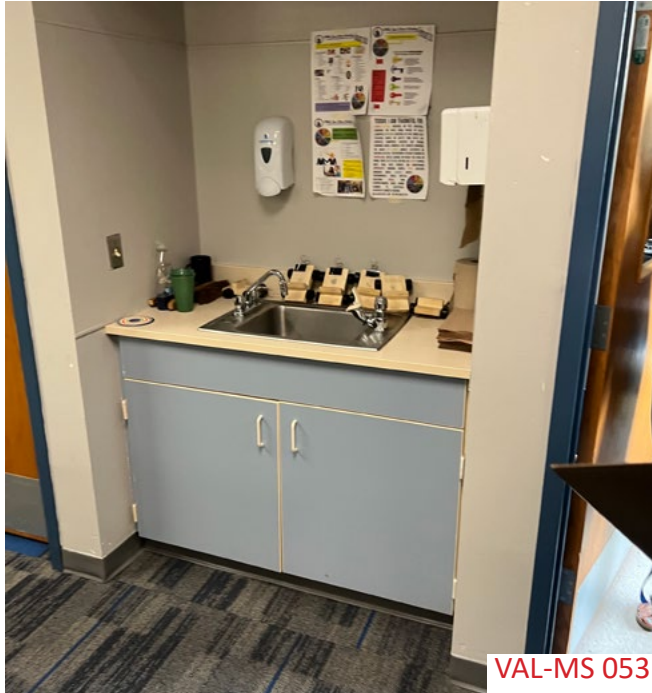
VAL-MS 053

Sinks in classrooms are not accessible.

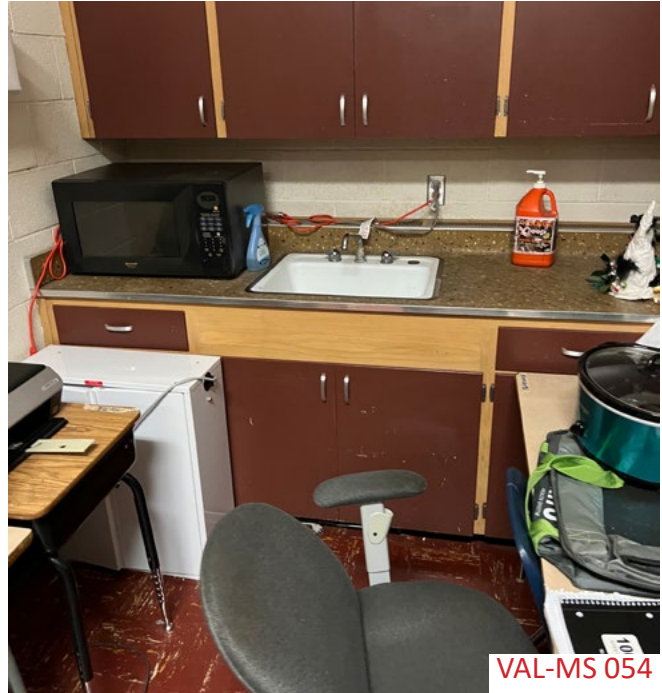
VAL-MS 054

Sinks in classrooms are not accessible.

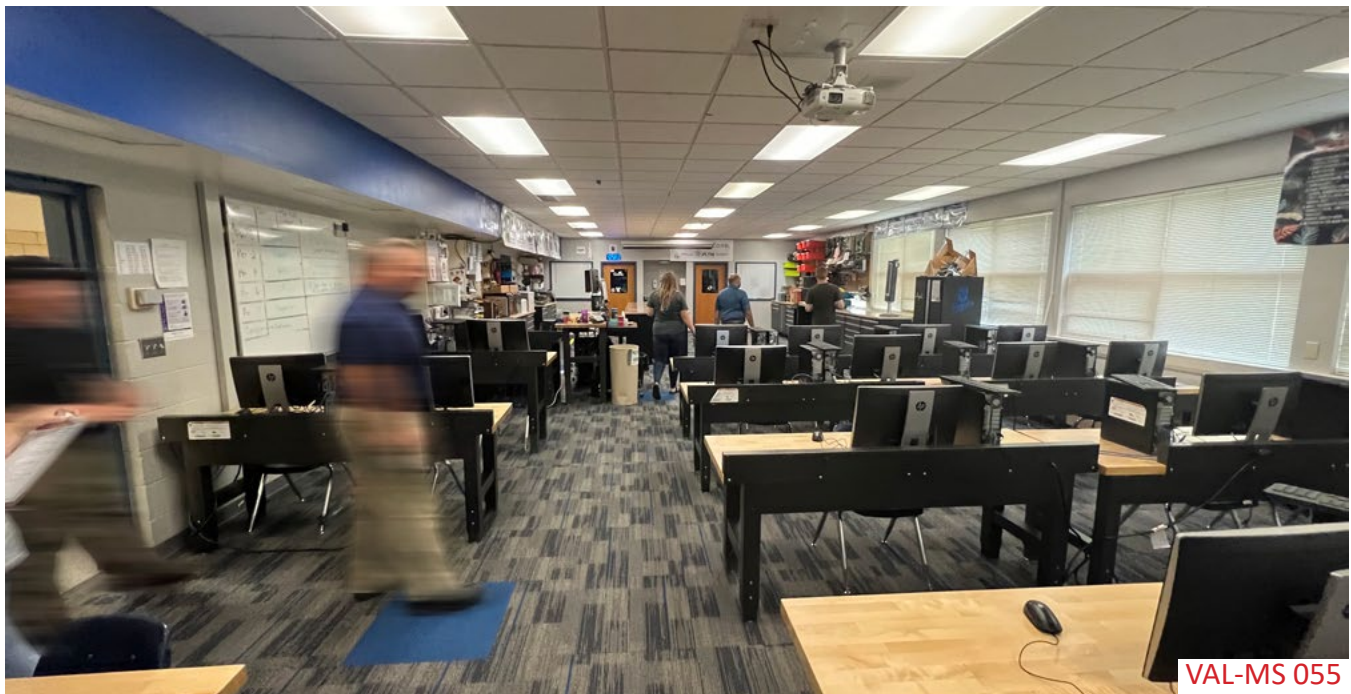
VAL-MS 055

Room B-5 needs an additional exit.

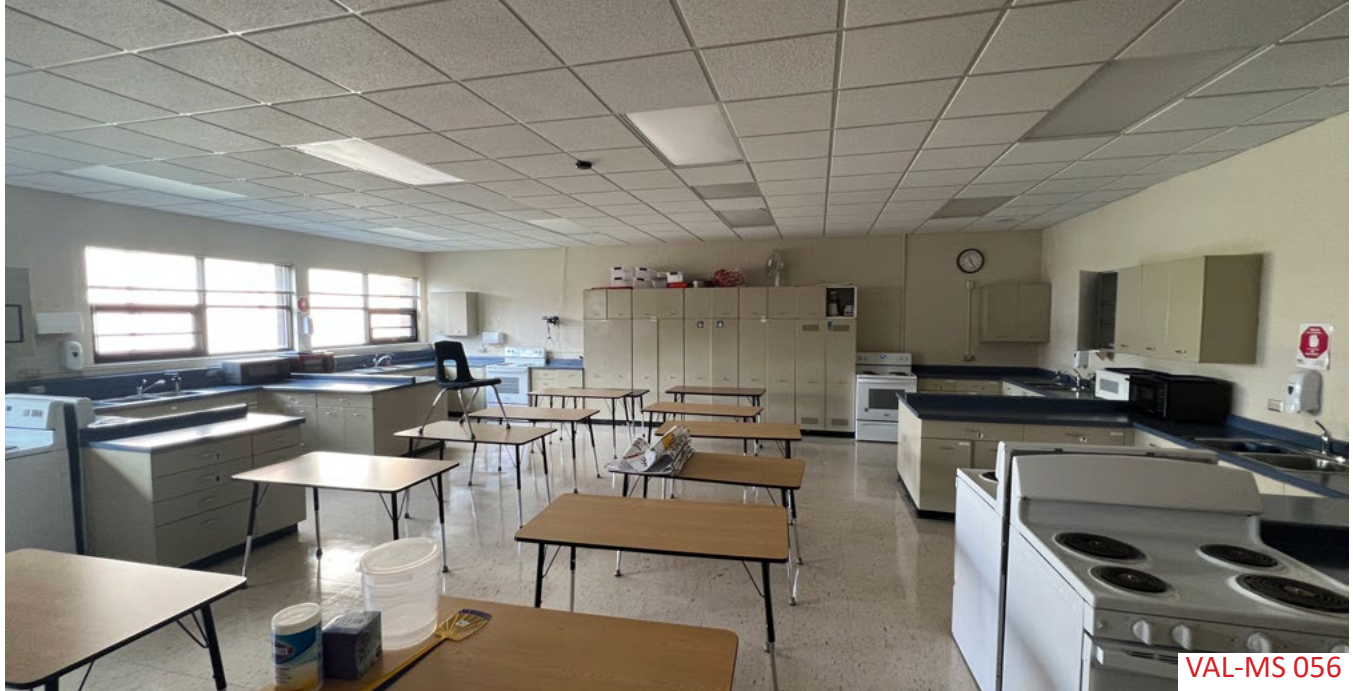
FACS classroom is not accessible.
