WILDER ELEMENTARY SCHOOL

A. EXISTING BUILDING INVENTORY

D. EXISTING DEFICIENCIES

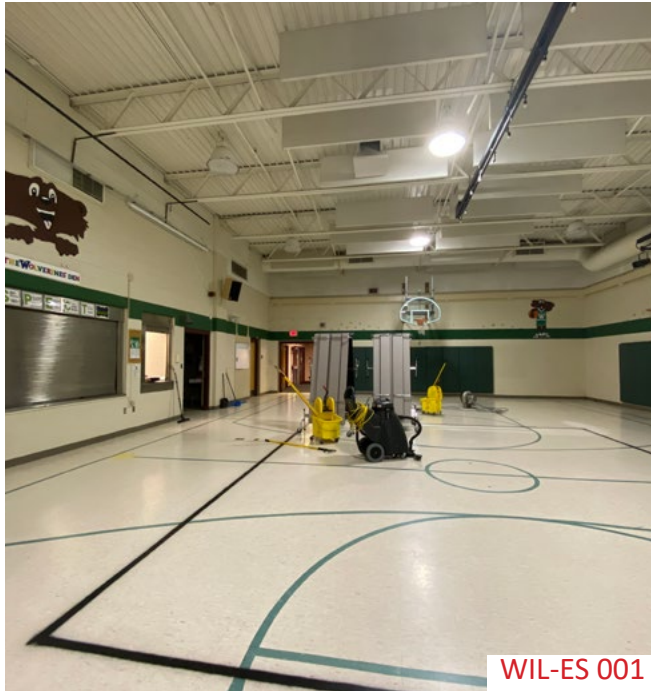
WIL-ES 001

The school lacks in space as larger classrooms were split into two, the gym is also used as the cafeteria, and the nurse's office is too small.

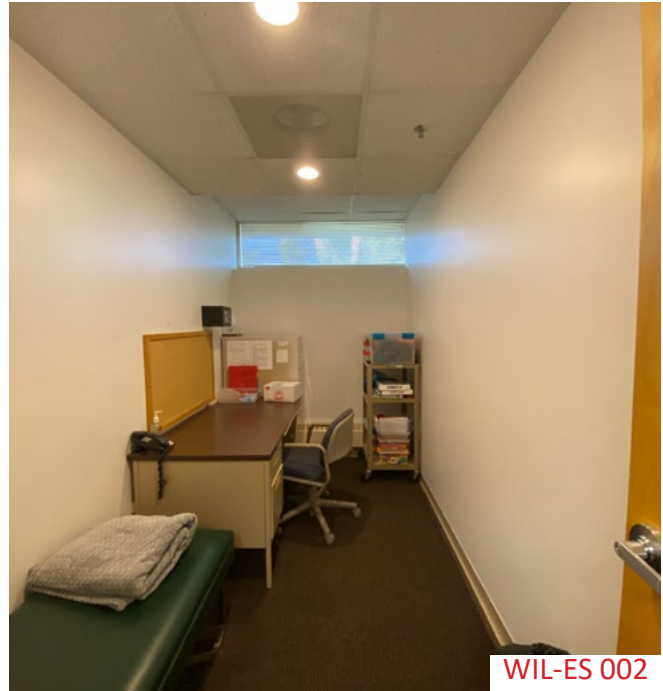
WIL-ES 002

The school lacks in space as larger classrooms were split into two, the gym is also used as the cafeteria, and the nurse's office is too small.

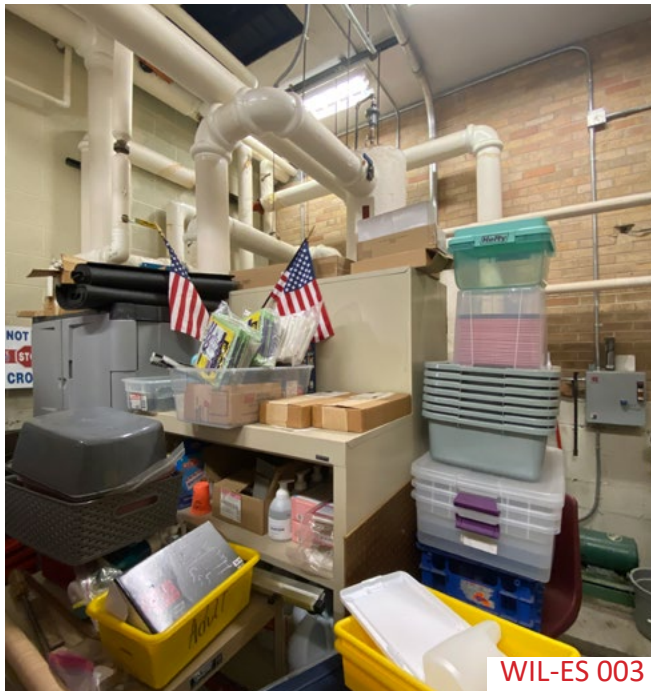
WIL-ES 003

There is also a lack of storage with the mechanical room acting as a storage room.

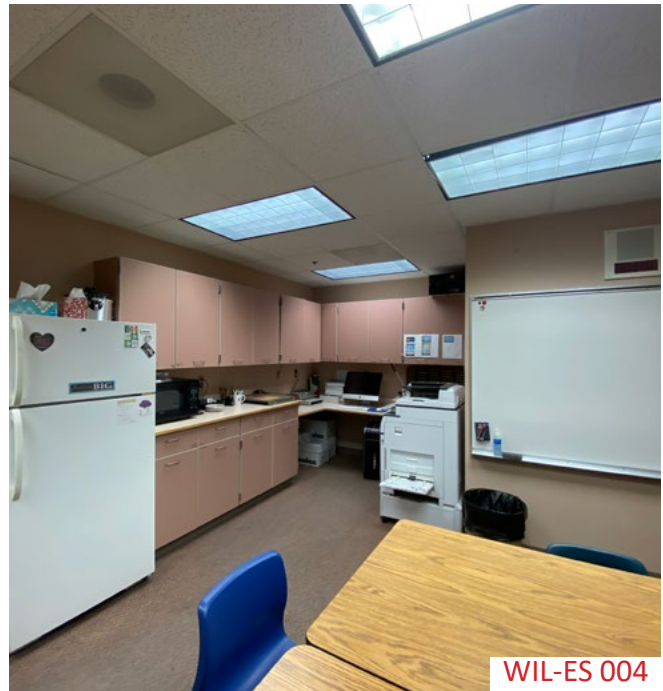
WIL-ES 004

Many elements in the school are dated including casework, tile, and classroom carpet.

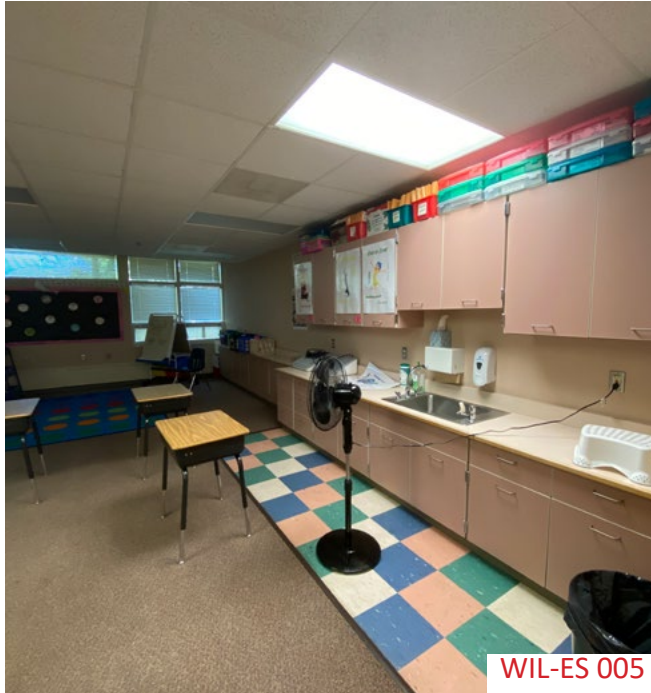
WIL-ES 005

Many elements in the school are dated including casework, tile, and classroom carpet.

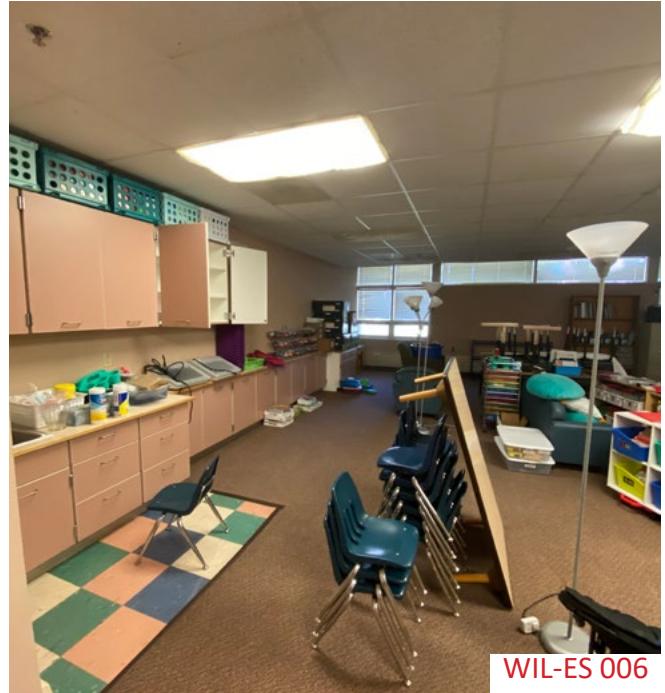
WIL-ES 006

Many elements in the school are dated including casework, tile, and classroom carpet.

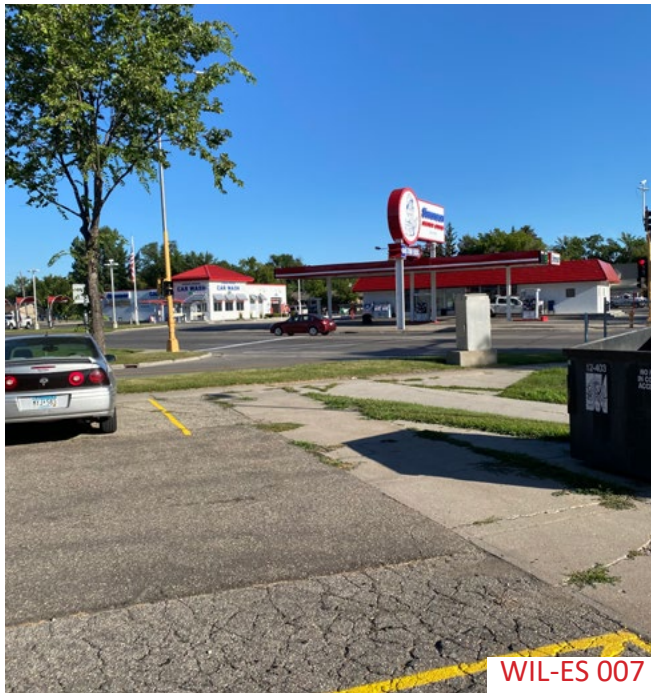
WIL-ES 007

Concrete and asphalt work around the school show cracking and are in bad condition (007). The school's parking lot is extremely small with current drop-off/pick-up not optimal (008, 009). Main entrance (Door 1) lacks security and is not ideal for accessibility (010). Two portable classrooms are located on the east side of the building (011). Ramps to the portable classrooms are in rough condition (012) as some metal paneling is coming off.

Concrete and asphalt work around the school show cracking and are in bad condition.

Exterior Upgrades									
Mill and overlay cracking asphalt parking lot (940 SY) and replace damaged concrete (600 sf)	36	1 Ea	\$52,868.98 / Ea			\$52,869			\$52,869
Add a ramp at main entrance (Door 1) and address security	37	100 SF	\$79.50 / SF	\$7,950					\$7,950
Replace ramp decking and railing (deck structure and stairs to remain) on to the portable	38	600 SF	\$109.11 / SF			\$65,464			\$65,464
Classrooms that are in rough condition and repair damaged flashing	39	11,720 SF	\$13.86 / SF		\$162,476				\$162,476
Replace caulking that is in bad condition on exterior traditional brick	40	1,000 LF	\$2.52 / LF	\$2,521					\$2,521
Caulk the cracking along the EFIS	41	1 Ea	\$855.85 / Ea		\$856				\$856
Unstick the windows (wire mesh) that are painted shut	42	22,233 SF	\$34.46 / SF			\$766,149			\$766,149
Replace the roof when it nears the end of its useable lifetime	43	14 Ea	\$504.11 / Ea		\$7,058				\$7,058

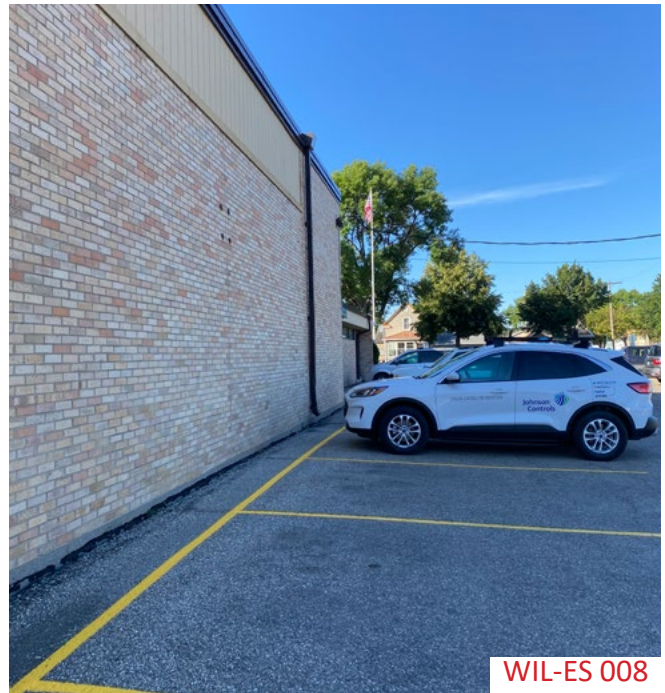
WIL-ES 008

The school's parking lot is small with current drop-off/pick-up not optimal.

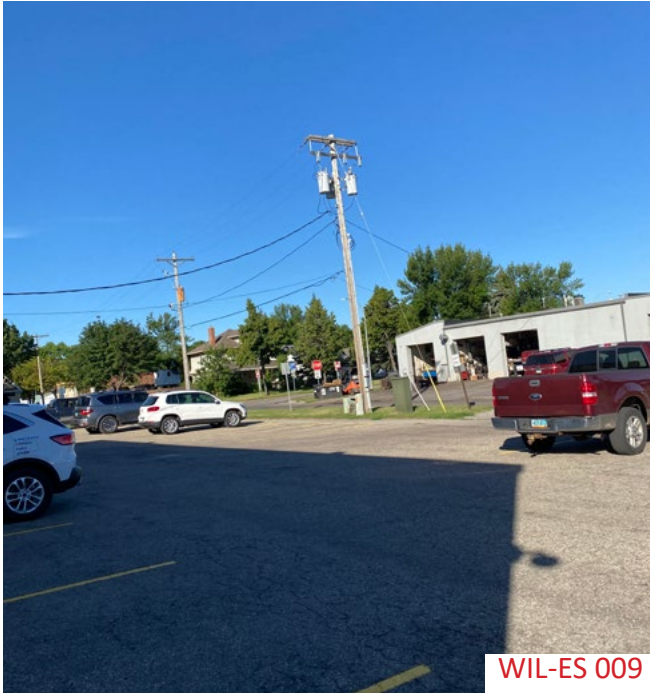
WIL-ES 009

The school's parking lot is small with current drop-off/pick-up not optimal.

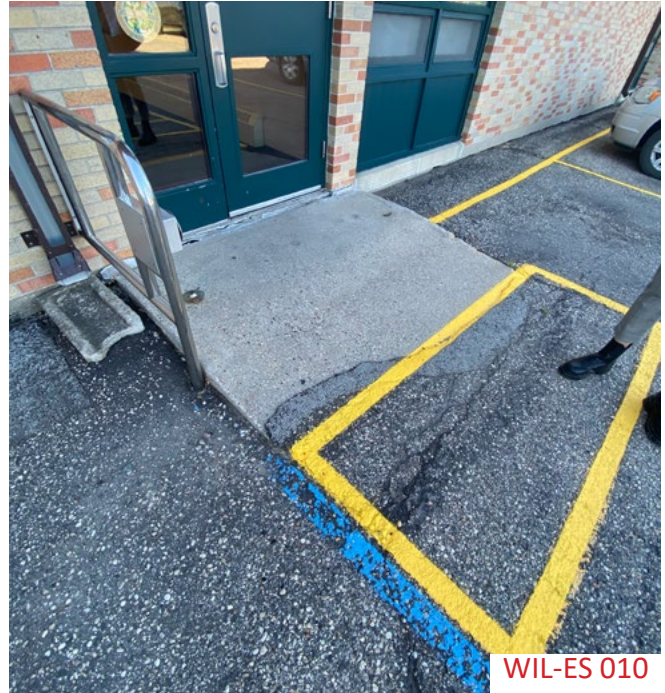
WIL-ES 010

Main entrance (Door 1) lacks security and is not ideal for accessibility.

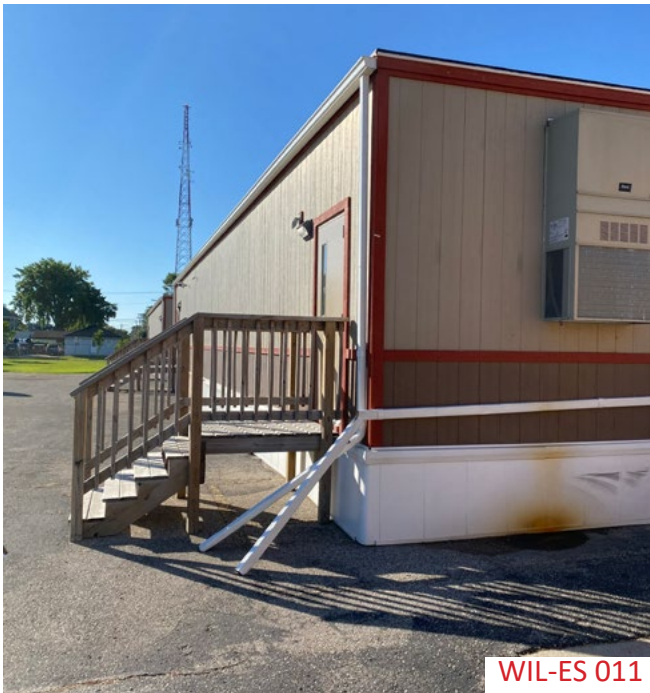
WIL-ES 011

Two portable classrooms are found on the east side of the building.

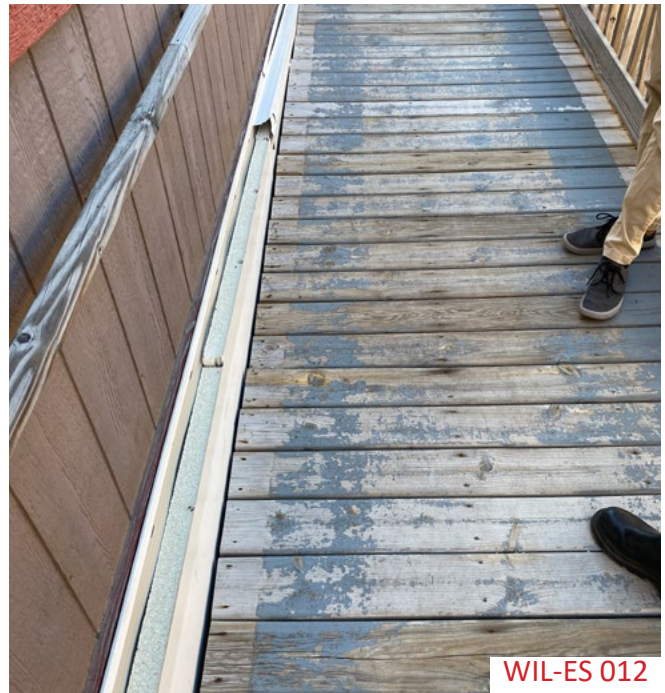
WIL-ES 012

Ramps to the portable classrooms are in rough condition as some metal paneling is coming off.

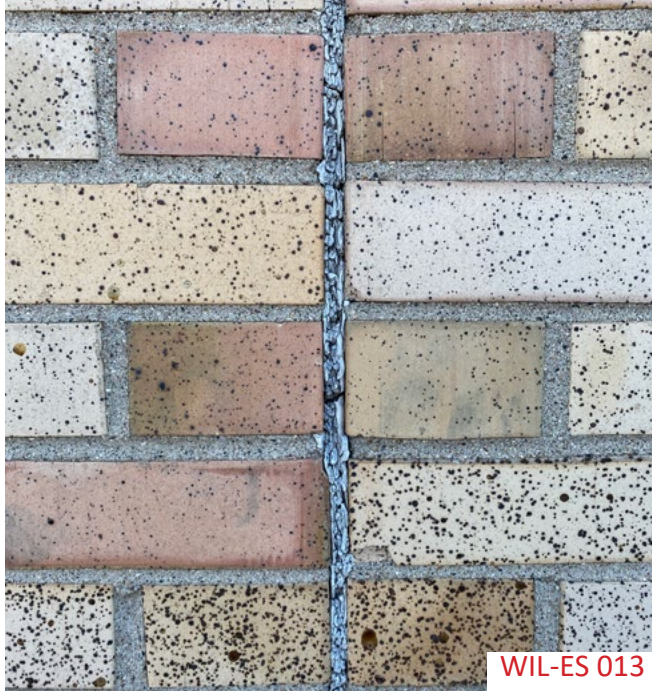
WIL-ES 013

The exterior of the building is traditional brick. No visible issues were seen with the brick. Caulking is in bad condition and should be redone (013).

Caulking is in bad condition and should be redone.

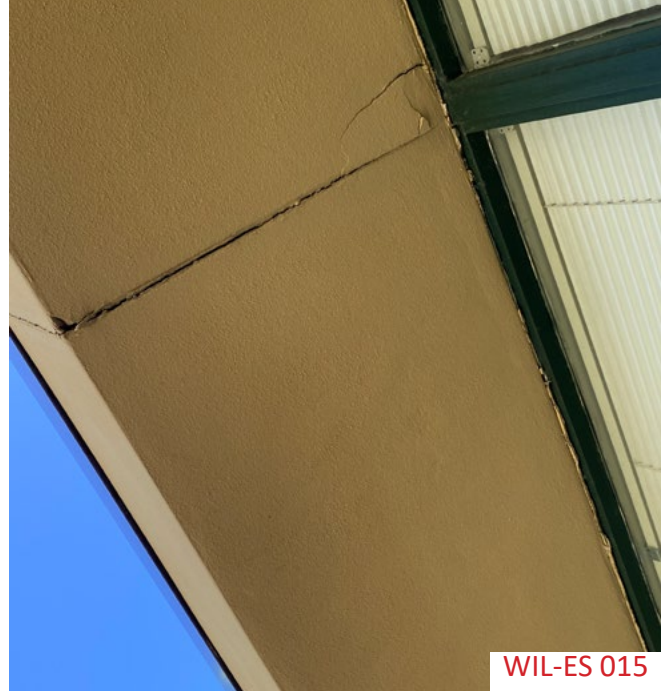
WIL-ES 015

Other exterior materials include EIFS and wood paneling. Cracking is seen along the span of the EIFS and the caulking needs to be redone (014, 015). The wood paneling has no visible issues (016).

Cracking was seen along the span of the EFIS along with the caulking needing to be redone.

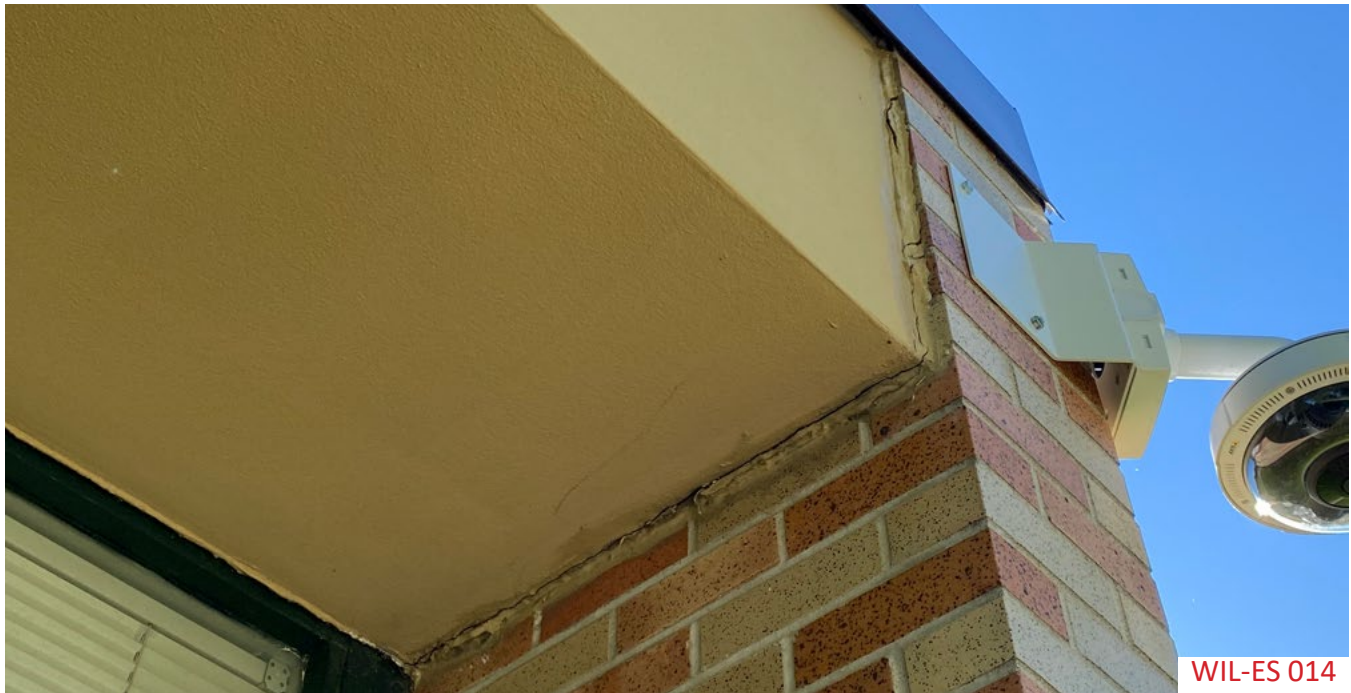
WIL-ES 014

Cracking was seen along the span of the EFIS along with the caulking needing to be redone.

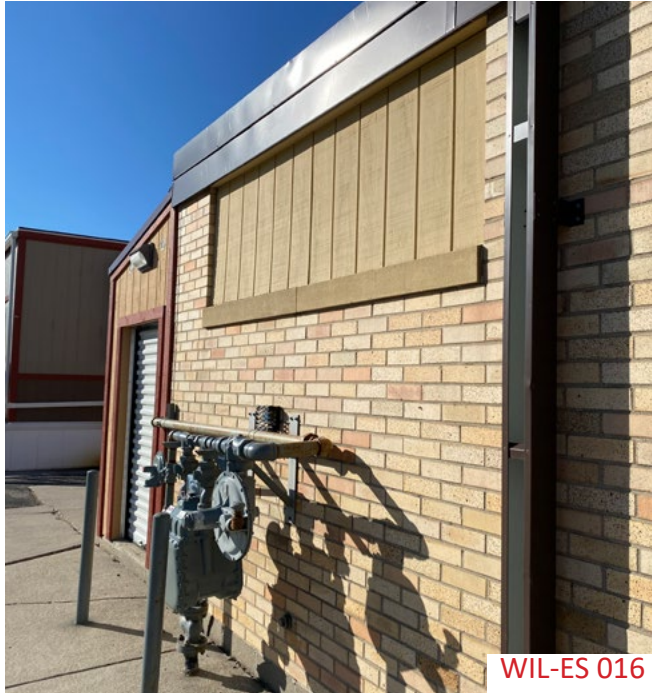
WIL-ES 016

The wood paneling had no visible issues.

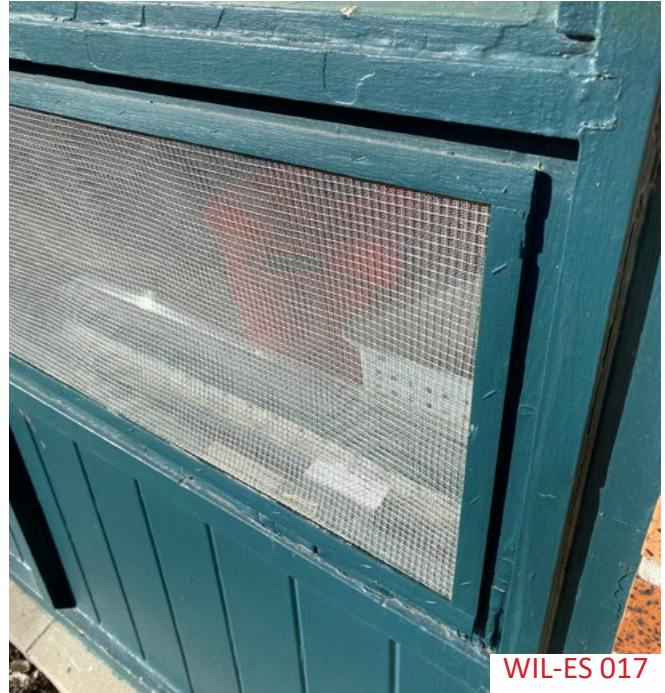
WIL-ES 017

The door openings within the school are in good condition. Wire mesh windows outside are painted shut (017). Due to the age of the windows, the sealant has shrunk and no longer runs the entire width of the glass panels (018). Staff noted that windows and doors are the biggest loss of air.

Wire mesh windows outside are painted shut.

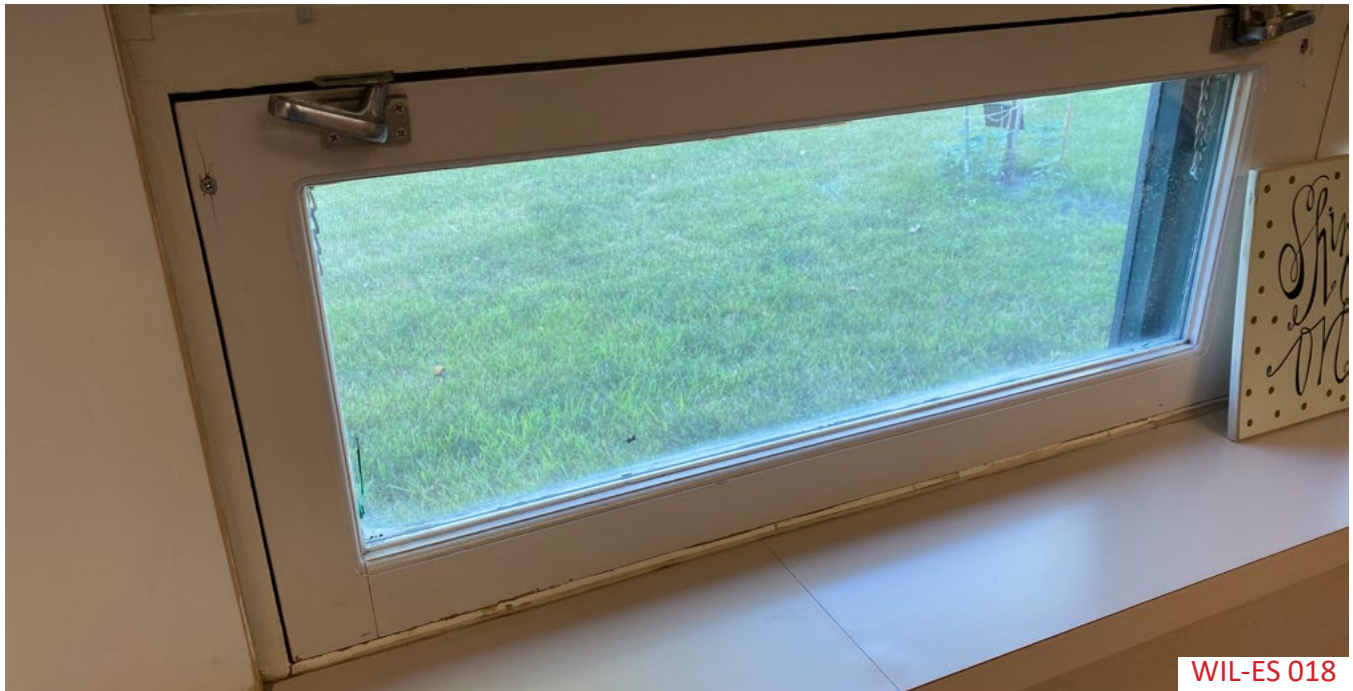
WIL-ES 018

Due to the age of the windows, the sealant has shrunk and no longer runs the entire width of the glass panels.

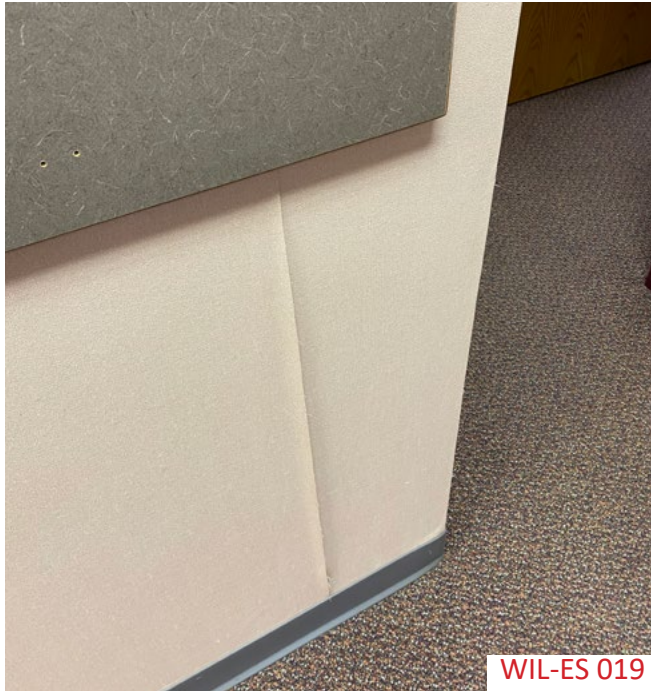
WIL-ES 019

The interior walls are either painted masonry, painted gypsum board, have vinyl wall coverings, or have tiling. There are several areas where the vinyl wall covering is releasing from the gypsum substrate (019). Portions of exterior walls are covered with vinyl covering on the interior. It is recommended the vinyl wall covering be removed from the interior surface of exterior walls, as this could potentially create a double vapor barrier and trap moisture within the walls. Current code does not permit the use of vinyl wall covering on outside walls for this reason.

There were several areas where the vinyl wall covering is releasing from the gypsum substrate..

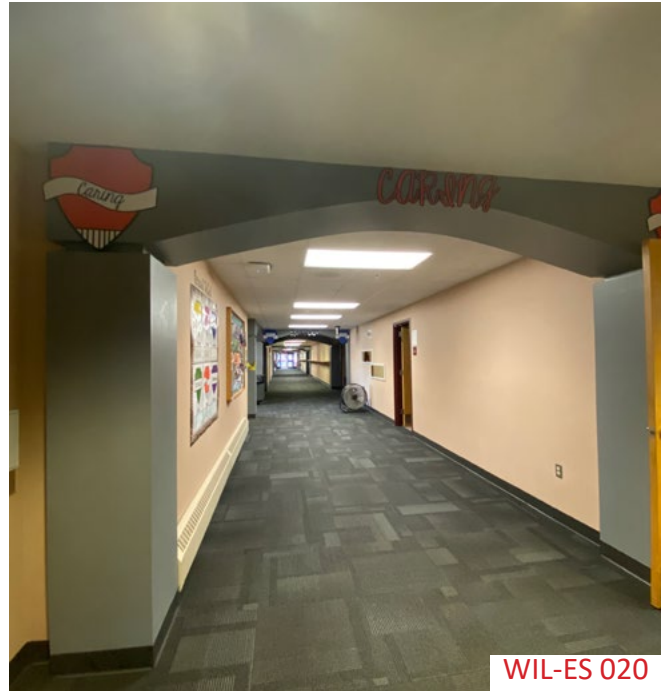
WIL-ES 020

Most of the school consists of carpet. Carpet in the hallways is newer, and the classrooms have older carpet that is worn and dated (020, 021). Portions of the carpet in the library is warping (022). Some classrooms have dated tile in front of the cabinetry (023).

New carpet was installed in the hallways but the classrooms have worn, dated carpet.

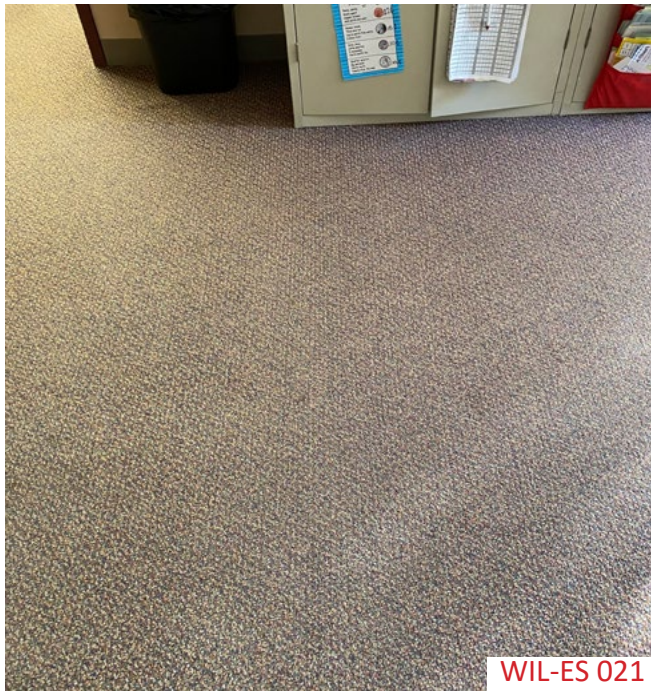
WIL-ES 021

New carpet was installed in the hallways but the classrooms have worn, dated carpet.

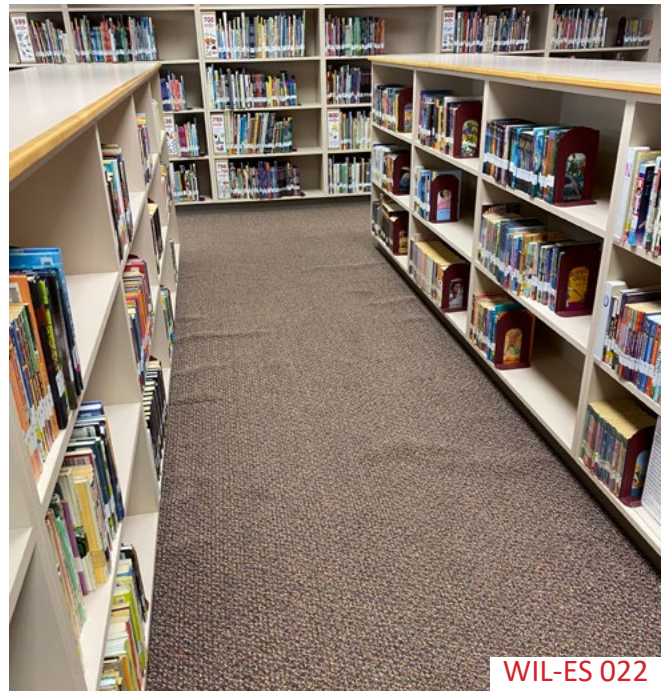
WIL-ES 022

Portions of the carpet in the library is warping.

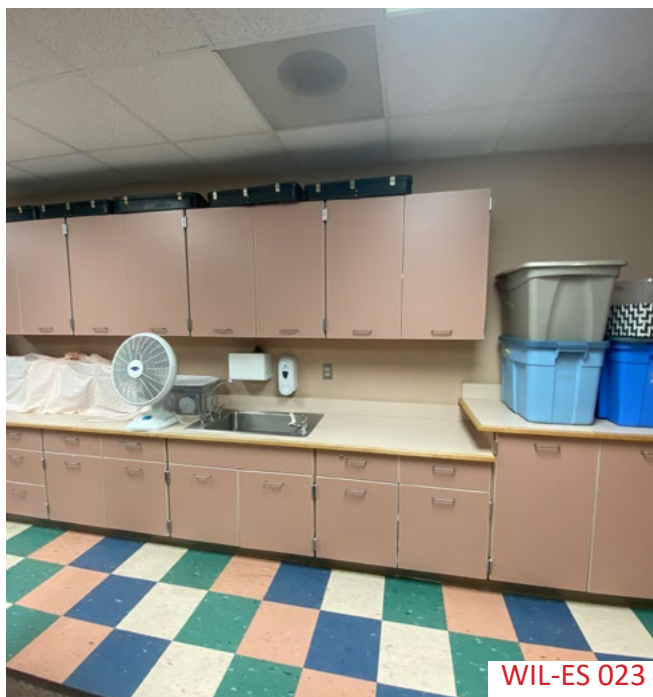
WIL-ES 023

Some classrooms have dated tile in front of cabinetry.

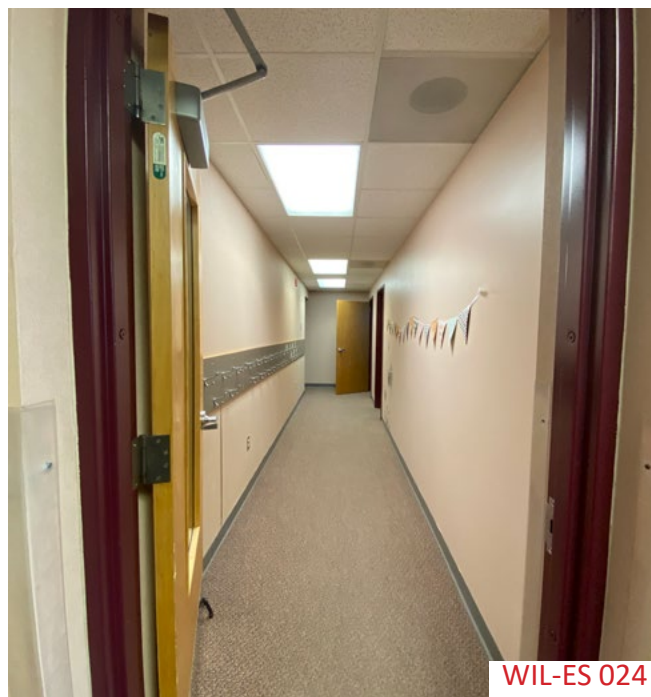
WIL-ES 024

- Entry hallway door needs to swing out per occupancy loads, and panic hardware is needed as well. (024)
- Drinking fountains throughout the building do not meet the required ratio of wheelchair accessible fountains to standing person accessible fountains. (025, 026)

Entry hallway door needs to swing out per occupancy loads, and panic hardware is needed as well.

Description	Item Number	Takeoff Qty	Total Cost/Unit	Critical	5 yrs Deferred Maint	10 yrs Deferred Maint	Educational Adequacy	Synergistic with other needs	Total Cost
Code Compliance									
Change swing on entry hallway doorway for occupancy loads and add panic hardware	1	1 Ea	\$3,615.44 /Ea	\$3,615					\$3,615
Replace water fountains within sinks that are not to code	2	1 Ea	\$22,055.01 /Ea	\$22,055					\$22,055
Replace wire glass throughout the building that is no longer up to code (frame to remain)	3	40 Ea	\$499.29 /Ea	\$19,972					\$19,972
Remodel girls and boys restrooms to make them ADA accessible	4	2 Ea	\$50,964.43 /Ea	\$101,929					\$101,929
Add ADA accessible sinks in staff office, staff restroom, and music room by replacing 10 lf of base, tops, and upper cabinets in each of staff office and music room	5	3 Ea	\$15,340.23 /Ea	\$46,021					\$46,021
Change faucet in the sinks throughout that have a water fountain within them which is no longer to code	6	5 Ea	\$5,671.29 /Ea	\$28,356					\$28,356

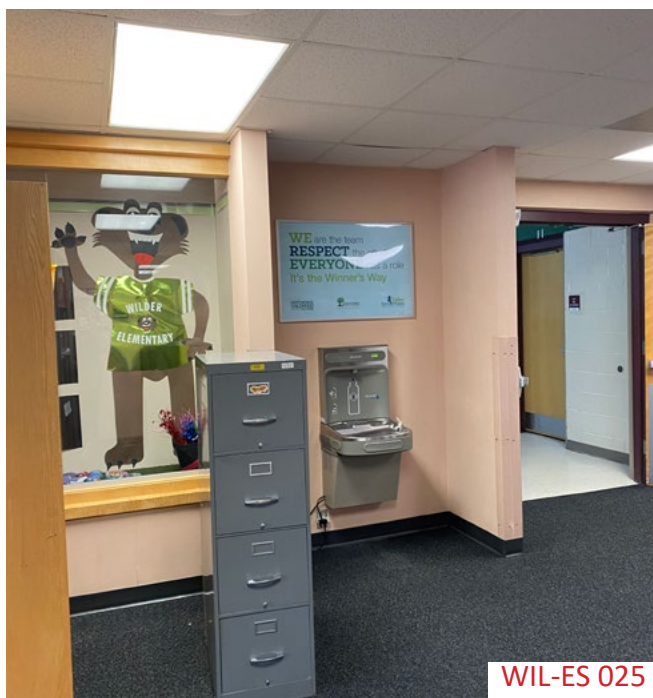
WIL-ES 025

Drinking fountains throughout the building do not meet the required ratio of wheelchair accessible fountains to standing person accessible fountains.

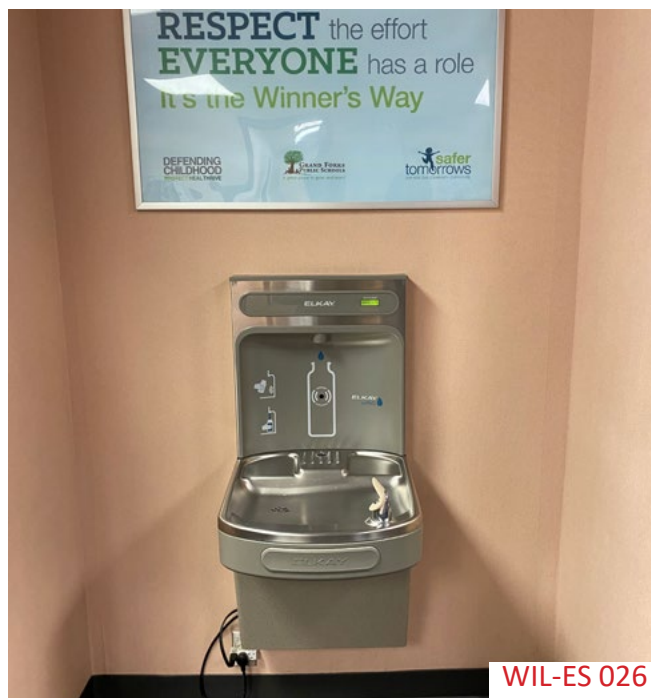
WIL-ES 026

Drinking fountains throughout the building do not meet the required ratio of wheelchair accessible fountains to standing person accessible fountains.

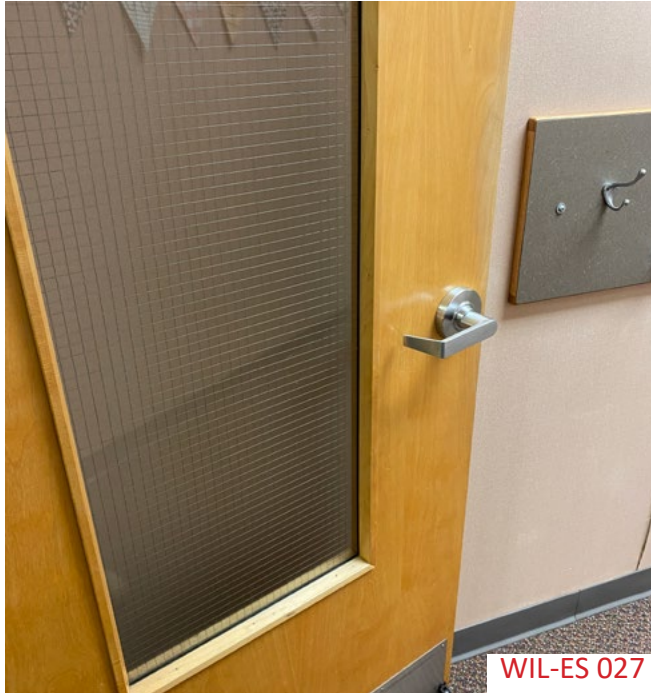
WIL-ES 027

- Traditional wire glass throughout building is no longer to code as an acceptable type of safety glass. (027, 028)
- Both girl's and boy's restrooms are not accessible. (029, 030, 031)

Traditional wire glass throughout building is no longer to code as an acceptable type of safety glass.

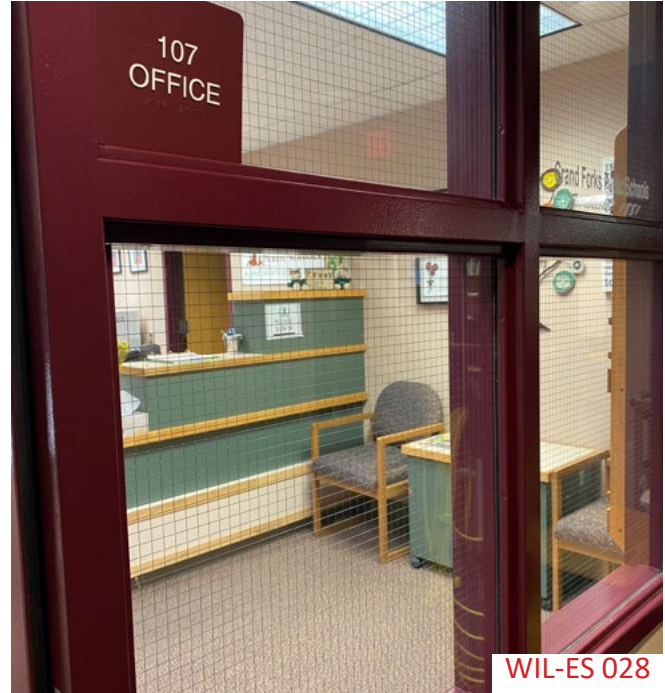
WIL-ES 028

Traditional wire glass throughout building is no longer to code as an acceptable type of safety glass.

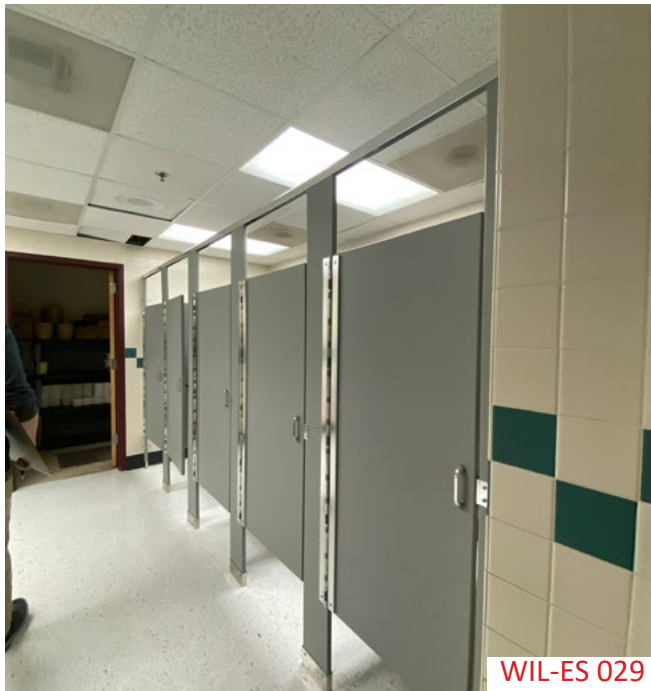
WIL-ES 029

Both girl's and boy's restrooms are not accessible.

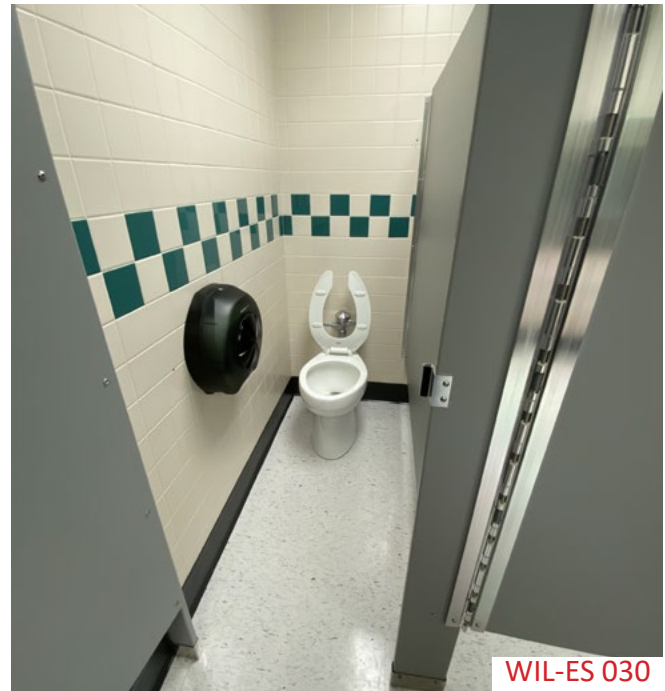
WIL-ES 030

Both girl's and boy's restrooms are not accessible.

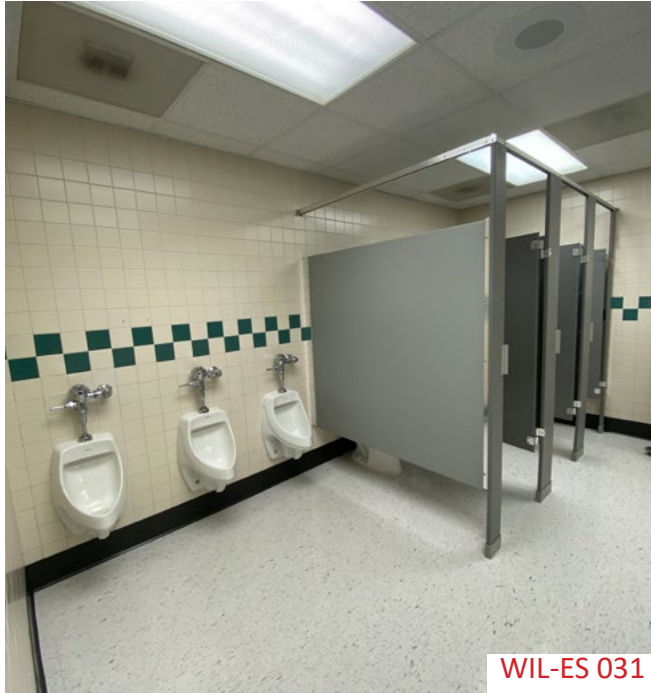
WIL-ES 031

Both girl's and boy's restrooms are not accessible.

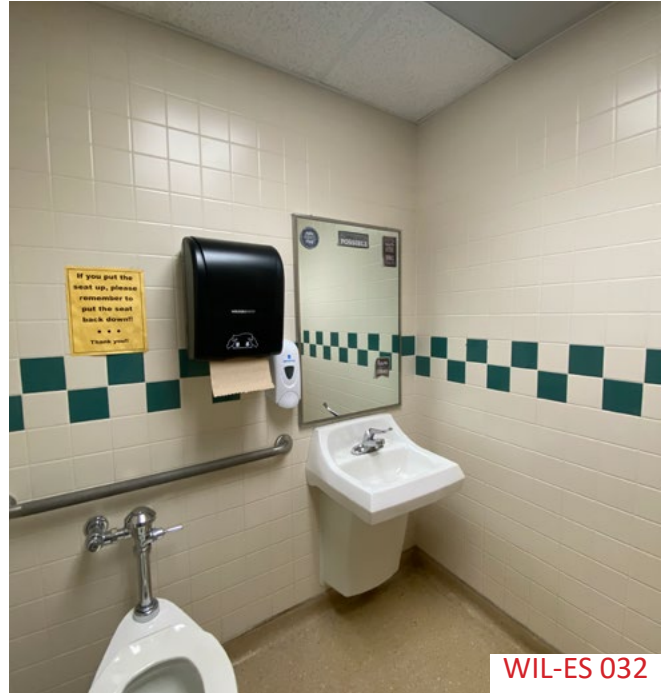
WIL-ES 032

Sinks in staff office, staff restroom, and music room are not accessible.

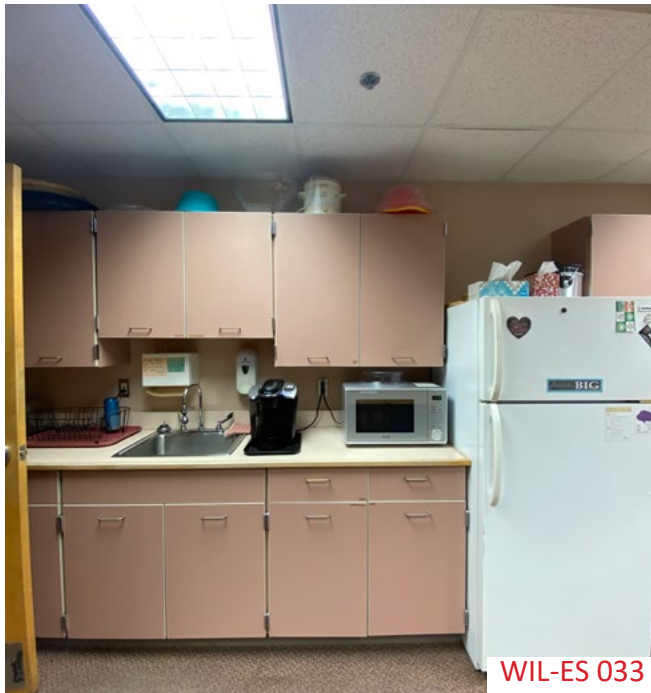
WIL-ES 033

Sinks in staff office, staff restroom, and music room are not accessible.

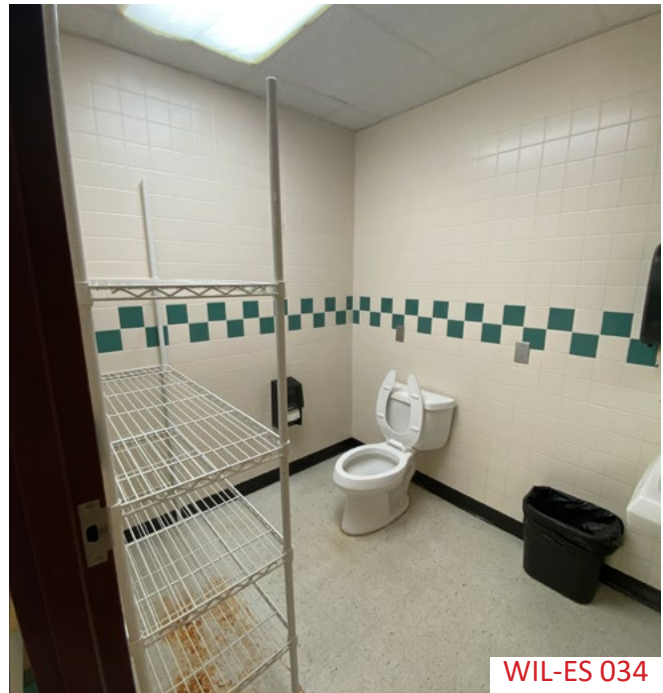
WIL-ES 034

- Sinks in staff office, staff restroom, and music room are not accessible. (032, 033)
- Restrooms in Kindergarten classes are not accessible as they are missing grab bars. (034)

Restrooms in Kindergarten classes are not accessible as they are missing grab bars.

Add grab bars in the kindergarten restrooms that are missing grab bars	7	2 Ea	\$478.09 /Ea	\$956					\$956
Add handrails to the stairs in mechanical area	8	120 LF	\$131.89 /LF	\$15,826					\$15,826
Add interior vestibule to doors 1 and 2	9	2 Ea	\$18,446.81 /Ea	\$36,894					\$36,894
Create an ADA accessible entrance to the playground	10	1 LS	\$12,602.87 /LS	\$12,603					\$12,603
Replace the sheetrock (tape and paint) on the exterior walls where moisture was trapped in side	11	4,800 SF	\$14.80 /SF	\$71,046					\$71,046
Total Code Compliance		22,333 SF	\$16.09 / SF	\$359,273	\$0	\$0	\$0		\$359,273
Security									
Secure entrance, administration office and special education relocation remodel	12	2,720 SF	\$266.94 /SF				\$726,077		\$726,077
Total Security		2,720 SF	\$266.94 / SF	\$0	\$0	\$0	\$726,077		\$726,077
Addition/Remodel (Educational Adequacy)									
Administration	13	117 SF	\$339.20 /SF				\$39,686		\$39,686

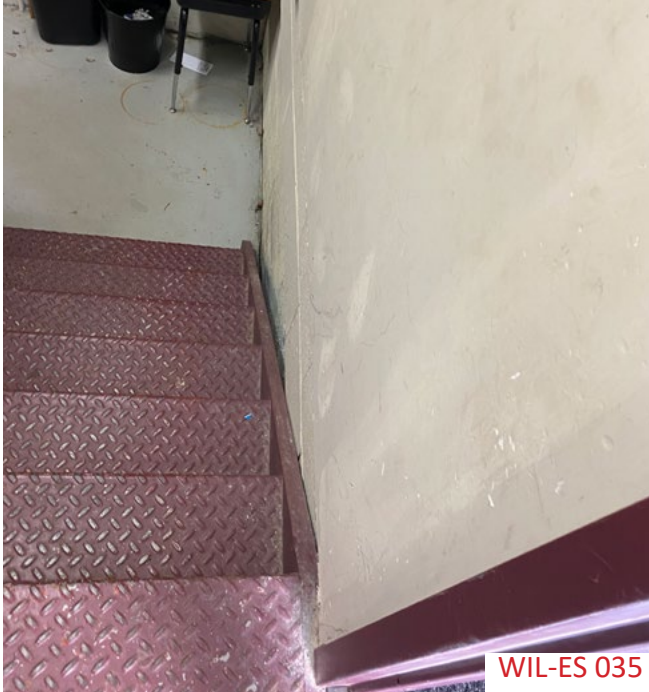
WIL-ES 035

All stairs in mechanical rooms do not have handrails on both sides, as required by code.

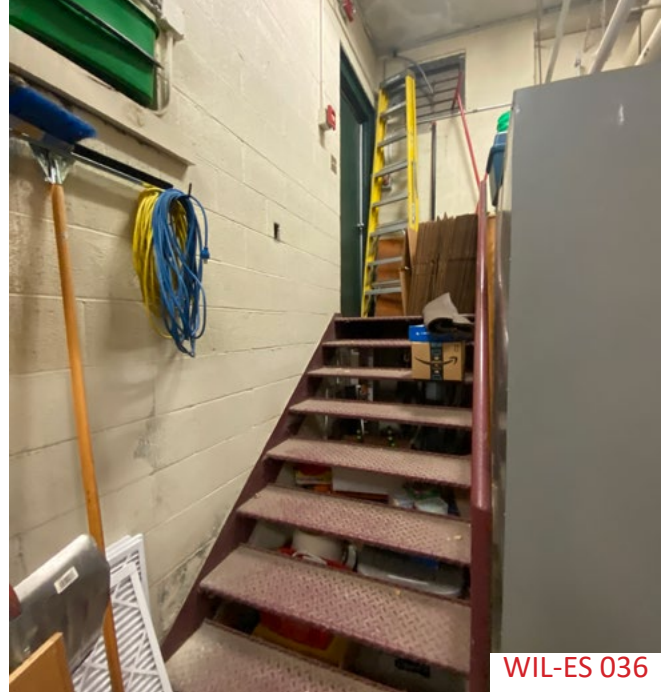
WIL-ES 036

All stairs in mechanical rooms do not have handrails on both sides, as required by code.

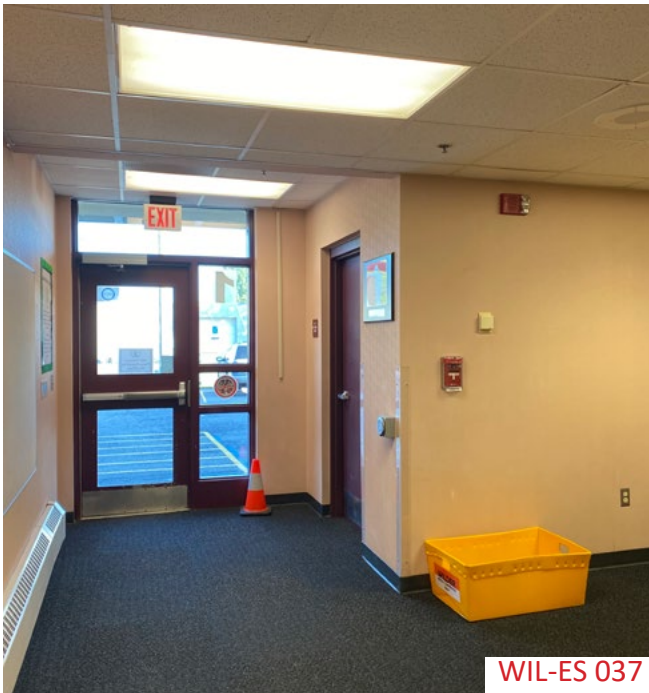
WIL-ES 037

Doors 1 and 2 are not protected with enclosed vestibules, as required by energy code.

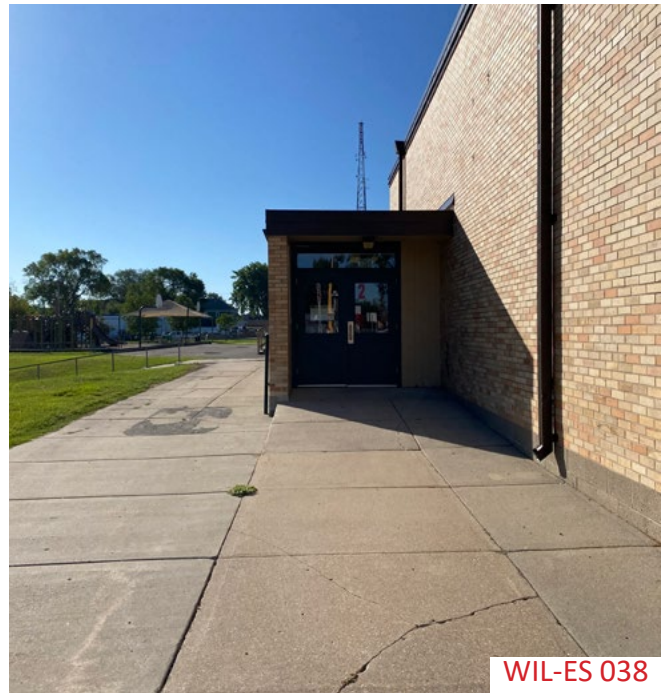
WIL-ES 038

Doors 1 and 2 are not protected with enclosed vestibules, as required by energy code.

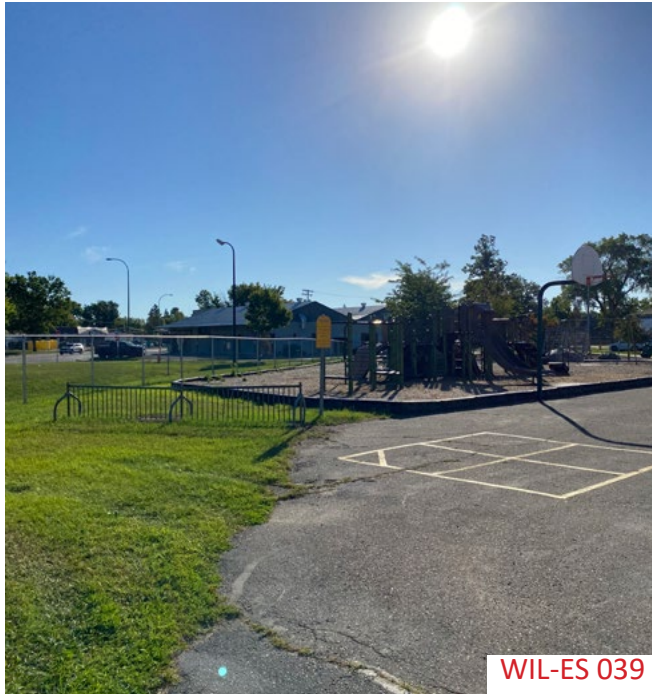
WIL-ES 039

- The playground is not accessible on all sides. (039)
- Portions of exterior walls are covered with vinyl wall covering on the interior side, which is not to code. (040)

The playground is not accessible on all sides.

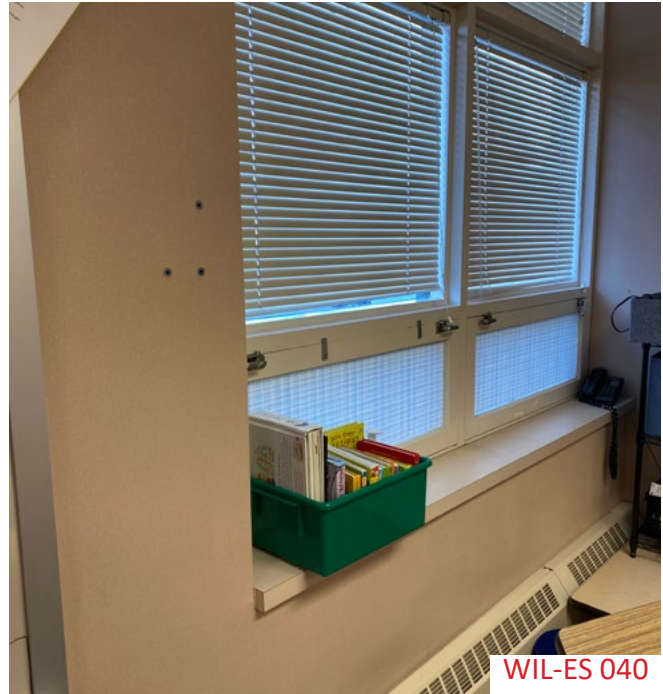
WIL-ES 040

Portions of exterior walls are covered with vinyl wall covering on the interior side, which is not to code.
