Project No. TS - 5872

Arborist Report

TO: Sunrise Elementary
SITE: 2323 39th Ave SE, Puyallup, WA 98374
RE: Tree Inventory and Assessment
DATE: May 16, 2017
PROJECT ARBORISTS: Katie Hogan
ISA Certified Master #PN- 8078A
ISA Qualified Tree Risk Assessor
Sean Dugan, Registered Consulting Arborist #457
ISA Board Certified Master Arborist #PN- 5459B
ISA Qualified Tree Risk Assessor
ATTACHED: Table of Trees; Site Map

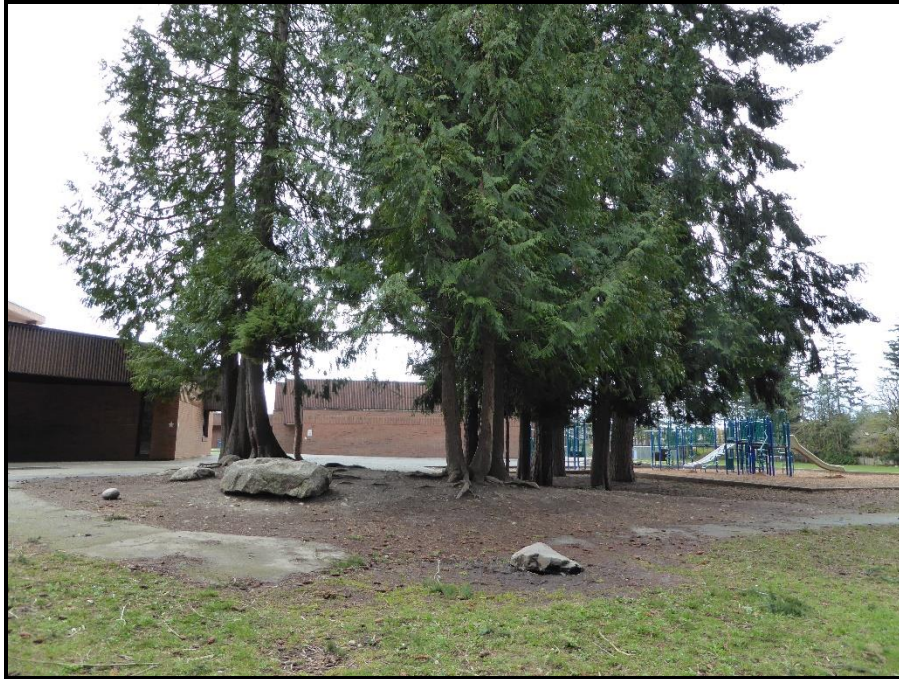
Trees 1 through 12 are located just east of the existing playground near the northern edge of the site. These trees were overall all in good condition but there was significant soil compaction at the tree bases due to heavy foot traffic. Compacted soil can limit nutrient uptake and root growth, causing trees to decline over time. In order to improve long-term soil conditions we recommend installing a coarse woodchip mulch throughout this area to depths of 3 to 6 inches. Care should be taken not to bury the trunks of the trees when installing mulch. Mulch or soil directly in contact with tree trunks can sometimes lead to bark decomposition, insect activity, or disease.

Photo 1: Looking south toward grove of trees 1 through 12 that we recommend mulching (photo credit: Tree Solutions, Inc.)

- Install coarse wood chip mulch throughout tree protection areas where soil is compacted.
- Retain clusters of healthy trees wherever feasible to decrease chance of windthrow.
- Retain mature, healthy conifers and their native understory species where possible.
- Consider removing invasive species in the northeast corner of site and replanting with native species.
- Monitor tree 327 after severe storm events. Install plumb bob to monitor for increased lean if desired.
- Tree protection areas should be established prior to the commencement of site work activities, and maintained throughout all phases of development until completion. See additional Tree Protection Specifications below.

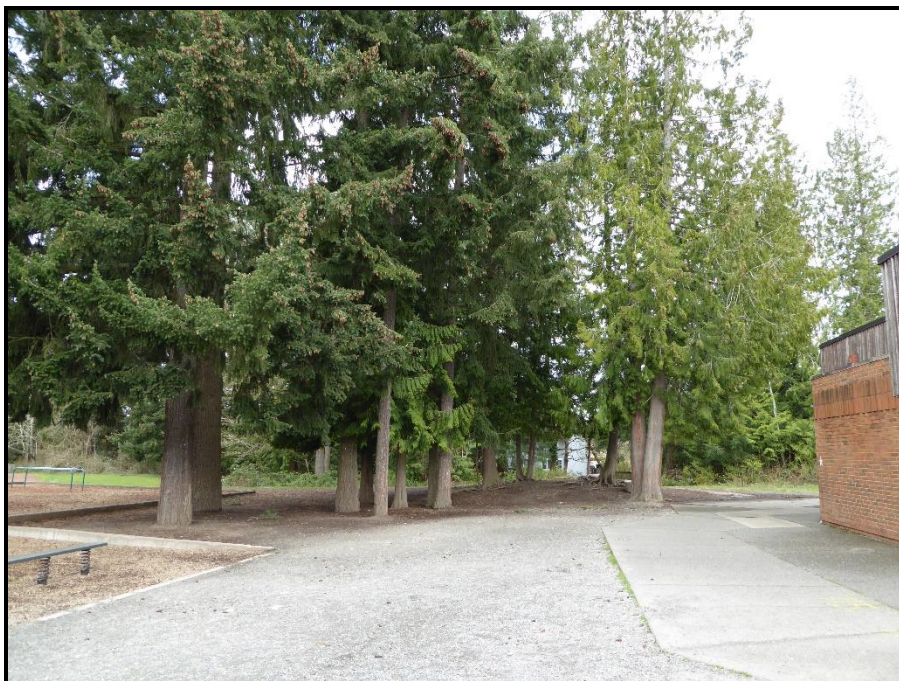
Photo 2: Looking north toward grove of trees 1 through 12 (photo credit: Tree Solutions, Inc.)

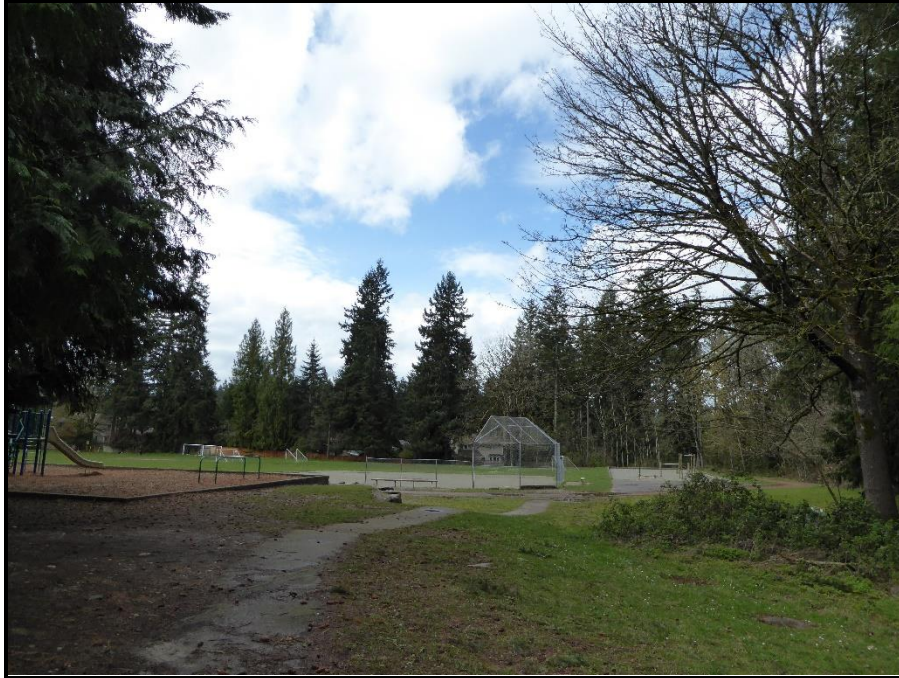
The perimeter of the site had many trees that were mostly in good condition. The majority of the Douglas-fir trees had high live crown ratios. Live crown ratio is the length of live canopy compared to the total tree length. Trees that are more open grown or were on site prior to successional vegetation typically have higher live crown ratios because sunlight was available to lower parts of the trunk. When the site was cleared for the school construction, this allowed more light to reach the perimeter trees and likely contributed to their current crown form.

Photo 3: Looking west toward the existing grass playfield at typical trees along property borders (photo credit: Tree Solutions, Inc.)

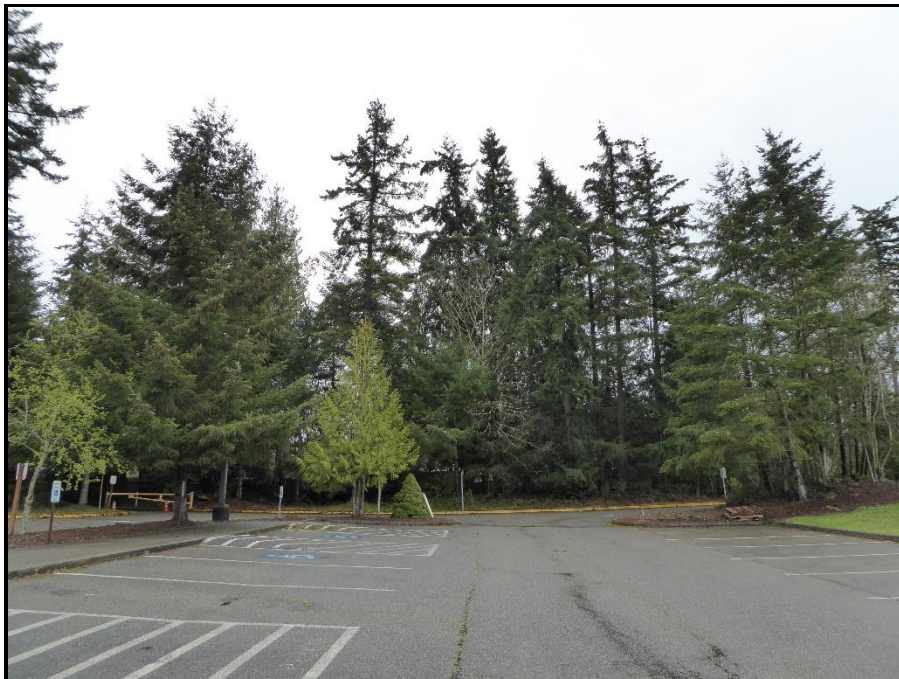
There is a grove of trees located at the southeast corner of the existing playfield (trees 165 through 175) that will likely require removal to construct the updated parking lot, new school building, and associated walkways. This grouping of trees was in good condition and individual trees would likely be suitable for retention if desired.

Photo 4: Looking east toward tree grove in southeast corner of the site (photo credit: Tree Solutions, Inc.)

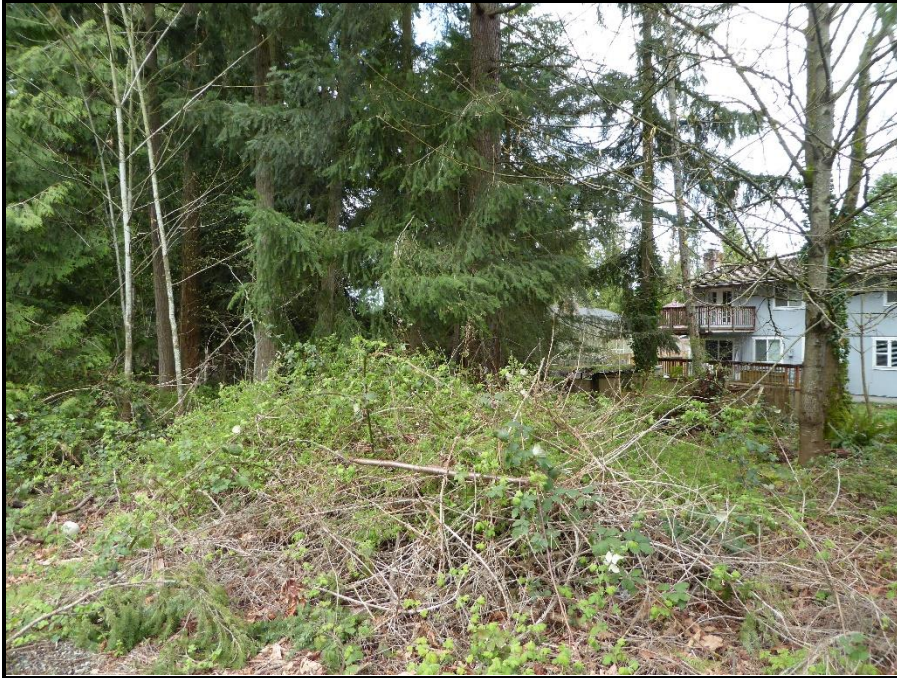
The northeastern corner of the site consisted of mostly red alder trees with scattered conifer trees. Red alder is generally a fast growing, short-lived species that is highly susceptible to decay. We observed that most of the alders throughout this section were in a state of decline. Due to location, the risk presented by these trees is relatively low, however it would be worthwhile to begin to replant with better long-term trees. We also observed a moderate volume of invasive species encroaching throughout this area including Himalayan blackberry (*Rubus bifrons*) and ivy (*Hedera* spp.). As the alder trees decline, more light will be available for low-growing invasive species to continue to populate this area. The invasive plants are currently at a manageable level throughout this area and could be removed and replaced with native plants.

Photo 5: Invasive blackberry encroaching throughout northern section of property (photo credit: Tree Solutions, Inc.)

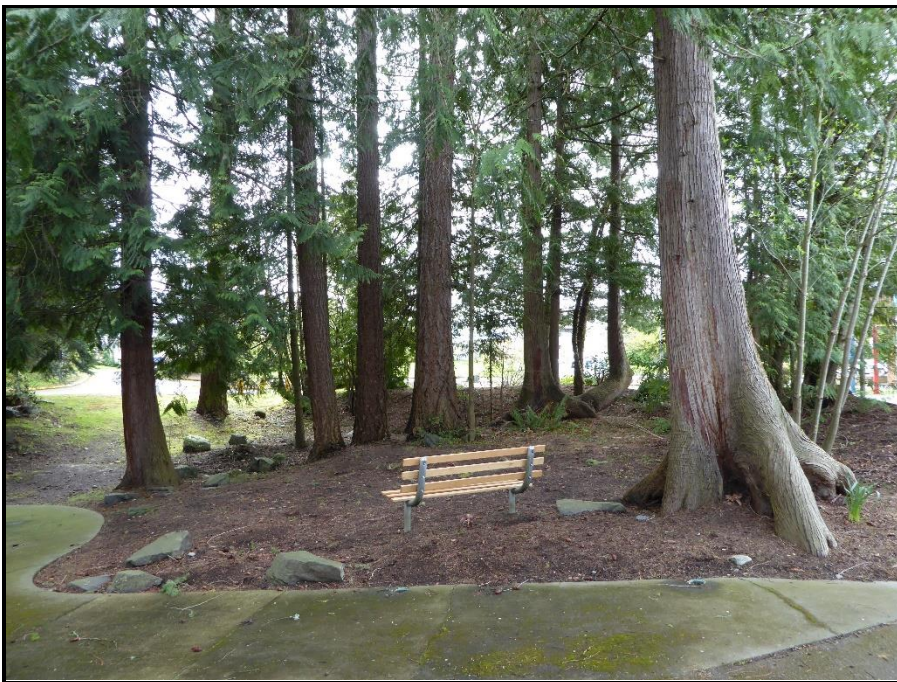
The existing courtyard just south of the main school building consists of thirty trees (trees 259 through 288). Most of these trees can likely be retained based on the current design concept for the site. Several of the fir trees in this grouping were very tall. If adjacent trees are removed, these trees should be assessed for windthrow potential. Soils throughout the courtyard were also fairly compacted due to foot traffic. We recommend installing woodchip mulch throughout the tree protection zone to promote good long-term growing conditions if this tree grove is retained.

Photo 6: Tree grove located south of existing building that was in good condition (photo credit: Tree Solutions, Inc.)

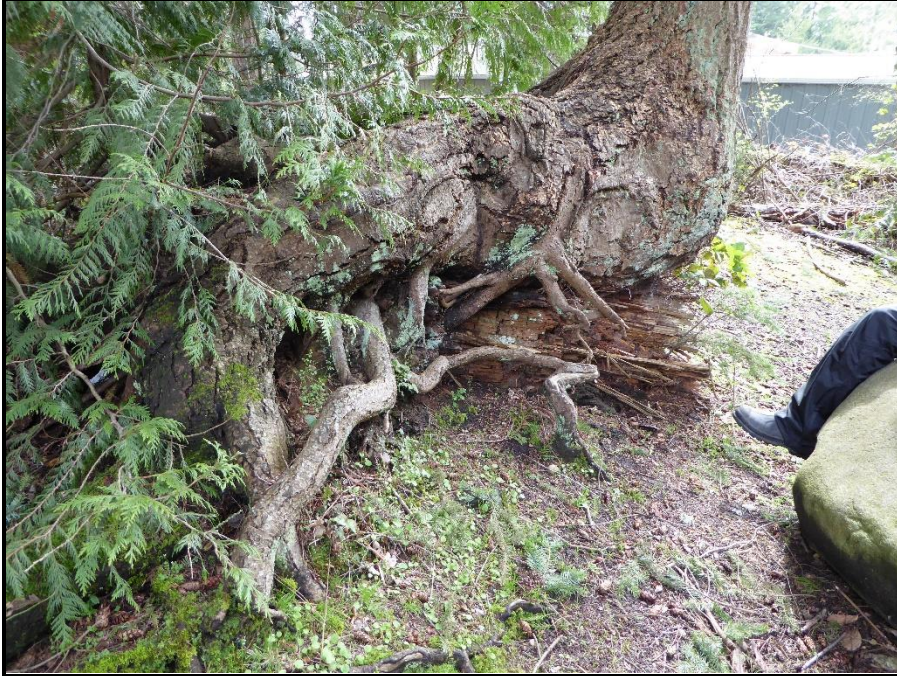
We identified one tree along the northern boundary of the site, tree 327, that had an abnormal basal structure. The tree measured over 30 inches DSH but appeared to have originally grown out of an old stump or decayed log.

Photo 7: Tree 327 that has abnormal trunk growth and should be monitored (photo credit: Tree Solutions, Inc.)

As a result, the tree had a swept base with a silted root system. We did not observe any severe defects that warrant removal, however we recommend monitoring the tree after strong weather events. A plumb bob could be installed in the tree to monitor if there is an increase in lean.
