Project Observation Report

Project Name:	Tri Tech East Building C 1.5	Project No.	2208
Report #:	38		
Observation Date:	6-21-23	Last Report:	6-14-23
Prepared By:	Steve Mallory, AIA	Contractor:	Banlin

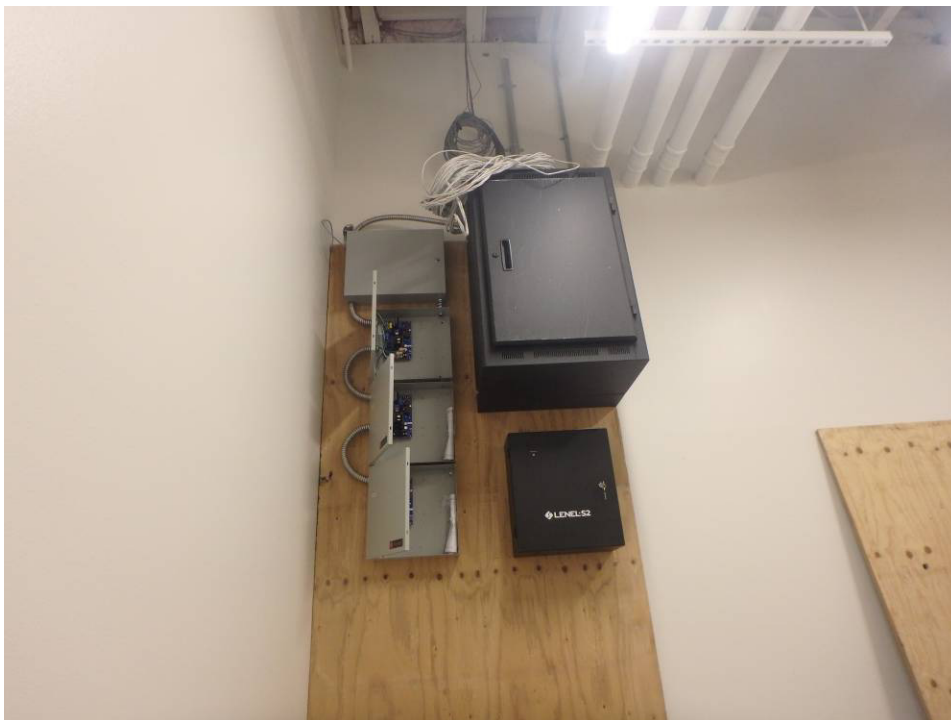
Storage room backboard and equipment, relocate lower panels to north wall, and raise
