**VERONA AREA SCHOOL DISTRICT  
FACILITIES STUDY**

Updated April 2023  
EUA Project: 322693

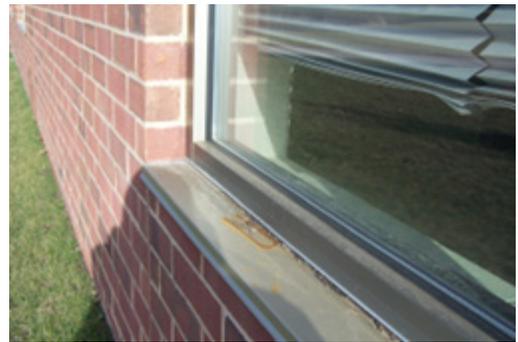
- Expected Life Span: 25-30 years
- Current Condition: Good
- The windows are double pane thermally broken aluminum windows with an operable hopper section.
- Glass is tinted to reduce/block UV rays and reduce glare.
- Interior sun control, (blinds, and shades). Blinds are integral in the original windows.
- Window sill flashing on various west facing widows do not have slope/draft to shed water away from the window as seen by the residue of sitting water. VASD to monitor.

SLOPE OF WINDOW SILL

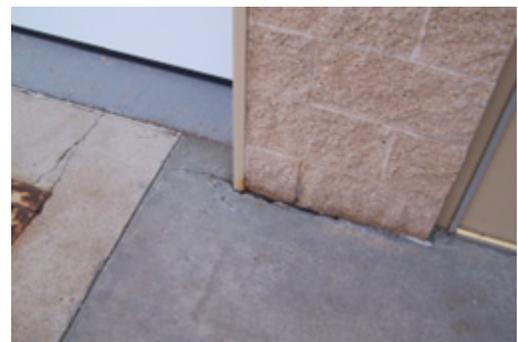
RUST STEEL AT OVERHEAD DOOR IN LOADING AREA

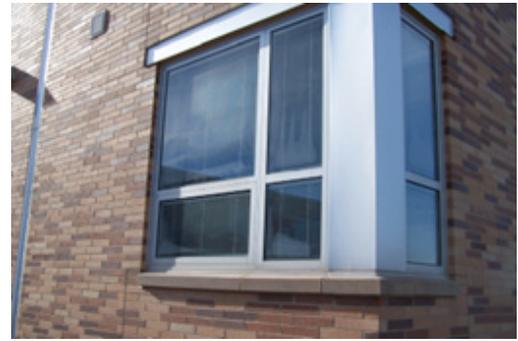
WINDOW CONDENSATION

- No fix for the condensation other than replacement. Recommend monitoring over the life of the building.

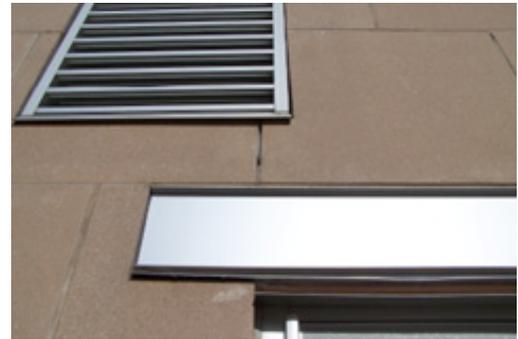
TUCK POINTING REUIRED IN SECTIONS

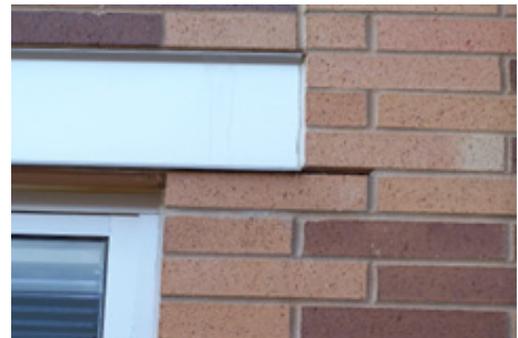
TUCK POINTING AT MASONRY

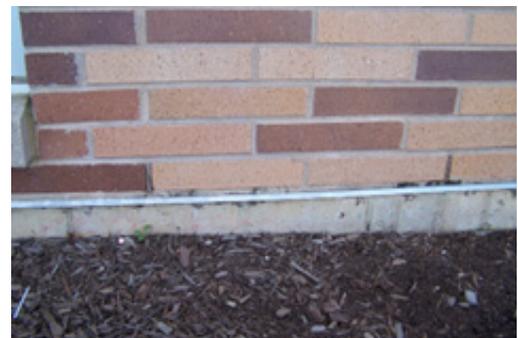
MISSING MORTAR AT BASE FLASHING

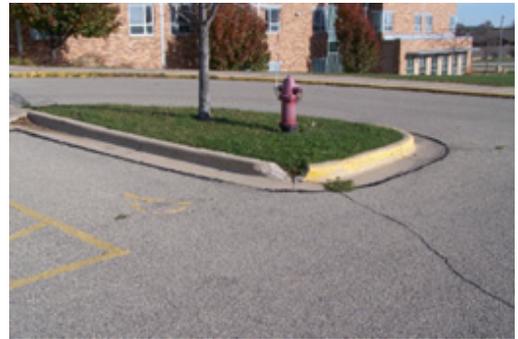
CRACKS IN ASPHALT

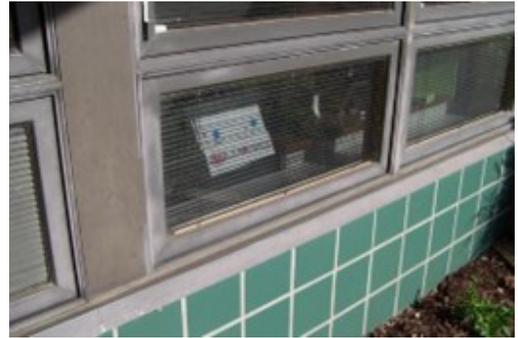
WINDOW CONDITION

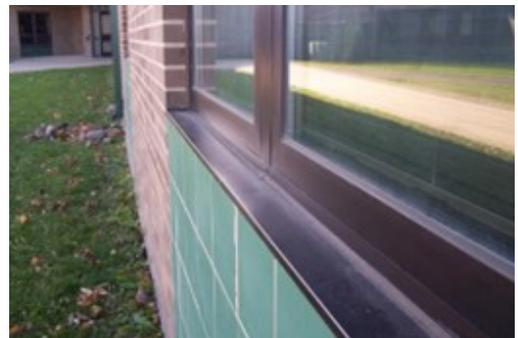
SILL SLOPES INWARD ON THE 2005 ADDITION

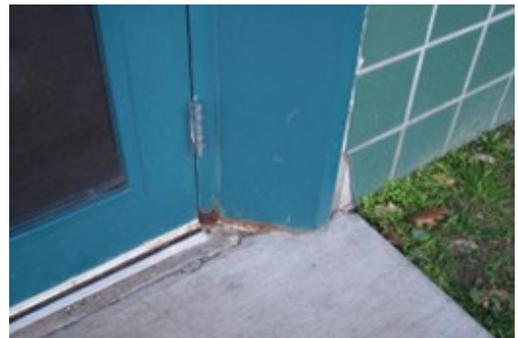
STEEL DOORS AND FRAMES DETERIORATING

- VASD to monitor doors and frames and repair/replace as required. Long term fix to rusting door frames would be to replace with Aluminum doors and frames.

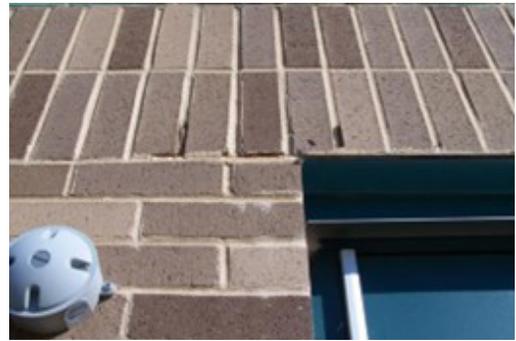
TUCK POINTING REQUIRED IN SECTIONS, SUMMER 2023 PROJECT

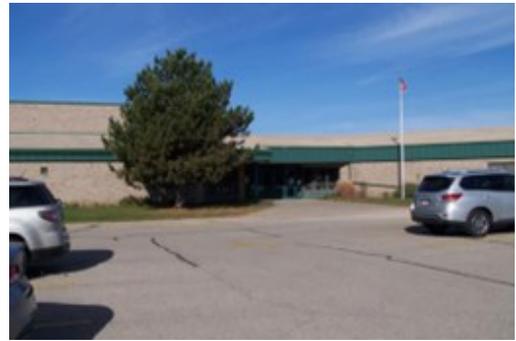
ASPHALT PARKING LOT CONDITION

- Monitor sections of concrete showing signs of wear and repair/replace as required. Freeze thaw cycles will increase deterioration.
- Landscape the eroded sections next to drive aisles to reduce the amount of erosion which is causing the sides of the drives to crack.
- Repair asphalt sections next to eroded landscape areas.
- Asphalt at drive and parking needs to be replaced.
- Consider placing a gravel mow strip around the back of the building.

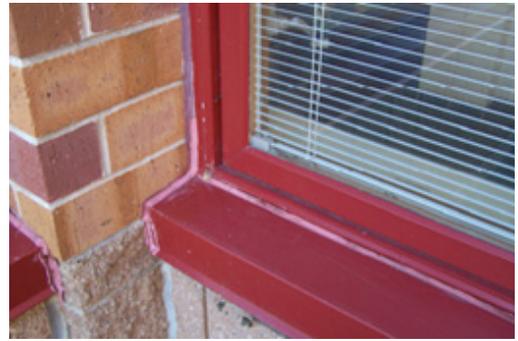
SEALANT REPAIRS NEEDED

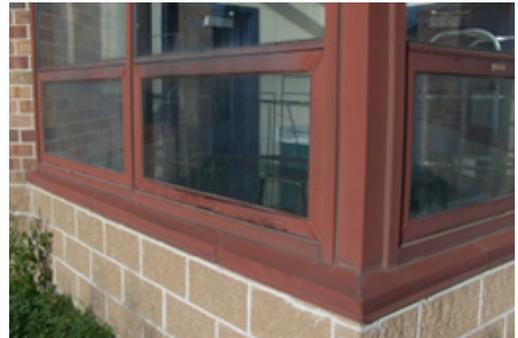
GREENHOUSE WINDOW FRAMES WEARING

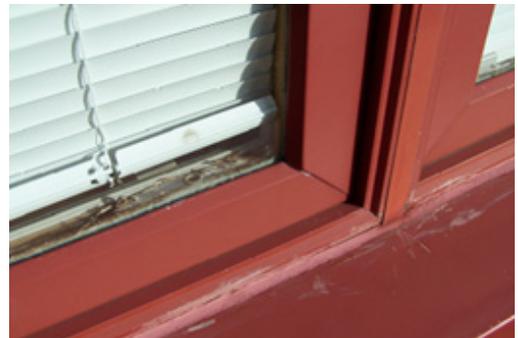
WINDOW INTEGRITY

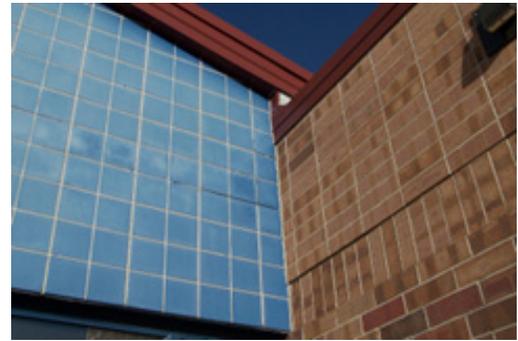
TUCK POINTING AT TILE

- Cover tile areas with metal.
- Remove/grind deteriorated mortar joints and tuck point masonry and CMU areas. Due to the apparent movement of bricks at the door jamb recommend a structural engineer evaluate for movement of the supporting structure.
- Tuck point all tile areas. Consider covering the tile material with metal panel.
- Continue routine maintenance

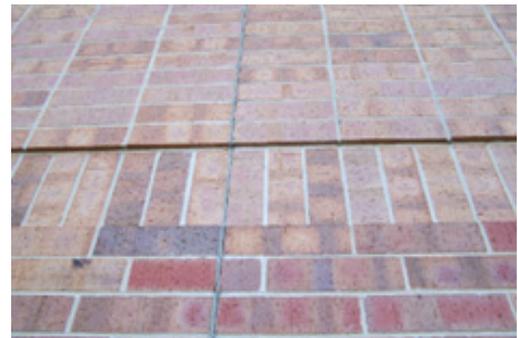
- Steel lintels above windows are in good condition
- Building control joints are in place and sealant should be replaced
- Cracking of the bricks at the doors on the West side of the building by the service doors.

REPLACE SEALANT

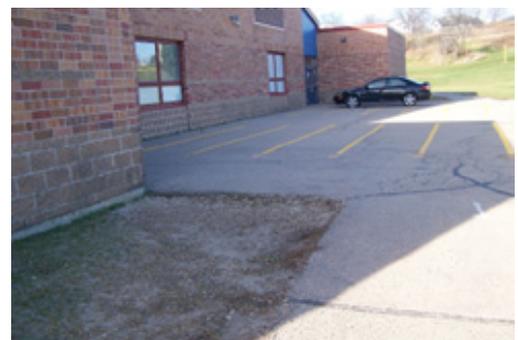
ASPHALT CONDITION AND ADJACENT LANDSCAPE

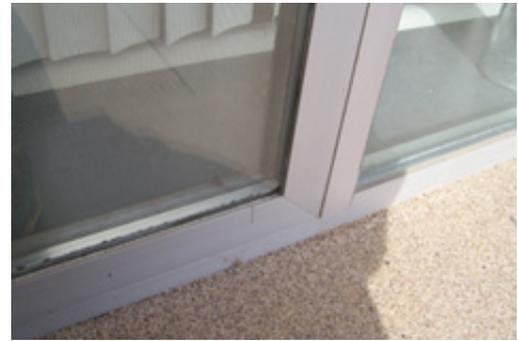
WINDOW GASKETS DETERIORATED

- Although the physical condition of the windows in the original 1963 building is fair, recommend budgeting for window replacements to benefit from the thermal and daylight performance of new products.
- Replace original window frames with thermally broken aluminum frames.
- Monitor the windows and frames in the 1993 addition areas as they are approaching the end of their life expectancy.
- Remove the existing sealant at window to wall conditions and replace with new backer rod and sealant.

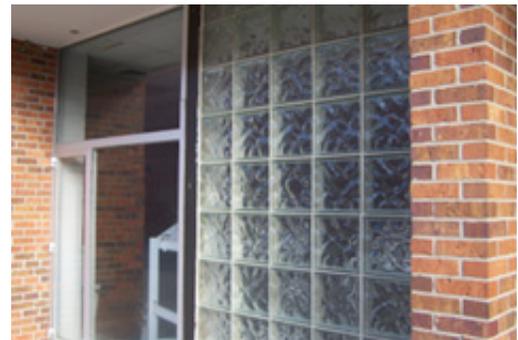
SINGLE PANE GLASS AND GLASS BLOCK

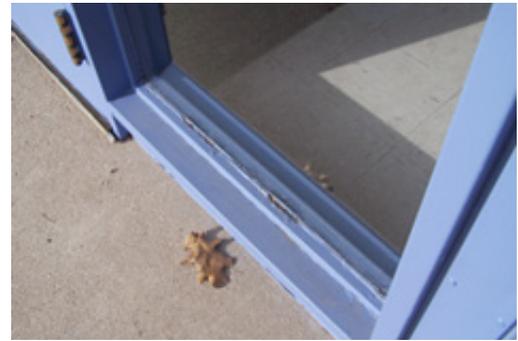
SINGLE PANE GLASS

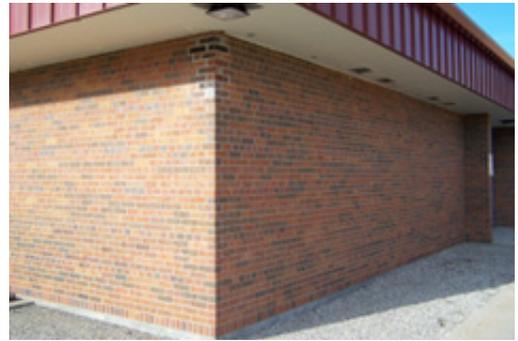
NO CONTROL JOINTS

- Remove/grind deteriorated mortar joints and tuck point masonry.
- Remove old sealant at window to wall conditions and replace with backer rod and sealant.
- Remove and replace sealant at building control joints.
- Inspect and repair site cast concrete sections.
- Remove rust from steel lintels and paint with high quality enamel.
- Verify the masonry joint condition at the exterior of the

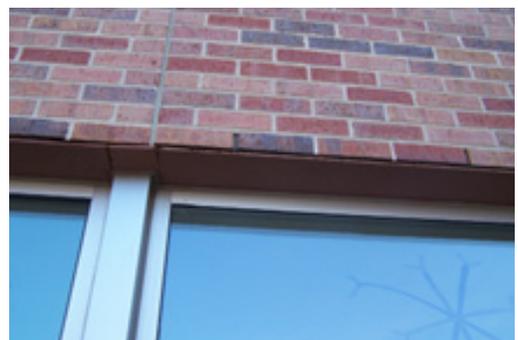
SLIGHT RUST ON SOME LINTELS

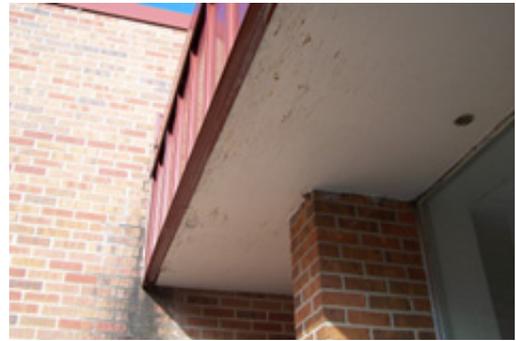
SOFFIT DETERIORATION

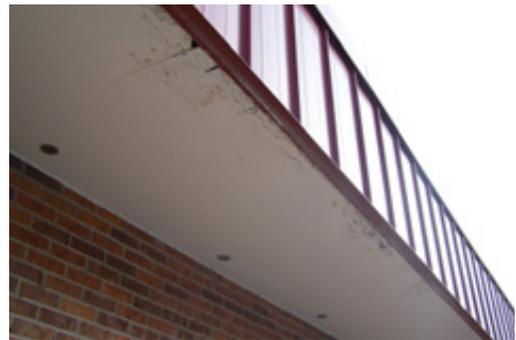
SOFFIT DETERIORATION

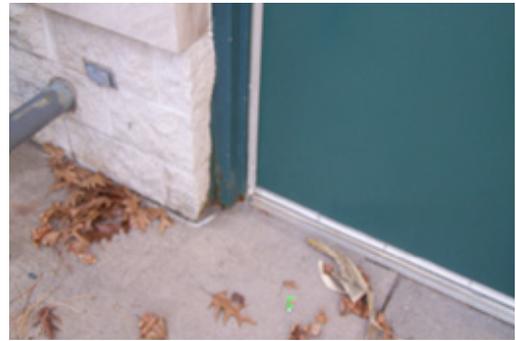
STEEL OVERHEAD DOOR AT LOADING  
SOME RUST

- None at this time. Clean and paint as required. A long term fix would be to replace steel doors and frames with aluminum for durability.

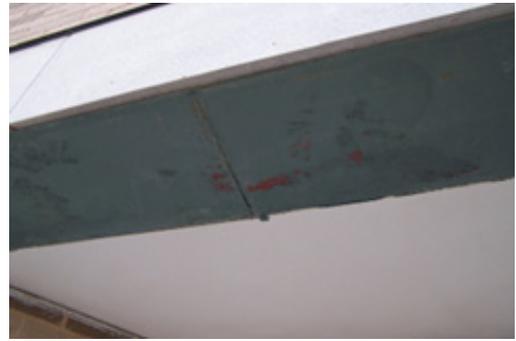
LINTEL CONDITION

- Monitor and maintain as required.
- Clean and paint lintels as required.
- Clean and paint rusted steel column bases.

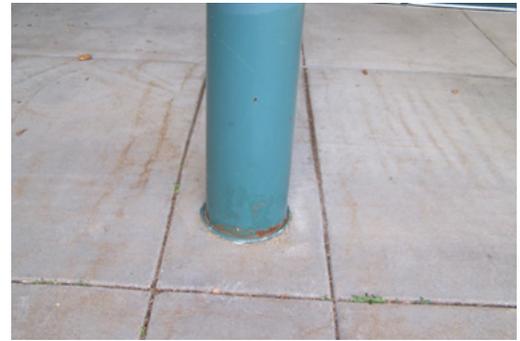
STEEL COLUMN BASE DETERIORATION

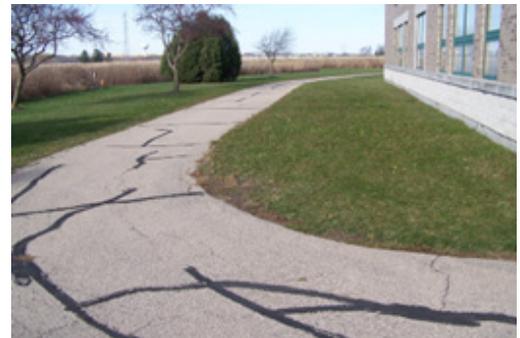
CRACKED ASPHALT

- Monitor concrete for settlement and repair as required.
- Maintain asphalt around the West side of the building. Consider future replacement.
- Monitor the landscape sections close to drive aisles and repair to minimize undercutting of asphalt areas.

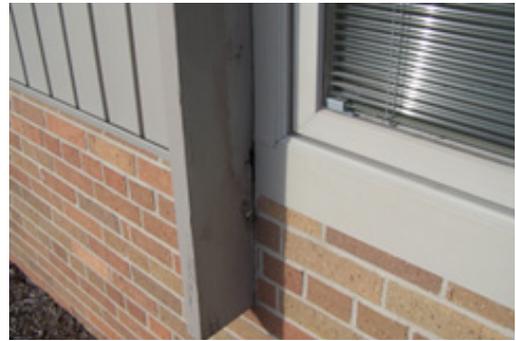
WOOD TRIM CONDITION

- Remove rust from steel lintels and paint with high quality enamel.
- Strip and repaint all wood surfaces with high quality exterior paint. Inspect all wood trim and siding replace as needed.
- Where brick is set back from the exterior building plane tuck point or consider grinding and inserting backer rod and sealant.
- Patch hole in wall at mechanical space with brick and mortar.
- Continue routine maintenance.

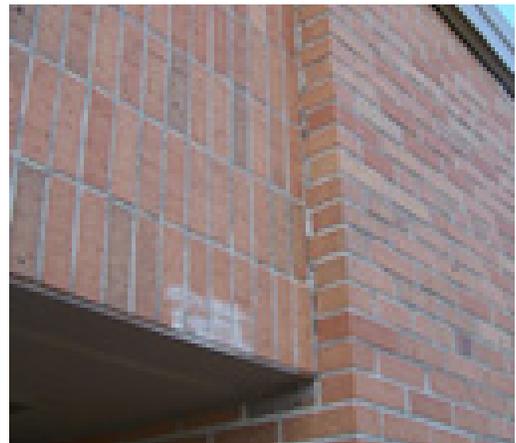
TUCK POINTING

- Remove/grind deteriorated mortar joints and tuck point masonry.

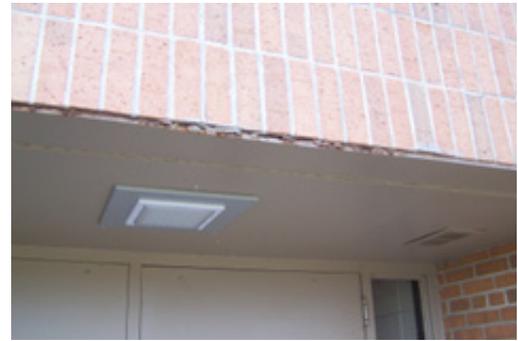
LINTEL RUST AND SEALANT
