Lead Levels in Drinking Water at Weybridge Elementary School, Weybridge, VT

Technical Summary

February 3, 2019

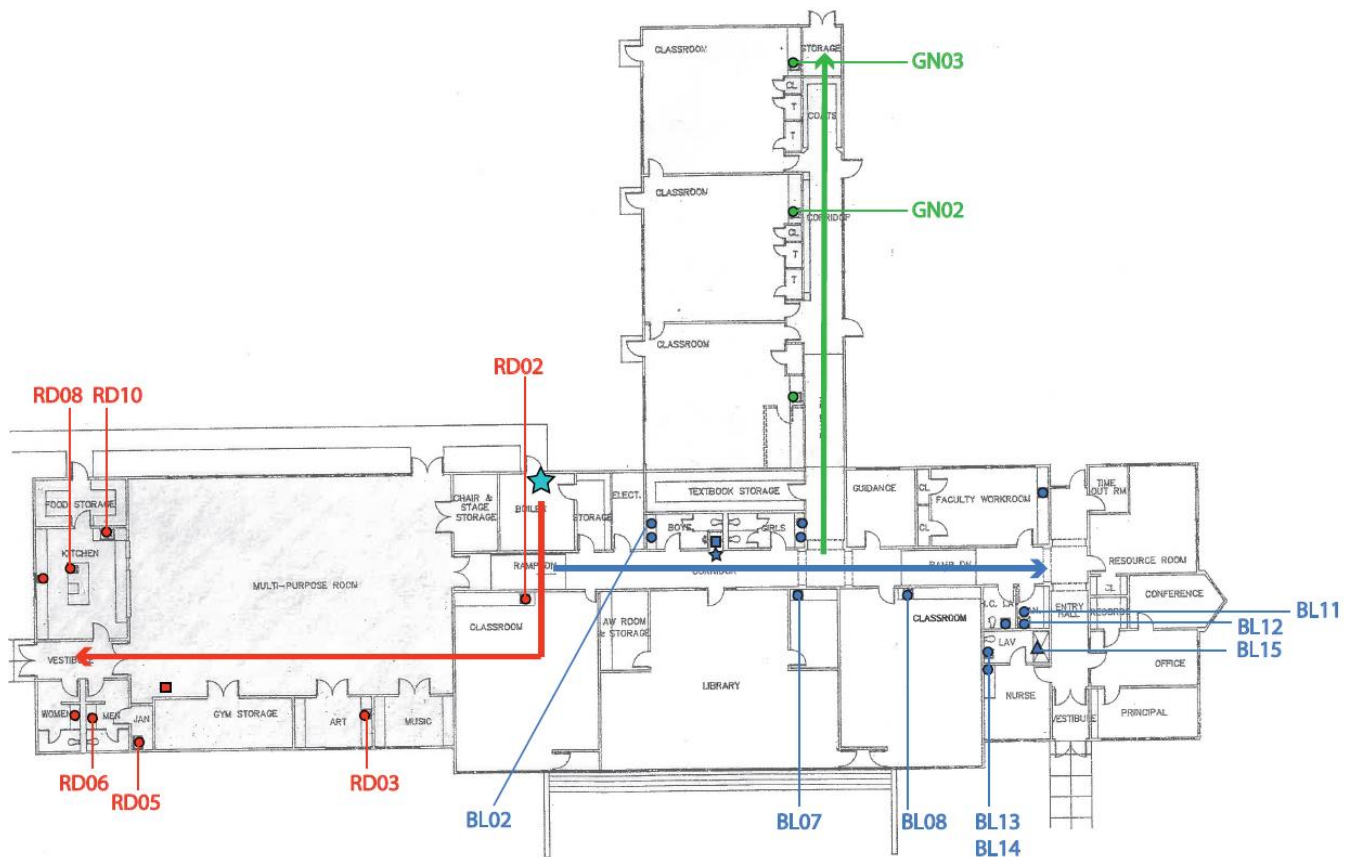
Low FL sample lead concentrations for outlets that delivered elevated FD samples suggest that the predominant source of lead is the fixtures or their immediate connections rather than more distal pipes or the incoming water supply, which may simplify potential remediation approaches.

Figure 1. Floor plan showing locations of Weybridge Elementary School outlets that exceeded the EPA action level or the American Academy of Pediatrics safety level (see also **Table1**).

We recommend that WES pursue the following permanent remediation approaches for priority outlets:

- 1) replace existing outlet fixtures with “lead-free” fixtures/solder or remove the outlets entirely
- 2) if replaced, verify remediation efficacy via follow-up lead testing

Until priority outlets are permanently remediated, we suggest the following temporary approaches:

- 1) disconnect water supply to priority water fountains and kitchen sinks/sprayers
- 2) disconnect water supply to priority sinks in locations where water is not needed for non-consumption uses
- 3) for priority sinks/showers/sprayers in locations where water *is* needed for non-consumption uses,
 - a. establish school-wide policies for water consumption from outlets by outlet type (e.g., “only drink from water fountains and bottle fillers”), rather than location-specific policies
 - b. complement school-wide water consumption policy with age-appropriate signage at each priority outlet instructing against consumption and with educational outreach regarding the policy and its rationale
