## Lead Levels in Drinking Water at Bridport Central School, Bridport, VT

July 1, 2018

### TECHNICAL SUMMARY of RESULTS

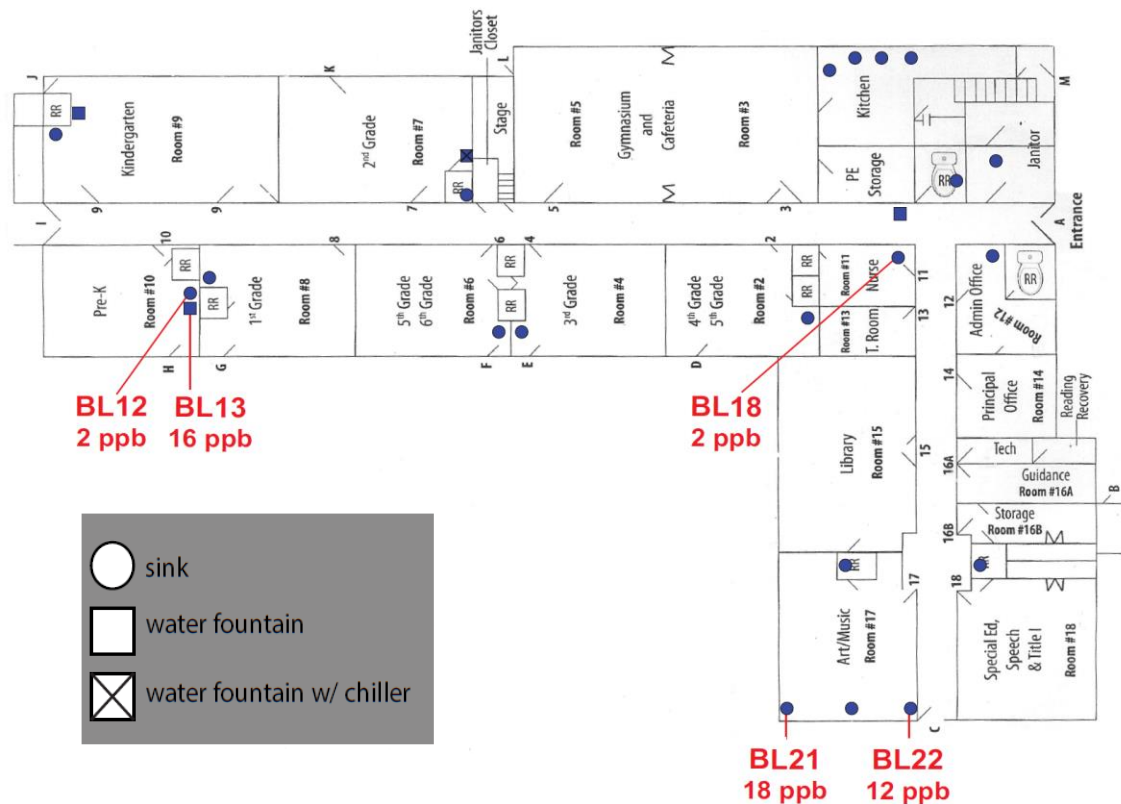
Most outlets (15 outlets, 62%) produced FD samples with detectable lead, but for most of these (67%), the lead was at 1 ppb or lower and, therefore, meets the American Academy of Pediatrics (AAP) health-based recommendation for school water fountains. **Table 1** and **Figure 1** summarize the five outlets prioritized for remediation.

Remedial actions include permanent (preferred) and temporary measures; appropriate actions depend on the source of lead in the water. FL samples had lower lead levels as compared to their associated FD sample, which suggests that the predominant source of the lead in the FD samples is the outlet fixtures or immediate connections (e.g., solder) rather than incoming water or pipes within the school. All but one FL sample were either non-detect for lead or lead was present only at trace levels (e.g., <1 ppb), which suggests that flushing may serve as an effective temporary measure for four of the five priority outlets. The BL13 outlet (classroom water fountain), which produced one of the FD EPA exceedances, produced water at 3 ppb, exceeding the AAP recommendation, even after the 30-second flush.

**Figure 3.** Bridport Central School outlets prioritized for remediation due to FD samples that exceeded either the administrative (not health-based) 15-ppb EPA action level and/or the health-based 1-ppb 2016 American Academy of Pediatrics recommended safety level.

**We recommend that BCS pursue the following *permanent* remediation approach for priority outlets:**

- 1) replace existing outlet fixtures with “lead-free” fixtures/solder or remove the outlets

entirely

- 2) if replaced, verify remediation efficacy via follow-up lead testing following replacement

Until priority outlets are permanently remediated, we suggest the following *temporary* approaches:

- 1) disconnect water supply to the priority water fountain (BL13)
- 2) disconnect water supply to priority sinks in locations where water is not needed for non-consumption uses
- 3) for priority sinks in locations where water *is* needed for non-consumption uses,
  - a. establish school-wide policies for water consumption from outlets by outlet type (e.g., “only drink from water fountains and bottle fillers,” or “do not drink from sinks” or “flush prior to use for consumption”), rather than location-specific policies
  - b. complement school-wide policy with age-appropriate signage at each priority outlet instructing on the school-wide policy and with educational outreach regarding the policy and its rationale
