Project Observation Report

Project Name:	Tri Tech East Building C 1.5	Project No.	2208
Report #:	39		
Observation Date:	6-28-23	Last Report:	6-21-23
Prepared By:	Steve Mallory, AIA	Contractor:	Banlin

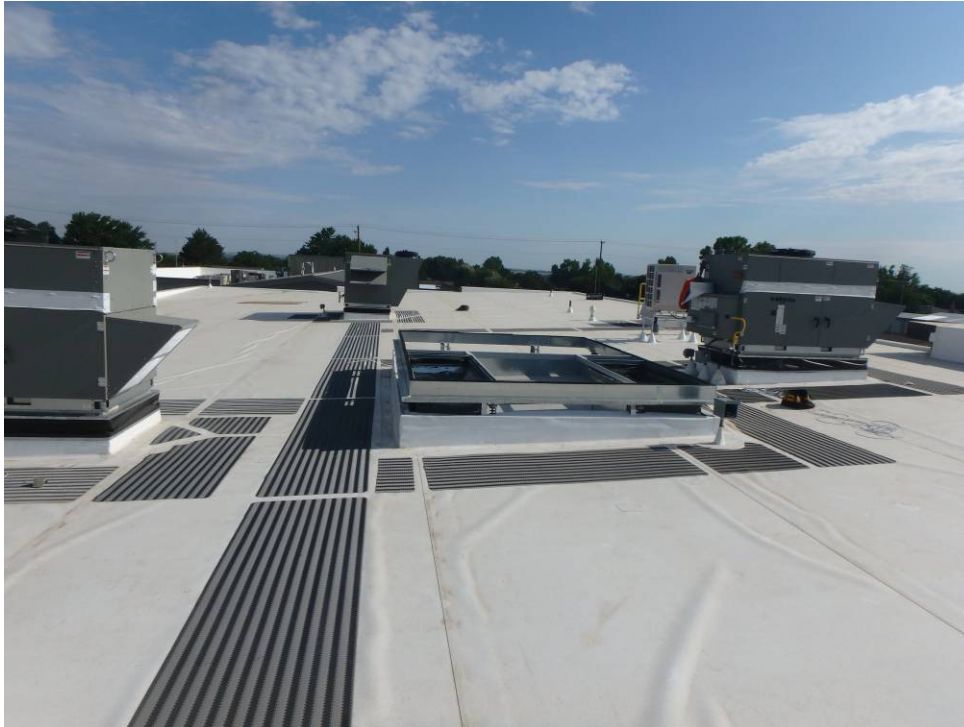
Ready for the DOAS air handler unit (6/27)

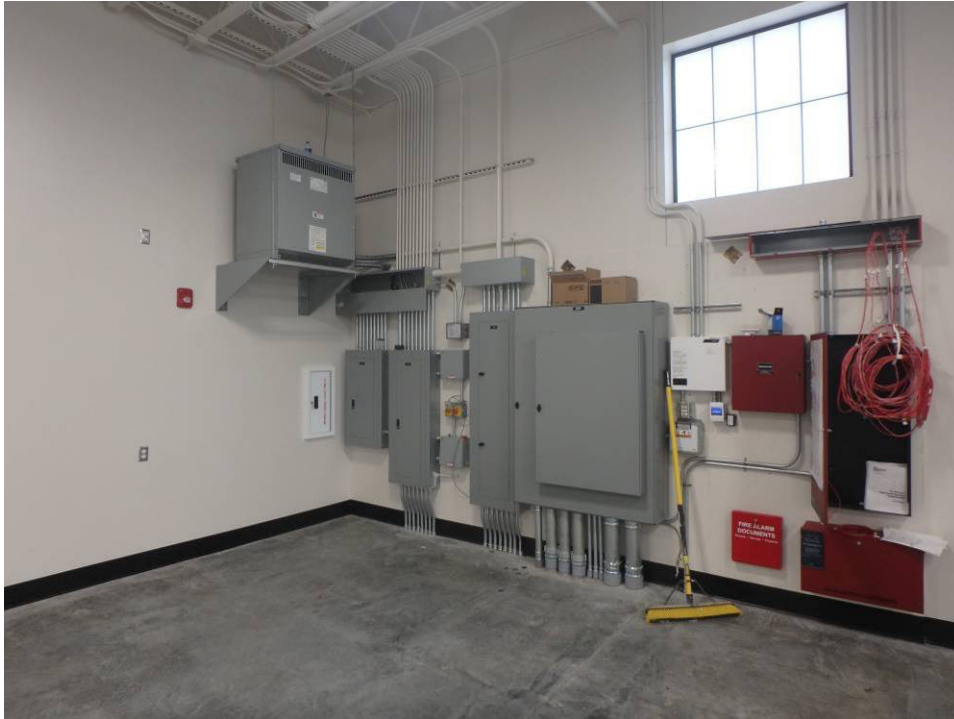
Looking northwest towards the shop's electrical panels and transformer mounted on the wall

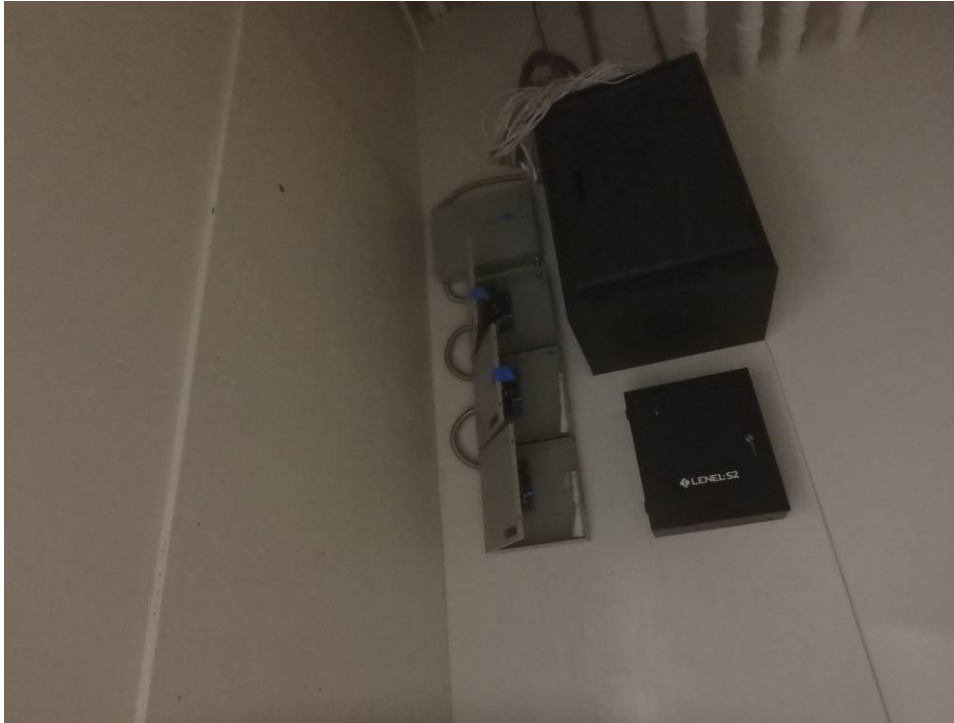
Storage room backboard and equipment, relocate lower panels to north wall - painted
