Darlington County School District
Facility Study
July 29, 2019

Brockington Elementary Magnet School for Science and Technology

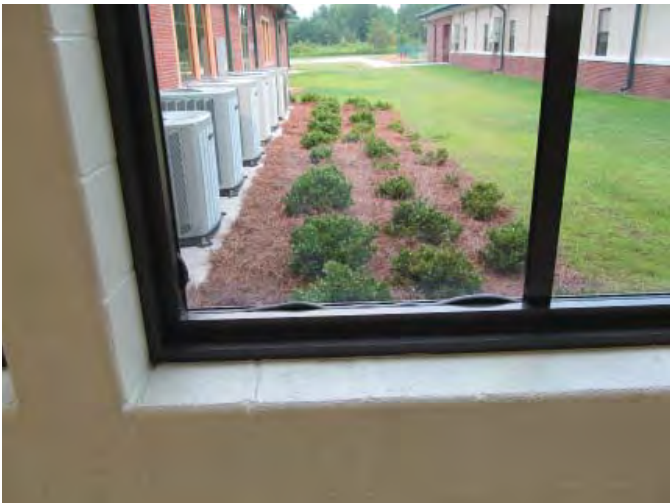
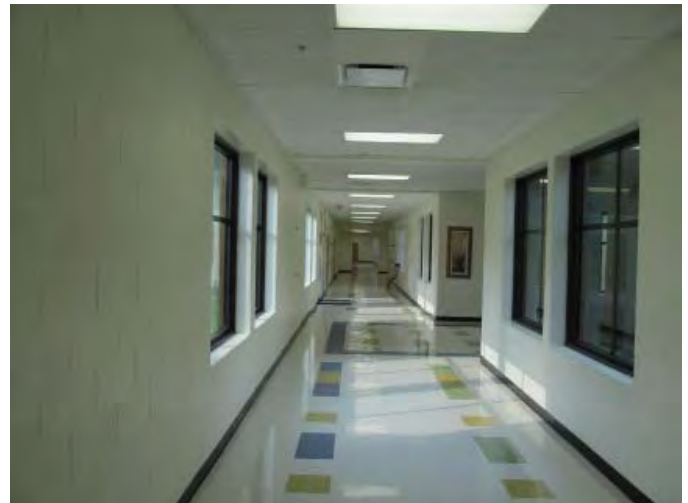
- In older wings, hardware does not meet ADA requirements
- Several fixtures are in poor condition and/or do not meet ADA requirements
- Some door clearances do not meet ADA

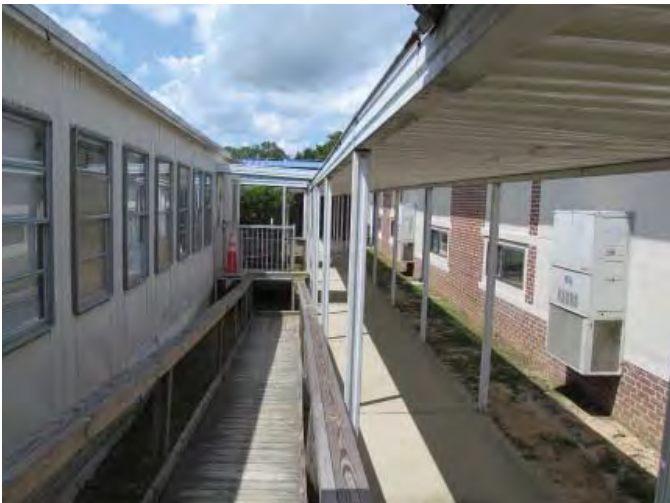
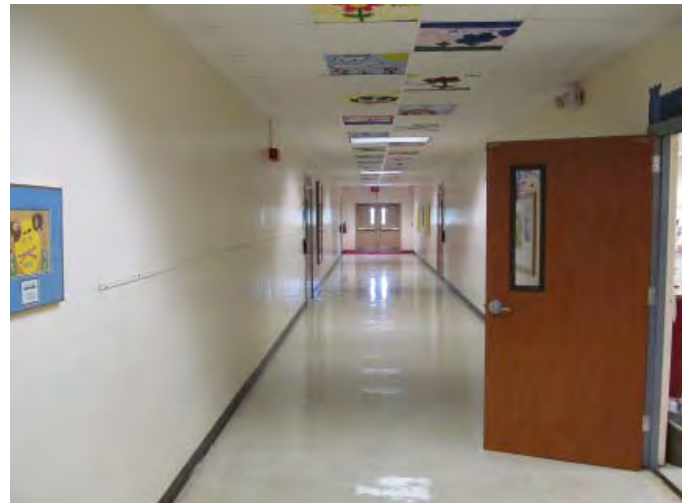
- Several restrooms not in good condition nor meet ADA requirements

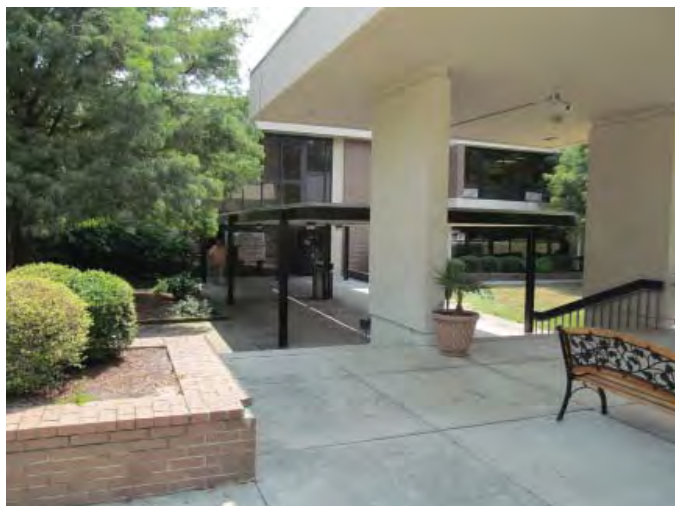
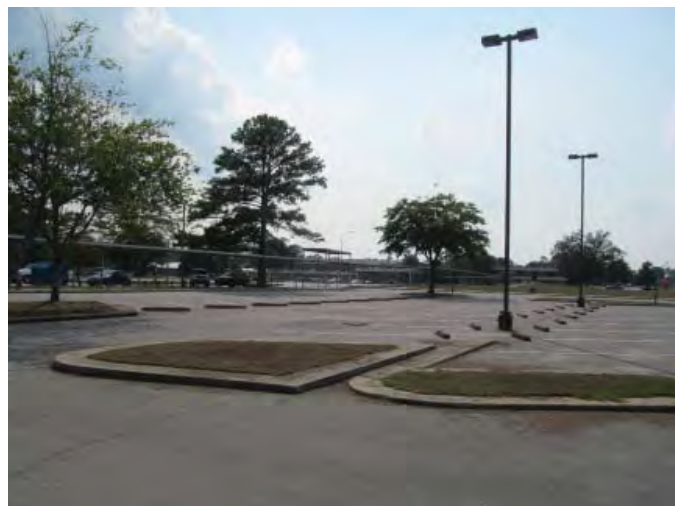
- Drainage goes towards the building causing moisture issues on brick and needs to be monitored/addressed
- ADA access to building entrances lacking
- Covered walk needed for access from band building and 9th Grade building to main campus building

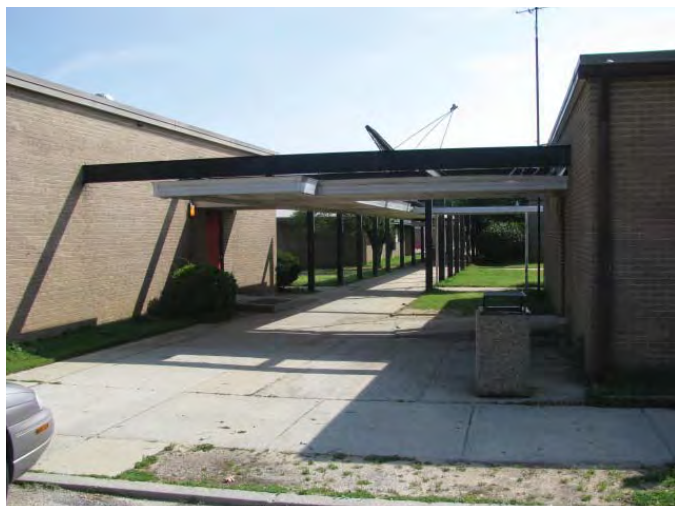
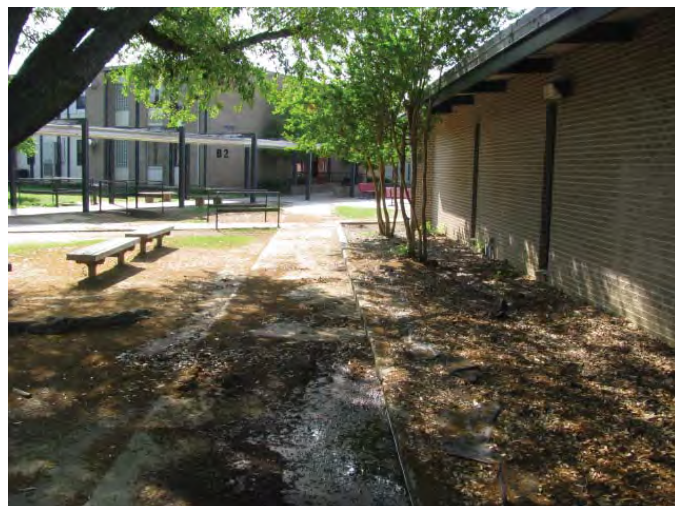
- Site drainage an immediate concern
- Reworking and striping of parking lots and drives recommended

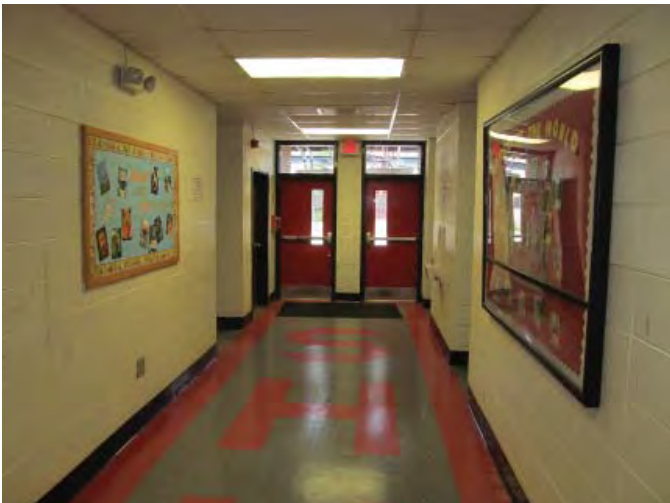
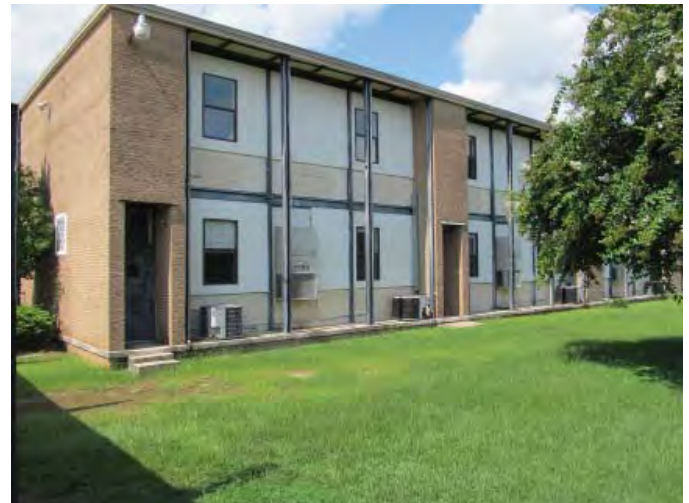
- Some interior doors not rated
- ADA restrooms needed
- Renovation of classrooms to include finishes is recommended

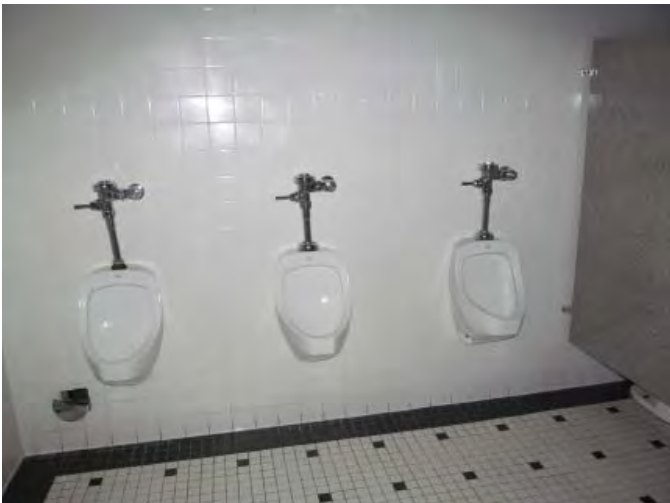
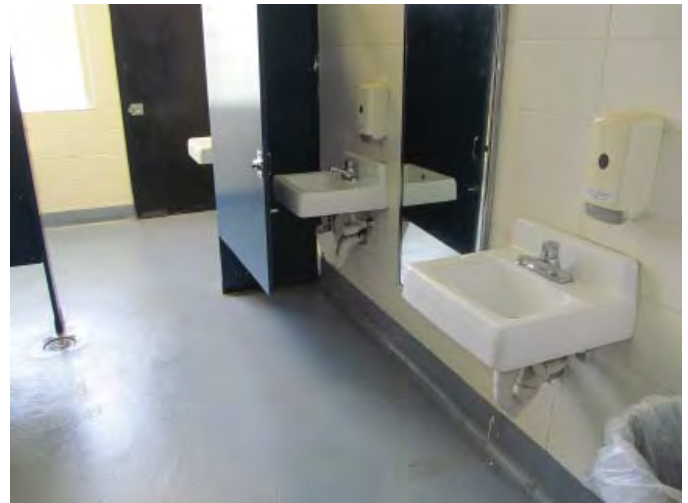
- Air quality will need to be tested
- Mold and moisture need to be monitored for cause of either HVAC or drainage and addressed

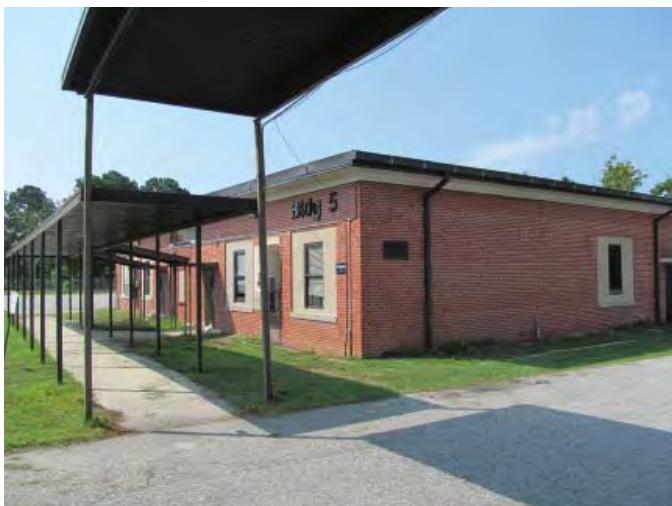
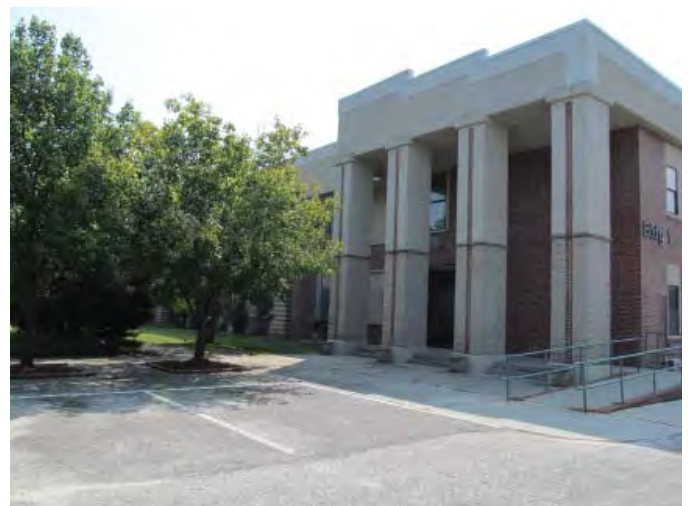
- Drainage towards buildings causing moisture issues
- Grade changes and ramps need to be address for ADA access
- Drives and parking lots would benefit from repaving and striping

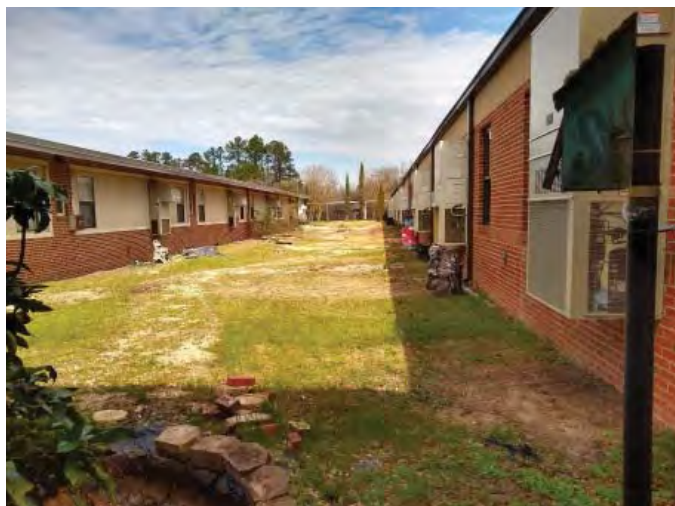
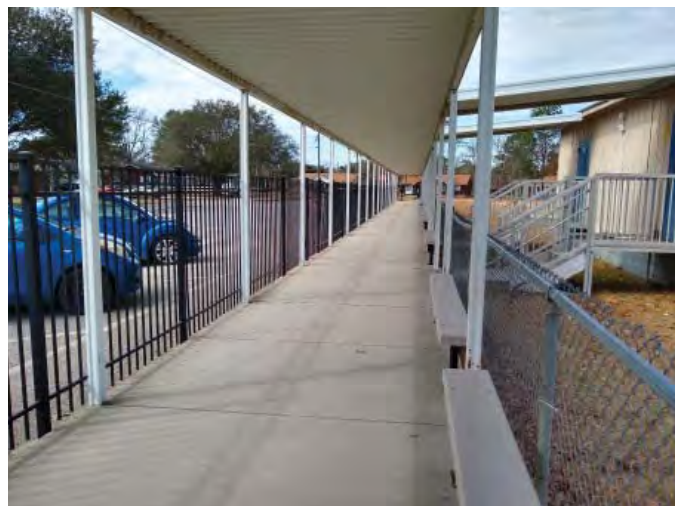
- Traffic patterns are awkward and lack stacking space for parent pick up and causes backups in neighborhood
- Modular classrooms lack ADA ramps

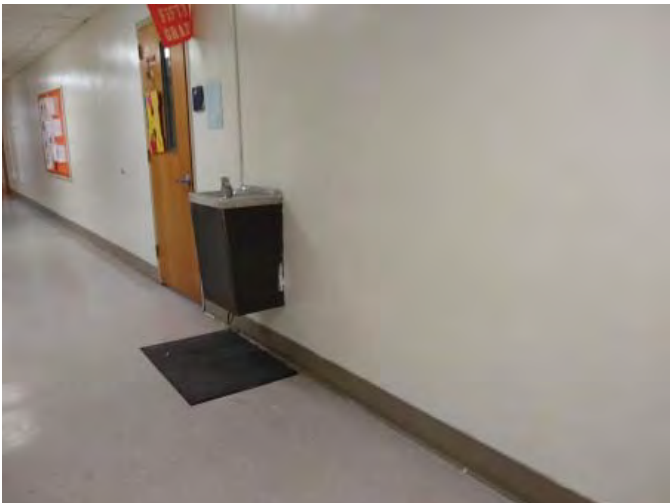
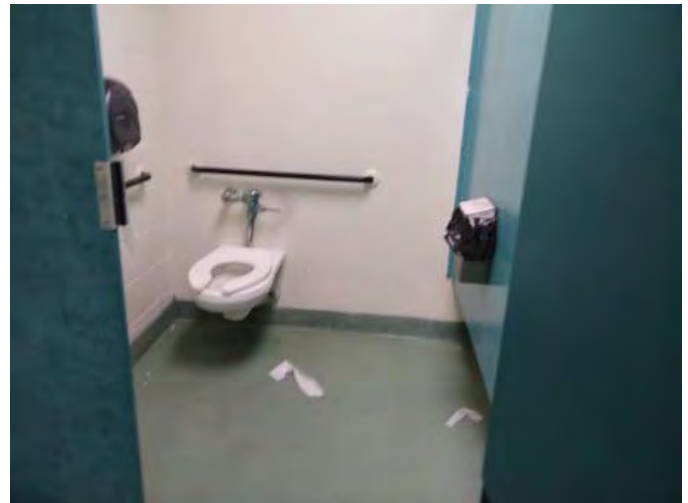
- Air quality needs to be tested
- Moisture issues present in some spaces

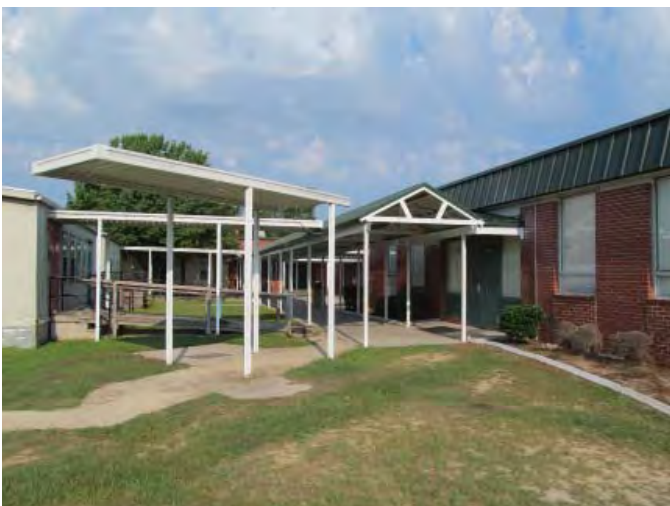
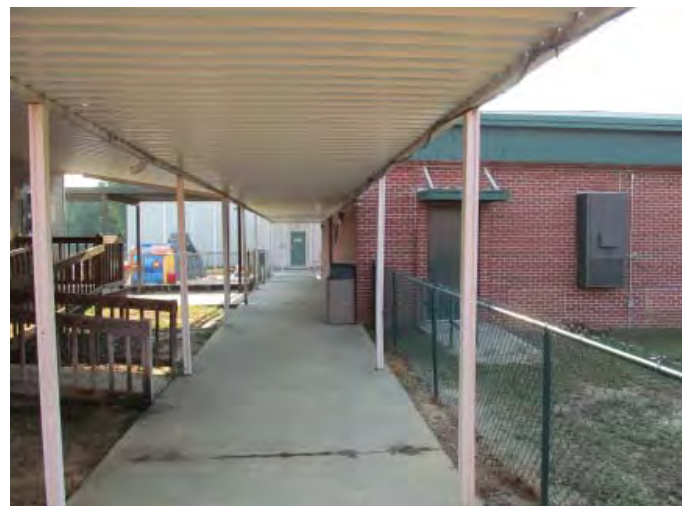
- Traffic patterns are awkward for parent drop off
- Drainage issue around media center building
- Continuity of covered walk from bus drop off recommended

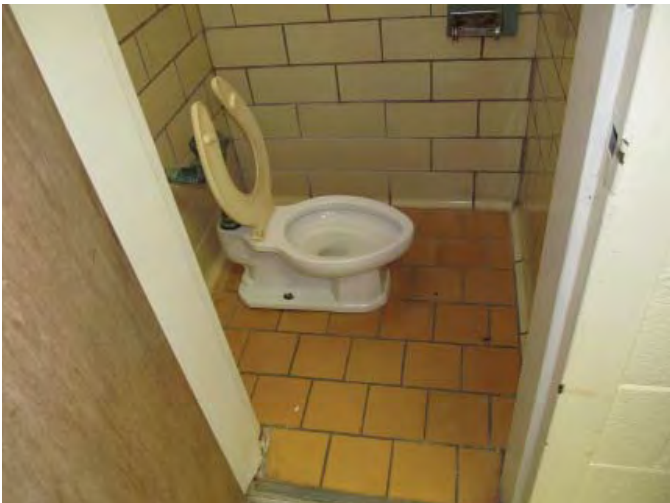
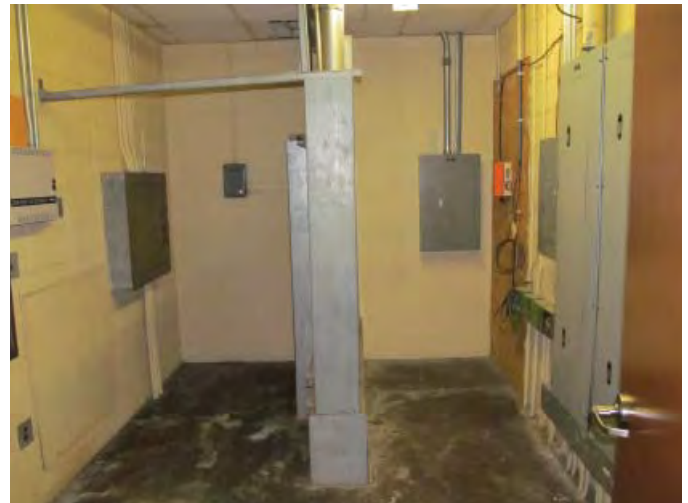
- PE lacks air quality creating a smell and moisture issues

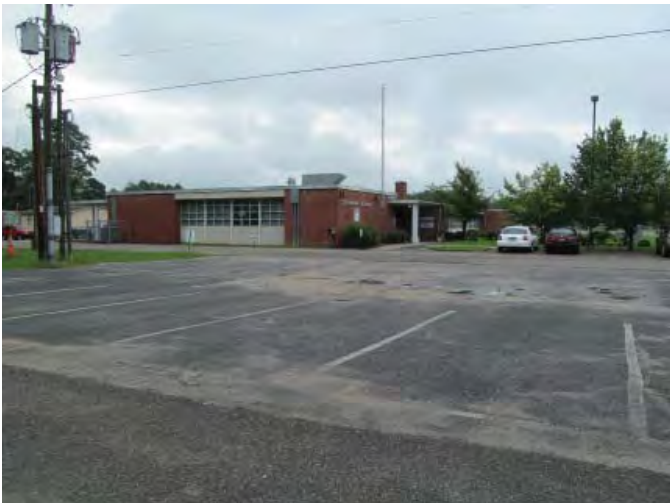
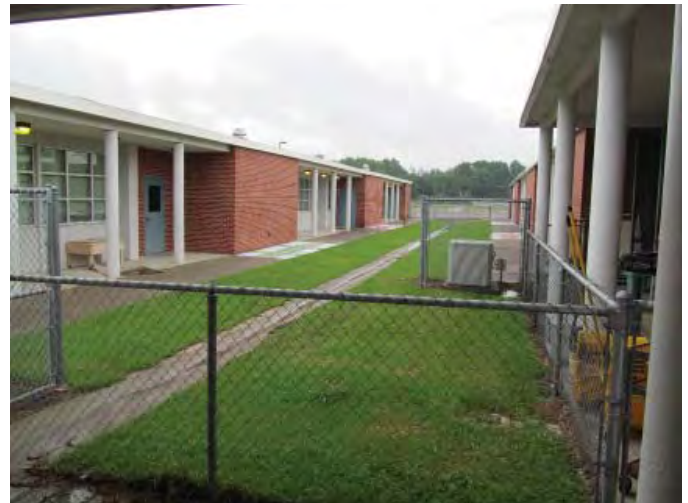
- Improvements to parking circulation and efficiency is recommended
- Ramps to some doors in Building 3 do not meet ADA

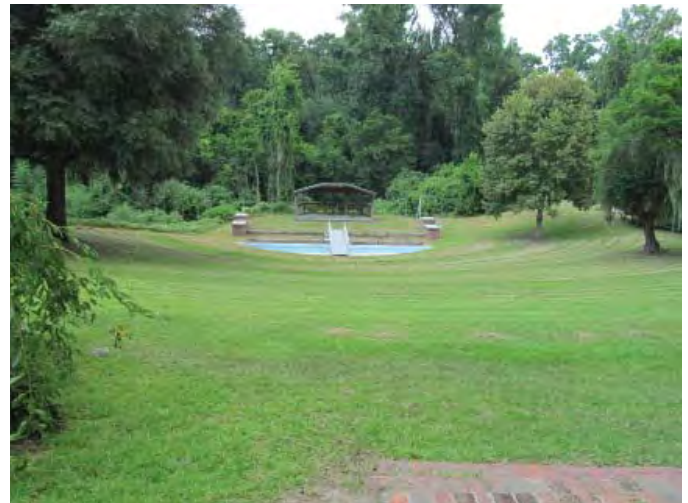
- Site drainage needs to be addressed to address mold on brick
- Restriping of parking areas is recommended
- Traffic patterns are awkward for parent and bus drop off
- Have to cross the street to access play areas
- Sidewalks between buildings create accessibility issues for entry to buildings

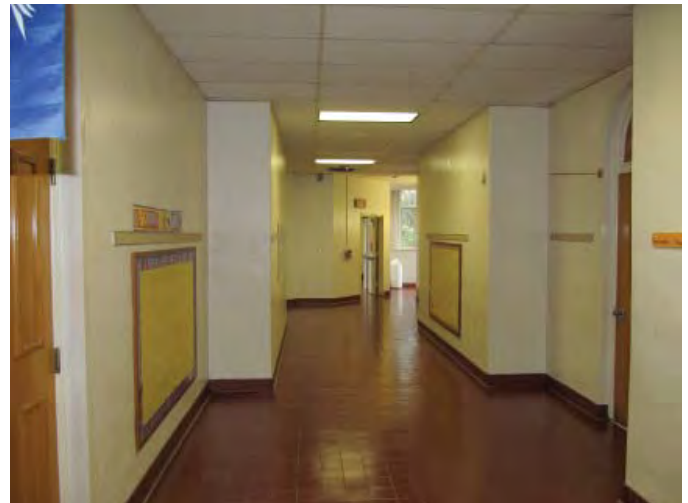
- Some doors are not rated
- Door clearances or hardware replacement needed to meet ADA compliance
- Restrooms and fixtures need to address ADA

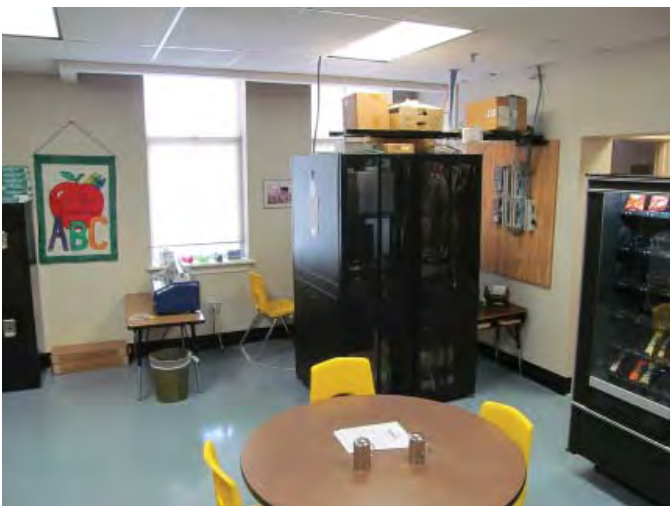
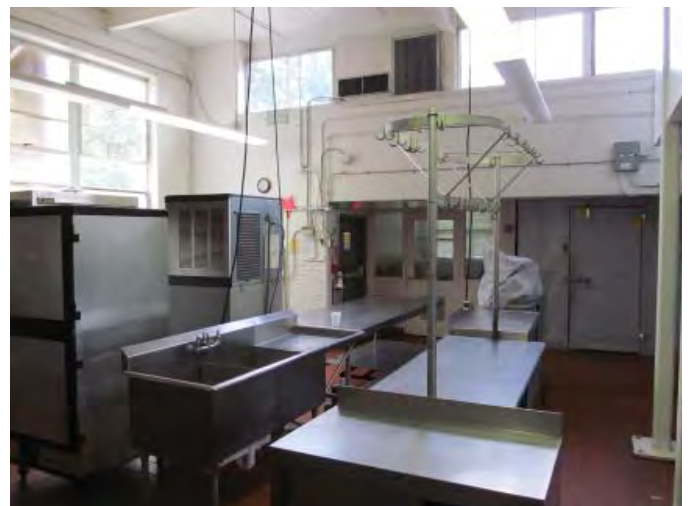
- GFI breakers at wet areas needed
- Some panels are older and need replacement
- Some wiring does not meet NEC
