Principal	Arlene Wallace
Grades	9-12
Staff	32
Current Enrollment	279
Site Size	7.95 Acres
Square Footage	76,204
Year Constructed	1949, 1954, 1956, 1962, 1967, 1975
Renovations	Various

Mayo High School for Math, Science, & Technology

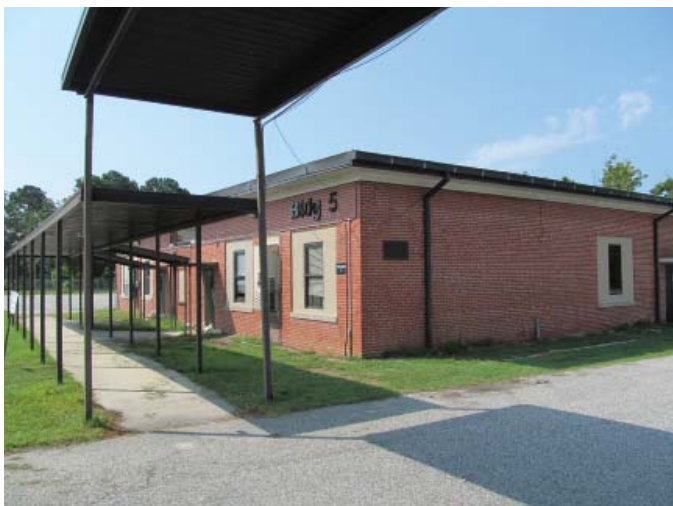
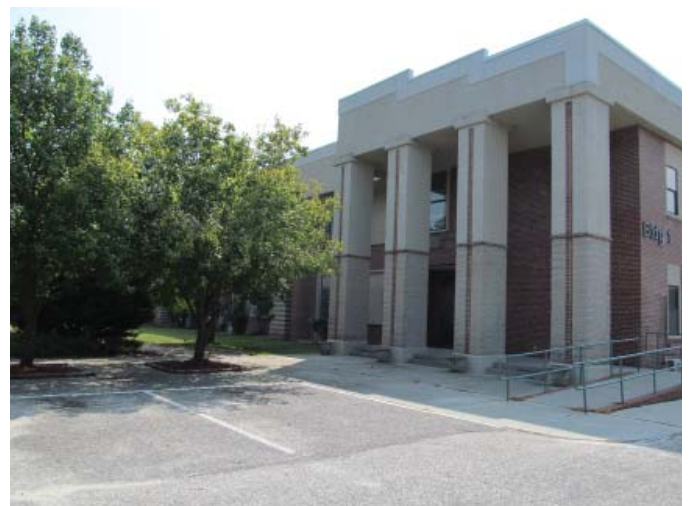
- Drainage towards buildings causing moisture issues
- Grade changes and ramps need to be address for ADA access
- Drives and parking lots would benefit from repaving and striping

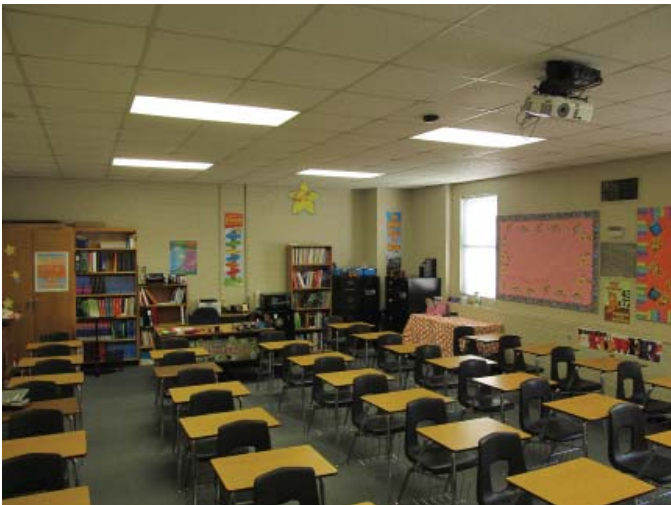
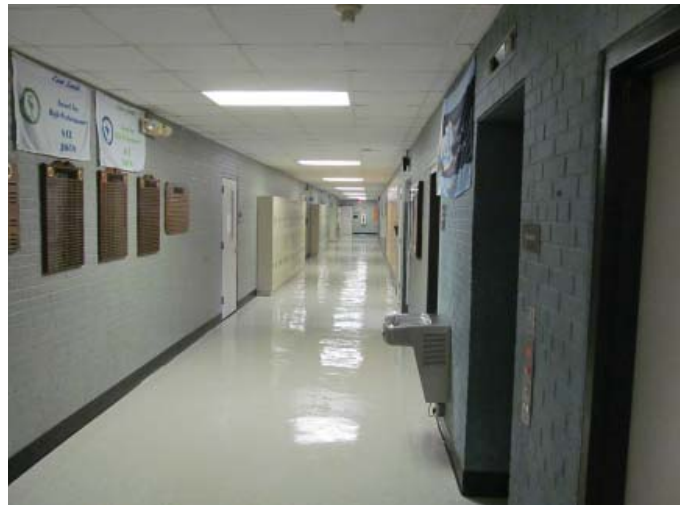
- Exterior doors have ADA and hardware issues
- Windows are not energy efficient and some are non-operating

- Some doors not rated
- ADA issues with door clearances and hardware
- Fixtures and access create ADA issues at the restrooms

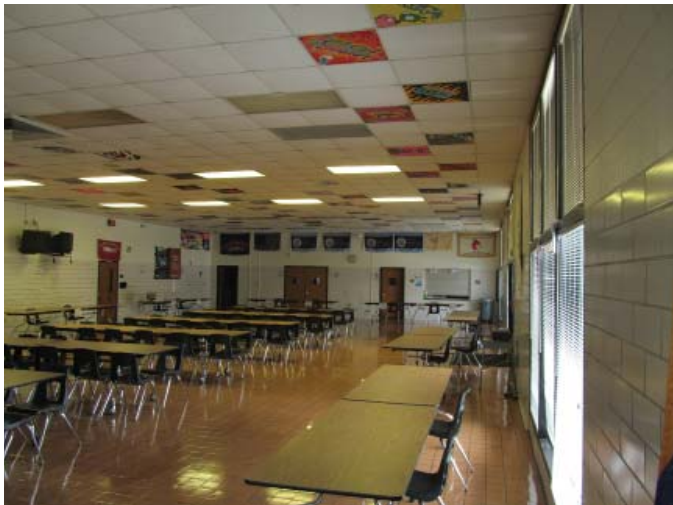
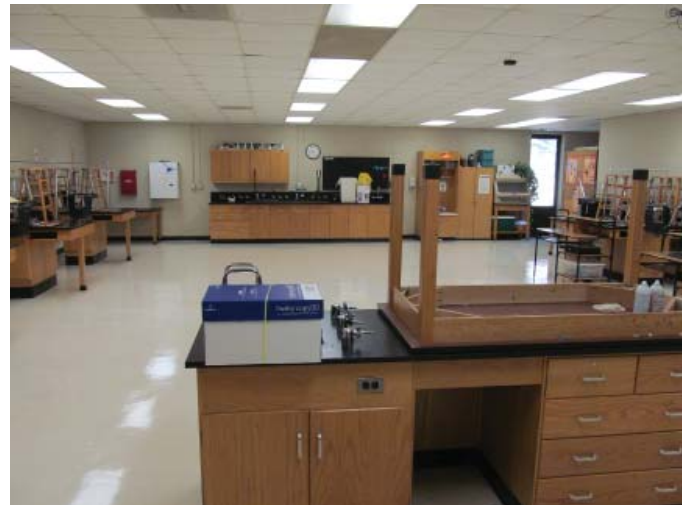
- Office and waiting areas are small
- Media center lacks natural lighting
- Gym and support spaces are inadequate
- Art room needs more sinks and lacks natural light
- Band and Music rooms need additional acoustical treatments

As on most campus style schools security is an issue with students walking to and from buildings. At Mayo High, this problem is exasperated by the fact that there are basically two vacant buildings on campus, the old admin building and the janitorial storage building. It is our recommendation to remove abandoned buildings and renovate those that are to remain. Address site security with enclosed connecting corridors, secure entry, and fencing.
