Principal	Kristi Austin
Grades	1-5
Staff	49
Current Enrollment	631
Site Size	11 Acres
Square Footage	66,200
Year Constructed	1951, 1985, 1999
Renovations	1999

North Hartsville Elementary School

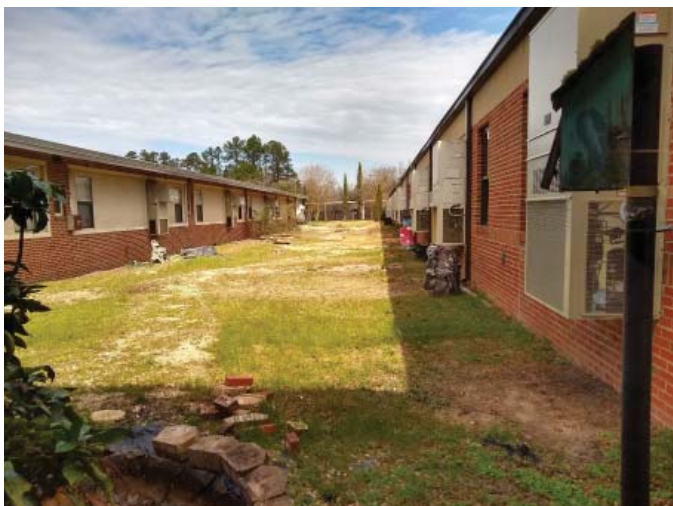
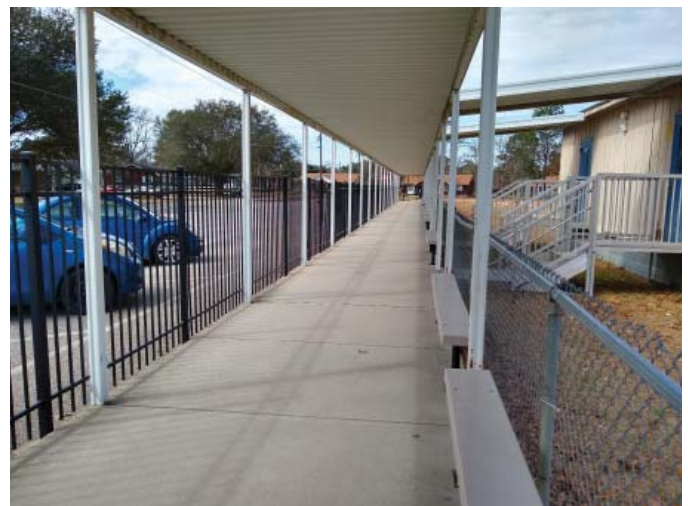
- Traffic patterns are awkward and lack stacking space for parent pick up and causes backups in neighborhood
- Modular classrooms lack ADA ramps

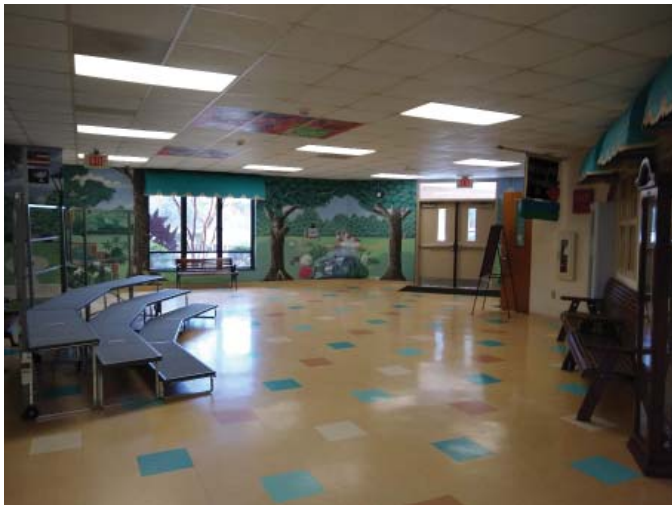
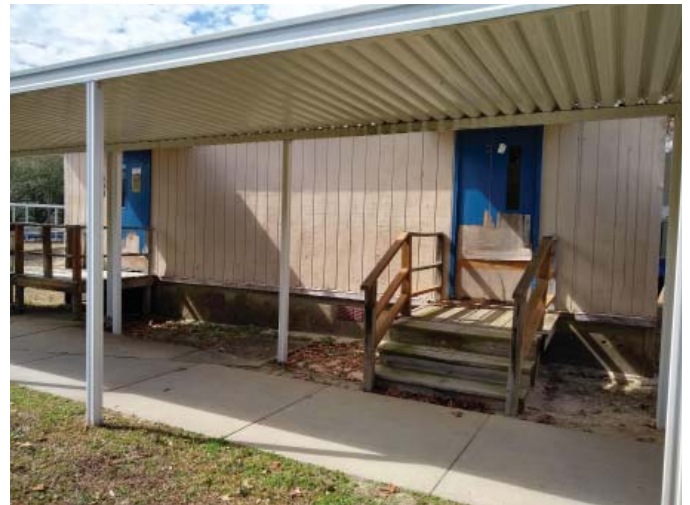
- Exterior doors have hardware and ADA issues
- Brick requires some tuck-pointing
- Windows are not energy efficient

- Some interior doors are not ADA accessible
- Some restrooms and plumbing fixtures are not ADA compliant

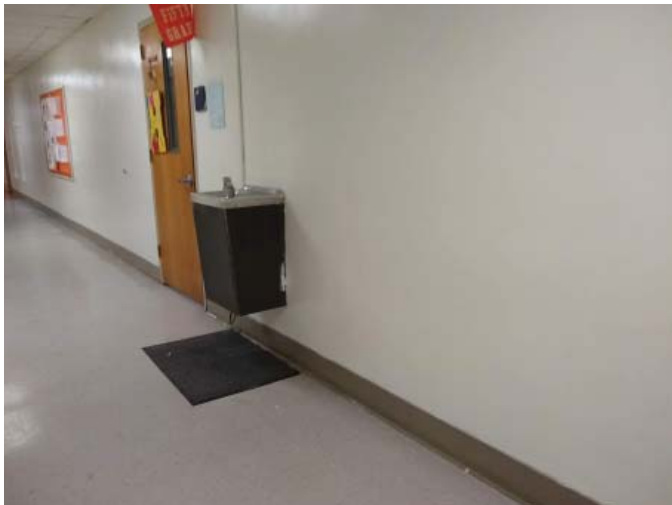
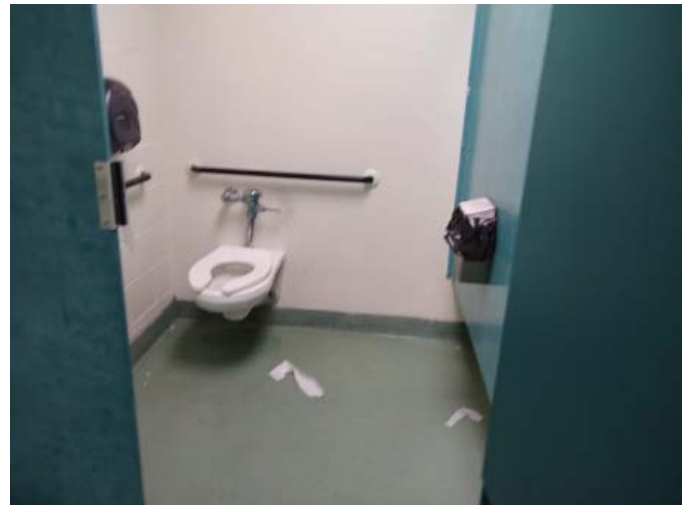
- Air quality needs to be tested
- Moisture issues present in some spaces

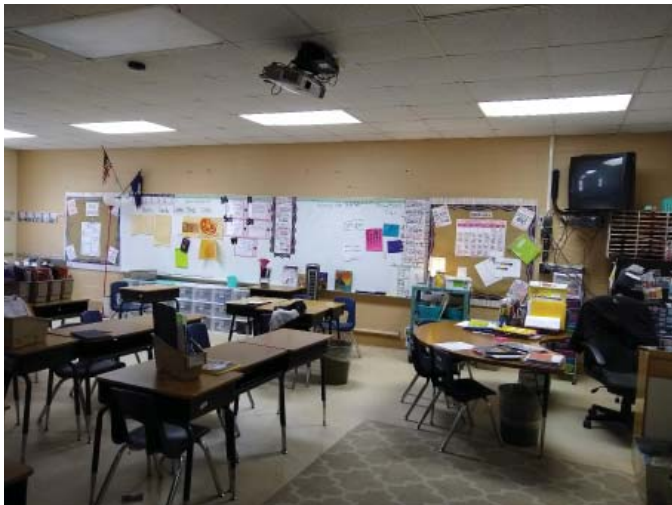
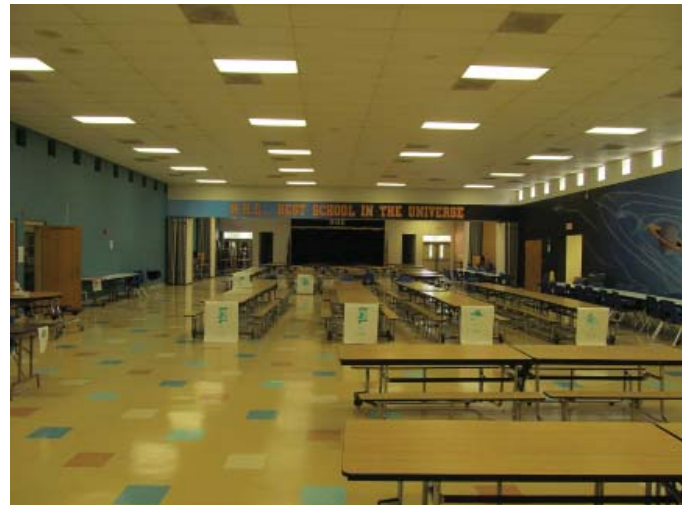
- Secure entry at main entrance is recommended
- Guidance, music, and PE are currently in portable classrooms
- Additional natural light recommended in the cafeteria, media center, and art room
- Access from art room to outdoor space is recommended
