Darlington County School District

Darlington Area Schools - Building Evaluations

School Name: Brunson-Dargan Observed By: Creed/Carter
Principal: Mrs. Ada O Sindab
Grade Levels: 3rd – 5th
Site Size: Approximately 16 Acres
Student Population: 221 (Approximate Student Population)
Staff Size: 34 (Approximate Staff Size)

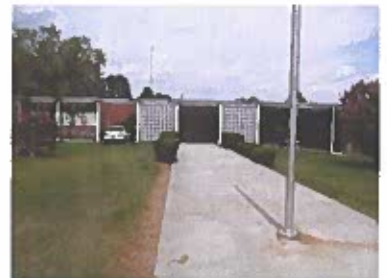
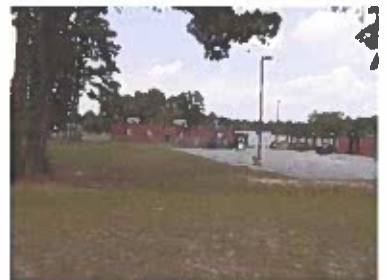
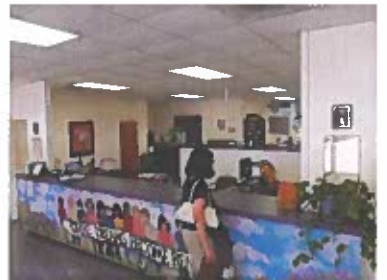
Building 1: Administration

Footings:	Spread
Structure:	Load Bearing Masonry w/bar joist
Exterior Walls:	Brick Veneer
Fenestration:	Aluminum Double Hung and fixed Storefront
Exterior Doors:	Hollow Metal Frames and Aluminum Storefront
Roof System:	Built Up Roof
Finishes:	Carpet in Media Center, VCT and Tile
Plumbing Systems	Copper Supply/Cast Iron Waste
Mechanical Systems:	Free blow exterior hung Bard Units
Electrical System:	240/480V System
Fire Alarm:	In need of upgrades
Emergency Lights:	Ceiling battery backup

Utilities	City of Darlington
Occupancy	Educational Type "E"
Construction Type	II B Unprotected/Un-sprinkled
Area Allowed	14,500 sf
Maximum Stories	Two (2) Stories
Fire Rated Assemblies:	
Fire Barriers	Corridors - Not Rated (1 hr. req.)
Structural Steel	No Ratings (1 hr. req.)
Roof/Ceiling	No Ratings (1 hr. req.)
Fire Walls	None Required
Toilets:	
Toilet Counts	Appear to be inadequate
ADA Accessibility	Noncompliant

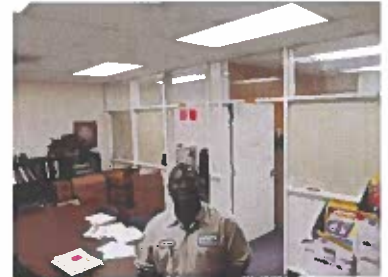
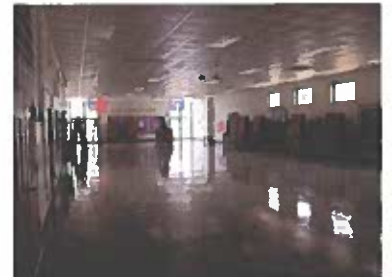
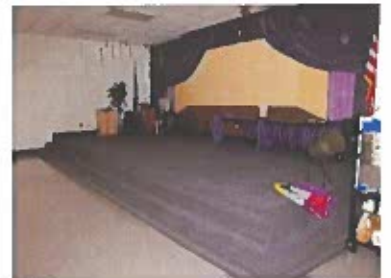
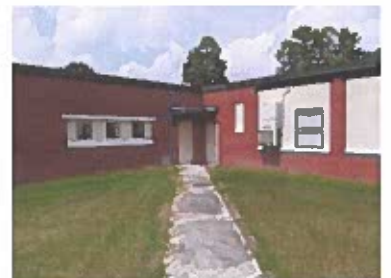
Building 2: Classroom/Cafeteria

Footings: Spread
Structure: Load bearing masonry w/ Bar Joist
Exterior Walls: Brick veneer / Dryvit
Fenestration: Aluminum double hung and Fixed Storefront
Exterior Doors: Hollow Metal Frames and Doors
Elevated Floor: Slab on grade
Roof System: Built up Roof
Finishes: Quarry Tile and VCT on Floors
Plumbing Systems: Copper Supply/Cast Iron Waste
Mechanical Systems: Free Blow Bard Units
Electrical System: 240/480V System
Fire Alarm: Needs upgrading
Emergency Lighting: Wall mounted battery backup

Utilities: City of Darlington
Occupancy: Educational Type "E"
Construction Type: II B Unprotected/Un-sprinkled
Area Allowed: 14,500 sf
Maximum Stories: Two (2) Stories
Fire Rated Assemblies:
Fire Barriers: Corridors - No Ratings (1 hr. req.)
Structural Steel: No Ratings (1 hr. req.)
Floor/Ceiling: No Ratings (1 hr. req.)
Roof/Ceiling: No Ratings (1 hr. req.)
Fire Walls: None Required
Toilets:
Toilet Counts: In adequate
ADA Accessibility: Noncompliant

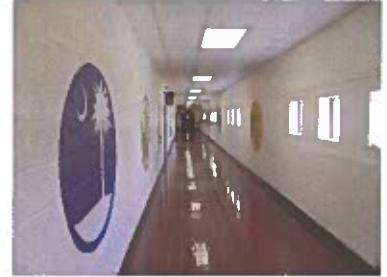
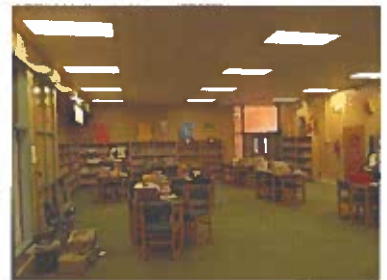
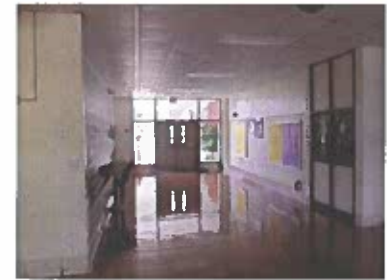
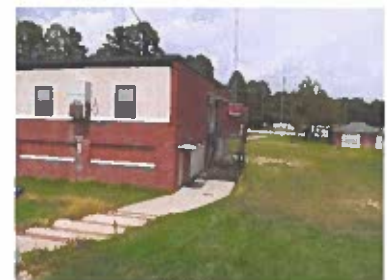
Building 3: Classroom/Media Center

Footings: Spread
 Structure: Load Bearing Masonry w/ Bar Joist
 Exterior Walls: CMU/Brick Veneer/Dryvit
 Fenestration: Aluminum Double Hung
 Exterior Doors: Hollow Metal Frames and Doors
 Roof System: Built up Roof
 Finishes: VCT, Quarry Tile, Carpet
 Plumbing Systems: Copper Supply/Cast Iron Waste
 Mechanical Systems:
 First Floor: Free blow exterior hung Bard Unit
 Electrical System: 240/480V System
 Fire Alarm: Needs Upgrading
 Emergency Lighting: Wall mounted battery backup

Utilities: City of Darlington
 Occupancy: Educational Type "E"
 Construction Type: II B Unprotected/Un-sprinkled
 Area Allowed: 14,500 sf
 Maximum Stories: Two (2) Stories
 Occupant Load:
 Fire Rated Assemblies:
 Fire Barriers: Corridors- No rating (1 hr. req.)
 Structural Steel: No Ratings (1 hr. req.)
 Floor/Ceiling: No Ratings (1 hr. req.)
 Roof/Ceiling: No Ratings (1 hr. req.)
 Fire Walls: None Required
 Toilets:
 Toilet Counts: In adequate
 ADA Accessibility: Noncompliant

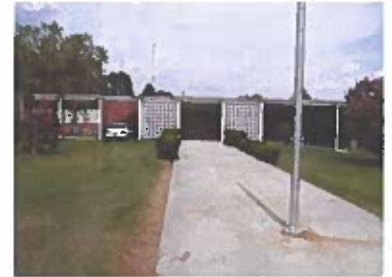
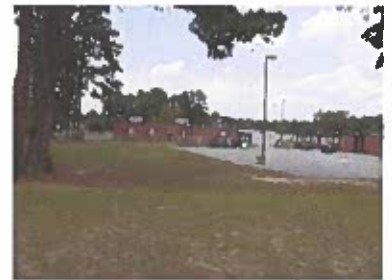
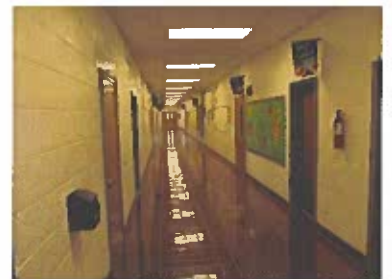
Building 4: Third Grade and Art Room Classroom Building

Footings:	Spread
Structure:	Load Bearing Masonry w/bar joist
Exterior Walls:	Brick Veneer/Dryvit
Fenestration:	Aluminum Double Hung and fixed Storefront
Exterior Doors:	Hollow Metal Frames and Aluminum Storefront
Roof System:	Built Up Roof
Finishes:	VCT and Quarry Tile
Plumbing Systems:	Copper Supply/Cast Iron Waste
Mechanical Systems:	Free blow exterior hung Bard Units
Electrical System:	240/480V System
Fire Alarm:	In need of upgrades
Emergency Lights:	Ceiling battery backup

Utilities	City of Darlington
Occupancy	Educational Type "E"
Construction Type	II B Unprotected/Un-sprinkled
Area Allowed	14,500 sf
Maximum Stories	Two (2) Stories
Fire Rated Assemblies:	
Fire Barriers	Corridors - Not Rated (1 hr. req.)
Structural Steel	No Ratings (1 hr. req.)
Roof/Ceiling	No Ratings (1 hr. req.)
Fire Walls	None Required
Toilets:	
Toilet Counts	Appear to be inadequate
