Darlington County School District
Darlington, South Carolina
August 2, 2012

Darlington Area Schools - Building Evaluations

School Name: Cain Elementary School Observed By: Creed/Carter
Principal: Ms. Wanda Odom
Grade Levels: 4K – 2nd
Site Size: Approximately 20 Acres
Student Population: 376 (Approximate Student Population)
Staff Size: 40 (Approximate Staff Size)

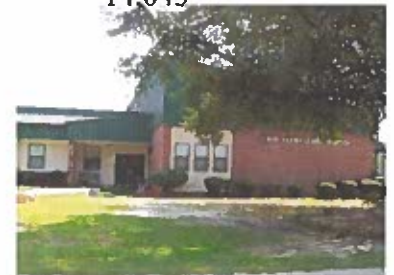
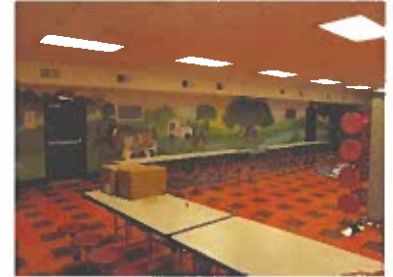
Building 1: Main Office/Cafeteria/Kitchen/Media/Kindergarten

Footings: Spread
Structure: Load Bearing Masonry w/bar joist
Exterior Walls: Brick Veneer/Dryvit
Fenestration: Aluminum Double Hung and fixed Storefront
Exterior Doors: Hollow Metal Frames and Aluminum Storefront
Roof System: Standing Seam Metal Roof
Finishes: Carpet in Media Center, VCT and Tile
Plumbing Systems: Copper Supply/Cast Iron Waste
Mechanical Systems: Free blow exterior hung Bard Units
Electrical System: 240/480V System
Fire Alarm: Recently upgraded
Emergency Lights: Ceiling battery backup

Utilities: City of Darlington
Occupancy: Educational Type "E"
Construction Type: II B Unprotected/Un-sprinkled
Area Allowed: 14,500 sf
Maximum Stories: Two (2) Stories
Fire Rated Assemblies:
Fire Barriers: Corridors - Not Rated (1 hr. req.)
Structural Steel: No Ratings (1 hr. req.)
Roof/Ceiling: No Ratings (1 hr. req.)
Fire Walls: None Required
Toilets:
Toilet Counts: Appear to be inadequate
ADA Accessibility: Noncompliant

Building 1: Renovate Cafeteria and Kitchen area into new administration front office area, with new security airlock entry leading into front reception area. Existing office area could be converted into Guidance area.

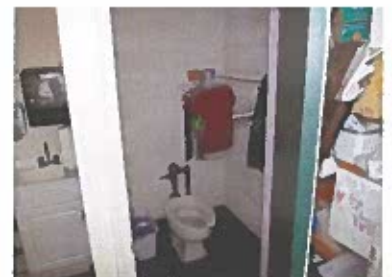
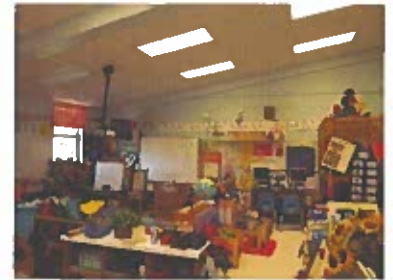
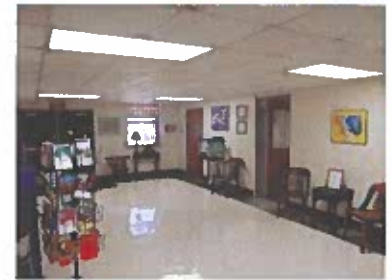
Building 2: Classroom

Footings:	Spread
Structure:	Load bearing masonry w/ Bar Joist
Exterior Walls:	Brick veneer / Dryvit
Fenestration:	Aluminum double hung and Fixed Storefront
Exterior Doors:	Hollow Metal Frames and Doors
Elevated Floor:	Slab on grade
Roof System:	Standing Seam Metal Roof
Finishes:	VCT on Floor
Plumbing Systems	Copper Supply/Cast Iron Waste
Mechanical Systems:	Free Blow Bard Units
Electrical System:	240/480V System
Fire Alarm:	Recently upgraded
Emergency Lighting:	Wall mounted battery backup

Utilities	City of Darlington
Occupancy	Educational Type "E"
Construction Type	II B Unprotected/Un-sprinkled
Area Allowed	14,500 sf
Maximum Stories	Two (2) Stories
Fire Rated Assemblies:	
Fire Barriers	Corridors - No Ratings (1 hr. req.)
Structural Steel	No Ratings (1 hr. req.)
Floor/Ceiling	No Ratings (1 hr. req.)
Roof/Ceiling	No Ratings (1 hr. req.)
Fire Walls	None Required
Toilets:	
Toilet Counts	In adequate
ADA Accessibility	Noncompliant

Building 2: If possible renovate restrooms so one ADA compliant stall is achieved.

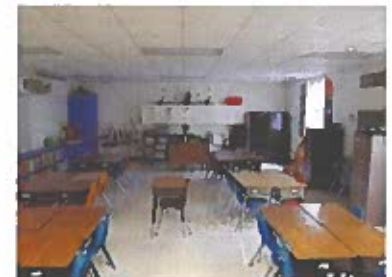
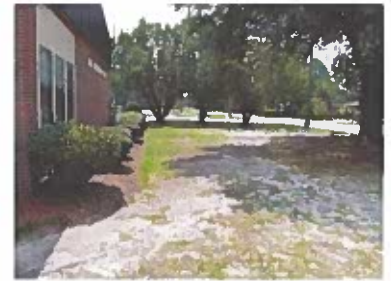
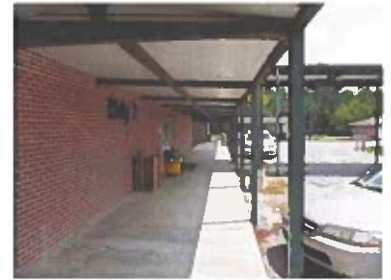
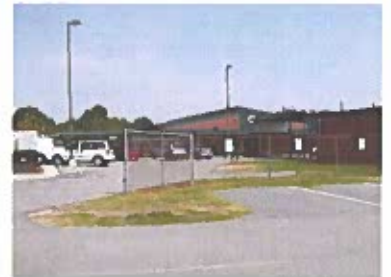
Building 3: Classroom

Footings: Spread
 Structure: Load Bearing Masonry w/ Bar Joist
 Exterior Walls: CMU/Brick Veneer
 Fenestration: Aluminum Double Hung
 Exterior Doors: Hollow Metal Frames and Doors
 Roof System: Standing Seam Metal Roof
 Finishes: VCT. Glazed CMU in corridor
 Plumbing Systems: Copper Supply/Cast Iron Waste
 Mechanical Systems:
 First Floor: Free blow exterior hung Bard Unit
 Electrical System: 240/480V System
 Fire Alarm: Recently upgraded
 Emergency Lighting: Wall mounted battery backup

Utilities: City of Darlington
 Occupancy: Educational Type "E"
 Construction Type: II B Unprotected/Un-sprinkled
 Area Allowed: 14,500 sf
 Maximum Stories: Two (2) Stories
 Occupant Load:
 Fire Rated Assemblies:
 Fire Barriers: Corridors (1 hr. req.)
 Structural Steel: No Ratings (1 hr. req.)
 Floor/Ceiling: No Ratings (1 hr. req.)
 Roof/Ceiling: No Ratings (1 hr. req.)
 Fire Walls: None Required
 Toilets:
 Toilet Counts: In adequate
 ADA Accessibility: Noncompliant

Building 3: If possible renovate restrooms so one ADA compliant stall is achieved.
Add sinks at art room.

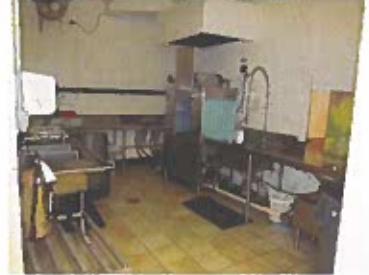
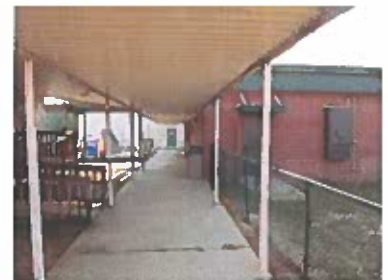
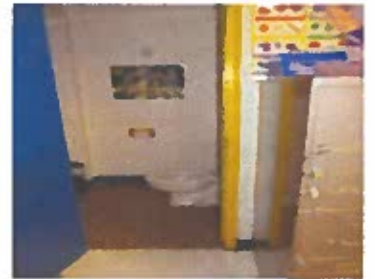
Building 5: Classroom – Learning Center

Footings: Spread
 Structure: Load Bearing Masonry w/ Bar Joist
 Exterior Walls: CMU/Brick Veneer
 Fenestration: Aluminum Double Hung
 Exterior Doors: Hollow Metal Frames and Doors
 Roof System: Built Up Roof
 Finishes: VCT
 Plumbing Systems: Copper Supply/Cast Iron Waste
 Mechanical Systems:
 First Floor:
 Electrical System: 240/480V System
 Fire Alarm: Recently upgraded
 Emergency Lighting: Wall mounted battery backup

Utilities: City of Darlington
 Occupancy: Educational Type "E"
 Construction Type: II B Unprotected/Un-sprinkled
 Area Allowed: 14,500 sf
 Maximum Stories: Two (2) Stories
 Occupant Load:
 Fire Rated Assemblies:
 Fire Barriers: Corridors (1 hr. req.)
 Structural Steel: No Ratings (1 hr. req.)
 Floor/Ceiling: No Ratings (1 hr. req.)
 Roof/Ceiling: No Ratings (1 hr. req.)
 Fire Walls: None Required

Toilets:
 Toilet Counts: In adequate
 ADA Accessibility: Noncompliant

Building 5: Room 12, to become new Reading Recovery Room.
