Darlington County School District
Darlington, South Carolina
August 8, 2012

Lamar Area Schools - Building Evaluations

School Name: Lamar Elementary Observed By: Cannon/Carter
Principal: Mr. Garry Fowlers
Grade Levels: Pre-K – 2nd Grades
Site Size: Approximately 10 Acres
Student Population: 300 (Approximate Student Population)
Staff Size: 37 (Approximate Staff Size)

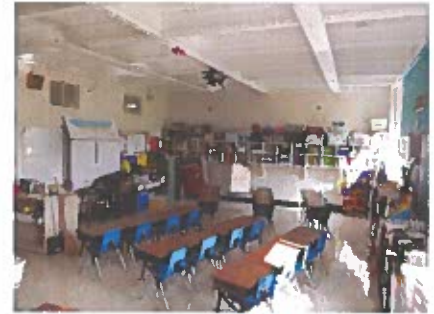
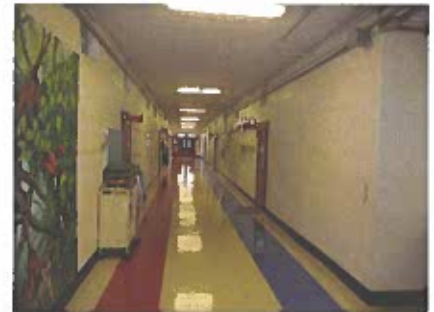
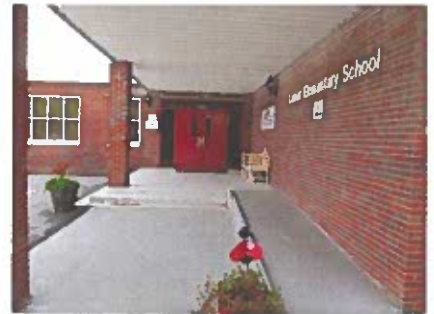
Main Building: (5K and 1st & 2nd Grades)

Footings: Spread
Structure: Concrete Beams on Load Bearing Masonry
Exterior Walls: Load Bearing CMU/Brick Veneer
Fenestration: Aluminum Double Hung and fixed

Exterior Doors: Storefront
Hollow Metal Frames and Aluminum Storefront
Roof System: Metal Retrofit and low slope
Finishes: Average
Plumbing Systems: Copper Supply/Cast Iron Waste
Mechanical Systems:

Classrooms: Wall Hung Bard Units
Office: Wall Hung Bard Units
Electrical System: 277/480V System
Fire Alarm: Recently upgraded
Emergency Lighting: Wall Mounted Battery Backup

Fire Rated Assemblies:
Fire Barriers: Corridors Not Rated 1 hr. req.
Structural Steel: No Ratings Required
Roof/Ceiling: No Ratings Required
Fire Walls: Not Required

Toilets:
Toilet Counts: Appear to be adequate
ADA Accessibility: New toilets appear to be compliant

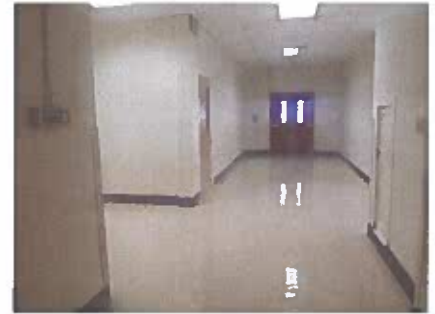
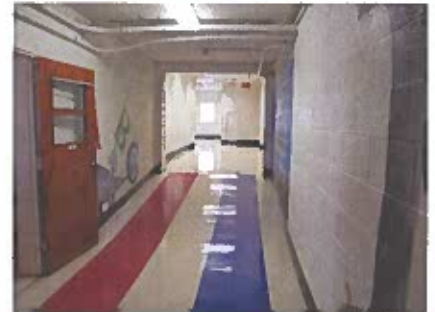
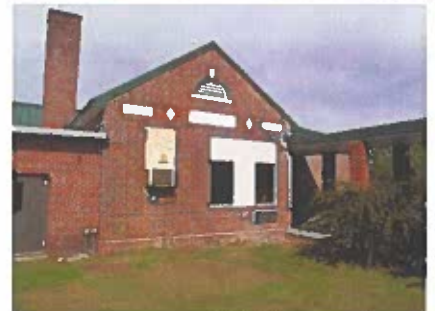
Primary Building: (3K, 4K, 5K, PE and Music)

Footings: Spread
 Structure: Wood trusses on Load Bearing
 Masonry
 Exterior Walls: Load Bearing CMU/Brick Veneer
 Fenestration: Aluminum Double Hung and fixed
 Storefront
 Exterior Doors: Hollow Metal Frames and
 Aluminum Storefront
 Roof System: Metal Retrofit
 Finishes: Average
 Plumbing Systems: Copper Supply/Cast Iron Waste
 Mechanical Systems:
 Classrooms: Wall Hung Bard Units
 Office: Wall Hung Bard Units
 Electrical System: 277/480V System
 Fire Alarm: Recently upgraded
 Emergency Lighting: Wall Mounted Battery Backup

Fire Barriers: Corridors Not Rated 1 hr. req.
 Structural Steel: No Ratings Required
 Roof/Ceiling: No Ratings Required
 Fire Walls: Not Required

Toilet Counts: Appear to be adequate
 ADA Accessibility: Appear to be compliant

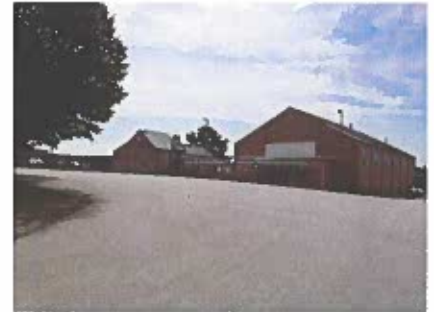
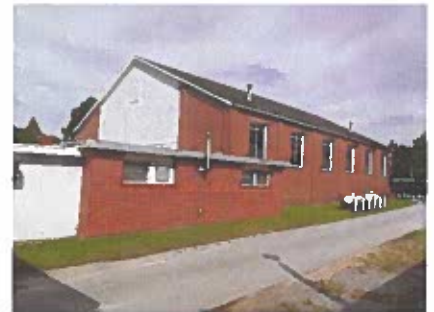
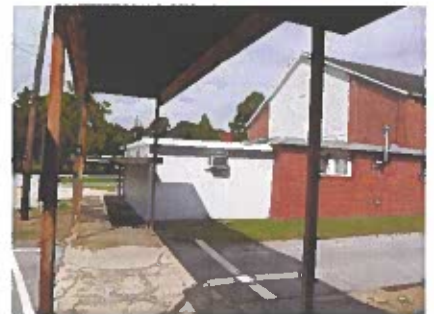
Gymnasium Building: (PE)
 Year Const.: 1930's
 Renovations: Various Years
 Square Footage: 12,300 Single Story
 Total: 12,300 12,300

Building Systems:
 Footings: Spread
 Structure: Steel trusses on Load Bearing
 Masonry
 Exterior Walls: Load Bearing CMU/Brick Veneer
 Fenestration: Aluminum Double Hung and fixed
 Storefront
 Exterior Doors: Hollow Metal Frames and
 Aluminum Storefront
 Roof System: Metal Retrofit
 Finishes: Average
 Plumbing Systems: Copper Supply/Cast Iron Waste
 Mechanical Systems:
 Classrooms: Wall Hung Bard Units
 Office: Wall Hung Bard Units
 Electrical System: 277/480V System
 Fire Alarm: Recently upgraded
 Emergency Lighting: Wall Mounted Battery Backup

Fire Rated Assemblies: 1 hr. req.
 Fire Barriers: Corridors Not Rated
 Structural Steel: No Ratings Required
 Roof/Ceiling: No Ratings Required
 Fire Walls: Not Required
 Toilets:
 Toilet Counts: Appear to be adequate
 ADA Accessibility: Appear to be compliant
