Darlington County School District
Darlington, South Carolina
August 8, 2012

Darlington Area Schools - Building Evaluations

School Name: Mayo High School Observed By: Creed/Carter
Principal: Ms. Arlene Johnson
Grade Levels: 9th – 12th
Site Size: Approximately 10 Acres
Student Population: 359 (Approximate Student Population)
Staff Size: 36 (Approximate Staff Size)

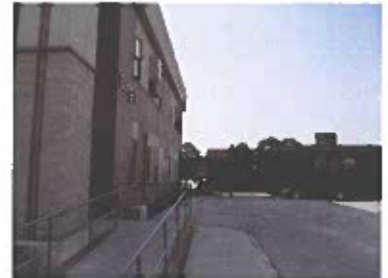
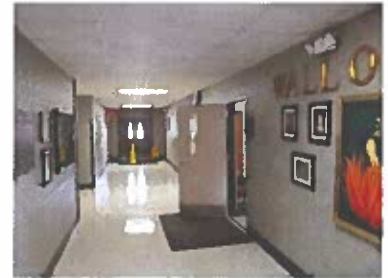
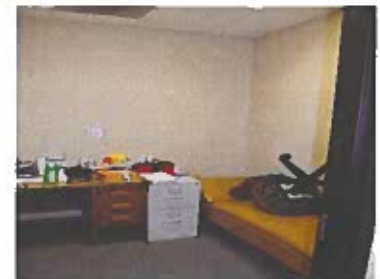
Building 1: Two Storey Classroom Building

Utilities	City of Darlington	
Occupancy	Educational Type "E"	
Construction Type	II B Unprotected/Un-sprinkled	
Area Allowed	14,500 sf	
Maximum Stories	Two (2) Stories	
Fire Rated Assemblies:		
Fire Barriers	Corridors - Not Rated	(1 hr. req.)
Structural Steel	No Ratings	(1 hr. req.)
Floor/Ceiling	No Ratings	(1 hr. req.)
Roof/Ceiling	No Ratings	(1 hr. req.)
Fire Walls	Required

Toilets:
Toilet Counts Appear to be adequate
ADA Accessibility Noncompliant

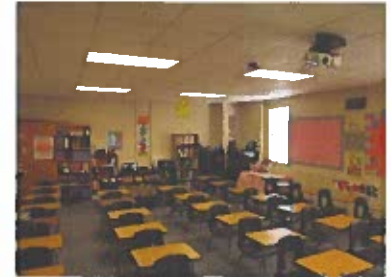
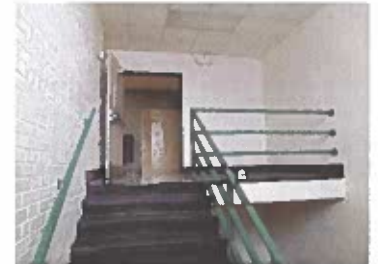
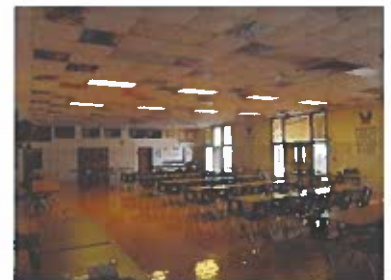
Building 2: Mayo Annex

Utilities City of Darlington
Occupancy Educational Type "E"
Construction Type II B Unprotected/Un-sprinkled
Area Allowed 14,500 sf
Maximum Stories Two (2) Stories
Fire Rated Assemblies:
 Fire Barriers Corridors - No Ratings (1 hr. req.)
 Structural Steel No Ratings (1 hr. req.)
 Floor/Ceiling No Ratings (1 hr. req.)
 Roof/Ceiling No Ratings (1 hr. req.)
 Fire Walls Required

Toilets:
Toilet Counts Appear to be inadequate
ADA Accessibility Noncompliant

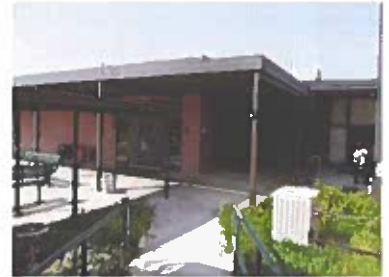
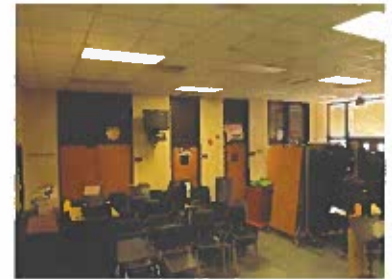
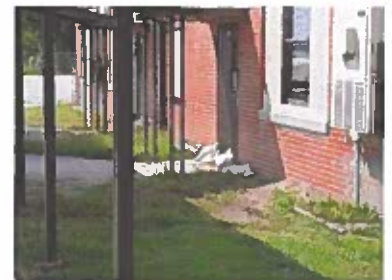
Building 3: Classroom/Media Center

Utilities: City of Darlington
 Occupancy: Educational Type "E"
 Construction Type: II B Unprotected/Un-sprinkled
 Area Allowed: 14,500 sf
 Maximum Stories: Two (2) Stories
 Occupant Load:
 Fire Rated Assemblies:
 Fire Barriers: Corridors - No Ratings (1 hr. req.)
 Structural Steel: No Ratings (1 hr. req.)
 Floor/Ceiling: No Ratings (1 hr. req.)
 Roof/Ceiling: No Ratings (1 hr. req.)
 Fire Walls: Required
 Toilets:
 Toilet Counts: Appear to be inadequate
 ADA Accessibility: Noncompliant

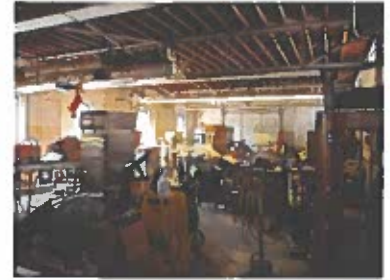
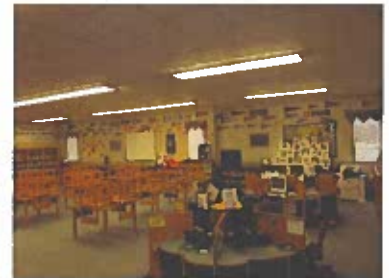
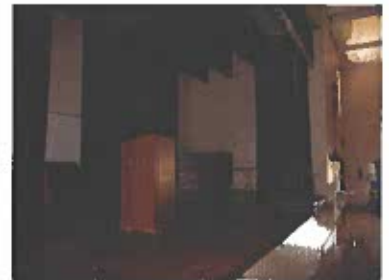
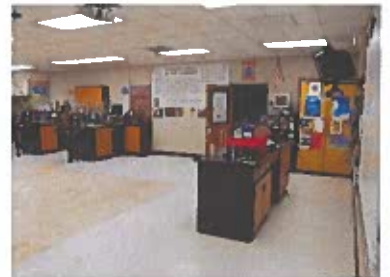
Building 4: Janitorial Storage

Footings:	Spread
Structure:	Steel Bar Joist on Load Bearing Masonry
Exterior Walls:	Load Bearing CMU/Brick Veneer
Fenestration:	Aluminum Double Hung and fixed Storefront
Exterior Doors:	Hollow Metal Frames and Aluminum Storefront
Roof System:	4-Ply Built-up Roof on light weight concrete deck
Finishes:	Poor. Floors-VCT popping loose due to moisture
Plumbing Systems	Copper Supply/Cast Iron Waste
Mechanical Systems:	
Gym and Lobby:	No A/C, electric heat
Electrical System:	277/480V System
Fire Alarm:	
Emergency Lighting:

Utilities	City of Darlington
Occupancy	Educational Type "E"
Construction Type	II B Unprotected/Un-sprinkled
Area Allowed	14,500 sf
Maximum Stories	Two (2) Stories
Occupant Load	
Fire Rated Assemblies:	
Fire Barriers	None
Structural Steel	No Ratings Required
Roof/Ceiling	No Ratings Required
Fire Walls	No Ratings Required
Toilets:	
Toilet Counts	None
ADA Accessibility	Appear to be noncompliant

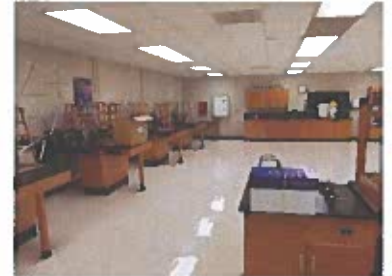
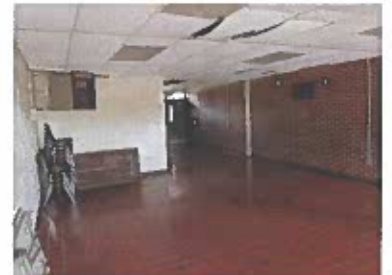
Building 5: Gymnasium/Multipurpose

Footings:	Spread
Structure:	Masonry Load bearing
Exterior Walls:	CMU/Brick Veneer
Fenestration:	Aluminum Double Hung and fixed Storefront
Exterior Doors:	Hollow Metal Frames and Storefront
Elevated Floor:	None
Roof System:	4-Ply built up roof
Finishes:	Quarry Tile, Ceramic Tile, hardwoods. ACT needs replacing
Plumbing Systems	Copper Supply/Cast Iron Waste
Mechanical Systems:	
First Floor:	
Second Floor:	
Other:	
Electrical System:	240/480V System
Fire Alarm:	Recently upgraded
Emergency Lighting:	Wall mounted battery backup

Utilities	City of Darlington
Occupancy	Educational Type "E"
Construction Type	II B Unprotected/Un-sprinkled
Area Allowed	14,500 sf
Maximum Stories	Two (2) Stories
Occupant Load	
Fire Rated Assemblies:	
Fire Barriers	Corridors - No Ratings (1 hr. req.)
Structural Steel	No Ratings (1 hr. req.)
Floor/Ceiling	No Ratings (1 hr. req.)
Roof/Ceiling	No Ratings (1 hr. req.)
Fire Walls	Required
Toilets:	
Toilet Counts	Inadequate
ADA Accessibility	Noncompliant
