## **Darlington County School District**

### **Darlington Area Schools - Building Evaluations**

**School Name:** Pate Elementary School    Observed By: Creed/Carter  
**Principal:** Mrs. Terry Martin  
**Grade Levels:** 4K – 2<sup>nd</sup>  
**Site Size:** Approximately 21 Acres  
**Student Population:** 435 (Approximate Student Population)  
**Staff Size:** 58 (Approximate Staff Size)

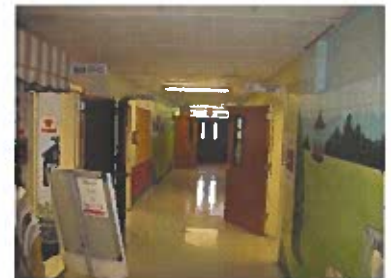
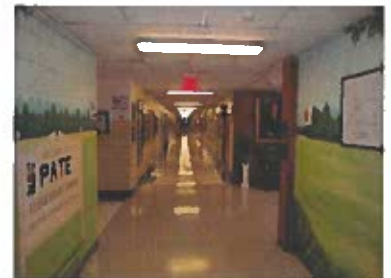
**Building 1: Main Classroom/Cafeteria/Kitchen/Media**

Footings: Spread  
 Structure: Load Bearing Masonry w/bar joist  
 Exterior Walls: CMU/Brick Veneer  
 Fenestration: Aluminum Double Hung and fixed Storefront  
 Exterior Doors: Hollow Metal Frames and Aluminum Storefront  
 Roof System: 4-Ply Built-up Roof on light weight concrete deck  
 Finishes: Average. Upgrades suggested: Acoustic ceilings in corridors  
 Plumbing Systems: Copper Supply/Cast Iron Waste  
 Mechanical Systems: Free blow exterior hung Bard Units  
 Electrical System: 240/480V System  
 Fire Alarm: Recently upgraded  
 Emergency Lights: Ceiling battery backup

Construction Type	II B Unprotected/Un-sprinkled	
Area Allowed	14,500 sf	
Maximum Stories	Two (2) Stories	
Fire Rated Assemblies:		
Fire Barriers	Corridors - Not Rated	(1 hr. req.)
Structural Steel	No Ratings	(1 hr. req.)
Roof/Ceiling	No Ratings	(1 hr. req.)
Fire Walls	None Required	
Toilets:		
Toilet Counts	Appear to be adequate	
ADA Accessibility	Noncompliant

- Building 1:** A major renovations to electrical systems to include addition of outlets throughout the classrooms areas should occur. Renovation should also include toilet areas to insure that some ADA compliant fixtures are included. A new MDF room should be created to house computer systems. An interior corridor could be created and a two classroom addition constructed adjacent to media center where two portables are currently housed. This addition would house the students currently served by the two portables. The bus loop would need to be re-configured if the district wishes to maximize addition to include two more rooms.

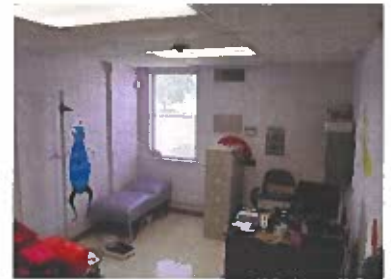
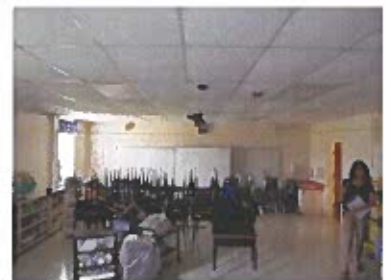
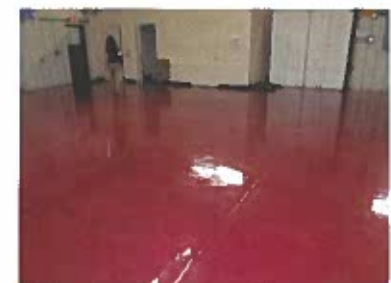
**Building 2: Multi-Purpose**

Footings:	Spread
Structure:	Pre-engineered
Exterior Walls:	Aluminum siding
Fenestration:	Fixed Storefront
Exterior Doors:	Hollow Metal Frames and Doors
Elevated Floor:	Slab on grade
Roof System:	Standing Seam Metal Roof
Finishes:	Poor. VCT on Floor has cracked due to crack in slab, wood panels and insulation on interior
Plumbing Systems	Copper Supply/Cast Iron Waste

Mechanical Systems:	
First Floor:	One mechanical unit for entire building and ceiling hung electrical unit. Fans open to outside for ventilation

Fire Barriers	Corridors - No Ratings	(1 hr. req.)
Structural Steel	No Ratings	(1 hr. req.)
Floor/Ceiling	No Ratings	(1 hr. req.)
Roof/Ceiling	No Ratings	(1 hr. req.)
Fire Walls	None Required	
<b>Toilets:</b>		
Toilet Counts	In adequate	
ADA Accessibility	Noncompliant

- Building 2:** It is the opinion of the architect that the existing multi-purpose building is torn down and that a new multipurpose building be built to include a stage, this could occur directly off the back of the cafeteria building. If district wishes new classrooms could be constructed as part of this addition for future growth.

**Building 2:** Considering the building shape, a new multi-purpose room with adequate toilets, storage and playing surface would serve the schools needs as well as the community.

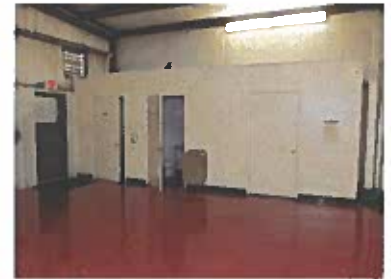
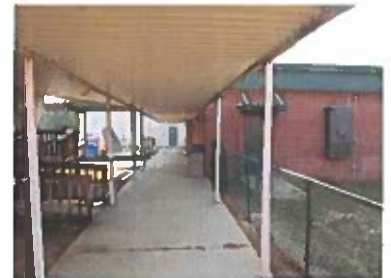
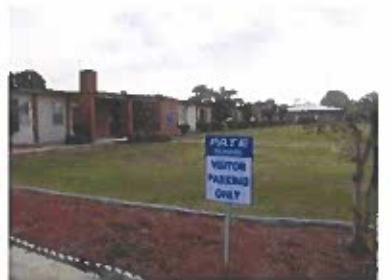
**Building 3: Kindergarten/Art/Music**

Footings:	Spread
Structure:	Load Bearing Masonry w/ Bar Joist
Exterior Walls:	CMU/Brick Veneer
Fenestration:	Aluminum Double Hung
Exterior Doors:	Hollow Metal Frames and Doors
Roof System:	4-Ply Built-up Roof on light weight concrete deck
Finishes:	ACT Grid in corridor is yellowed. ACT in classrooms would help with acoustics
Plumbing Systems	Copper Supply/Cast Iron Waste
Mechanical Systems:	
First Floor:	Free blow exterior hung Bard Unit
Electrical System:	240/480V System
Fire Alarm:	Recently upgraded
Emergency Lighting:	Wall mounted battery backup

- Building 3:** A two classroom addition, where the 4k play area and read well portables are currently located could house a new art room with kiln and a new music room. This addition could also connect adjacent to existing classroom 7, creating support areas for the kindergarten fine arts building. The two rooms where Music and Art were once located could house two 5k rooms currently located in the cafeteria area.
