Darlington County School District

Hartsville Area Schools - Building Evaluations

School Name: Thornwell School of the Arts Observed By: Cannon/Carter
Principal: Ms. Julie Mahn
Grade Levels: 1st – 5th Grades
Site Size: Approximately 10 Acres
Student Population: 400 (Approximate Student Population)
Staff Size: 48 (Approximate Staff Size)

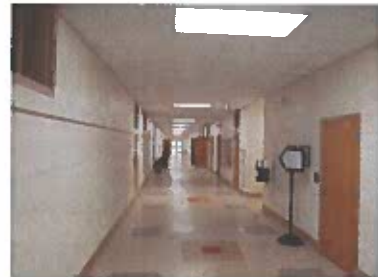
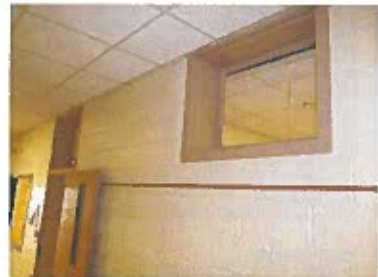
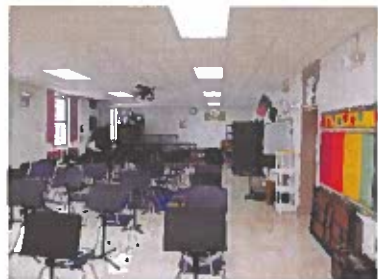
Building 1: (Administration/3rd, 4th, 5th, Strings)

Year Const.:	1962	
Renovations:	2006	
Square Footage:	<u>12,250</u>	Two Story
Total:	24,500	24,500

Footings:	Spread
Structure:	Steel Bar Joist on Load Bearing Masonry
Exterior Walls:	Load Bearing CMU/Brick Veneer
Fenestration:	Aluminum Double Hung and fixed Storefront
Exterior Doors:	Hollow Metal Frames and Aluminum Storefront
Roof System:	Built-up
Finishes:	Good. Floors-VCT Corridors and Classrooms; Acoustic ceilings; and Painted CMU walls
Plumbing Systems	Copper Supply/Cast Iron Waste
Mechanical Systems:	
Classrooms:	Wall Hung Bard Units
Office:	Wall Hung Bard Units
Electrical System:	277/480V System
Fire Alarm:	Recently upgraded
Emergency Lighting:	Wall Mounted Battery Backup

Utilities	City of Hartsville	
Occupancy	Educational Type "E"	
Construction Type	II B Unprotected/Un-sprinkled	
Area Allowed	14,500 sf	
Maximum Stories	Two (2) Stories	
Occupant Load		
Fire Rated Assemblies:		
Fire Barriers	Corridors Not Rated	(1 hr. req.)
Structural Steel	1 hr. Required	Not Rated
Roof/Ceiling	1 hr. Required	Not Rated
Fire Walls	Not Required	
Toilets:		
Toilet Counts	Appear to be adequate	
ADA Accessibility	Compliant in most cases

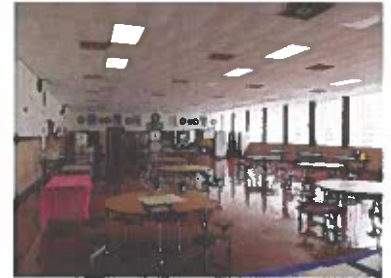
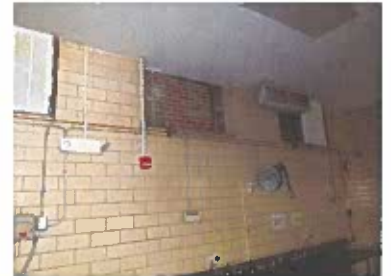
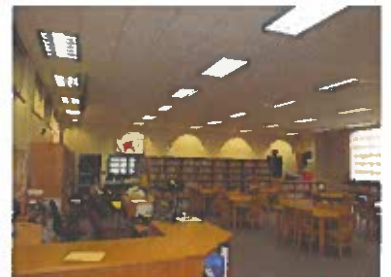
Building 3: (Media Center, Cafeteria, Kitchen)

Year Const.:	1954	
Renovations:	Various Years	
Square Footage:	<u>13,200</u>	Single Story
Total:	13,200	13,200

Footings:	Spread
Structure:	Steel Bar Joist on Load Bearing Masonry
Exterior Walls:	Load Bearing CMU/Brick Veneer
Fenestration:	Aluminum Double Hung and fixed Storefront
Exterior Doors:	Hollow Metal Frames and Aluminum Storefront
Roof System:	Built-up
Finishes:	Average. Floors-VCT Corridors/Carpet in Media; Acoustic ceilings; and Painted CMU walls
Plumbing Systems	Copper Supply/Cast Iron Waste
Mechanical Systems:	
Classrooms:	Wall Hung Bard Units
Office:	Wall Hung Bard Units
Electrical System:	277/480V System
Fire Alarm:	Recently upgraded
Emergency Lighting:	Wall Mounted Battery Backup

Utilities	City of Hartsville	
Occupancy	Educational Type "E"	
Construction Type	II B Unprotected/Un-sprinkled	
Area Allowed	14,500 sf	
Maximum Stories	Two (2) Stories	
Occupant Load		
Fire Rated Assemblies:		
Fire Barriers	Corridors Not Rated	(1 hr. req.)
Structural Steel	No Ratings Required	
Roof/Ceiling	No Ratings Required	
Fire Walls	Not Required	
Toilets:		
Toilet Counts	Appear to be adequate	
ADA Accessibility	Appear to be compliant

1. Media Center
2. Cafeteria and Kitchen
3. Gymnasium and Locker Rooms

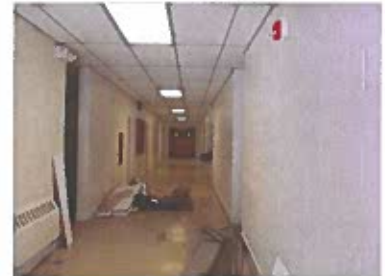
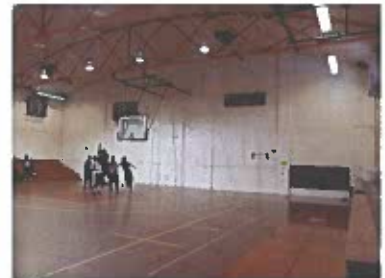
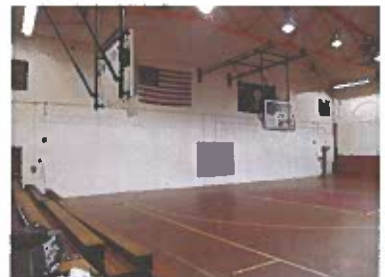
Building 4: (Gymnasium and Locker Rooms)

Year Const.:	1947	
Renovations:	Various Years	
Square Footage:	<u>15,000</u>	Single Story
Total:	15,000	15,000

Footings:	Spread
Structure:	Steel Bar Joist on Load Bearing Masonry
Exterior Walls:	Load Bearing CMU/Brick Veneer
Fenestration:	Aluminum Double Hung and fixed Storefront
Exterior Doors:	Hollow Metal Frames and Aluminum Storefront
Roof System:	Built-up
Finishes:	Average. Floors-VCT Corridors/Wood gym floor/CT Locker rooms; Acoustic ceilings; and Painted CMU walls
Plumbing Systems	Copper Supply/Cast Iron Waste
Mechanical Systems:	
Classrooms:	Wall Hung Bard Units
Other:	Gas heaters; No A/C
Electrical System:	277/480V System
Fire Alarm:	Recently upgraded
Emergency Lighting:	Wall Mounted Battery Backup

Utilities	City of Hartsville	
Occupancy	Educational Type "E"	
Construction Type	II B Unprotected/Un-sprinkled	
Area Allowed	14,500 sf	
Maximum Stories	Two (2) Stories	
Occupant Load		
Fire Rated Assemblies:		(1 hr. req.)
Fire Barriers	Corridors Not Rated	
Structural Steel	No Ratings Required	
Roof/Ceiling	No Ratings Required	
Fire Walls	Not Required	
Toilets:		
Toilet Counts	Noncompliant	
ADA Accessibility	Noncompliant

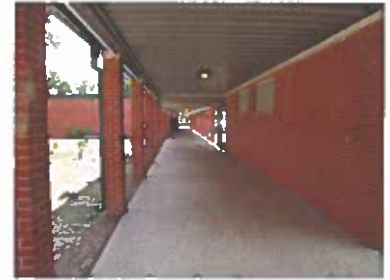
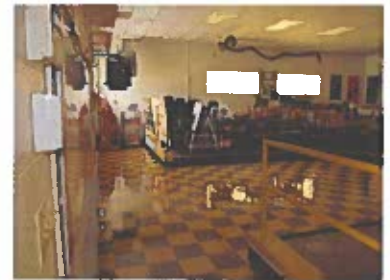
Building 5: (Music Room)
 Year Const.: 1956
 Renovations: Various Years
 Square Footage: 2,400 Single Story
 Total: 2,400

Footings: Spread
 Structure: Steel Bar Joist on Load Bearing
 Masonry
 Exterior Walls: Load Bearing CMU/Brick Veneer
 Fenestration: Aluminum Double Hung and fixed
 Storefront
 Exterior Doors: Hollow Metal Frames and Aluminum
 Storefront
 Roof System: Built-up
 Finishes: Good. Floors-VCT; Acoustic ceilings;
 and Painted CMU walls
 Plumbing Systems: Copper Supply/Cast Iron Waste
 Mechanical Systems:
 Classrooms: Wall Hung Bard Units
 Office: Wall Hung Bard Units
 Electrical System: 277/480V System
 Fire Alarm: Recently upgraded
 Emergency Lighting: Wall Mounted Battery Backup

Utilities: City of Hartsville
 Occupancy: Educational Type "E"
 Construction Type: II B Unprotected/Un-sprinkled
 Area Allowed: 14,500 sf
 Maximum Stories: Two (2) Stories
 Occupant Load:
 Fire Rated Assemblies:
 Fire Barriers: Not Applicable
 Structural Steel: No Ratings Required
 Roof/Ceiling: No Ratings Required
 Fire Walls: Not Required
 Toilets:
 Toilet Counts: Appear to be adequate
 ADA Accessibility: Appear to be compliant
