Project Observation Report

Project Name:	Tri Tech East Building C 1.5	Project No.	2208
Report #:	40		
Observation Date:	7-5-23	Last Report:	6-28-23
Prepared By:	Steve Mallory, AIA	Contractor:	Banlin

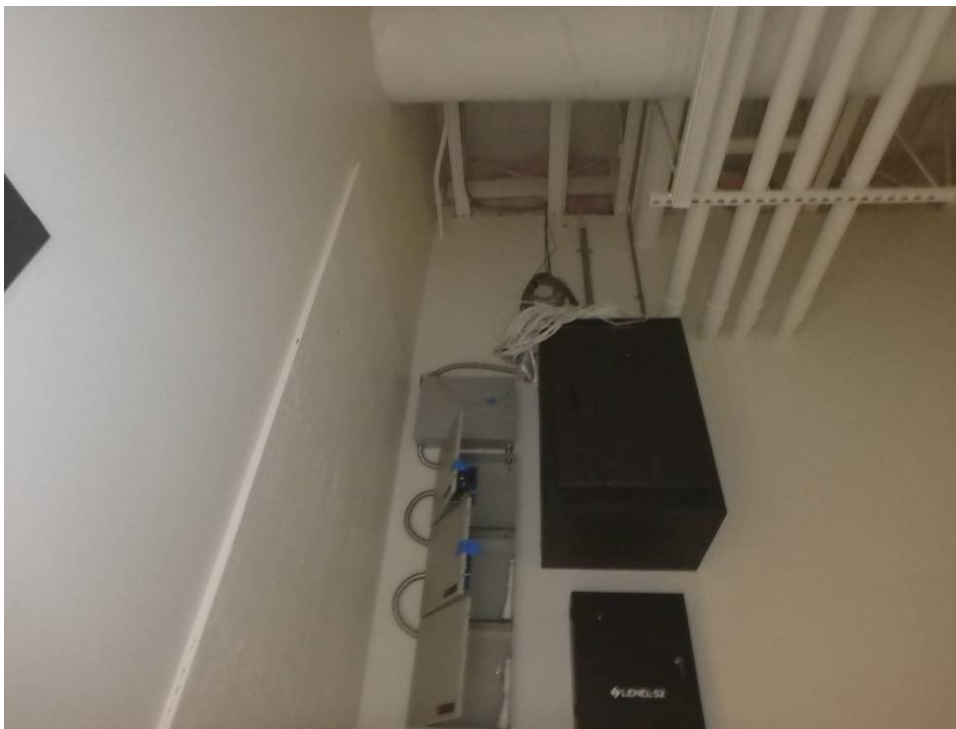
Storage room backboard and equipment, relocate lower panels to north wall - painted
