Project Observation Report

Project Name:	Tri Tech East Building C 1.5	Project No.	2208
Report #:	41		
Observation Date:	7-12-23	Last Report:	7-5-23
Prepared By:	Steve Mallory, AIA	Contractor:	Banlin

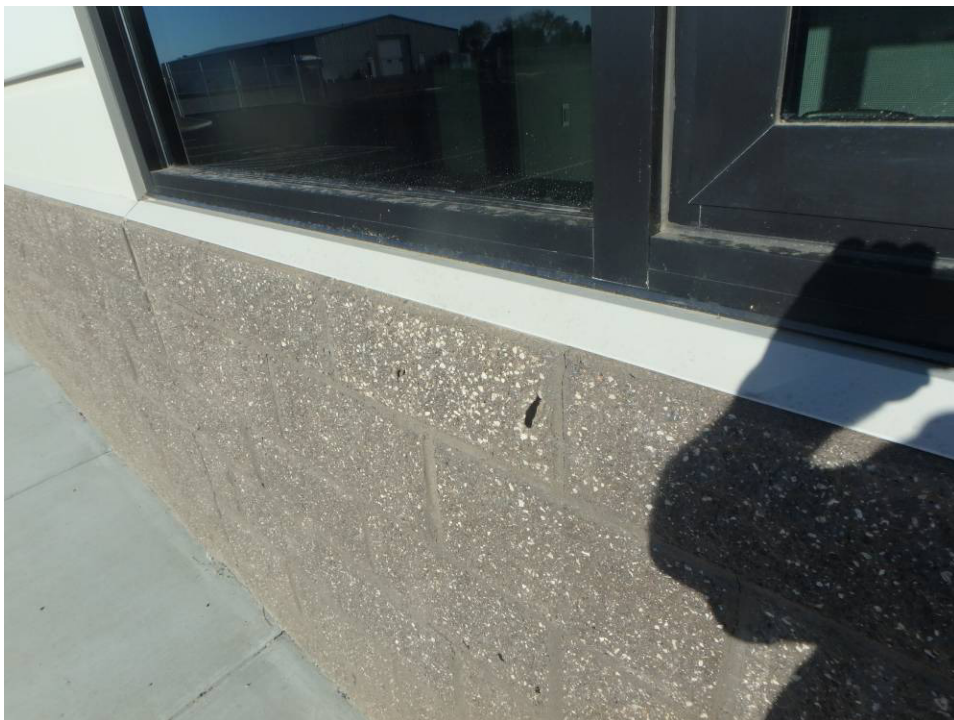
CMU voids

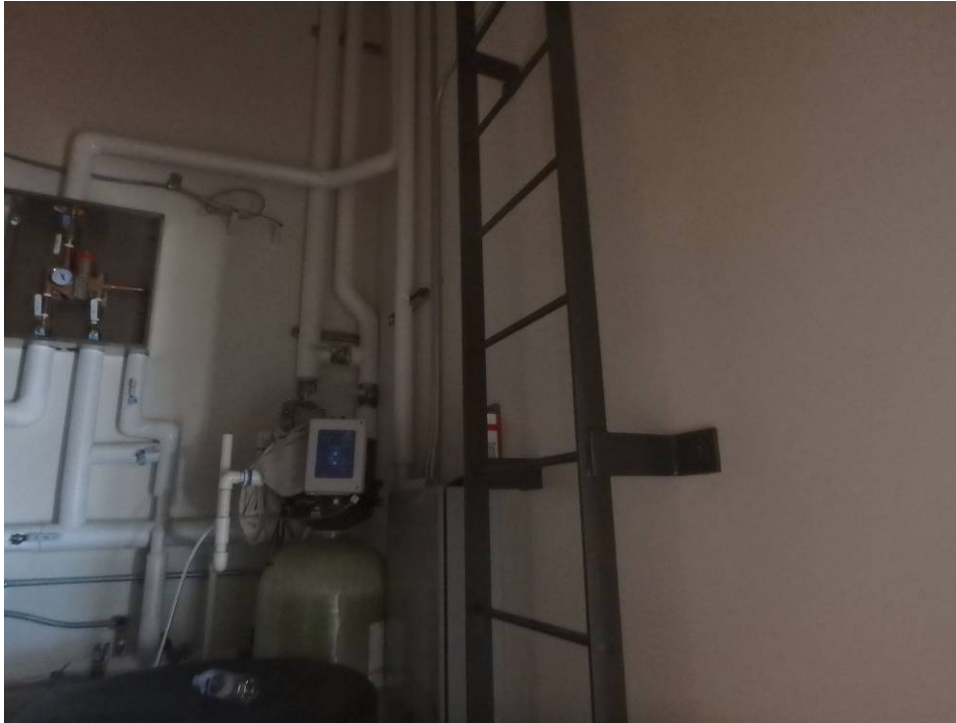
Mechanical room – Piping revision area

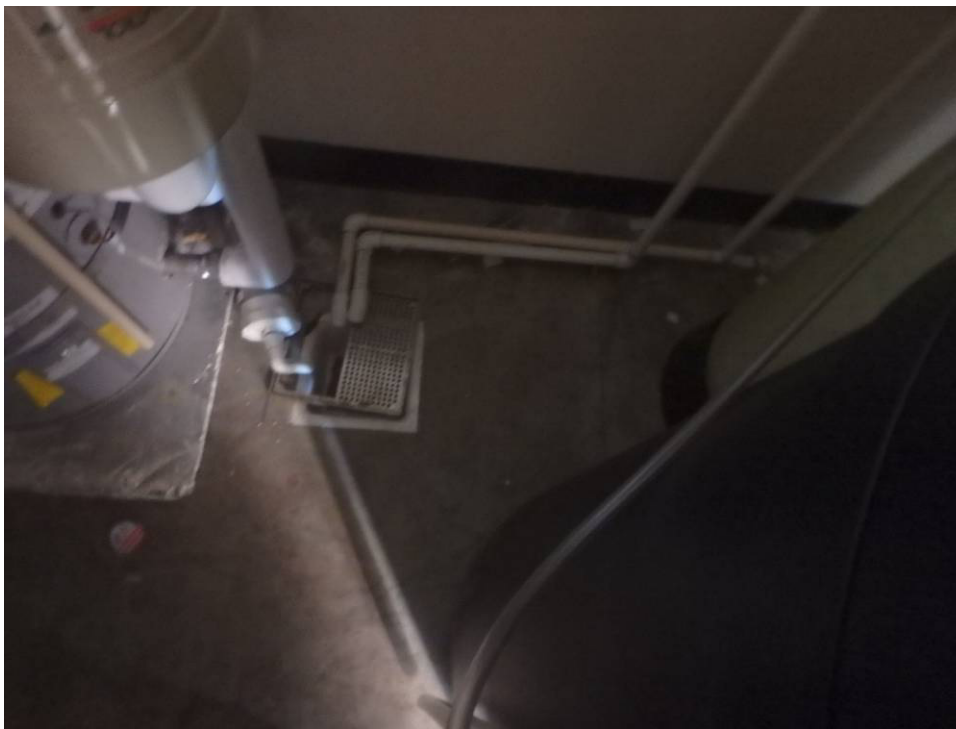
Mechanical room – floor sink behind the water softener and brine tank

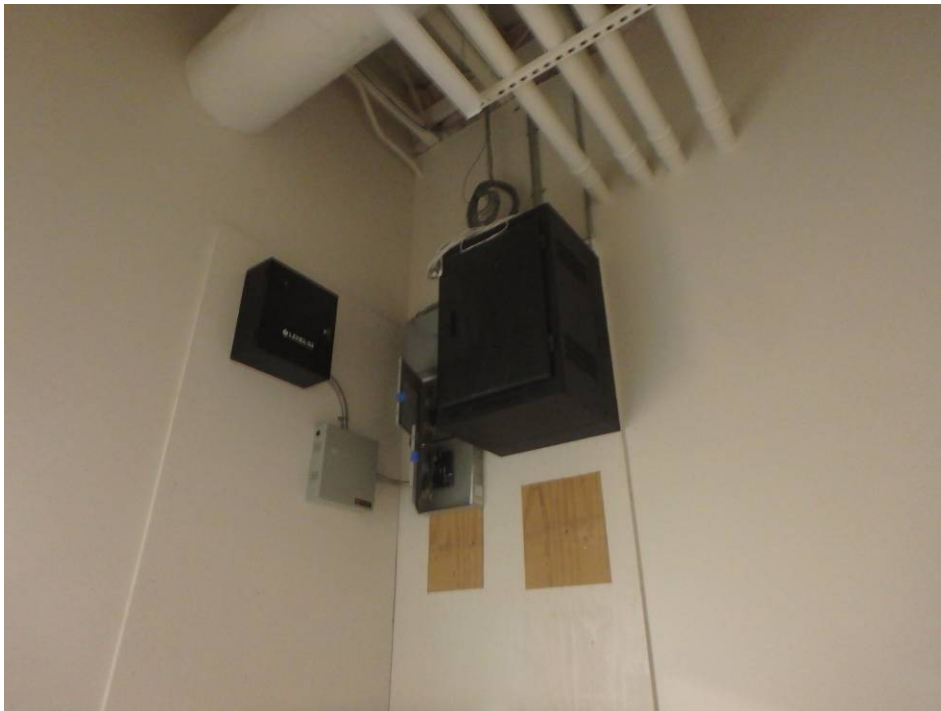
Storage room backboard and equipment, relocated lower panels to north wall - paint
