DAMIANO BARILE ENGINEERS, P.C.

September 18, 2015

RE: CROTON-HARMON UNION FREE SCHOOL DISTRICT
VENTILATION EVALUATION

RE: CROTON-HARMON UFSD
5 YEAR CAPITAL PLAN
ENGINEERING SERVICES
VENTILATION EVALUATION

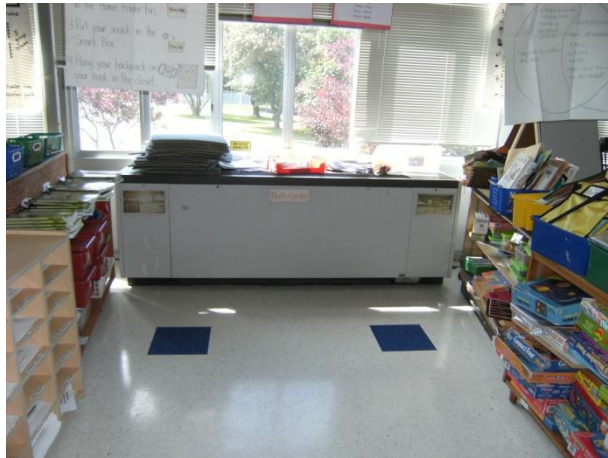
Classrooms in the 1954 portion of the building are served by floor mounted unit ventilators (UV) that introduce outdoor air and recirculate room air. Exhaust air is transferred through the classroom coat closets into the corridors below the corridor ceilings. It then exits the building by non-powered gravity vents in the roof.

Although this type of system conformed to the current NYS code at the time of original construction, this does not conform to current code mainly because it would allow for smoke to transfer into a means of egress in the event of a fire in the classroom.

The unit ventilators were replaced in approximately 2003 and are within their estimated useful life of 20 years per the ASHRAE Applications Handbook.

Figure 2: Typical 1954 wing UV

Provide powered exhaust from occupied spaces, ducted in corridor ceilings to new fans on roof.

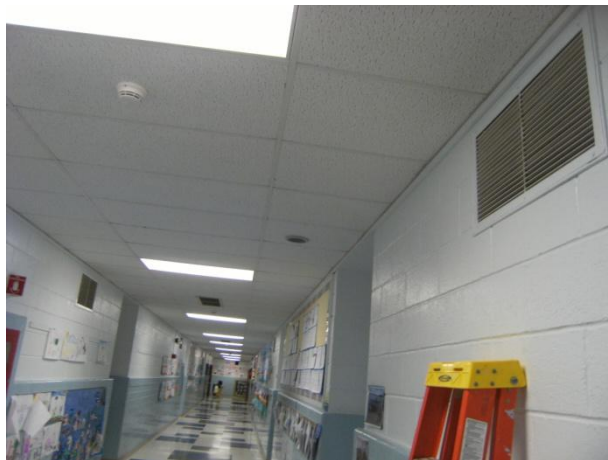
Figure 3: 1954 Wing Classroom - Corridor Air Transfer Grille

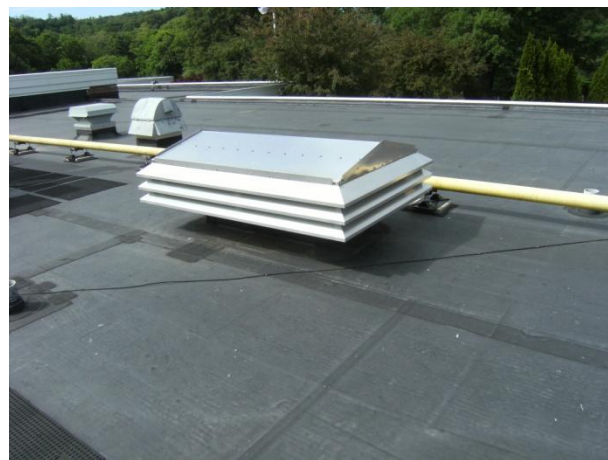
Figure 4: Typical 1954 Wing – Gravity Roof Outlet

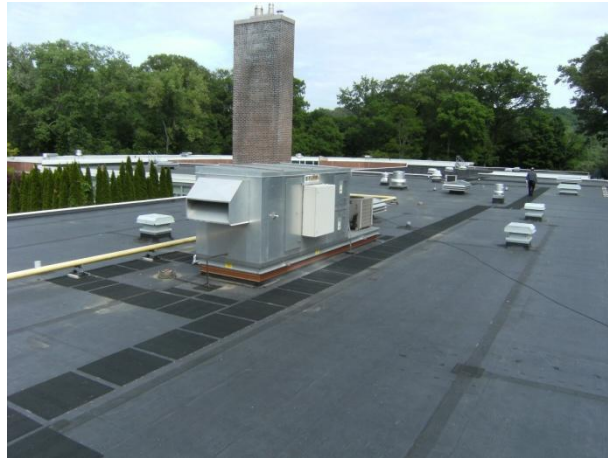
The General Administration Offices and Principal's Office areas are all served by a roof mounted HVAC unit that was installed roughly 15 years ago and is functioning without any reported problems.

Figure 5: Administration Roof Top Unit

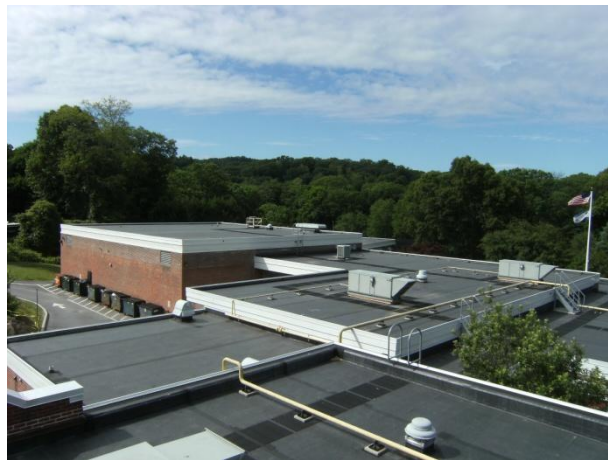
The Library was formerly the Cafeteria and is now served by two gas fired rooftop units that were installed in 2010. The adjacent Reference Room, Librarian's Office, Story Room and Computer Rooms are also served by one of these units. Each space has different usages, occupancies, cooling loads and outdoor air requirements. Occupants have complained of discomfort in some of these spaces.

Figure 6: Two Library Roof Top Units

Modify the Library system by cutting off and redirecting the branch ductwork to the other spaces so these serve the library only. Provide dedicated HV systems for the Reference Room. The Librarian's Office, Story Room and Computer Room with the proper outdoor air and heating/cooling capacities.

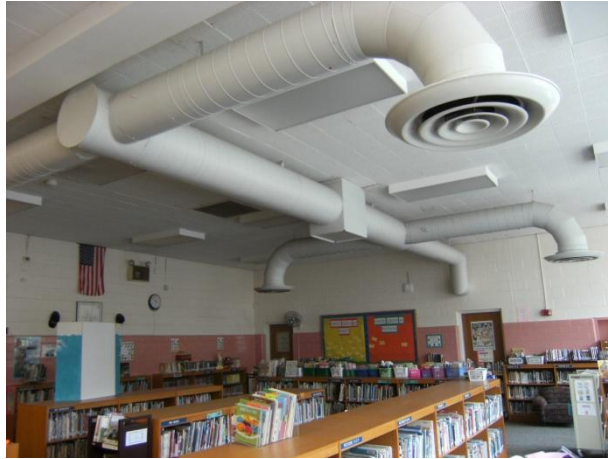
Figure 7: Library Duct Distribution

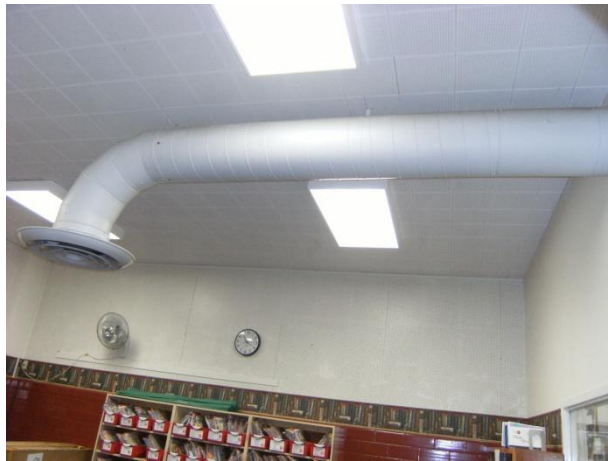
Figure 8: Reference Room Branch Duct

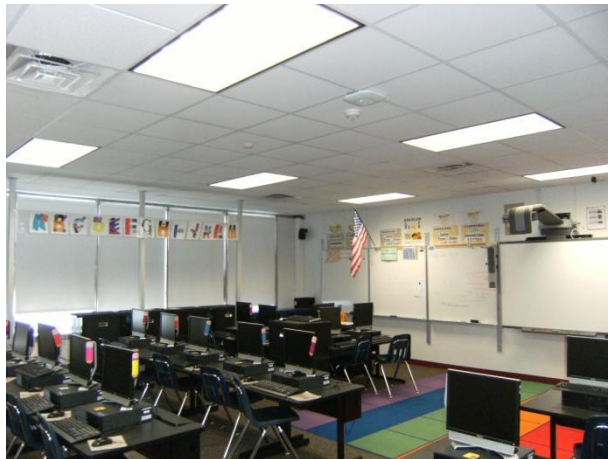
Figure 9: Computer Room

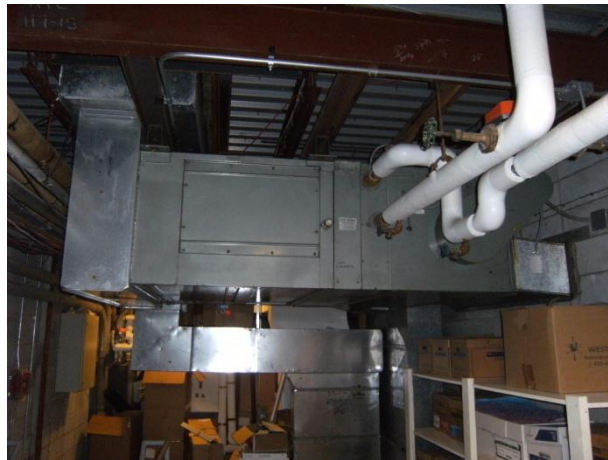
The gymnasium is served by two air handling units in an interior mechanical equipment room adjacent to the gym. The supply and return air are both on the same side of the gym with relief air from two trough the wall propeller fans. At the time of our inspection the air handlers were on but the relief air fans were not. Air distribution in the space is not optimal and the air handlers are well past their useful life.

Figure 10: Gymnasium Air Handler

Replace old Gym HV units and provide ducted supply air distribution at the ceiling of the Gym with low returns. Eliminate the hard to service propeller fans and incorporate new exhaust fans on the roof or in the mechanical room to relieve air from the return air ducts.

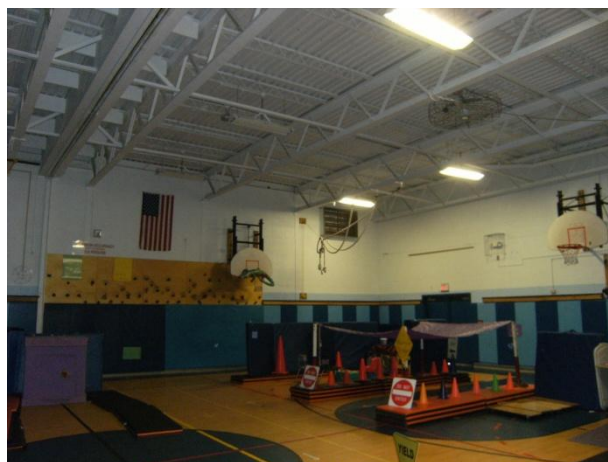
Figure 11: Gymnasium Corner Air Relief Fan

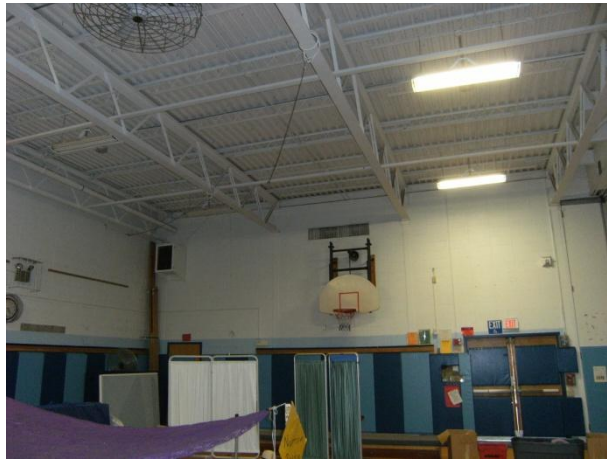
Figure 12: Gymnasium Supply Air Outlet and Corner Return Grille

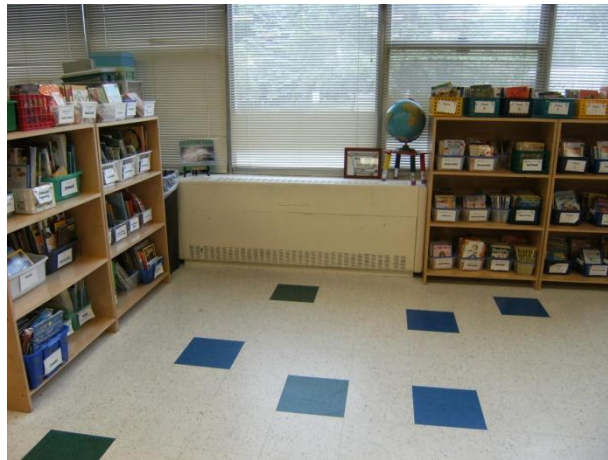
The 1961 Wing is served by unit ventilators that are well beyond their useful life. There is no visible exhaust. Ceilings were replaced and it is possible that the exhaust is blocked or obscured. There are large exhaust shafts in the core of the building that suggest that air was transferred into the corridors in a similar fashion as the original building, which does not meet current code.

There are also reported controls problems with the unit ventilators. The outdoor air damper closes when the fan is energized and opens when the fan is de-energized. The opposite should happen and the fan should be on at all times during occupied mode.

Figure 13: 1961 Wing Unit Ventilator

Replace existing classroom unit ventilators with new unit ventilators, providing the required quantity of outside ventilation air. Provide ducted exhaust fans for powered relief air.

Replace the existing classroom unit ventilators with new self-contained unit ventilators, providing the required quantity of outside ventilation air. Provide ducted exhaust fans for powered relief air.

Replace existing classroom unit ventilators with new roof mounted energy recovery units (minimum 3) and associated ductwork, providing the required quantity of outside ventilation air and relief/exhaust air. Provide heating coils in ductwork for final air tempering. New ductwork installation will require existing ceiling removal/modifications and soffits in classrooms, structural steel on roof, etc.

Replace existing classroom unit ventilators with new packaged roof mounted air conditioning/energy recovery units (minimum 3) and associated ductwork, providing the required quantity of outdoor ventilation air and relief/exhaust air. Provide heat coils in the ductwork for final air tempering. Provide variable refrigerant flow (VRF) type ductless cooling system throughout for individual classroom zone control. New ductwork installation will require existing ceiling removal/modifications and soffits in classrooms, structural steel on roof, etc.

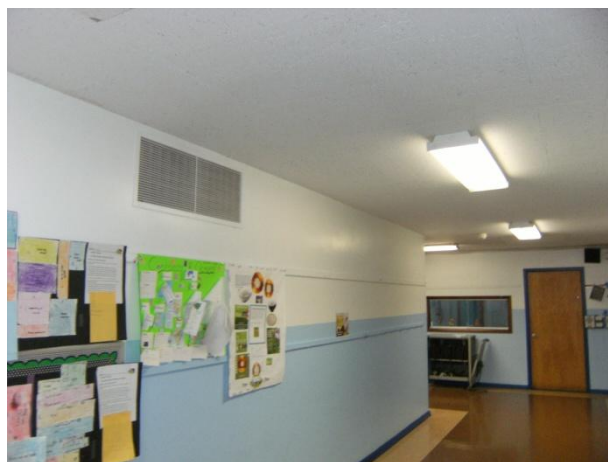
Figure 14: 1961 Wing Corridor Exhaust Transfer Grille

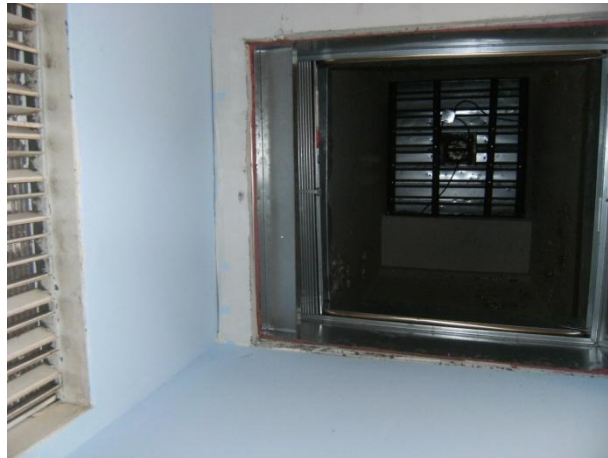
Figure 15: 1961 Wing Exhaust Shaft

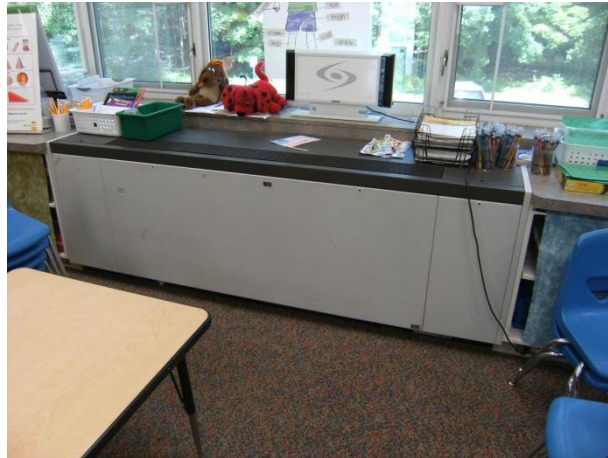
Ventilation air enters the classrooms in the 2003 wing through unit ventilators, is transferred into open ceiling plenums, and then vented by gravity through roof hoods. There is no powered classroom exhaust in this wing.

Figure 19: 2003 Wing Unit Ventilator

Provide powered exhaust from occupied spaces ducted in corridor ceilings to new fans on roof.

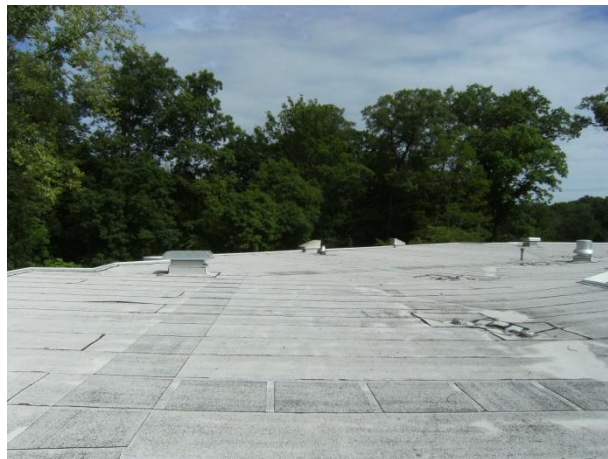
Figure 20: Typical 2003 Wing Roof Relief Hoods

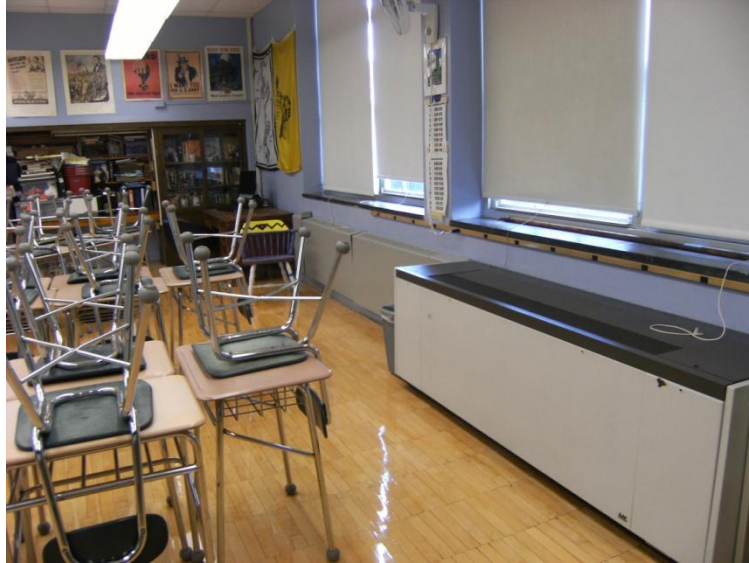
With some exceptions, typical classroom spaces in the original building have unit ventilators with exhaust being removed through the back coat closets. Air is then ducted up through the attic to a number of roof mounted exhaust fans that are beyond their useful life. There is no indication that there are fire dampers at any of the floor to floor penetrations.

Figure 22: Typical Classroom Unit Ventilator

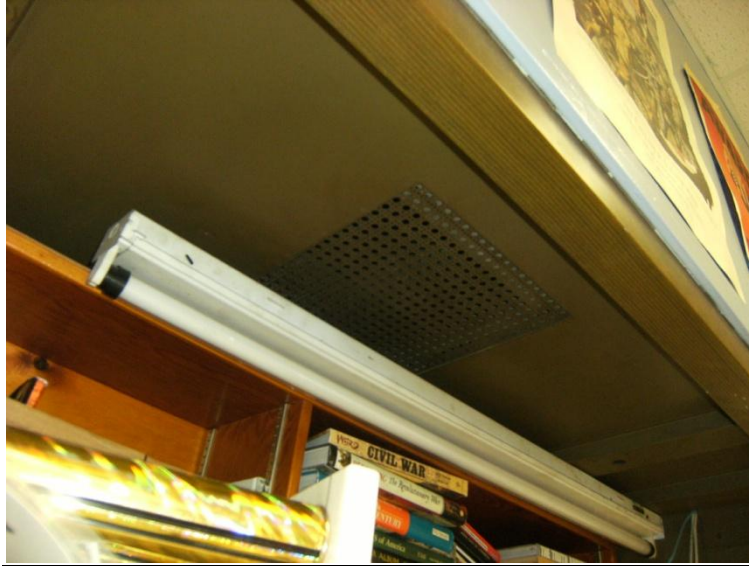
Figure 23: Typical Classroom Closet Exhaust Register

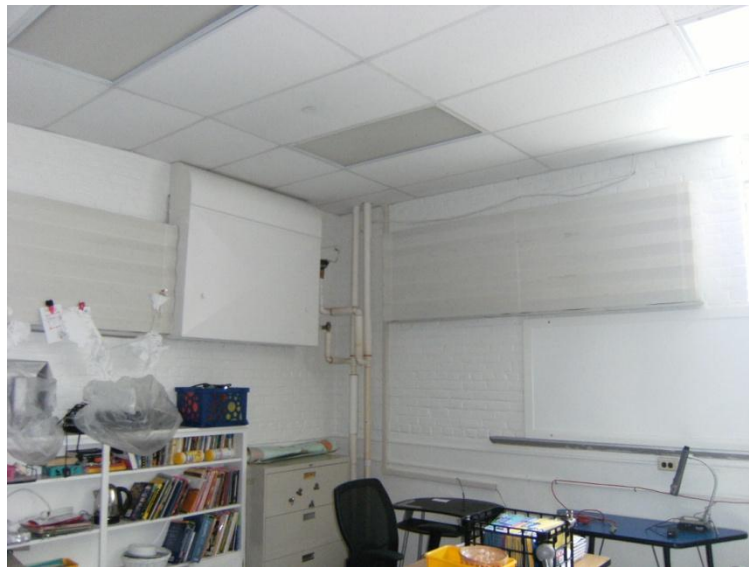
There is no visible outdoor air or exhaust air in the Classroom Room 224 or Faculty Room 223. The adjacent Custodian's Office 221 has exhaust but no powered outdoor air.

Figure 26: Music Keyboarding Room 224 Radiators

Provide four new exhaust fans on roof. Add ventilation to Classroom 224, Faculty 223 and Custodian's Office 221.

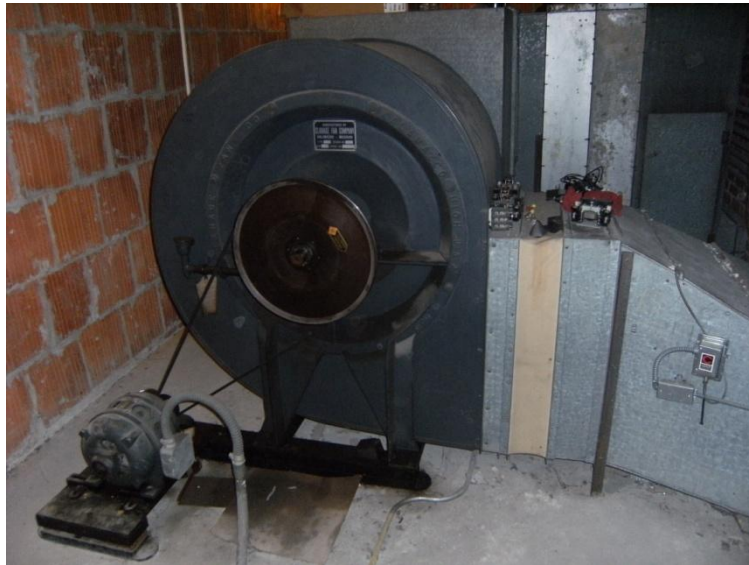
The gymnasium is ventilated by an attic mounted utility set supply fan which appears to be original to the building. Although it is well past its expected useful life, this fan is of very solid construction, quiet, and well maintained.

Figure 27: Gym Supply Fan

Add ventilation and air conditioning to Health Room 319. Add ventilation to the Guidance area rooms 307, 308 and 309. Replace gym supply fan.

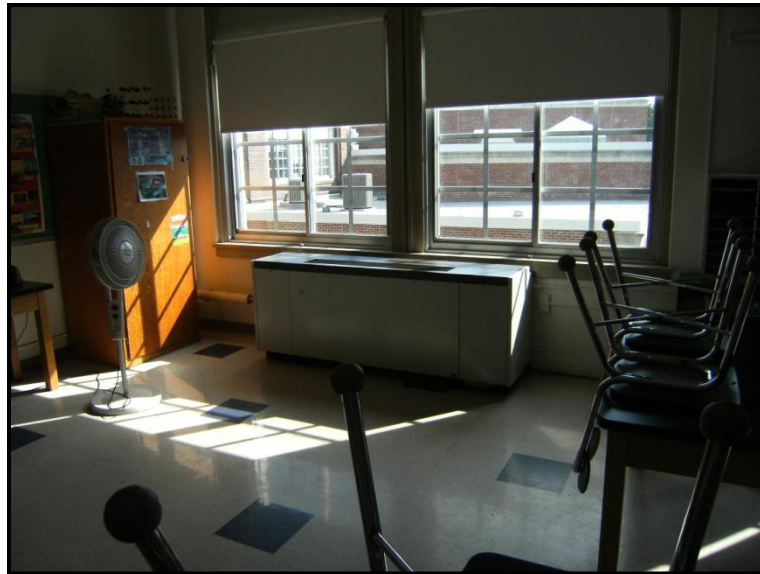
Typical classroom spaces in the original building have unit ventilators with no visible signs of exhaust. Some of the older doors into the corridors have louvers on them which suggest that at one time air was transferred from the classrooms into the corridors and out of the building by gravity shafts. That system is no longer used and there is no powered exhaust. This is also the case for the three science rooms on the top floor, which are required to have dedicated powered exhaust. (Rooms 310, 311, and 312)

Figure 31: Original Building Typical Unit Ventilator

Provide powered exhaust to all areas that do not have it. It may be possible to re-use some of the original relief shafts, but fire dampers will need to be added from floor to floor. Ducted exhaust would need to be provided from the shafts on the top floor to roof mounted exhaust fans.

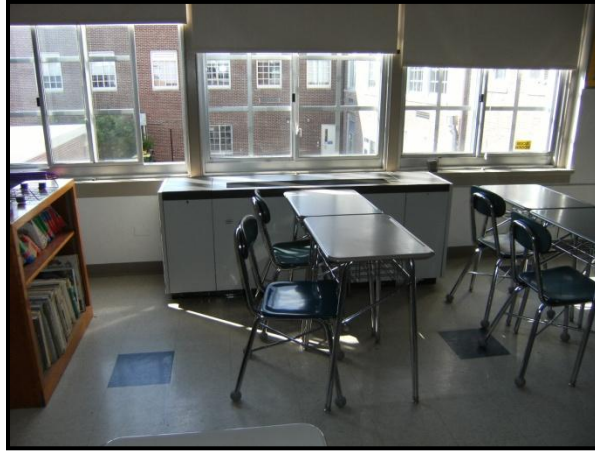
Rooms 214, 215, 216, 217, and 218 had unit ventilators replaced in approximately 2003. Relief air is transferred into the corridors then through relief vents in the roof. There is no powered exhaust. Air transferred into a corridor is currently non-conforming because in the event of a fire smoke could be transferred into a means of egress.

Figure 32: Room 214 Unit Ventilator

Provide ducted powered exhaust in rooms 214 through 218 with an exhaust fan on roof.

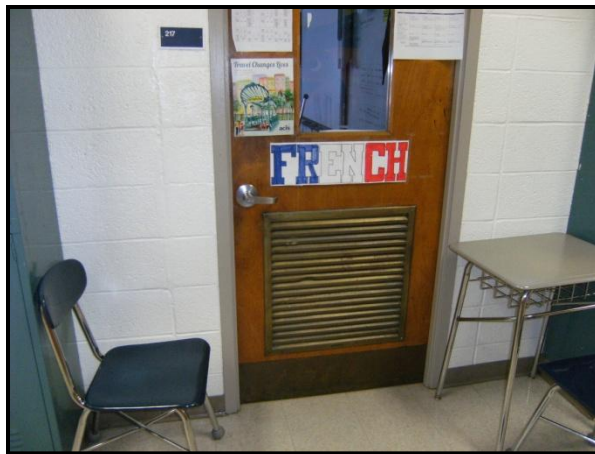
Figure 33: Air Transfer Grille into Corridor

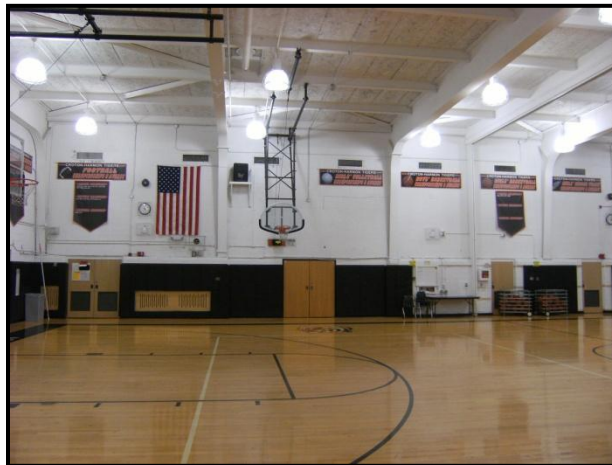
The Main gym is served by two roof mounted air handling units located on the adjacent lower roof that supply and return air on one side of the gym. They were installed in 2003. Air is exhausted through two wall mounted propeller exhaust fans above the bleachers on the opposite side of the room. The air distribution in this space is not ideal but there is still remaining useful life in the equipment. Revised ductwork for better air flow could be considered in the future when the equipment is at the end of its useful life.

Figure 34: 1960's Gym High Supply Air and Low Return Outlets

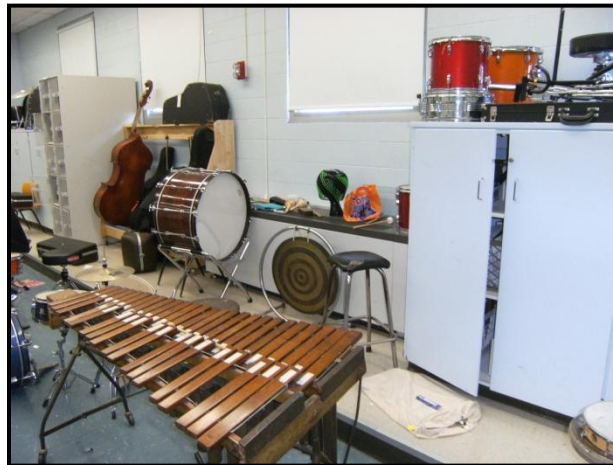
The Music/Choral Room only has one unit ventilator that is sized for a typical classroom, and is too small to provide required outdoor air for a fully occupied room, and there is no visible exhaust in the space.

Figure 36: Music/Choral Room Unit Ventilator

Provide an ERU for the Music/Choral room outside of the space to minimize equipment sound.
