CROTON-HARMON UFSD
2015 BUILDING CONDITION SURVEY
CARRIE E. TOMPKINS ELEMENTARY SCHOOL
SED # 66-02-02-03-0-003

Architectural Survey

Plumbing/ Electrical/Mechanical Survey

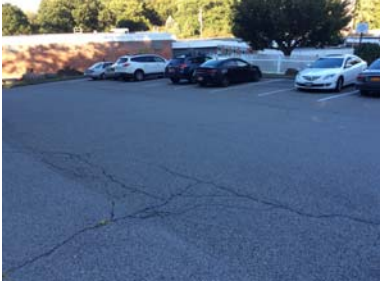
<p>SS 2 Asphalt Paving Repave main parking lot and pave gravel parking lot to improve site parking.</p>

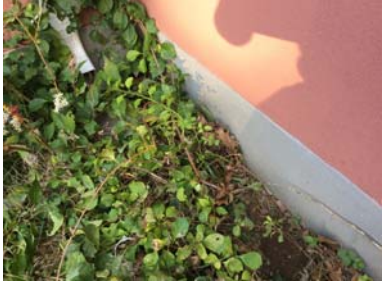
<p>SS 4 Site Drainage Leader and splash block directs water into abandoned crawlspace vent. Crawlspace vent will need to be excavated and properly closed and sealed. Leader should be extended to direct water away from building.</p>

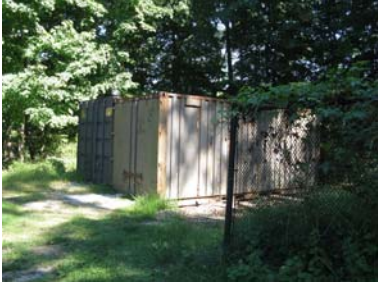
<p>SS 6 Site Storage The State Education Department requires storage containers to be provided with ventilation and door hardware that can be opened from the inside without a key.</p>

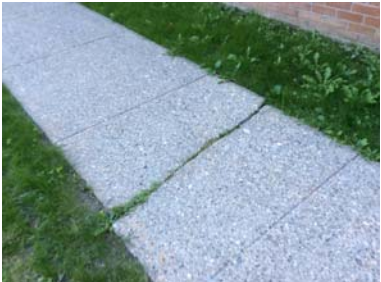
<p>SS 8 Concrete Sidewalks Replace cracked and broken concrete sidewalks.</p>

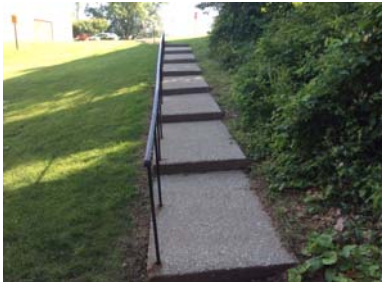
<p>SS 12 Concrete Site Stairs Concrete site stairs are at the end of their useful life and should be replaced.</p>

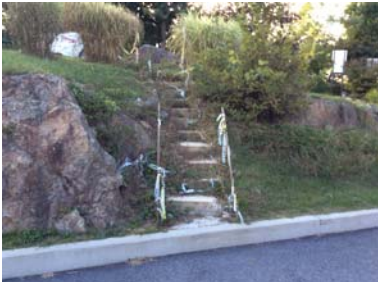
<p>SS 12 Concrete Site Stairs Concrete site stairs are in poor condition and missing handrails. Stairs are a safety hazard and should be replaced.</p>

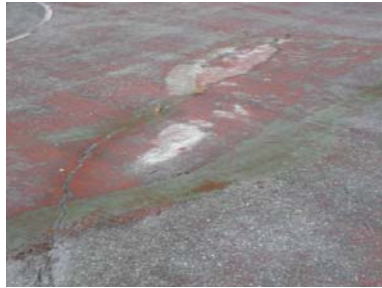
SS 13 Concrete Play Area
Repave paved play area
basketball courts

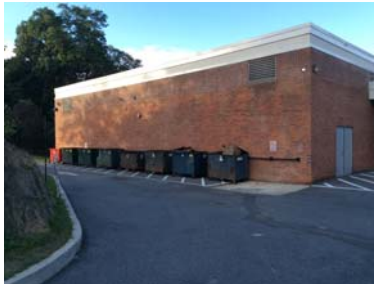
SS 15 Relocate Dumpsters
Dumpsters adjacent the
building create a potential
health and fire hazard. Work
would include relocating the
dumpster area to away from
the building on a concrete
pad enclosed by chain link
fencing for protection from
vandalism

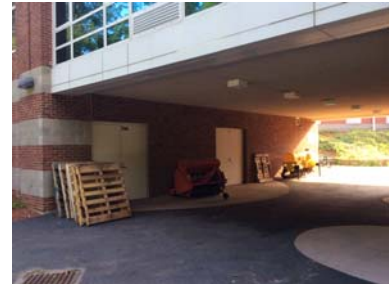
**SS 16 Maintenance
Equipment Storage
Building**
Power maintenance
equipment is stored outside
and under the Kindergarten
wing, which is a health and
safety hazard. A Storage
building is needed to house
all of the District's
equipment in one location.

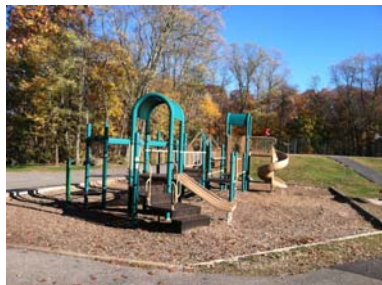
**SS 18 Playground
Equipment:**
Replace aging existing
playground equipment and
expand equipment to reduce
current overcrowding.

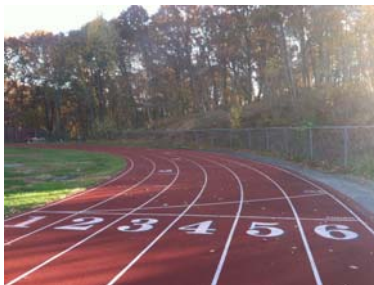
**SS 19 Resurface and
Reconfigure Track:**
Track will soon need to be
resurfaced as part of
maintenance cycle.
Reconfigure track during
resurfacing to allow sprints
to be run on bleacher side
instead of far side of track.

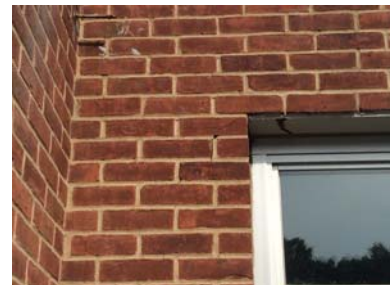
**EB 2 Replace Rusted
Lintels**
Lintels at the Gymnasium
louvers, custodial office and
room 5 are starting to expand
due to rusting. Lintels
should be replaced before
they expand further and
crack the brick veneer.

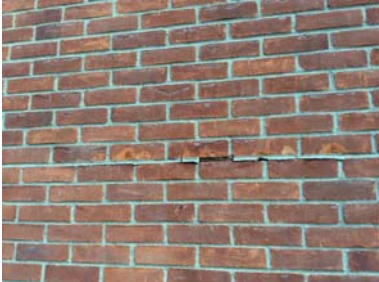
<p>EB 3 Brick Veneer Repointing Brick joints are beginning to show signs of deterioration, open mortar joints and rusting brick ties. Work would include masonry repointing / repair to select areas around the building showing signs of the worst deterioration.</p>

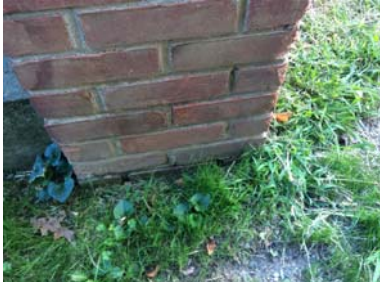
<p>EB 3 Rebuild Brick Veneer Brick Veneer at the bottom of the wing walls at the 3rd/4th grade wing are undermined and require removal and replacement of brick veneer to repair.</p>

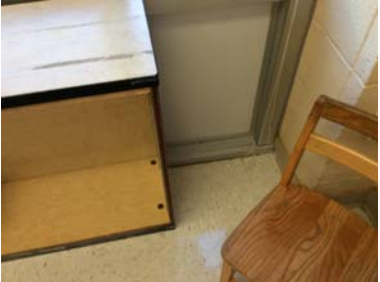
<p>EB 4 Window Wall Office and First grade window wall are sitting on deteriorating wood blocking and allow moisture to enter the building. Window wall should be removed and replaced with a new properly designed window wall system.</p>

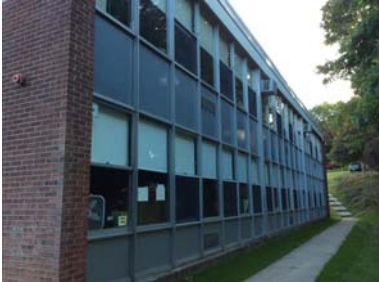
<p>EB 4 Window Wall The window wall at the third and fourth grade wing is a single glazed system with poor thermal and air infiltration performance. System should be replaced with a double glazed curtain wall system to increase the buildings thermal performance.</p>

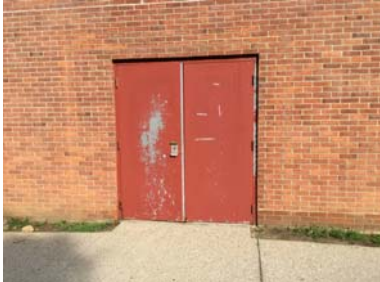
<p>EB 7 Exterior Doors Exterior doors at the gym, computer room, custodian's office, storage room, and exit doors from the modular wing are beyond their useful life and no longer functioning properly. Work would include the replacement of the doors with new doors and hardware to ensure ADA compliance.</p>

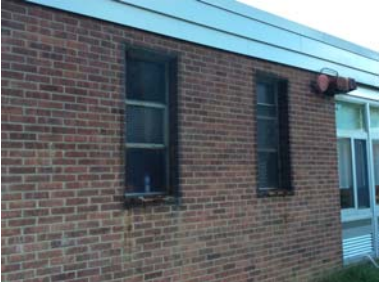
<p>EB 8 Scrape and paint Windows: Existing paint on windows is deteriorated and peeling. Windows should be scraped and repainted to extend their useful life.</p>

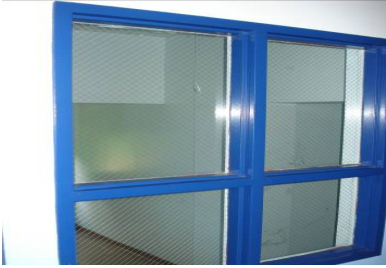
BIC 1 Wire Glass
Wire glass is no longer allowed by the State Education Department. Although replacement is not mandatory, it is recommended that large areas of glass be replaced with approved safety glazing as time and budget permit.

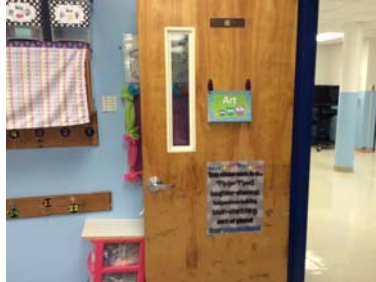
BIC 2 Interior Wood Doors
Interior wood doors are at the end of their useful life. Fatigue at the hinges and latch hardware is causing the doors to stick or not latch properly. Replacement is recommended.

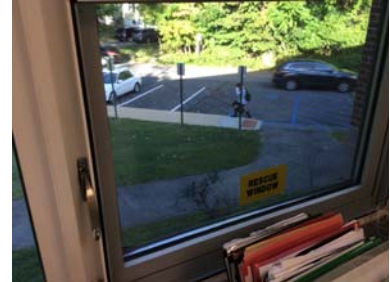
BIC 5 Rescue Windows
Rescue windows at the Kindergarten wing have screens that are secured in place with screws and do not allow for egress. Screens must be removed.

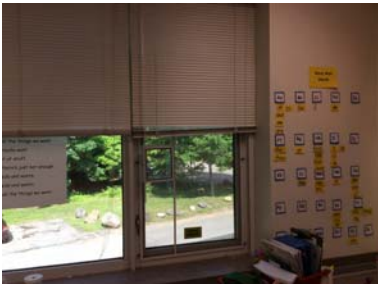
BIC 5 Rescue Windows
Window treatments at rescue windows should be labeled with rescue window labels.

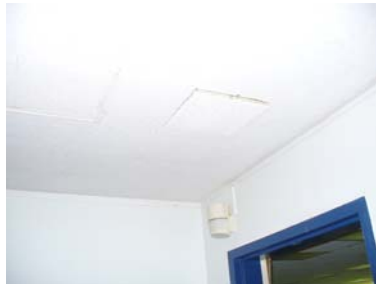
BIR 2 Concealed Spline Ceilings
Concealed spline ceilings were installed when the building was first built and restrict access above ceiling for maintenance. Work would include the replacement of these ceiling areas

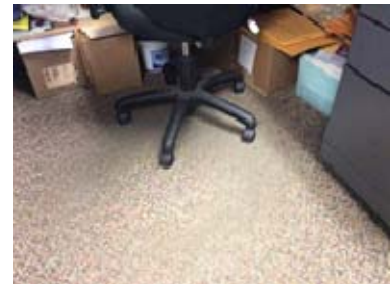
BIR 3 Carpet:
Replace
Worn and stained carpet at the end of its useful life should be removed and replaced

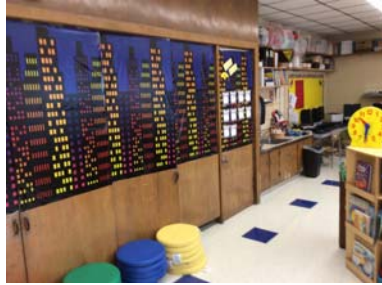
BIR 9 Replace Casework
Built in casework at the first grade wing is coming to the end of its useful life. Work would include the replacement of casework.

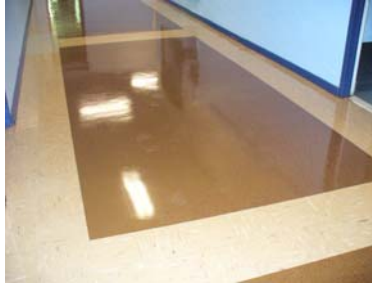
BIR 10 Vinyl Asbestos Tile
Vinyl asbestos tile installed during the original construction of the building has served its useful life and requires replacement. Work would include removal of existing floor tile and rubber base and installation of new vinyl composite tile and rubber base.

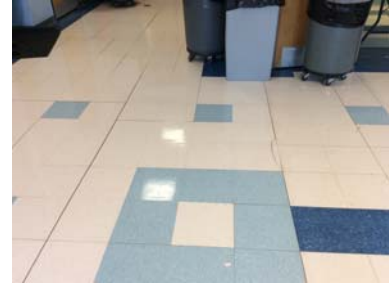
BIR 11 Vinyl Composite Tile:
Seams at the common areas vinyl composite tile in the 2004 addition are expanding and widening. Vinyl composite tile should be removed and replaced with new vinyl composite tile and wall base.

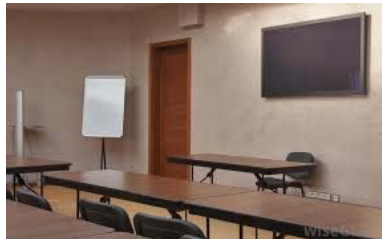
BIR 14 Flat Screen Monitors:
Upgrade smart boards to flat screen monitors at all classrooms.

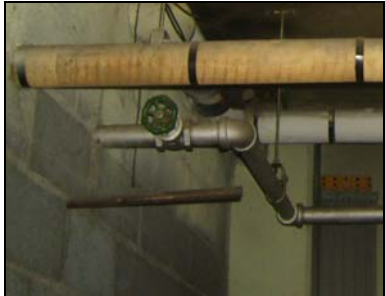
<p>P1 Galvanized Water Piping Replace existing galvanized steel water piping in crawl space (1954 Building).</p>

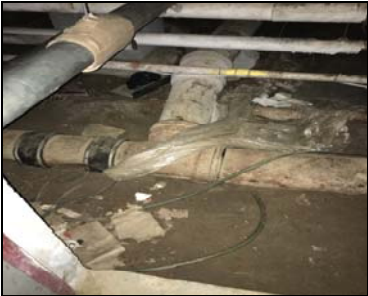
<p>P2 Storm Piping Replace existing cast iron storm piping in crawl space (1954 Building).</p>

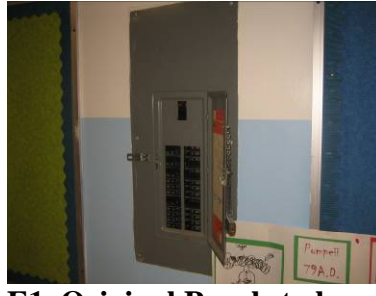
<p>E1 Original Panels to be upgraded Upgrade all remaining original branch panel boards due to its end of life.</p>

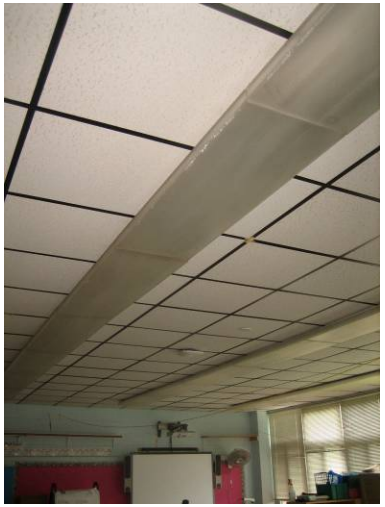
<p>E2 Add occupancy sensors Add occupancy sensors in remaining classrooms and offices.</p>

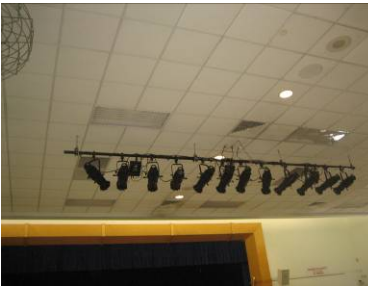
<p>E3 Cafetorium Stage Lighting and Dimming System Replace existing stage lighting and dimming system with new due to its end of life.</p>

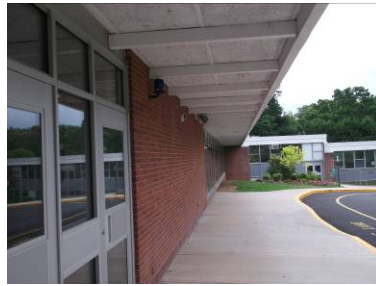
<p>E4 Additional Camera Coverage Add additional security cameras for coverage.</p>

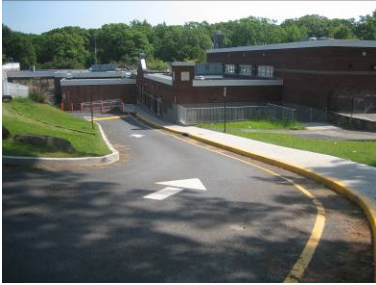
E5 Add Security Lighting
Add/Supplement wall mounted security lighting behind gymnasium.

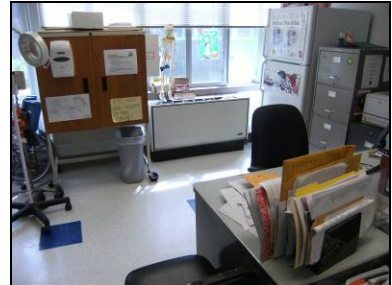
M1 Nurse's Office
Provide outdoor air and powered exhaust.

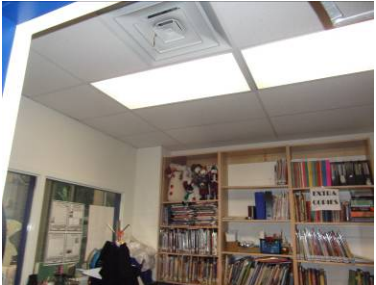
M2 Librarian's Office
Provide dedicated HVAC unit.

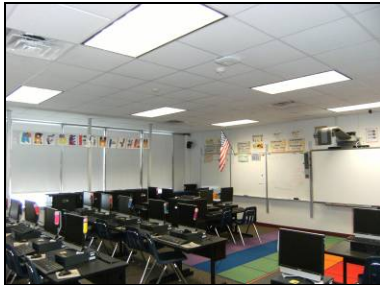
M3 Computer Room
Provide dedicated HVAC unit.

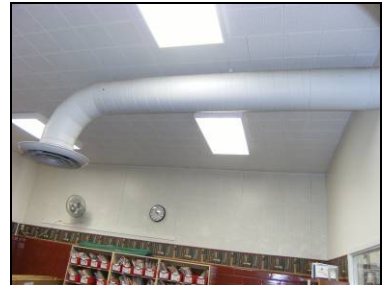
M4 Reference Room
Provide dedicated HVAC unit.

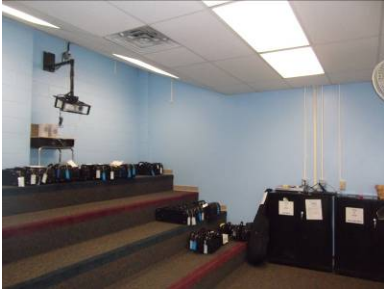
M5 Story Room
Provide dedicated HVAC unit.

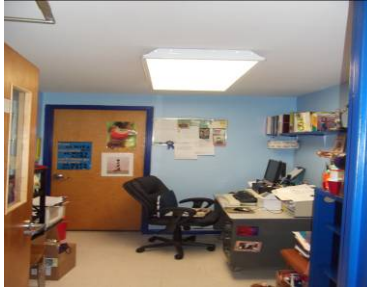
M6 Gymnasium Offices
Provide outdoor air, powered exhaust and air conditioning.

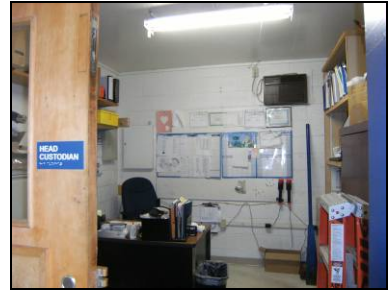
M7 Head Custodian Office
Provide outdoor air, powered exhaust and air conditioning.

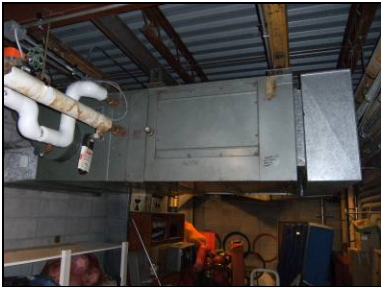
M8 Gymnasium air handlers
Replace existing units.

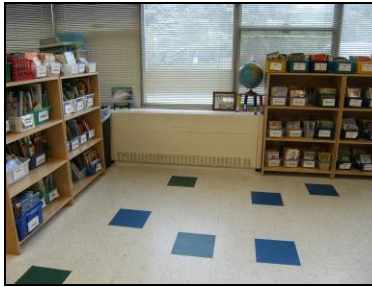
M9 Typical Unit Ventilator (1961 Addition)
Replace unit ventilators with central energy recovery unit systems and VRF air conditioning.

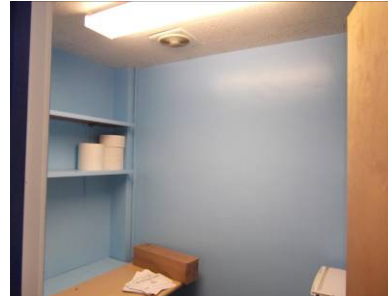
M10 Lactation Room
Provide dedicated HVAC unit.

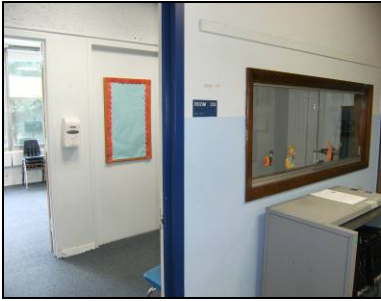
M11 Room 213
Provide dedicated HVAC unit

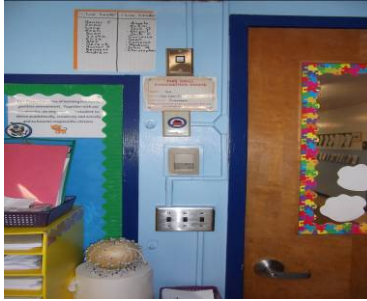
M12 HVAC Controls (1961 Addition)
Upgrade existing pneumatic controls to DDC and connect to existing BMS.

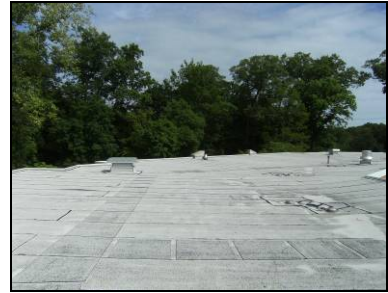
M13 Classroom Air Relief System (2003 Addition)
Provide ducted powered exhaust to replace the existing rooftop plenum vent system.

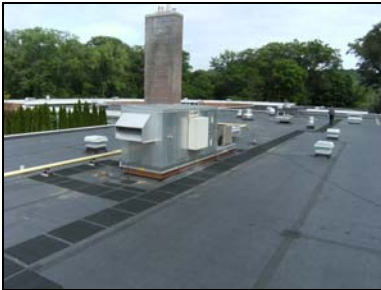
M14 Ducted Powered Exhaust (1954 Building):
Provide ducted powered exhaust ventilation system.

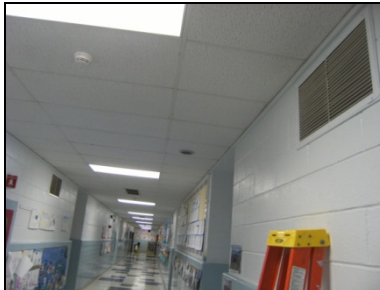
M15 Corridors:
Provide ducted powered exhaust in Corridors throughout.

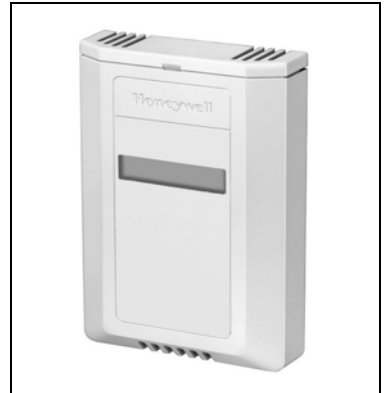
M16 CO2 Monitoring:
Provide CO2 wall

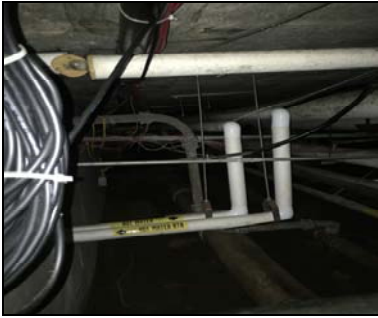
M17 Crawlspace:
Provide powered exhaust
ventilation
