**CROTON-HARMON UFSD
2015 BUILDING CONDITION SURVEY
CROTON-HARMON HIGH SCHOOL
SED # 66-02-02-03-0-001**

Croton-Harmon UFSD 2015 Five Year Plan Croton Harmon High School

KSQ Project #151400240

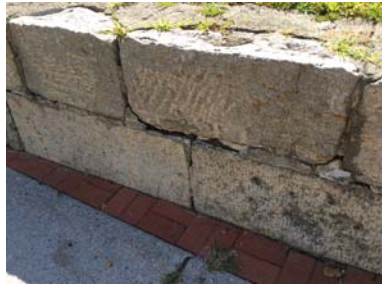
SS 1 Stone Site Wall:
Restore and rebuild stone site walls. Reset loose stones and remove and replace deteriorated mortar joints.

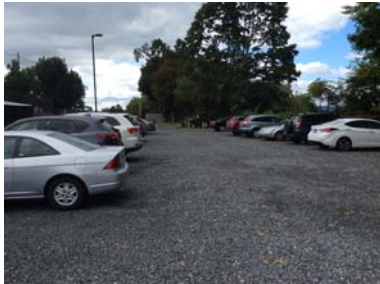
SS 2 Asphalt Paving
Repave main parking lot and pave asphalt parking lot to improve site parking.

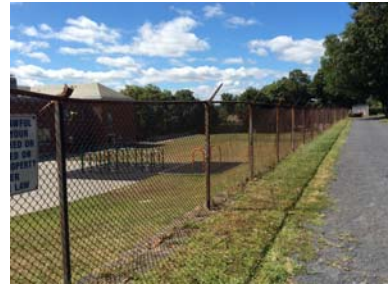
SS 3 Site Fencing
Chain link site fencing is showing signs of age including rusted and damaged sections of wire fabric. Work includes replacement of damaged areas.

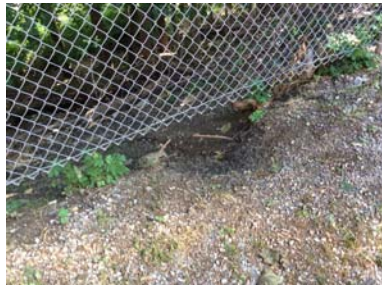
SS 4 Site Drainage
Improve site drainage to reduce storm runoff to the adjacent neighboring properties.

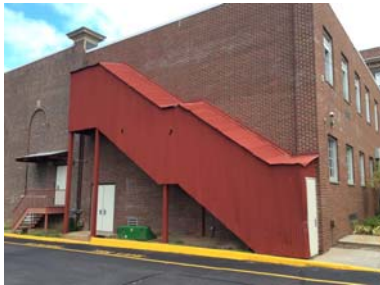
SS 5 Egress Stair
The corrugated metal walls of the exterior egress Stair enclosure are rusting and damaged. Replace existing metal stairs and walls with new stairs and enclosure that would be opaque partially to allow for natural light during the day.

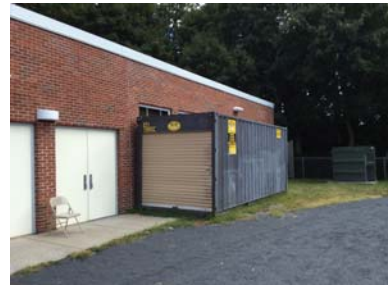
SS 6 Site Storage
The State Education Department requires storage containers to be provided with ventilation and door hardware that can be opened from the inside without a key.

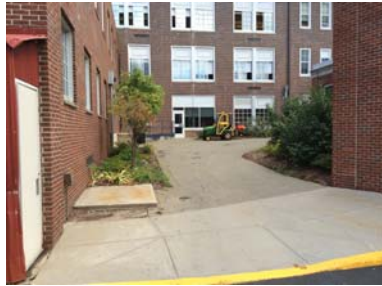
SS 6 Site Storage

Power equipment is stored outside at several locations including the courtyard. A maintenance storage building is needed to properly house the District's equipment. A building is proposed at the Carrie E. Tompkins ES site.

SS 16 Storage Building:
Replace existing storage container with storage building.

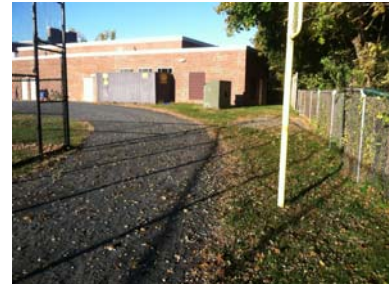
SS 17 Sidewalk:

No paved path exists between the High school and Middle School. Add sidewalk along gravel running track to provide a paved walkway between the Middle school and High school that can be easily maintained and cleared of snow in the winter.

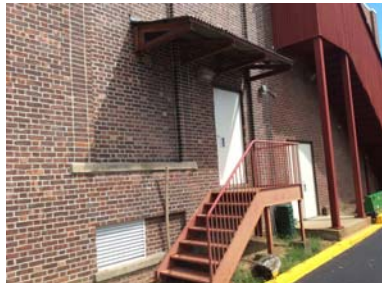
EB-1 Paint Stairs and Canopy

The Band Room stairs and canopy should be repainted to protect them from rusting

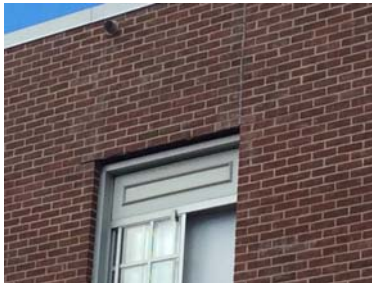
EB-2 Replace Rusted Lintels

Lintels at the music wing addition are starting to expand due to rusting. Lintels should be replaced before they expand further and crack the brick veneer.

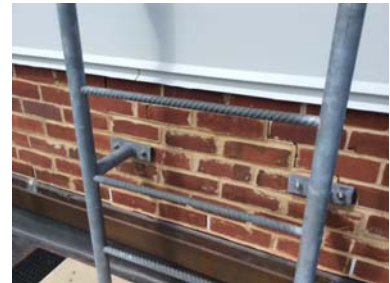
EB-3 Brick Repairs

Brick veneer has pulled away at ladder. Brick veneer needs to be removed and rebuilt.

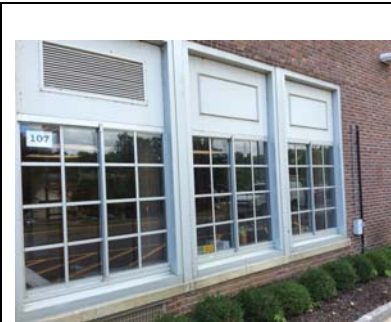
EB-4 Windows

Windows at the 1924 building were installed during a renovation project that appears to have been completed during the early 1990's. The windows are at the end of their useful life. Work would include replacement with energy-efficient insulating type windows.

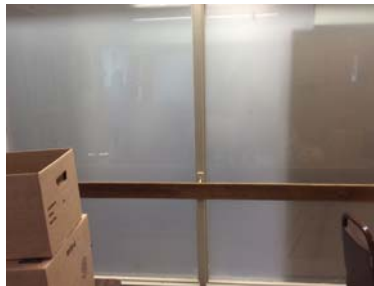
BIC 1 Wire Glass

Wire glass is no longer allowed by the State Education Department. Although replacement is not mandatory, it is recommended that large areas of glass be replaced with approved safety glazing as time and budget permit.

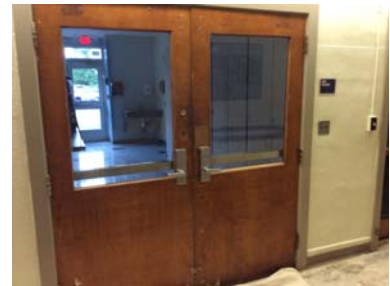
BIC 2 Interior Wood Doors

Interior wood doors at the end of their useful life. Fatigue at the hinges and latch hardware is causing the doors to stick or not latch properly. Replacement is recommended

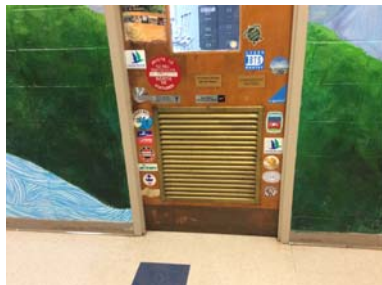
BIC 2 Interior Wood Doors

Interior wood corridor doors with vents do not provide smoke separation and are no longer allowed by the State Education Department. Replacement is recommended.

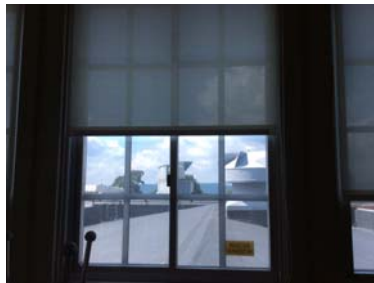
BIC 5 Rescue Windows

Window treatments at rescue windows should be labeled with rescue window labels.

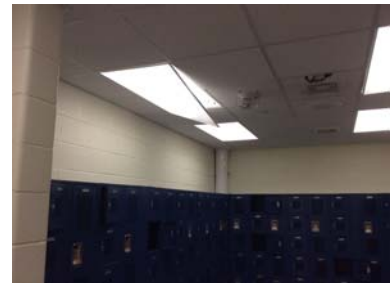
BIR 1 Ceilings

Suspended acoustic ceilings are beginning to show signs of wear and water staining. Work would include the replacement of these ceiling areas.

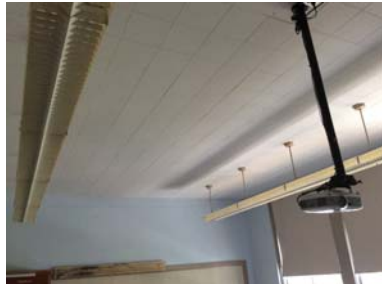
BIR 2 Ceilings

Concealed spline ceilings were installed when the building was first built and restrict access above ceiling for maintenance. Work would include the replacement of these ceiling areas.

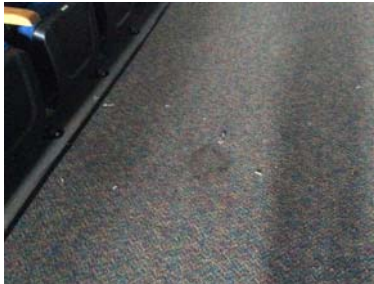
BIR 3 Carpet

Worn and stained carpet at the end of its useful life should be removed and replaced.

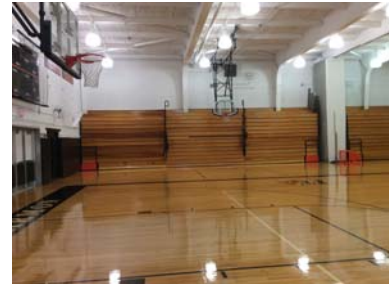
BIR 4 Wood Gymnasium

Bleachers: Replace
Wood Gymnasium Bleachers are worn from age and difficult to open and close

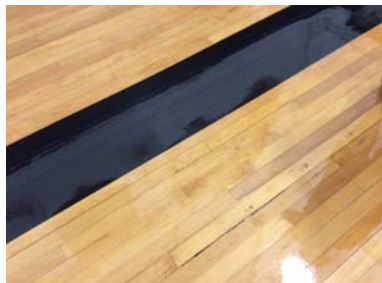
BIR 5 Gymnasium floor: Replace

Wood Gymnasium floor is original to the gymnasium addition. Floor has been repaired and refinished many times and is in need of replacement.

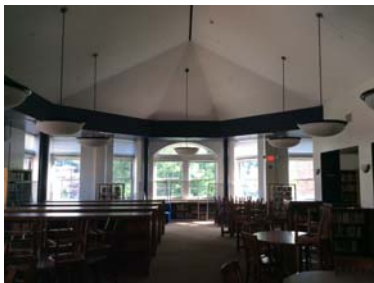
BIR 6 Library

Acoustics in the library are unsatisfactory. The District has plans to reduce the number of books housed in the library. Library renovations are recommender to improve acoustics and the use of the space due to programmatic changes.

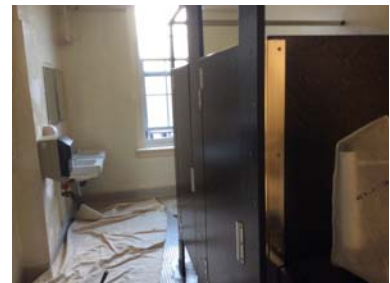
BIR 7 Multi-Use Toilet Renovations

Several toilet rooms are from the original construction. Work would include the renovation of original plumbing fixtures, flooring, ceramic tile walls, old ceilings, etc. with new.

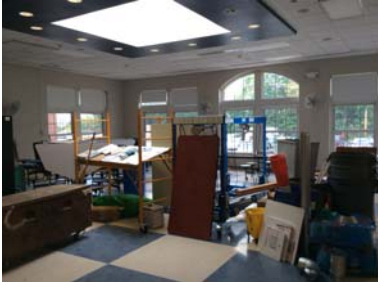
BIR 8 Cafeteria; Increase Seating Capacity:

There is not enough seating during lunch periods in the existing cafeteria. Recommendations include additional lunch periods and expansion of the cafeteria capacity through renovations and additions.

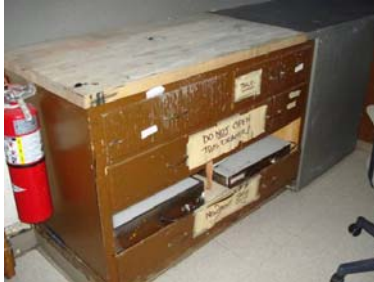
BIR 9 Replace Casework Cabinets, shelving, etc. (casework) is from the original 1924 construction and is coming to the end its useful life. Work would include the replacement of casework items.

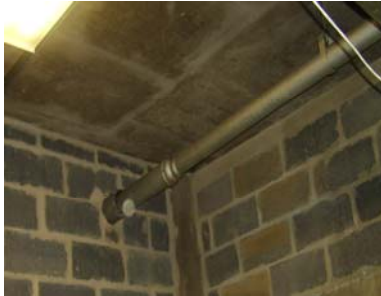
<p>P1 Domestic Water Piping (1924 Building) Replace existing galvanized steel piping and valves.</p>

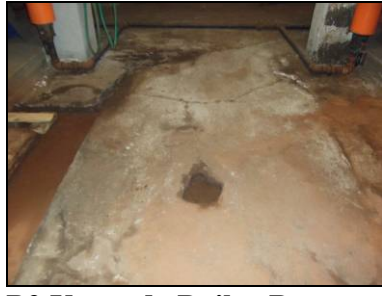
<p>P2 Upgrade Boiler Room Floor Drains (1924 Building) Provide new floor drain in proper locations and run new piping to existing sump pump.</p>

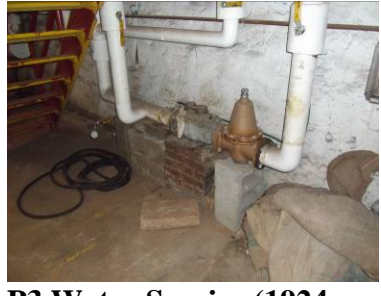
<p>P3 Water Service (1924 Building) Replace existing domestic water service and valves.</p>
  <p>P4 Domestic Water Heater (2004 Addition) Provide dedicated gas fired heater for domestic water heater system (to allow main boiler to shut down when not required for space heating).</p>

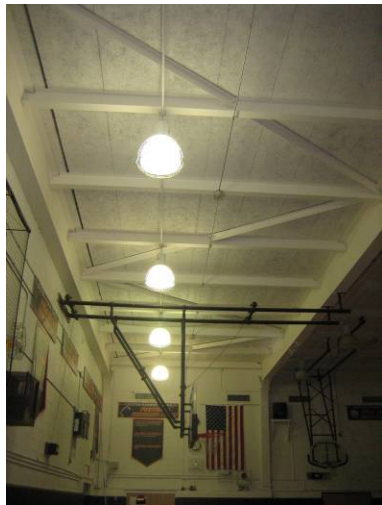
<p>E1 Main Gym Lighting: Replace existing gym lighting with new. Broken and cracked lamp sockets were found.</p>

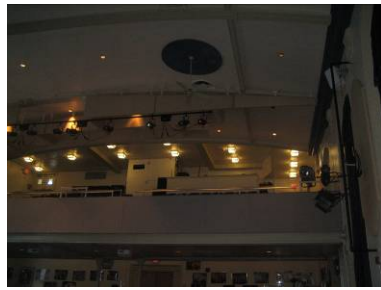
<p>E2 Auditorium General Lighting: Replace general auditorium lighting with new due to old age.</p>

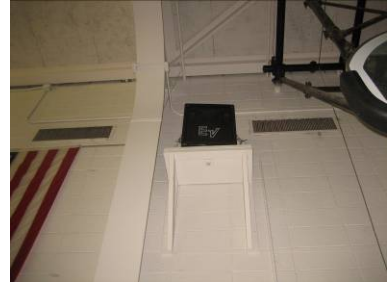
E5 Sound system in both gyms:
Replace stand-alone sound system in both main and aux. gym due to old age. Tie new system to PA.

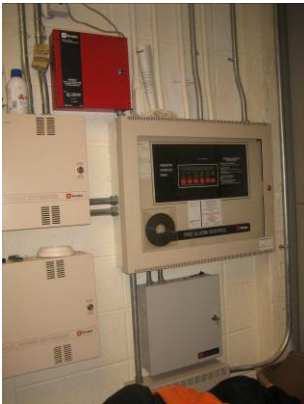
E6 Fire Alarm System:
Replace fire alarm system with new due to end of life. The capacity has reached its limit.
