Project Observation Report

Project Name:	Tri Tech East Building C 1.5	Project No.	2208
Report #:	42		
Observation Date:	7-19-23	Last Report:	7-12-23
Prepared By:	Steve Mallory, AIA	Contractor:	Banlin

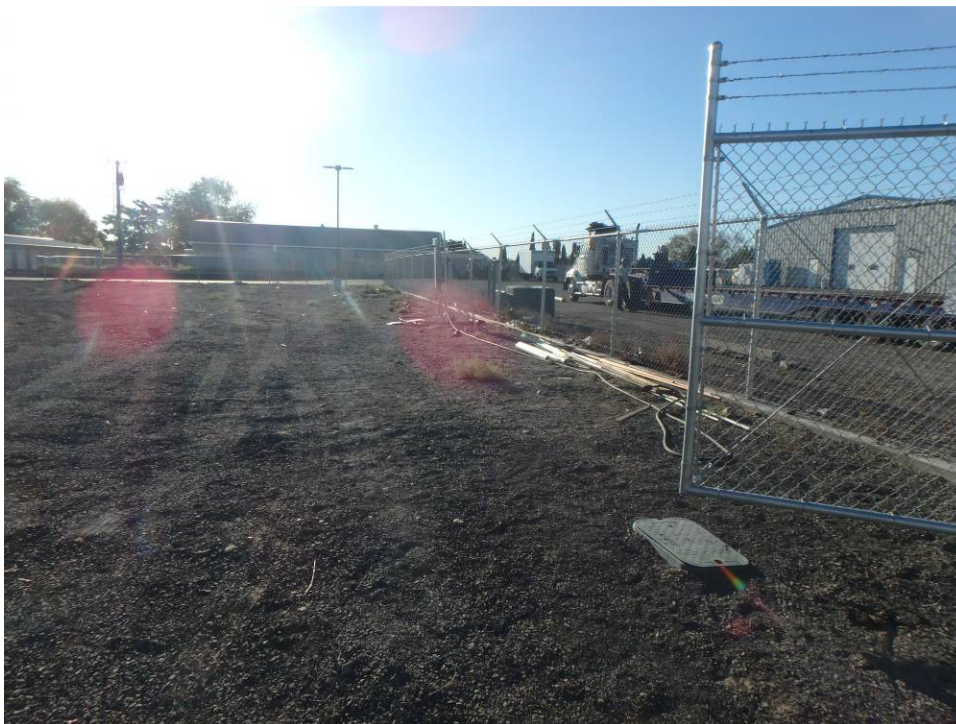
Looking east at the remaining plumbing items along the south property line

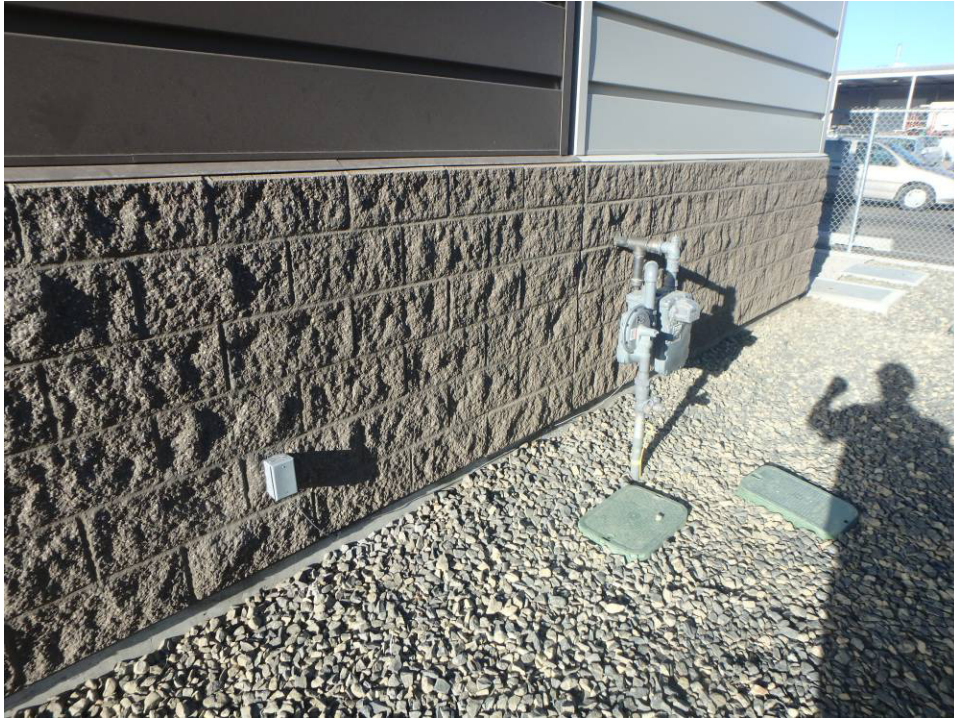
Sender wire mounted at gas meter

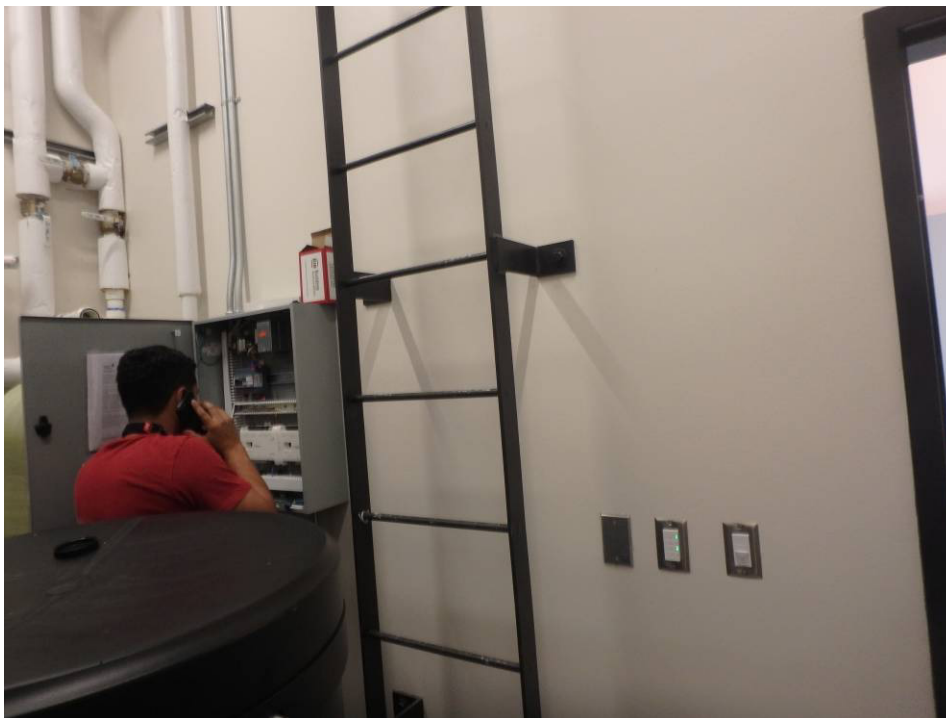
Wiring access control

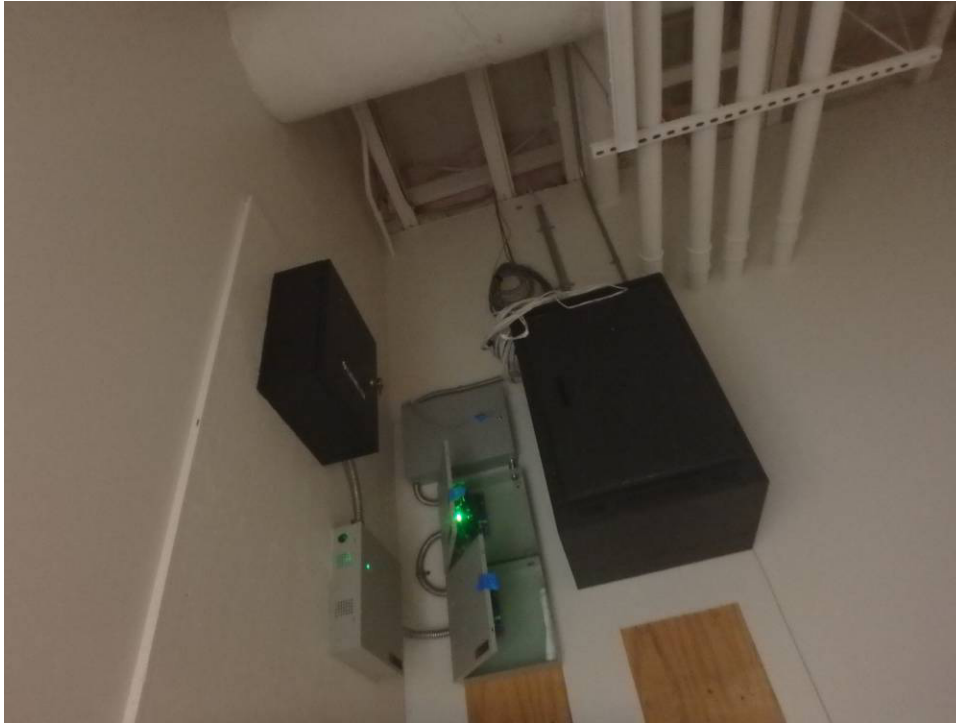
Storage room backboard and equipment, relocated lower panels to north wall - paint

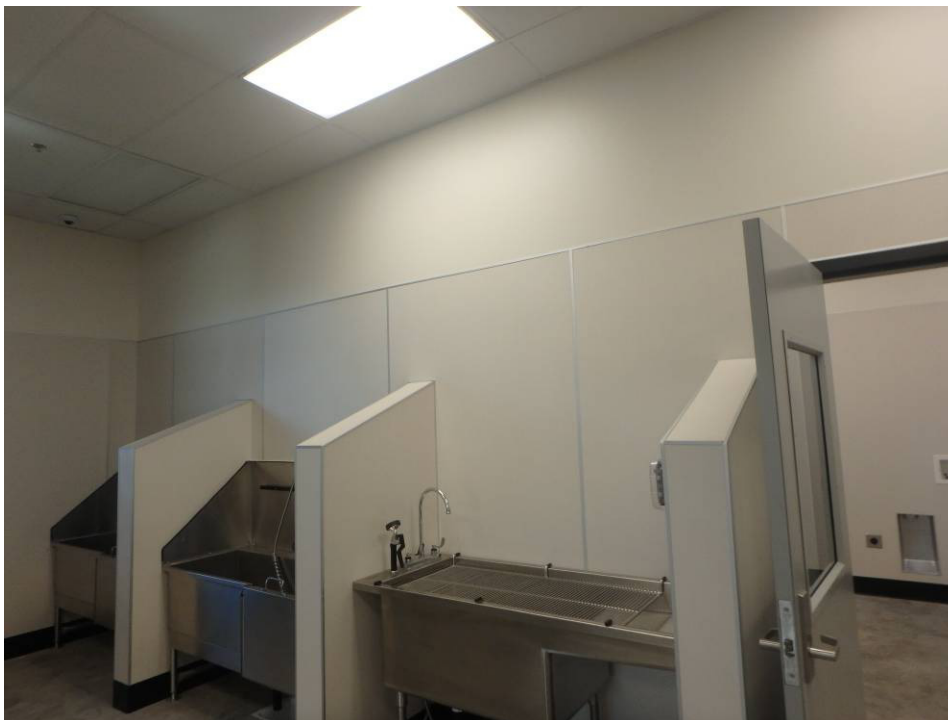
Lab- looking southwest at the dogwash stations

Field Discussions: Checked in with Matt. No issues, except call for grass sprinklers on the south side of the building. Subs here today are working on electrical and low voltage. Plumber here to reinstall/ pipe in the water softener. Tyler mounting electrical cord reels (14). Low voltage – lighting control work on-going. Big D’s here this week to do their punchlist including the east site grading and the northwest water valve uncovering. Air barrier test passed on Monday, Vacuum system parts being replaced this week. EVCO here early next week to install the S2 panel (S2 parts here on Monday) and access controls. Audio visual here next week. Matt to seal the sidesplashes on the dogwash stations.
