Project Observation Report

Project Name:	Tri Tech East Building C 1.5	Project No.	2208
Report #:	43		
Observation Date:	7-26-23	Last Report:	7-19-23
Prepared By:	Steve Mallory, AIA	Contractor:	Banlin

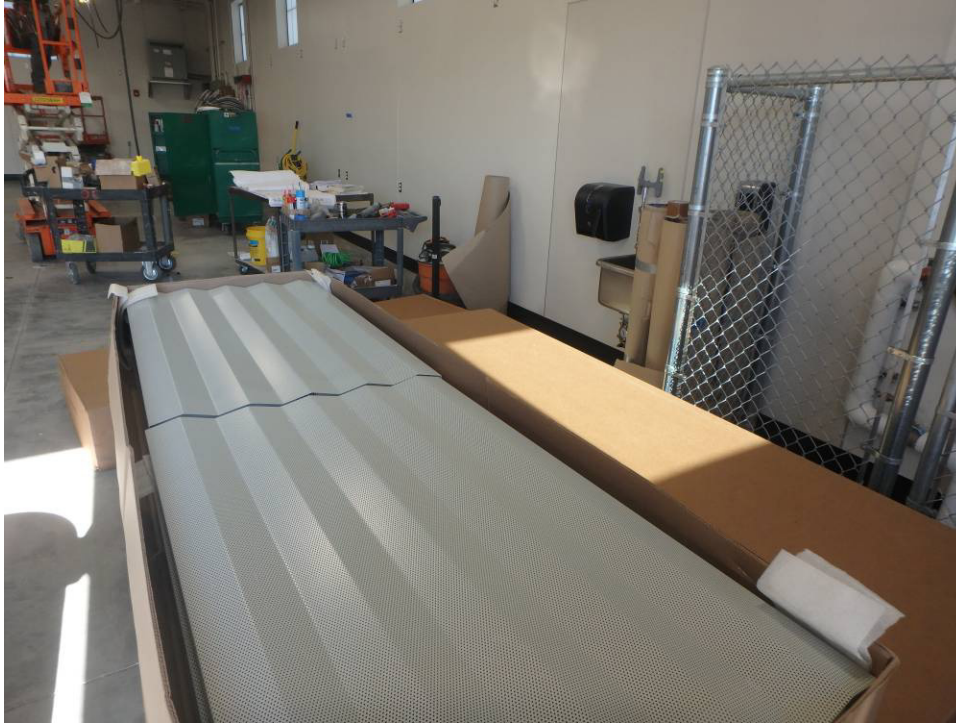
Acoustic panels

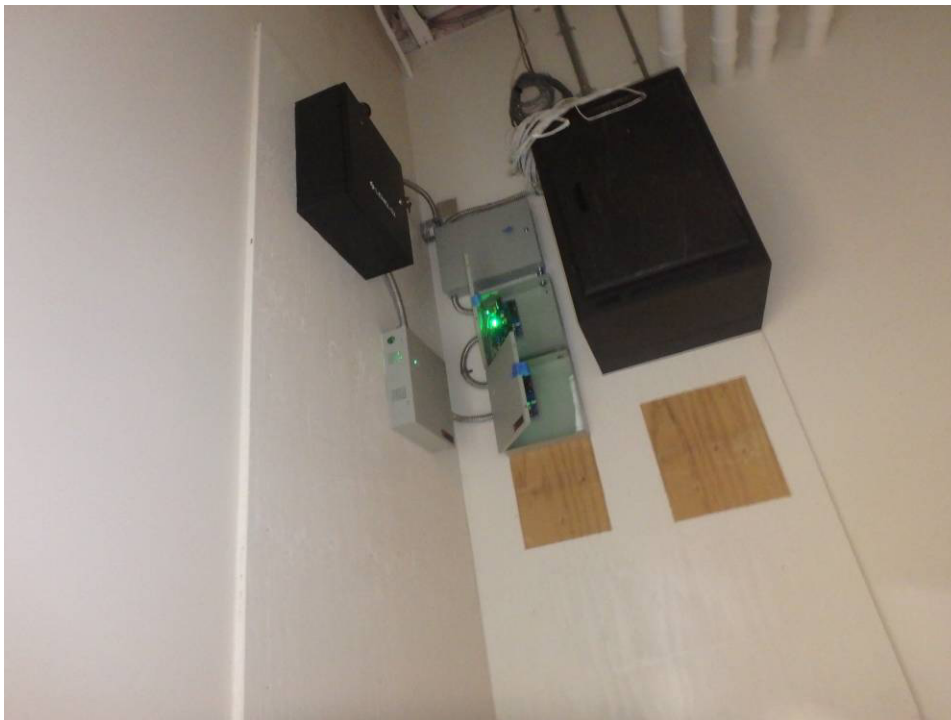
Storage room backboard and equipment, relocated lower panels to north wall - paint

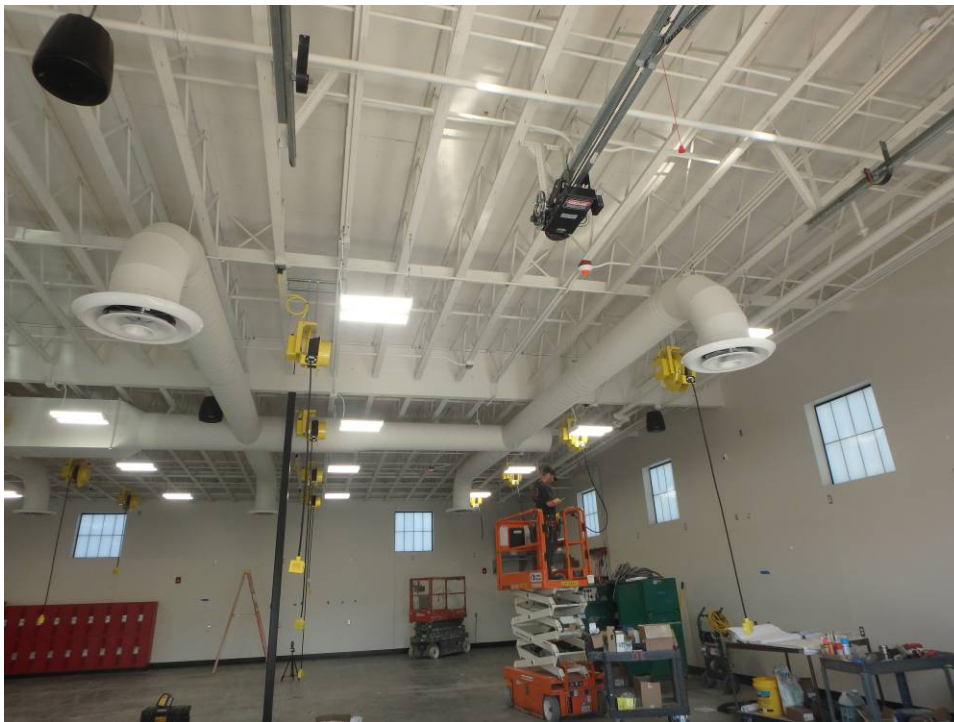
Wiring cord reels in the shop- north half

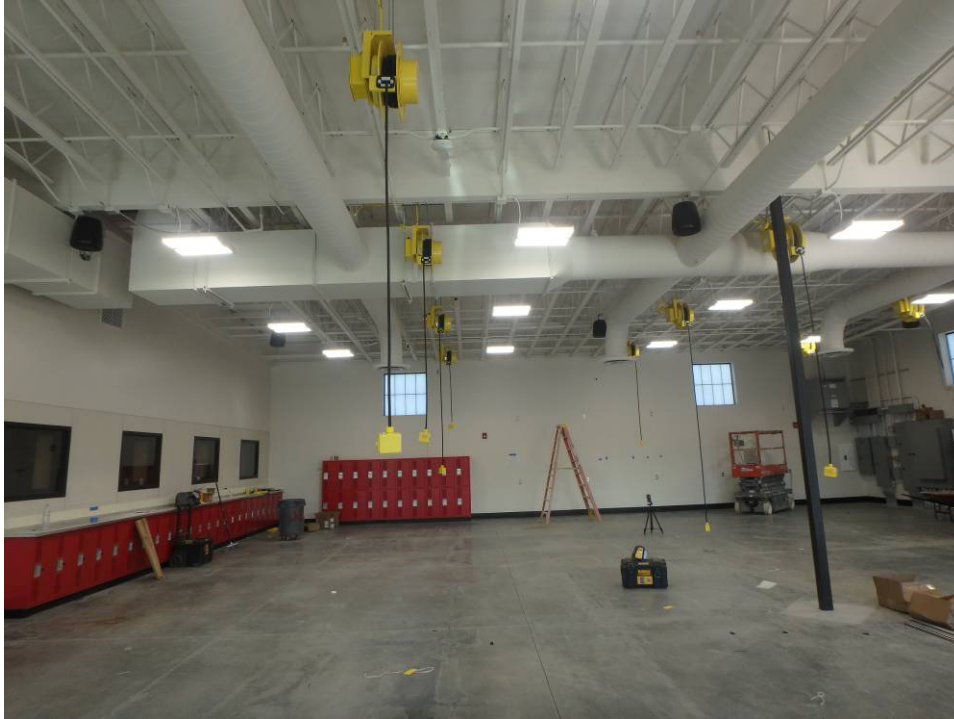
Wiring cord reels in the shop- south half

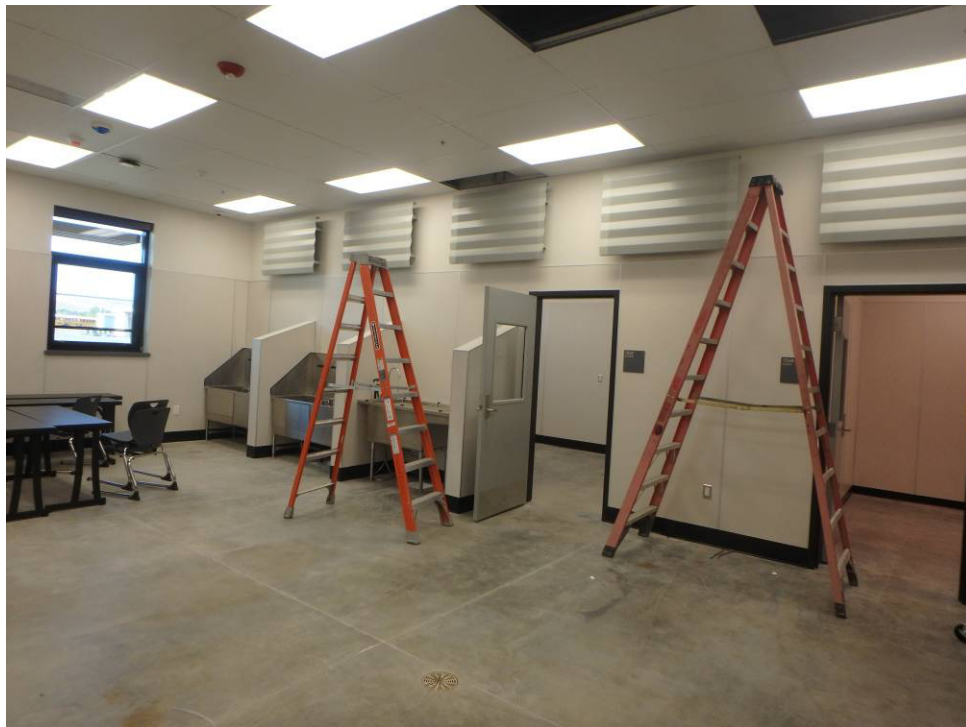
Lab – looking southwest at the new acoustical wall panels
