Project Observation Report

Project Name:	Tri Tech East Building C 1.5	Project No.	2208
Report #:	44		
Observation Date:	8-2-23	Last Report:	7-26-23
Prepared By:	Steve Mallory, AIA	Contractor:	Banlin

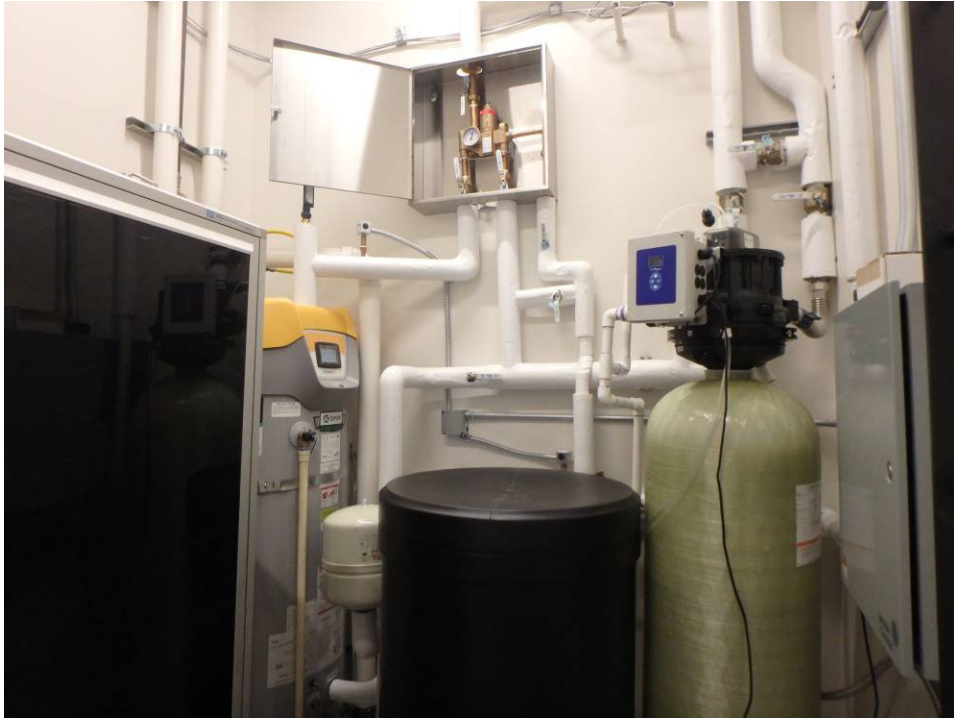
Water softener

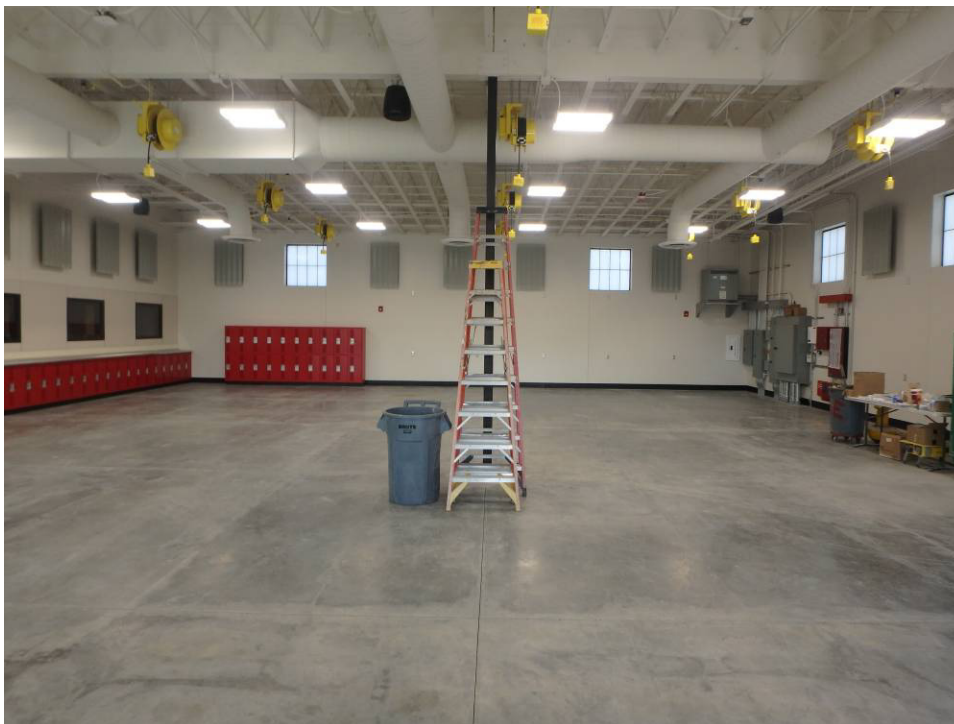
Wiring cord reels in the shop- north half

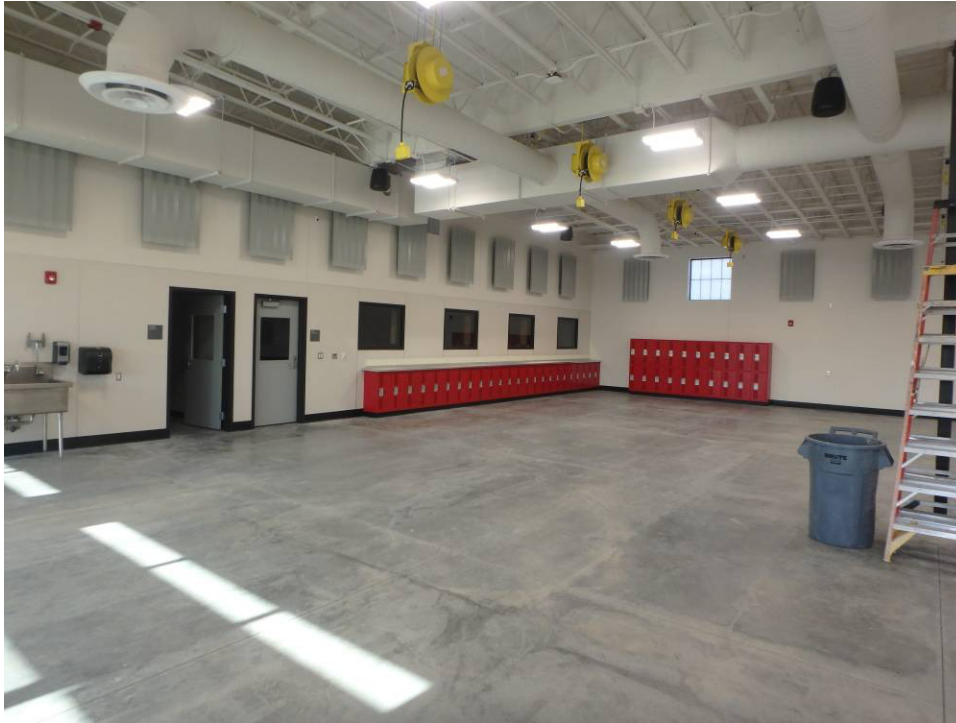
Wiring cord reels in the shop- south half

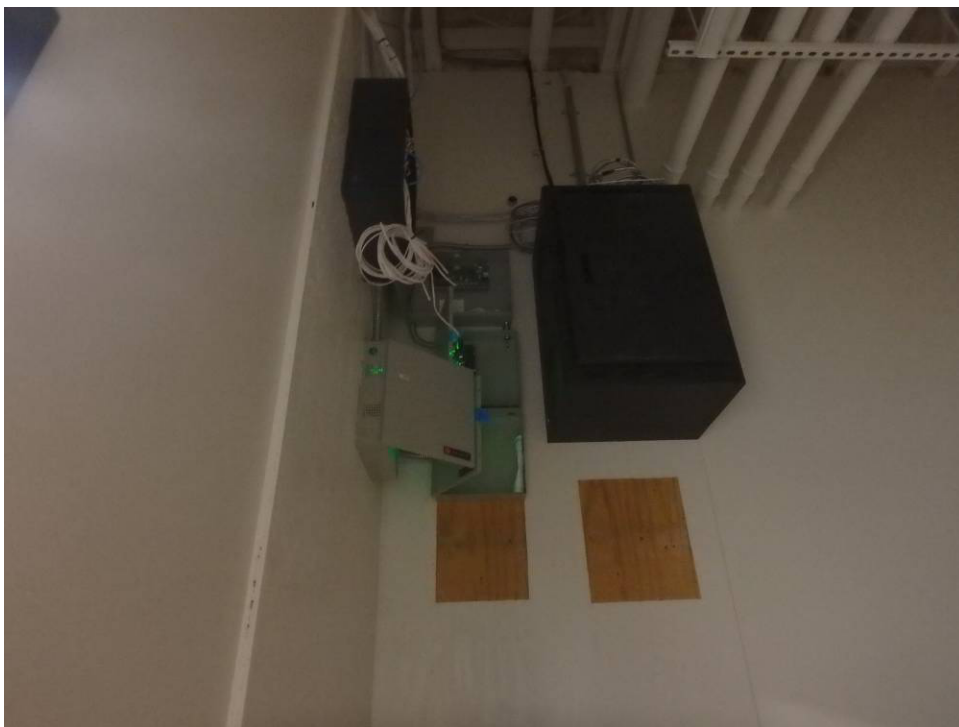
Storage room backboard and equipment, relocated lower panels to north wall - paint
