Project Observation Report

Project Name:	Tri Tech East Building C 1.5	Project No.	2208
Report #:	45		
Observation Date:	8-9-23	Last Report:	8-2-23
Prepared By:	Steve Mallory, AIA	Contractor:	Banlin

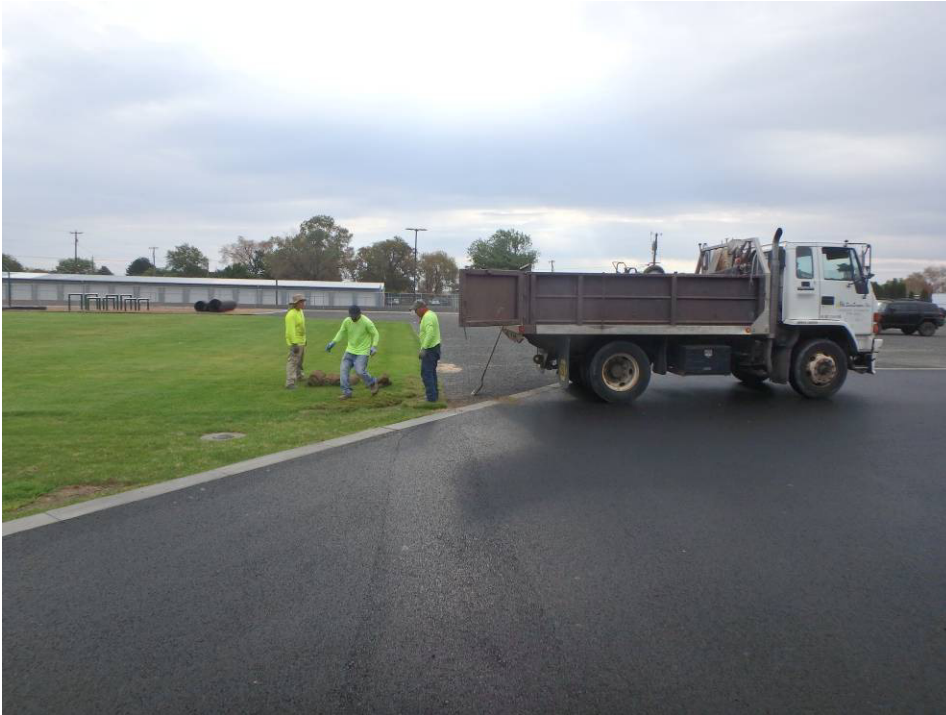
North site, sod patching

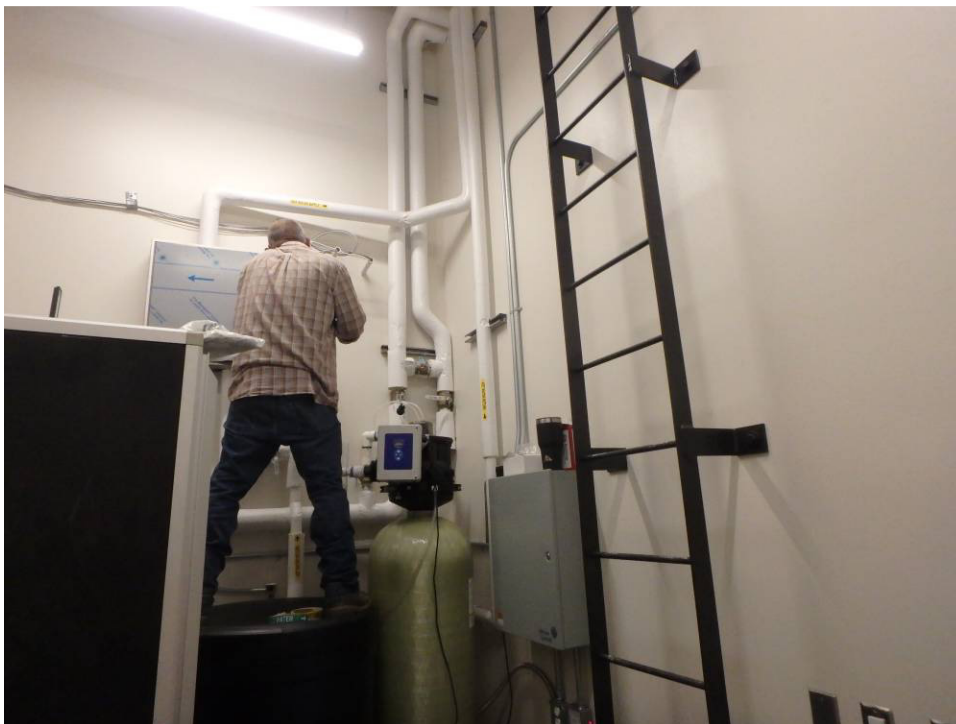
Working on the piping above the water softener

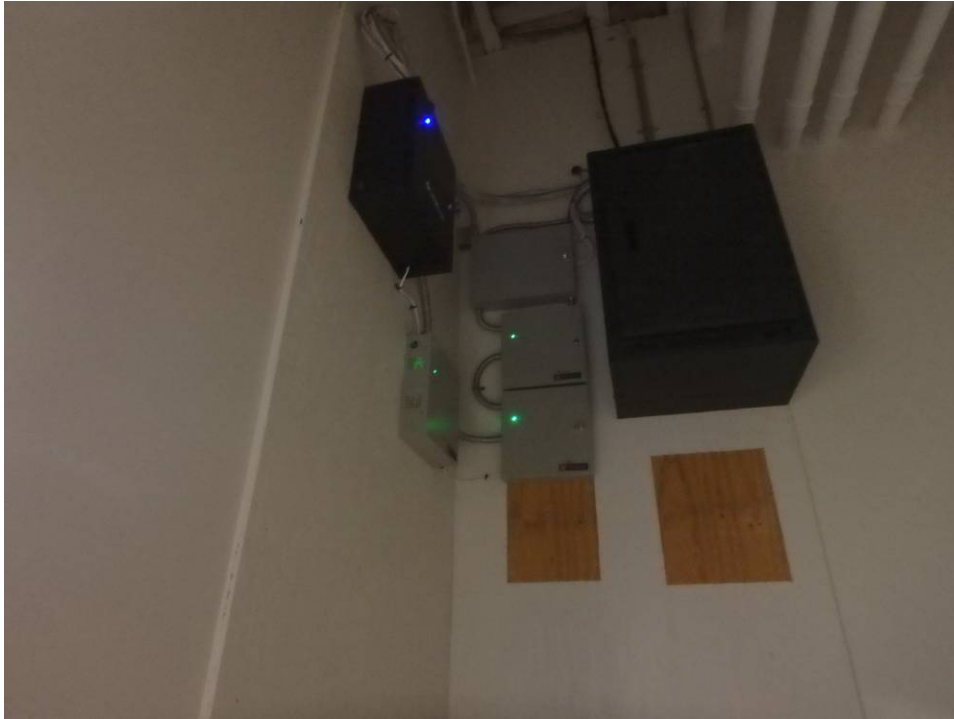
Storage room backboard and equipment, relocated lower panels to north wall - paint

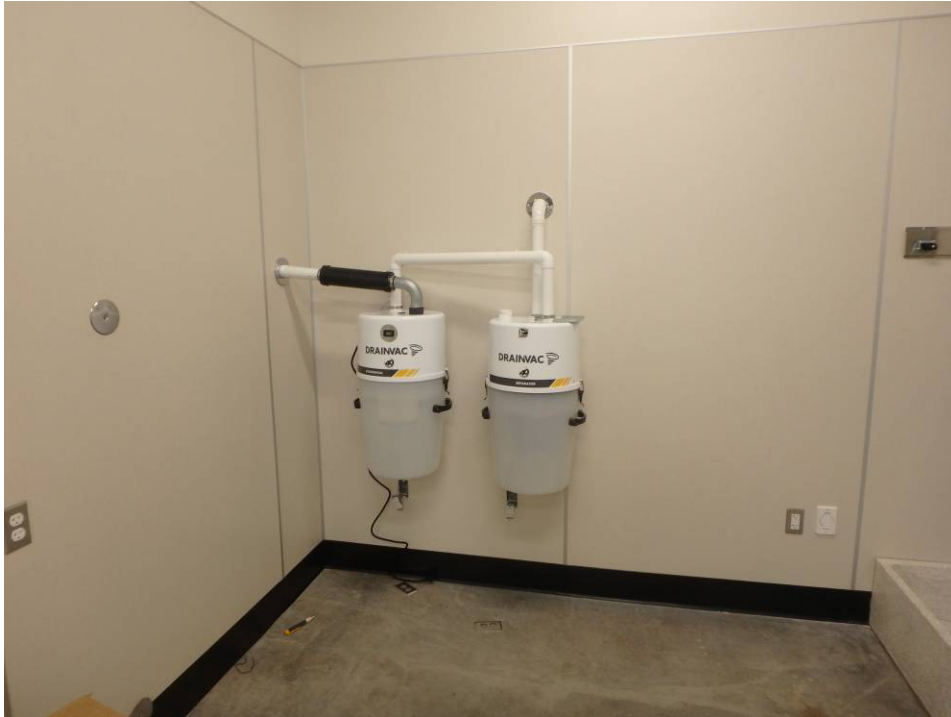
Kennel Room acoustical wall panels, vacuum (replaced) and janitor sink on the north wall

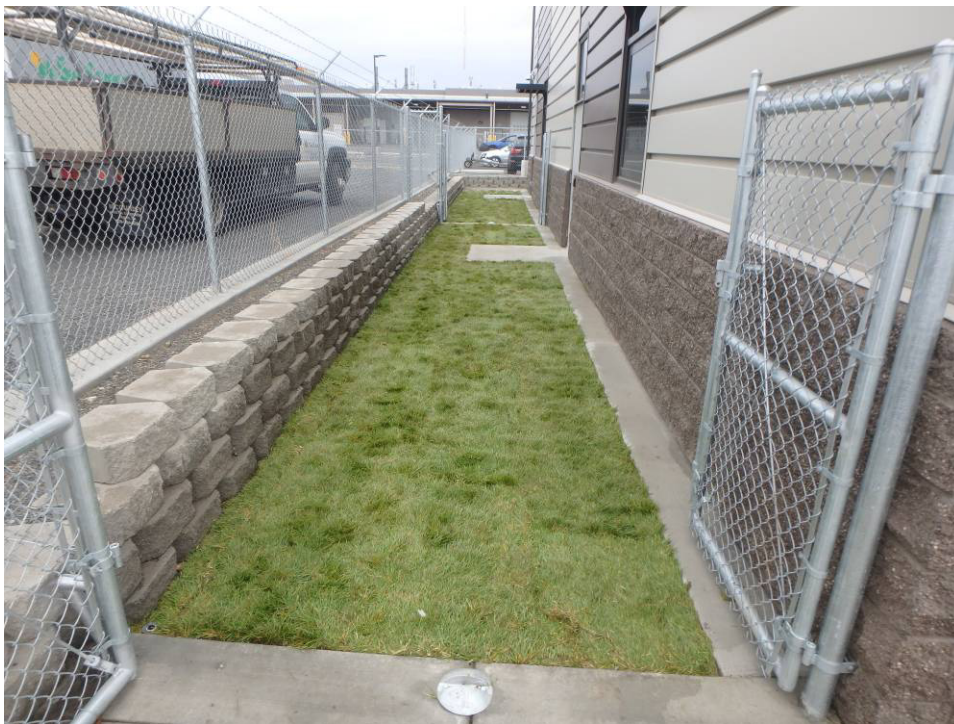
Looking west along the south elevation of the building and new sod
