## Management Report

Emmett Independent School District #221  
Emmett Bus Barn  
1380 North Washington Avenue, Emmett, ID

Prepared For  
Emmett Independent School District #221

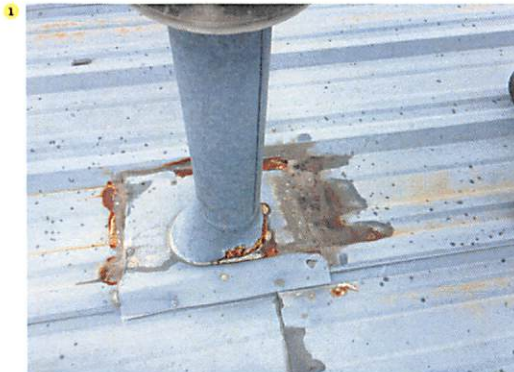
### METAL - Pipe removal-Abandoned - Metal (Emergency)

Abandoned Pipe flashing to be removed and roof patched. Metal deck patching to be done by other.

Technicians will remove Pipe and pip flashing's and install a metal patch.

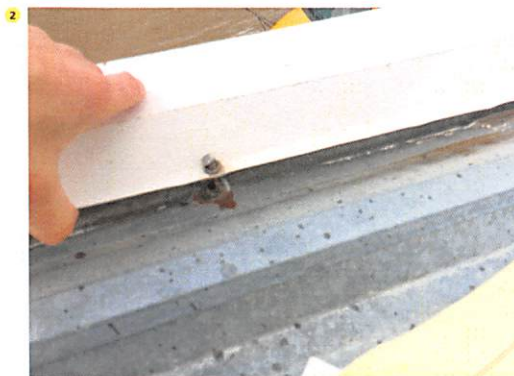
### METAL - Metal Trims- Reseal (Emergency)

Rake metal is missing fasteners and sealant allowing water into the roofing system.

Remove the fasteners on rake metal, clean, install butte tape between rake metal to metal panel, install fasteners as needed on rake metal.

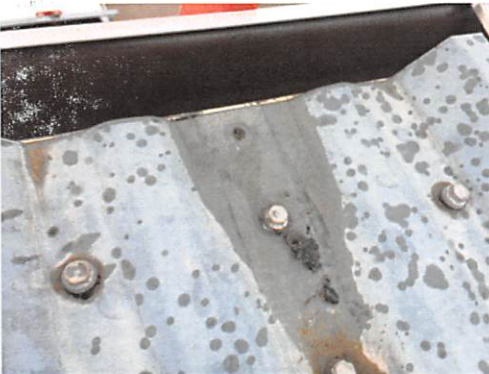
**METAL - Fasteners - Failing/Missing (Emergency)**

As the building moves and flexes the fasteners will loosen up and eventually back out completely resulting in water infiltration.

A new fastener, 1 size larger, would be installed to ensure a water tight seal.

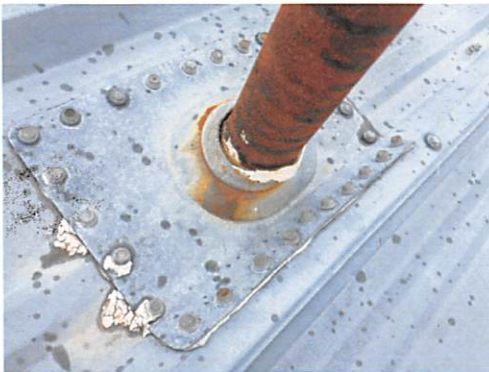
**METAL - Pipe Penetration Restoration (Emergency)**

Pipe penetration needs restored to bring it up to manufacturers requirements. This is usually caused by age or environmental issues.

Seal penetrations or damaged areas at pipe.

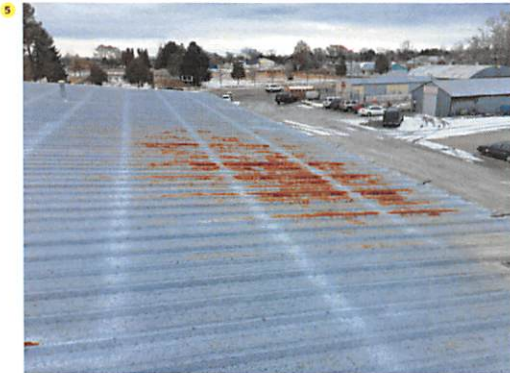
**METAL - Coating of rust areas (Emergency)**

Panels have rust on the surface and will need to have a rust inhibitor applied to stop the panel from rusting.

Clean loose debris from rust areas apply top coat with rust inhibitor to extend the life of the affected panels.

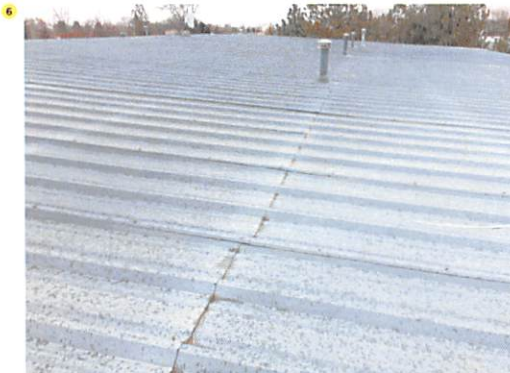
**METAL - Metal Seams - open (Remedial)**

Open seams in the waterproofing material are typically caused by failing seam adhesives, coupled with material shrinkage and stress on the seams, and expansion and contraction.

The area surrounding the open seam must be cleaned and sealed between panel laps. Initial attempt for repair is to clean between laps and install new sealants and refasten. Pricing is dependent on materials and quantity

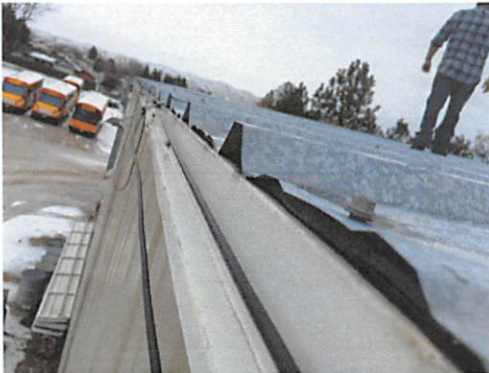
### METAL - Edge Detail Re-flashing (Emergency)

Edge detail is missing fasteners and in some areas the panel does not extend over the drip edge.

Option 1- \*\* Pricing includes a lift to access the roofs edge. \*\*

Clean, prep, and remove fasteners at the edge detail flashing install a bead of caulk between the drip and the panel, add fasteners at edge to compress the sealant keeping water from wicking back into the building. \$14,770.00

Option 2-

Clean, prep, and remove fasteners at the edge detail flashing install a new pc of drip with a hem to stop water from being able to back up into the building at the edge, add fasteners as needed \$18,955.00
