Project Observation Report

Project Name:	Tri Tech East Building C 1.5	Project No.	2208
Report #:	46		
Observation Date:	8-16-23	Last Report:	8-9-23
Prepared By:	Steve Mallory, AIA	Contractor:	Banlin

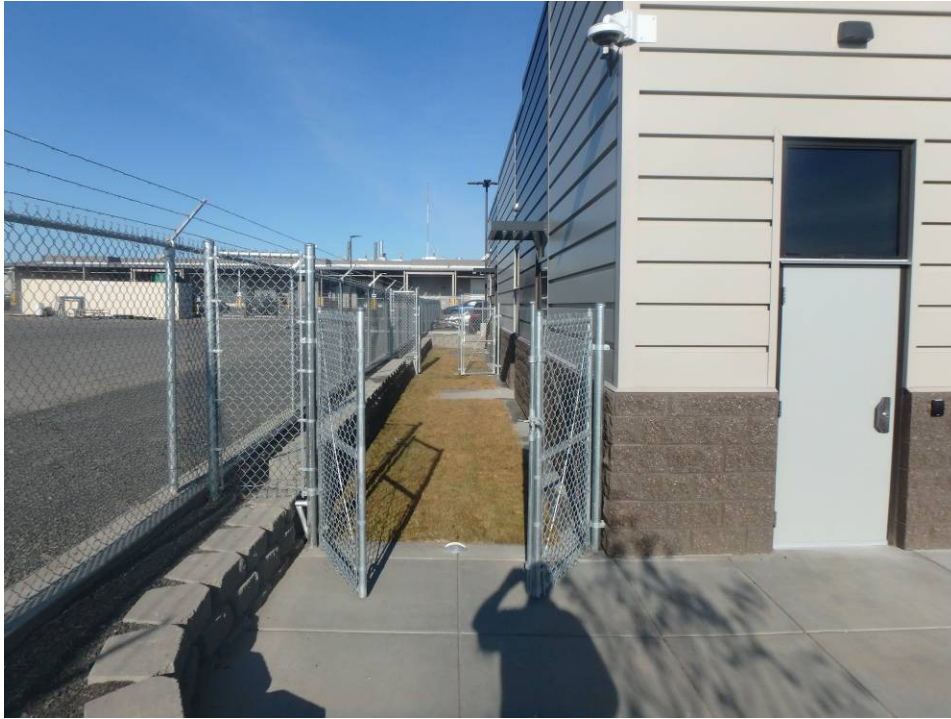
South grass area

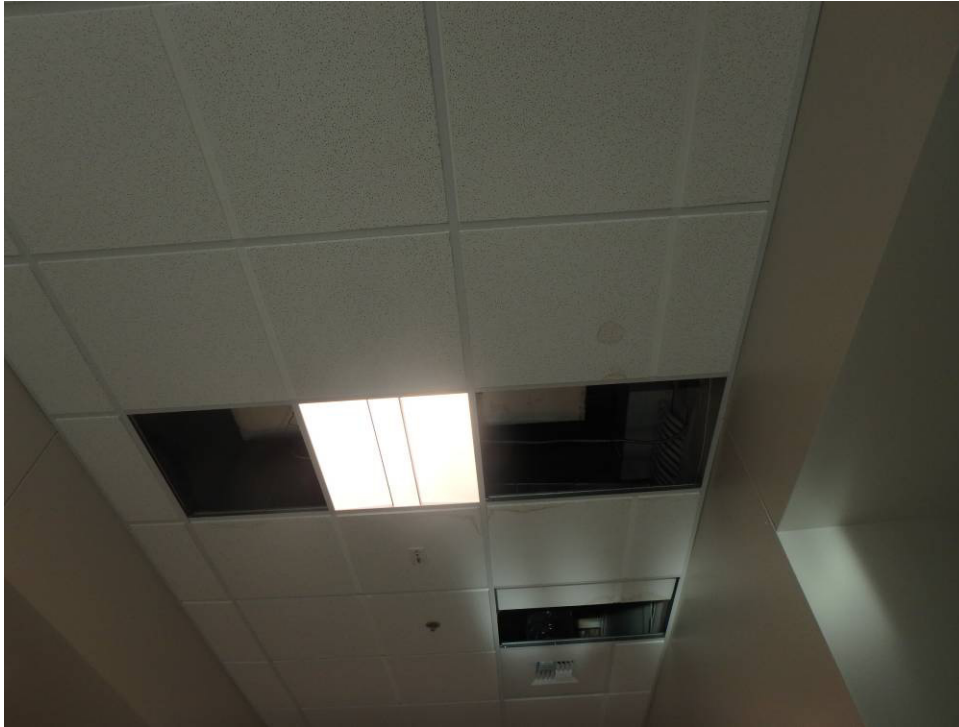
Ceiling panels to be replaced
