**Project Observation Report**

Project Name:	Tri Tech East Building C 1.5	Project No.	2208
Report #:	48		
Observation Date:	8-30-23	Last Report:	8-23-23
Prepared By:	Steve Mallory, AIA	Contractor:	Banlin

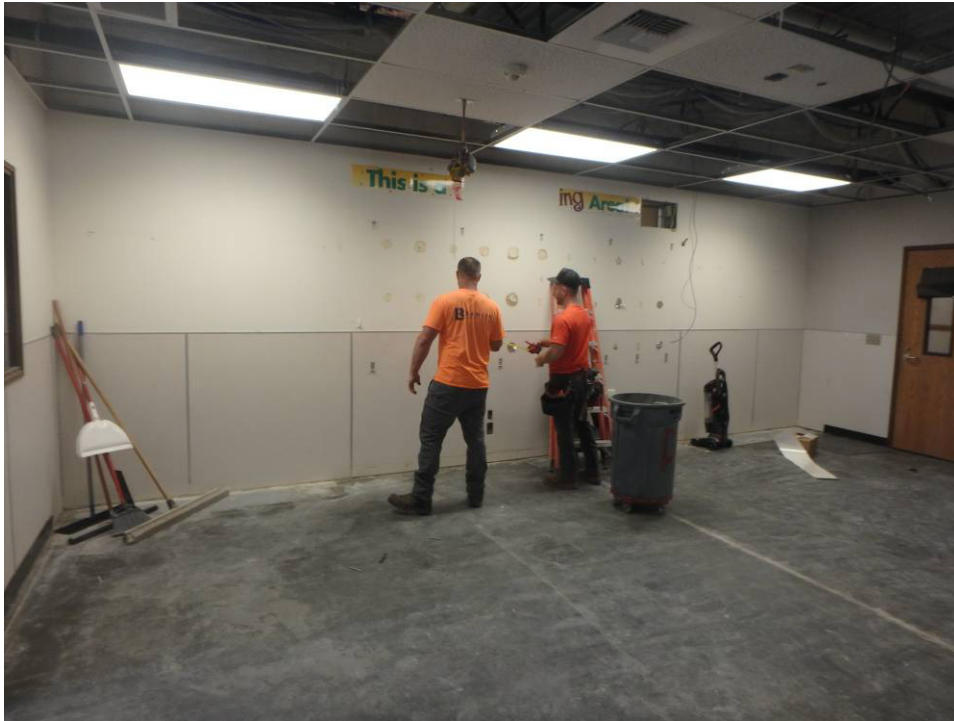
Alt. 1 main room north wall –location the projector

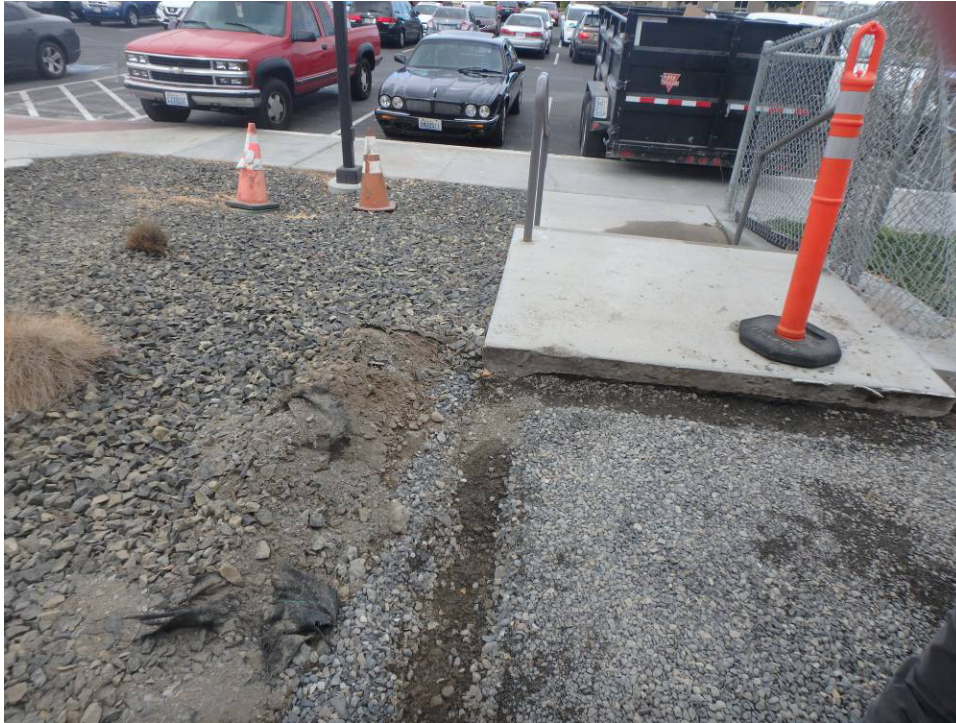
Demoed at the top of the stairs

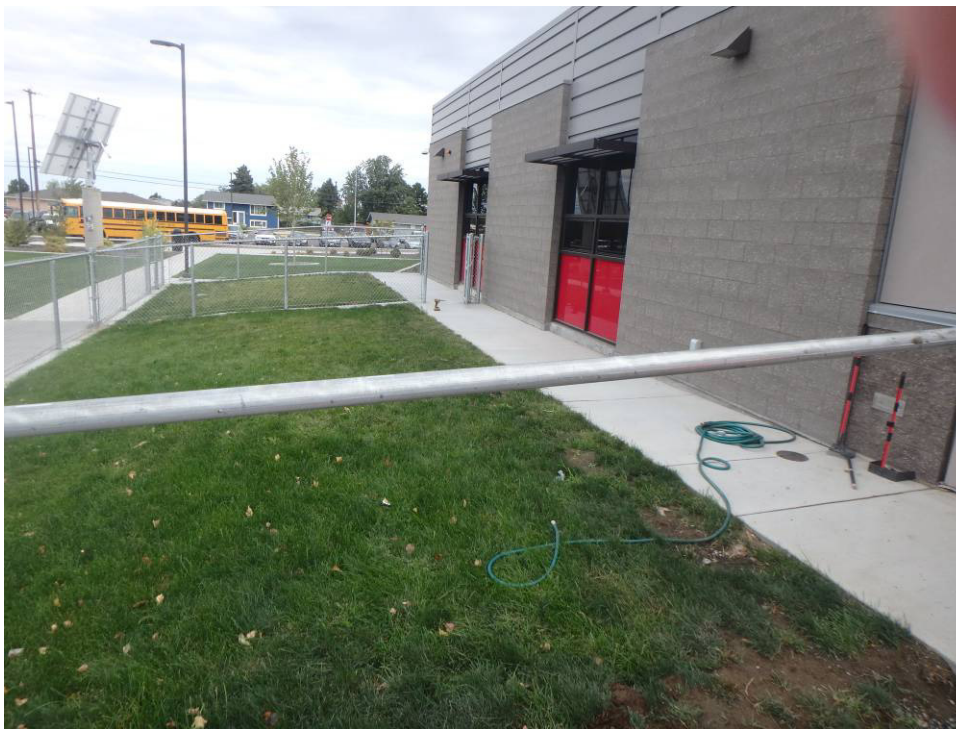
West grass area – looking north. Fencing and central mow strip to be removed.

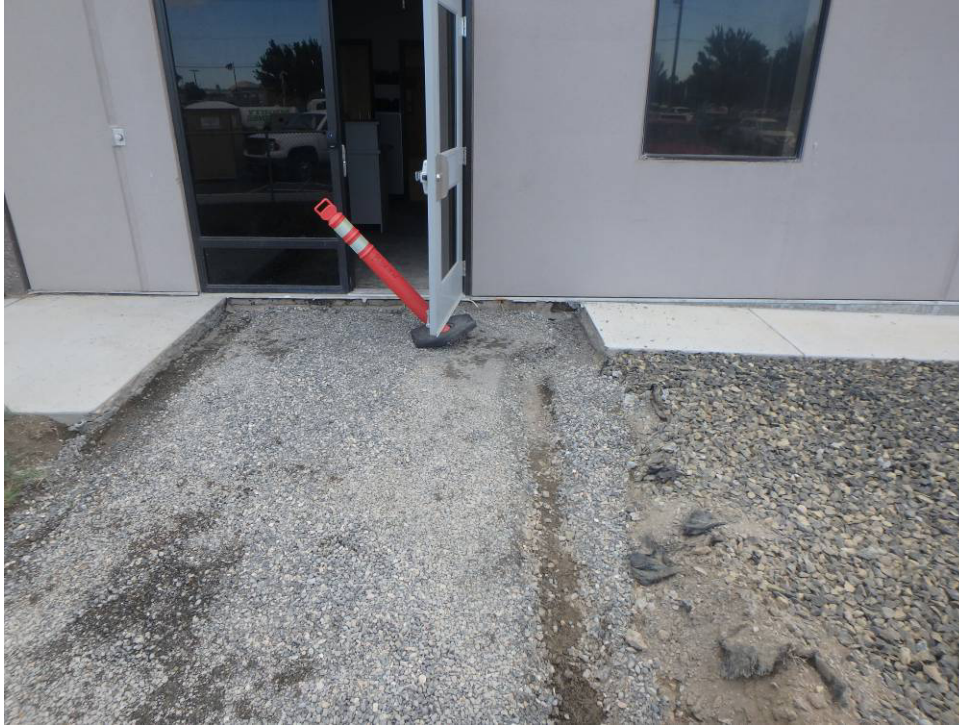
The Pre-Vet Alternate #1 area demolition is complete along with the plumbing work in the walls. Concrete has been removed at the porch and around the floor sink traps. Electrical work is on-going and is expected to be complete for a Monday wall inspection. The existing construction that remains is well suited for the new plumbing and electrical tie-ins.

Removed porch
