Project Observation Report

Project Name:	Tri Tech East Building C 1.5	Project No.	2208
Report #:	49		
Observation Date:	9-6-23	Last Report:	8-30-23
Prepared By:	Steve Mallory, AIA	Contractor:	Banlin

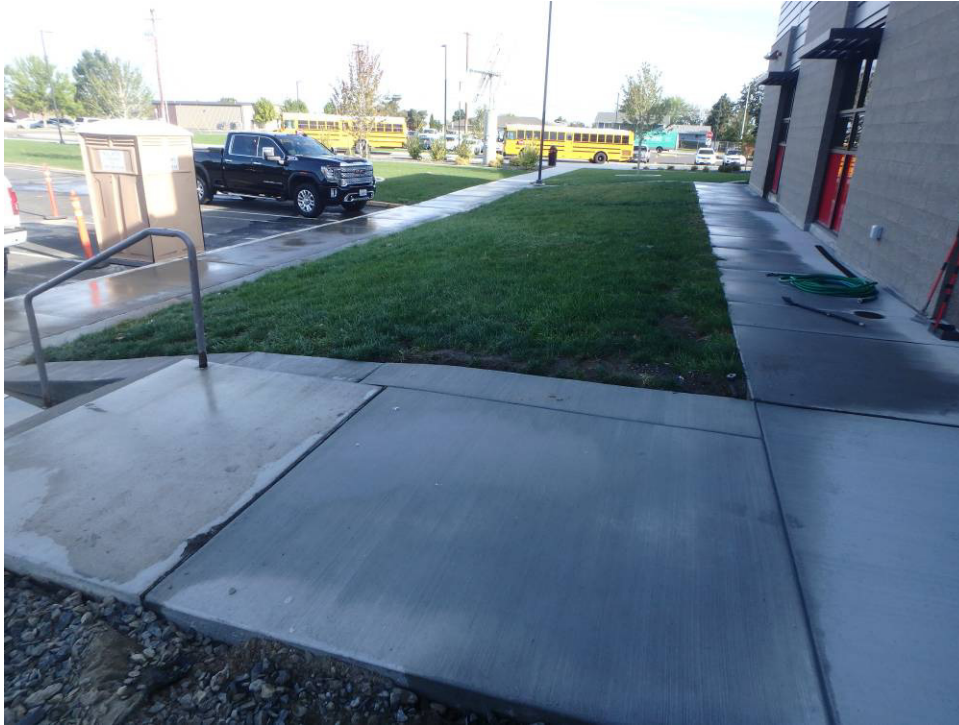
West grass area – looking north. Fencing removed and central mow strip removed and sidewalk is cast

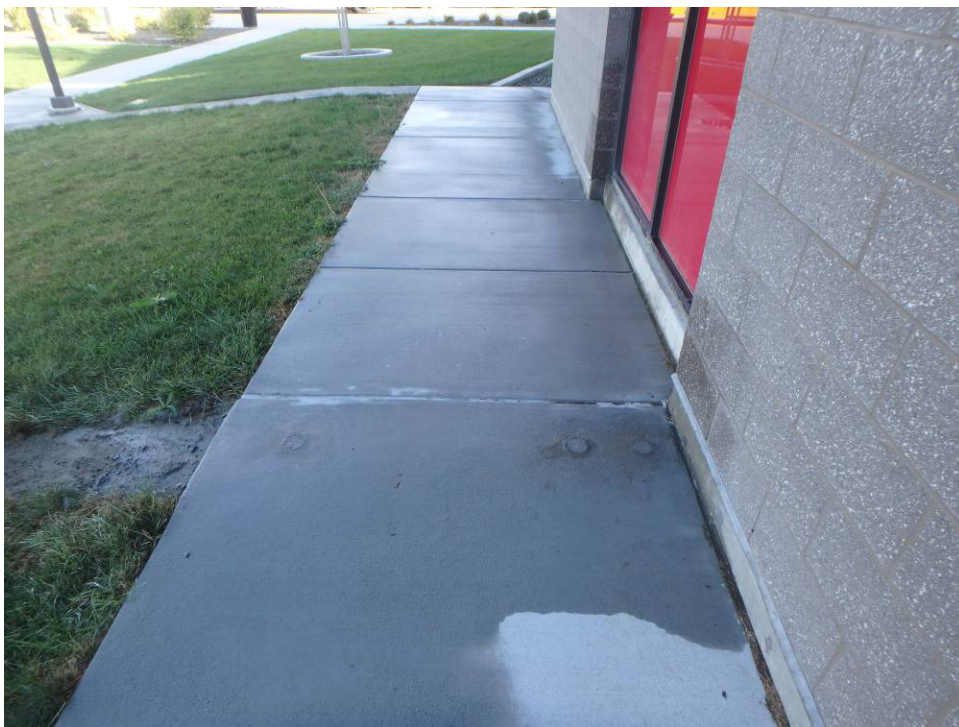
Infilled old fence pole bases

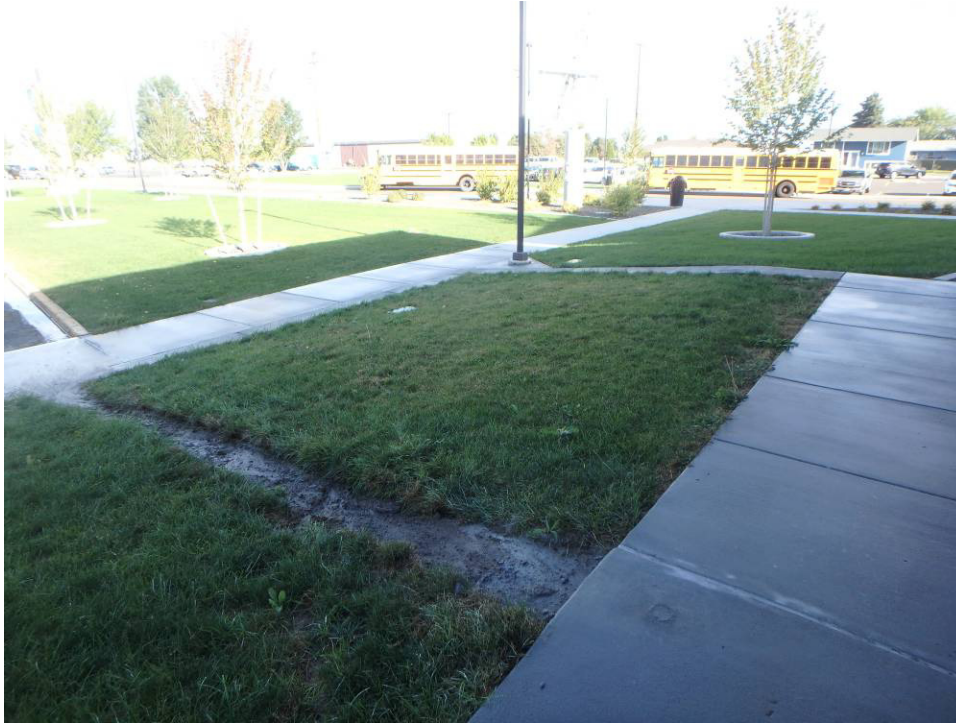
Mow strip removed

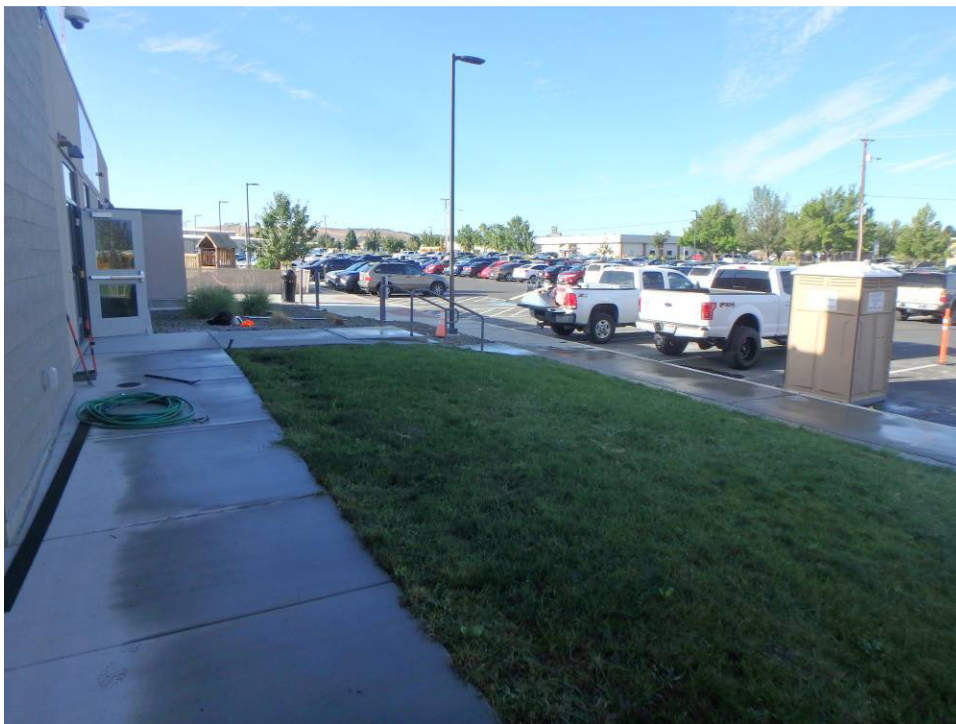
West grass area – looking south. Fencing removed and central mow strip removed and sidewalk is cast

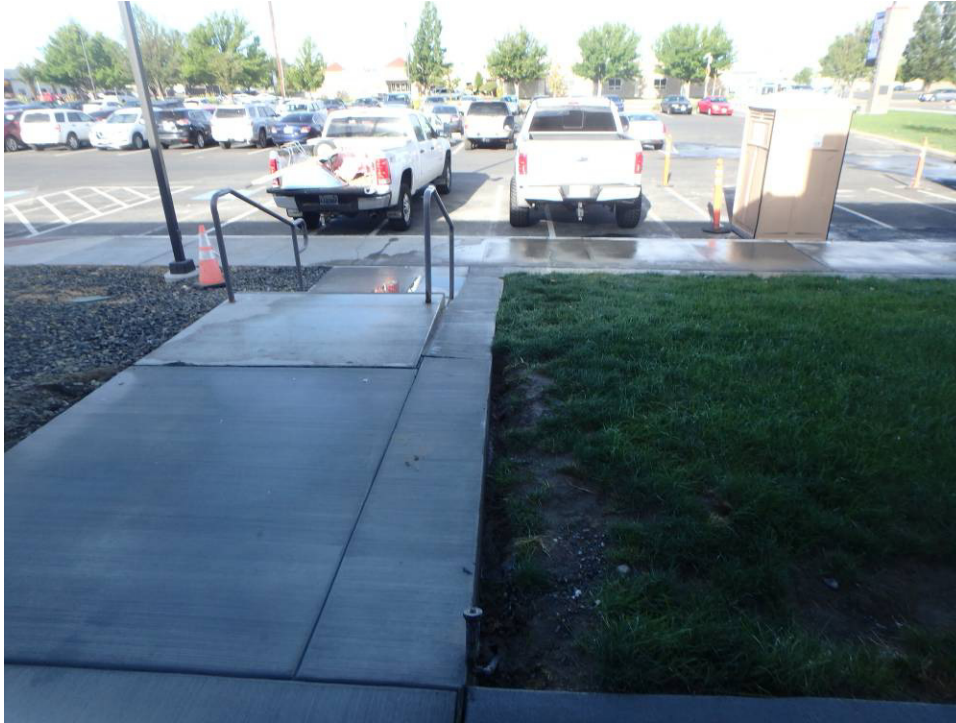
Cast sidewalk and mow strip

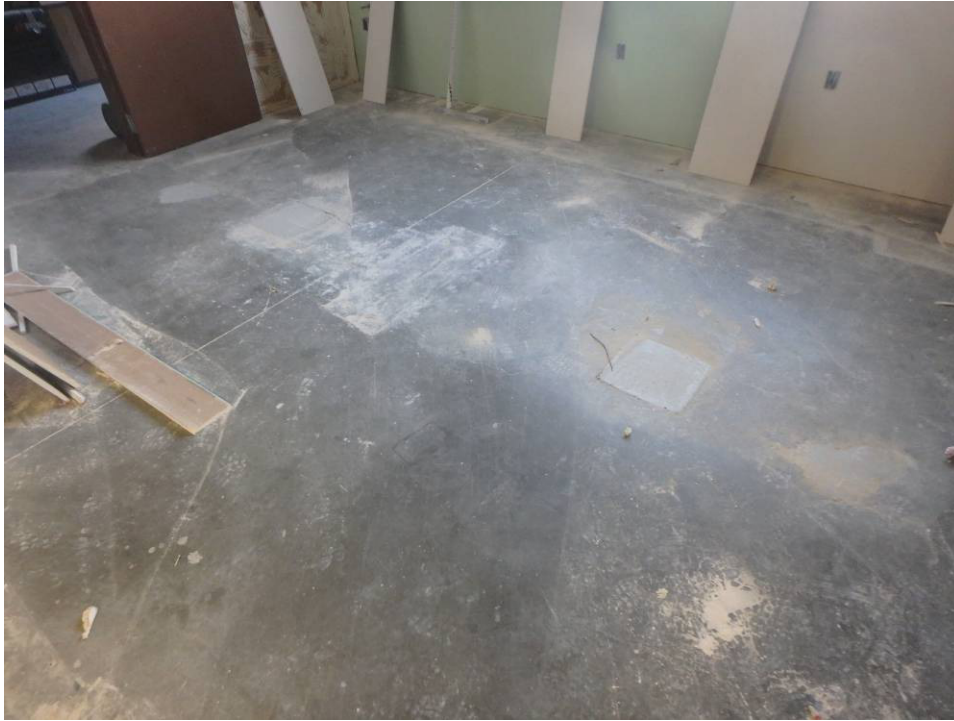
Alt. 1 Old exam room floor sinks infilled.

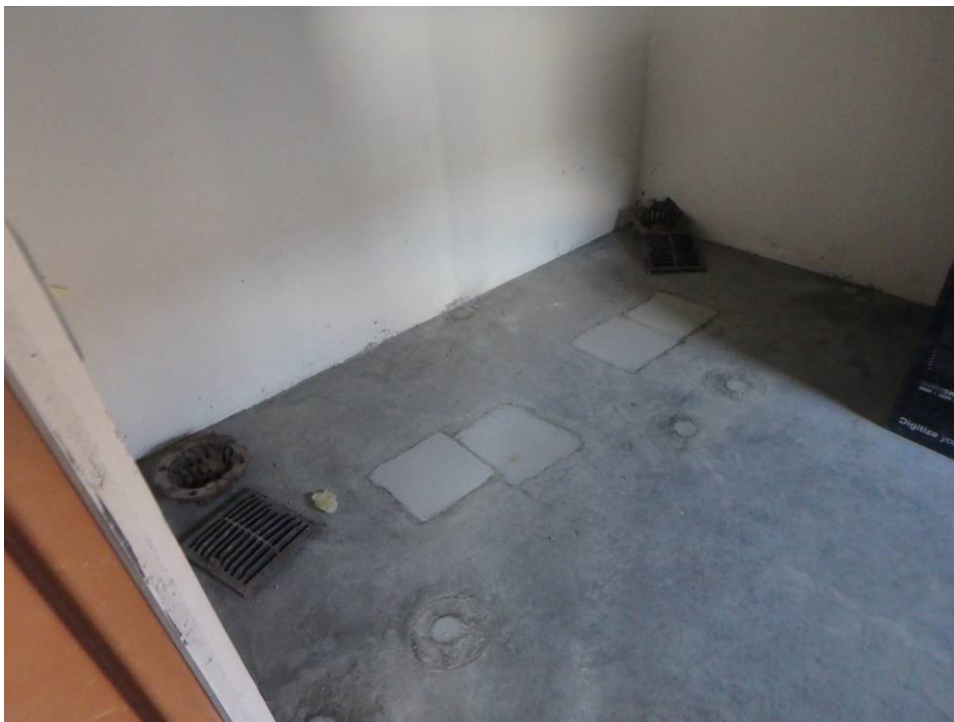
Alt. 1 Old kennel room infilled floor sinks
