Fort Stockton ISD - Condition Assessment

Alamo Elementary

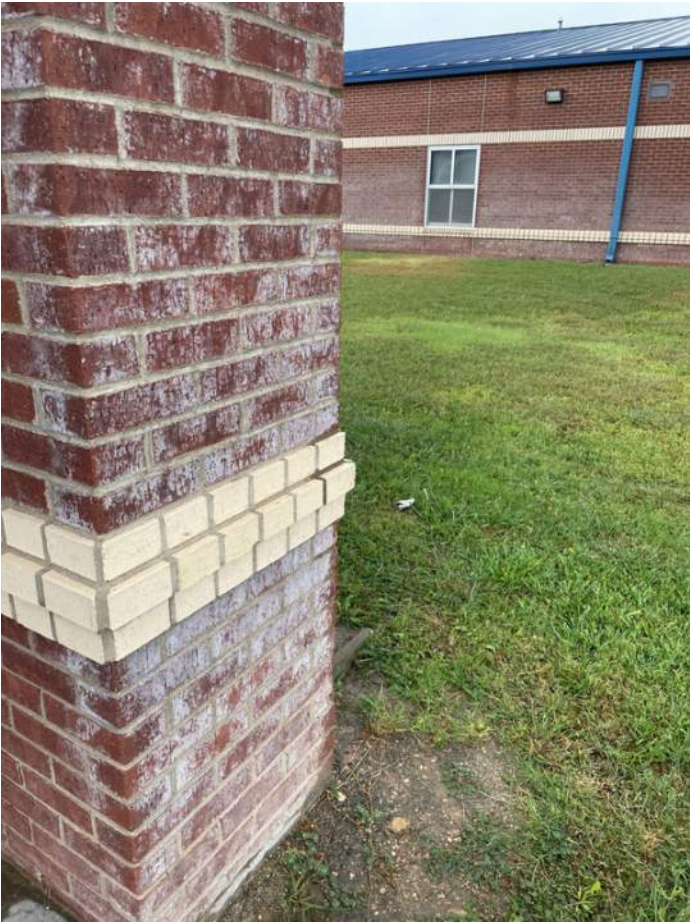
Photos-Exterior Walls

Exterior Walls - 1. Brick

Type Description-Exterior Walls	Brick
Condition Rating-Exterior Walls	Fair - exhibiting deficiencies requiring minor service/repair to extend useful life
Deficiency Category-Exterior Walls	Damaged/Failing
Quantity-Exterior Walls	100
Unit-Exterior Walls	%
Year Installed-Exterior Walls	n/a
Comments-Exterior Walls	Efflorescence is a major issue that needs to be resolved to extend life of brick.

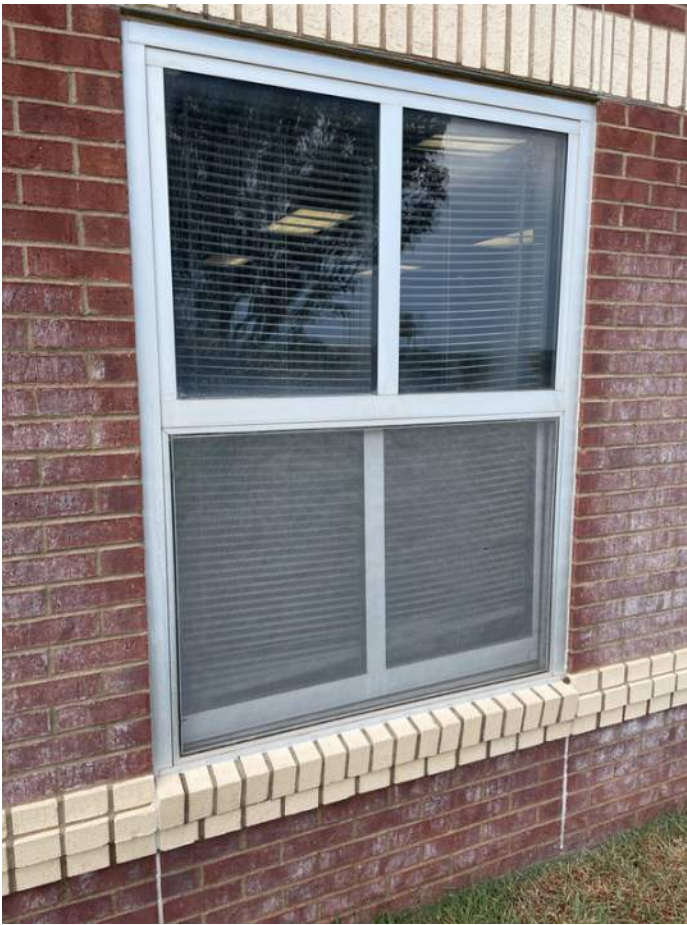
Photos-Windows

Windows - 1. Aluminum

Type Description-Windows	Aluminum
Condition Rating-Windows	Fair - exhibiting deficiencies requiring minor service/repair to extend useful life
Deficiency Category-Windows	No Immediate Action
Quantity-Windows	100
Unit-Windows	%
Year Installed-Windows	2001
Comments-Windows	Corrosion source, likely irrigation, needs to be removed to extend lifespan.

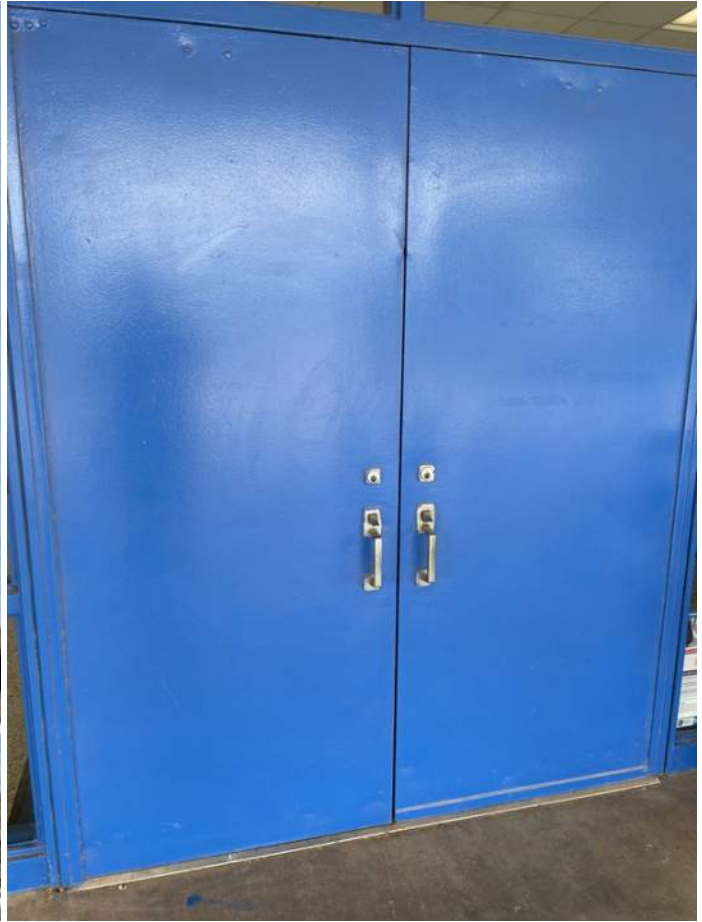
Photos-Exterior Doors

Exterior Doors - 1. Hollow Metal

Type Description-Exterior Doors	Hollow Metal
Condition Rating-Exterior Doors	Critical - failed or failing, and beyond useful life requiring immediate attention
Deficiency Category-Exterior Doors	Damaged/Failing

Quantity-Exterior Doors	100
Unit-Exterior Doors	%
Year Installed-Exterior Doors	1975
Comments-Exterior Doors	All doors past lifespan. Some are highly damaged from rust.

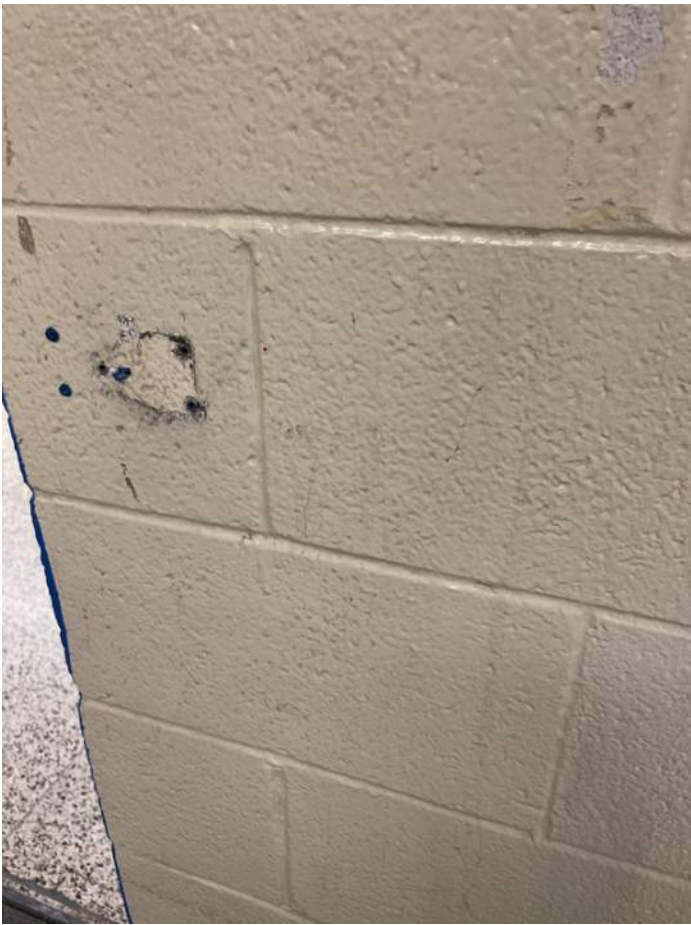
Photos-Wall Finishes

Type Description-Wall Finishes	Paint
Condition Rating-Wall Finishes	Poor - nearing end of useful life, and requiring major service/repair to remain operational
Deficiency Category-Wall Finishes	Beyond Useful Life
Quantity-Wall Finishes	70
Unit-Wall Finishes	%
Year Installed-Wall Finishes	n/a
Comments-Wall Finishes	n/a

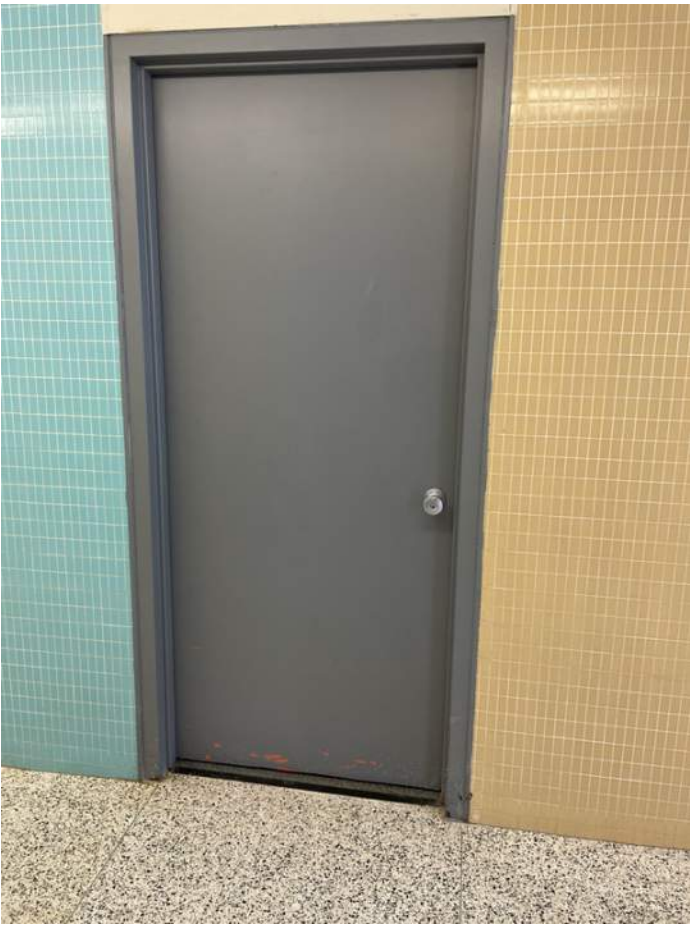
Photos-Interior Doors

Type Description-Interior Doors	Hollow Metal
Condition Rating-Interior Doors	Good - minimal depreciation, consistent with asset age
Deficiency Category-Interior Doors	No Immediate Action
Quantity-Interior Doors	5
Unit-Interior Doors	%
Year Installed-Interior Doors	1975
Comments-Interior Doors	Repainting needed.

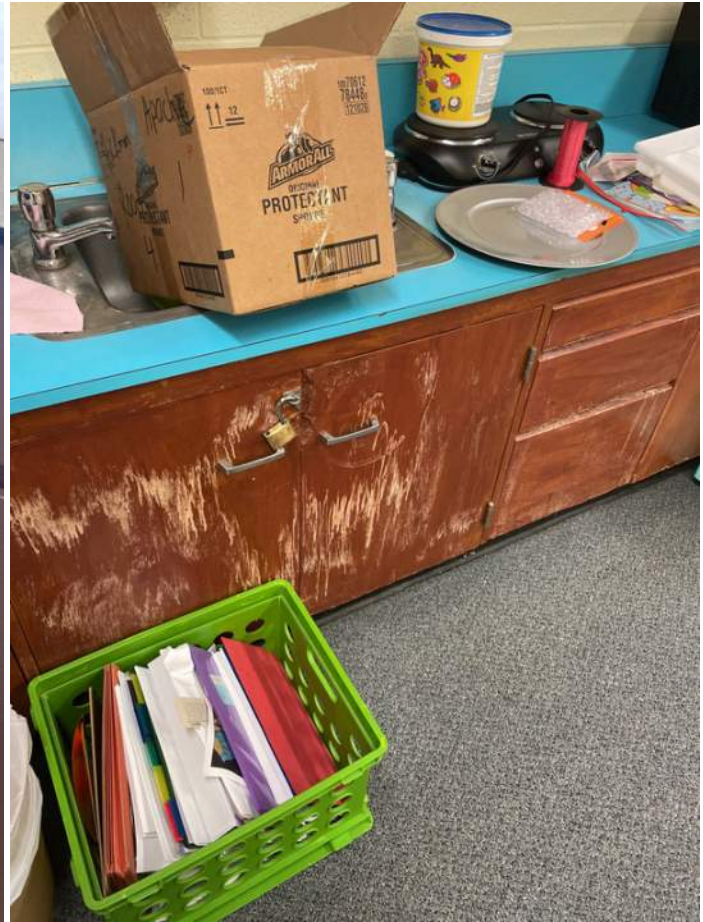
Photos-Fixed Furnishings

Type Description-Fixed Furnishings	Millwork
Condition Rating-Fixed Furnishings	Fair - exhibiting deficiencies requiring minor service/repair to extend useful life
Deficiency Category-Fixed Furnishings	Beyond Useful Life
Quantity-Fixed Furnishings	n/a

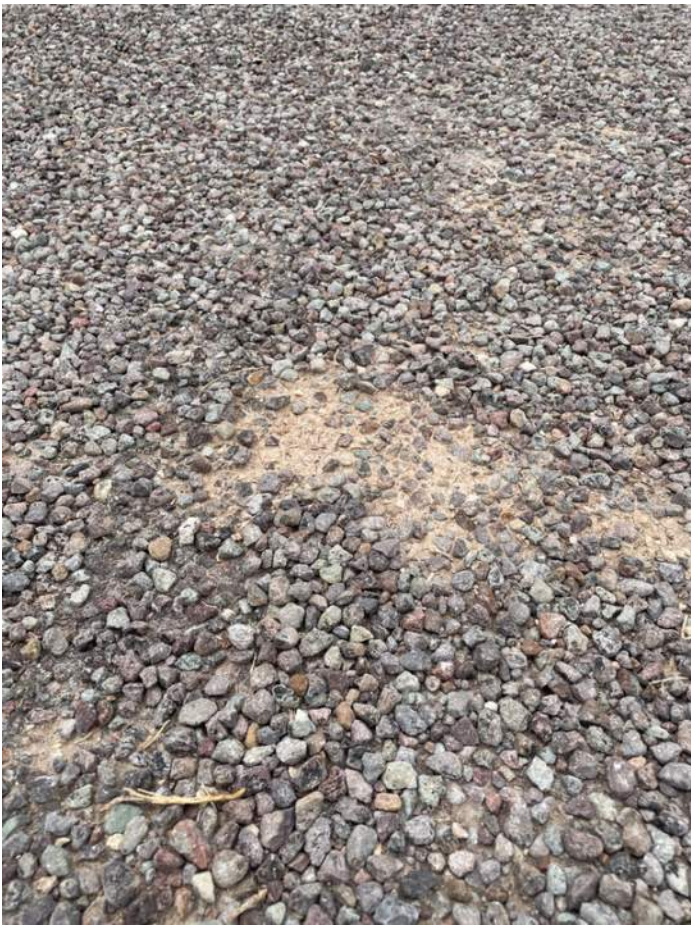
Photos-Site Development

Type Description-Site Development	Parking Lot
Condition Rating-Site Development	Poor - nearing end of useful life, and requiring major service/repair to remain operational
Deficiency Category-Site Development	Beyond Useful Life
Quantity-Site Development	n/a
Unit-Site Development	n/a
Year Installed-Site Development	n/a
Comments-Site Development	Little more than a gravel drive.

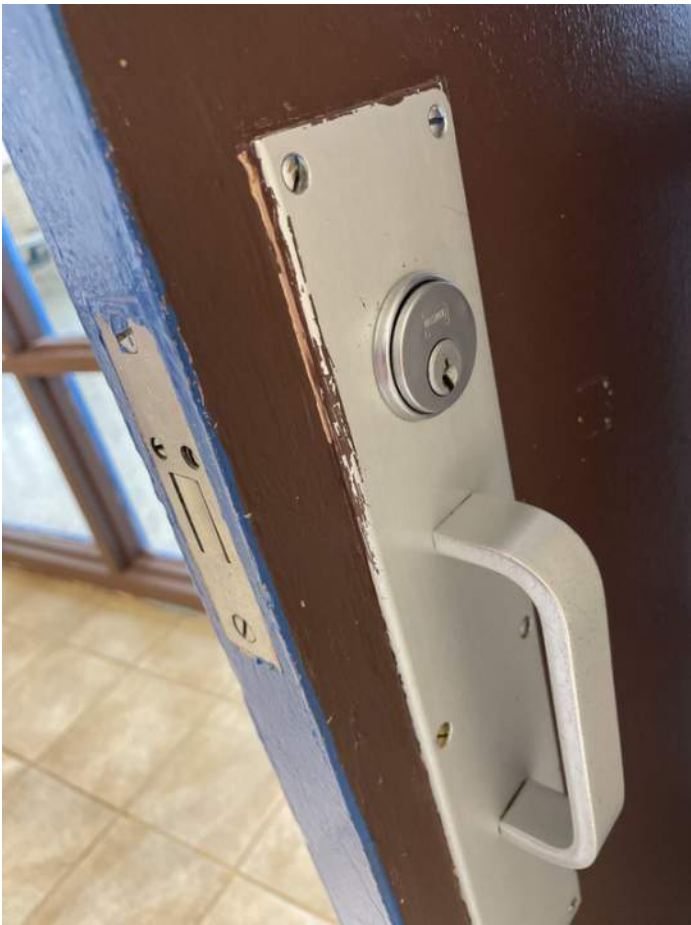
Photos-Building Codes

Building Codes - 1. Fire code issue. Non-egress deadbolt on main office door. Can be replaced without replacing door.

Fire code issue. Non-egress deadbolt on main office door. Can be replaced without replacing door.

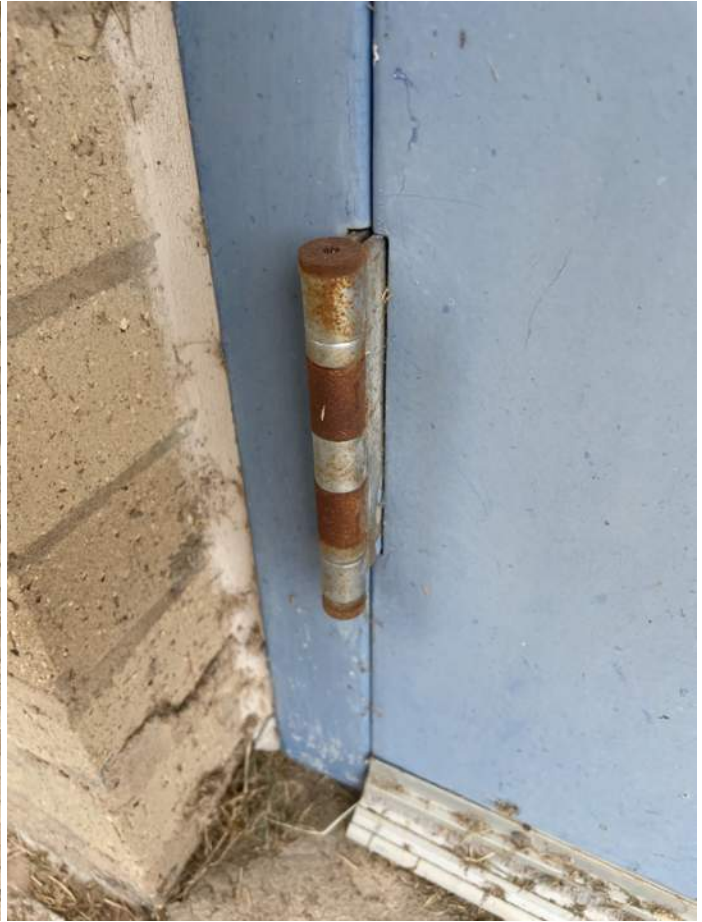
Photos-Exterior Doors

Exterior Doors - 1. Hollow Metal

Type Description-Exterior Doors	Hollow Metal
Condition Rating-Exterior Doors	Fair - exhibiting deficiencies requiring minor service/repair to extend useful life
Deficiency Category-Exterior Doors	Damaged/Failing

Quantity-Exterior Doors	30
Unit-Exterior Doors	%
Year Installed-Exterior Doors	2010
Comments-Exterior Doors	Repainting needed. Replace rusting hinges.

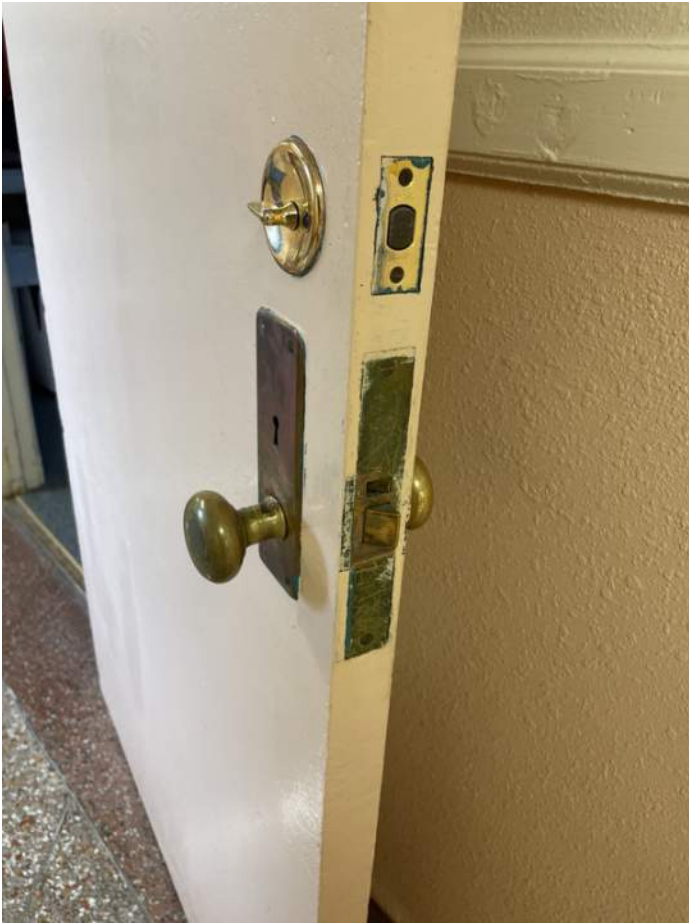
Photos-Building Codes

Fire code issue. Most doors have two locks.

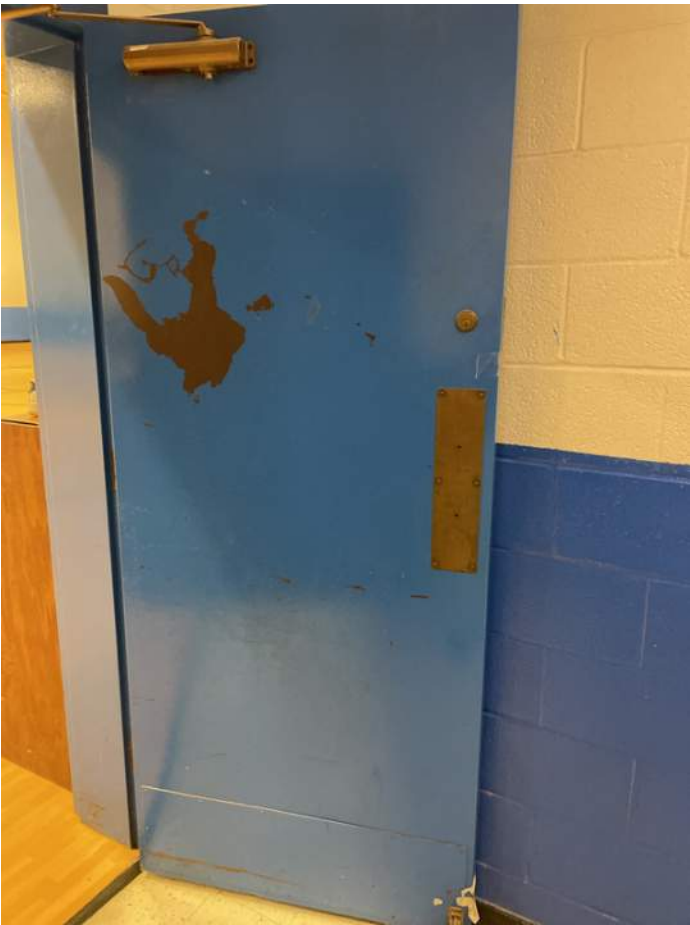
Photos-Interior Doors

Interior Doors - 2. Hollow metal

Type Description-Interior Doors	Hollow metal
Condition Rating-Interior Doors	Fair - exhibiting deficiencies requiring minor service/repair to extend useful life
Deficiency Category-Interior Doors	Beyond Useful Life
Quantity-Interior Doors	10
Unit-Interior Doors	%
Year Installed-Interior Doors	1980
Comments-Interior Doors	Painting could extend life.

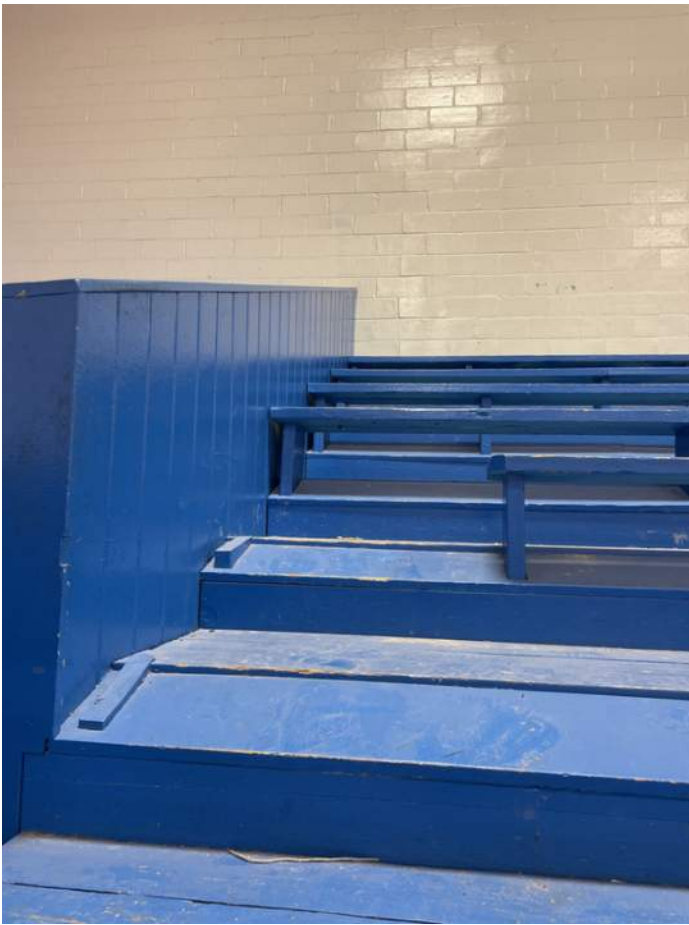
Photos-Building Codes

Building Codes - 5. Handrails missing on bleachers
