Limited Indoor Air Quality Report

Burr Elementary School

1960 Burr Street, Fairfield, Connecticut

**Re: Limited Indoor Air Quality Assessment
Burr Elementary School – Physical Education Office and Storage Room
1960 Burr Street, Fairfield, CT
Fuss & O'Neill, Inc. No. 20230741.A10**

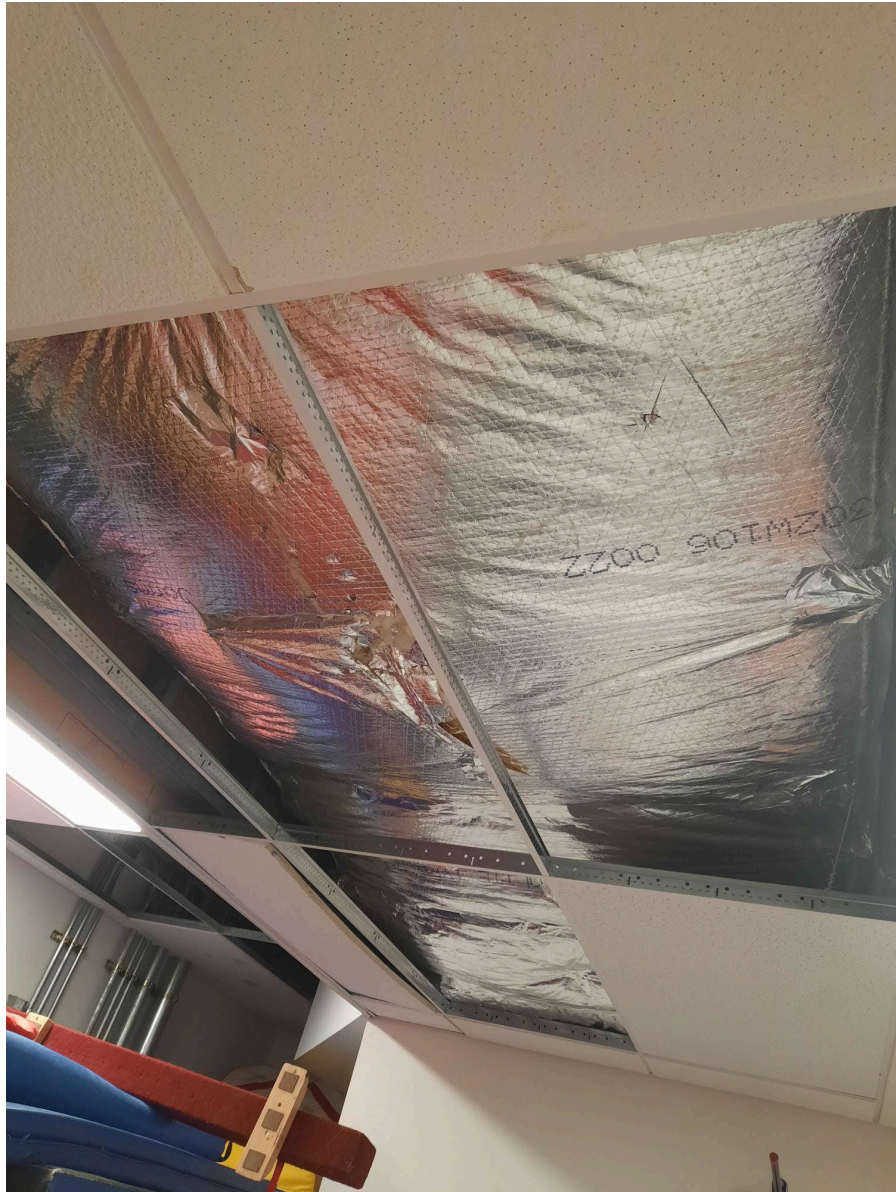
- Physical Education Storage Room
 - Obvious visible suspect mold growth was not observed
 - Mold or mildew odor was not observed
 - Approximately 48 square feet of suspended ceiling tiles were removed
 - Moisture readings of remaining suspended ceiling tiles determined to be insignificant
 - Moisture reading of drywall determined to be insignificant
 - Moisture reading of blue gym mats determined to be insignificant
 - Delaminated surfaces were not observed
 - Debris on blue gym mats stacked in storage room from ceiling

Physical Education Storage Room : Suspended ceiling tiles were removed

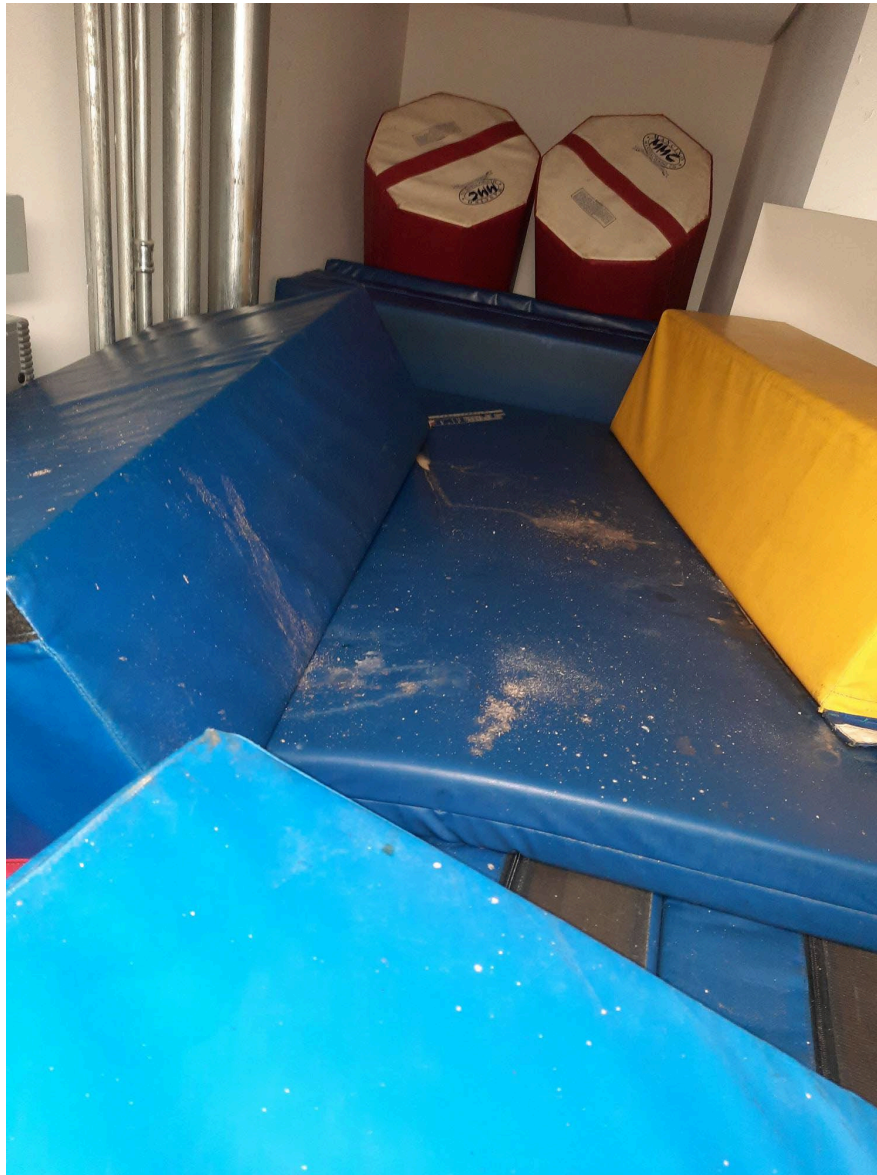
Physical Education Storage Room : Debris from water damaged ceiling tiles (previously removed) was observed on mats.

- Remove and replace water damaged ceiling tile identified in the Physical Education office.
- General housekeeping of Physical Education Office and Storage Room – HEPA vacuuming and wet wiping of surfaces observed to have debris resulting from the removal of moisture impacted ceiling tiles.

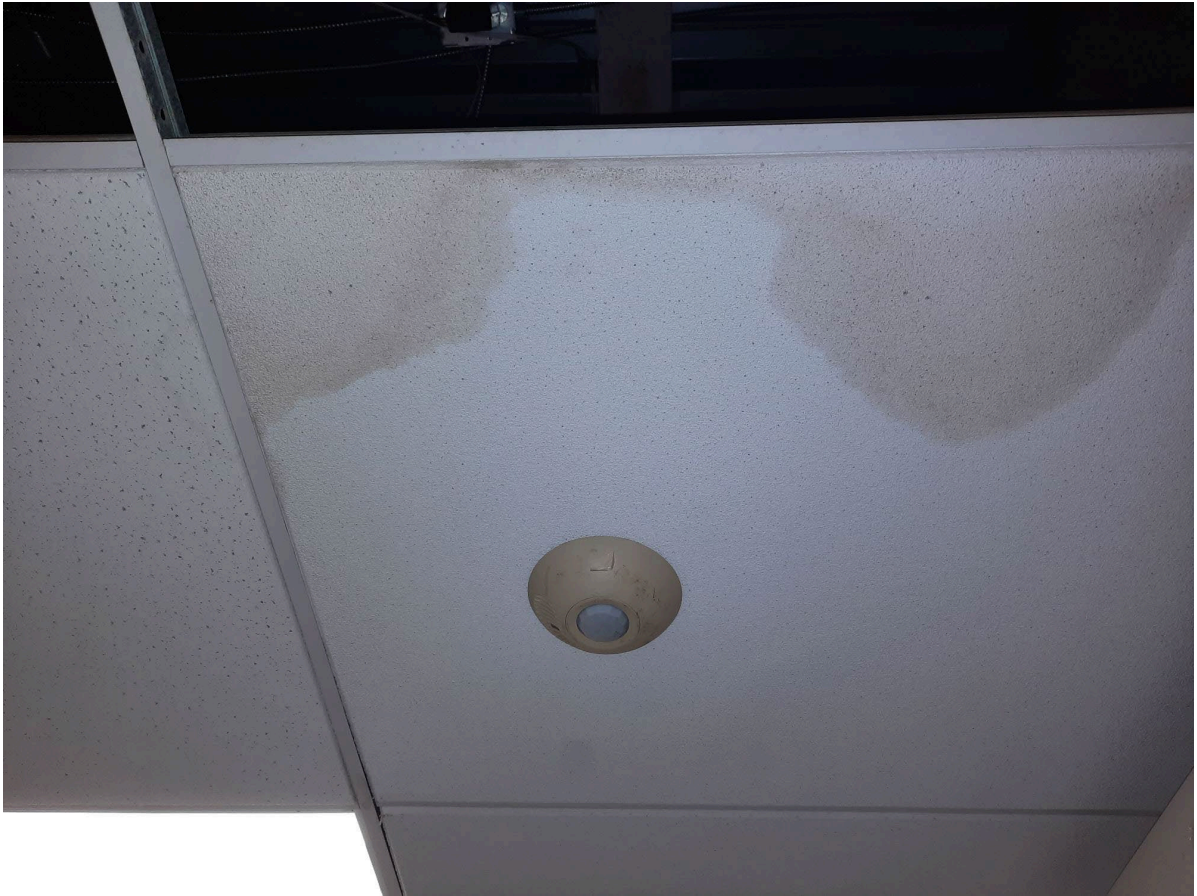
- Physical Education Office
 - Obvious visible suspect mold growth not observed
 - Mold or mildew odor not observed
 - Moisture reading of suspended ceiling tile determined to be insignificant
 - Moisture reading of drywall determined to be insignificant
 - Water staining was observed on approximately 2 square feet of ceiling tile
 - Delaminated surfaces were not observed

- Interior temperature measurements were within the ASHRAE recommended comfort range.
- Interior relative humidity measurements were within the ASHRAE recommended comfort range.
- Interior concentrations of carbon dioxide were acceptable in accordance with ASHRAE recommendations.
- Interior concentrations of carbon monoxide were acceptable and below levels specified by the NAAQS.
- Visible mold growth or mold/mildew odors were not identified in the areas included in the assessment
- Elevated moisture content was not identified in the representative building materials and surfaces evaluated.
- No significant active water intrusions were observed during the assessment.
- The majority of water damaged suspended ceiling tiles were removed with the exception of the Physical Education office where there was approximately 2 SF of visible water damage on ceiling tiles.

Physical Education Office : ~2 SF of water damaged ceiling tile
