# **Limited Indoor Air Quality Report**

Inspection Date: August 24, 2023 & August 31, 2023  
Fairfield Ludlowe High School  
785 Unquowa Road, Fairfield, CT

## **Fairfield Public Schools**

**RE: Limited Indoor Air Quality**  
**Fairfield Ludlowe High School**  
**785 Unquowa Road, Fairfield, CT**  
Fuss & O'Neill Project No. 20110458.A50

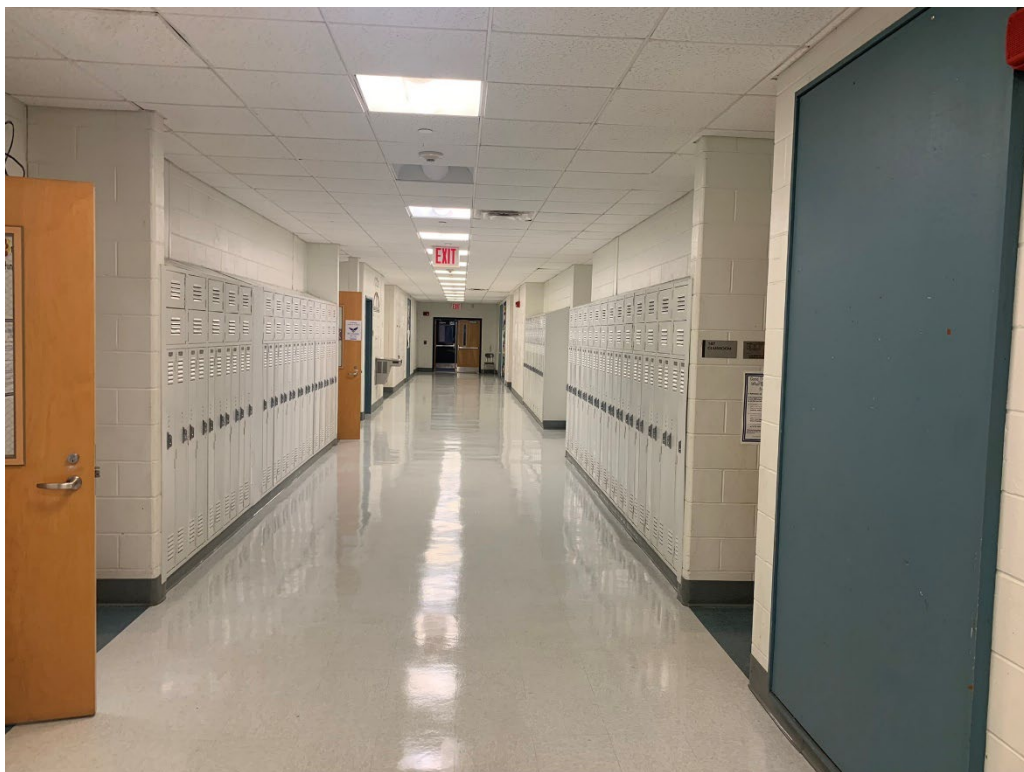
Ground level Hallway (facing south) – Typical conditions shown.

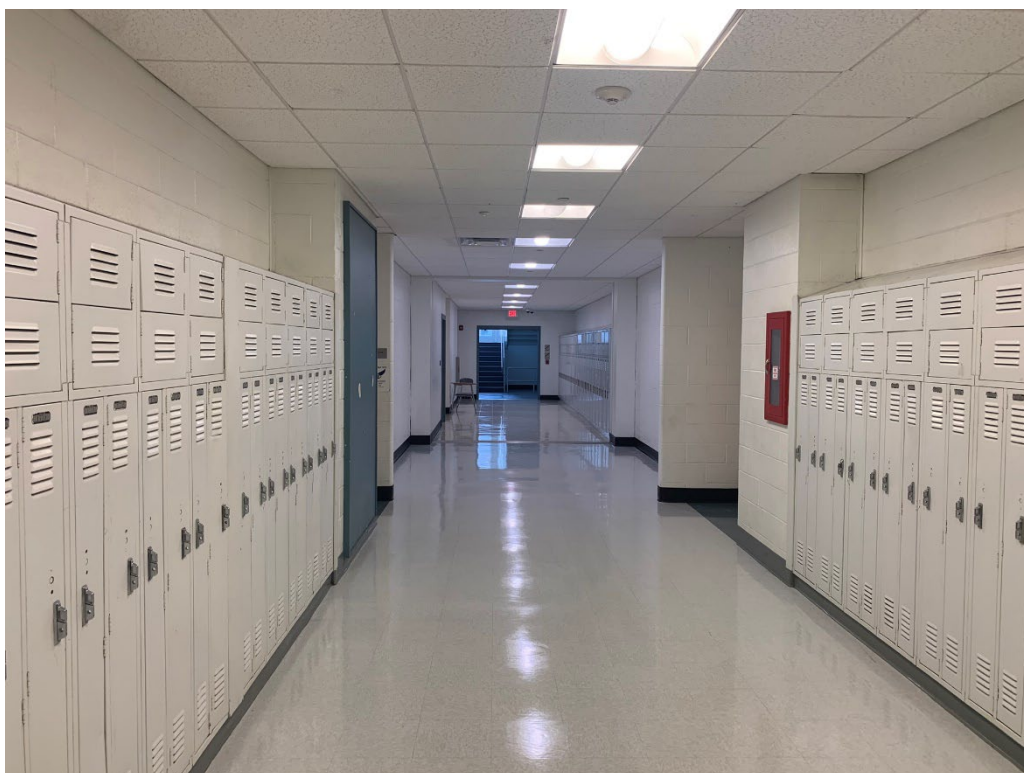
Ground level Hallway (facing north) – Typical conditions shown.

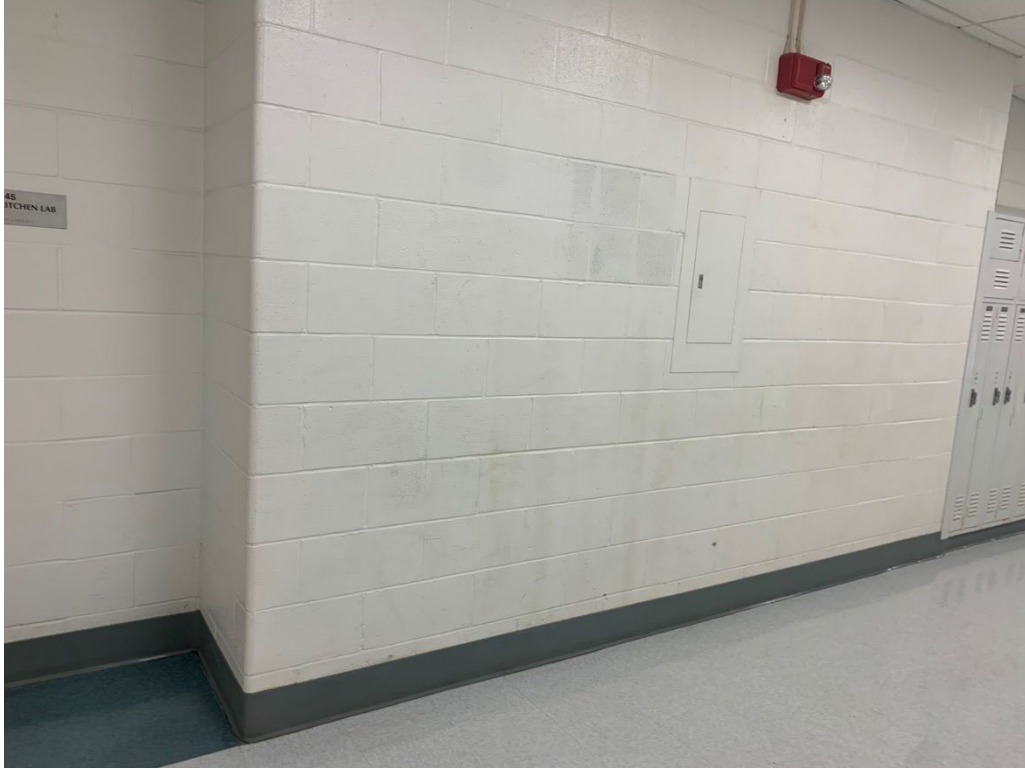
Ground level hallway – Staining on CMU walls shown. No obvious/suspect mold/mildew growth noted at the time of the assessment.

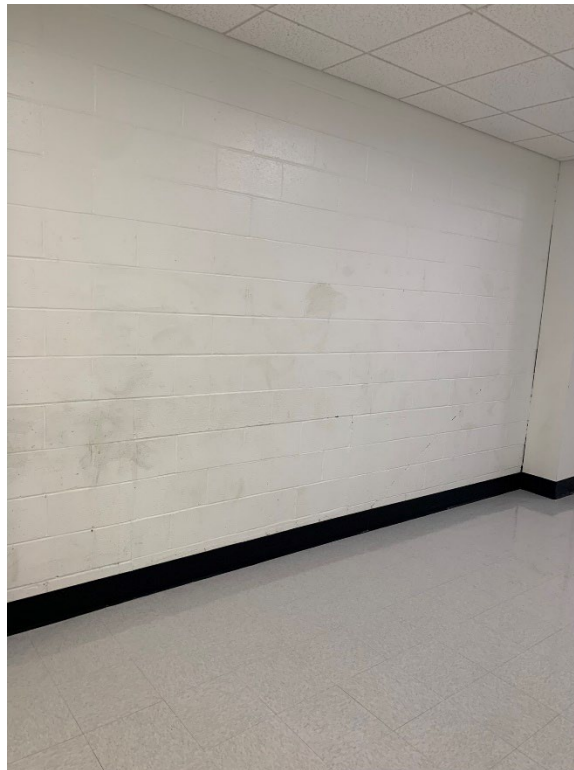
Ground level hallway – Staining on CMU walls shown. No obvious/suspect mold/mildew growth noted at the time of the assessment.

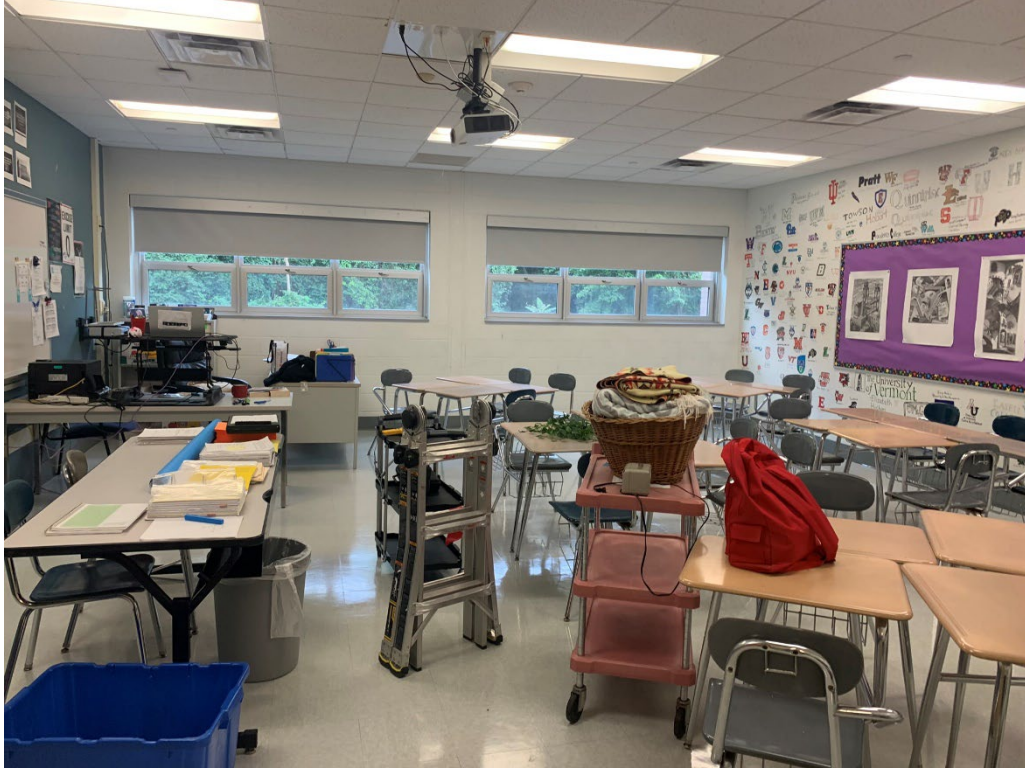
Room 148 classroom – Typical conditions shown.

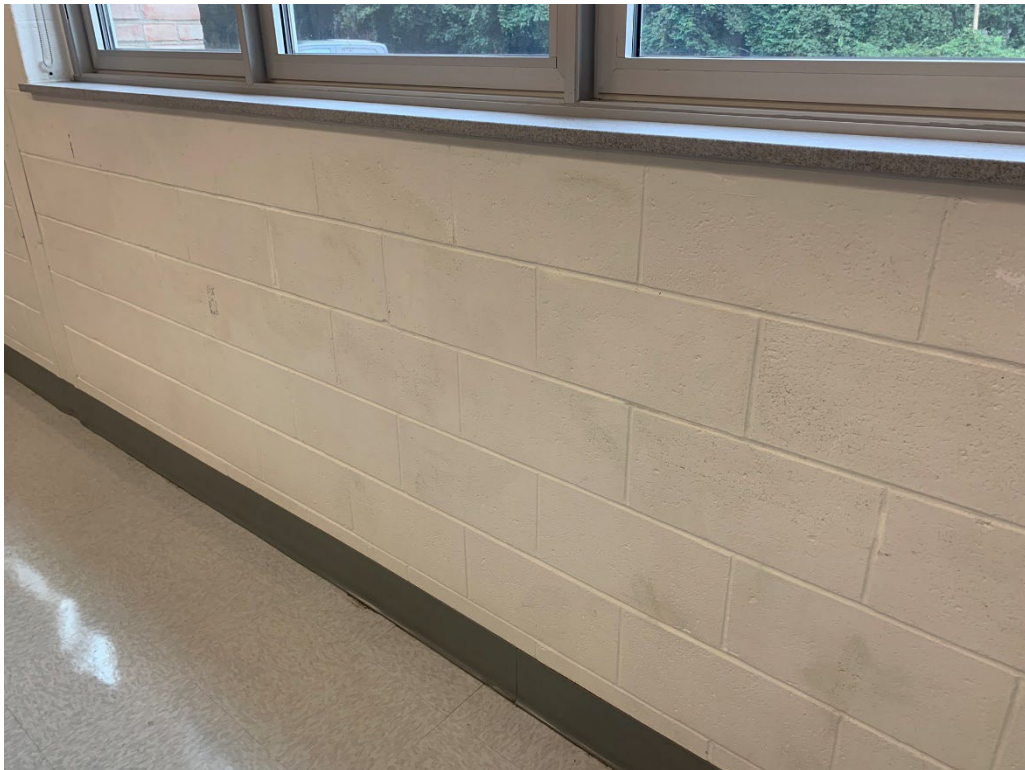
Room 148 classroom - Staining on CMU walls shown. No obvious/suspect mold/mildew growth noted at the time of the assessment.

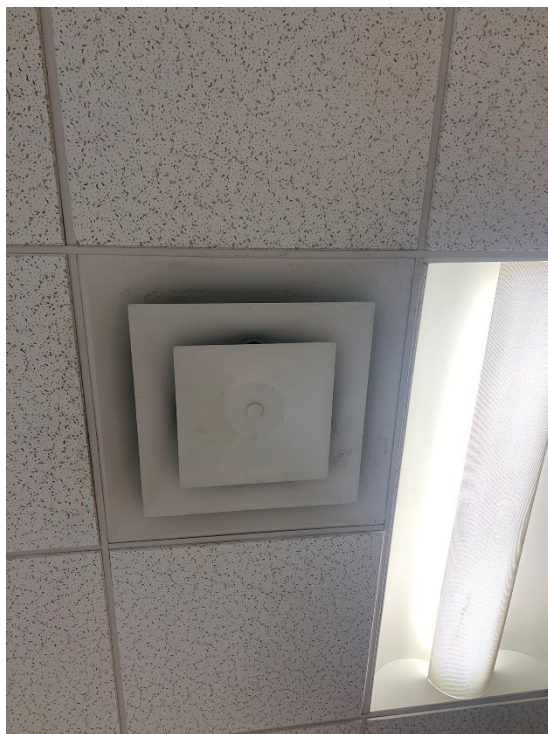
- In Rooms 148, 149, 150, 147, 151, 153, 145, and 146 suspect mold and/or dust build-up was observed on HVAC ceiling diffusers and adjacent ceiling tiles. These impacted ceiling tiles exhibited slightly elevated moisture readings in rooms 146, 149, 150, 151, and 153.

Room 148 classroom – HVAC diffuser with built-up dust and/or possible mold.

- Remediate the observed and suspected mold growth noted on the surfaces identified. Further investigation in the areas behind walls and wall finishes and above suspended ceiling tiles may be required to identify the extent of suspect mold growth. Any remediation and further inspection should be performed in a controlled manner by an Institute of Inspection Cleaning and Restoration (IICRC)-certified professionals to prevent the potential migration of concealed mold growth.

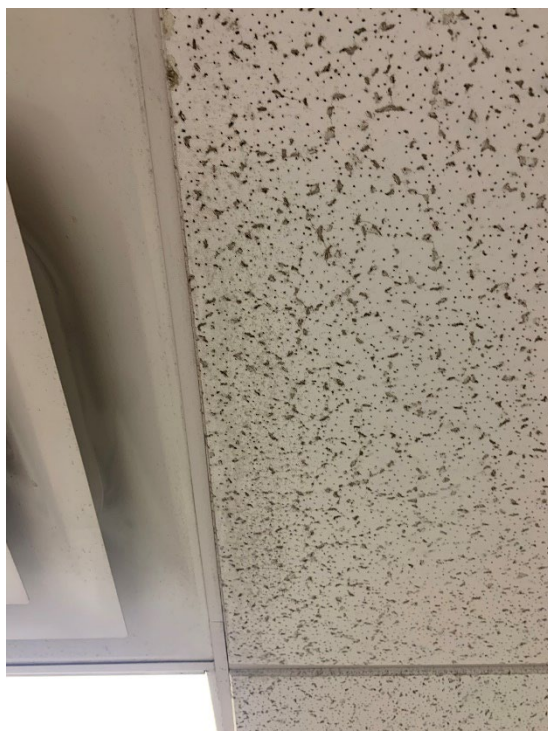
Room 148 classroom – Staining (dust build-up and/or possible mold) observed on suspended ceiling tile adjacent to HVAC diffuser (typical).

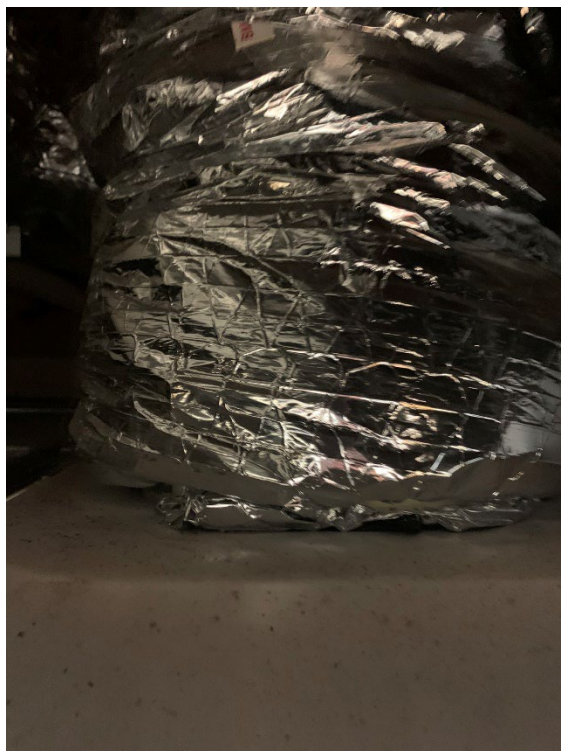
- In Room 148 the area above the suspended ceiling by impacted diffusers was inspected. Dust and/or possible mold observed on top of metal diffuser.

Room 148 classroom – Top of HVAC diffuser (above suspended ceiling tile).

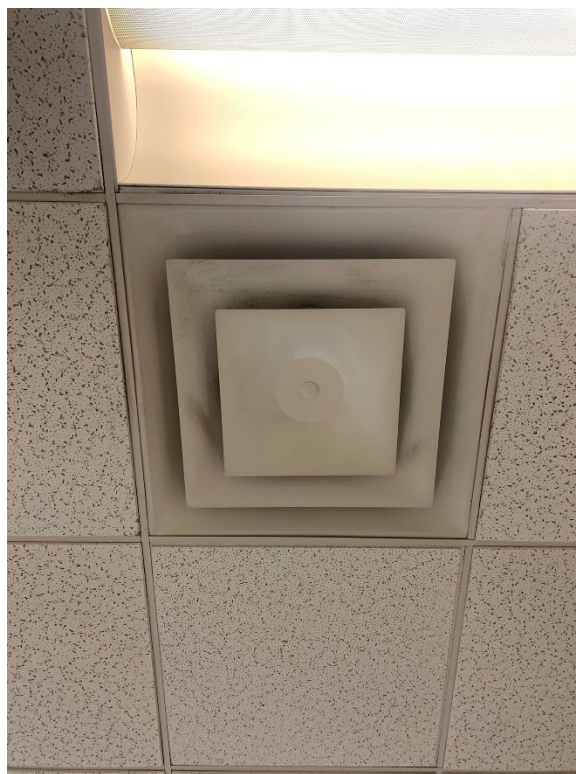
Room 147 classroom - HVAC diffuser with built-up dust and/or possible mold.

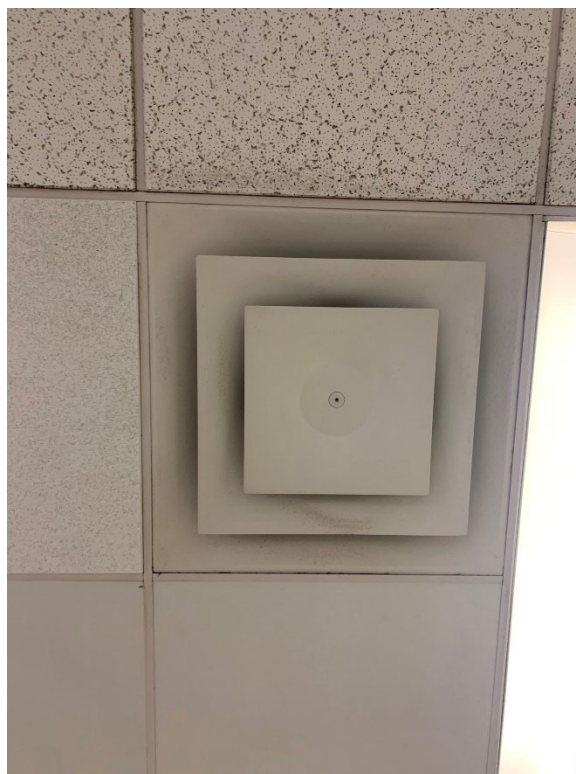
Room 149 classroom - HVAC diffuser and adjacent suspended ceiling tile with built-up dust and/or possible mold.

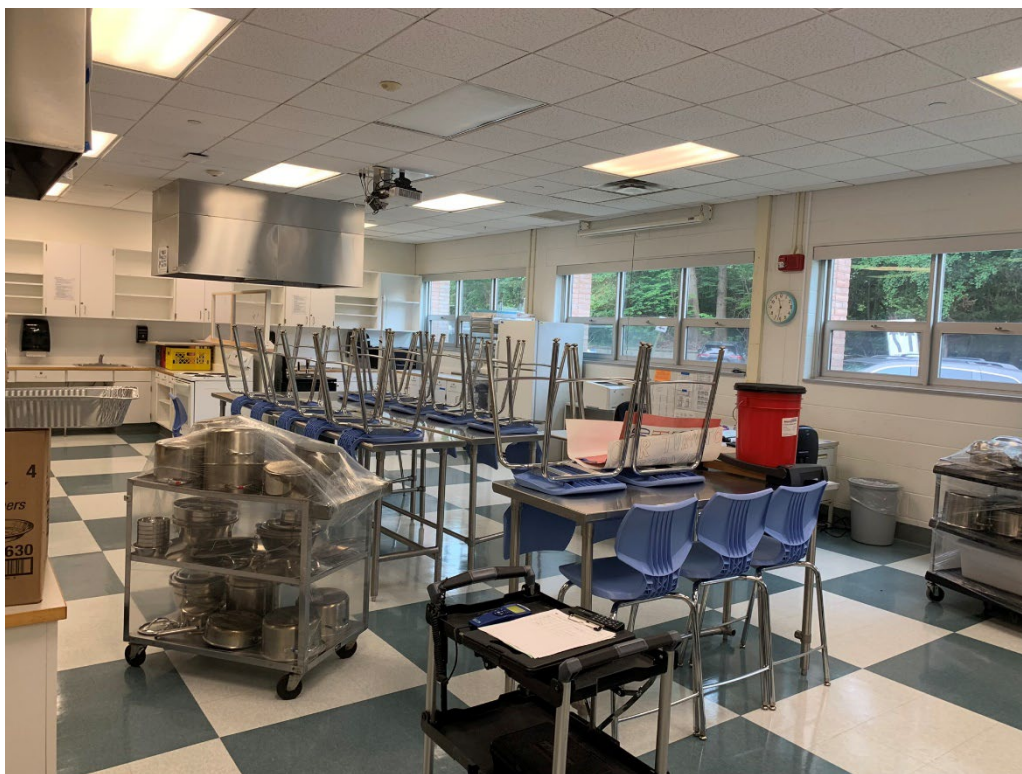
Room 145 Kitchen Lab – Typical conditions shown.

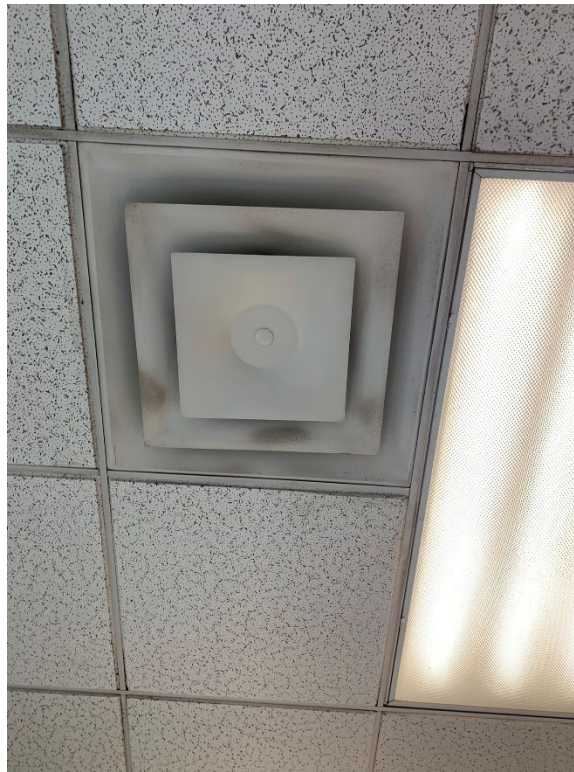
Room 145 Kitchen Lab - HVAC diffuser with built-up dust and/or possible mold.

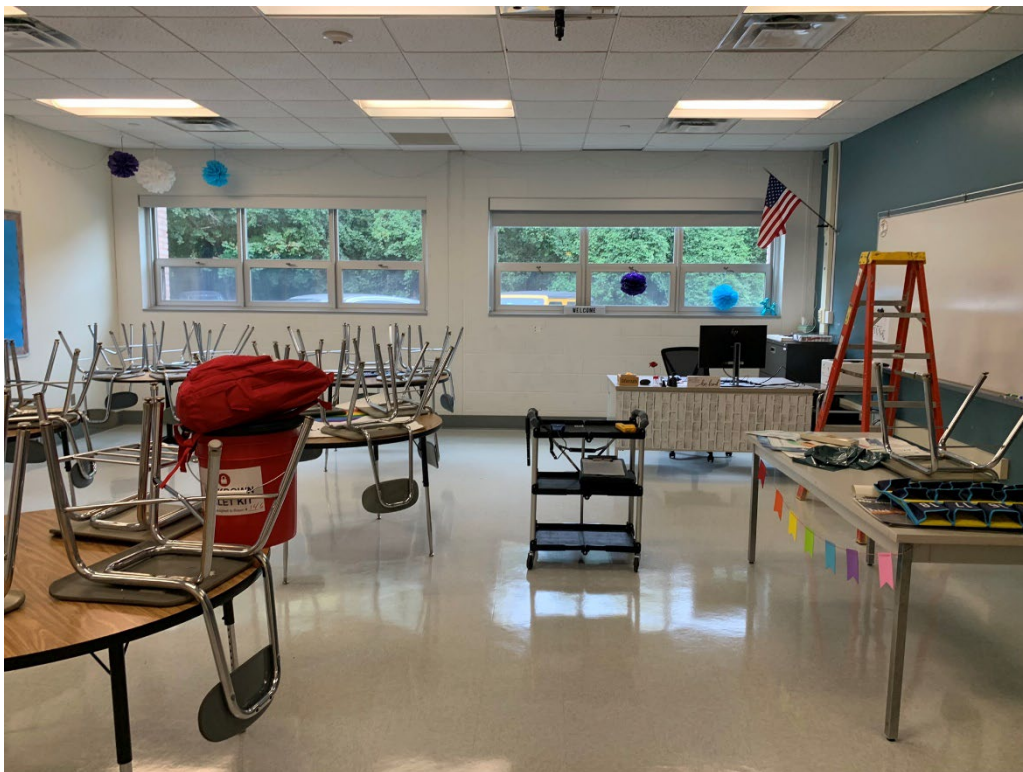
Room 146 Classroom – Typical conditions shown.

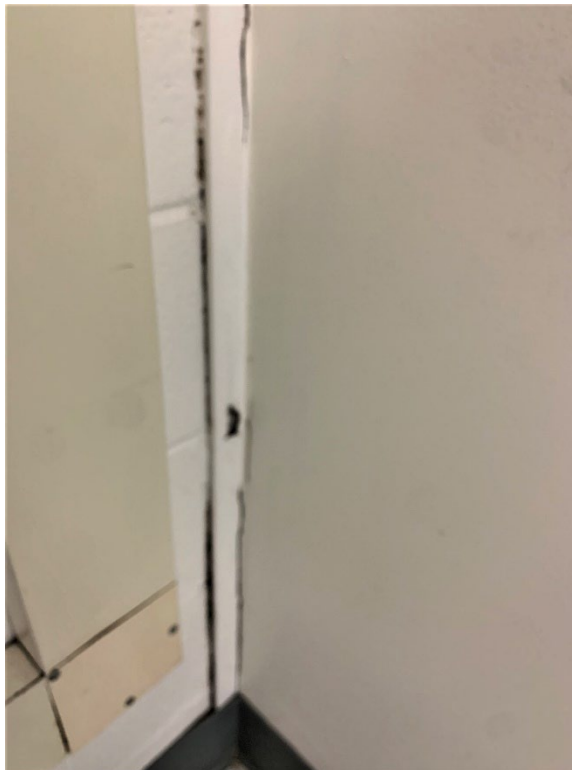
Room 146 Classroom – Suspect mold/mildew at southeast corner.

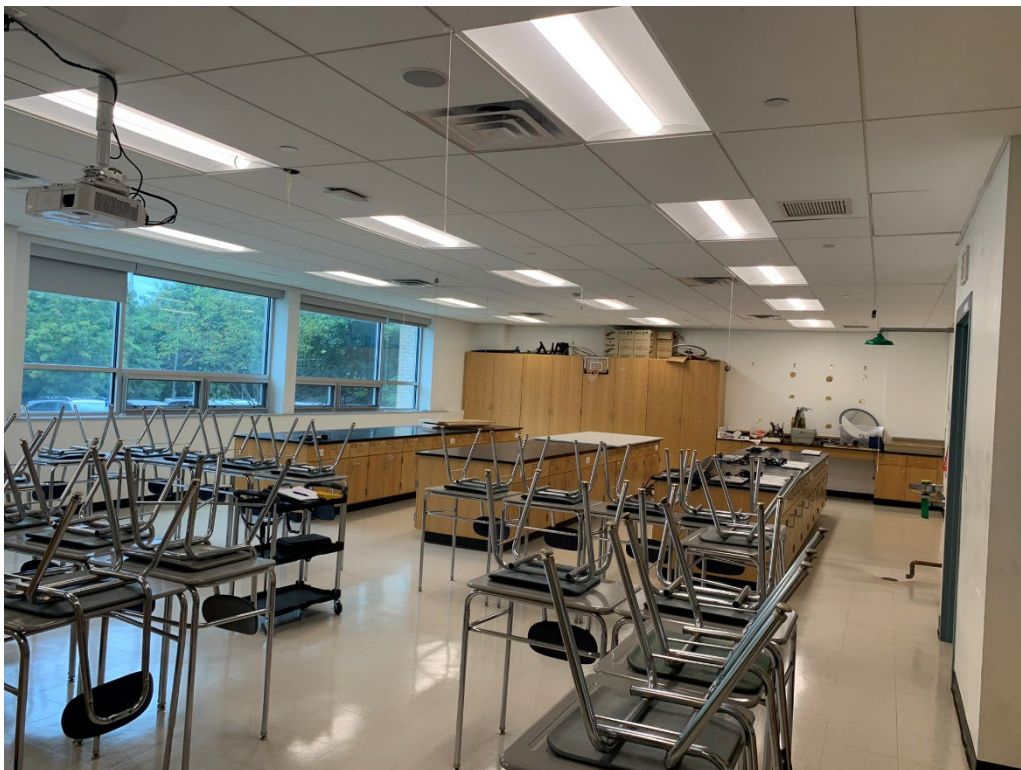
Room 181 Science Room – Typical conditions shown.

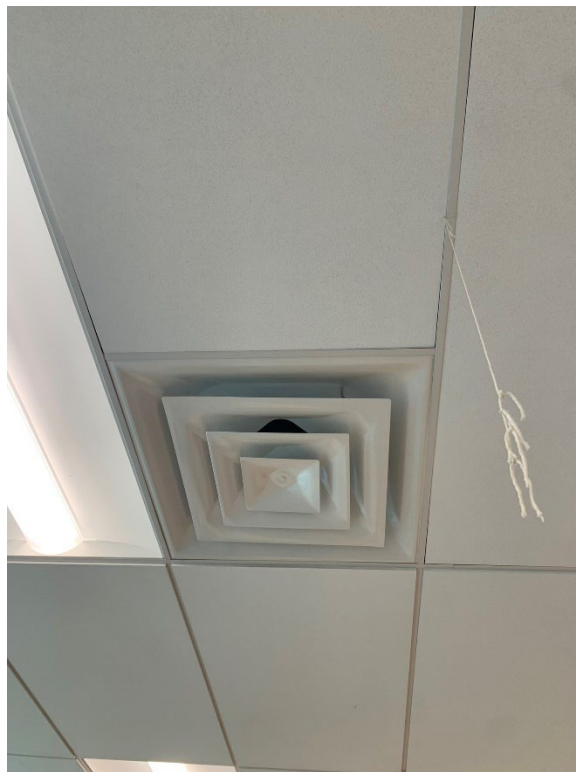
Room 181 Science Room – Typical HVAC diffuser vent.

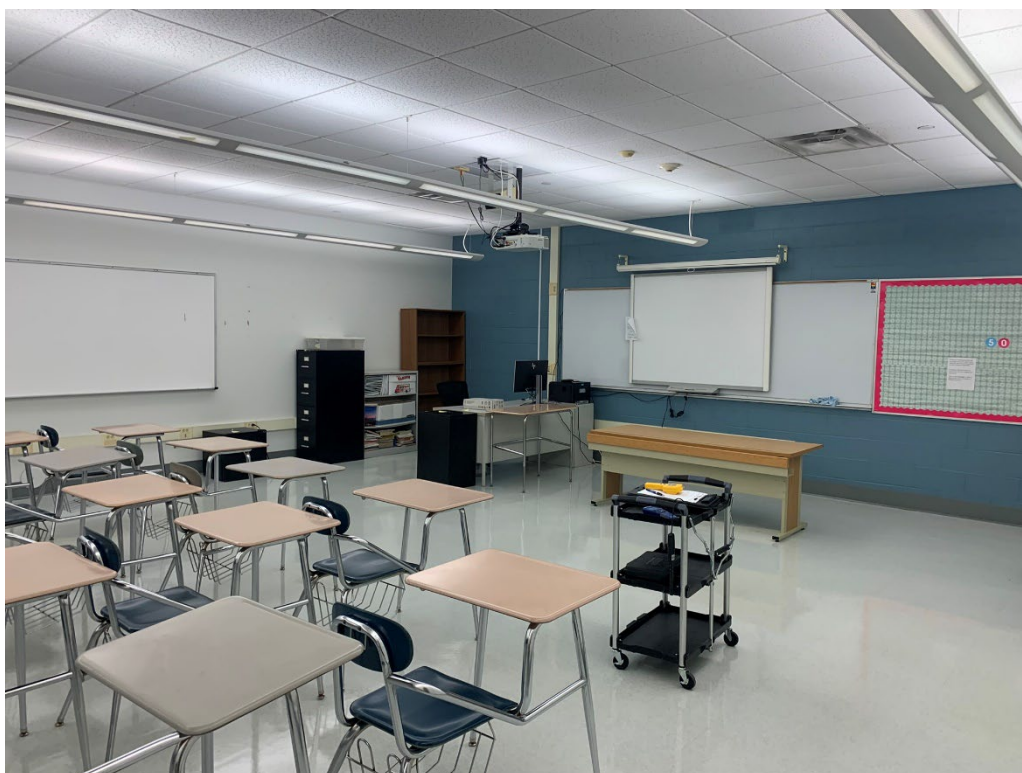
Room 150 Computer Lab – Typical conditions shown.

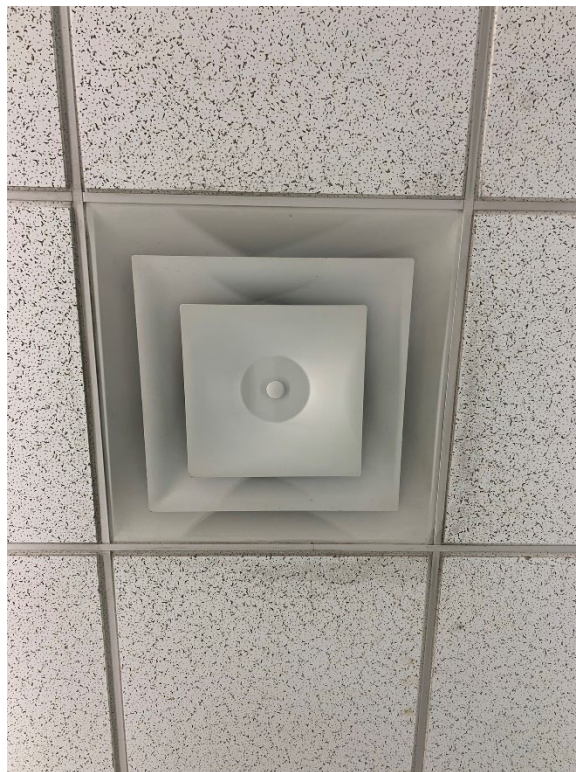
Room 150 Computer Lab - HVAC diffuser and adjacent suspended ceiling tile with built-up dust and/or possible mold.

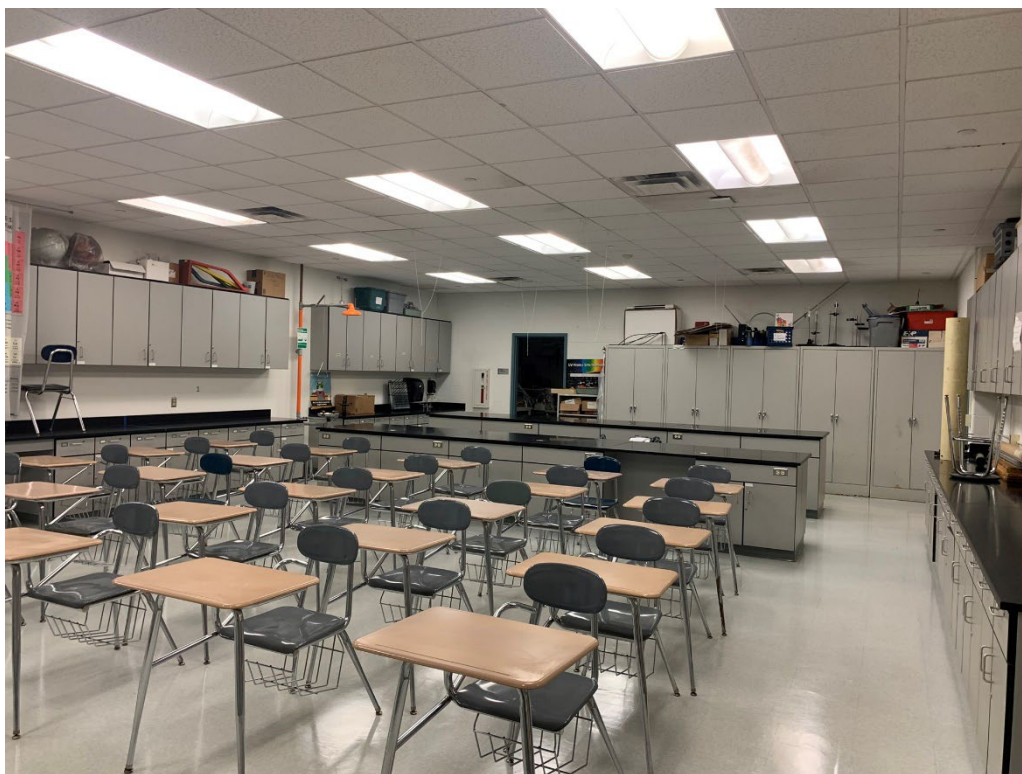
Room 151 Physics – Typical conditions shown.

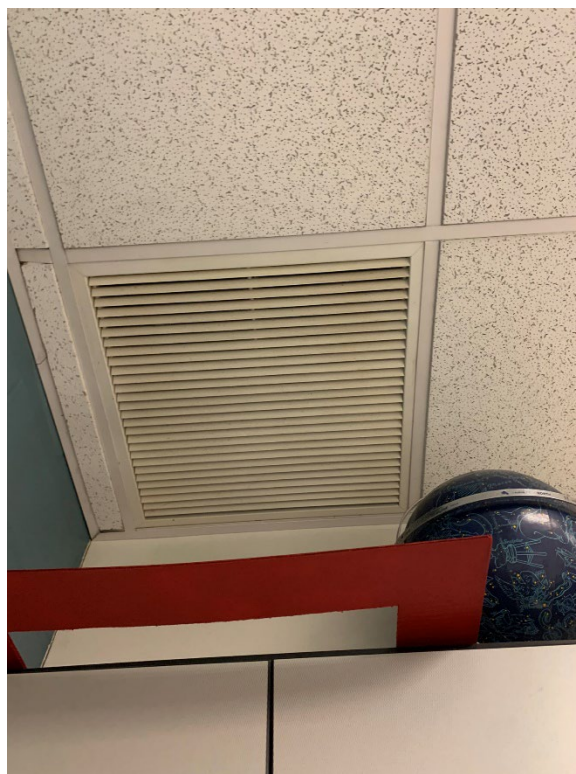
Room 151 Physics - Fresh air supply (typical).

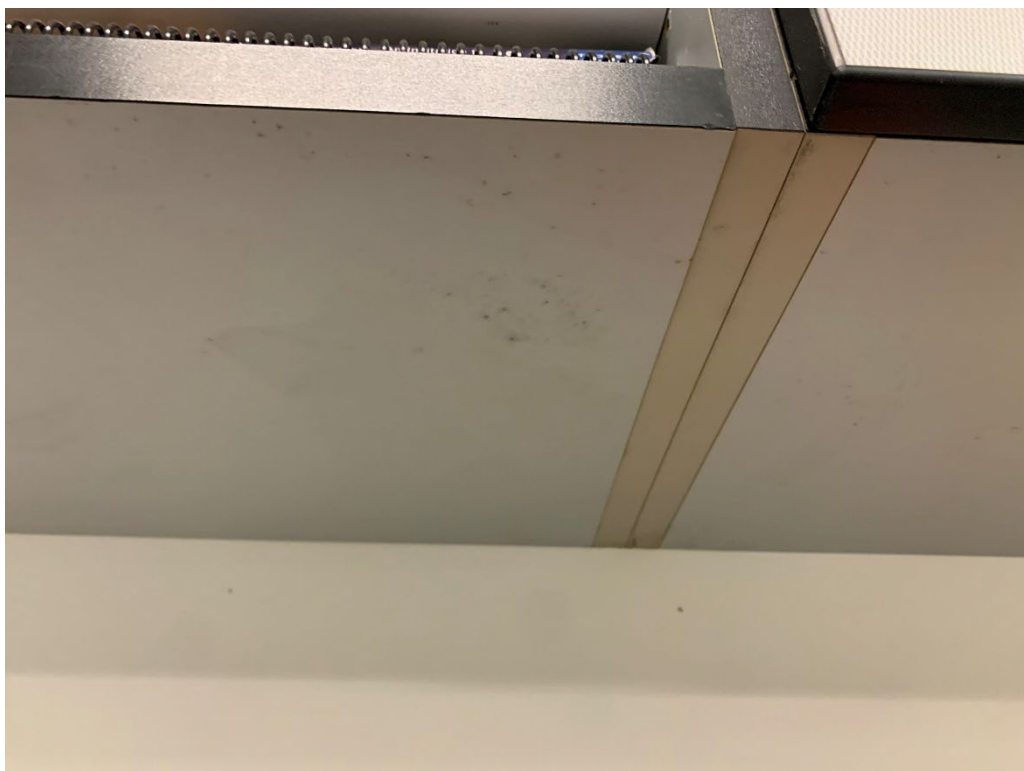
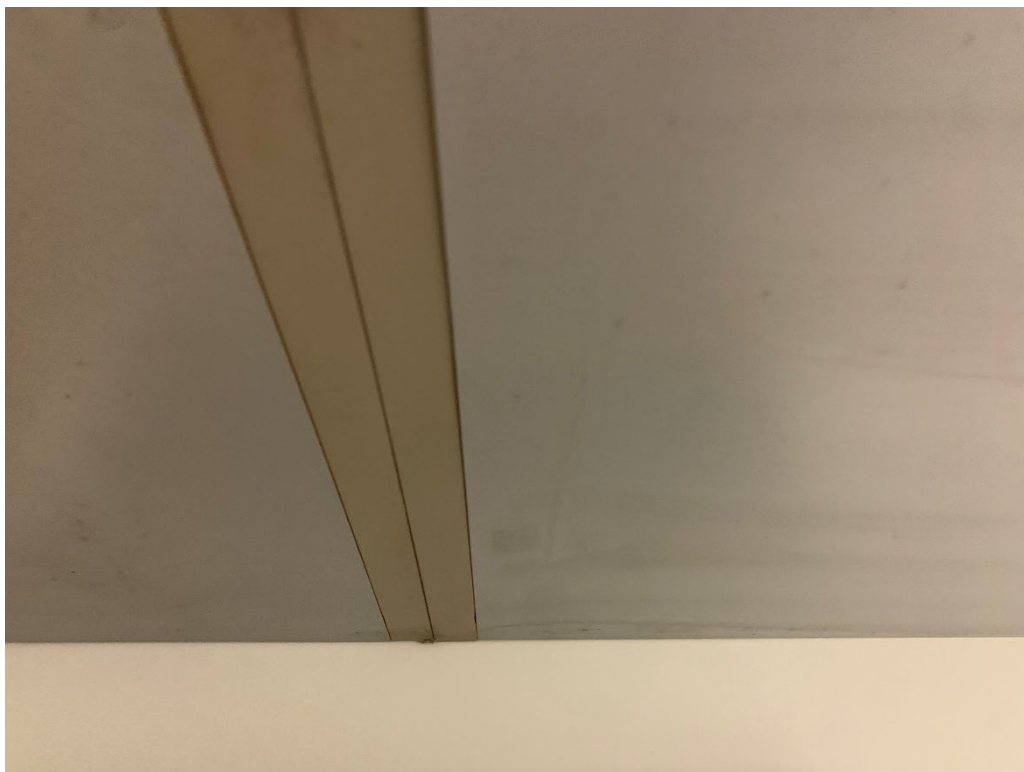
Room 151 Physics – Suspect mold below upper cabinets.

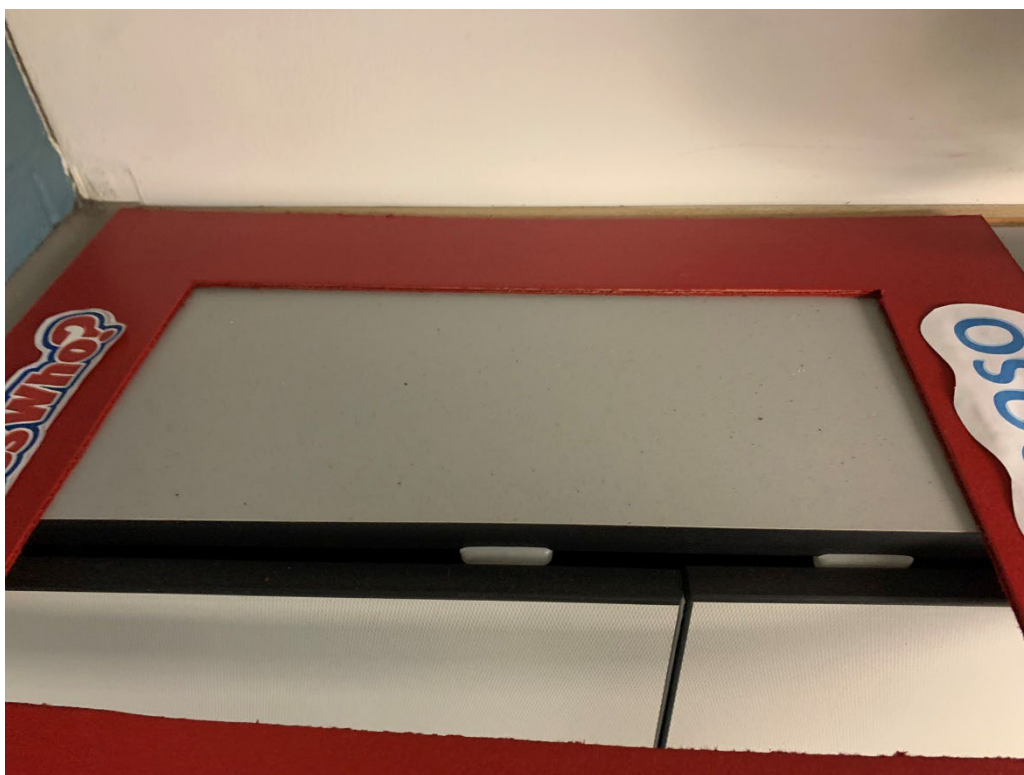
Room 151 Physics – Suspect mold on top of upper cabinets.

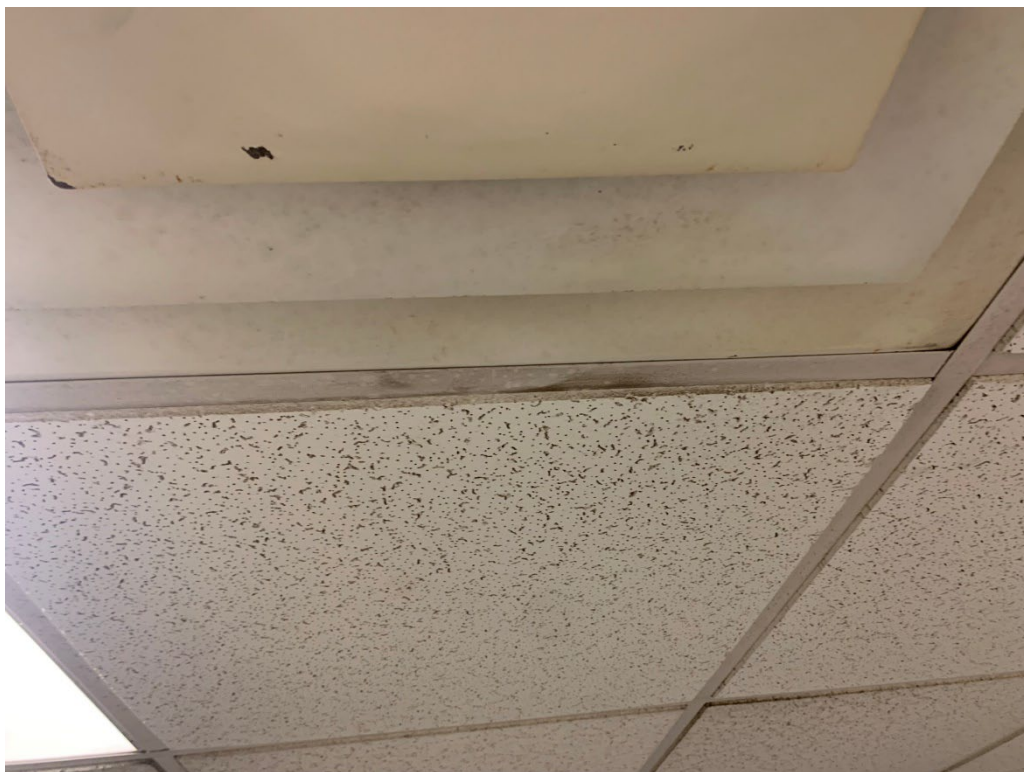
Room 151 Physics - HVAC diffuser and adjacent suspended ceiling tile with built-up dust and/or possible mold.

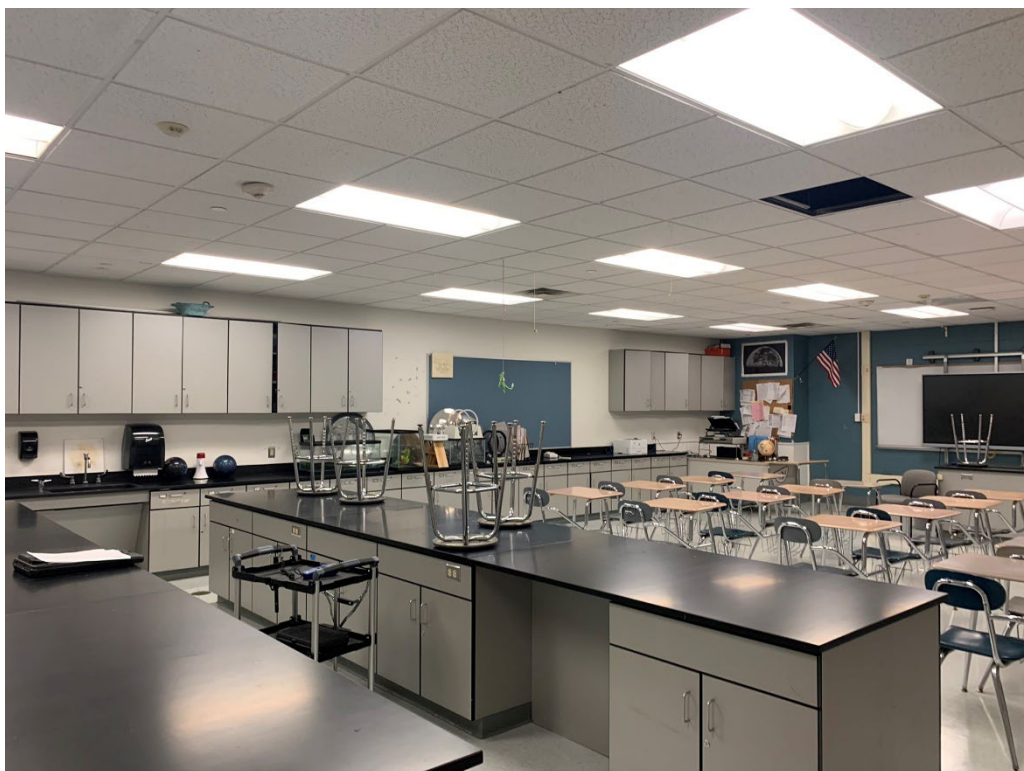
Room 153 Physics – Typical conditions shown.

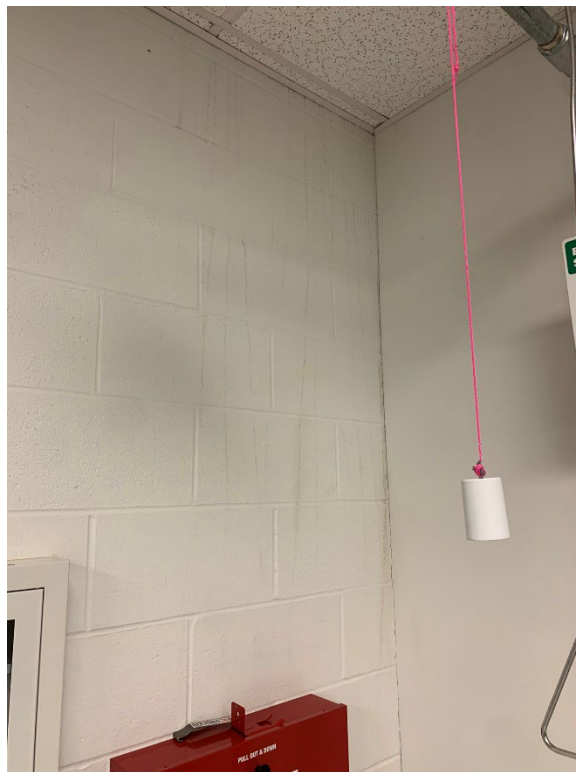
- The temperature measurements recorded were within the ASHRAE comfort range of 68°F and 79°F in areas tested during the assessment.
- Water-stains were observed during the initial assessment on a CMU wall and suspended ceiling tiles in Room 153. The ceiling tiles and stained CMU wall did not exhibit elevated moisture at the time of the assessment. Maintenance staff indicated the staining was likely due to isolated leaks from above and was not an on-going issue. The area was not reviewed during the supplemental assessment.

Room 153 Physics – Water staining (drips) on CMU wall.

- Verify and ensure the source(s) of water impacted surfaces identified in Room 153 are properly repaired. Replace any water damaged materials as needed after correcting moisture source(s).

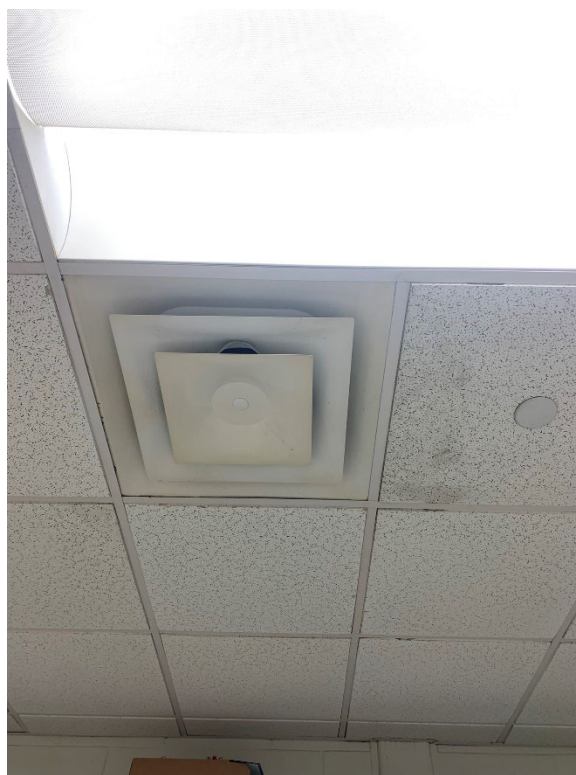
Room 153 Physics - HVAC diffuser and adjacent suspended ceiling tile with built-up dust and/or possible mold. Water stained ceiling tile shown.

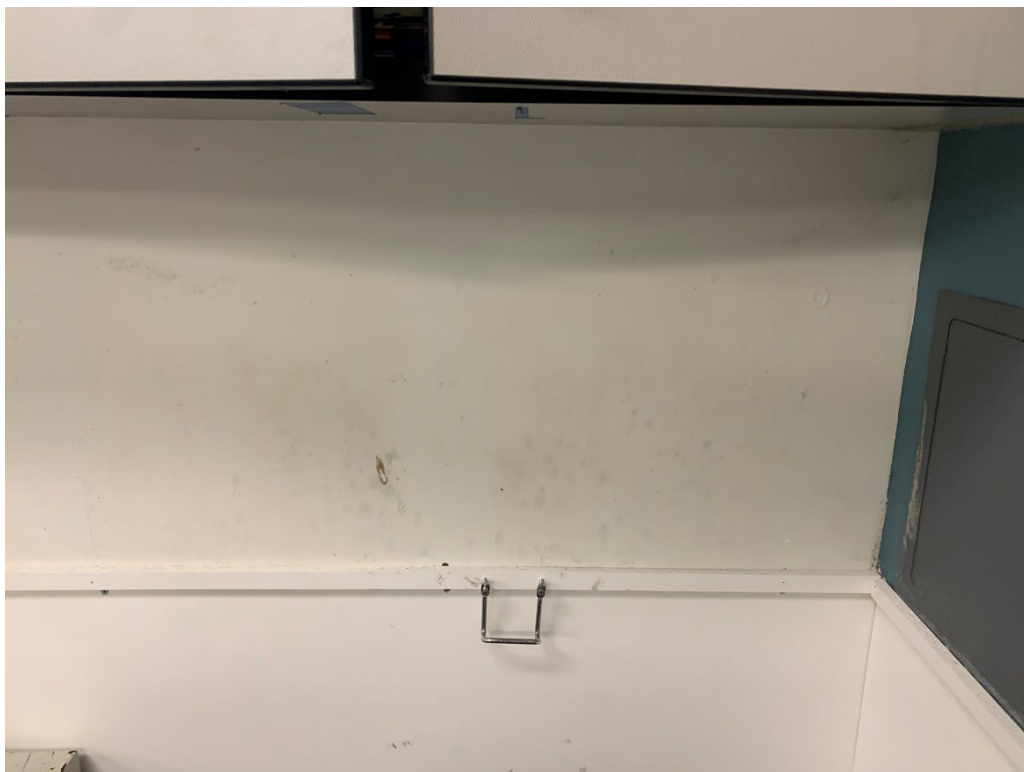
Room 153 Physics – Staining on gypsum wall in southeast corner of room.
