# INDOOR AIR QUALITY AND MOLD ASSESSMENT

FIRST FLIGHT ELEMENTARY & MIDDLE SCHOOLS

107 AND 109 VETERANS DRIVE  
KILL DEVIL HILLS, NORTH CAROLINA 27948

ECS PROJECT NO. 49:20986

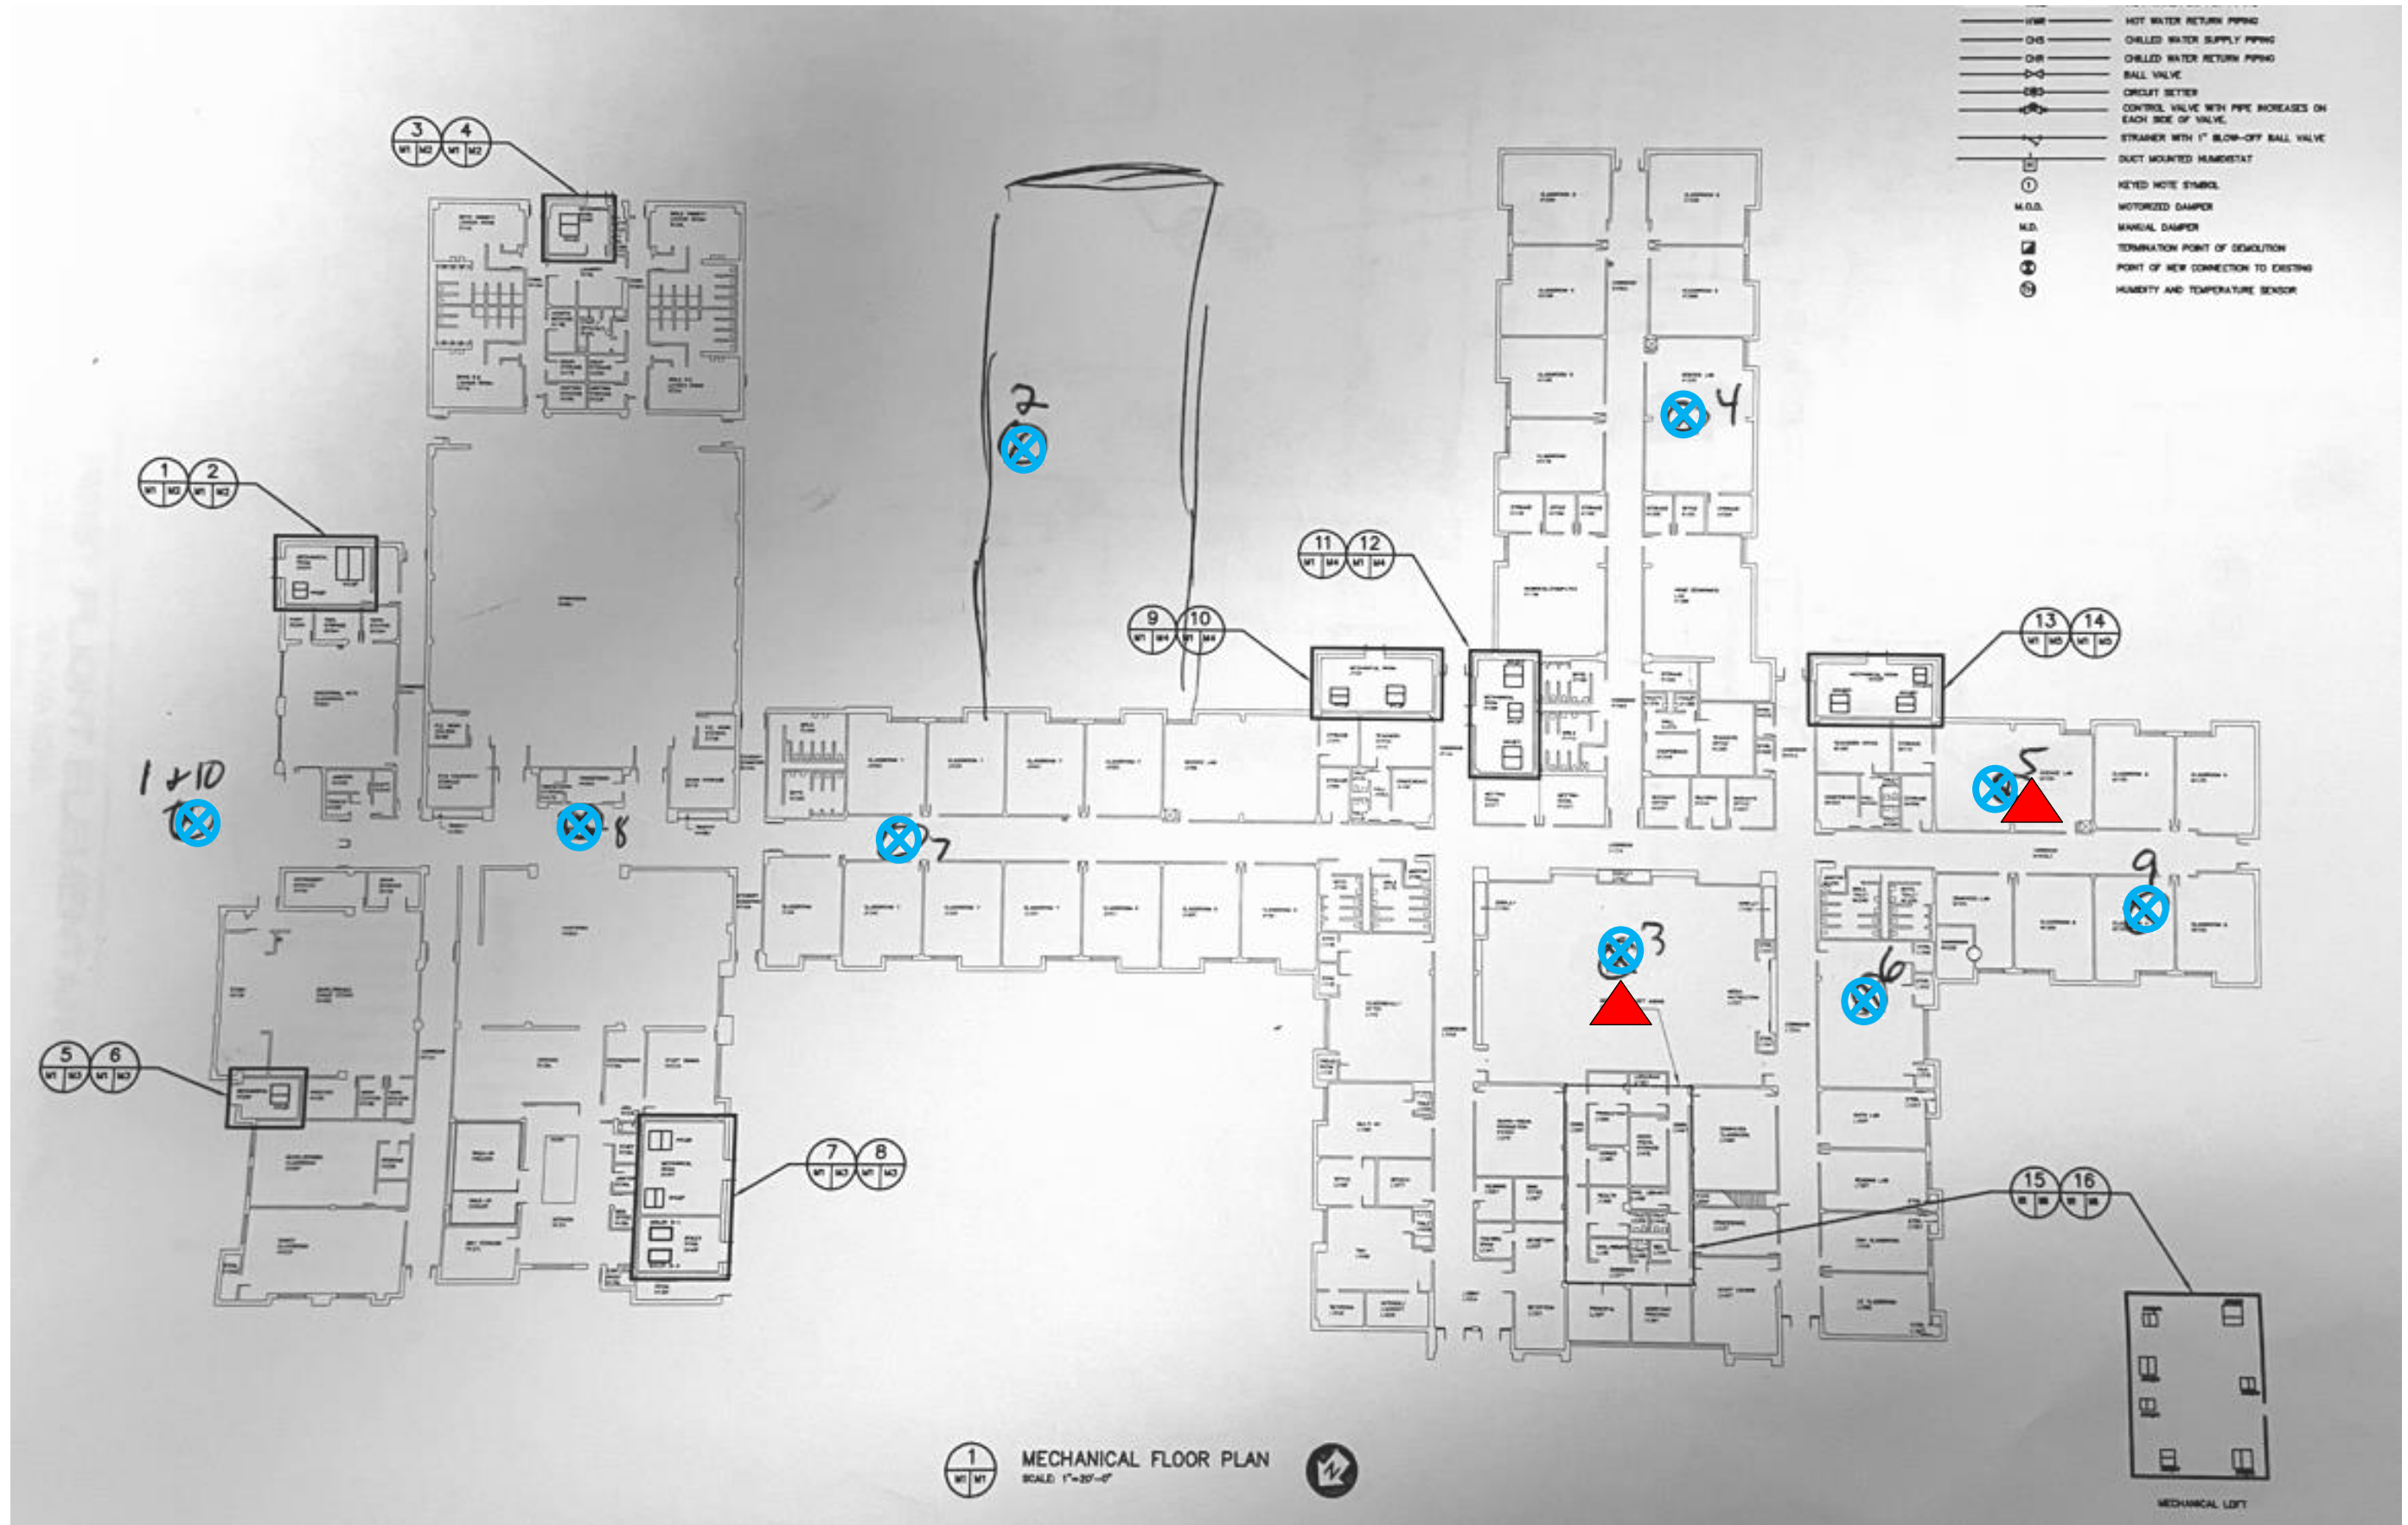
Figure 2

- Media Center
- Room M110

ECS recommends remediation be performed for water and mold impacted materials within the surveyed areas as soon as reasonably possible. This includes all materials that have visible suspected mold and/or have been subjected to elevated moisture conditions for greater than 48 hours without proper drying efforts. Particular emphasis should be placed on the following areas, where airborne mold levels were considered amplified at the time of assessment.

- Media Center
- Room M110

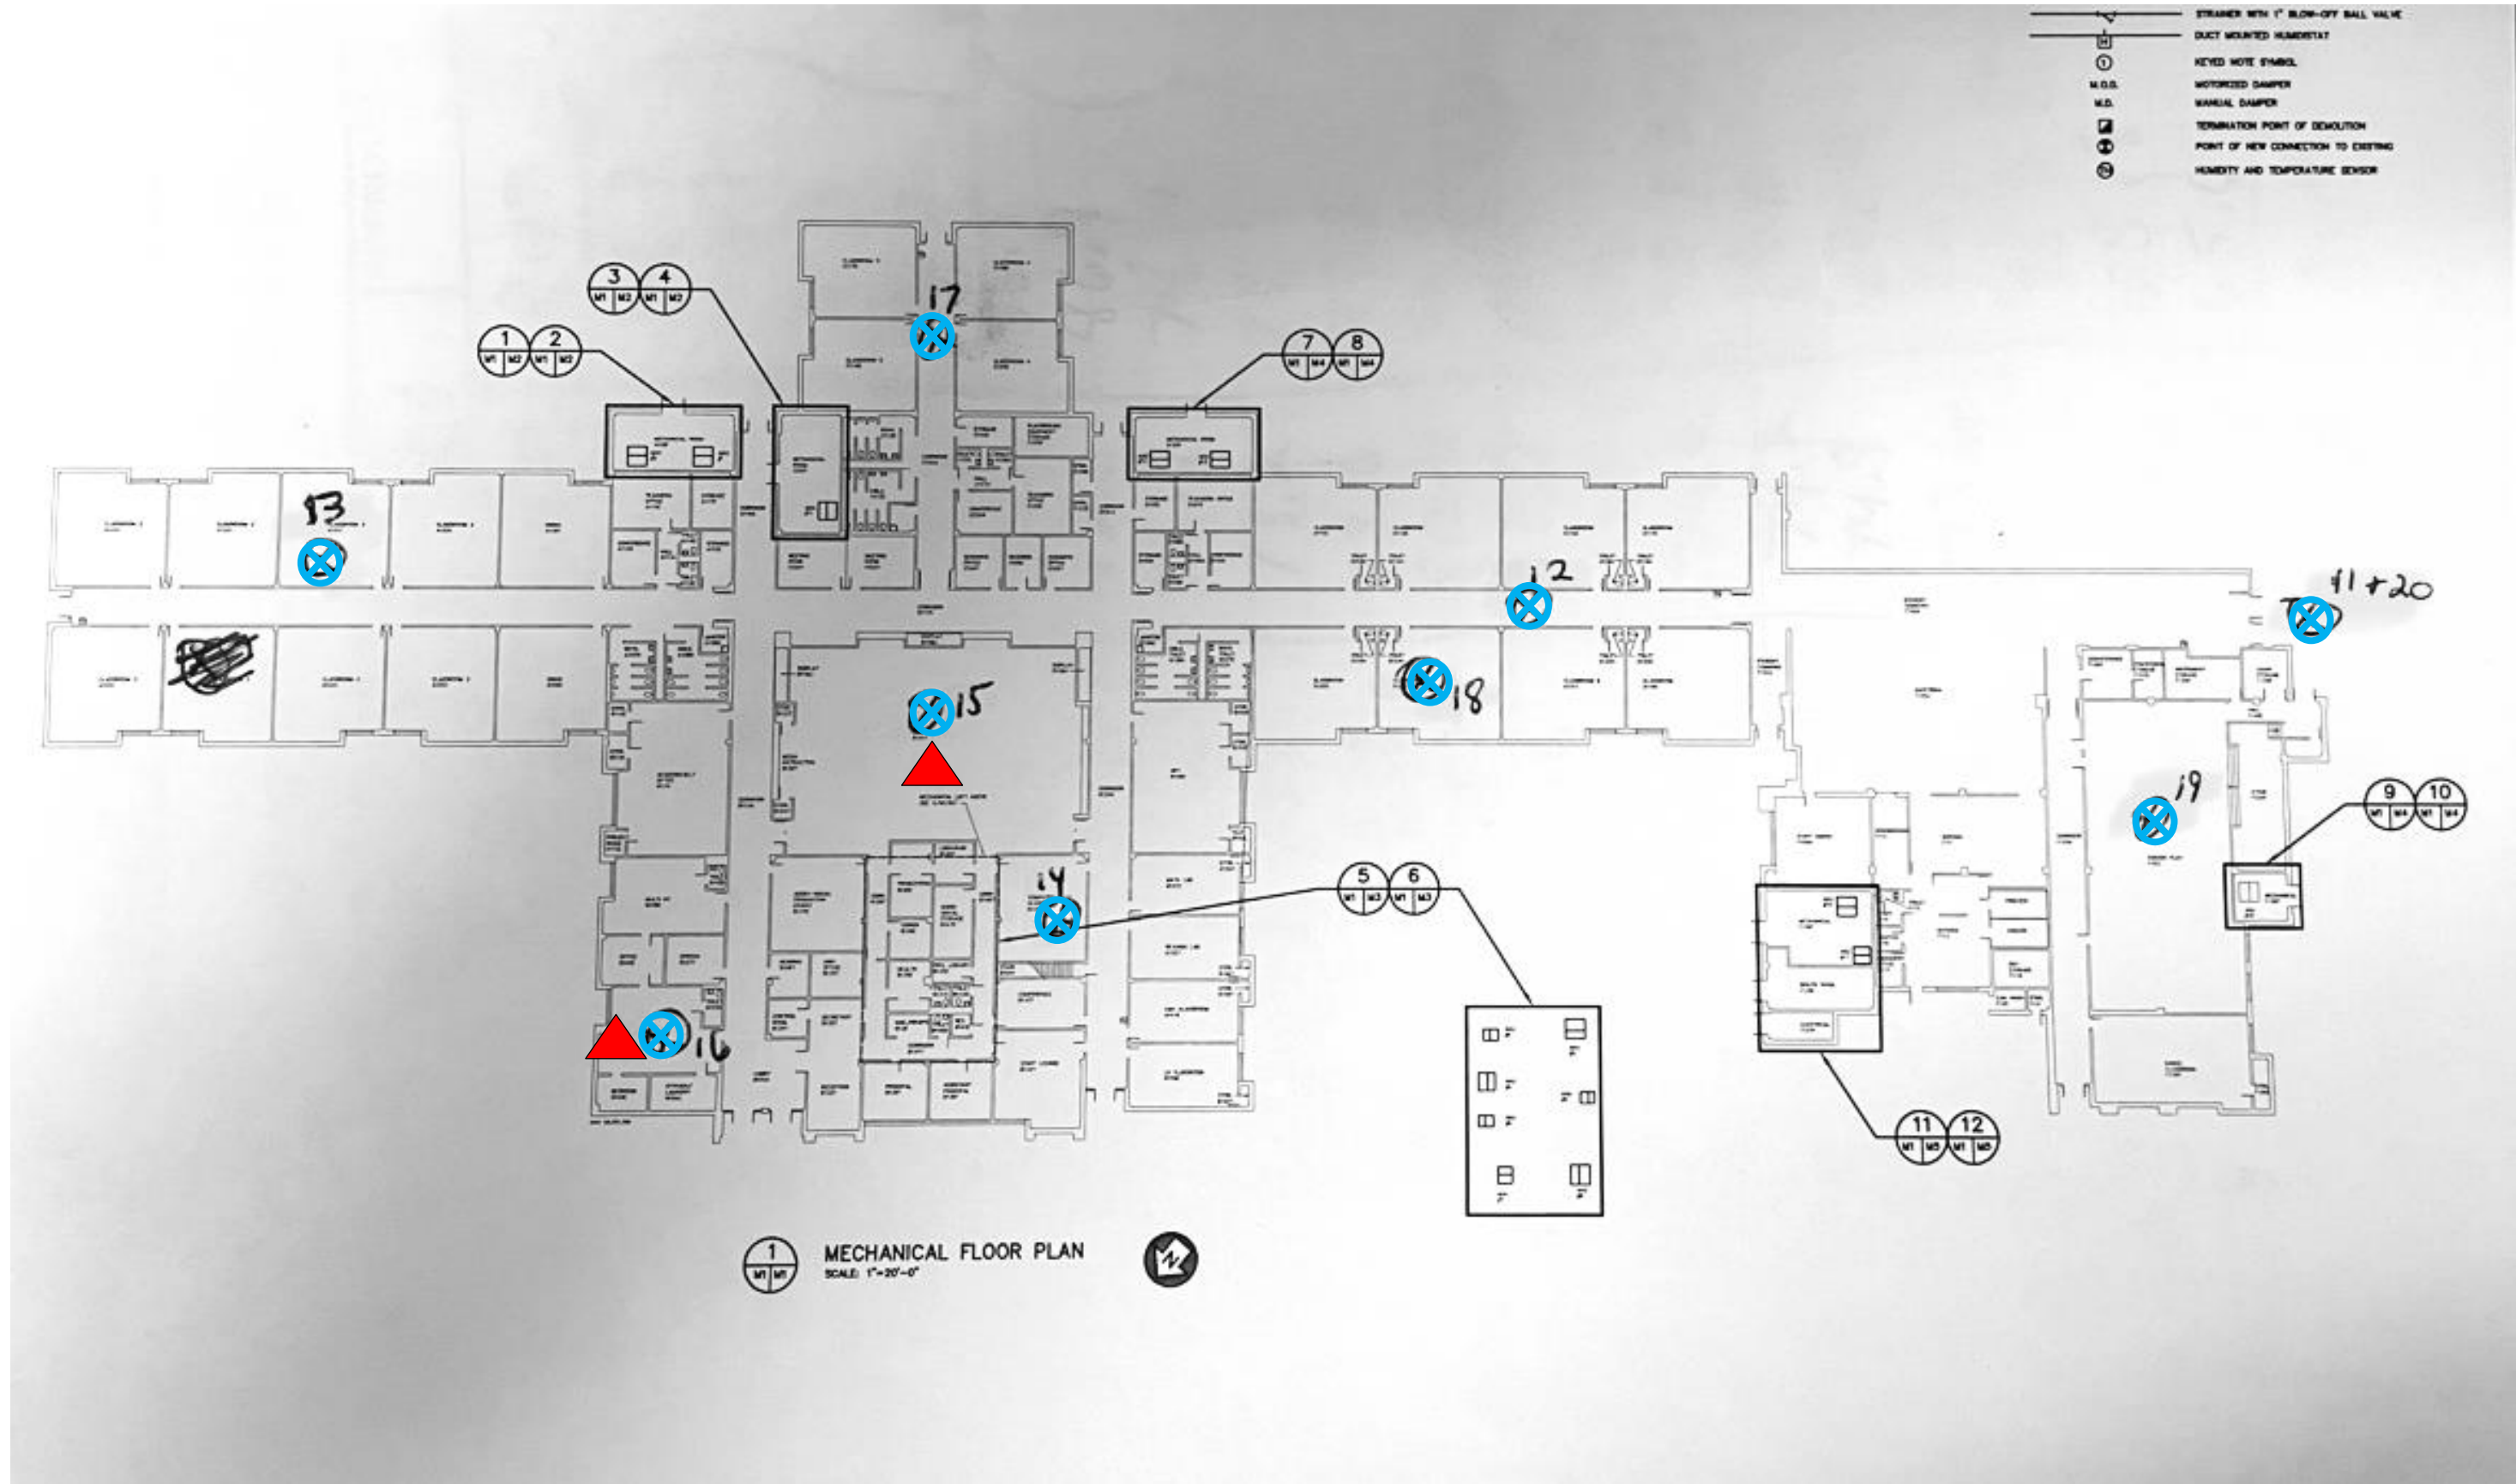
Figure 3

- Media Center
- Room B102

- Media Center
- Room B102

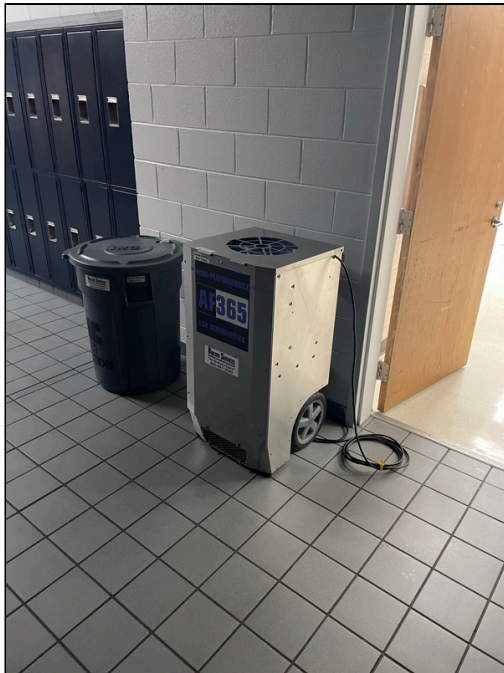
4 - Dehumidifiers were noted to be operating throughout each facility

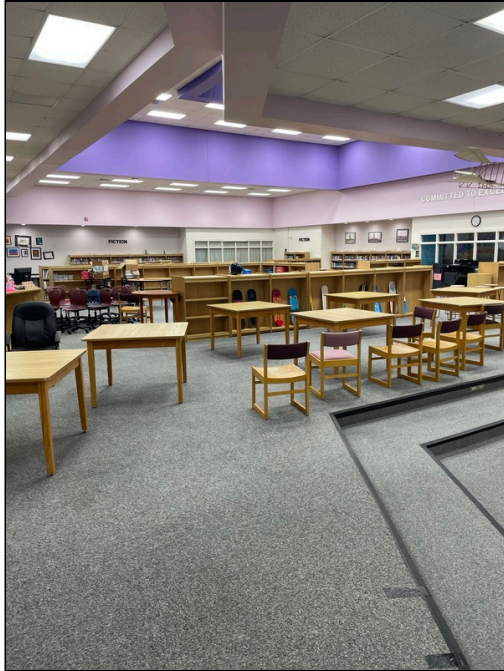
- Evidence of suspect visible mold growth was noted on books in the media centers and cloth items (bags) in various classrooms.
- Commercial dehumidifiers were in operation throughout each school at the time of assessment.
- Musty odors were not noted; and,
- The HVAC system was observed to be operating at the time of the assessment, but it was reported that facility-integrated dehumidifiers were not running.

7 - Media Center

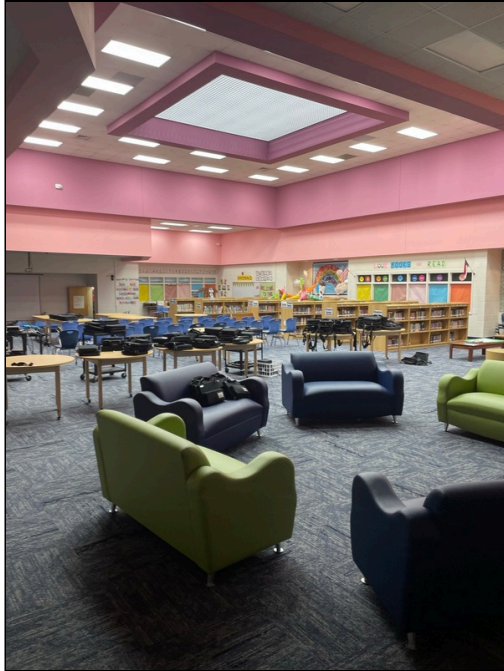
9 - Media Center
