# FACILITIES NEEDS ASSESSMENT

BORONDA DIAS

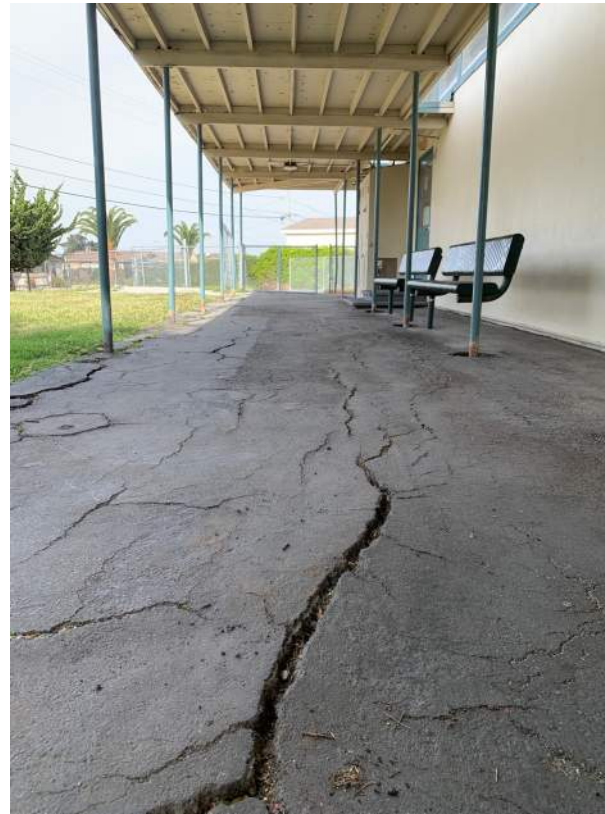
Images 2.1.2 Damaged walkways. Taken on 04/26/2022 by Belli Architectural Group.

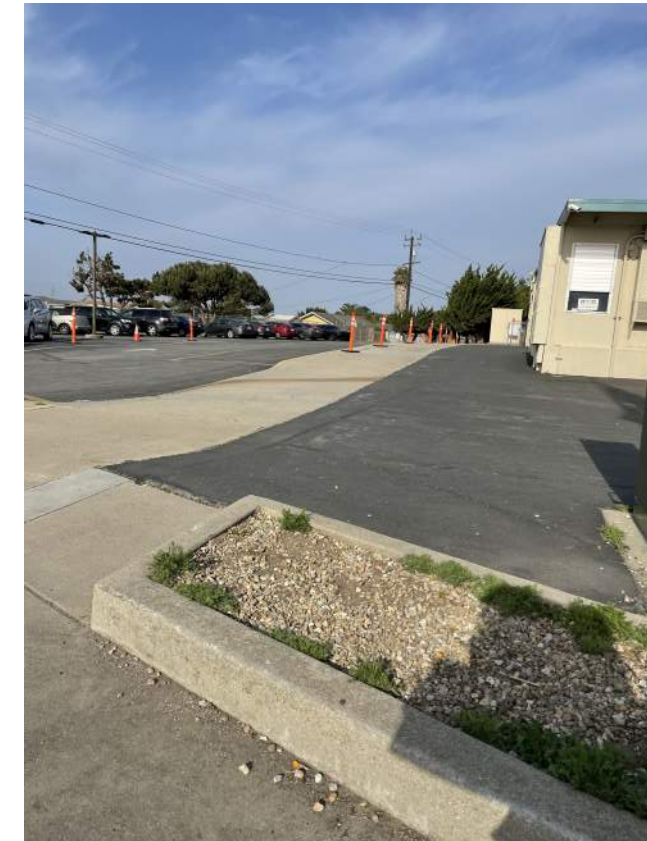
Image 2.1.4 Campus open to vehicular traffic. Taken on 04/26/2022 by Belli Architectural Group.

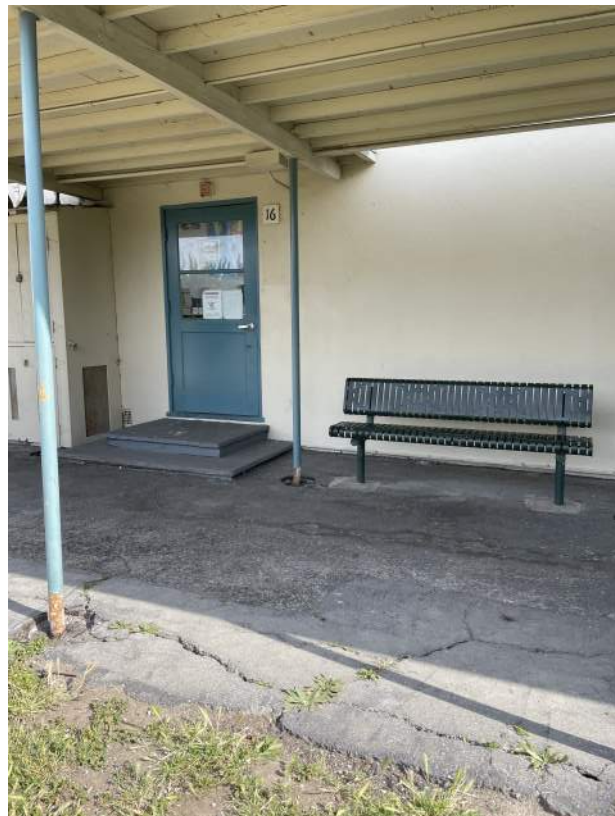
Image 2.1.1 Damaged walkways. Taken on 04/26/2022 by Belli Architectural Group.

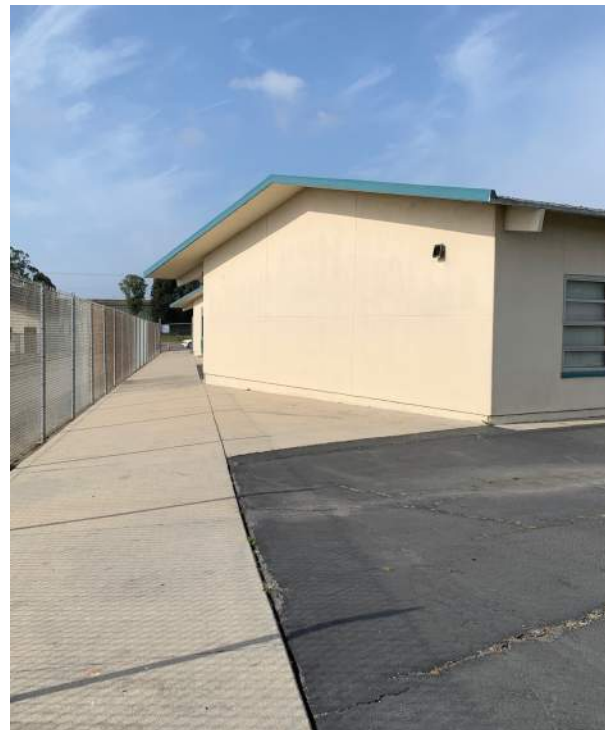
Image 2.1.3 Non-compliant cross-slope. Taken on 04/26/2022 by Belli Architectural Group.

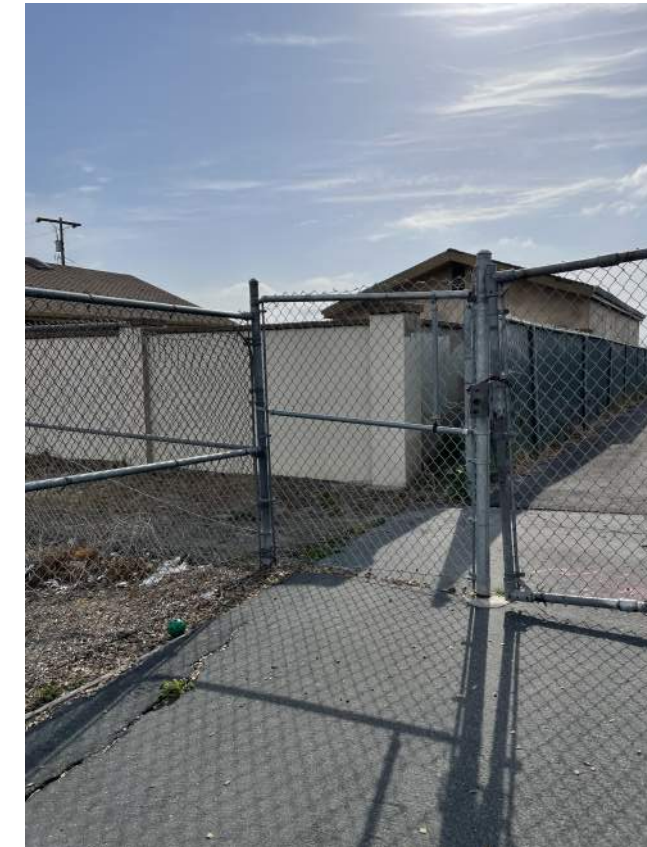
Image 2.1.5 Damaged fence. Taken on 04/26/2022 by Belli Architectural Group.

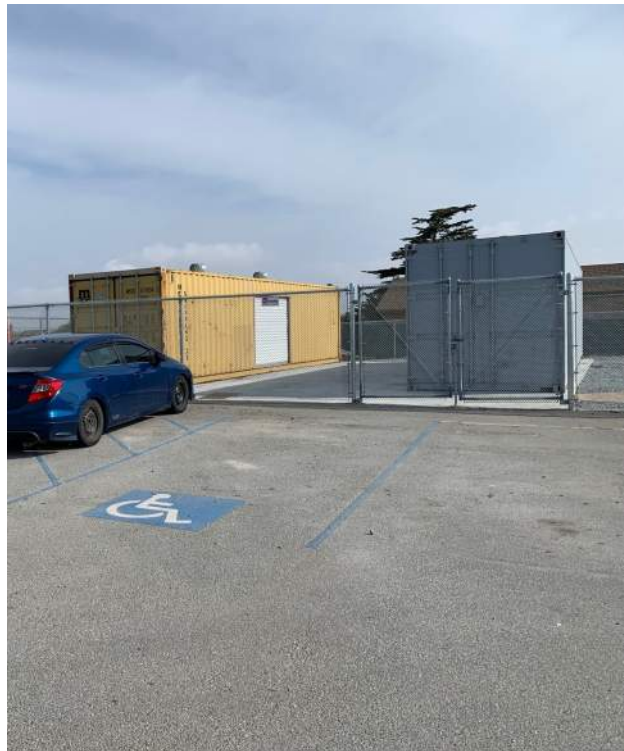
Image 2.1.6 Conex storage containers on site. Taken on 04/26/2022 by Belli Architectural Group.

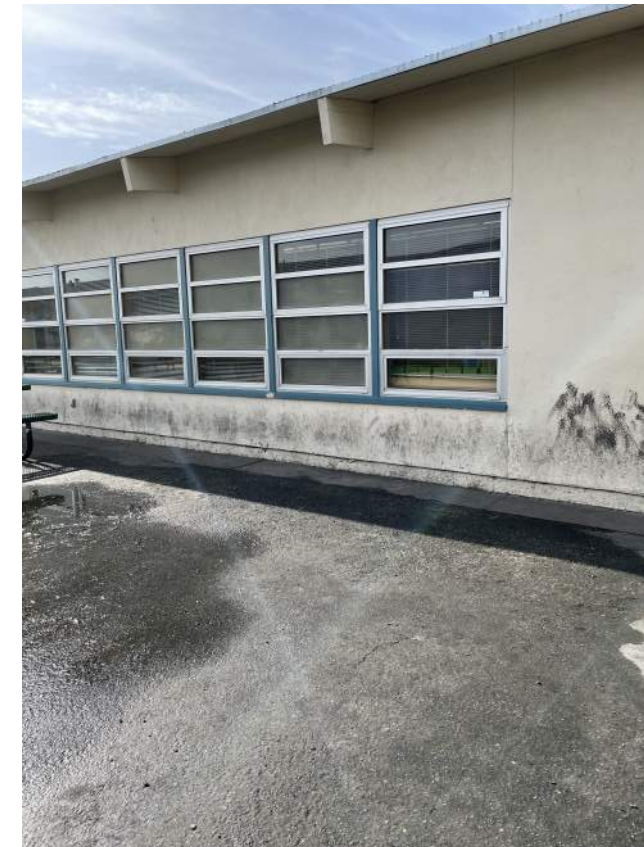
Image 2.2.1 Exterior paint conditions. Taken on 04/26/2022 by Belli Architectural Group.

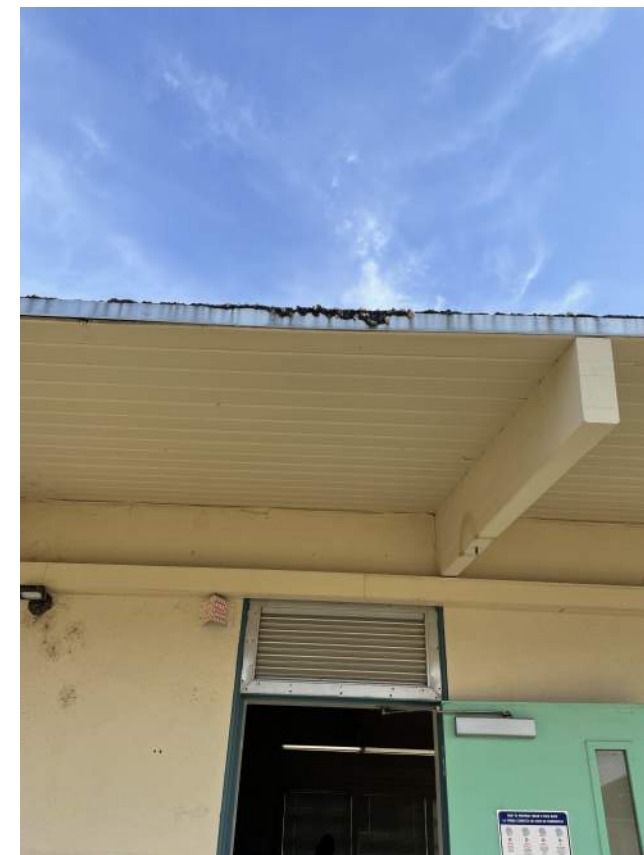
Image 2.2.2 Failing conditions at existing roof. Taken on 04/26/2022 by Belli Architectural Group.

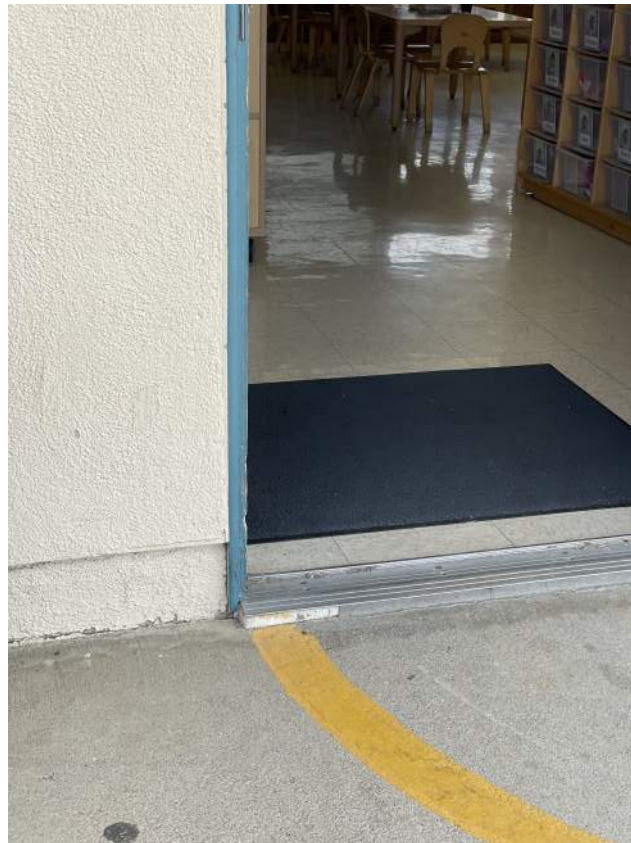
Image 2.2.3 Non-ADA compliant threshold. Taken on 04/26/2022 by Belli Architectural Group.

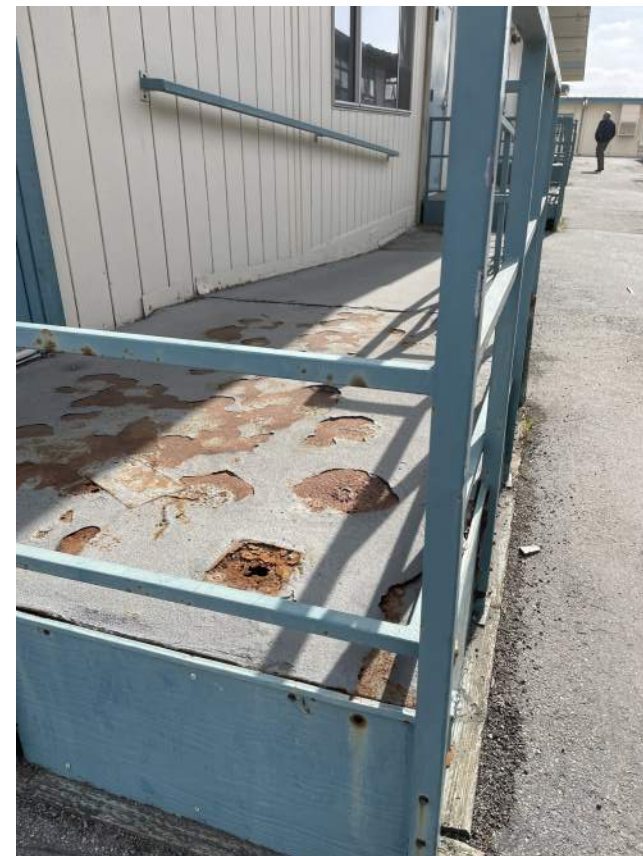
Image 2.2.5 Rust and holes present at portable access ramps. Taken on 04/26/2022 by Belli Architectural Group.

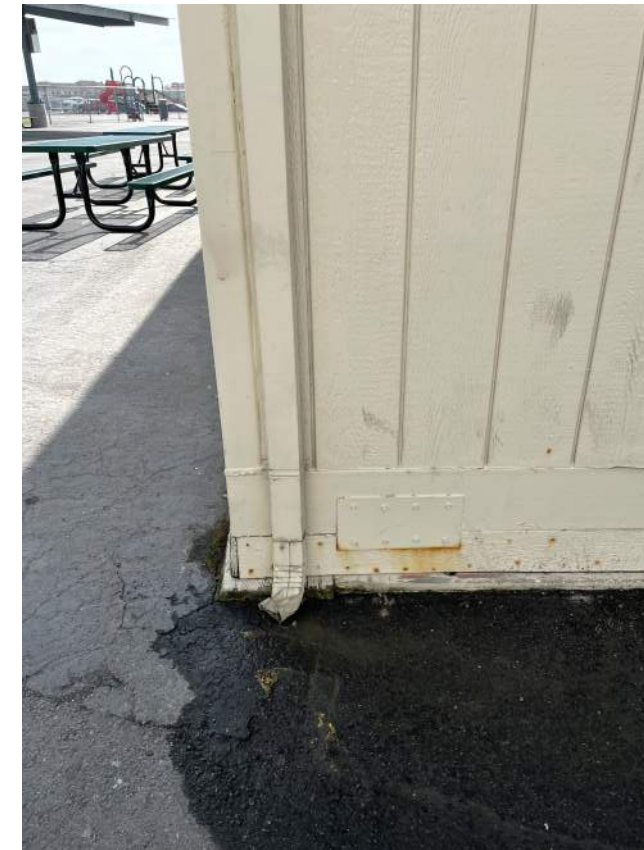
Image 2.2.7 Damaged gutter at portable classroom. Taken on 04/26/2022 by Belli Architectural Group.

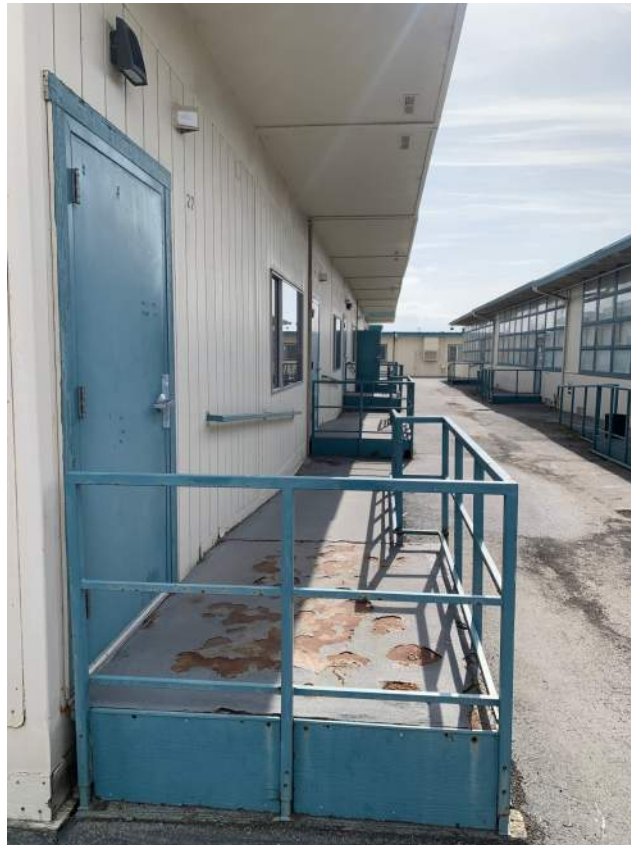
Image 2.2.4 Existing conditions at portable classrooms. Taken on 04/26/2022 by Belli Architectural Group.

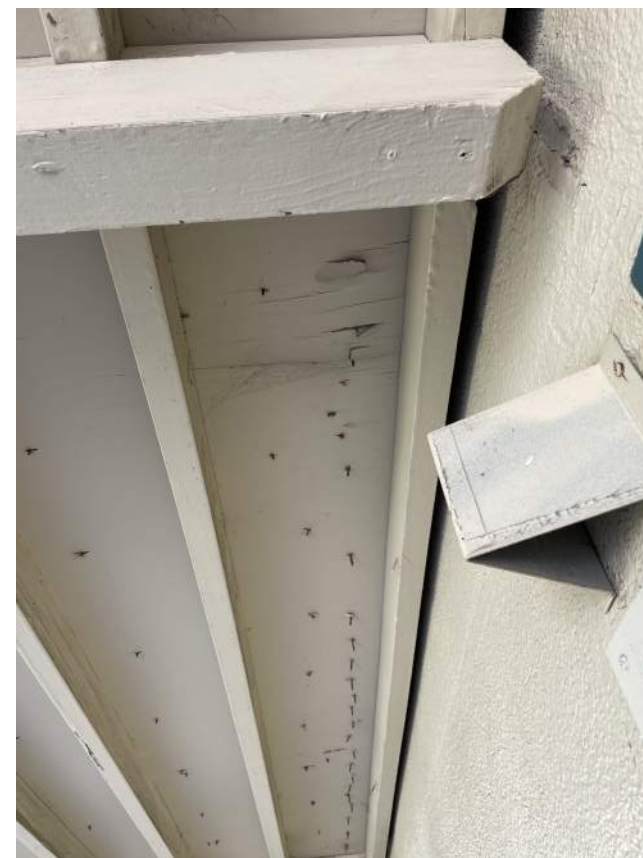
Image 2.2.6 Exposed nails present at portable classrooms. Taken on 04/26/2022 by Belli Architectural Group.

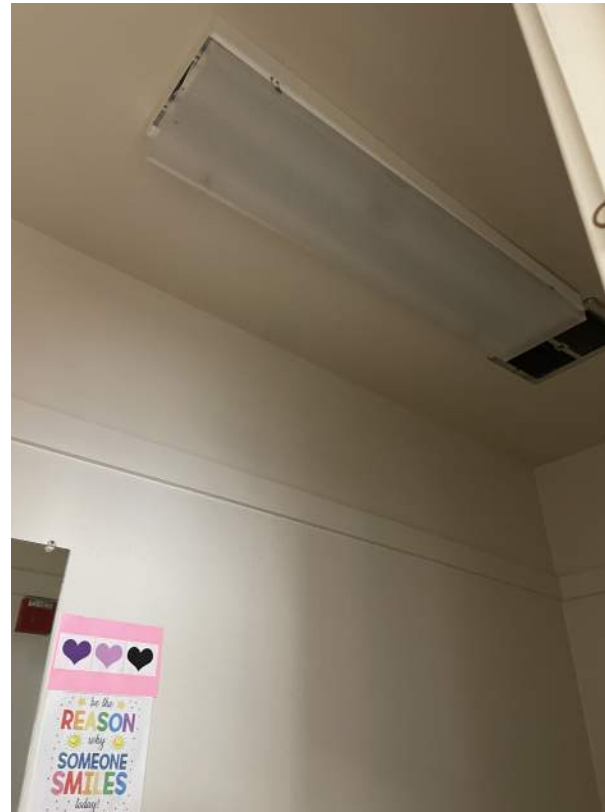
Image 2.3.1 Damaged light fixture. Taken on 04/26/2022 by Belli Architectural Group.

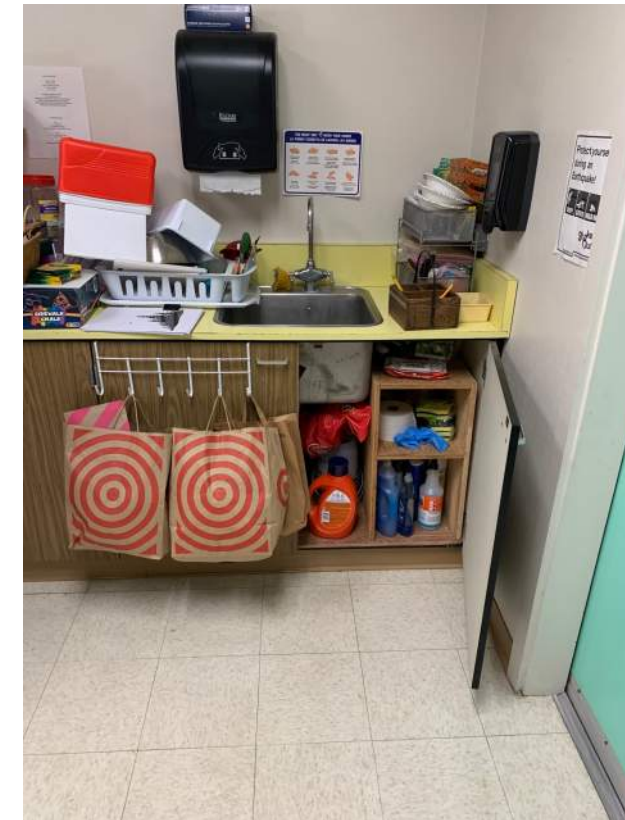
Image 2.3.5 Older finish materials and non-accessible sink. Taken on 04/26/2022 by Belli Architectural Group.

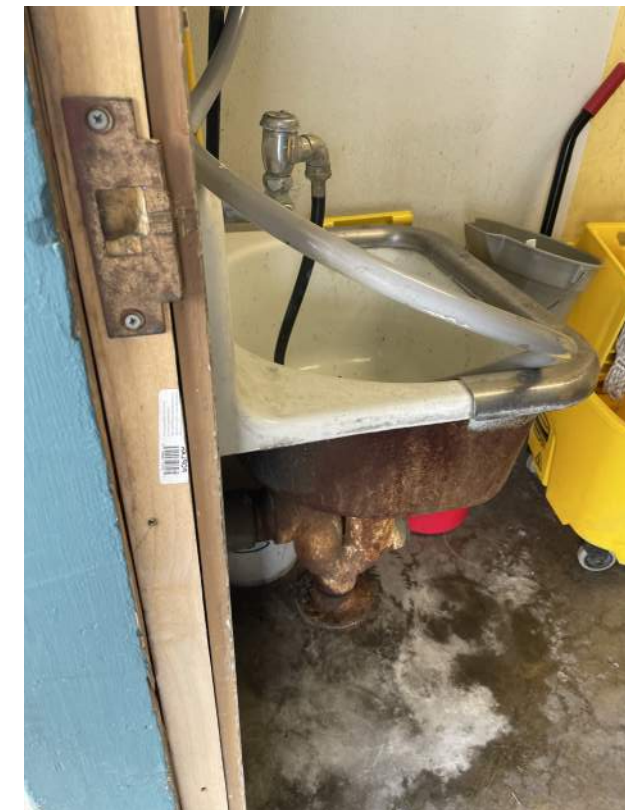
Image 2.3.6 Rust and deterioration at Janitorial Room. Taken on 04/26/2022 by Belli Architectural Group.

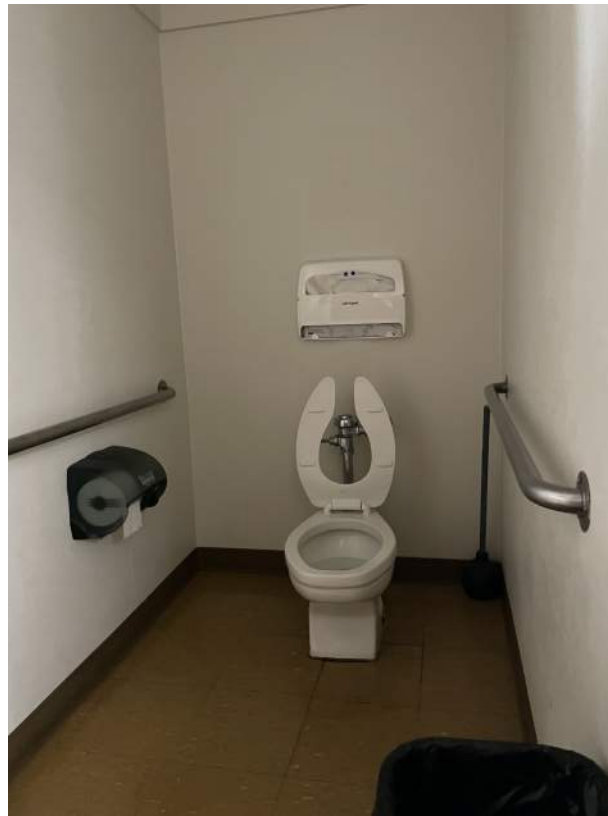
Image 2.3.7 Non-compliant restroom at Admin. Office. Taken on 04/26/2022 by Belli Architectural Group.

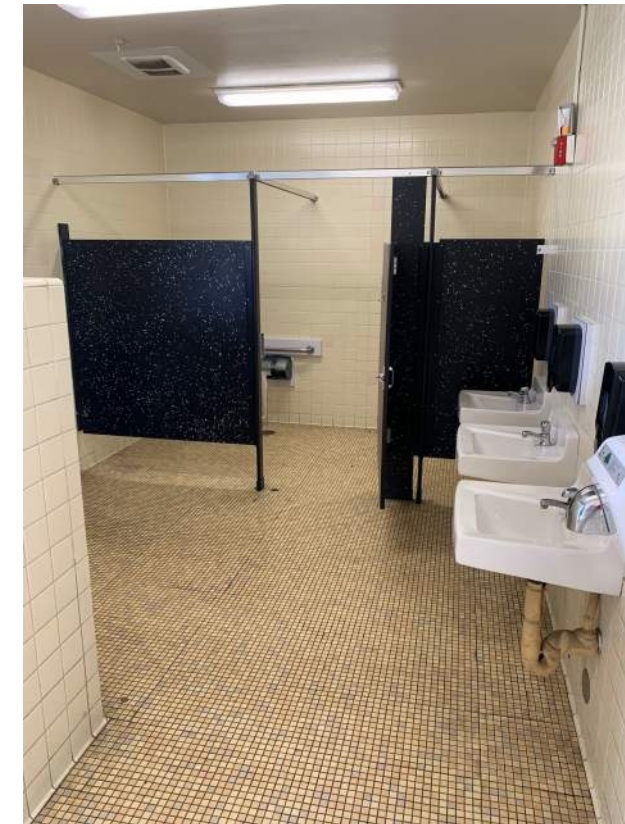
Image 2.3.11 Outdated, worn restroom conditions. Taken on 04/26/2022 by Belli Architectural Group.

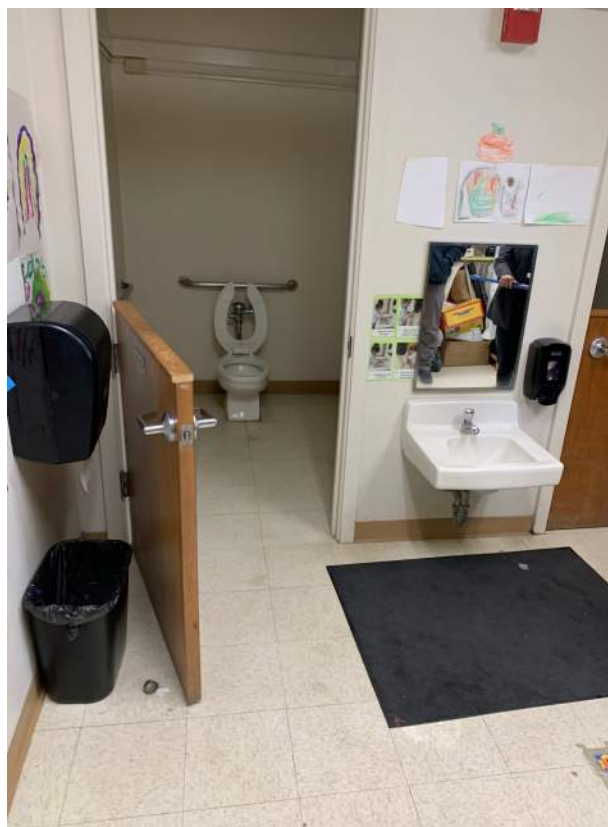
Image 2.3.8 Existing non-compliant Kindergarten restrooms. Taken on 04/26/2022 by Belli Architectural Group.

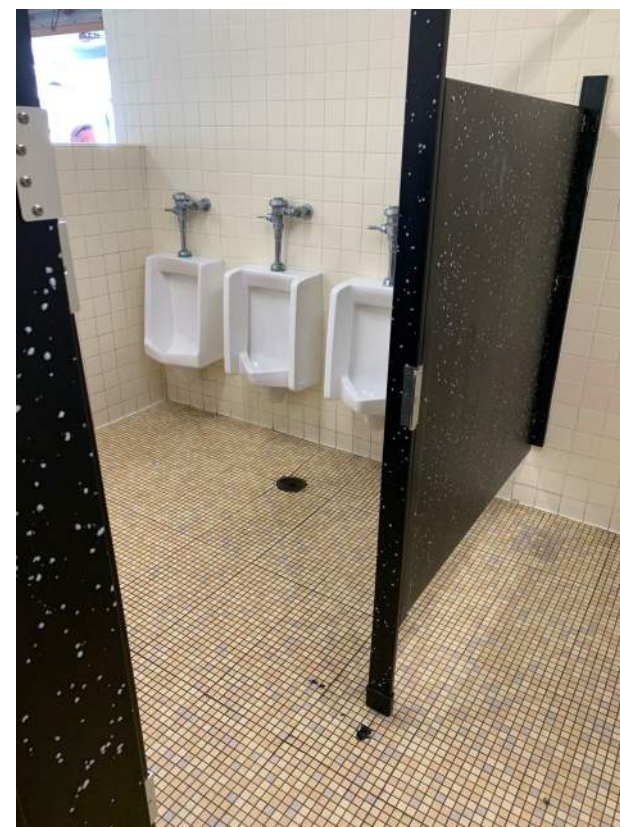
Image 2.3.10 Outdated, worn restroom conditions. Taken on 04/26/2022 by Belli Architectural Group.

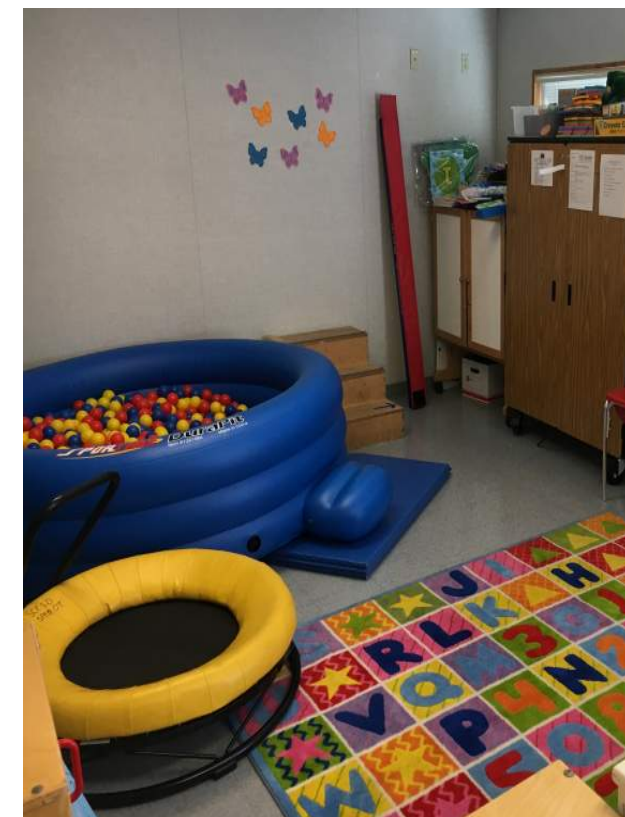
Image 2.3.12 Preschool. Taken on 04/26/2022 by Belli Architectural Group.

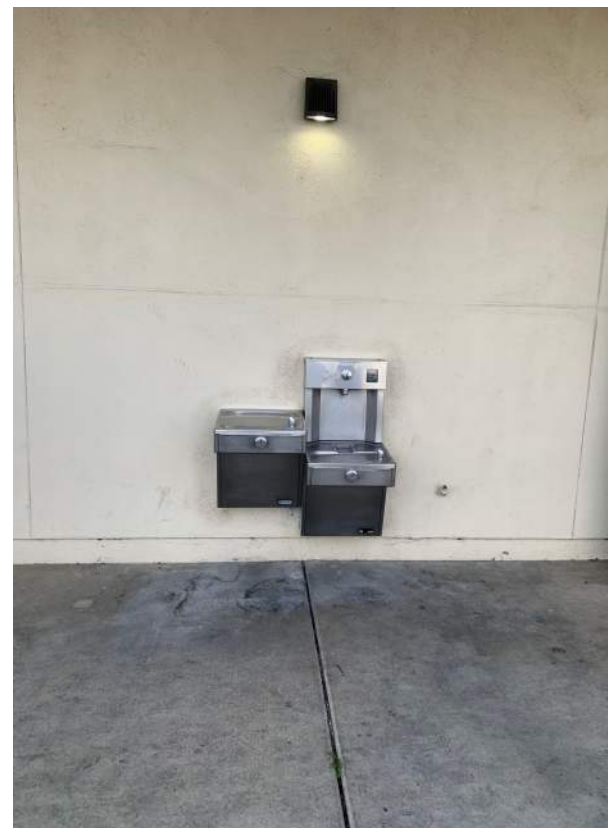
Image 2.4.2 Drinking fountains missing cane rails detection. Taken on 04/26/2022 by Belli Architectural Group.

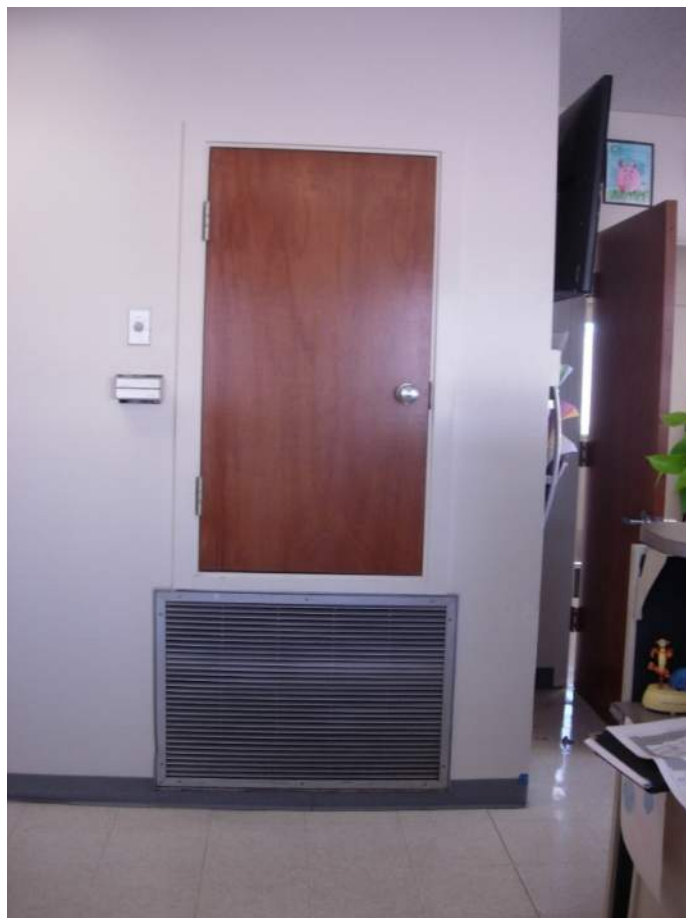
Classrooms 1 thru 6, 10 thru 16 and the Kinder Classroom:

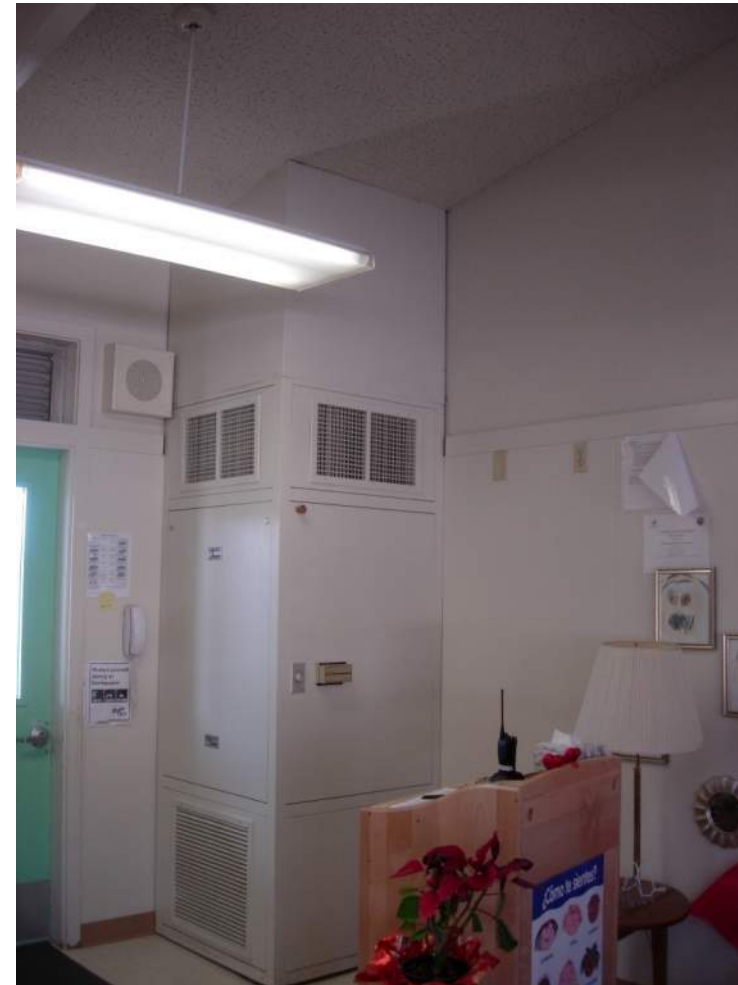
Classroom 7 thru 9, 23 thru 27, 30 thru 34, Library and Multi-Purpose Building:

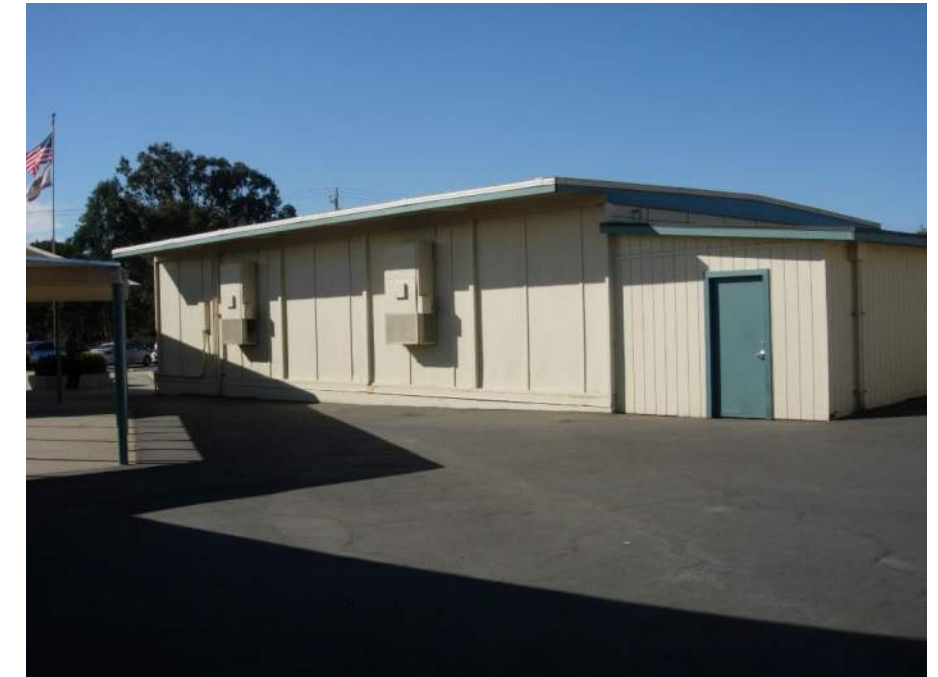
These are portable classroom consisting of the exterior wall mounted "Bard" type heat pump units. All portables utilize this type of equipment. These units throughout the campus appear to be from the 2003 modernization and should be replaced with new units. A new unit was recently installed in Classroom 8. The photo below is off the Library.

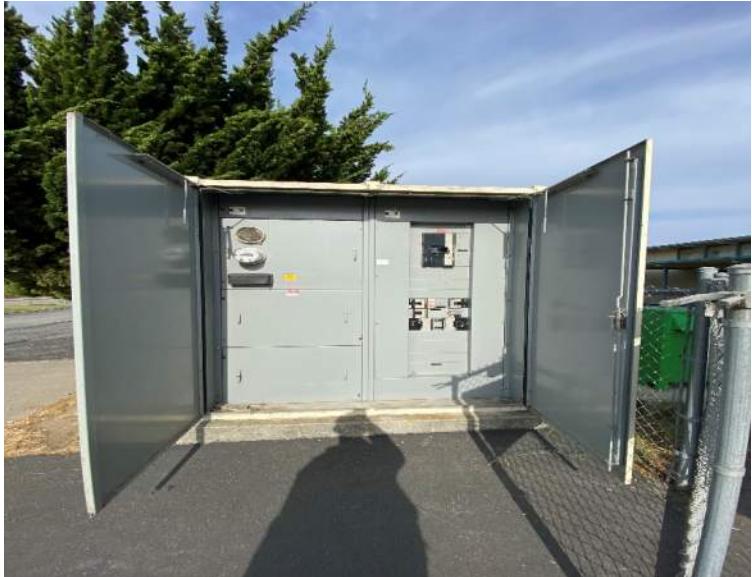
The raceways associated with low voltage systems around the campus may need to be verified/inspected for re-use where additional fiber optic cables/network cabling for any low voltage system upgrades is deemed necessary in order to verify cost impact of new trench vs. existing underground conduit re-use. Where a new building may be proposed at this site, an electrical survey will need to be completed and it is likely that the new building will require an Electrical (PG&E) service upgrade to accommodate any new proposed building (should an equivalent number of buildings/rooms not be slated to be removed due to new building added). In addition, Site Telecom, Fire Alarm, and Low Voltage Systems will need upgrades to accommodate new connections with newer technology and EM Voice Evacuation Fire Alarm System.
