FACILITIES NEEDS ASSESSMENT

BORONDA MEADOWS

PREPARED BY BELLI ARCHITECTURAL GROUP

2022

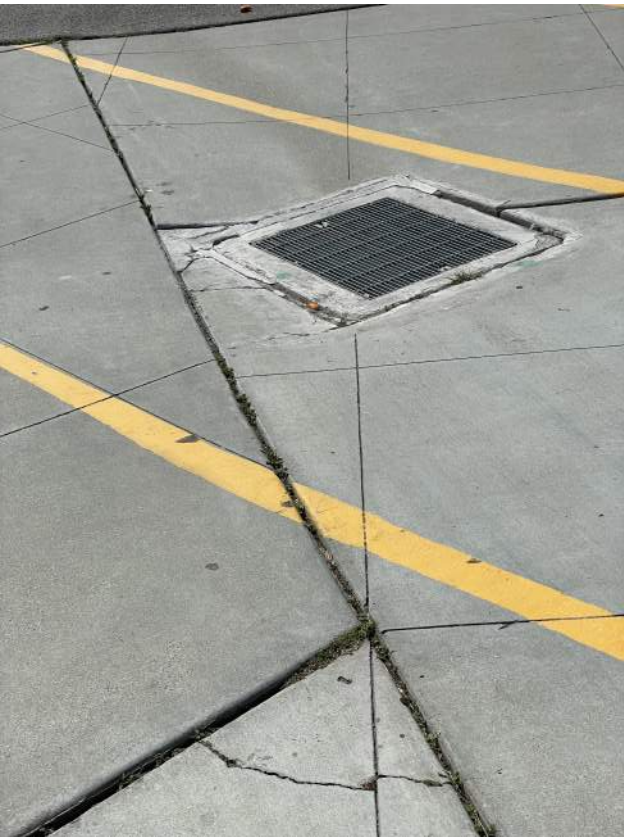
Image 2.1.1 Cracks in concrete walkways. Taken on 04/26/2022 by Belli Architectural Group.

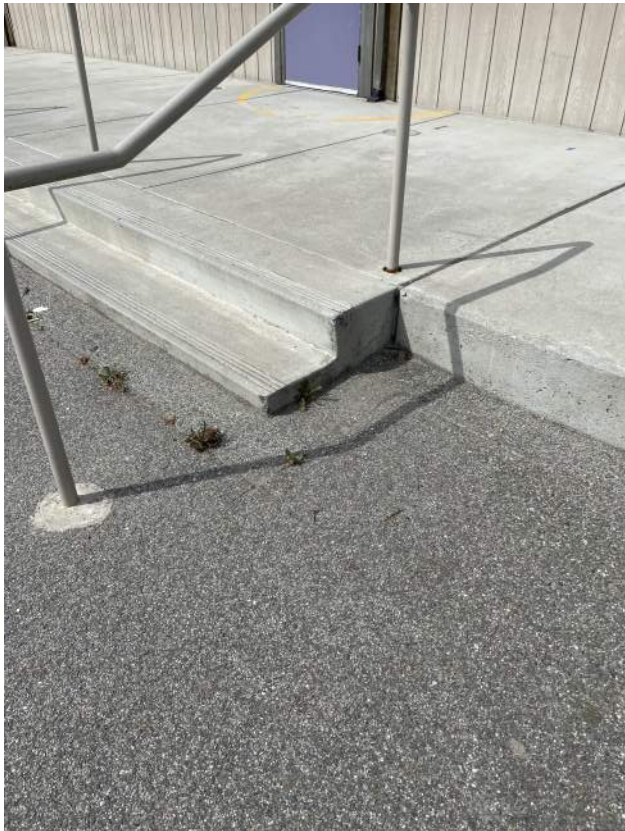
Image 2.1.2 Ingrown vegetation in asphalt. Taken on 04/26/2022 by Belli Architectural Group.

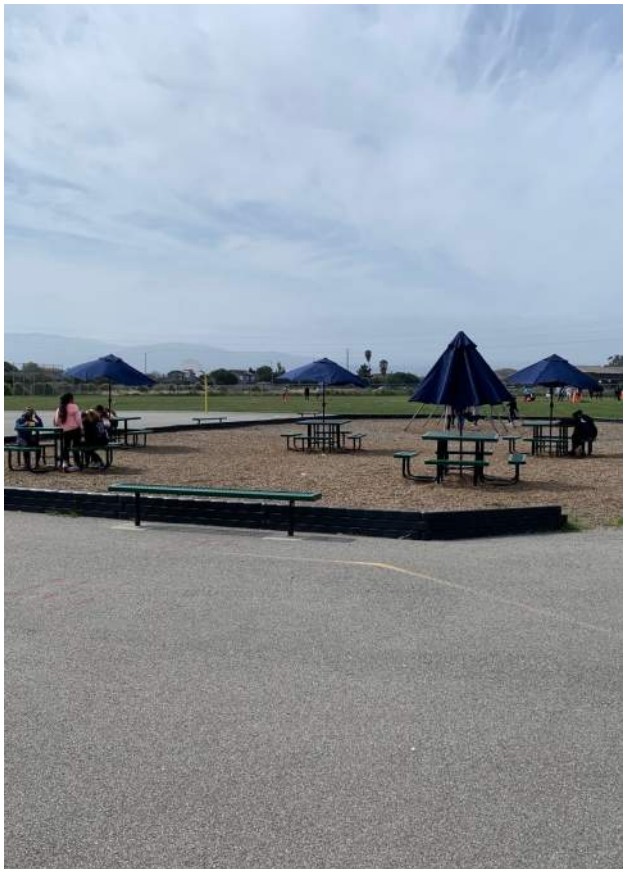
Image 2.1.3 Fading striping at asphalt. Taken on 04/26/2022 by Belli Architectural Group.

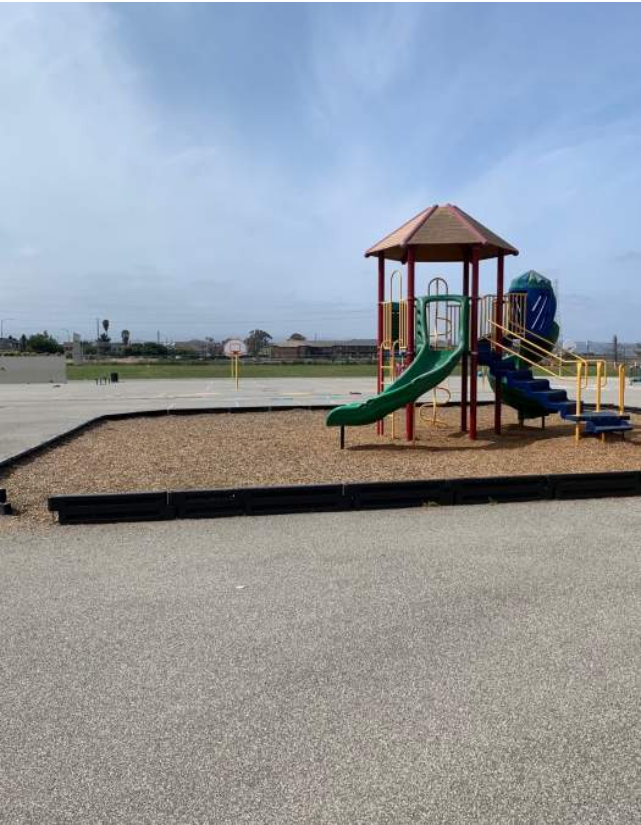
Image 2.1.4 Non-accessible play structure. Taken on 04/26/2022 by Belli Architectural Group.

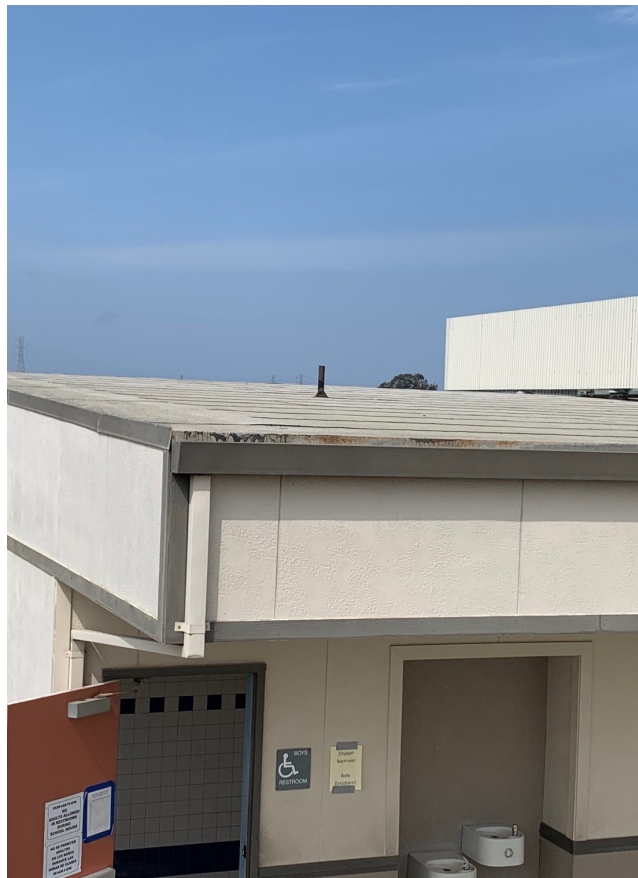
Image 2.2.1 Existing roof at permanent classroom building. Taken on 04/26/2022 by Belli Architectural Group.

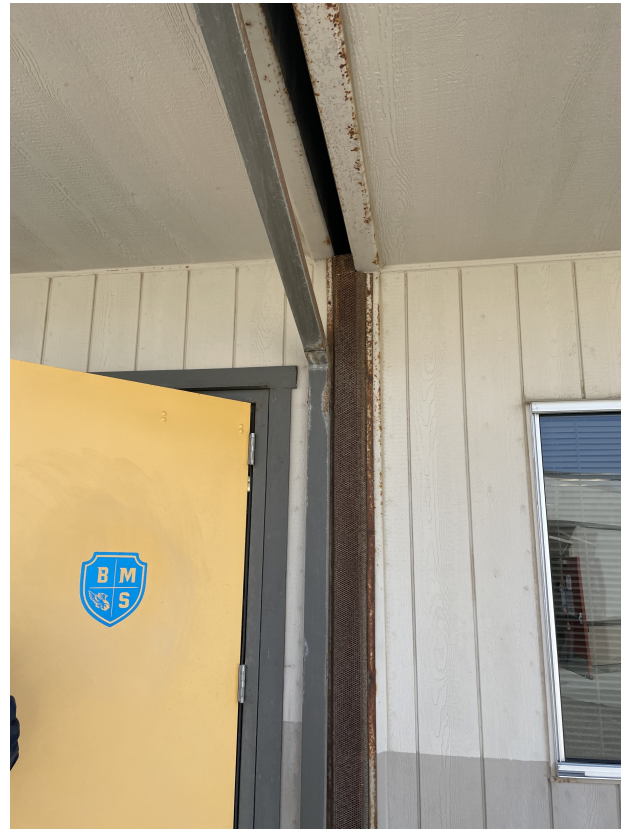
Image 2.2.2 Rust and rot at relocatable classroom. Taken on 04/26/2022 by Belli Architectural Group.

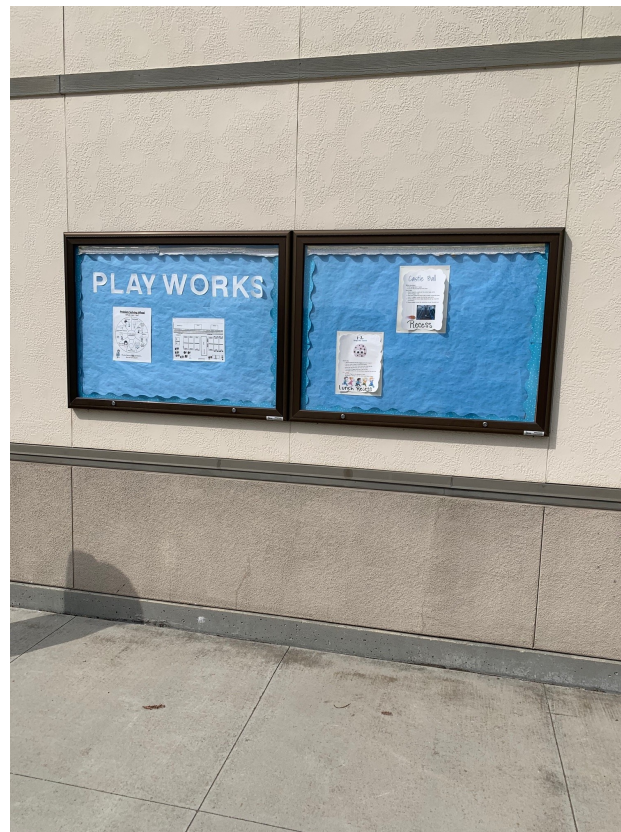
Image 2.2.3 Exterior paint conditions. Taken on 04/26/2022 by Belli Architectural Group.

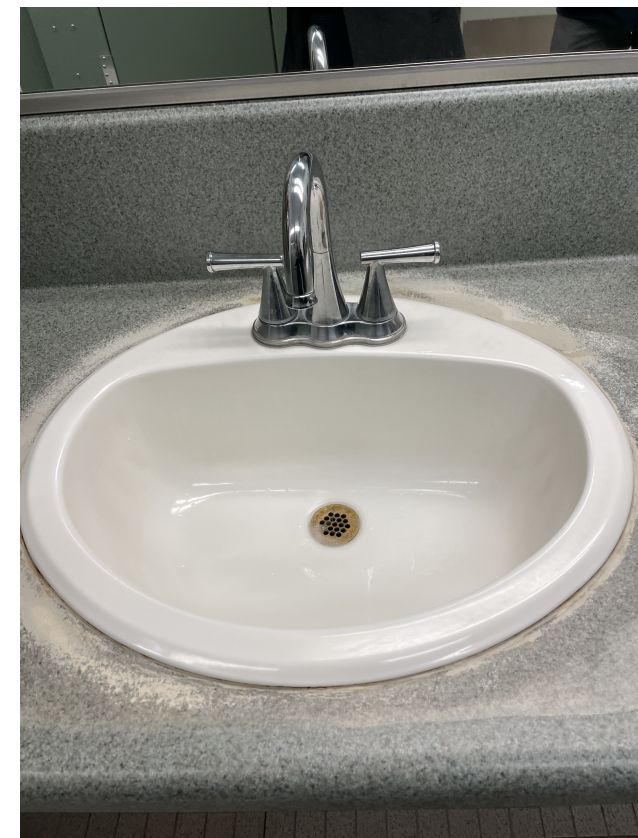
Image 2.3.1 Damaged countertop surfaces in restrooms. Taken on 04/26/2022 by Belli Architectural Group.

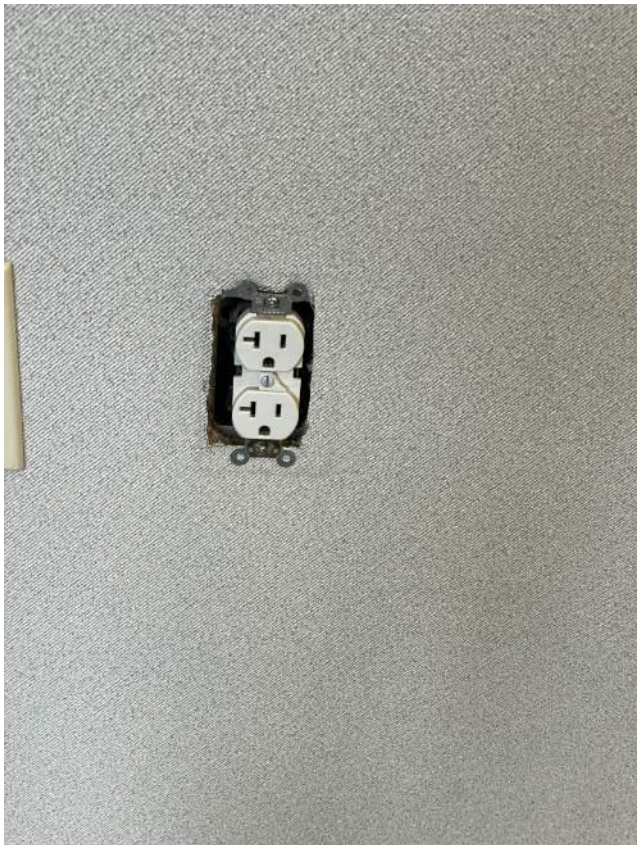
Image 2.3.2 Cover plates missing at electrical outlet. Taken on 04/26/2022 by Belli Architectural Group.

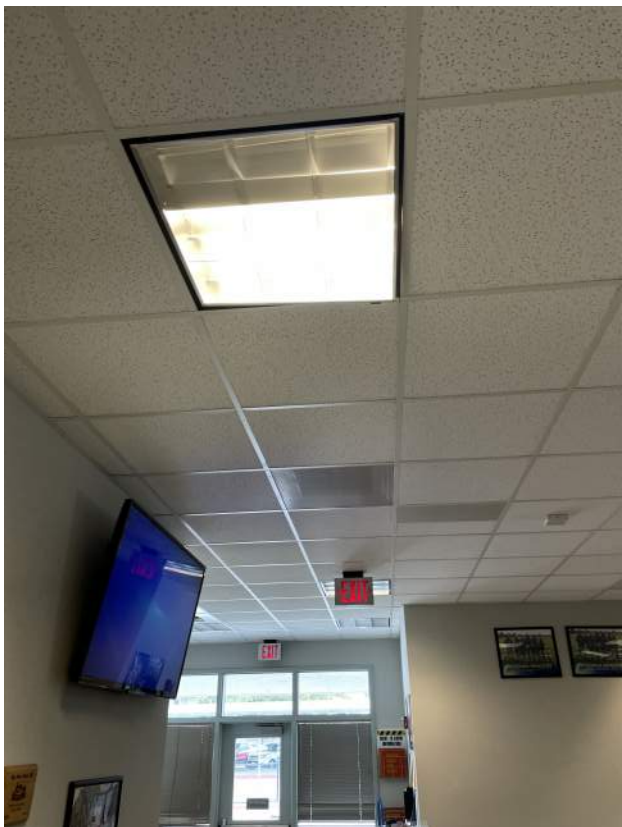
Image 2.3.4 Unbolted light fixture. Taken on 04/26/2022 by Belli Architectural Group.

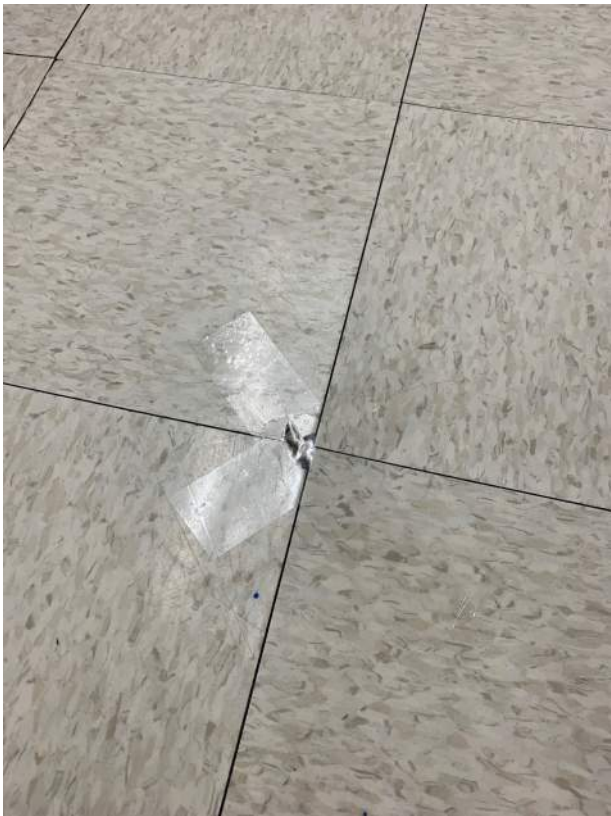
Image 2.3.6 Aging relocatable classroom floor. Taken on 04/26/2022 by Belli Architectural Group.

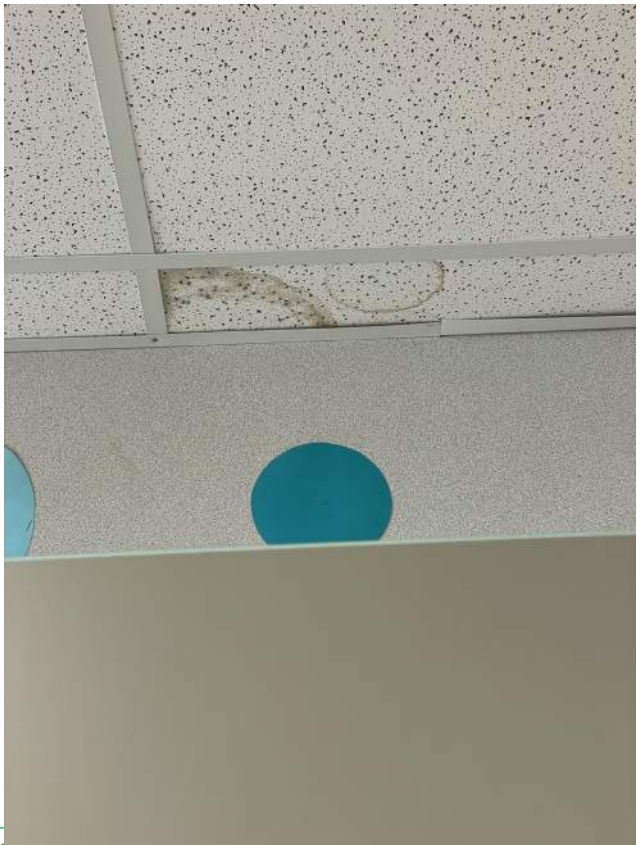
Image 2.3.3 Damaged ceiling tiles. Taken on 04/26/2022 by Belli Architectural Group.

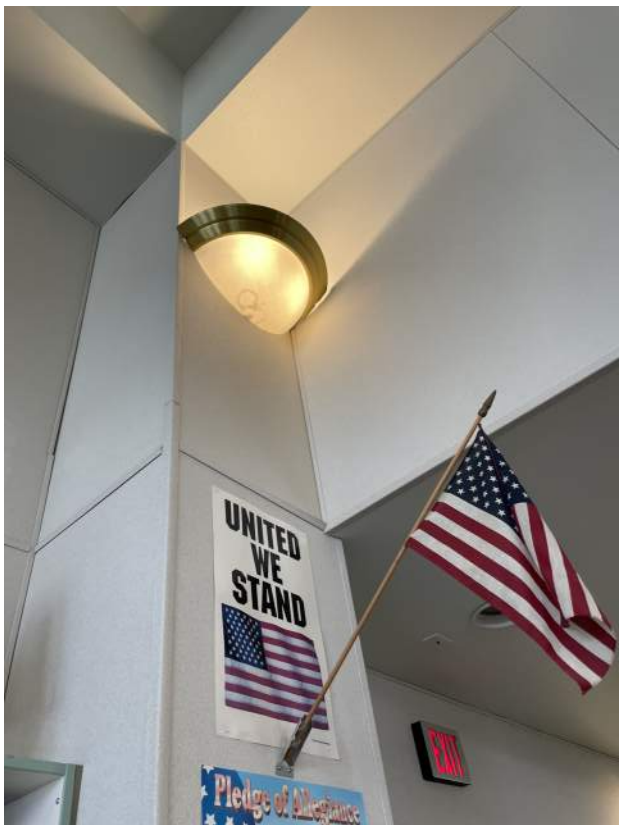
Image 2.3.5 Dirty light fixture. Taken on 04/26/2022 by Belli Architectural Group.

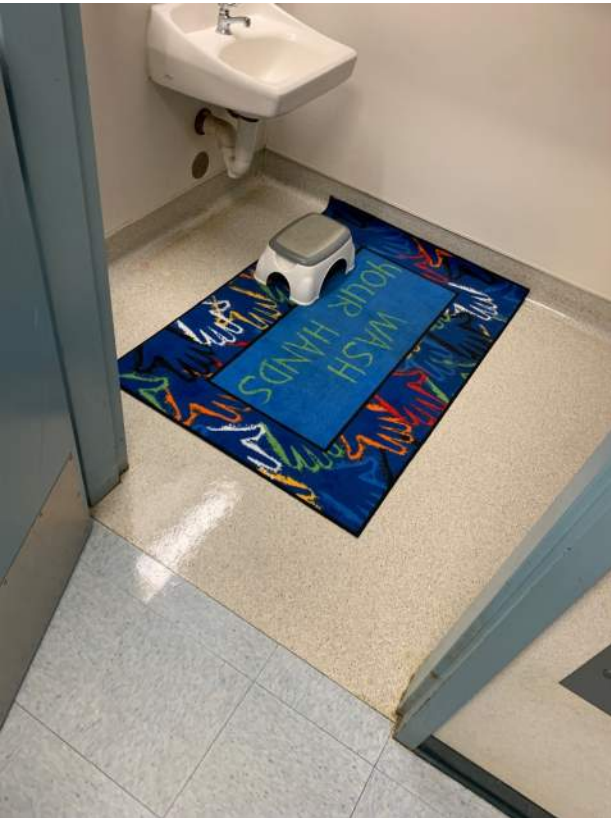
- Hand-washing sinks at kindergarten/preschool restrooms are not mounted at compliant heights for user age group.

Image 2.4.1 Kindergarten/preschool sinks at non-accessible height for students. Taken on 04/26/2022 by Belli Architectural Group.

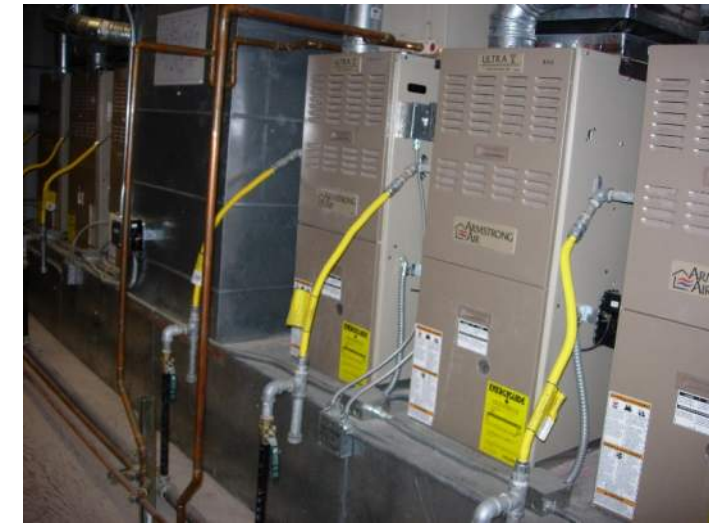
The heating system for this building consist of six (6) Armstrong up-flow gas-fired furnaces located in the attic. These furnaces are original and appear to be in good condition and operating satisfactory. Only one of these units has cooling (air conditioning). In 2010, a small Fujitsu split system cooling only unit was added to cool the IT Data/Server Room that was created. The ductwork from the furnace that is serving this space was not disconnected. It may be, that on a call for heat from the thermostat in the adjacent room, this room would be receiving heat. This duct should be capped.

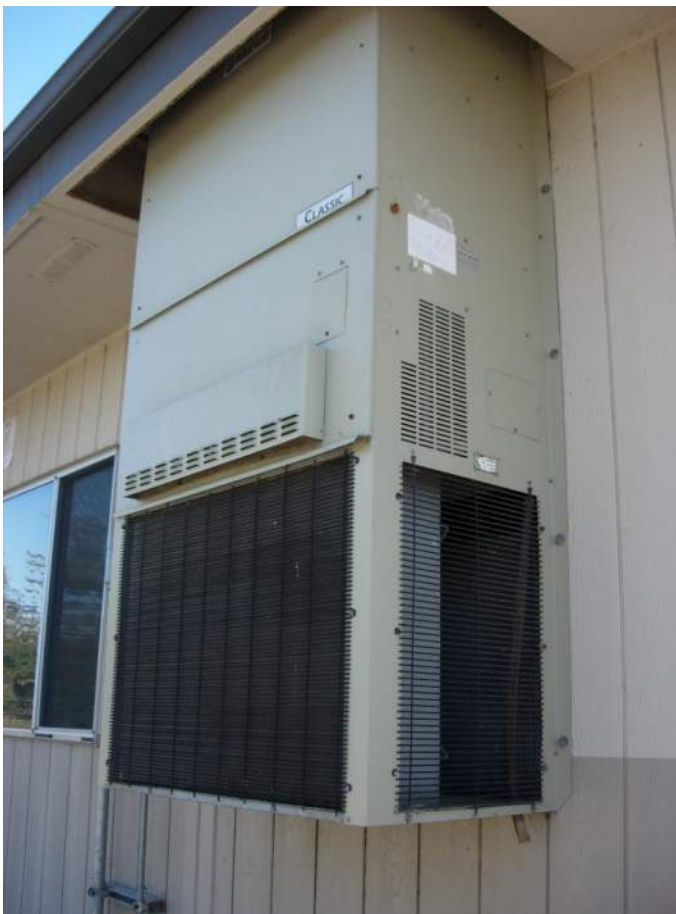
These are portable classrooms consisting of the exterior wall mounted “Bard” type heat pump units. All portables utilize this type of equipment. These units appear to be original and are operating. Older (20 years) units become a continual maintenance problem and should be replaced with new units.

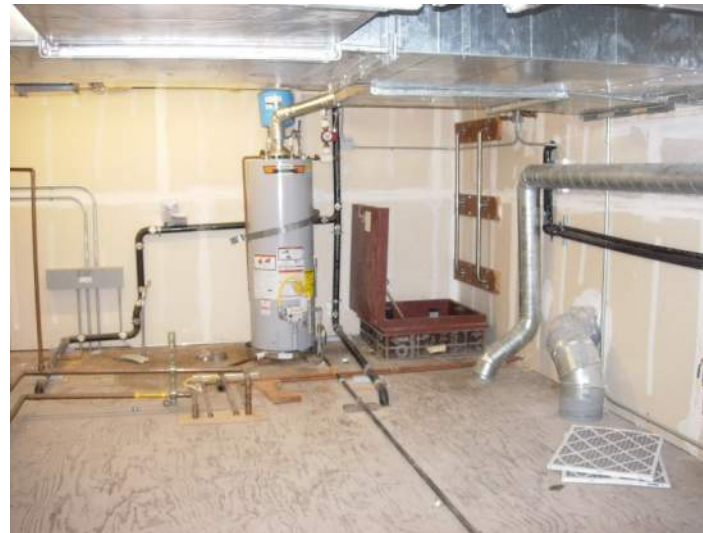
A gas-fired tank type water heater located in the attic serves this building. This water heater was recently replaced. The DSA approved seismic bracing was not reinstalled.

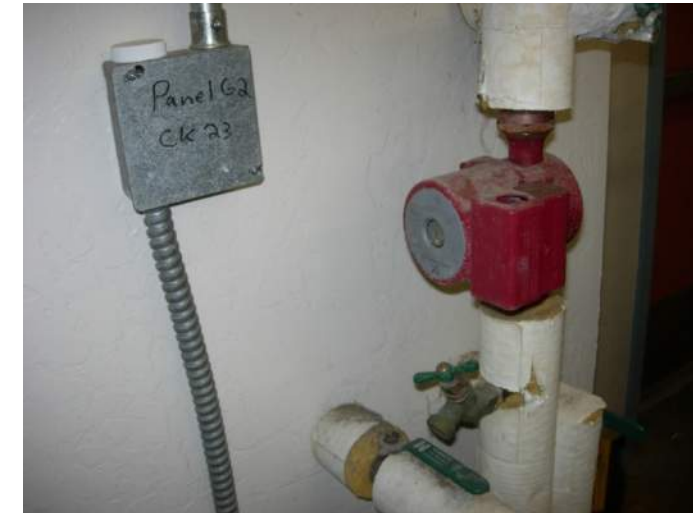
These buildings (there are four of them) have small electric tank type water heaters located in a janitor's closet. A small hot water recirculating pump that was installed when the school was built were never connected to a power source. These pumps require power to operate as designed.

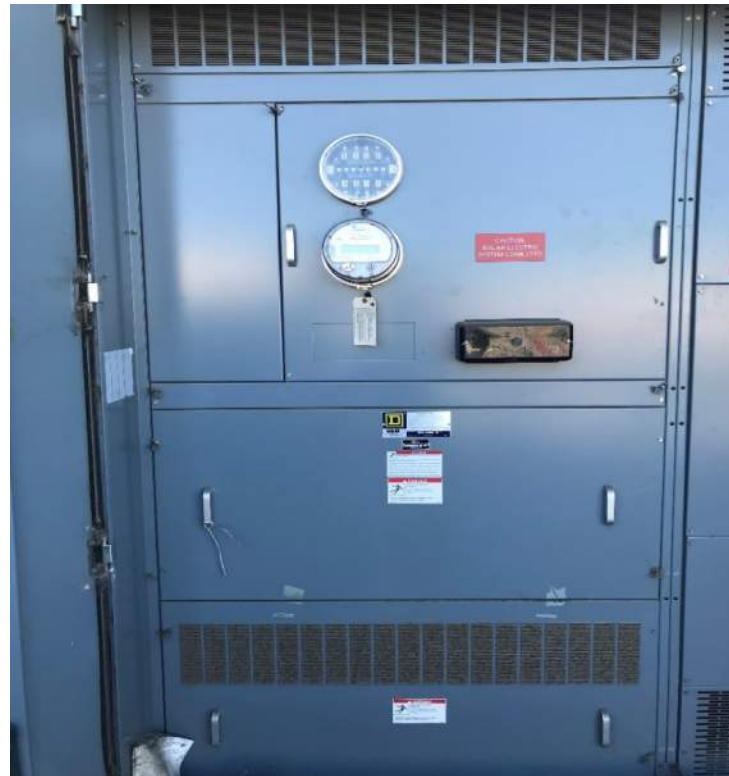
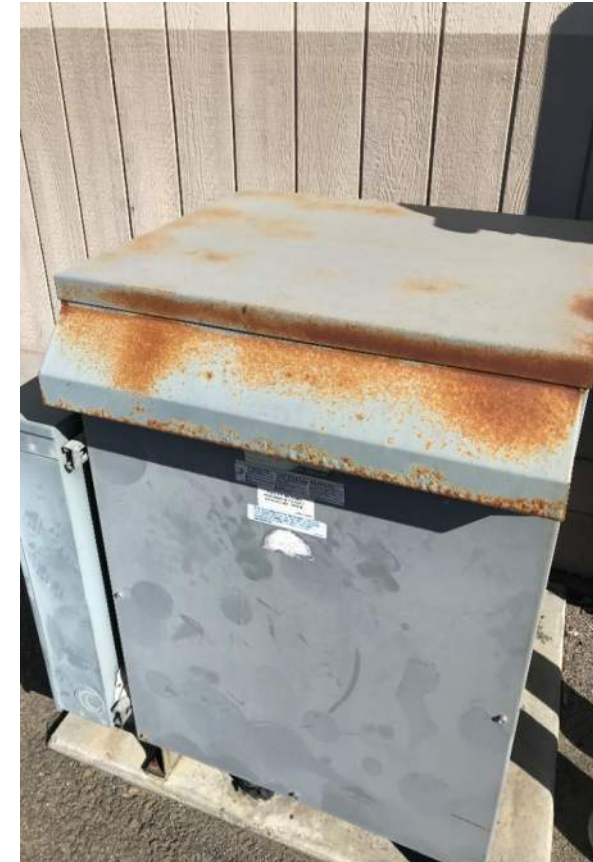
There is (1) existing main “metered” electrical service switchboard (MSB). MSB is a 2500 amp, 480/277 volt, 3 phase, NEMA 3R, Square D, service located on the northeast side of the exterior office building. MSB has a connection for the existing Solar PV system. The Solar PV is connected ahead of the main breaker at MSB. MSB serves the entire school campus including modular buildings. Each building has a 480V-208V/120V, 3 phase, step-down transformer located outside the buildings. The transformers are old and rusty. Expected life; 8 to 13 yrs. Moreover, each building has a 480V/277V panel for the lighting and mechanical loads and a 208V/120V panel for plug loads and small appliances. MSB expected life; 20 to 25 yrs. All of the electrical distribution system panels that are located around the site and are original to the main campus buildings when the school was built, seemed to be in good condition and most, if not all, electrical distribution panels and transformers are from Square D. Where the District plans to add HVAC to the site, the electrical switchboard MSB has the load capacity for the additional loads. The maximum additional load to be added is unknown so it is recommended to have an Electrical Engineer to conduct a load study prior to connection of new loads to MSB. See attached photo MSB and XFMR1.

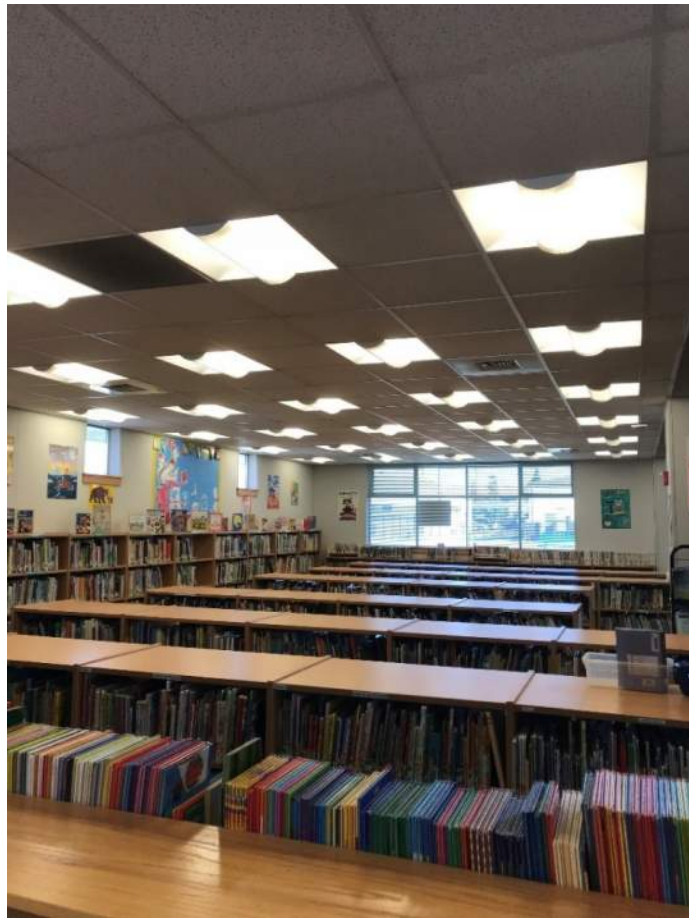
Interior Lighting is primarily fluorescent with T8 or T12 lamps at interior spaces that were observed. Most, if not all the lighting throughout the school campus is old and although there was no mention of complete failure, some light fixtures seemed original to the spaces, so they are likely near their “end of life”, especially with regards to efficiency. A few light fixtures were found to have missing lenses/diffusers and lamps, see attached photo LTG1. Most of the rooms have energy code compliant controls such as occupancy sensors. Emergency lighting with integrated battery back-up were found in common areas, offices and in the library building. In the multi-purpose building, classrooms and hallways, bug-eye type stand-alone emergency light fixtures were installed. However, no emergency lighting was found at the exterior landings. Multi-level switching/dimming necessary for energy conservation is almost non-existent. Expected life; Unknown. It is recommended to retrofit or replace campus wide lighting system with new LED technology in the near future. This would be a good opportunity for reduction in energy use from more efficient lighting fixtures, improved classroom lighting, smart lighting controls, daylight harvesting and would also reduce maintenance costs. See photo attached LTG2.

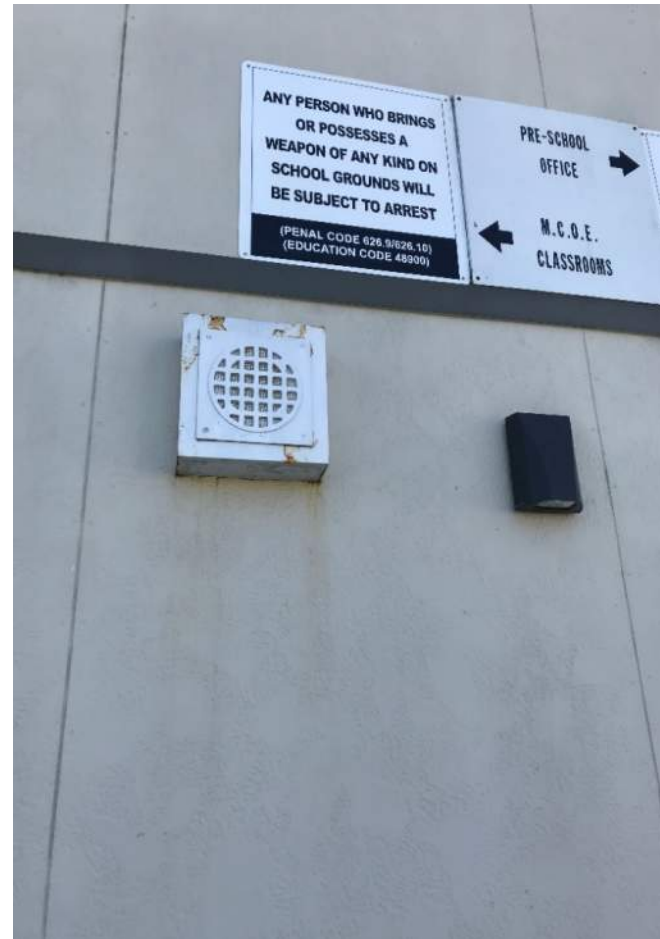
The existing PA System is an older Dukane model and is connected to speakers around the campus, some exterior speakers with separate amplifiers are located strategically to cover large open field areas. There are no ongoing issues with the system itself. However, several outdoor speaker enclosures seem to be in bad condition as they are old and rusty. Expected life; 3-5 yrs. See photo attached SPEAKER1.

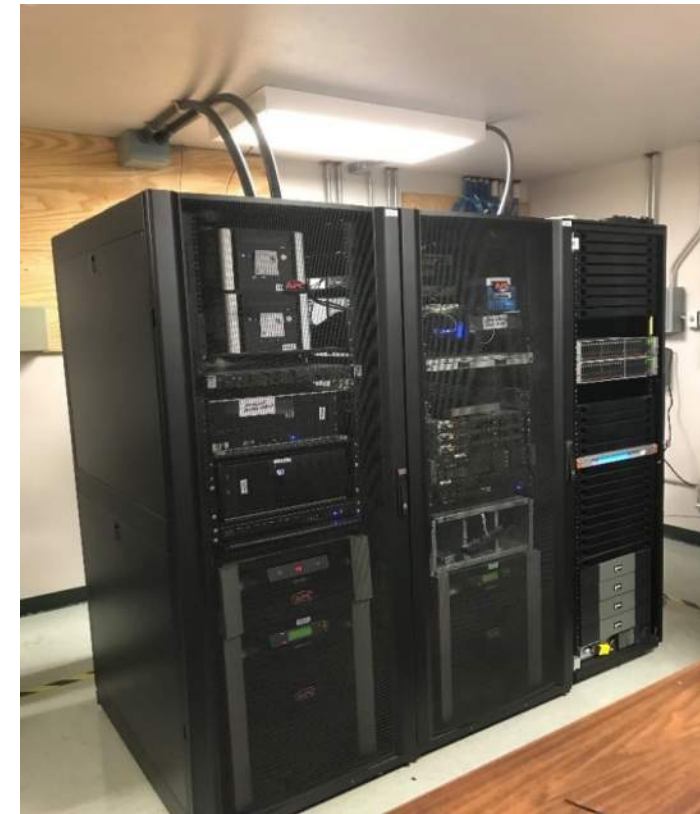
There are IDF's (Intermediate Distribution Frame) throughout the school campus with wireless routers in most of the buildings/classroom spaces. Since most classrooms have only a couple computers at most (except for computer labs), the existing campus wide data system seems to be working fine. Expected life; unknown. It is recommended to retrofit classrooms, in the near future, with additional outlets to accommodate a district standard quantity of devices in general classroom/space for computers, printers and multi-media equipment. This will require District IT input on available bandwidth and patch panels at existing distribution frames to accommodate an increase in connections. Moreover, per District Staff, it was brought to our attention that there is an MDF in the library building and

it seems that the MDF not only serves the Boronda Meadows school, but at least (3) other school campuses as well. Being that this MDF serves different school campuses, it is imperative to provide emergency power to the MDF, not only batteries, but also a stand-by diesel generator to maintain the data system running during power outages/interruptions. See attached photo MDF1.

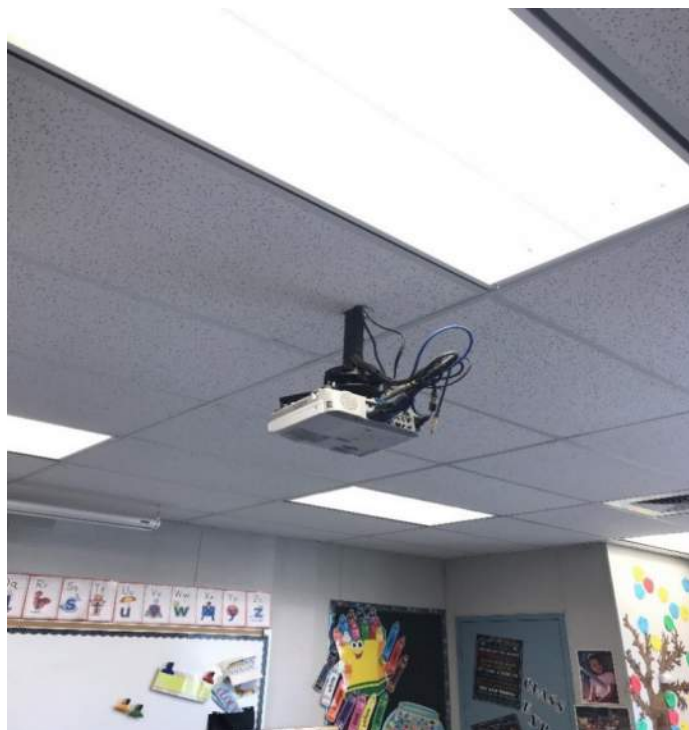
Most of the classrooms have ceiling mounted projectors with associated AV controls located near the teacher's station. There are no ongoing problems. However, where projectors were installed on an accessible ceilings (T-BAR), the associated receptacles were installed above the ceiling with the cord passing through the T-BAR up to the receptacle. Current code does not allow this installation. Where classroom renovations occur, it is required to mount the receptacles exposed on the ceiling. See attached photo PROJECTOR1.
