FACILITIES NEEDS ASSESSMENT

EL GABILAN

PREPARED BY BELLI ARCHITECTURAL GROUP

2022

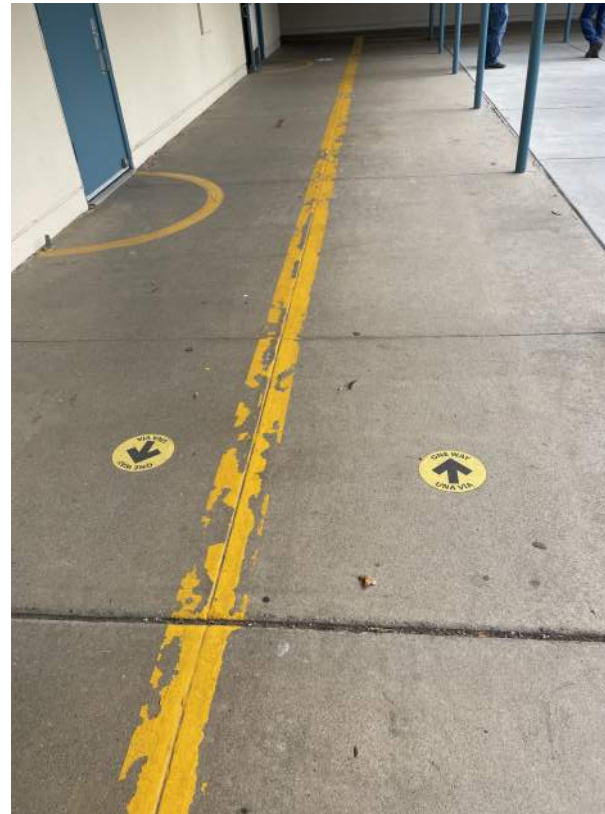
Image 2.1.1 Worn off exterior pavement striping. Taken on 05/02/2022 by Belli Architectural Group.

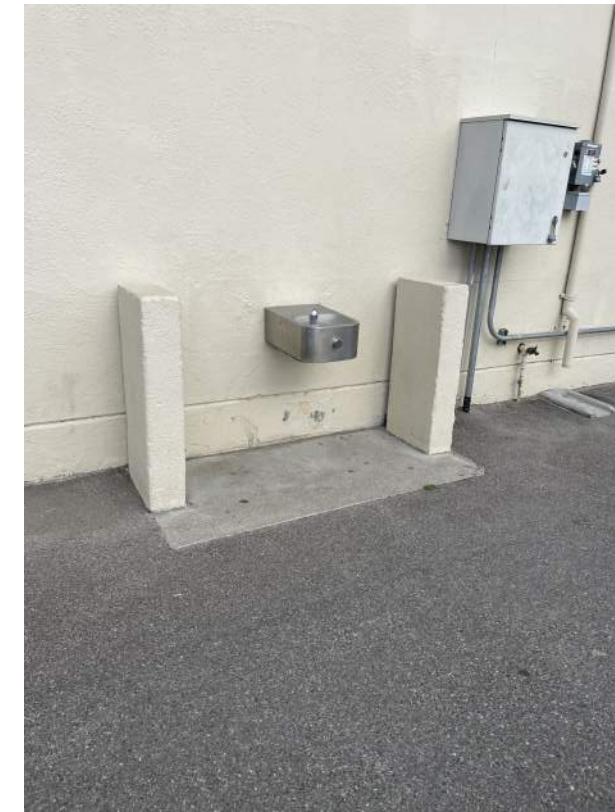
Image 2.1.3 Non-ADA compliant drinking fountain. Taken on 05/02/2022 by Belli Architectural Group.

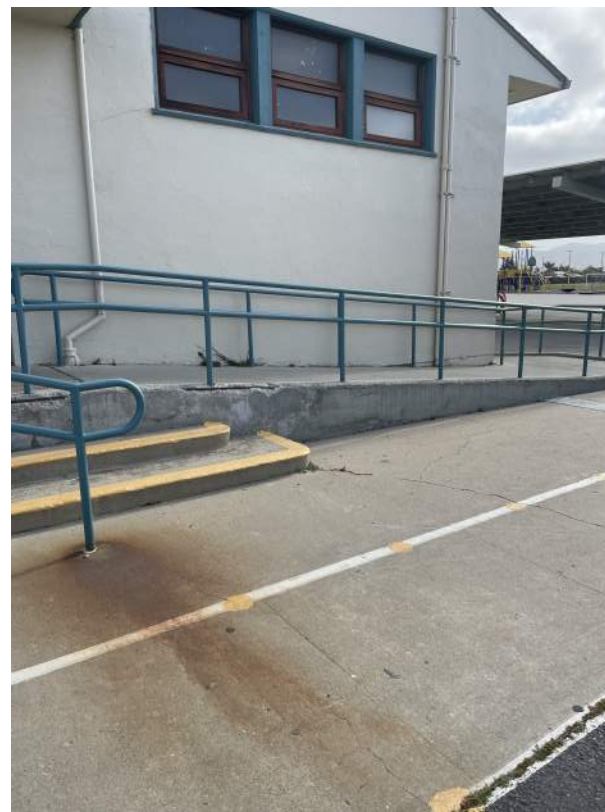
Image 2.1.2 Existing conditions at exterior pavement. Taken on 05/02/2022 by Belli Architectural Group.

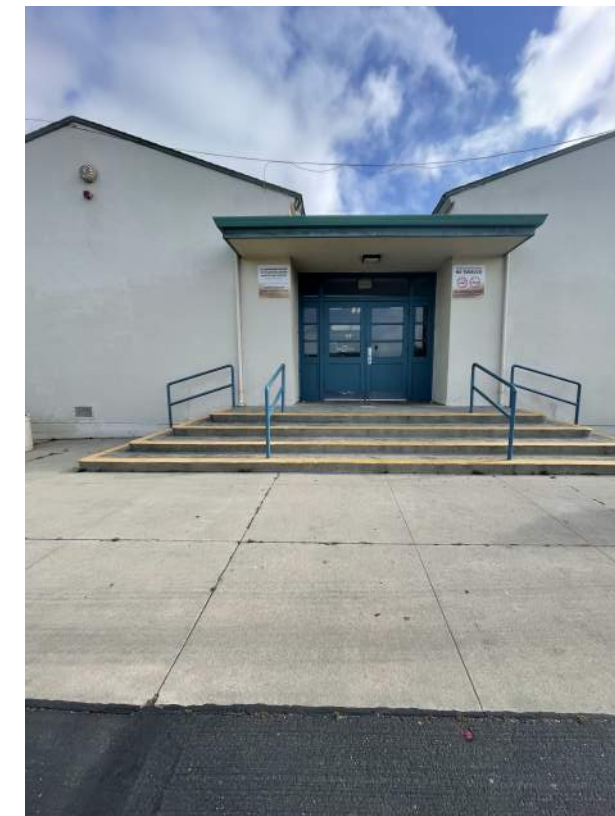
Image 2.1.4 Non-accessible stairs. Taken on 05/02/2022 by Belli Architectural Group.

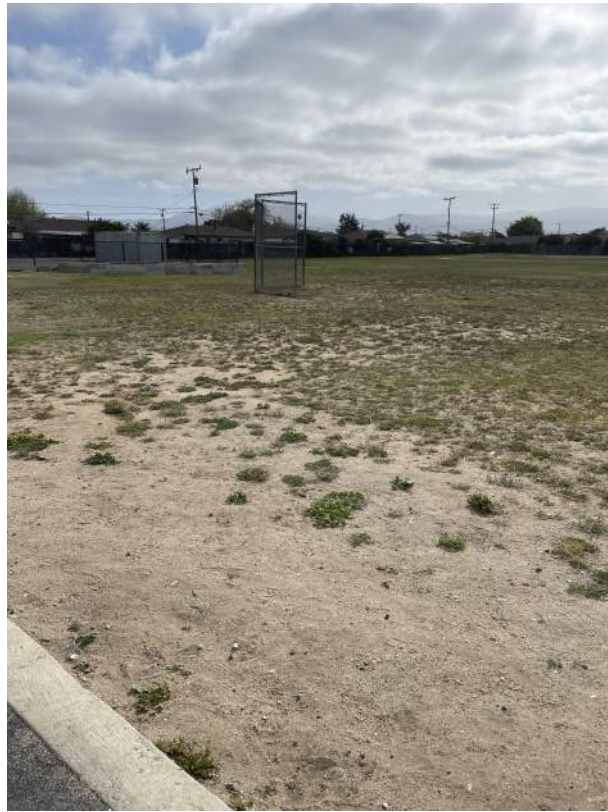
Image 2.1.5 Existing track and field. Taken on 05/02/2022 by Belli Architectural Group.

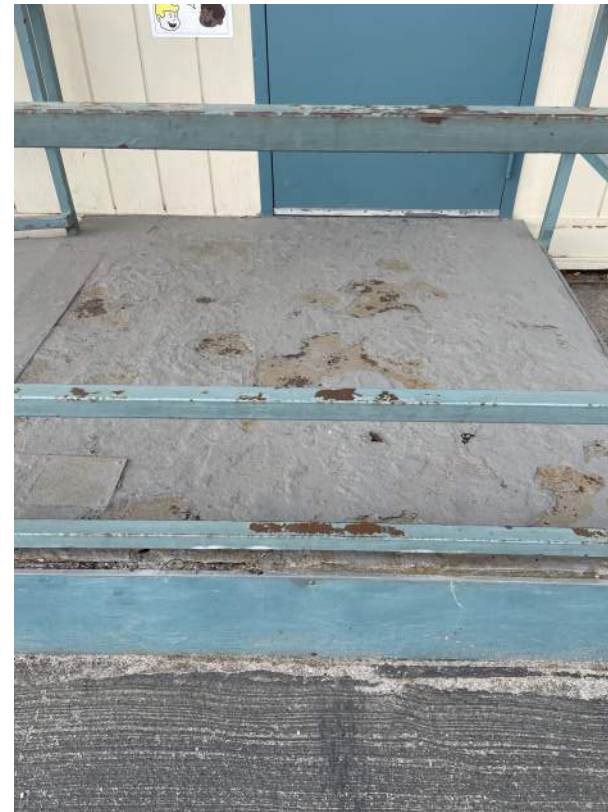
Image 2.1.1 Rot and rust at portable classroom ramps. Taken on 05/02/2022 by Belli Architectural Group.

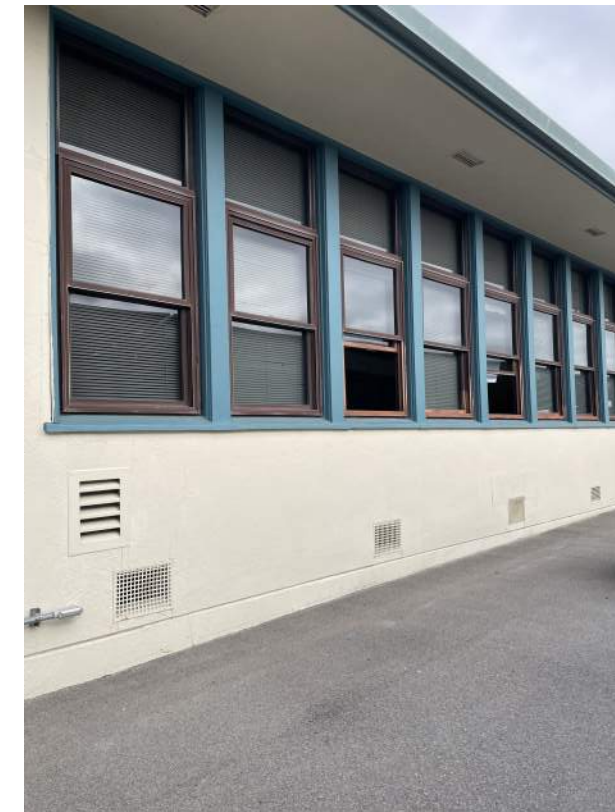
Image 2.2.1 Old windows. Taken on 05/02/2022 by Belli Architectural Group.

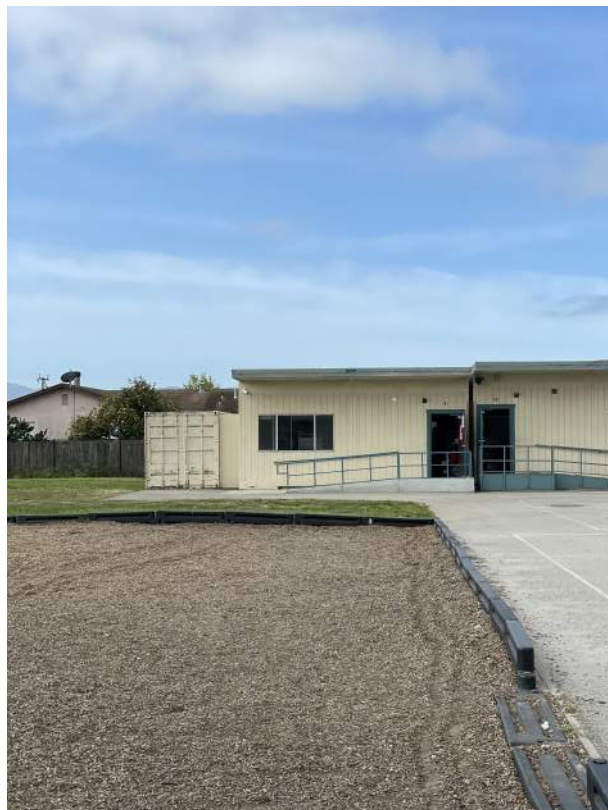
Image 2.1.1 Storage container next to classroom. Taken on 05/02/2022 by Belli Architectural Group.

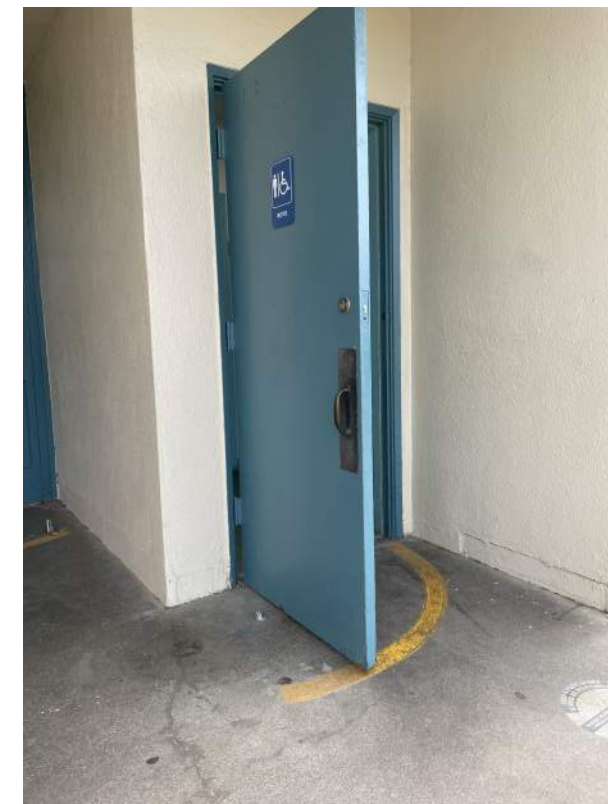
Image 2.2.2 Incorrect door swing in main building restrooms. Taken on 05/02/2022 by Belli Architectural Group.

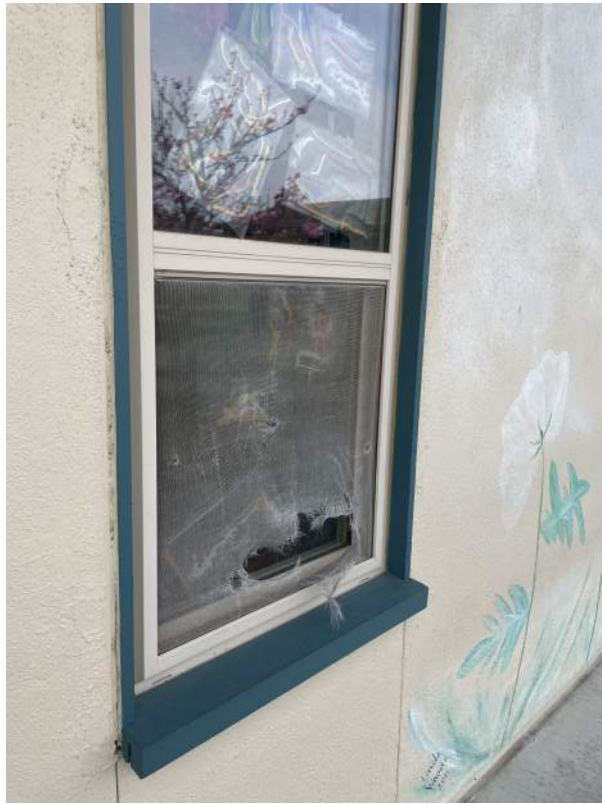
Image 2.2.3 Broken window screens. Taken on 05/02/2022 by Belli Architectural Group.

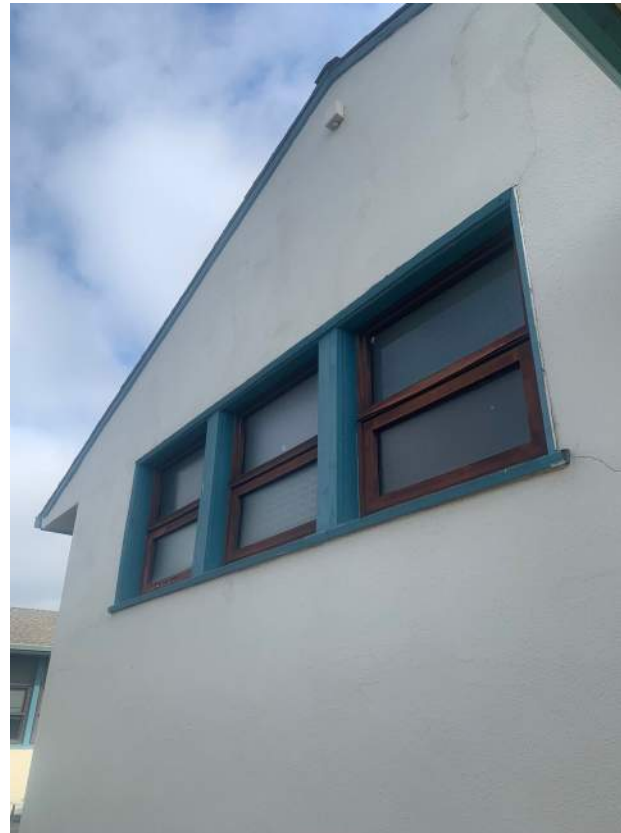
Image 2.2.5 Plaster cracks. Taken on 05/02/2022 by Belli Architectural Group.

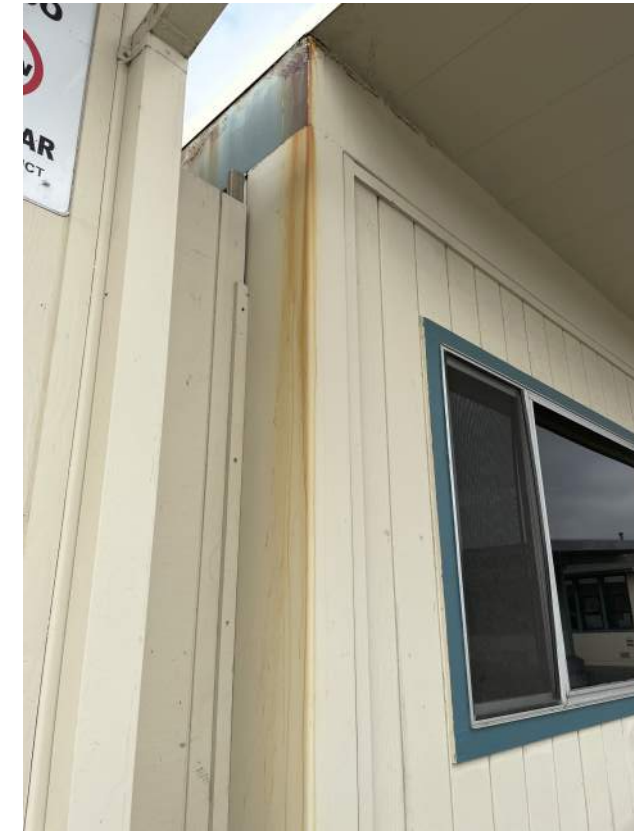
Image 2.2.7 Rust present at relocatable classrooms. Taken on 05/02/2022 by Belli Architectural Group.

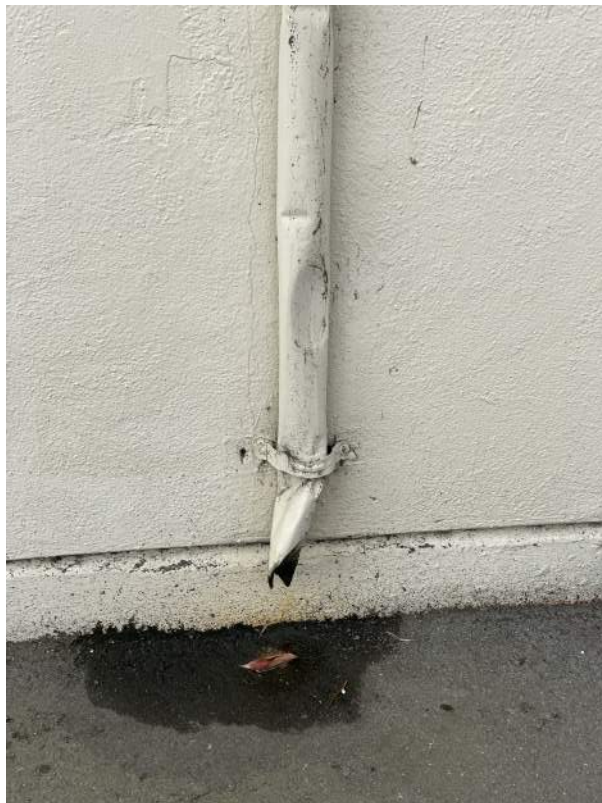
Image 2.2.4 Damaged gutter. Taken on 05/02/2022 by Belli Architectural Group.

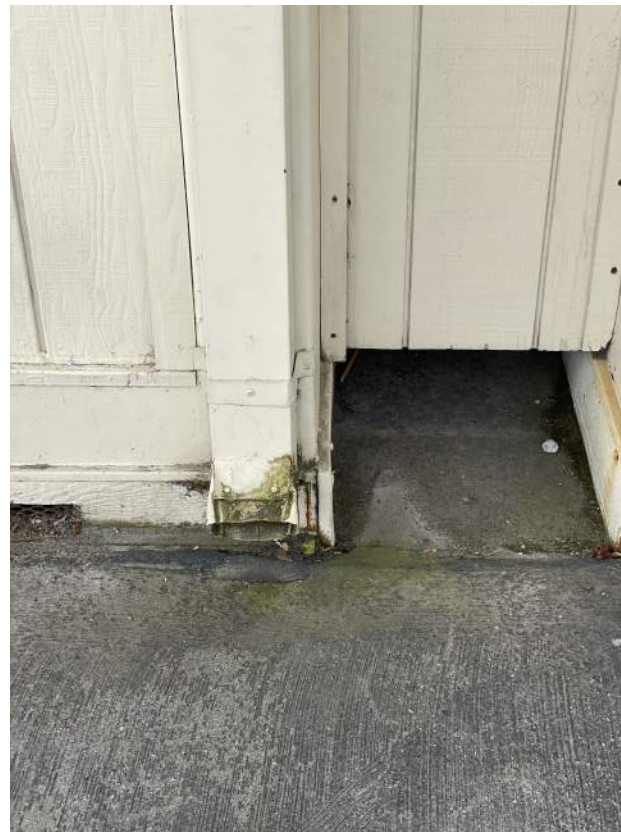
Image 2.2.6 Mold present on gutter. Taken on 05/02/2022 by Belli Architectural Group.

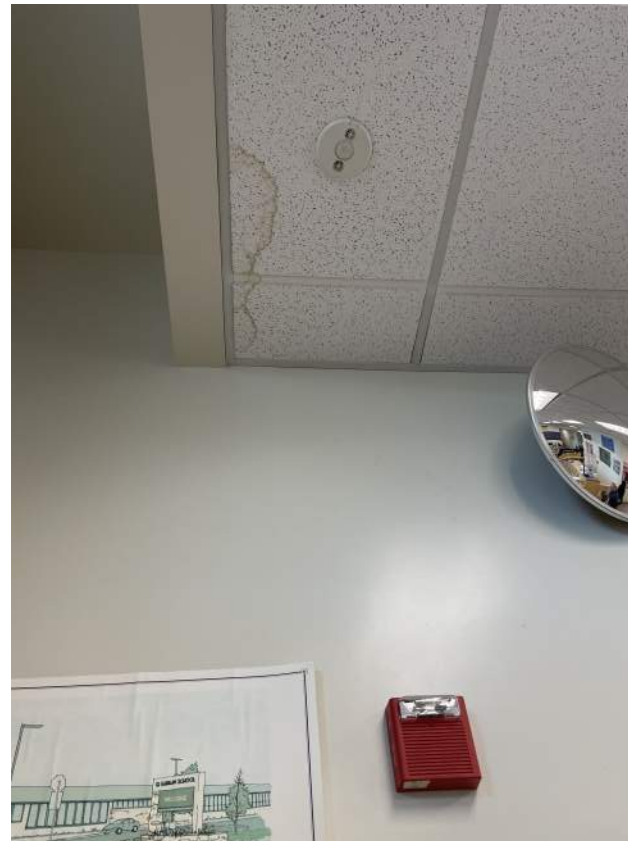
Image 2.3.1 Damaged ceiling panel. Taken on 05/02/2022 by Belli Architectural Group.

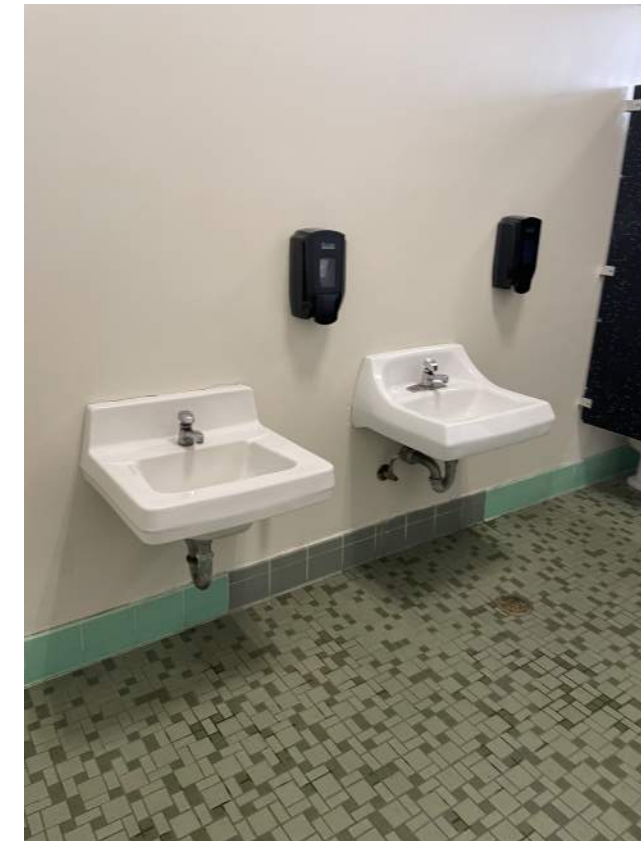
Image 2.3.3 Existing student restrooms. Taken on 05/02/2022 by Belli Architectural Group.

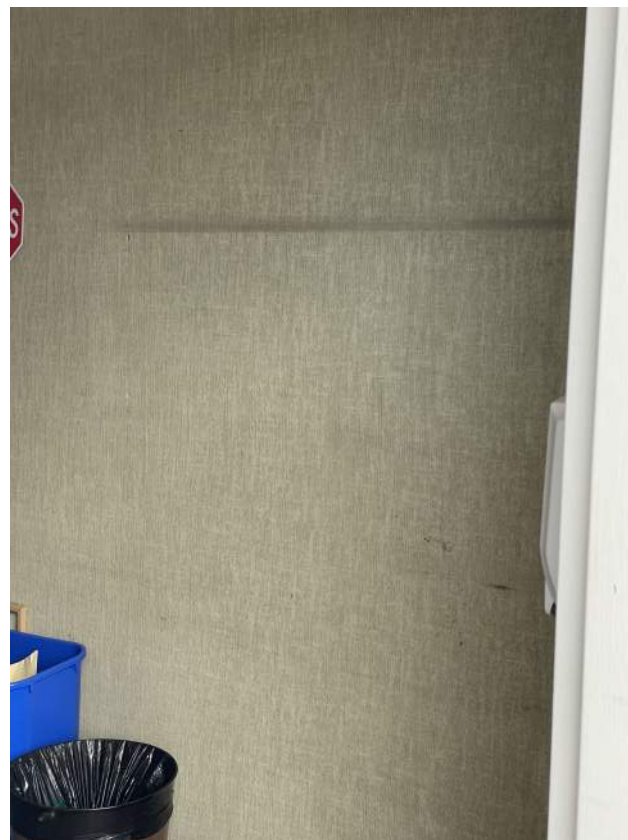
Image 2.3.2 Worn and dirty wall paper at library. Taken on 05/02/2022 by Belli Architectural Group.

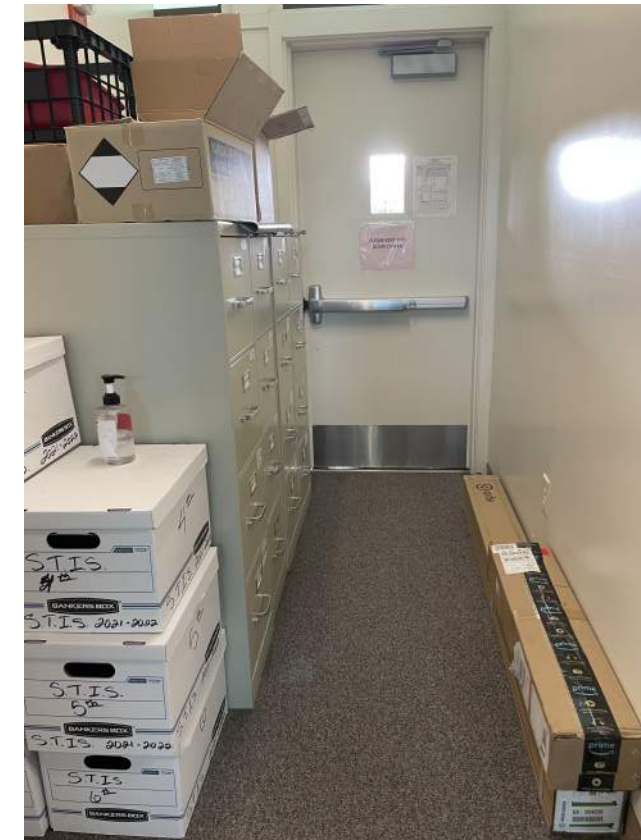
Image 2.3.4 Storage filing cabinets obstructing exit. Taken on 05/02/2022 by Belli Architectural Group.

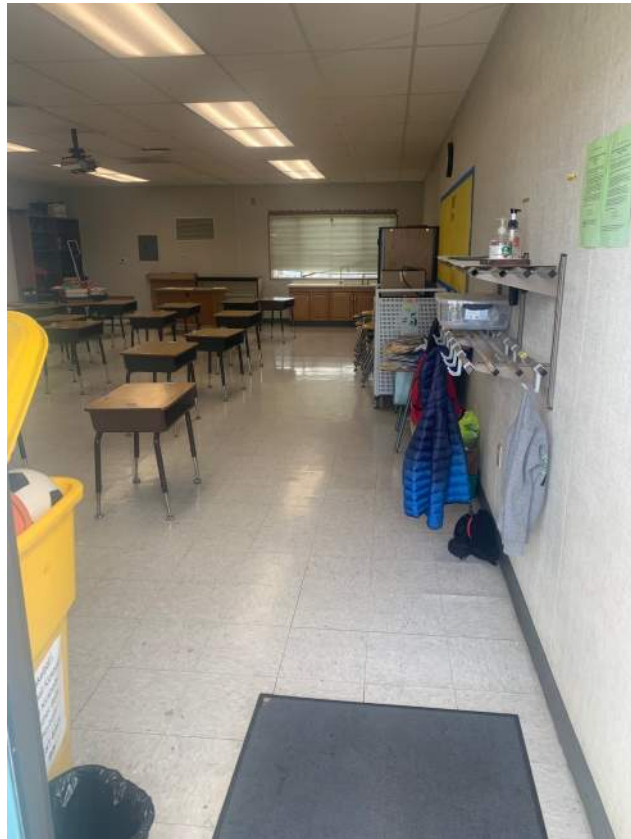
Image 2.3.5 Relocatable classroom interior. Taken on 05/02/2022 by Belli Architectural Group.

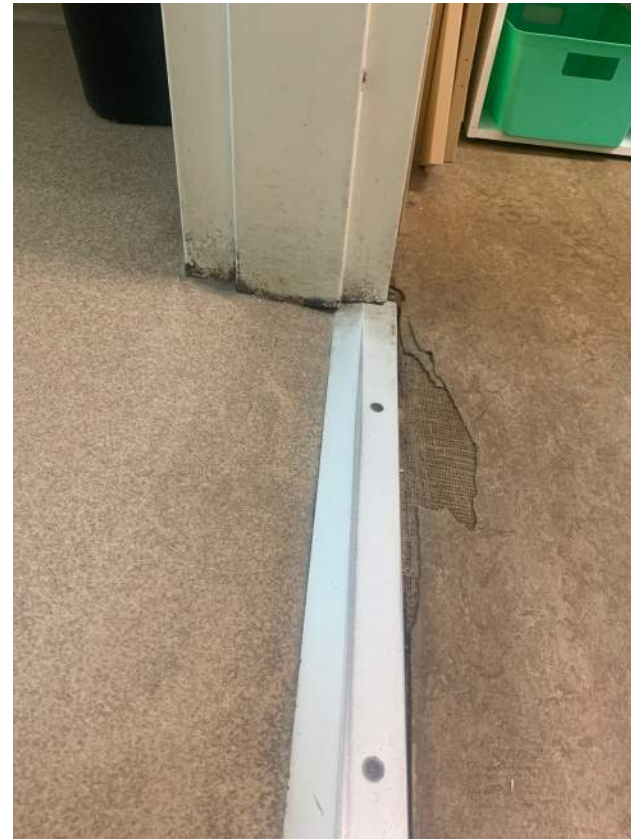
Image 2.3.7 Damaged flooring. Taken on 05/02/2022 by Belli Architectural Group.

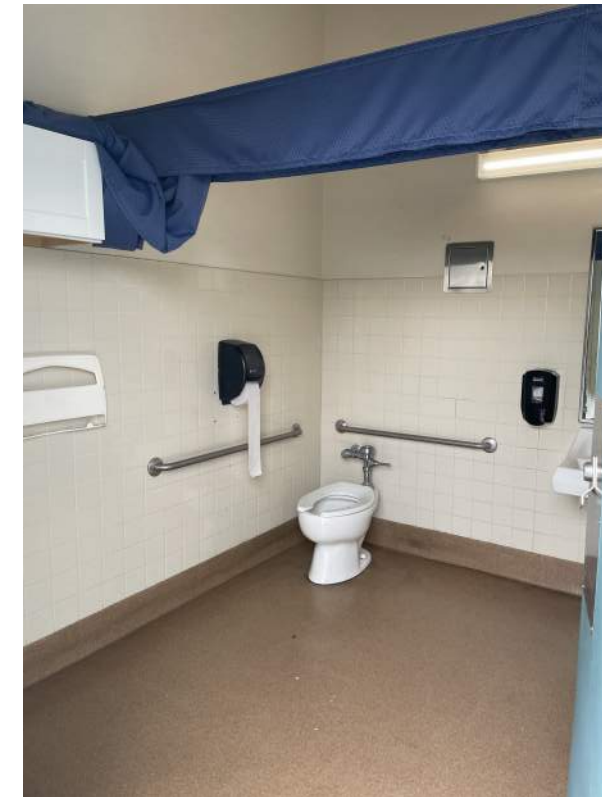
Image 2.3.9 Kindergarten restroom. Taken on 05/02/2022 by Belli Architectural Group.

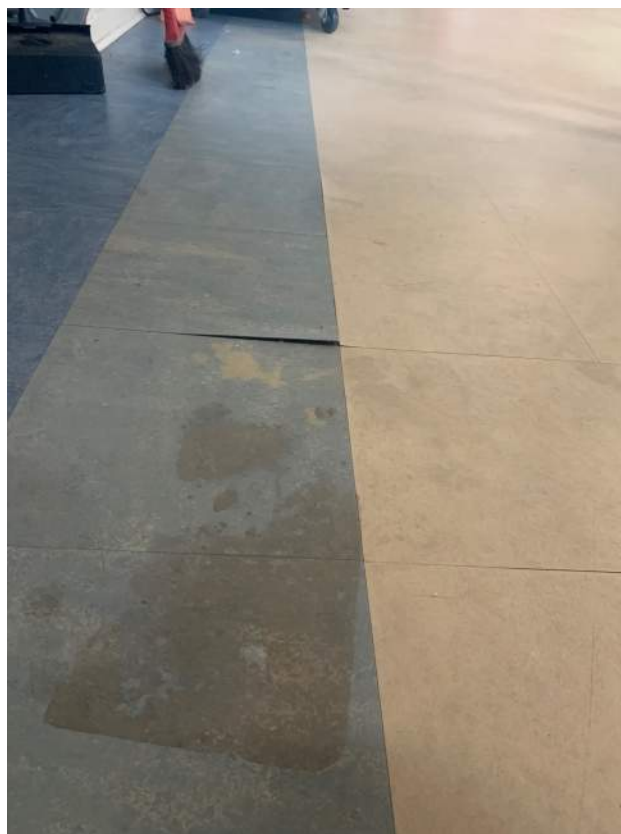
Image 2.3.6 MPR flooring. Taken on 05/02/2022 by Belli Architectural Group.

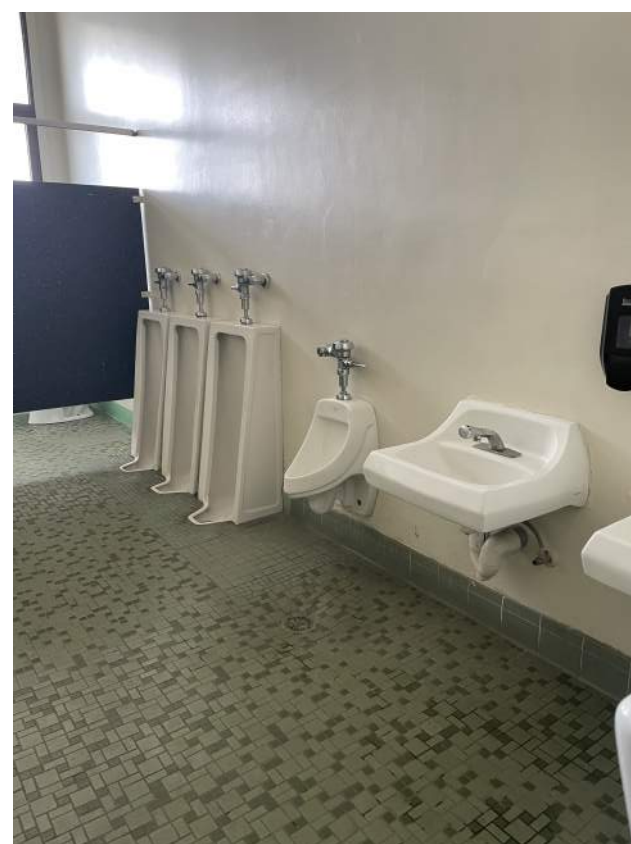
Image 2.3.8 Missing privacy partitions between urinals and sinks. Taken on 05/02/2022 by Belli Architectural Group.

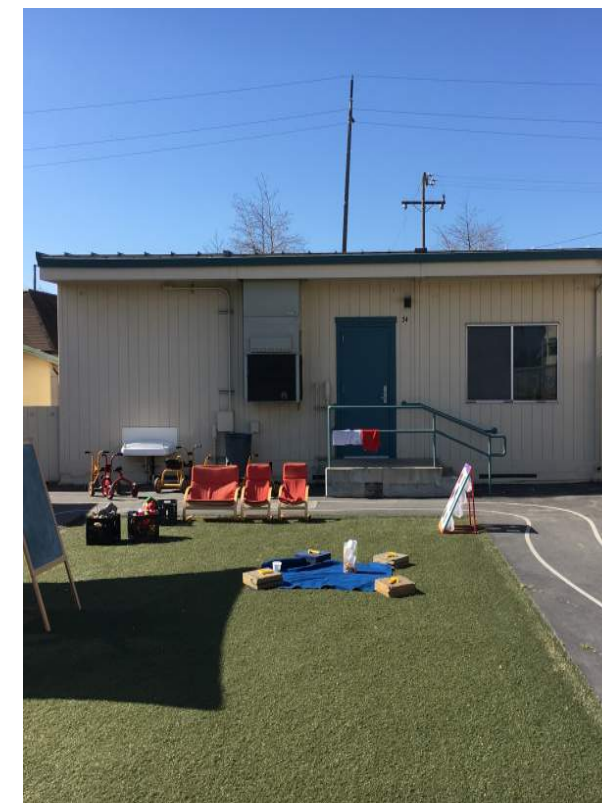
Image 2.3.10 Preschool. Non-accessible entrance. Taken on 05/02/2022 by Belli Architectural Group.

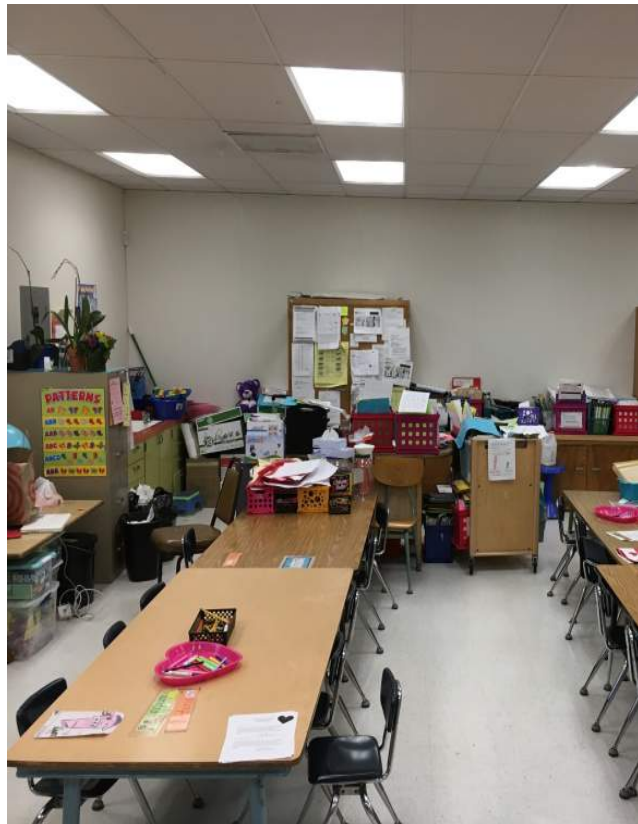
Image 2.3.11 Preschool. Taken on 05/02/2022 by Belli Architectural Group.

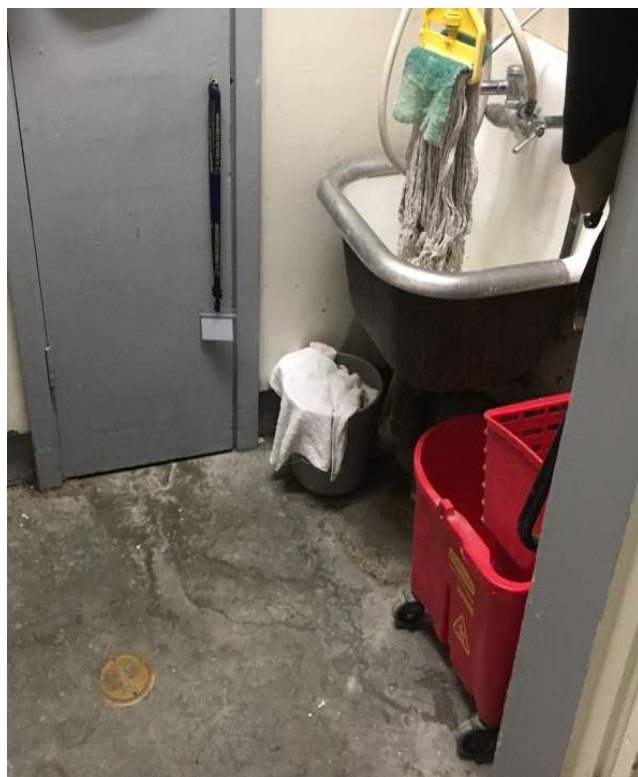
Image 2.3.12 Janitorial room. Taken on 05/02/2022 by Belli Architectural Group.

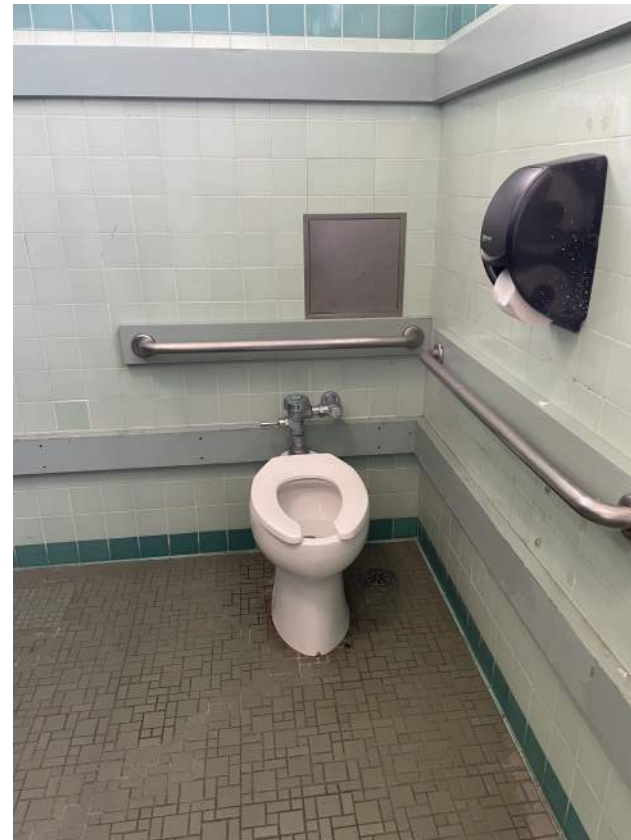
Image 2.4.1 Non-accessible toilet paper dispenser. Taken on 05/02/2022 by Belli Architectural Group.

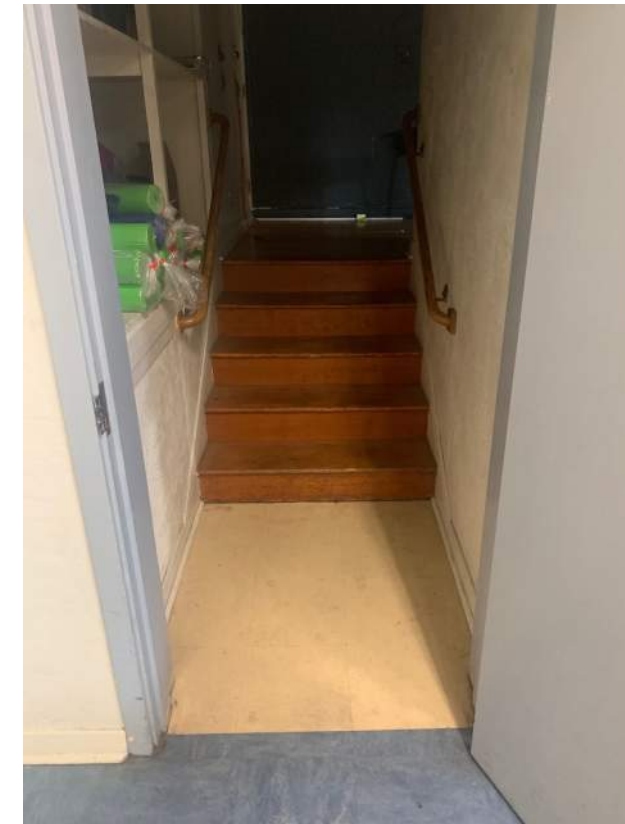
Image 2.4.2 Non-accessible entry to MPR stage. Taken on 05/02/2022 by Belli Architectural Group.

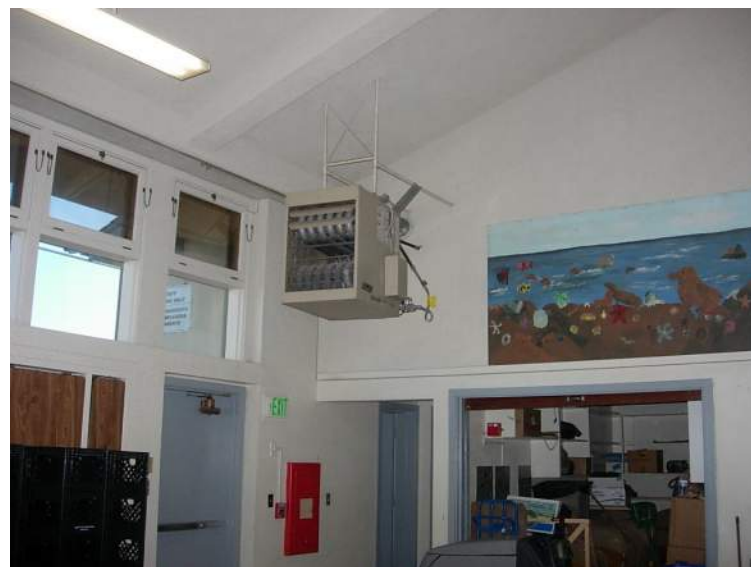
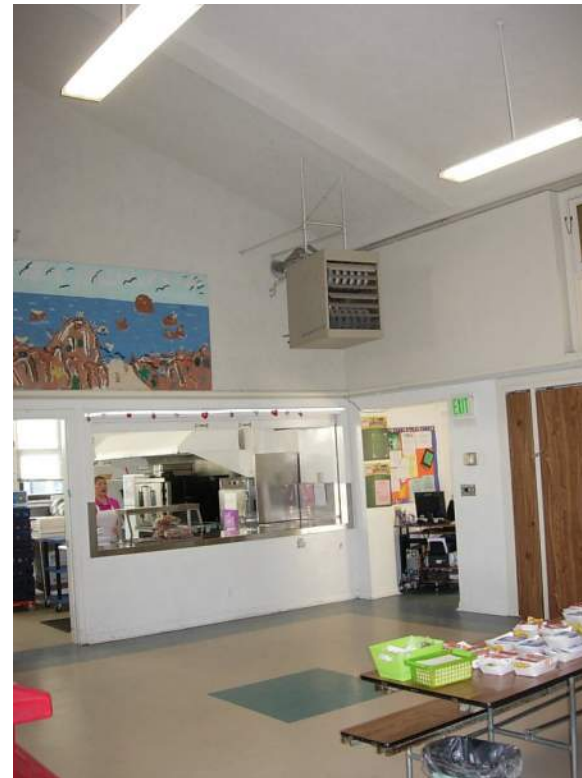
MP/Cafeteria:

This Multi-Purpose Room s heated with two (2) suspended gas-fired unit heaters. These heaters were installed in 2002 and appear to be operating.

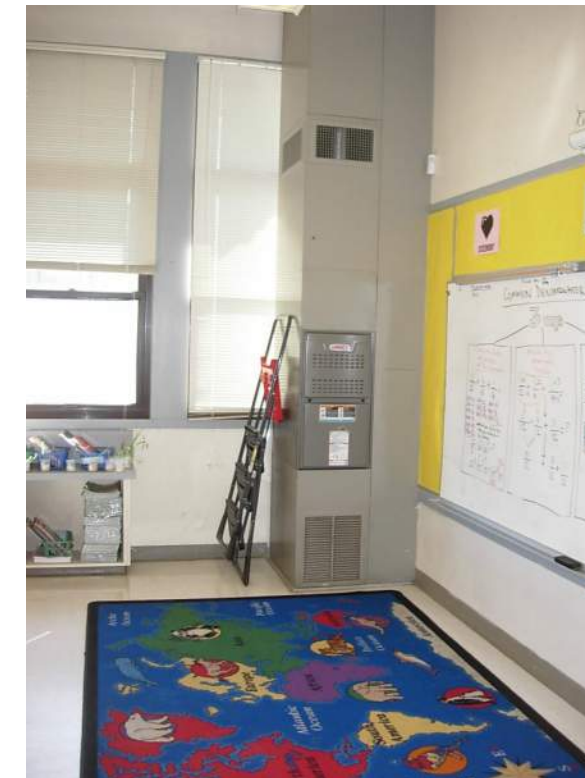
Classroom 1, Staff Lounge 2, Classroom 3 thru 8 and 11 thru 18:

These classrooms were heated with 1990's era corner classroom up-flow furnaces, similar to Kammann ES. The furnace sections were just replaced with new Lennox gas-fired heaters in December of 2017 and appear to be operating.

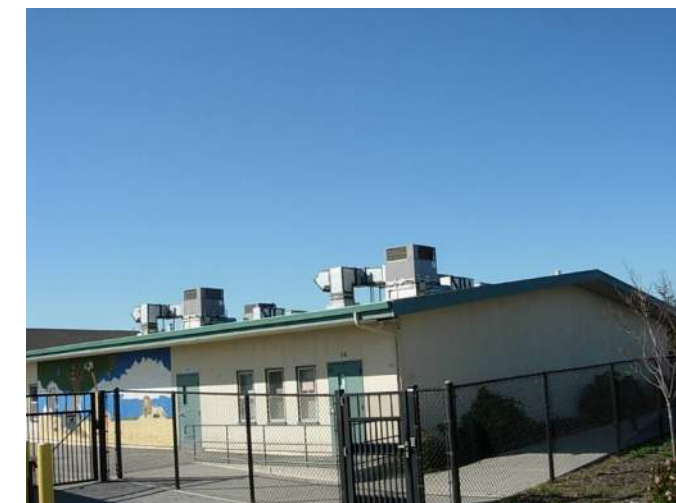
Classrooms 22, 23, 24 and the Library:

These classrooms have individual rooftop mounted gas heat/electric cooling units that have been replaced recently. This interior of the building appears to have not had a modernization prior to the 1990's and is in need of a new t-bar ceiling, diffusers, grilles and ductwork.

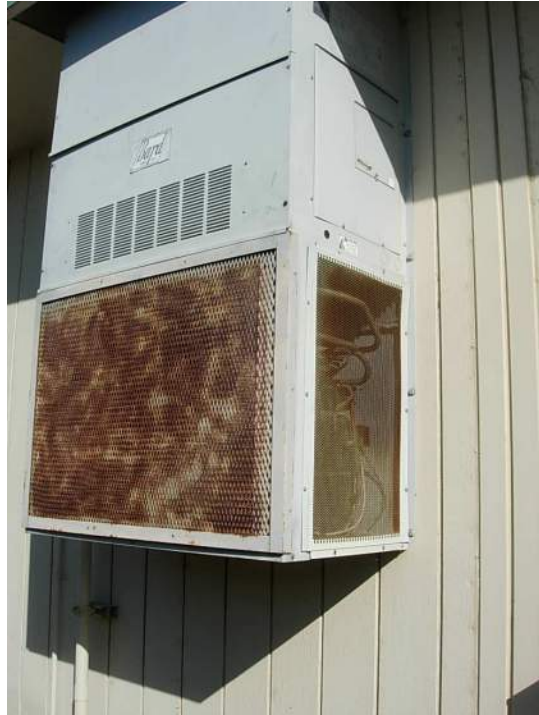
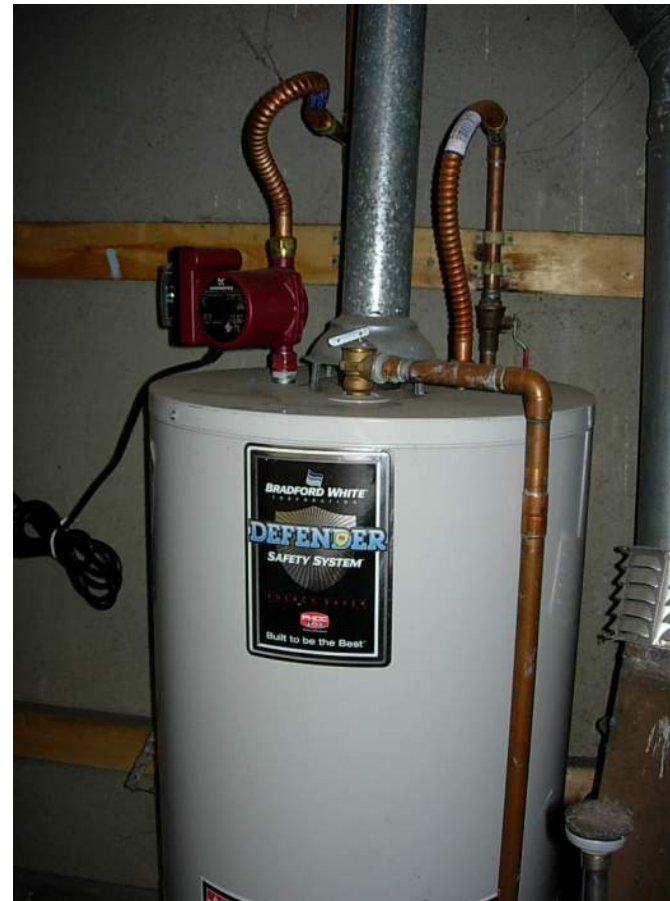
Classrooms 21, 26-32, 34 thru 39:

These are portable classroom consisting of the exterior wall mounted “Bard” type heat pump units. All portables utilize this type of equipment. These units throughout the campus appear to be original and are operating. Older (20 years) units should be replaced with new units.

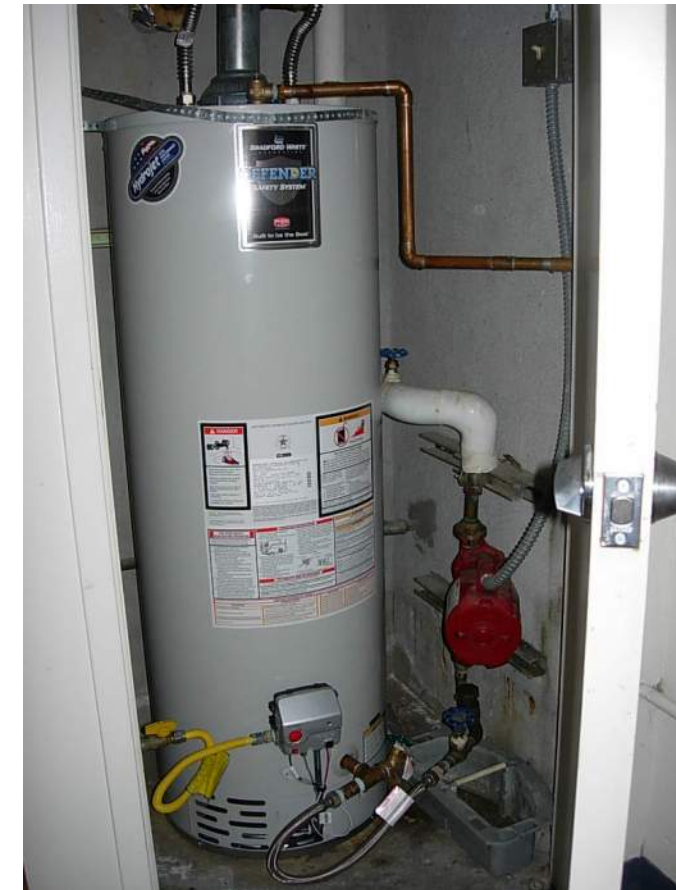
Room 8B:

A gas-fired water heater located in a closet requires seismic bracing.

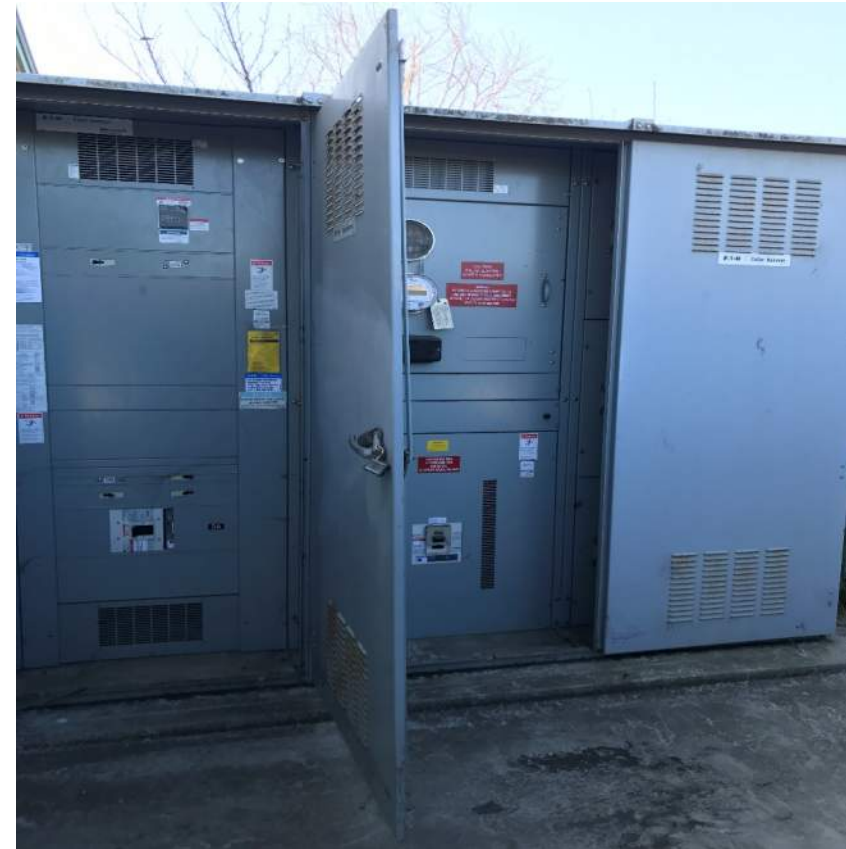
There are (2) existing main “metered” electrical service switchboards (MSB1, and MSB2). MSB1 is a 1200 amp, 120/208 volt, 3 phase, NEMA 3R service located at the front (north end) of the campus by the Cafeteria building. MSB1 has a connection for the existing Solar PV system. The Solar PV is connected ahead of the main breaker at MSB1. MSB1 serves in large part, the entire campus except for modular/portable buildings nearest the track and field (approximately 13 total modular buildings). MSB2 is an 800 amp, 120/240V, 1-phase, NEMA 3R service located along the residential fence line on the north/east end of the campus in the parking lot. This service is fed from a PG&E pole with a pole mounted transformer. MSB2 serves all of portables at the campus. The electrical switchboards and campus wide electrical distribution system appears to be in good condition. MSB1 expected life; 15 to 20 years. MSB2 expected life; 15 yrs. The electrical services are used primarily for lighting and heating equipment, with minimal plug loads. Some of the electrical distribution system panels are located around the site and are original to the main campus buildings when the school was built, are old and manufactured by a company that no longer exists. The reliability of the system’s breakers to function correctly when necessary cannot be relied upon. It is recommended to replace the oldest panels within the classroom wings of the main campus building. Where the District plans to add HVAC to the site, the switchboards that are serving those locations “may” require an upgrade based on what type of system is recommended for HVAC upgrades. See attached photos MSB1 & MSB2.

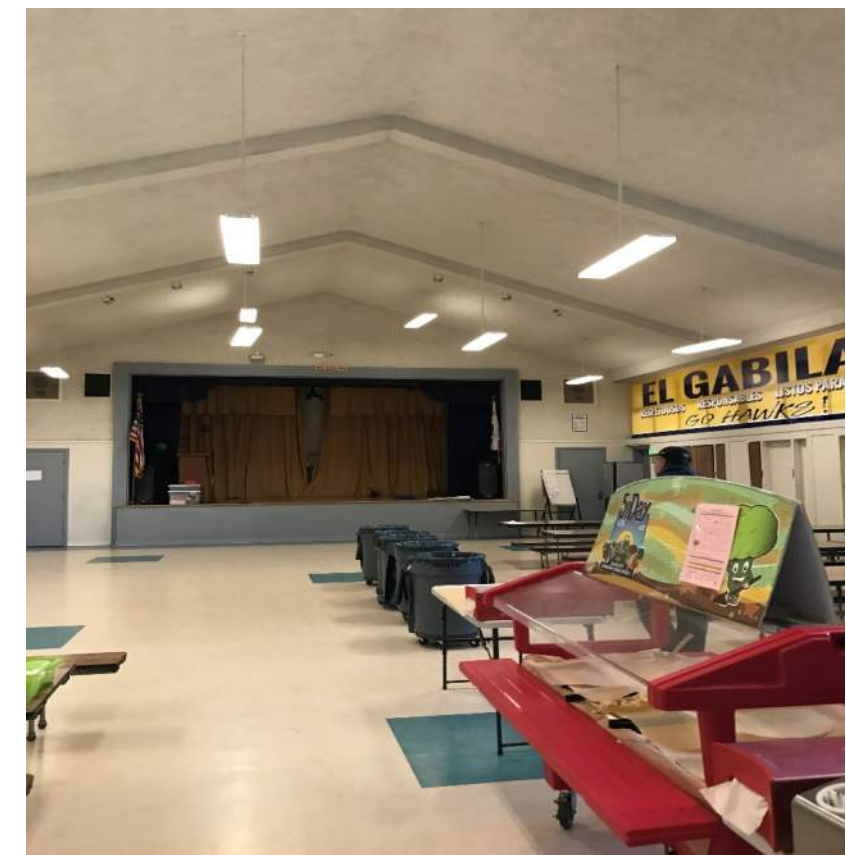
Interior Lighting is primarily fluorescent with T8 or T12 lamps at interior spaces. Most if not all the lighting throughout the school campus is old and although there was no mention of complete failure, some light fixtures seemed original to the spaces, so they are likely near their “end of life”, especially with regards to efficiency. Only newly remodeled spaces have energy code compliant controls such as occupancy sensors (Admin building area and remodeled classrooms #8b, #9 and #10). Emergency lighting was not apparent at any classrooms (except the few remodeled spaces), restrooms, or exterior landings. However, in multi-use spaces and hallways, bug-eye type stand-alone emergency light fixtures were installed. Occupant sensors and multilevel switching necessary for energy conservation is almost non-existent (except for remodeled spaces). Expected life; Unknown. It is recommended to retrofit campus wide lighting system in the near future. This would be a good opportunity for reduction in energy use from more efficient lighting fixtures, improved classroom lighting, smart lighting controls and reduced maintenance. See attached photo LTG1.
