FACILITIES NEEDS ASSESSMENT

KAMMANN

PREPARED BY BELLI ARCHITECTURAL GROUP

2022

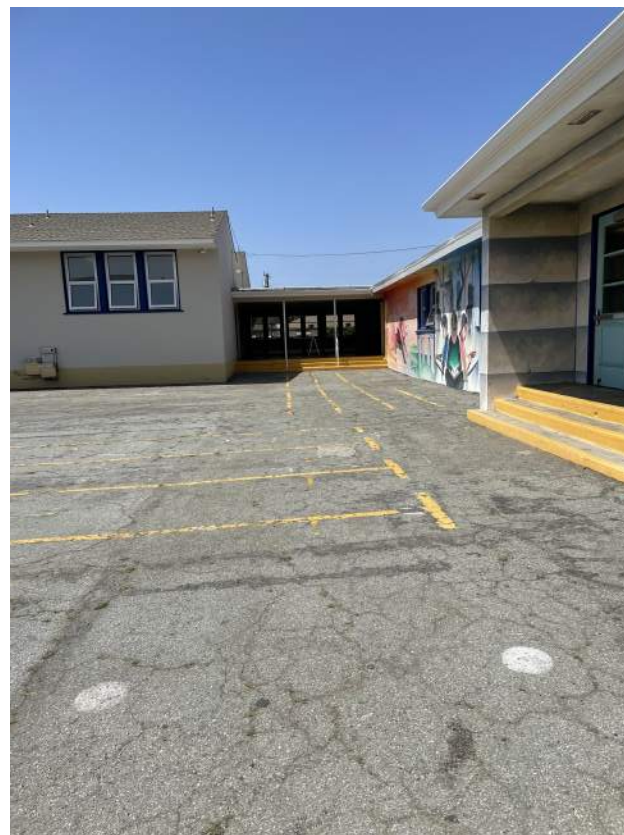
Image 2.1.1 Asphalt and striping existing conditions. Taken on 04/26/2022 by Belli Architectural Group.

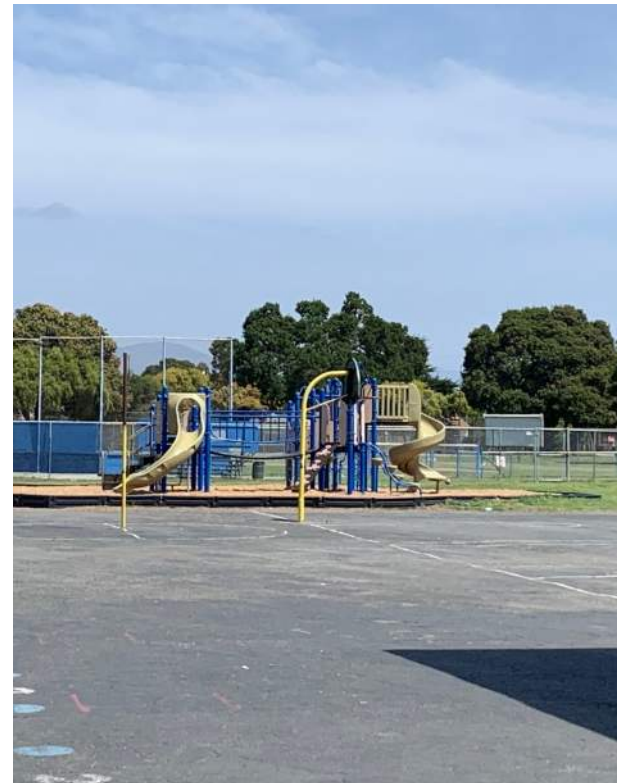
Image 2.1.2 Asphalt and striping existing conditions. Taken on 04/26/2022 by Belli Architectural Group.

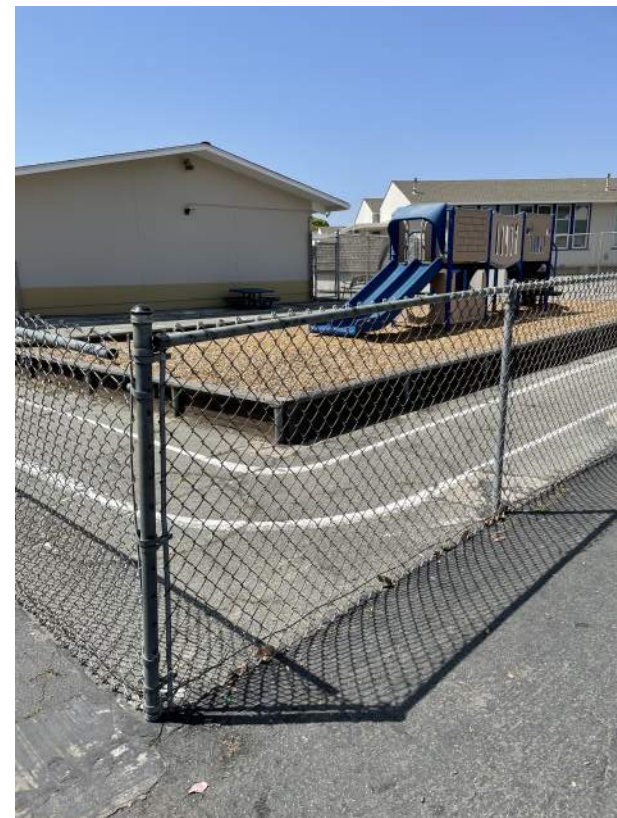
Image 2.1.3 Non-accessible deteriorated Kindergarten playground. Taken on 04/26/2022 by Belli Architectural Group.

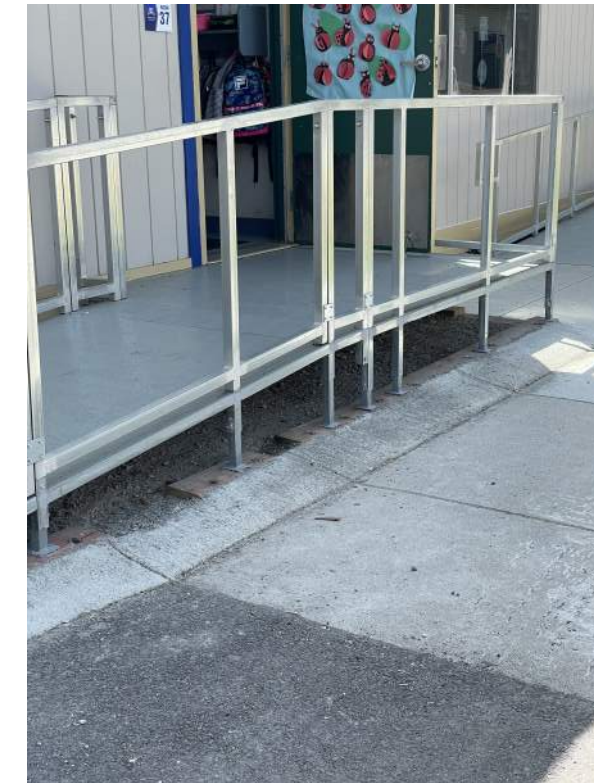
Image 2.1.4 Ramps to relocatable classrooms. Taken on 04/26/2022 by Belli Architectural Group.

- Unfinished condition at select metal ramps.
- Exterior dry rot present.

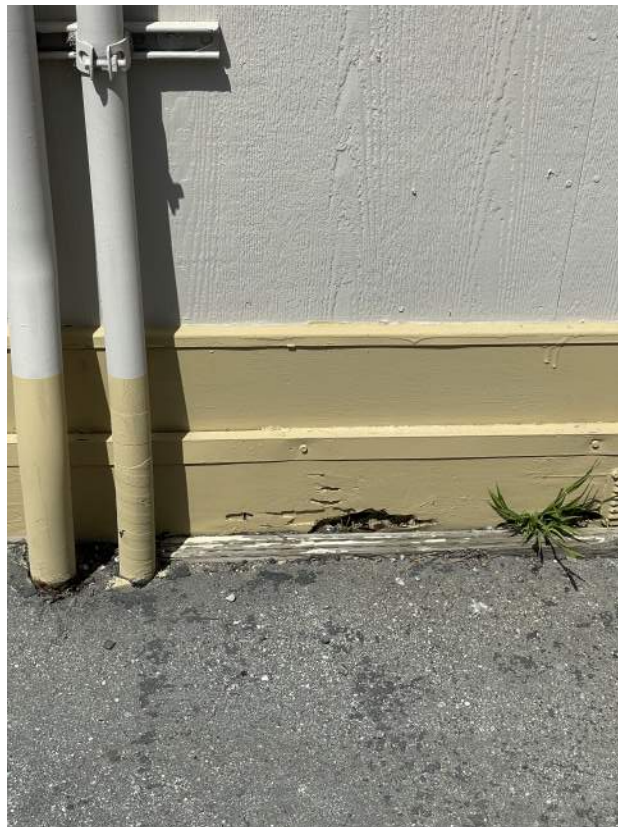
Image 2.2.1 Relocatable building wall. Taken on 04/26/2022 by Belli Architectural Group.

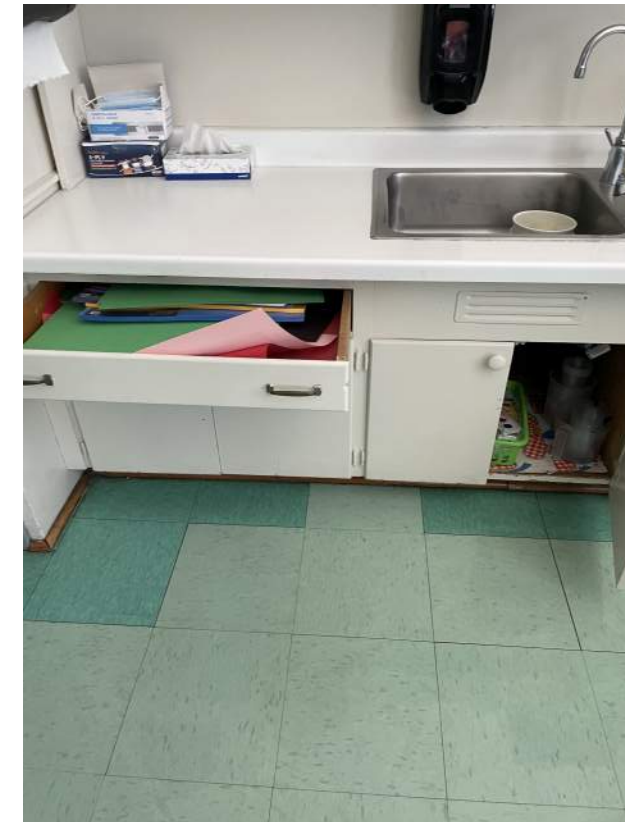
Image 2.3.1 Older, patched flooring at non-accessible classroom sink. Taken on 04/26/2022 by Belli Architectural Group.

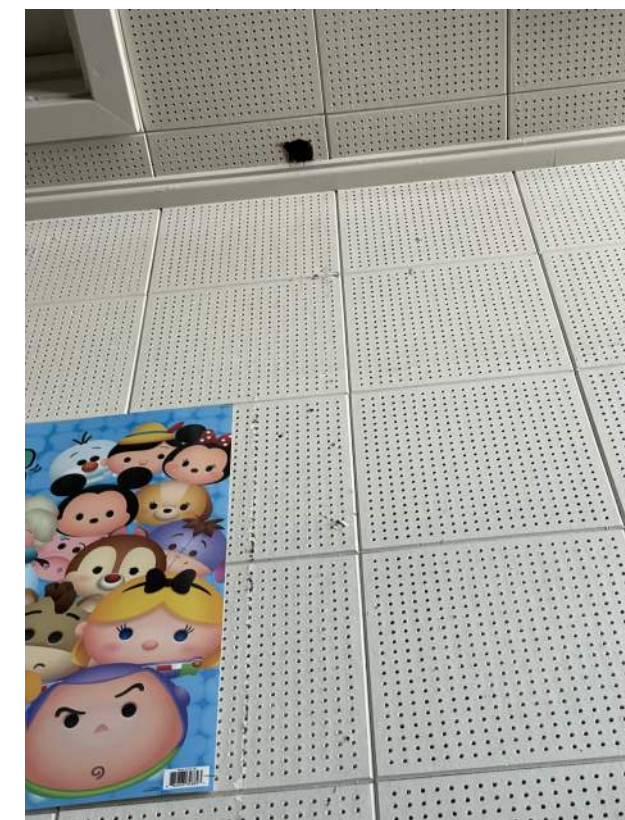
Image 2.3.2 Broken and aging acoustic panels. Taken on 04/26/2022 by Belli Architectural Group.

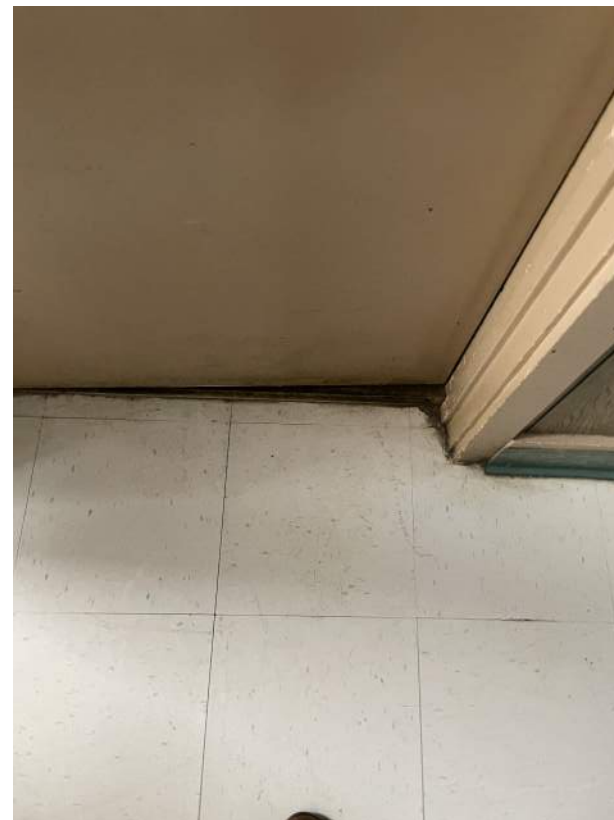
Image 2.2.5 Dirt accumulated at floors and walls. Taken on 04/26/2022 by Belli Architectural Group.

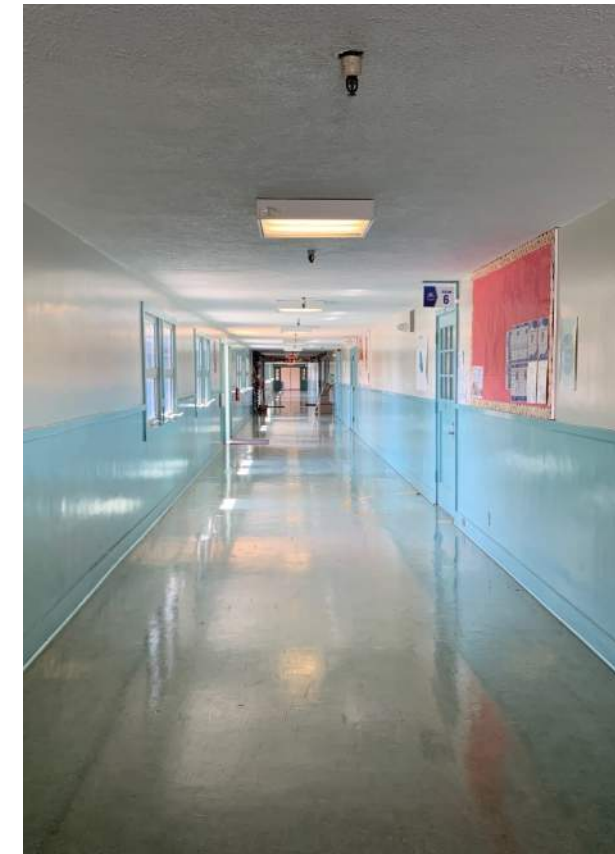
Image 2.2.7 Aging hallway flooring. Taken on 04/26/2022 by Belli Architectural Group.

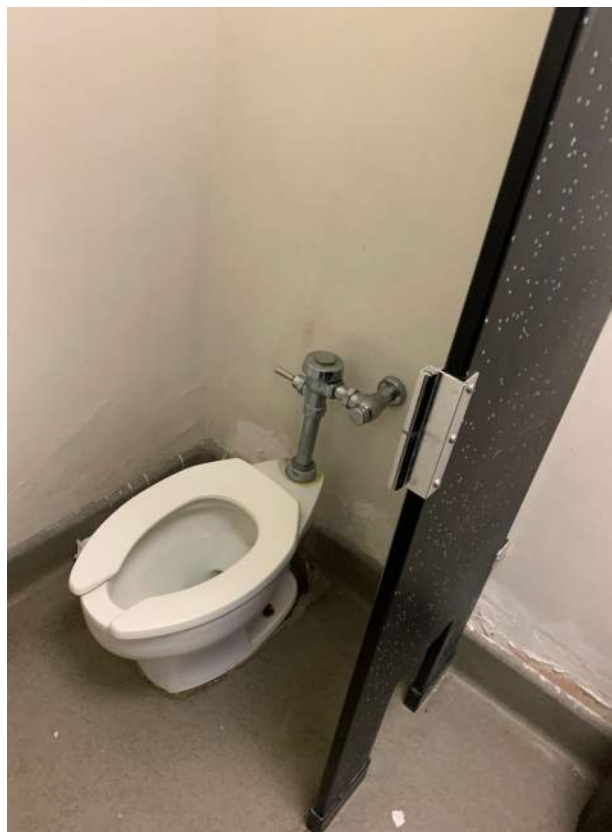
Image 2.2.4 Existing, non-accessible restroom at MPR. Taken on 04/26/2022 by Belli Architectural Group.

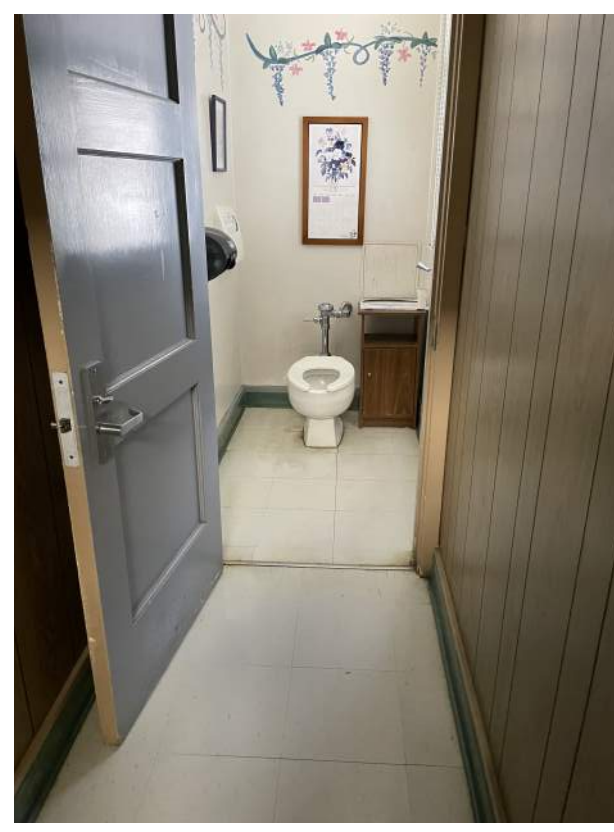
Image 2.2.6 Non-accessible staff restroom. Taken on 04/26/2022 by Belli Architectural Group.

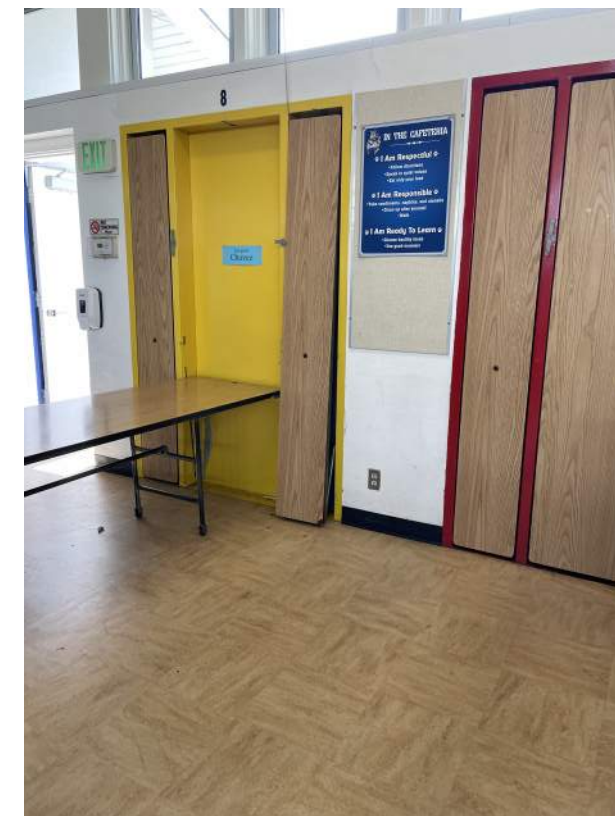
Image 2.2.8 Broken furniture at MPR. Taken on 04/26/2022 by Belli Architectural Group.

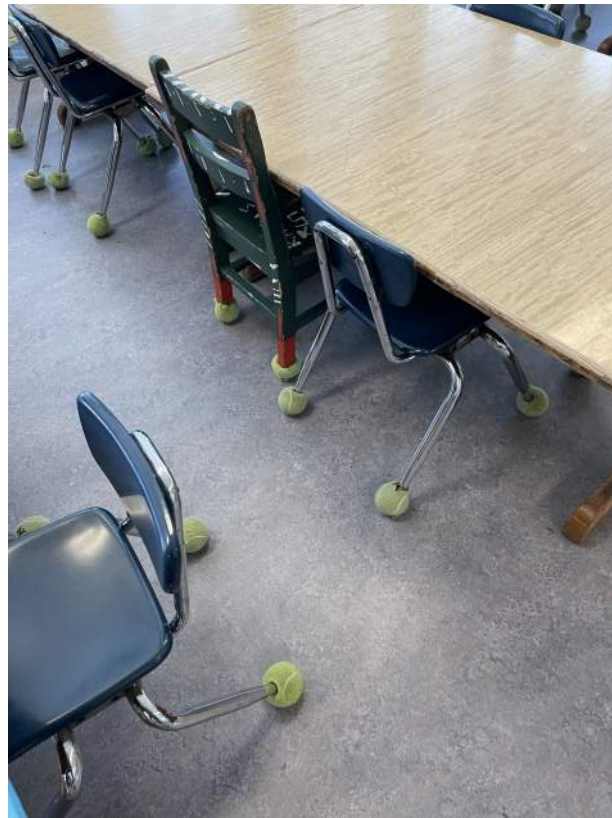
Image 2.2.9 Existing chairs damage floor surface. Taken on 04/26/2022 by Belli Architectural Group.

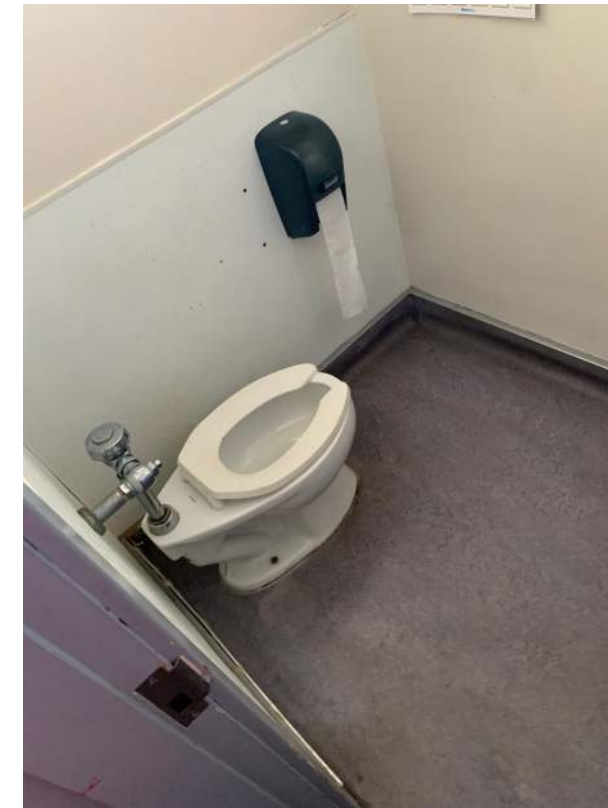
Image 2.4.1 Non-accessible restrooms. Taken on 04/26/2022 by Belli Architectural Group.

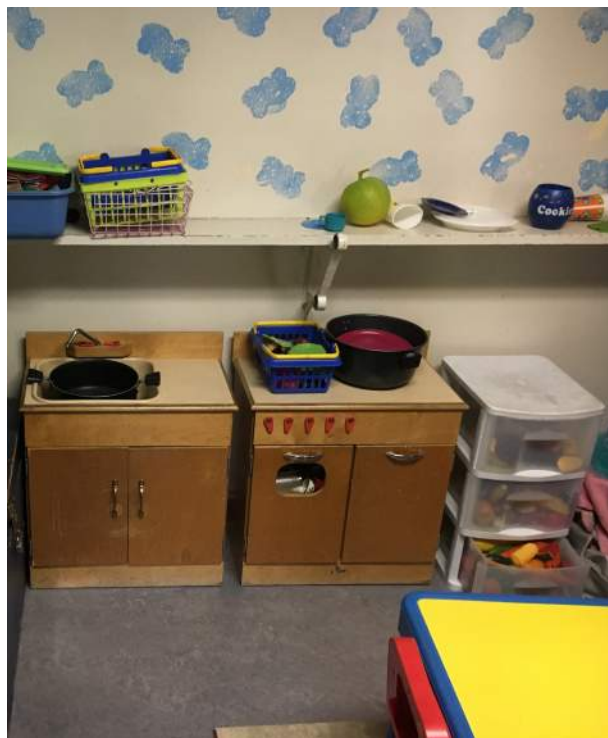
Image 2.3.16 Preschool. Non-accessible sink. Taken on 04/26/2022 by Belli Architectural Group.

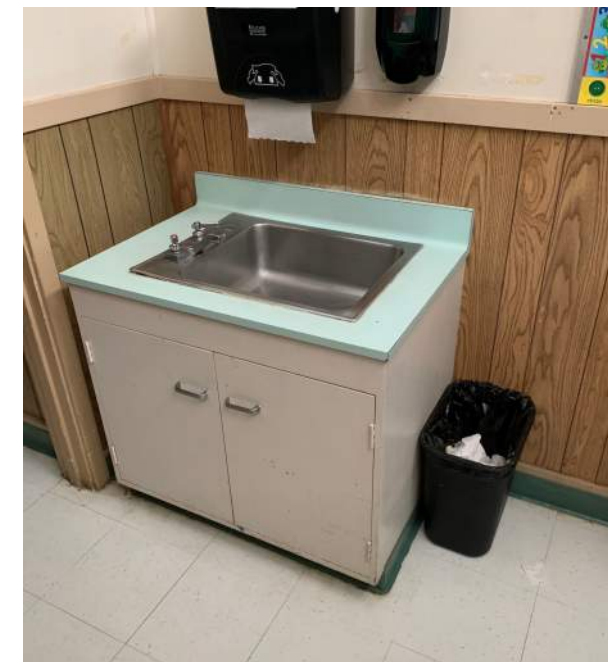
Image 2.4.2 Non-accessible sink at classroom. Taken on 04/26/2022 by Belli Architectural Group.

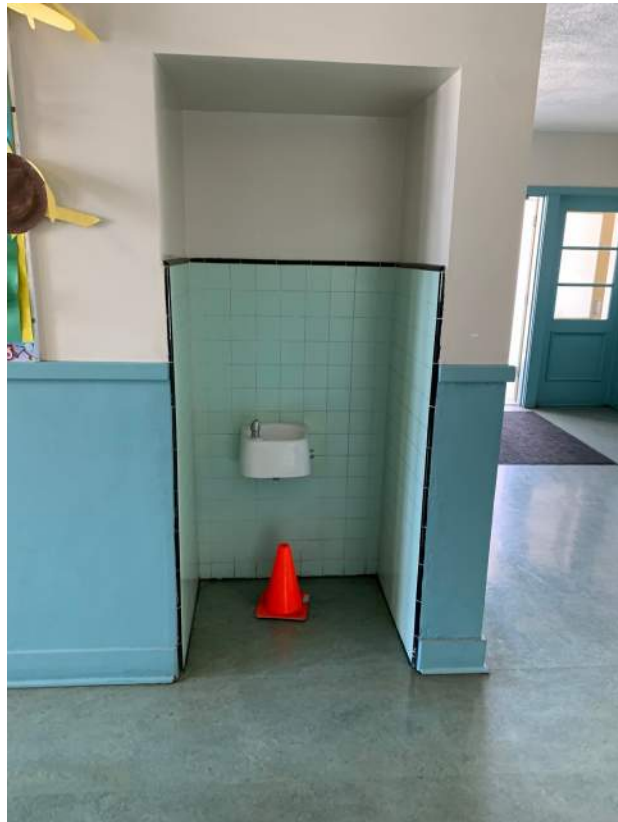
Image 2.4.3 Non-accessible drinking fountain. Taken on 04/26/2022 by Belli Architectural

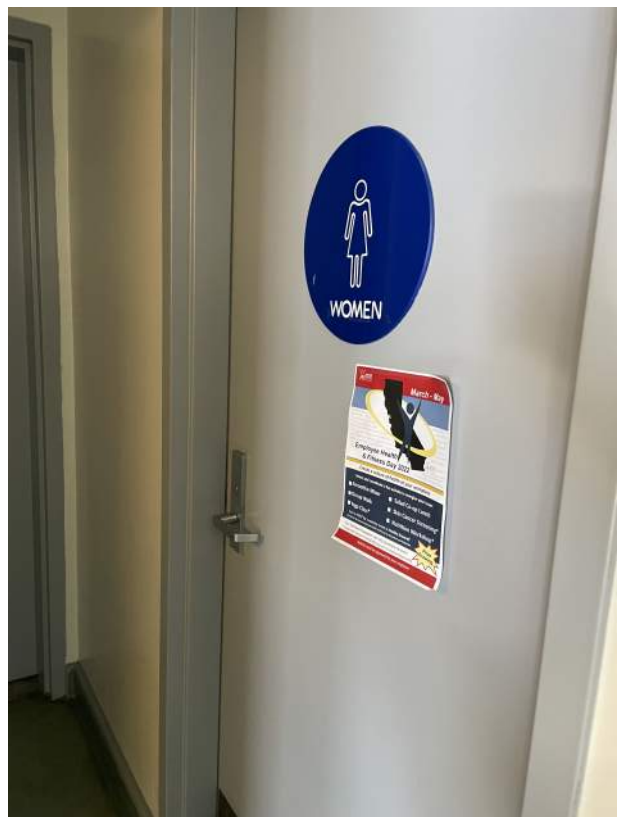
Image 2.4.4 Missing restroom wall signage. Taken on 04/26/2022 by Belli Architectural Group.

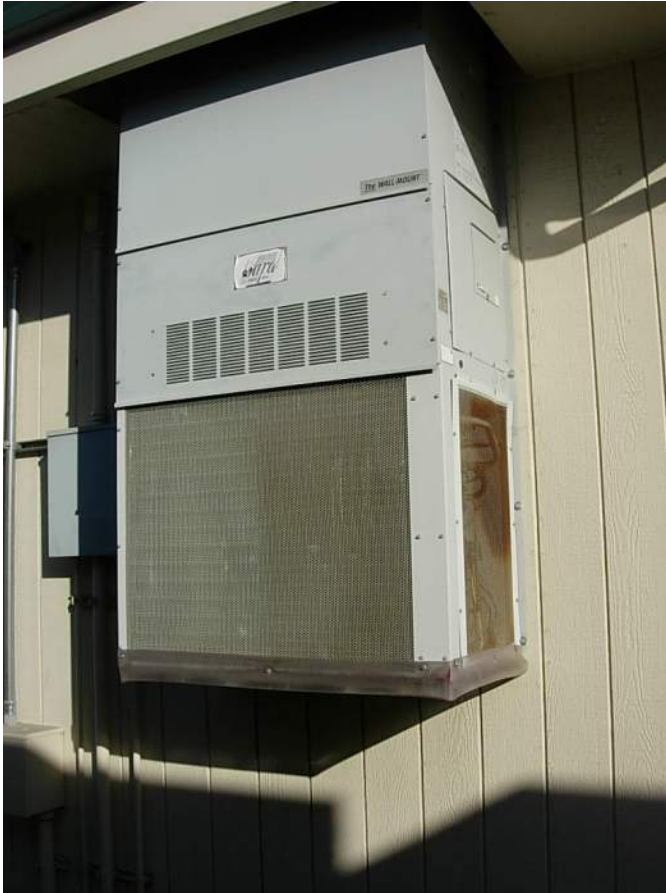
Classroom 29 thru 48:

These are portable classroom consisting of the exterior wall mounted “Bard” type heat pump units. All portables utilize this type of equipment. These units throughout the campus appear to be original and are operating. Older (20 years) units should be replaced with new units.

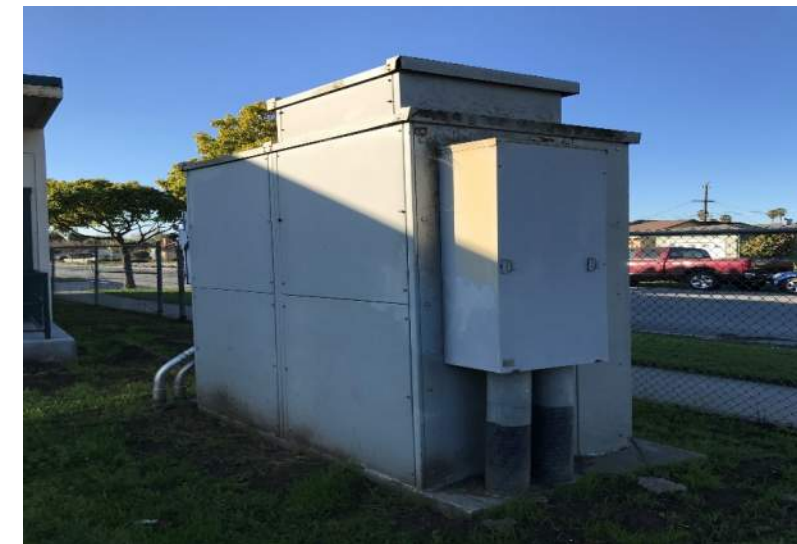
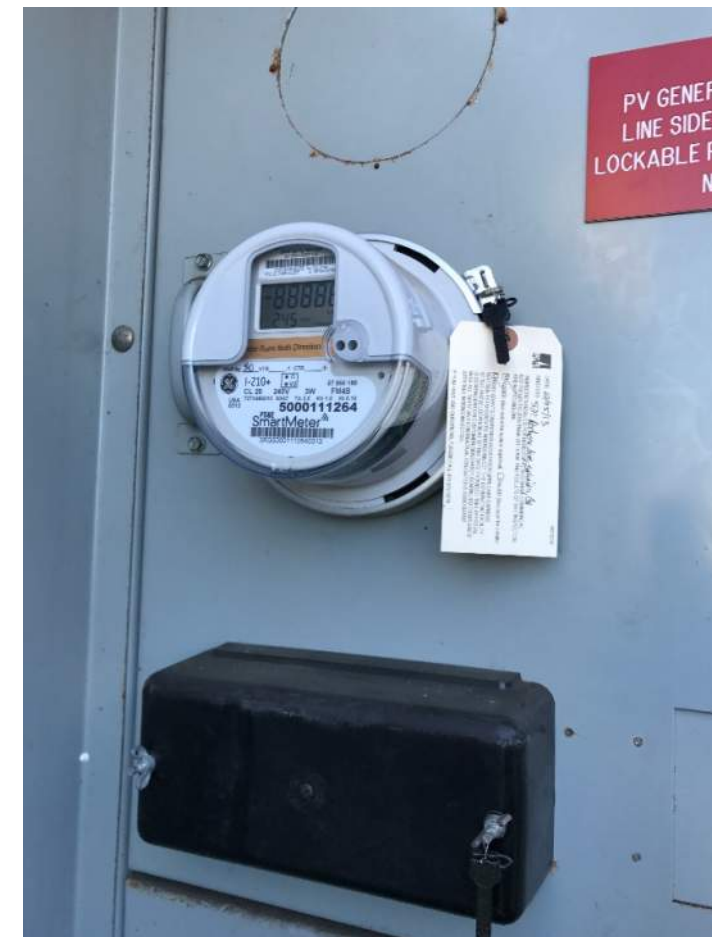
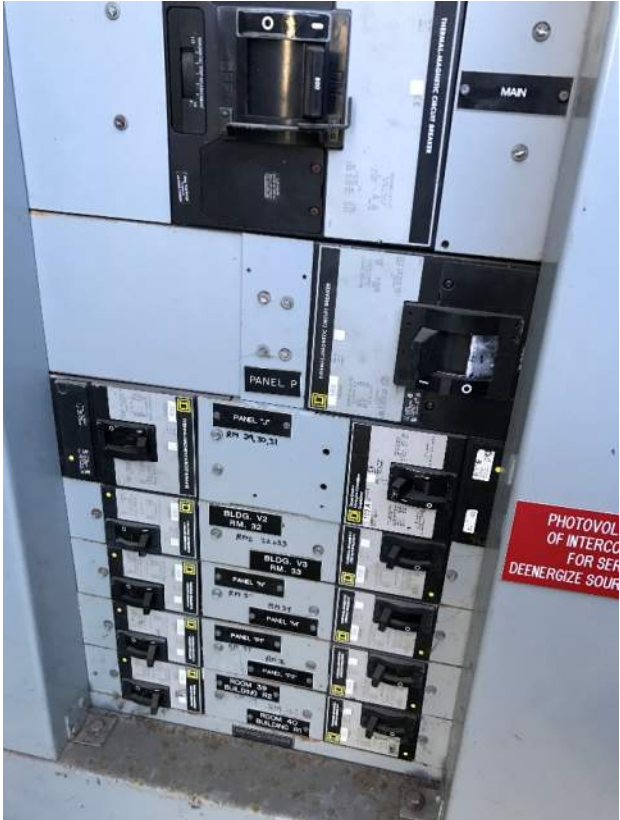
There are (3) existing main “metered” electrical service switchboards (MSB1, MSB2 and MSB3). MSB1 is a 600 amp, 120/240 volt, 1 phase, NEMA 3R service located at the south/east side of the campus across from the pre-school buildings. MSB1 has a connection for one of the existing Solar PV systems on the site and this Solar PV System is connected to MSB1 through a step-down voltage transformer (steps down 480V Solar PV system to 208V electrical distribution system) located adjacent to MSB1. The Solar PV is then connected ahead of the main breaker at MSB1. MSB1 serves in large part, the main campus buildings (not including the portables on the west side or the MPR/Cafeteria building) and the pre-school building. MSB2 is an 800 amp, 120/240V, 1-phase, NEMA 3R service located on the south north/west side of the campus along Tyler Street just behind Portable Building #40. MSB2 is served by a pad mounted PG&E transformer approximately 50 feet away. MSB2 provides service for Portable buildings #29 through #47. MSB2 has a connection for one of the existing Solar PV systems on the site and this Solar PV System is connected to MSB2 through a step-down voltage transformer (steps down 480V Solar PV system to 208V electrical distribution system) located approximately 100 feet away next to a storage building by the MPR/Cafeteria building on site. The Solar PV is then connected ahead of the main breaker at MSB2. MSB3 is a 600 amp, 120/208V, 3-phase, NEMA 3R service located on the north/west side of campus adjacent to Storage building/MPR/Cafeteria Buildings along Tyler Street approximately 100 plus feet away from MSB2. MSB3 is provided connection from PG&E from overhead service cables that are connected to a PG&E pole mounted transformer and riser down to the MSB3 switchboard. MSB3 serves in large part the MPR/Cafeteria building, storage building and a few miscellaneous connections such as irrigation controller and a pump. The electrical systems/switchboards appears to be in good condition. MSB1 expected life; 15 to 20 years, except it is not of any significant size to add connection for any upgrades. MSB2 expected life; 15 to 20 yrs. and it also does not seem to have much capacity for adding new connections. MSB3 expected life; 10 yrs. The electrical services are used primarily for lighting and heating equipment, with minimal plug loads. Some of the electrical distribution system panels that are located around the site at building interior locations and are original to the site should be replaced as remodels occur or as breakers fail. The reliability of the older panel system’s breakers to function correctly when necessary cannot be relied upon. Where the District plans to add HVAC to the site, the switchboards that are serving those locations will require an upgrade. The service upgrade should be larger if the district has plans for additional buildings or renovations of the existing buildings with added loads for HVAC upgrades and added computer loads. See attached photos MSB1, MSB2 & MSB3.

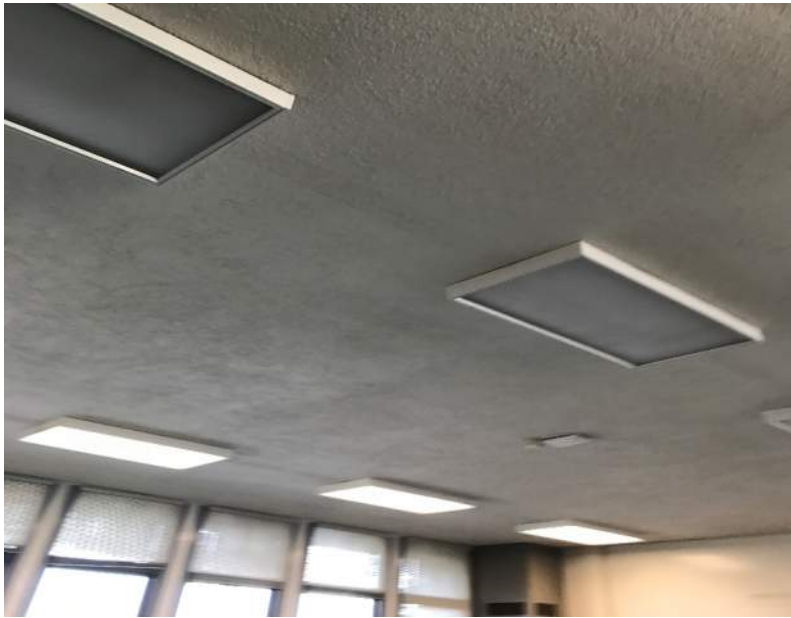
LTG1

Interior Lighting is primarily fluorescent with T8 or T12 lamps at interior spaces (with the exception of a few common areas that have been retrofitted to LED, but less than 5% of the interior areas). Most if not all the lighting throughout the school campus is old and although there was no mention of complete failure, some light fixtures seemed original to the spaces,

so they are likely near their “end of life”, especially with regards to efficiency. Emergency lighting was not apparent at any classrooms, restrooms, exterior landings. However, in multi-use spaces, bug-eye type stand-alone emergency light fixtures were installed. Occupant sensors and multilevel switching necessary for energy conservation is almost non-existent. Expected life; Unknown. It is recommended to retrofit campus wide lighting system in the near future. This would be a good opportunity for reduction in energy use from more efficient lighting fixtures, improved classroom lighting, smart lighting controls and reduced maintenance. See attached LTG1.
