# FACILITIES NEEDS ASSESSMENT

LAUREL WOOD

PREPARED BY BELLI ARCHITECTURAL GROUP

2022

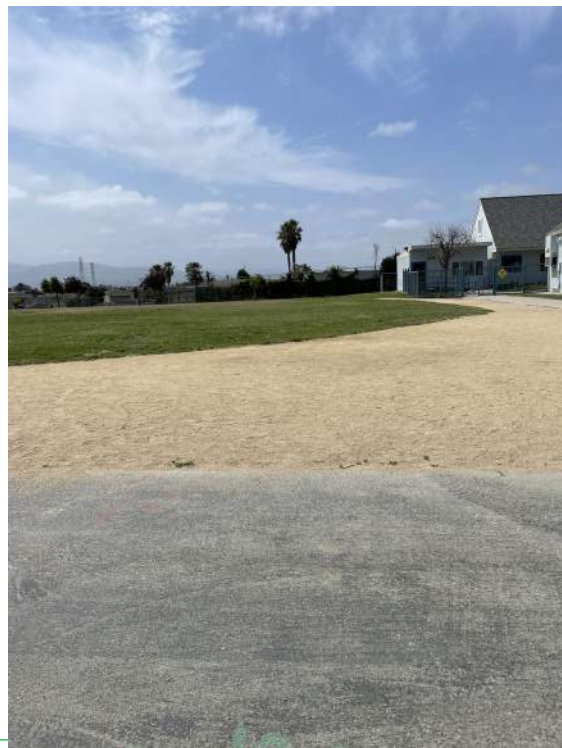
Image 2.1.1 Existing track. Taken on 04/26/2022 by Belli Architectural Group.

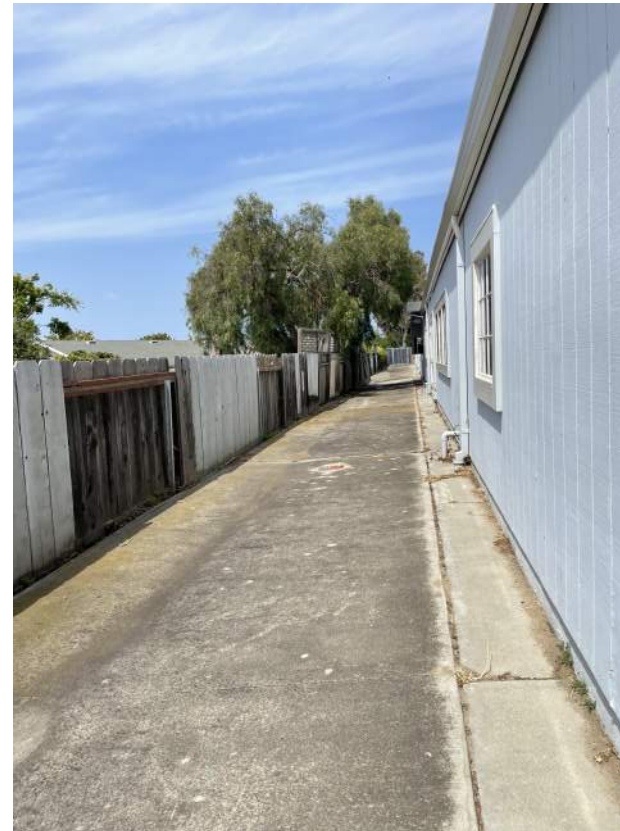
Image 2.1.2 Existing alley behind classrooms. Taken on 04/26/2022 by Belli Architectural Group.

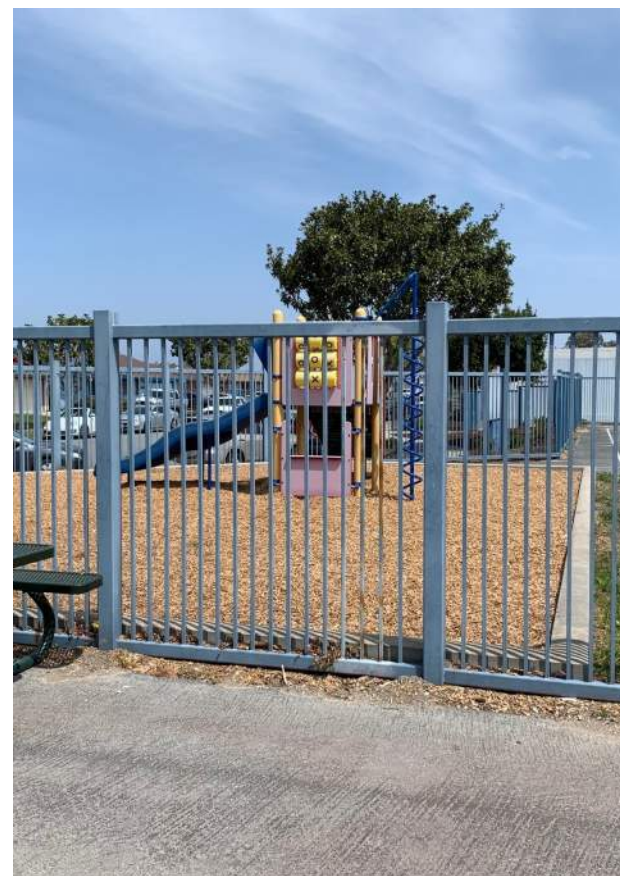
Image 2.1.3 Kindergarten playground. Taken on 04/26/2022 by Belli Architectural Group.

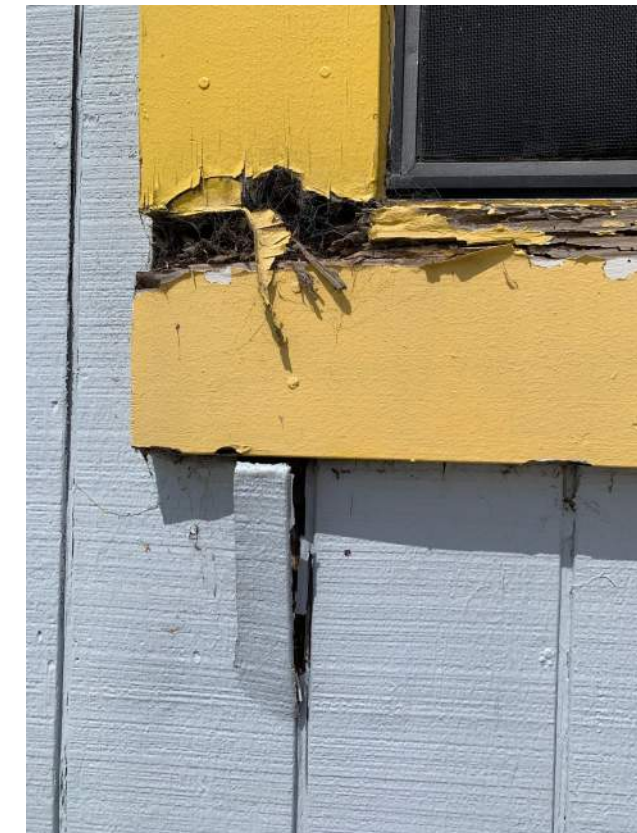
Image 2.2.1 Exterior dry rot. Taken on 04/26/2022 by Belli Architectural Group.

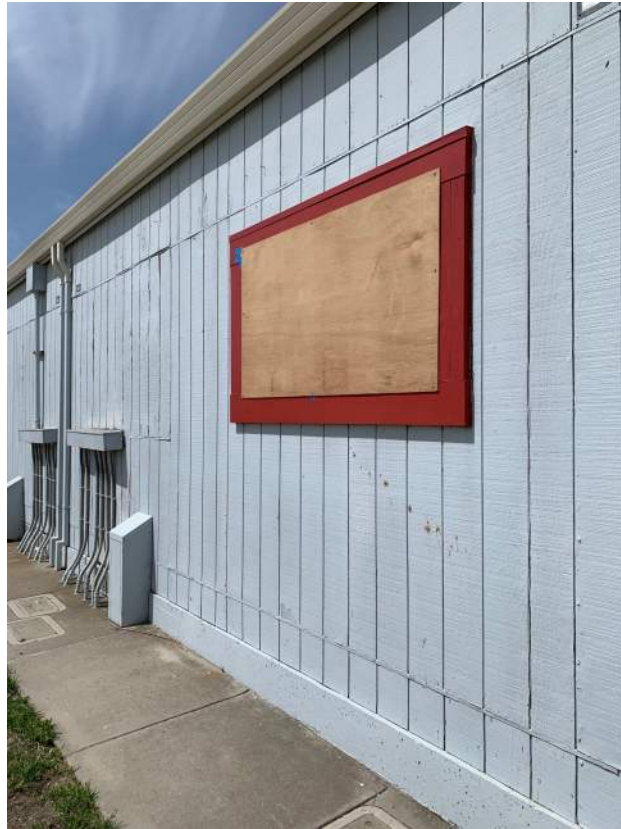
Image 2.2.2 Missing window. Taken on 04/26/2022 by Belli Architectural Group.

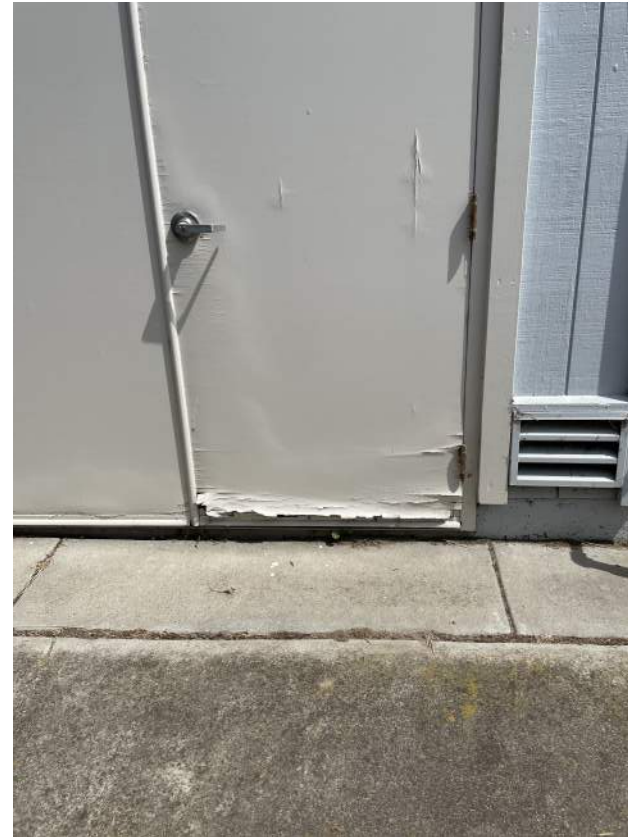
Image 2.2.4 Dry rot present at most exterior doors. Taken on 04/26/2022 by Belli Architectural Group.

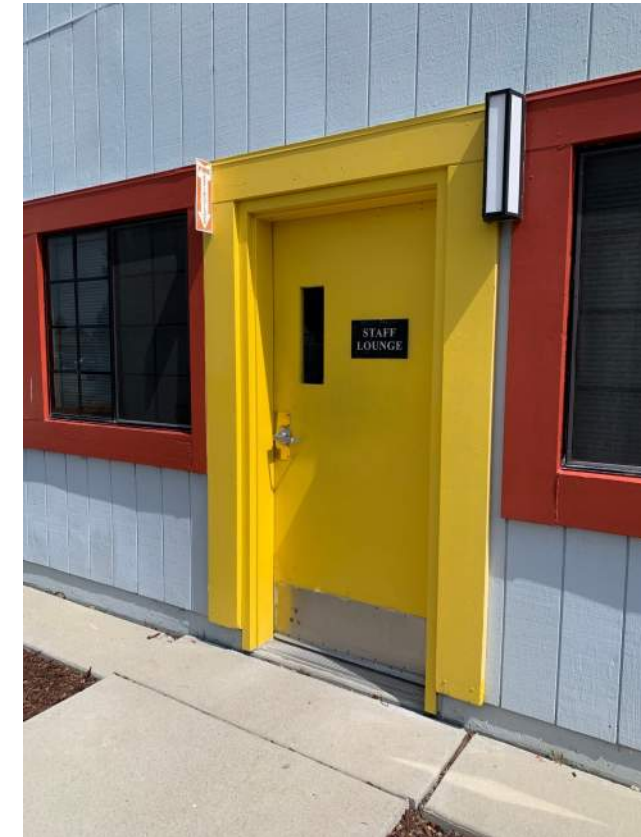
Image 2.2.5 Non-compliant door threshold. Taken on 04/26/2022 by Belli Architectural Group.

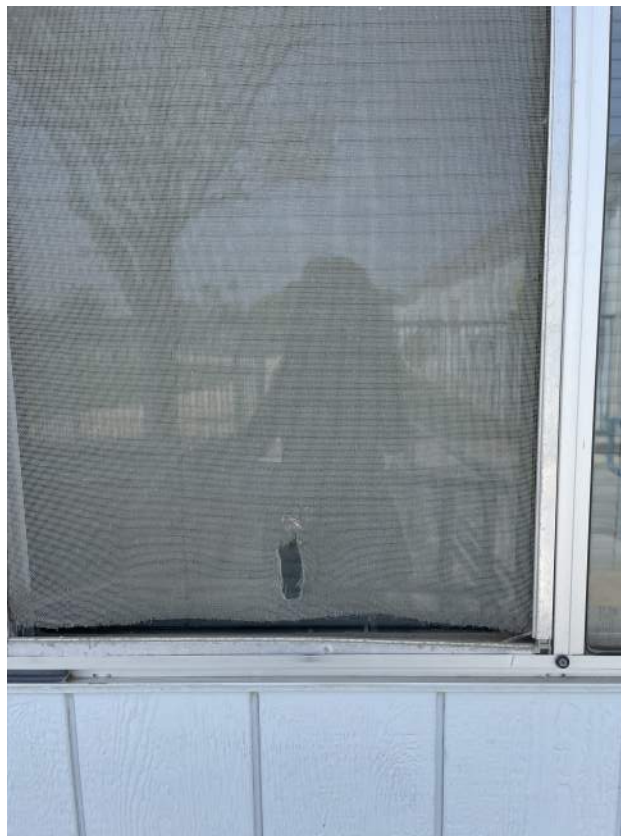
Image 2.2.3 Broken screens. Taken on 04/26/2022 by Belli Architectural Group.

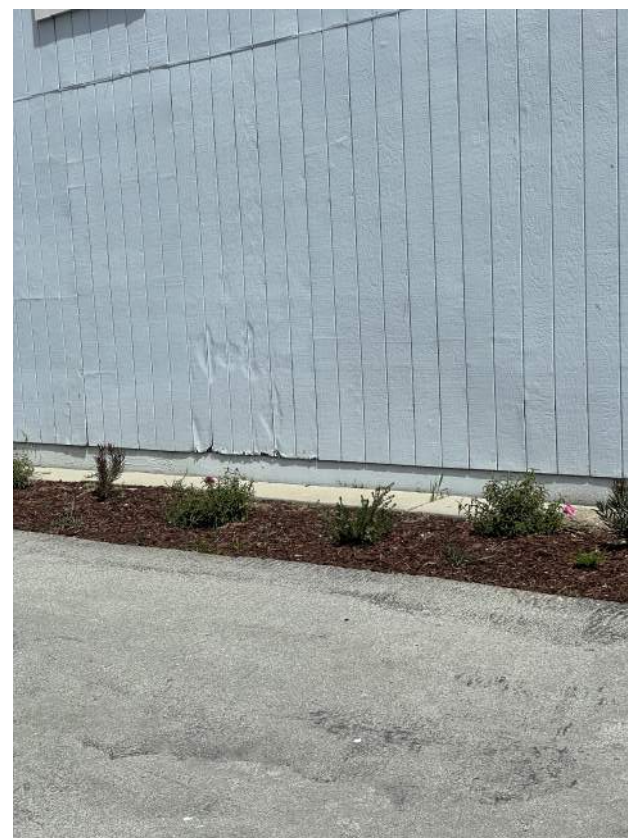
Image 2.2.5 Dry rot present at exterior wood paneling. Taken on 04/26/2022 by Belli Architectural Group.

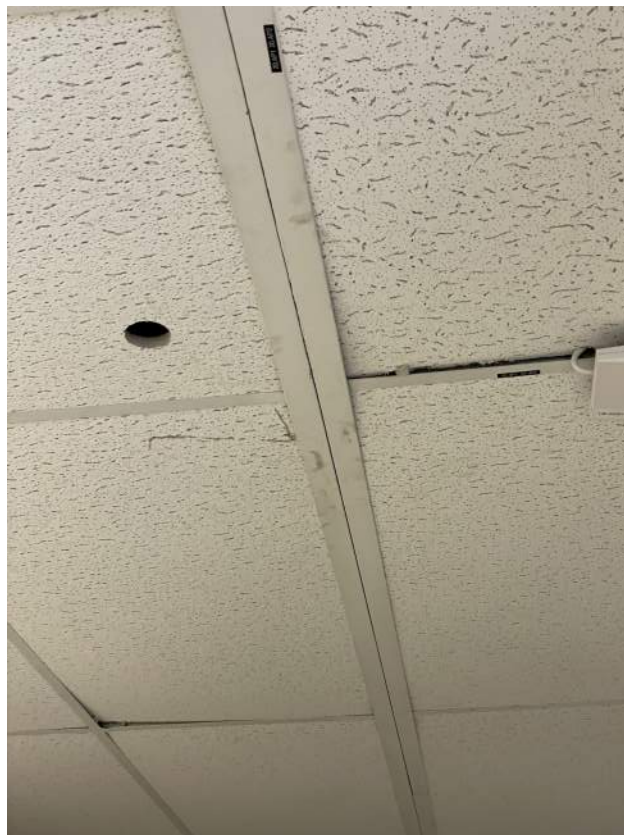
Image 2.3.1 Damaged ceiling panels. Taken on 04/26/2022 by Belli Architectural Group.

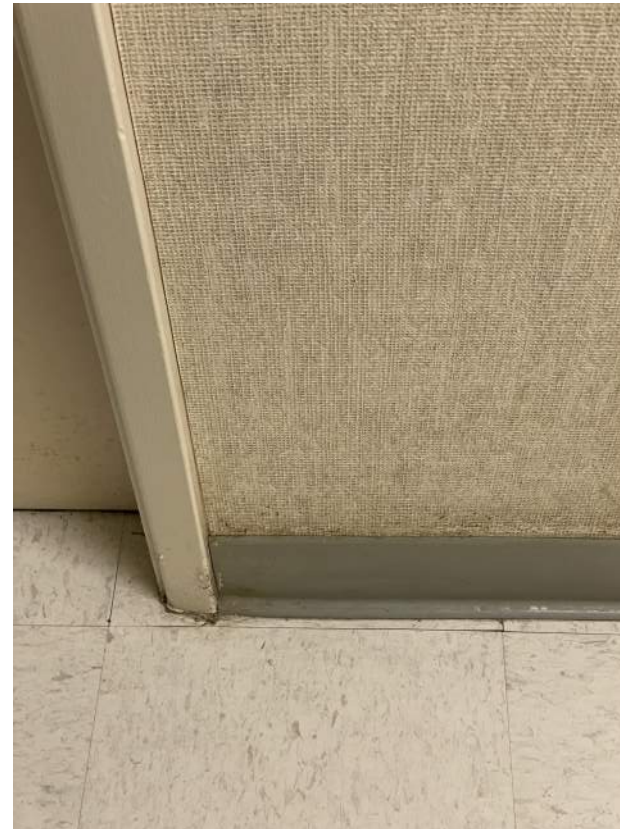
Image 2.3.2 Worn, dirty walls and floor finishes. Taken on 04/26/2022 by Belli Architectural Group.

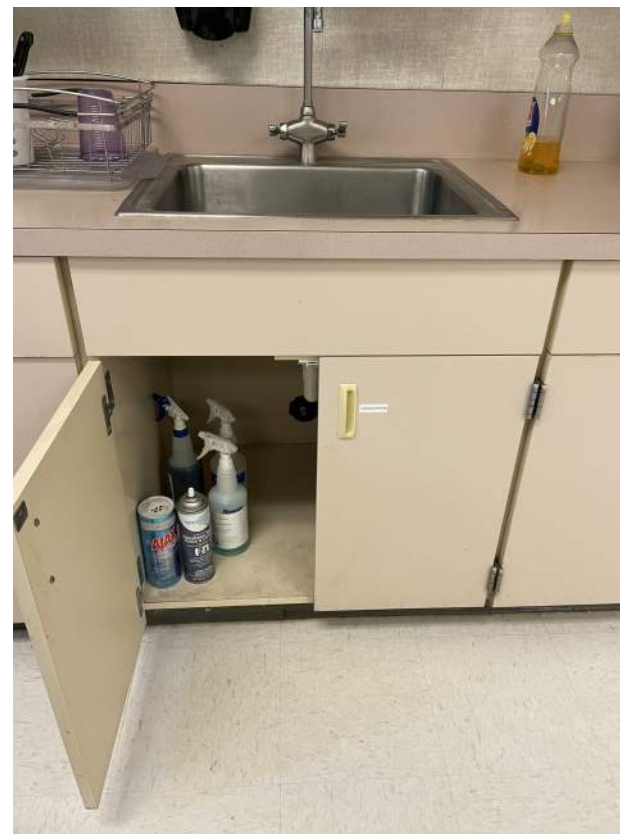
Image 2.3.3 Non-accessible sink. Taken on 04/26/2022 by Belli Architectural Group.

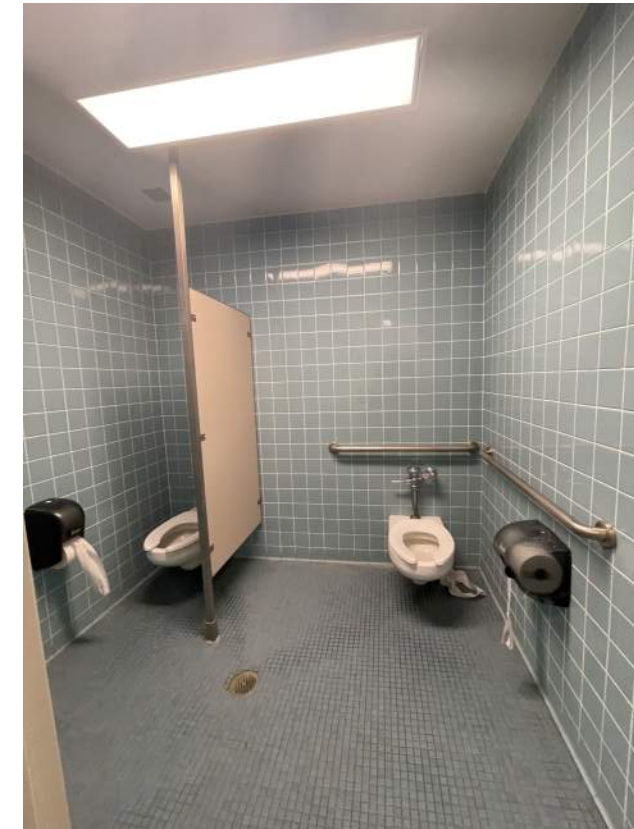
Image 2.3.4 Kindergarten restrooms. Taken on 04/26/2022 by Belli Architectural Group.

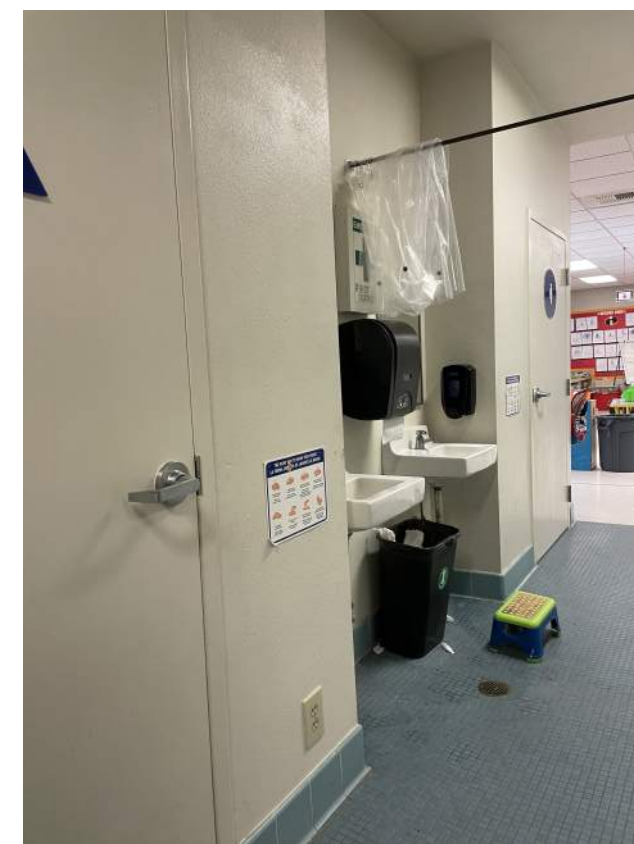
Image 2.3.5 Kindergarten sinks. Taken on 04/26/2022 by Belli Architectural Group.

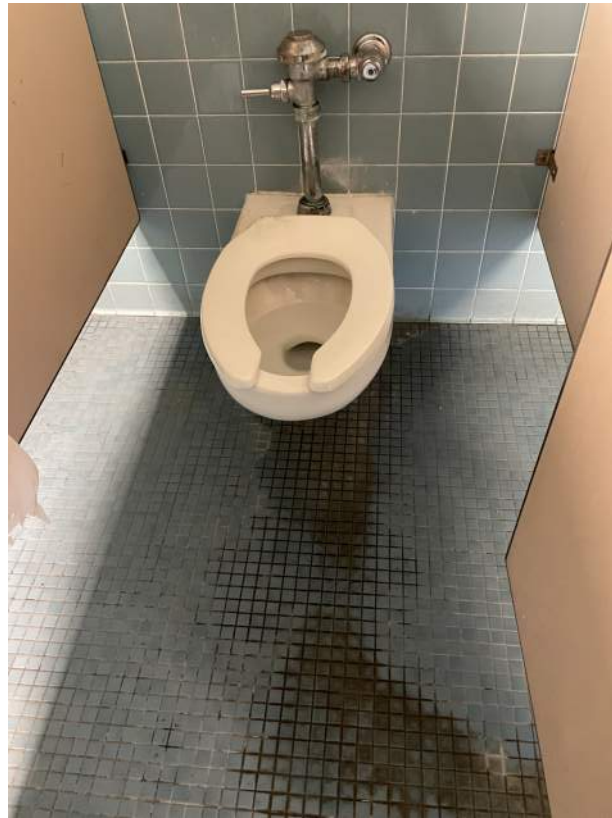
Image 2.3.6 Plumbing leak. Taken on 04/26/2022 by Belli Architectural Group.

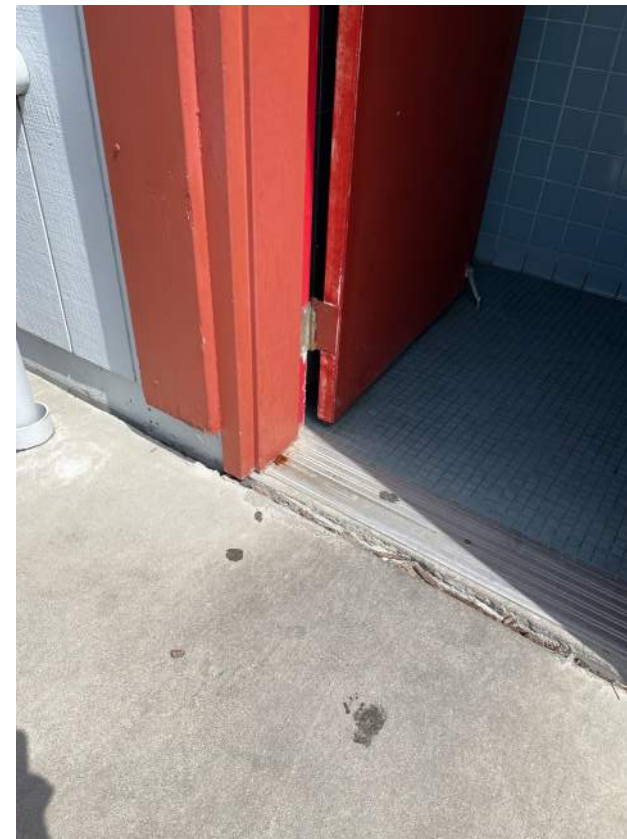
Image 2.4.1 Non-compliant threshold. Taken on 04/26/2022 by Belli Architectural Group.

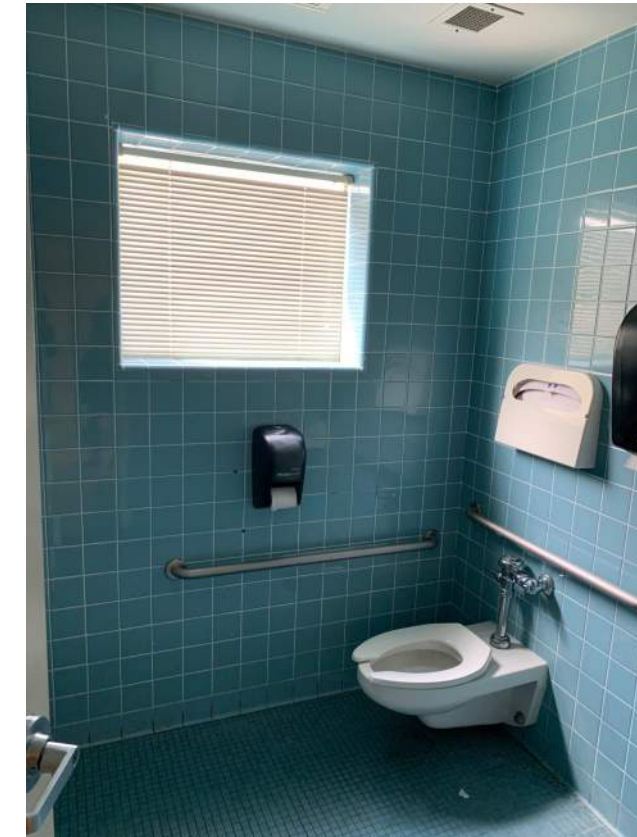
Image 2.4.2 Grab bars at different heights. Taken on 04/26/2022 by Belli Architectural Group.

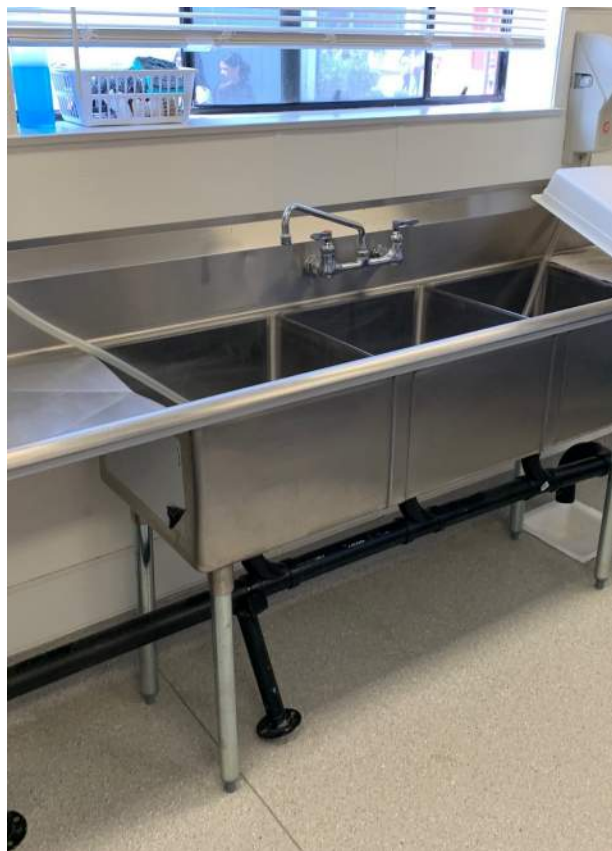
Image 2.3.7 Sink at MPR does not drain properly. Taken on 04/26/2022 by Belli Architectural Group.

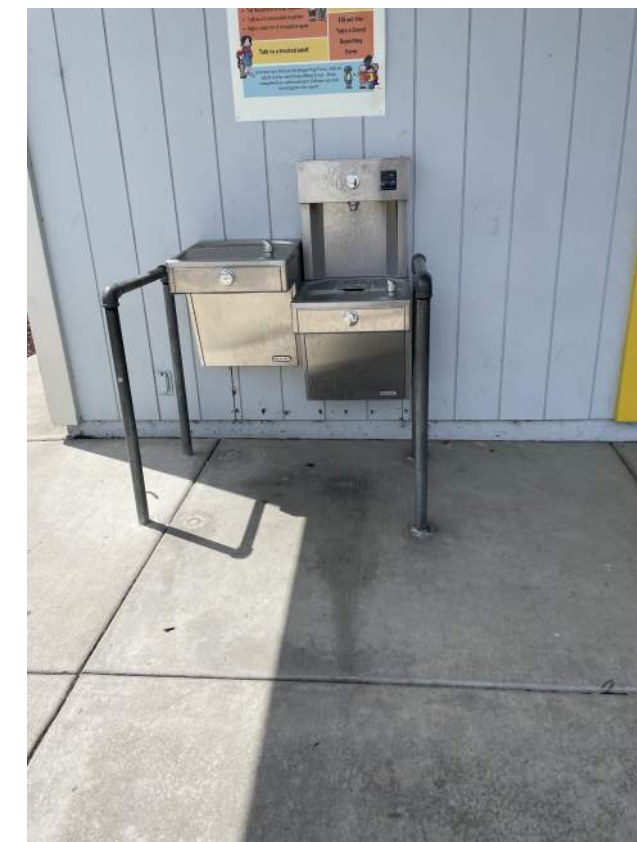
Image 2.4.3 Non-accessible drinking fountain. Taken on 04/26/2022 by Belli Architectural Group.

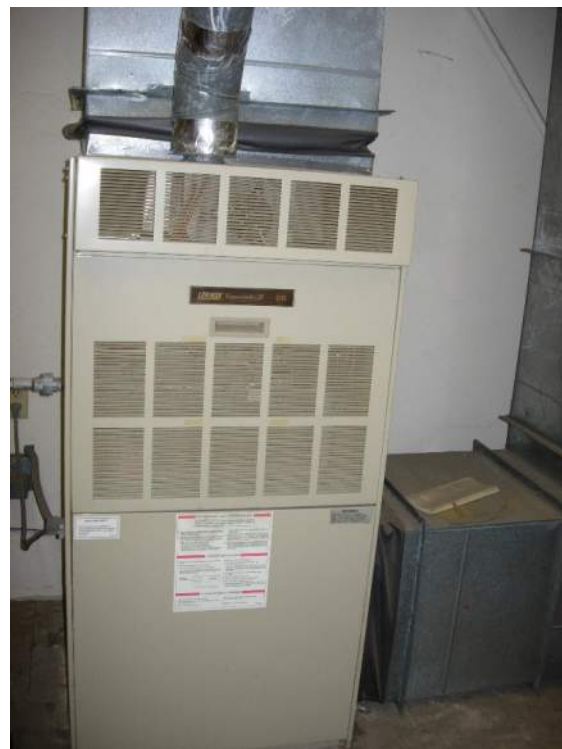
This area was heated with two (2) Lennox G16 gas-fired furnaces located in the attic. These furnaces are original and appear to be operating. They are more than 35 years old and should be replaced with new furnaces. The furnaces serving the teacher’s break room is on a timeclock and bypass timer.

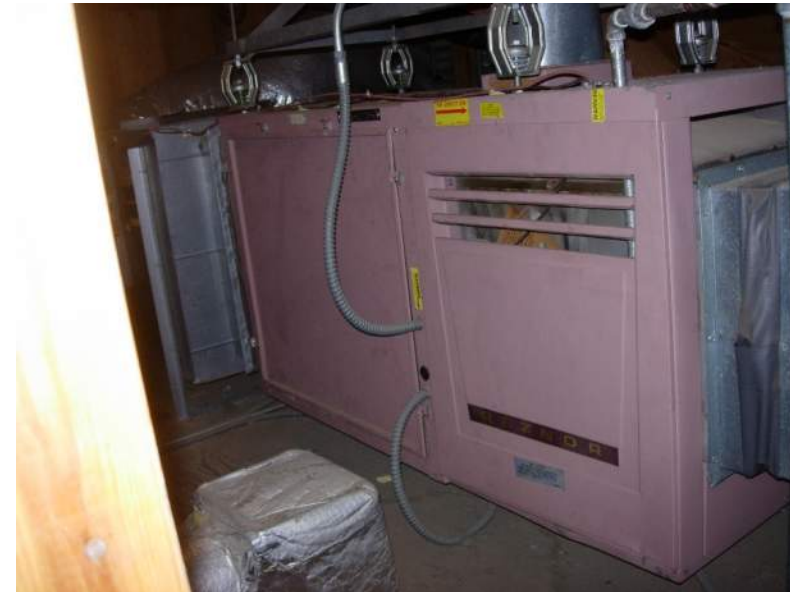
This building is heated with two (2) Reznor horizontal gas-fired heating units with blower fans located in the attic. These are original units from 1986 and should be replaced. These units have outside air inlets for ventilation.

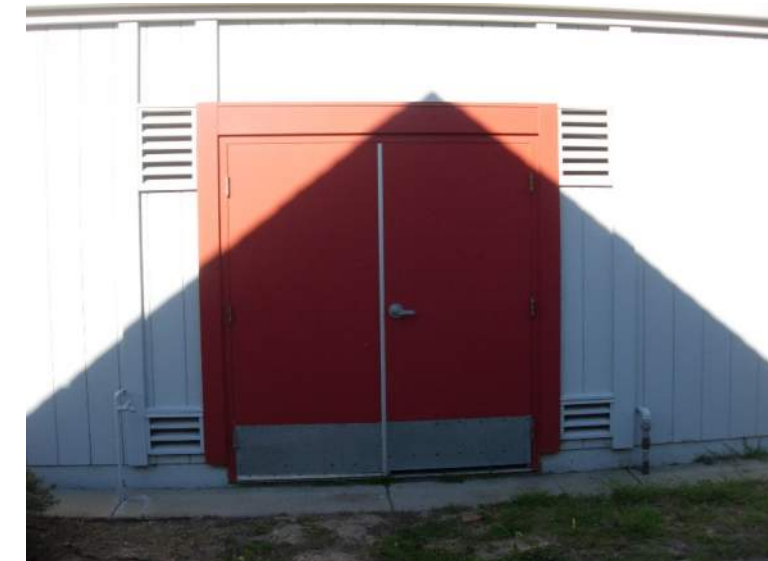
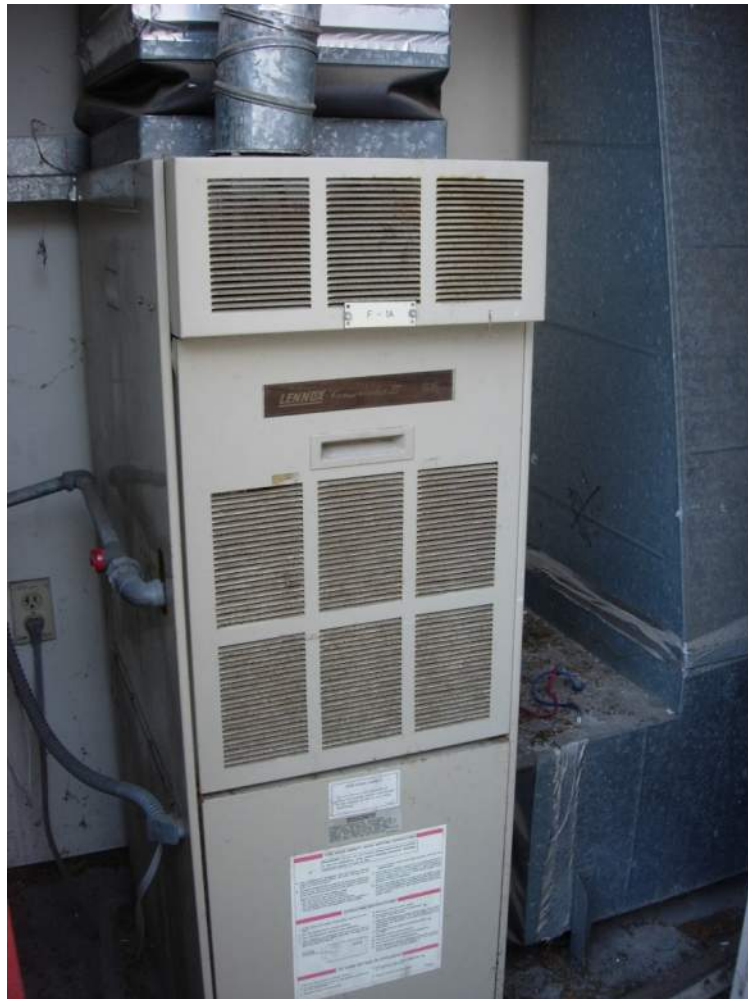
These classrooms are served by Lennox G16 gas-fired up-flow furnaces located in exterior mechanical rooms. These are original units from 1986 and should be replaced. It is noted that the mechanical room doors are rotting out at the floor and need replacing.

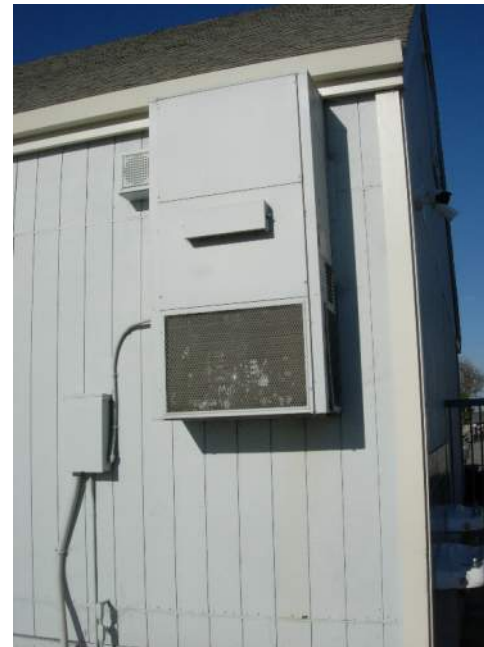
These are portable classroom consisting of the exterior wall mounted “Bard” type heat pump units. All portables utilize this type of equipment. These units throughout the campus appear to be original and are operating satisfactory. Older (20 years) units should be replaced with new units.

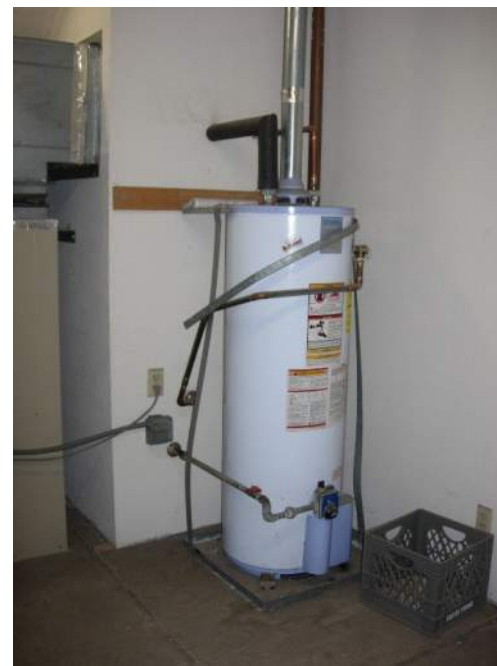
A gas-fired tank type water heater located in the attic does not have DSA approved seismic bracing. This seismic bracing is required.

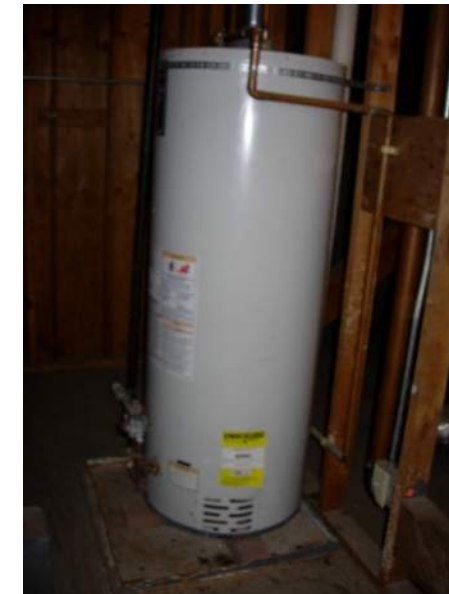
A gas-fired water heater located in the attic does not have DSA approved seismic bracing. This seismic bracing is required.

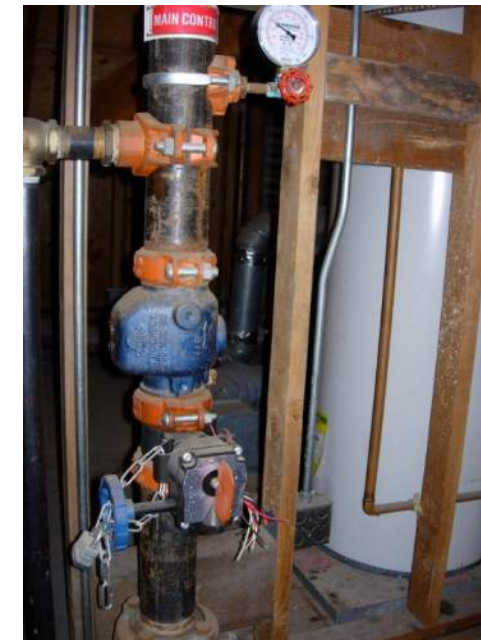
Some areas of the schools (storage rooms and attics over the office/staff lounge and multi-purpose room) have fire sprinklers that are connected to the domestic water system. The photo below is of the fire service that serves the attic over the Multi-Purpose/Cafeteria. It was noted that the tamper switch on the shut-off valve is not wired to a fire alarm system.

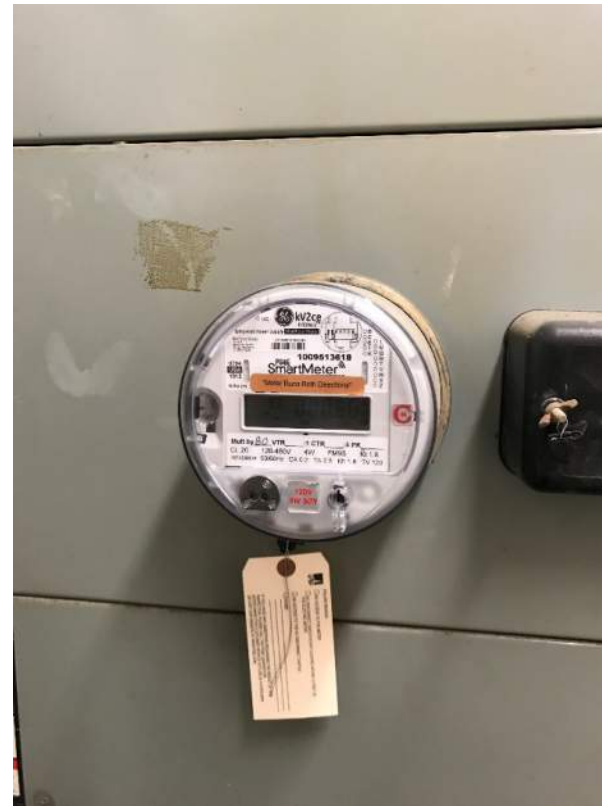
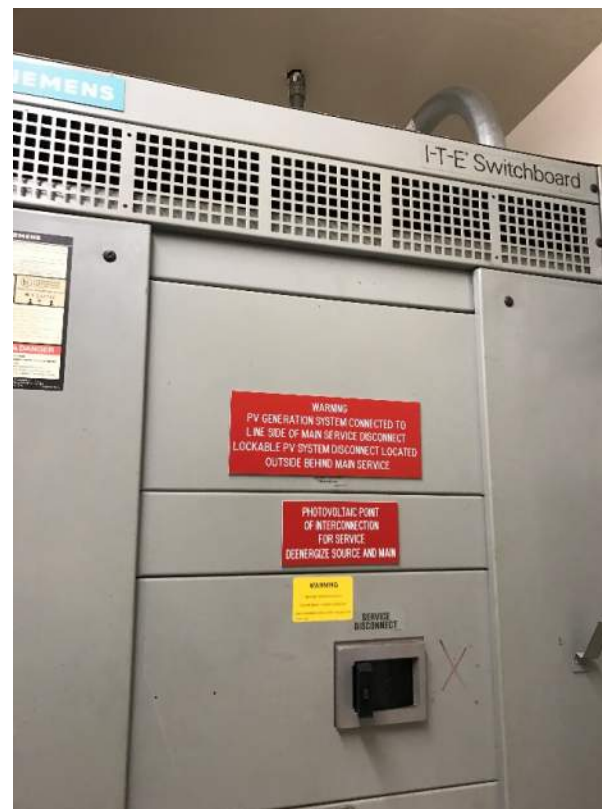
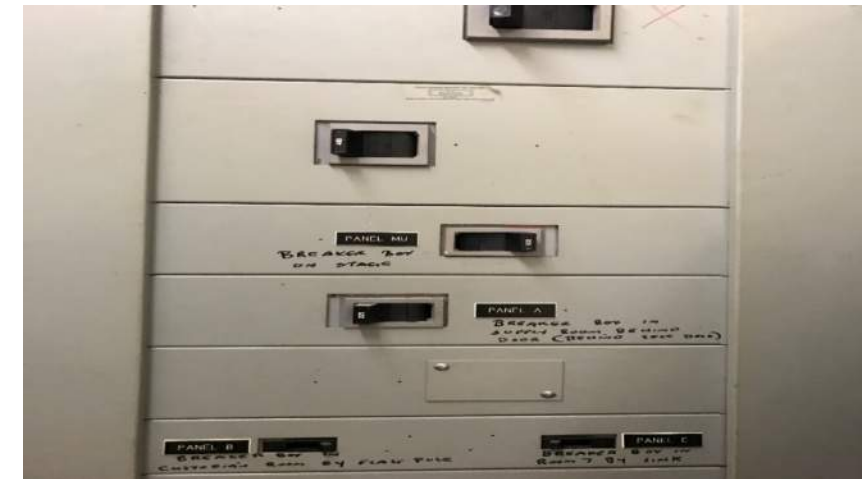
The existing main “metered” electrical service switchboard MSB1 is an 800 amp, 120/208 volt, 3 phase, NEMA 1 service located inside a custodian storage room near the library, front of the campus. MSB1 has a connection for the existing Solar PV systems on the site and this Solar PV System is connected to MSB1 through a step-down voltage transformer (steps down 480V Solar PV system to 208V electrical distribution system) located just outside the building from MSB1 location. The Solar PV is then connected ahead of the main breaker at MSB1. The electrical switchboards and campus wide electrical distribution system appears to be in good condition. MSB1 expected life; 10 to 15 years. The electrical service is primarily serving lighting and heating equipment, with minimal plug loads. Where the District plans to add HVAC to the site, the switchboard that is serving the site will “likely” require an upgrade based on what type of system is recommended for HVAC upgrades. See attached photos MSB1.

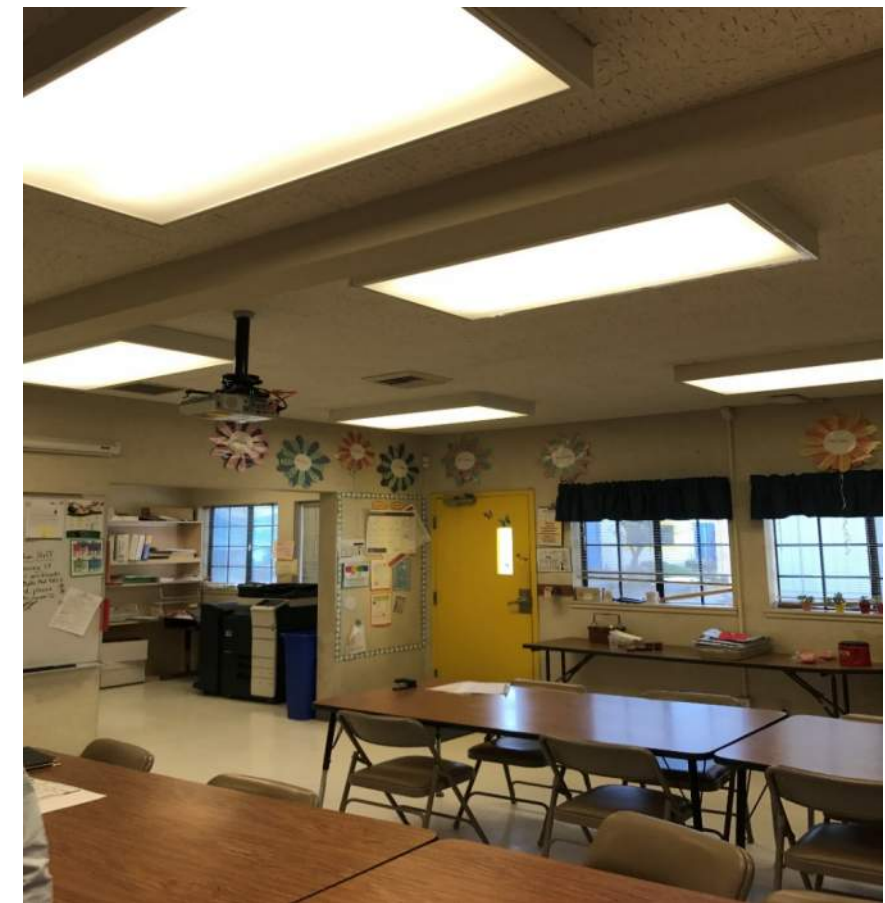
Interior Lighting is primarily fluorescent with T8 lamps at interior spaces. Most if not all the lighting throughout the school campus is older fluorescent technology which is still operating well except energy saving controls such as occupancy sensors or dimming switches are not provided (multi-purpose/cafeteria space has LED pendant light fixtures, but no dimming switches to control output). Emergency lighting was not apparent at any classrooms (except the few remodeled spaces), restrooms, or exterior landings. However, in multi-use spaces, bug-eye type stand-alone emergency light fixtures were installed. Expected life; 1-3 years. It is recommended to upgrade lighting as part of any remodel to more energy efficient light fixtures and just as important to provide dimming, automatic shut-off/occupancy sensor controls and possibly daylight controls to help realize energy savings for the school site and reduce maintenance. See attached photo LTG1.
