FACILITIES NEEDS ASSESSMENT

PREPARED BY BELLI ARCHITECTURAL GROUP

1. CAMPUS INFORMATION: Lincoln.

Address: 705 California Street, Salinas, CA 93901
 Year Built: 1924
 Current Principal: Juan Chaidez
 Current Enrollment: 581 students

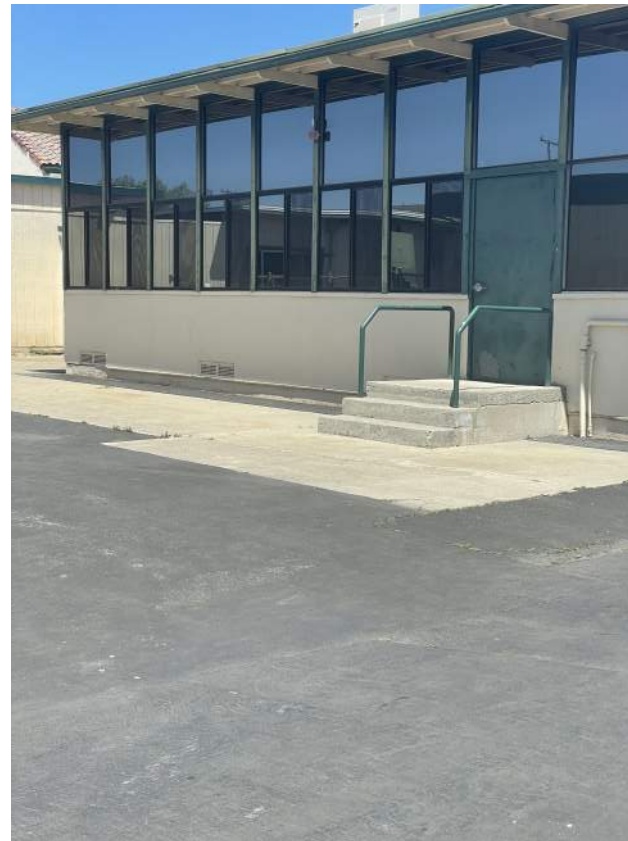
Image 2.1.2 Non-accessible relocatable building entrance. Taken on 05/03/2022 by Belli Architectural Group.

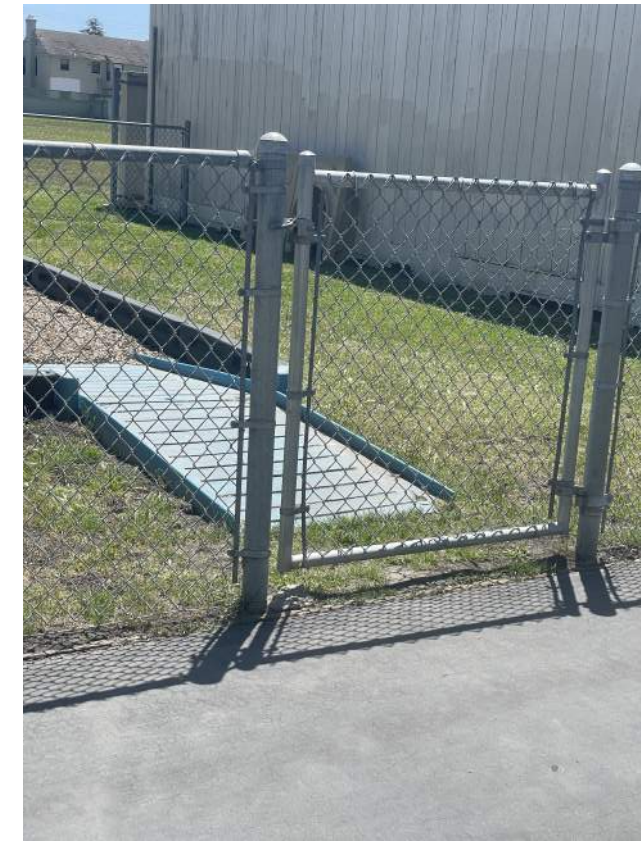
Image 2.1.4 Kindergarten playground access. Taken on 05/03/2022 by Belli Architectural Group.

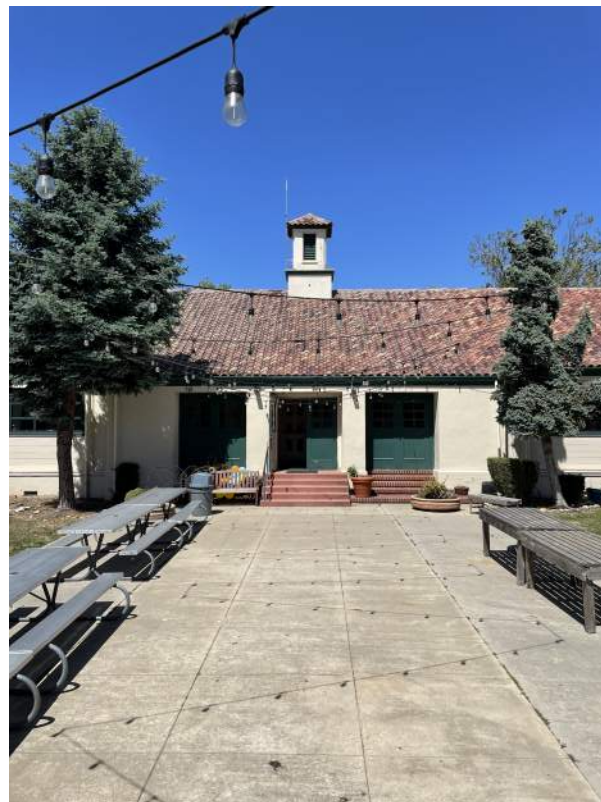
Image 2.1.1 Non-accessible Courtyard entrance. Taken on 05/03/2022 by Belli Architectural Group.

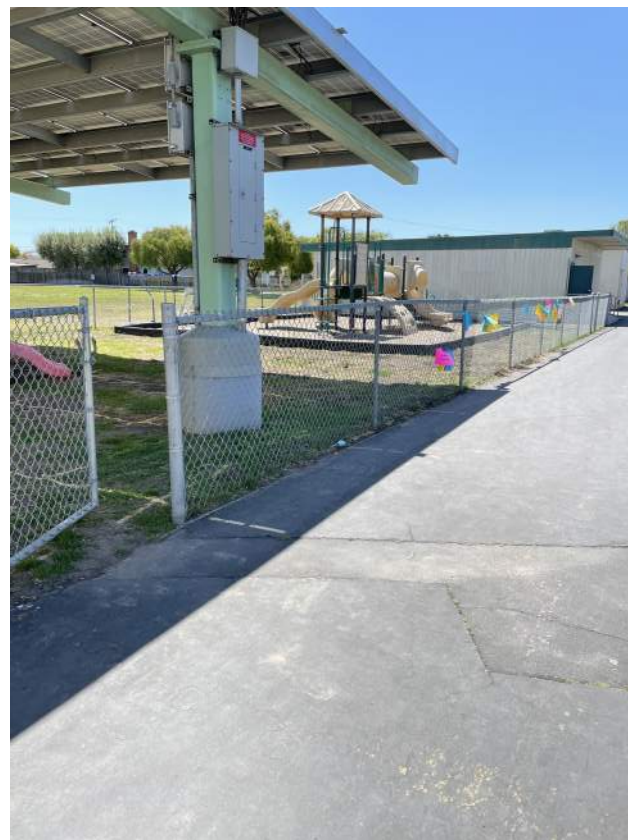
Image 2.1.3 Non-accessible second Kindergarten playground. Taken on 05/03/2022 by Belli Architectural Group.

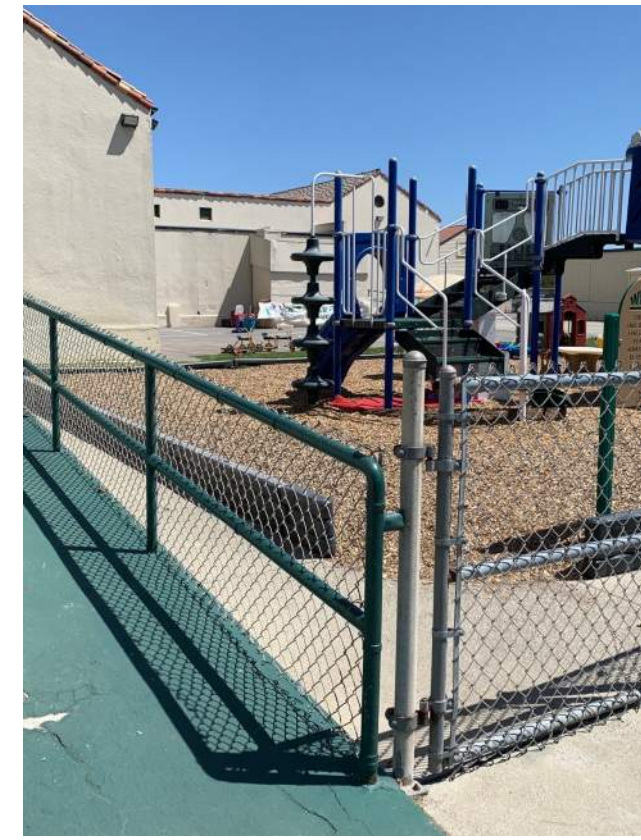
Image 2.1.5 Non-accessible ramp to kindergarten playground. Taken on 05/03/2022 by Belli Architectural Group.

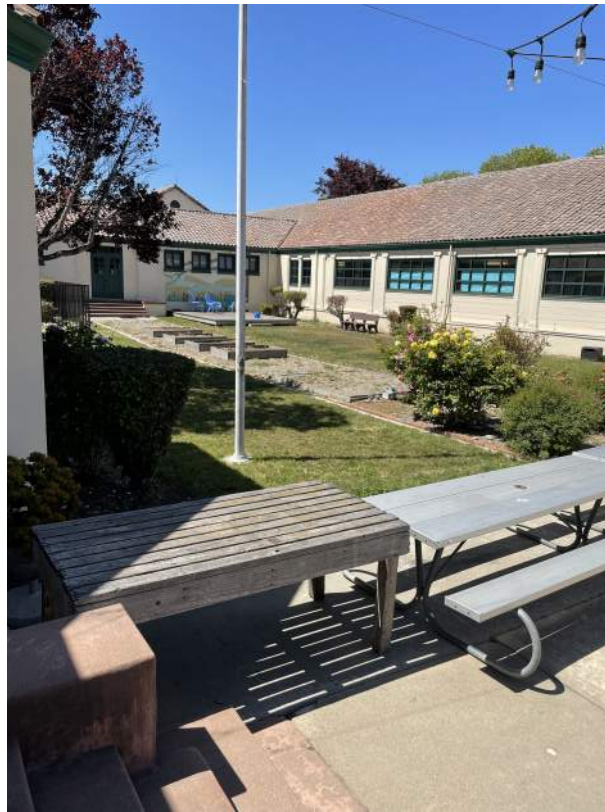
Image 2.1.5 Exterior furnishings. Taken on 05/03/2022 by Belli Architectural Group.

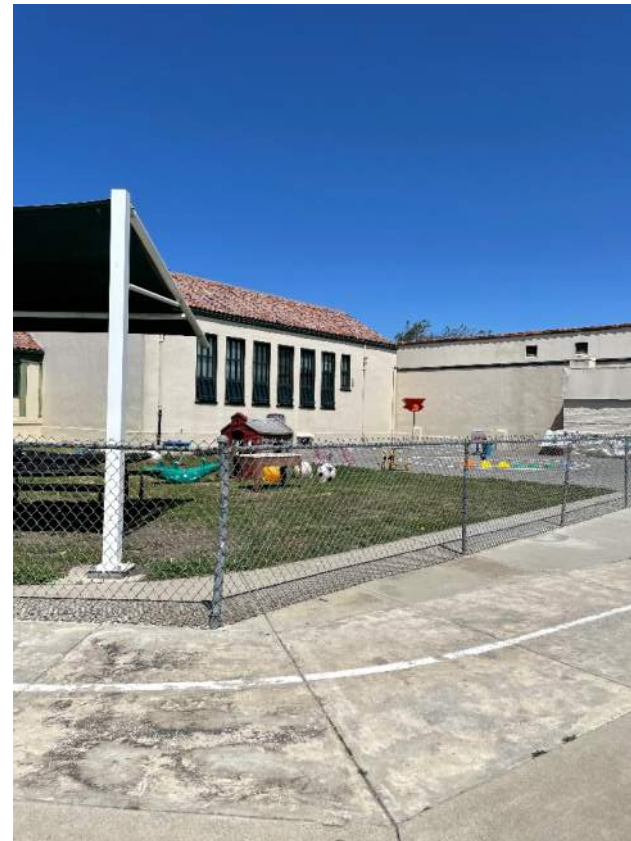
Image 2.1.7 Aging concrete surfaces. Taken on 05/03/2022 by Belli Architectural Group.

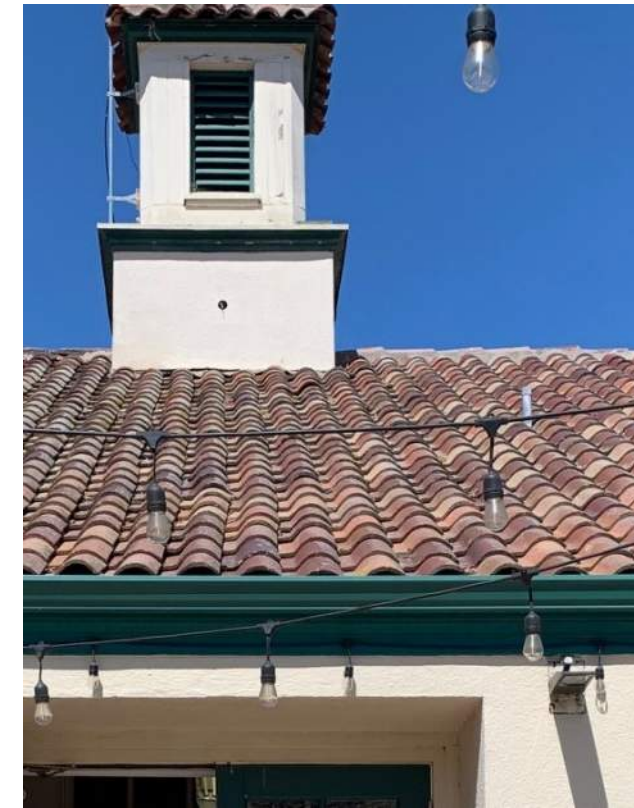
Image 2.2.1 Main building roof. Taken on 05/03/2022 by Belli Architectural Group.

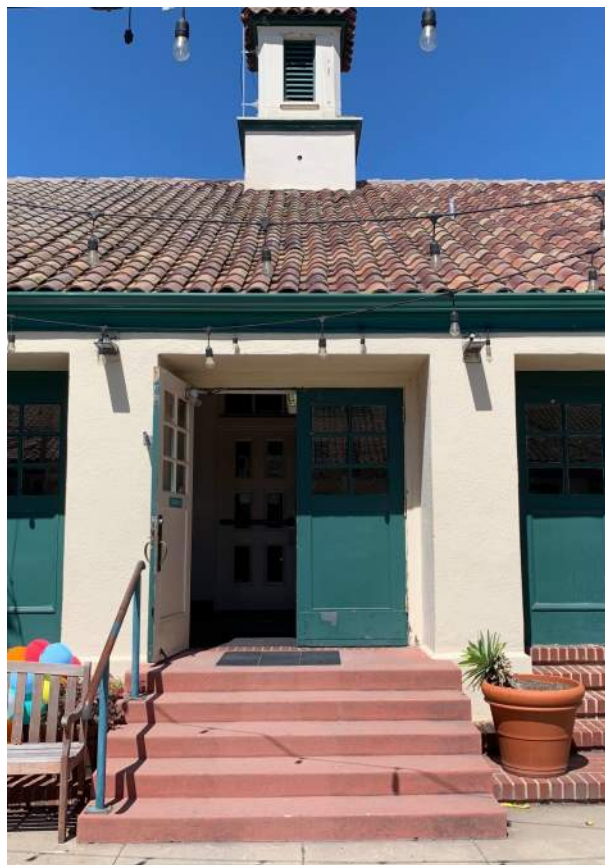
Image 2.1.6 Rusty handrail. Taken on 05/03/2022 by Belli Architectural Group.

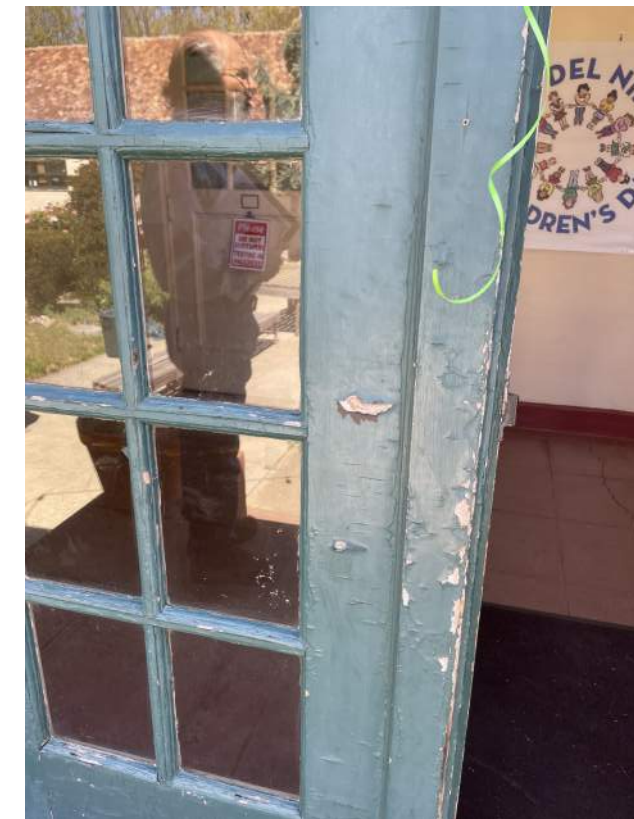
Image 2.2.2 Original wood doors. Taken on 05/03/2022 by Belli Architectural Group.

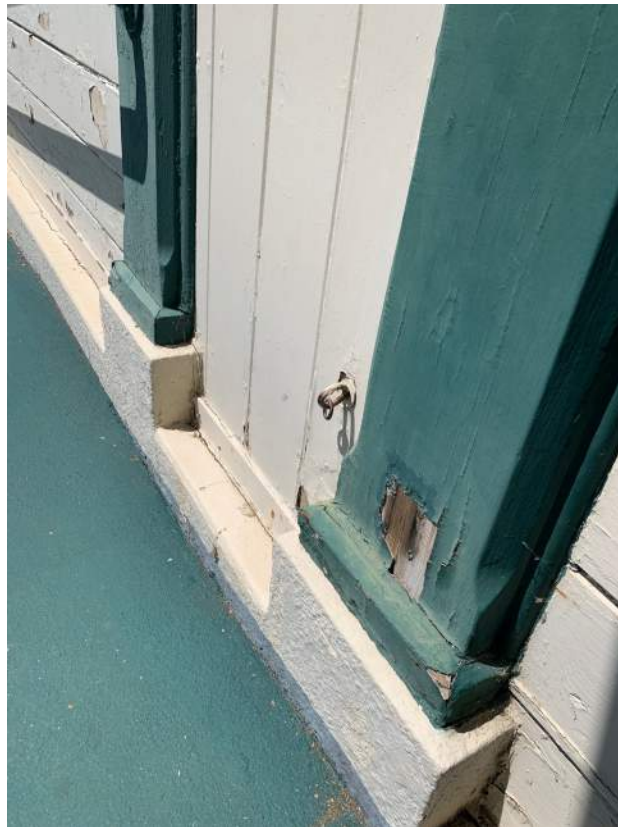
Image 2.2.3 Exterior paint. Taken on 05/03/2022 by Belli Architectural Group.

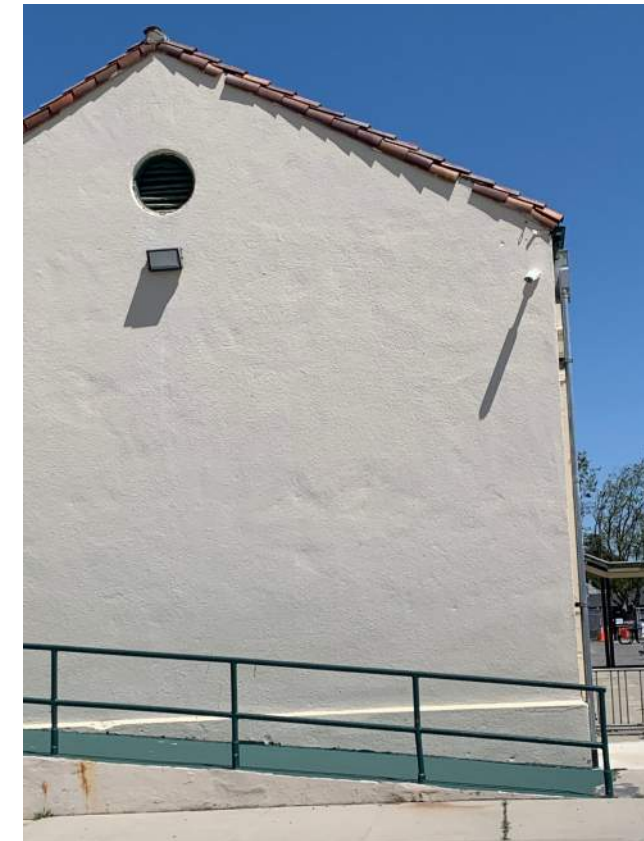
Image 2.2.7 Non-accessible ramp. Taken on 05/03/2022 by Belli Architectural Group.

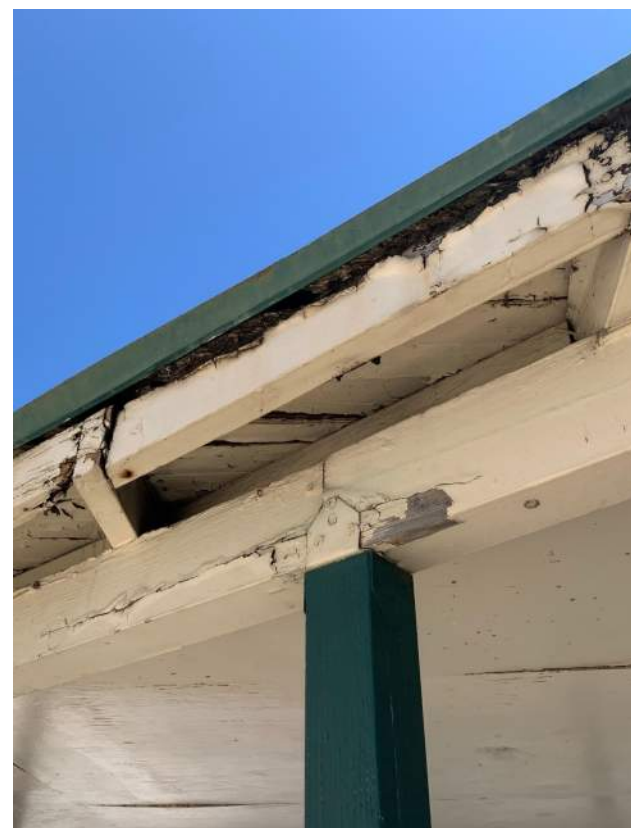
Image 2.2.6 Dry rot conditions at Library overhang. Taken on 05/03/2022 by Belli Architectural Group.

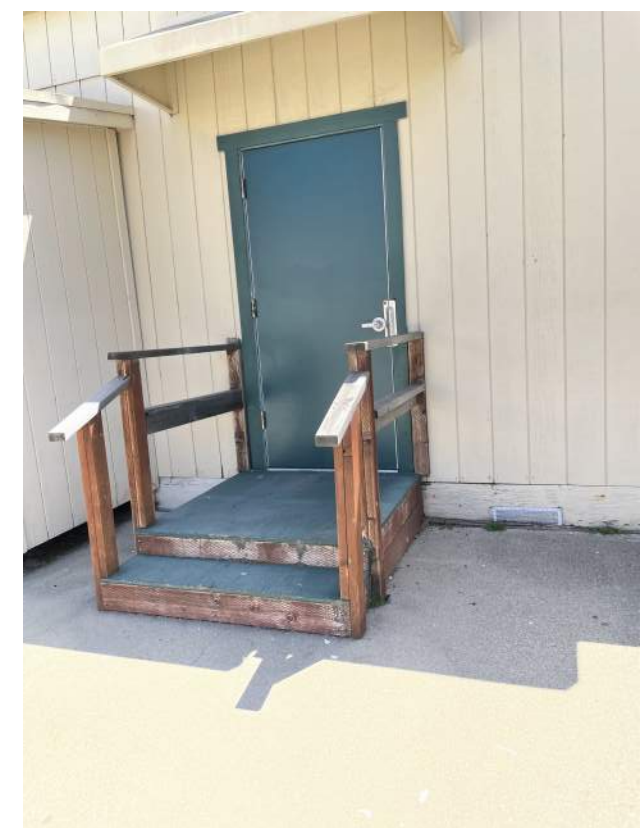
Image 2.2.8 Non-accessible stairs to relocatable building. Taken on 05/03/2022 by Belli Architectural Group.

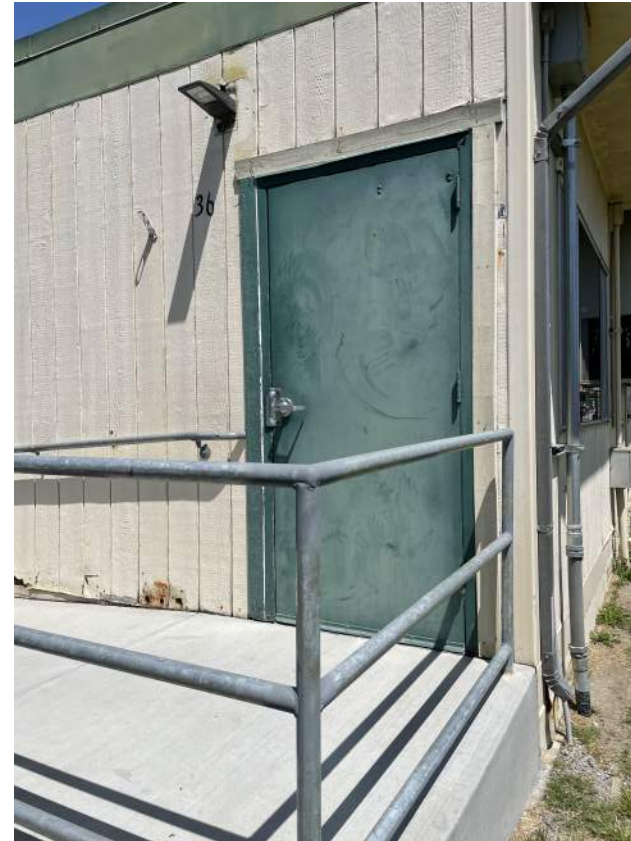
Image 2.2.11 Weathered exterior conditions and dry rot at portables. Taken on 05/03/2022 by Belli Architectural Group.

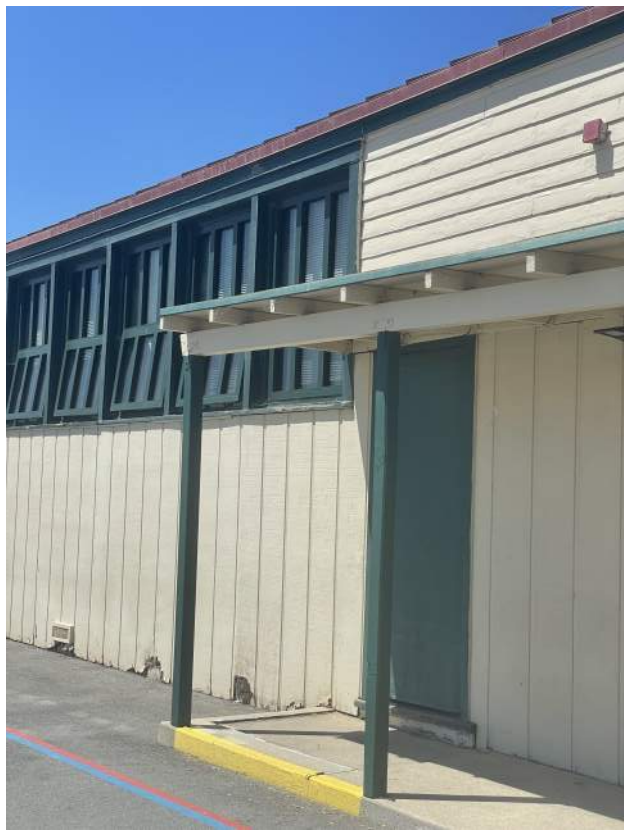
Image 2.2.10 Non-accessible door at relocatable classroom. Taken on 05/03/2022 by Belli Architectural Group.

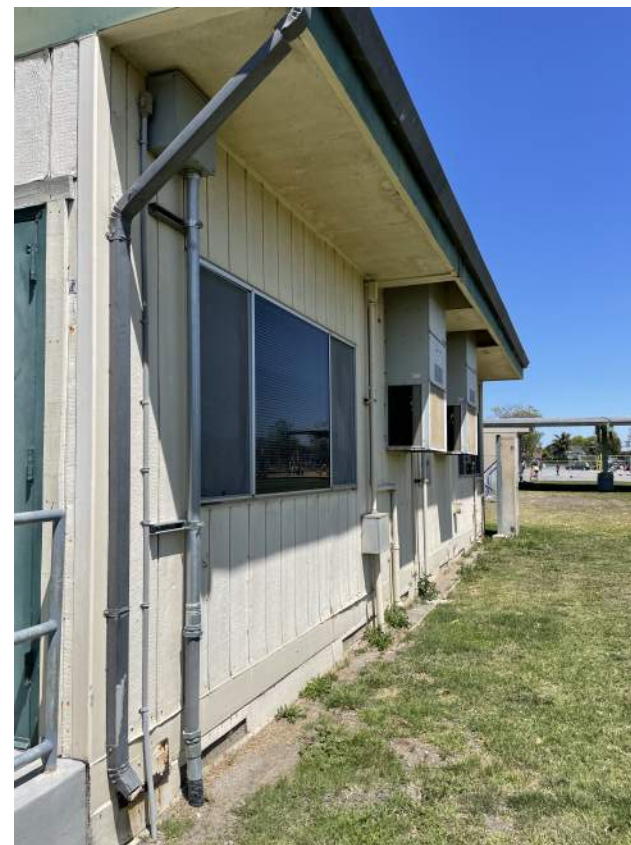
Image 2.2.12 Rusted HVAC units. Taken on 05/03/2022 by Belli Architectural Group.

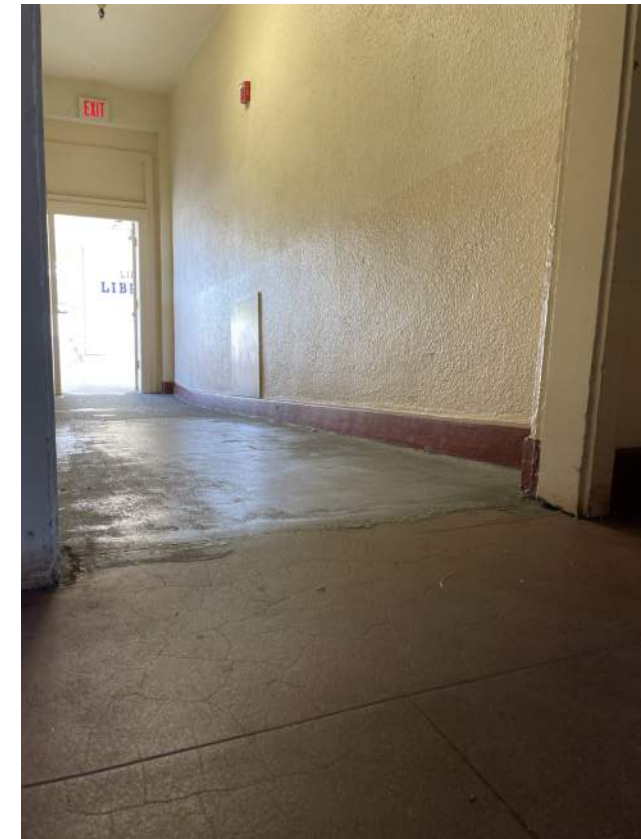
Image 2.3.3 Non-accessible interior ramp. Taken on 05/03/2022 by Belli Architectural Group.

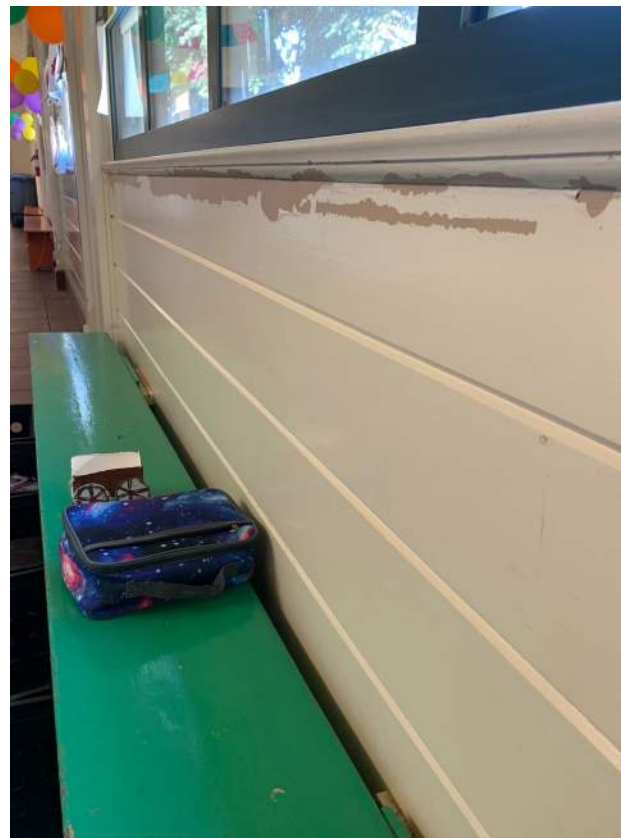
Image 2.3.2 Peeling interior paint. Taken on 05/03/2022 by Belli Architectural Group.

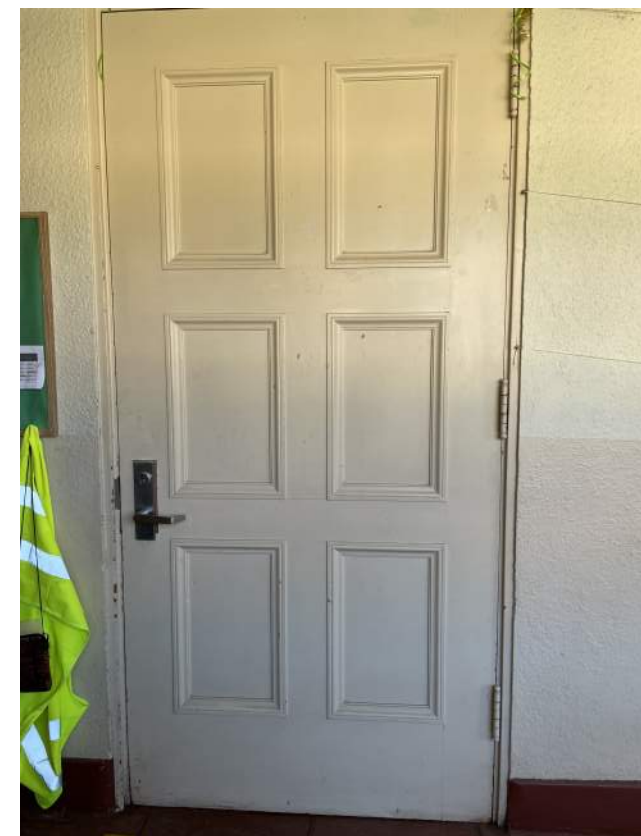
Image 2.3.4 Classroom door with no vision light. Taken on 05/03/2022 by Belli Architectural Group.

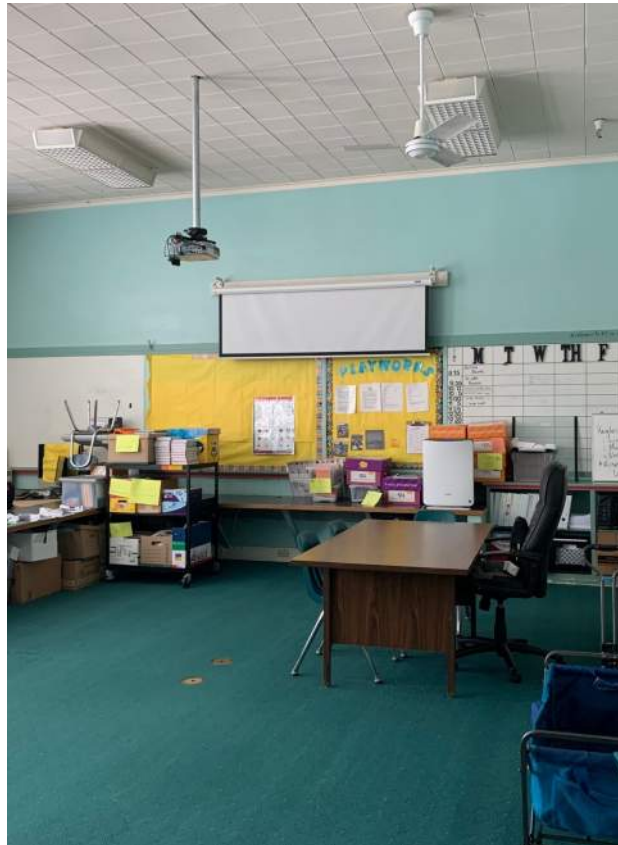
Image 2.3.5 Classroom with carpet flooring. Taken on 05/03/2022 by Belli Architectural Group.

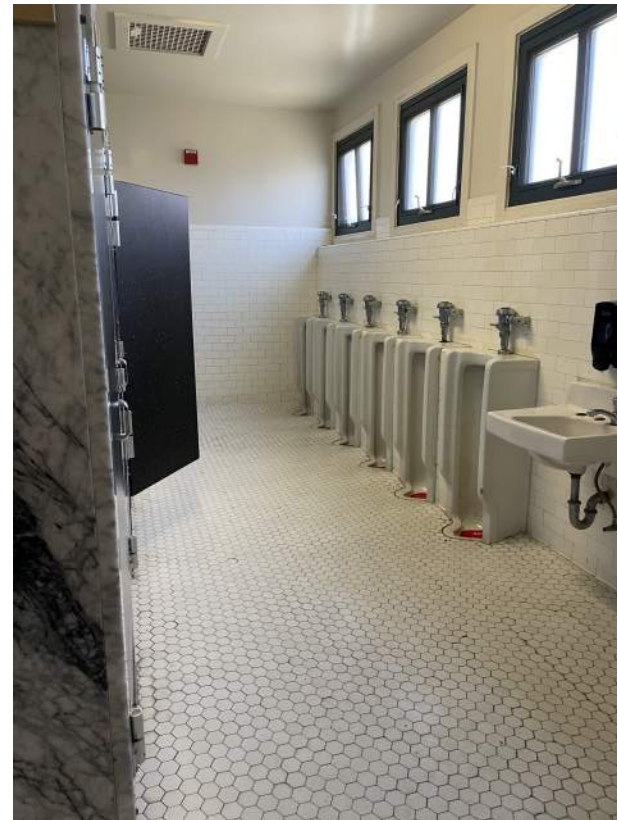
Image 2.3.7 Student restrooms. Taken on 05/03/2022 by Belli Architectural Group.

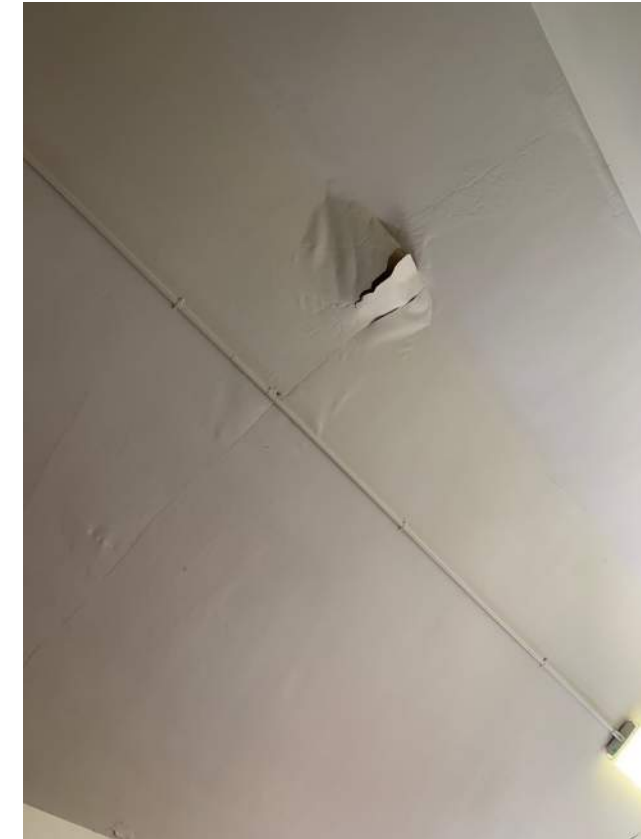
Image 2.3.9 Relocatable classroom ceiling. Taken on 05/03/2022 by Belli Architectural Group.

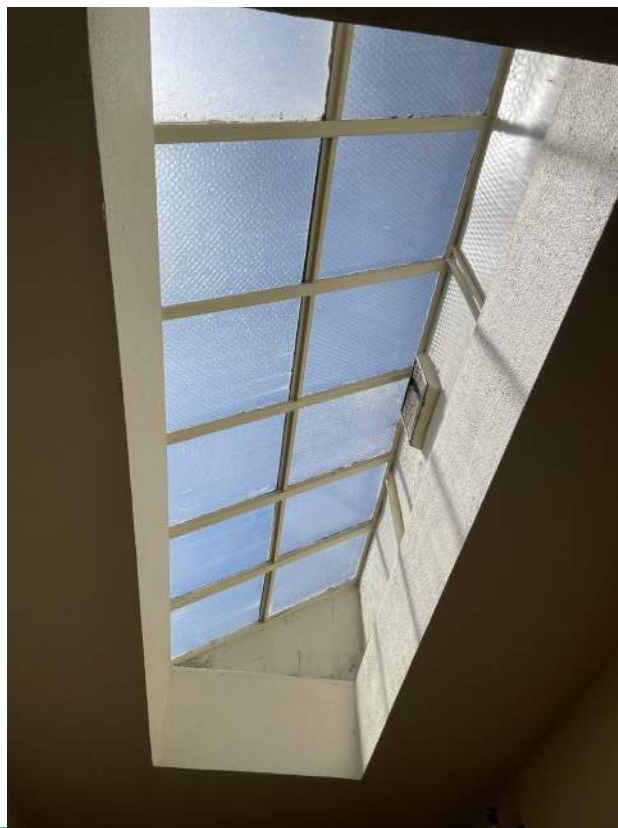
Image 2.3.6 Skylight. Taken on 05/03/2022 by Belli Architectural Group.

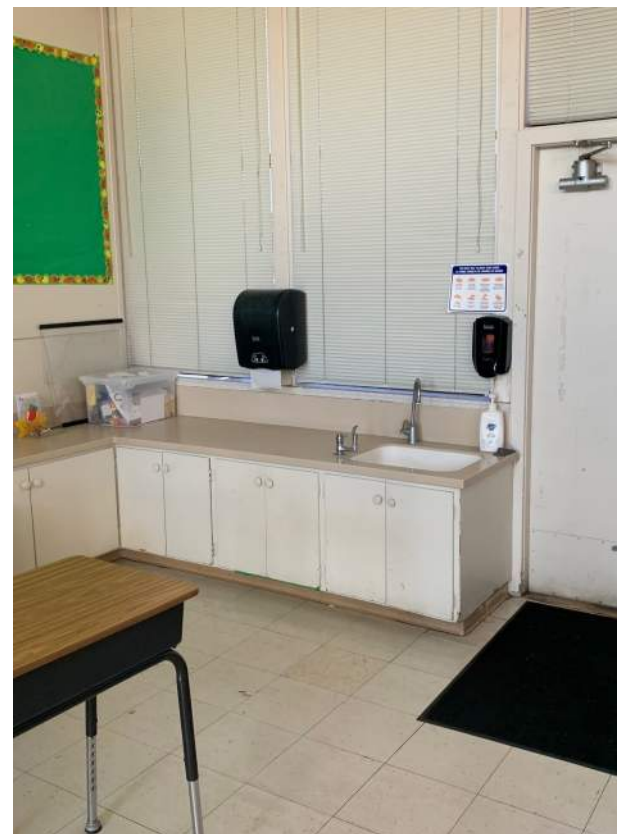
Image 2.3.8 VCT flooring. Taken on 05/03/2022 by Belli Architectural Group.

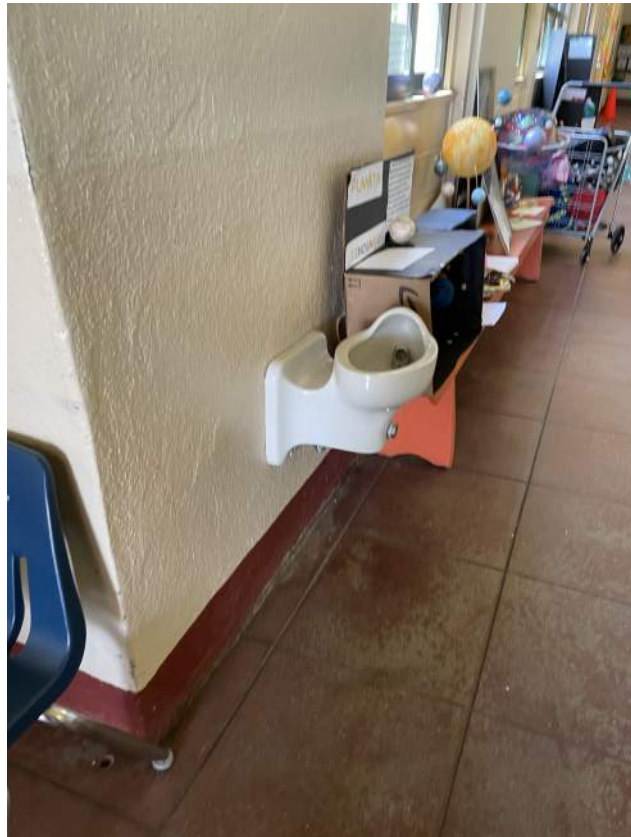
Image 2.3.11 Drinking fountain. Taken on 05/03/2022 by Belli Architectural Group.

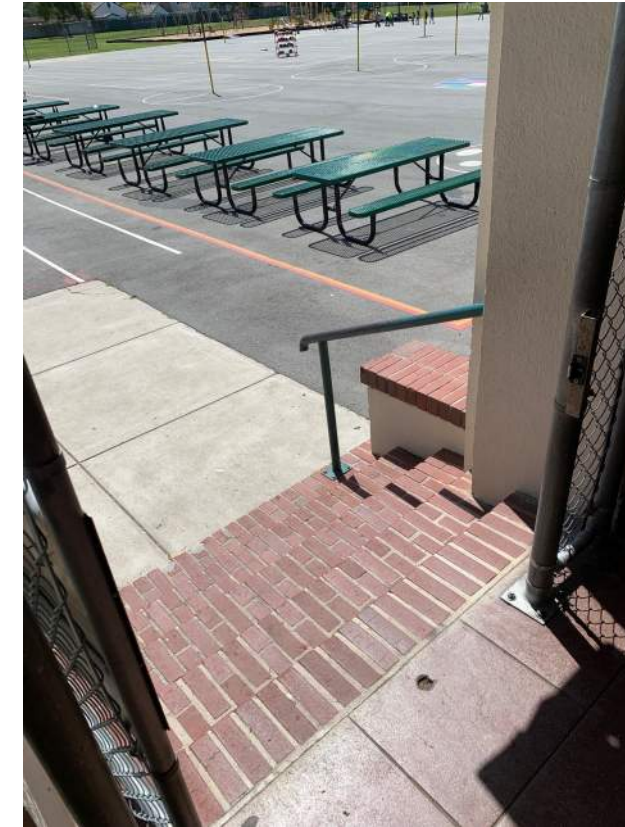
Image 2.4.1 Non-accessible playground entry. Taken on 05/03/2022 by Belli Architectural Group.

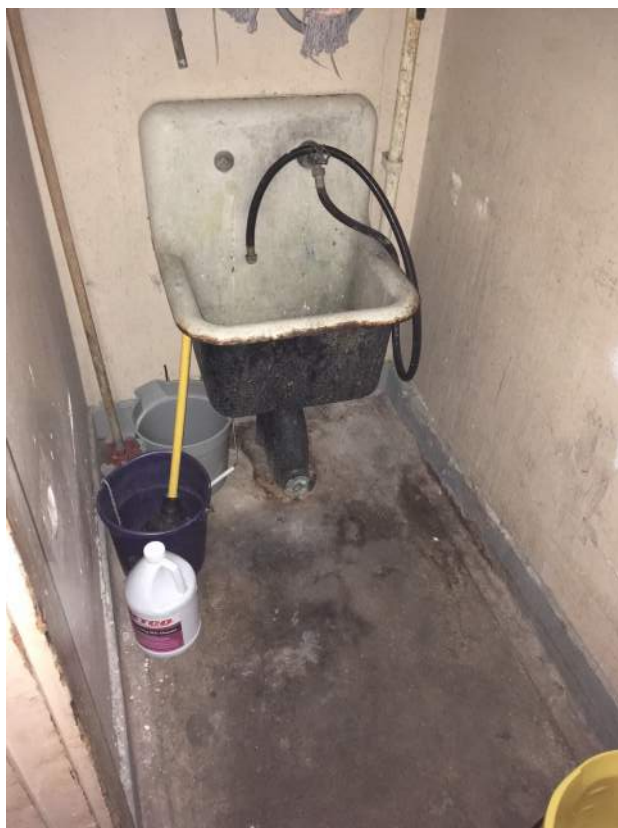
Image 2.3.12 Janitorial room. Taken on 05/03/2022 by Belli Architectural Group.

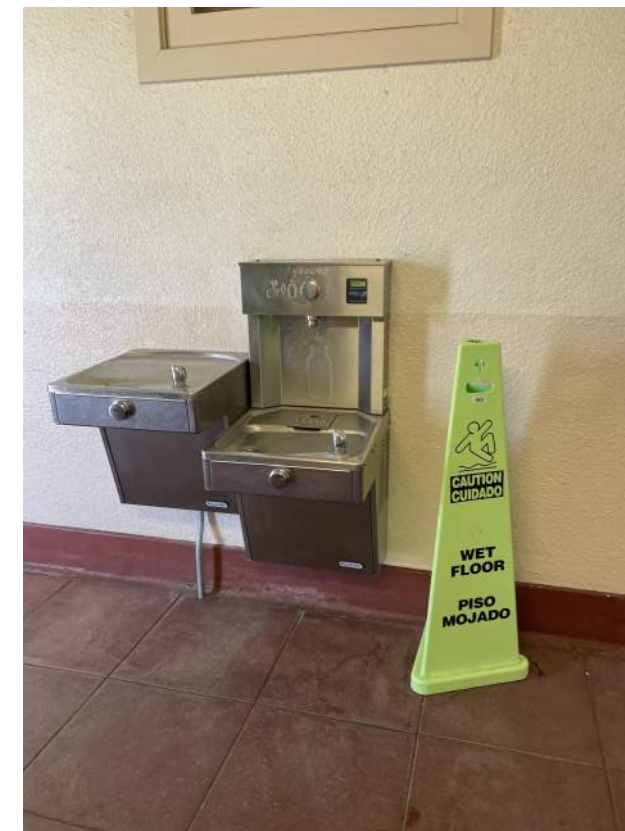
Image 2.4.2 Drinking fountain missing cane detection rails. Taken on 05/03/2022 by Belli Architectural Group.

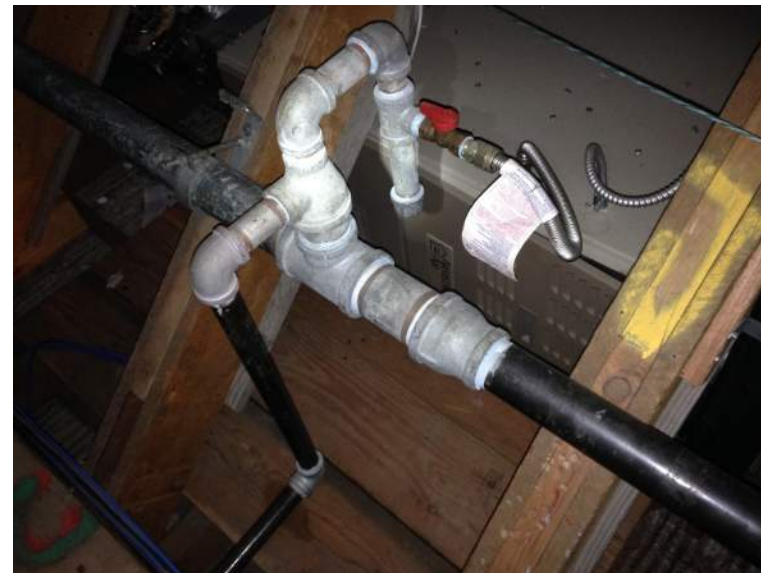
The heating system for the Administration area, the adjacent Teacher’s Lounge and Room 9 consist of a single (one) Armstrong horizontal gas-fired furnace located in the attic above. The furnace was installed during the 2003 modernization and appears to be fair condition and operating. This furnace is 20 years old and should be replaced.

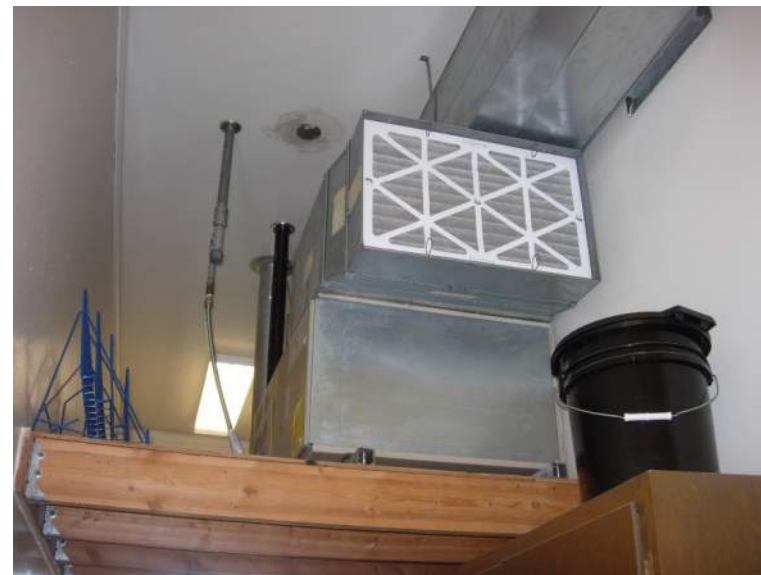
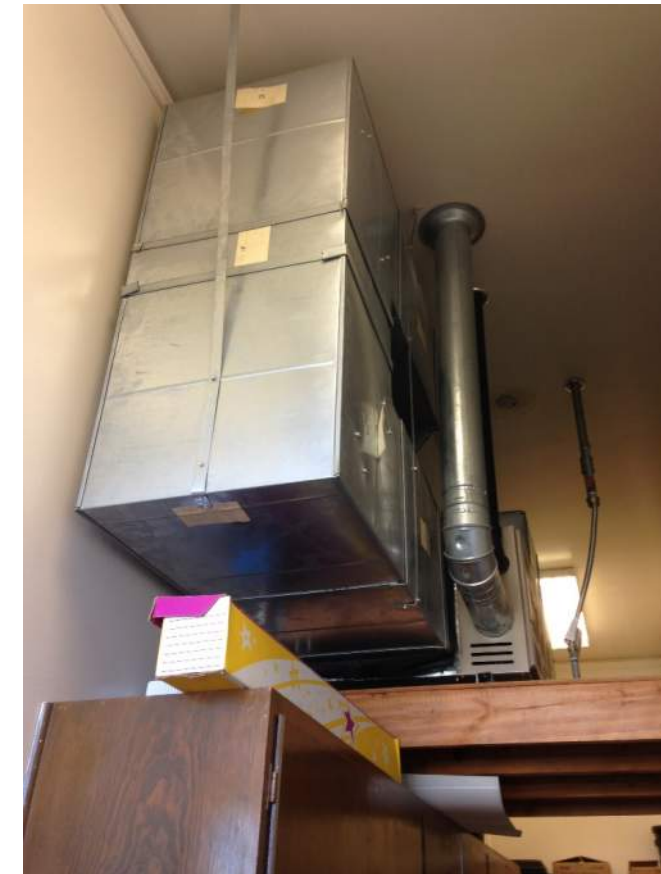
The heating system for these classrooms consist of an Armstrong horizontal gas-fired furnace located on a platform in the Teachers Workroom at the back of the classroom. These furnaces were installed during the 2003 modernization and appear to be fair condition and operating. These furnaces are 20 years old and should be replaced.

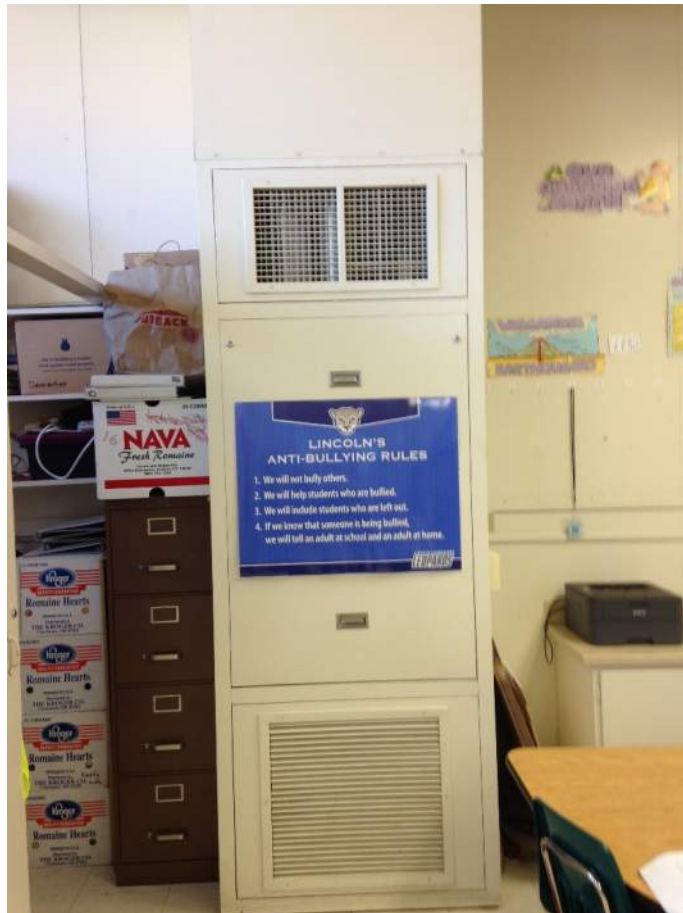
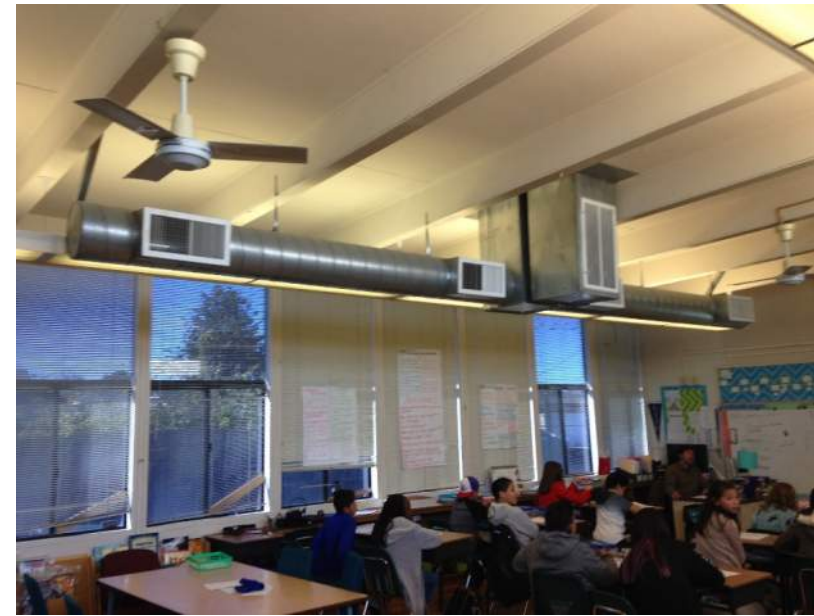
The classroom is heated with an up-flow gas-fired furnace located inside a TEAM Mfg. metal enclosure. This furnace was installed in the 2003 modernization and appears to be in fair condition and operating. The furnace inside the enclosure is 20 years old and should be replaced. This classroom also had a ceiling mounted Mitsubishi split system air conditioning unit and a ceiling mounted paddle fan.

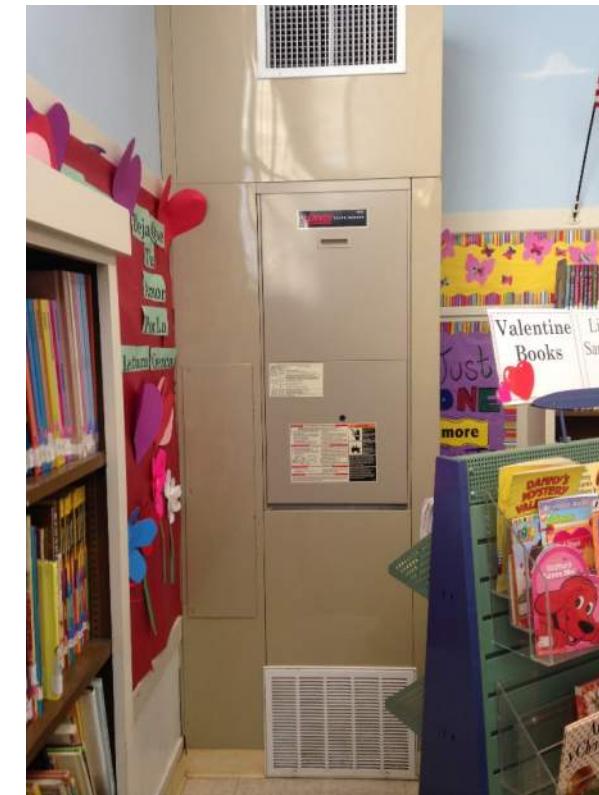
This is a stand-alone building heated by a Lennox up-flow gas-fired furnace in a corner classroom unit. This unit appears to be in fair condition and operating. This furnace is 20 years old and should be replaced.

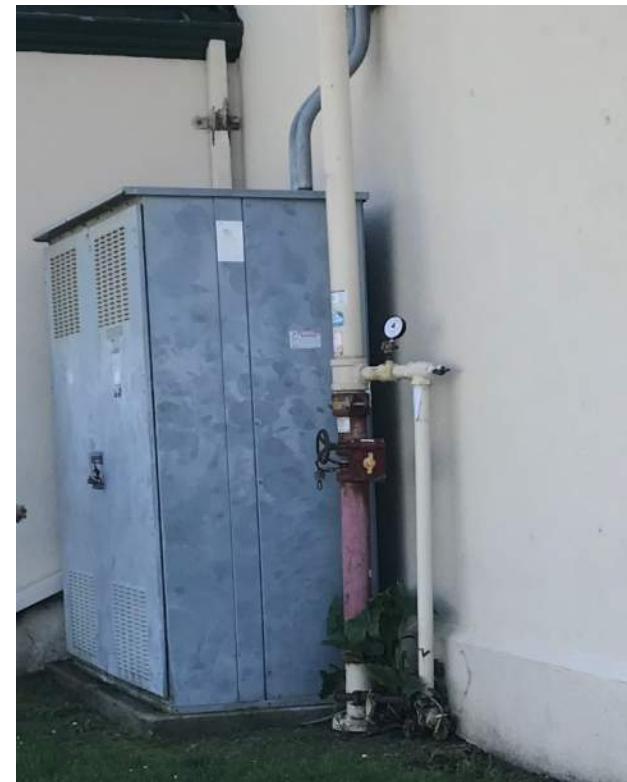
There are (2) existing main “metered” electrical service switchboards and (1) service panel (MSB1, MSB2 and a service panel). MSB1 is an 800 amp, 120/208 volt, 3 phase, NEMA 3R, Square D, service located outdoors on the south west side of main building. MSB1 feeds the main building and library. MSB1 expected life; 15 to 20 yrs. MSB2 is an 800 amp, 120/240V, single-phase, NEMA 3R, Square D, service located outdoors east side of campus. MSB2 has a connection for the existing Solar PV system. The Solar PV is connected ahead of the main breaker at MSB2. MSB2 feeds all modular classrooms and restrooms. MSB2 expected life; 15 to 20 yrs. There is a 200A, 120/240V, single-phase, NEMA 1, metered service panel with overhead service feeding the Multi-Purpose building. The electrical services are used primarily for lighting and heating equipment, with minimal plug loads. It appears that the electrical distribution equipment has been replaced by newer equipment. There are a few of the electrical distribution system panels that are original to the main campus buildings when the school was built, are old and manufactured by a company that no longer exists. The reliability of the system’s breakers to function correctly when necessary cannot be relied upon. It is recommended to replace the oldest panels within the classroom wings of the main campus building. Where the District plans to add HVAC to main building, MSB1 has the load capacity for the additional loads. The maximum additional load to be added is unknown so it is recommended to have an Electrical Engineer to conduct a load study prior to connection of new loads to MSB1. See attached photos MSB1, MSB2 and service panel.

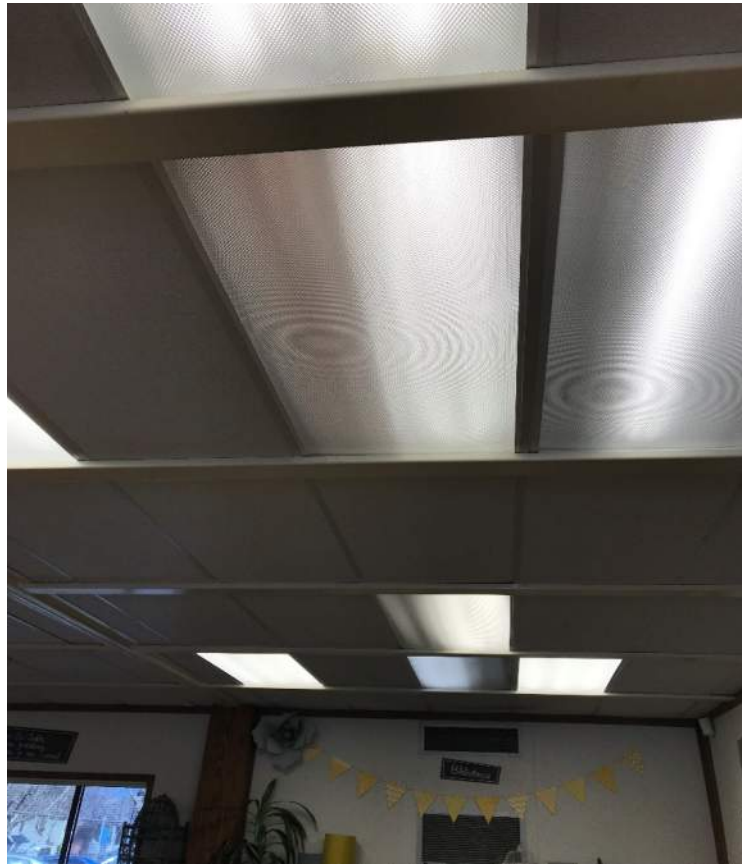
Interior Lighting is primarily fluorescent with T8 or T12 lamps at interior spaces in permanent buildings (with the exception of a very select few spaces recently remodeled...Admin area and a couple of Restrooms). Several light fixture lamps color temperature does not match and few lamps don’t work, see attached photo LTG1. The lighting throughout the school campus is old and although there was no mention of complete failure, some light fixtures seemed original to the spaces, so they are likely near their “end of life”, especially with regards to efficiency. The library building does not provide a good lighting distribution. Emergency lighting was not apparent at any classrooms, restrooms, or exterior landings. However, in multi-use spaces and hallways, bug-eye type stand-alone emergency light fixtures were installed. Occupant sensors and multilevel switching/dimming necessary for energy conservation is almost non-existent. Expected life; Unknown. It is recommended to retrofit or replace campus wide lighting system with new LED technology in the near future. This would be a good opportunity for reduction in energy use from more efficient lighting fixtures, improved classroom lighting, smart lighting controls, daylight harvesting and would also reduce maintenance costs. See attached photo LTG2.
