FACILITIES NEEDS ASSESSMENT

LOMA VISTA

PREPARED BY BELLI ARCHITECTURAL GROUP

1. CAMPUS INFORMATION: Loma Vista

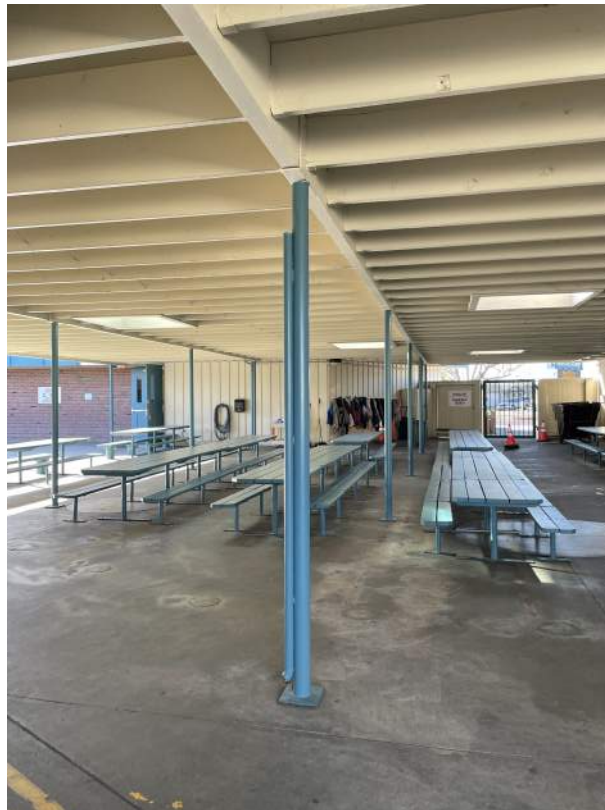
Image 2.1.1 Surfaces in need of seal coating. Taken on 05/03/2022 by Belli Architectural Group.

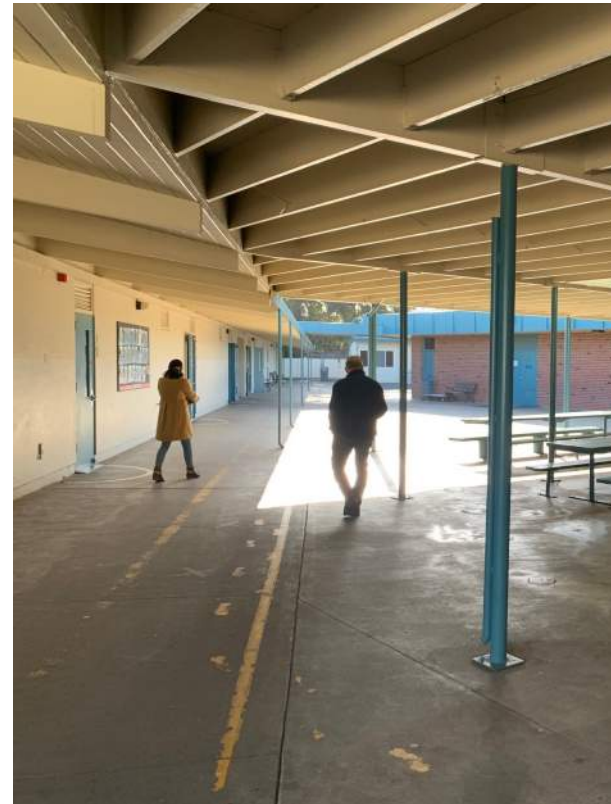
Image 2.1.2 Site paint striping. Taken on 05/03/2022 by Belli Architectural Group.

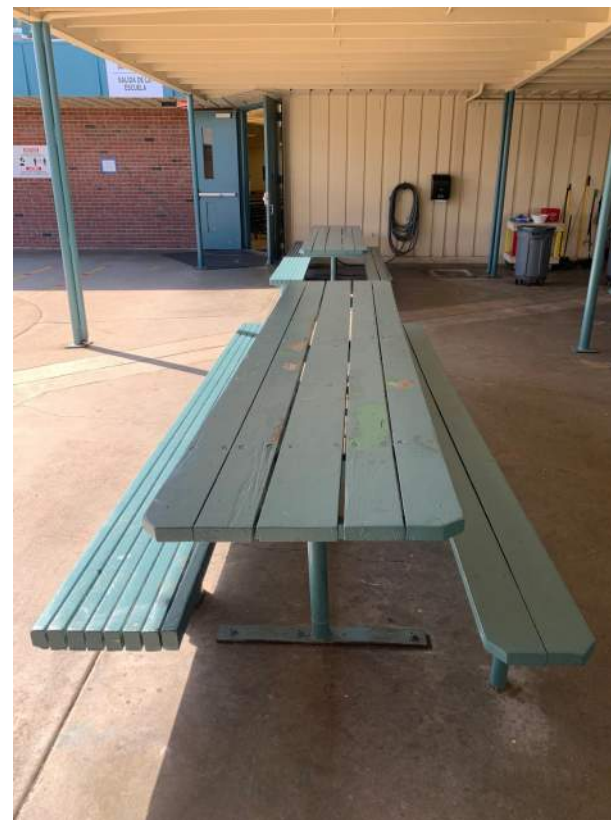
Image 2.1.3 Exterior lunch tables. Taken on 05/03/2022 by Belli Architectural Group.

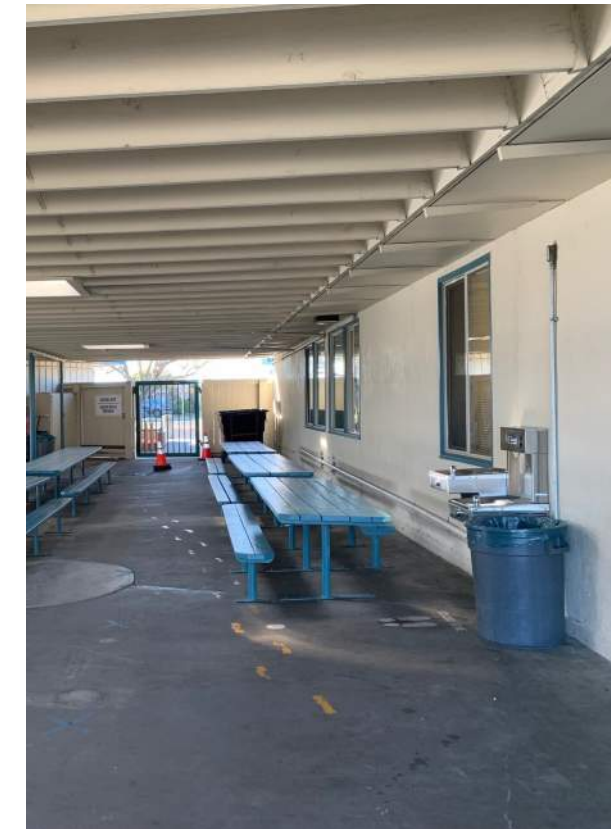
Image 2.1.4 Non-accessible drinking fountain. Taken on 05/03/2022 by Belli Architectural Group.

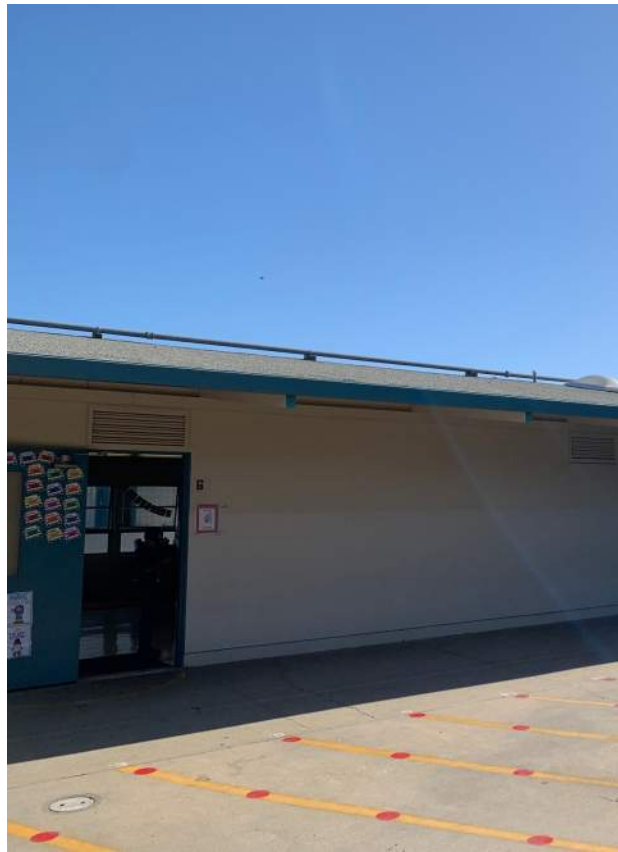
Image 2.2.1 Permanent building gravel roof. Taken on 05/03/2022 by Belli Architectural Group.

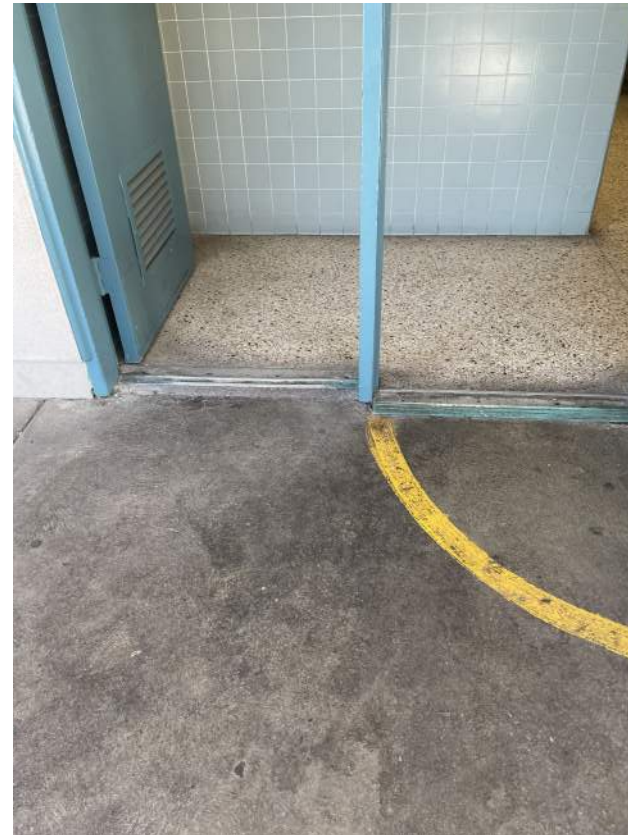
Image 2.2.2 Restroom threshold. Taken on 05/03/2022 by Belli Architectural Group.

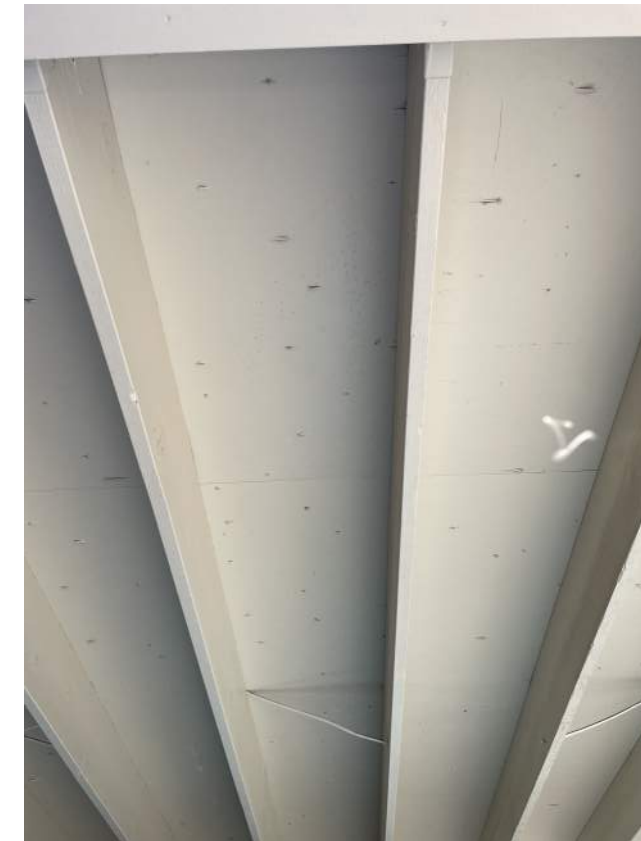
Image 2.2.4 Damaged plywood at fixed breezeway cover between MPR and Admin. Building. Taken on 05/03/2022 by Belli Architectural Group.

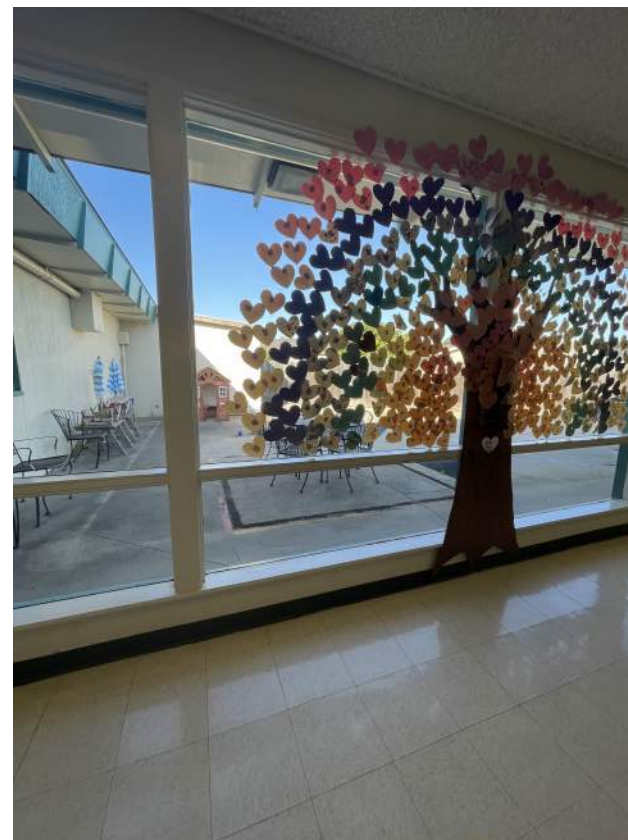
Image 2.2.3 Original windows at admin. office. Taken on 05/03/2022 by Belli Architectural Group.

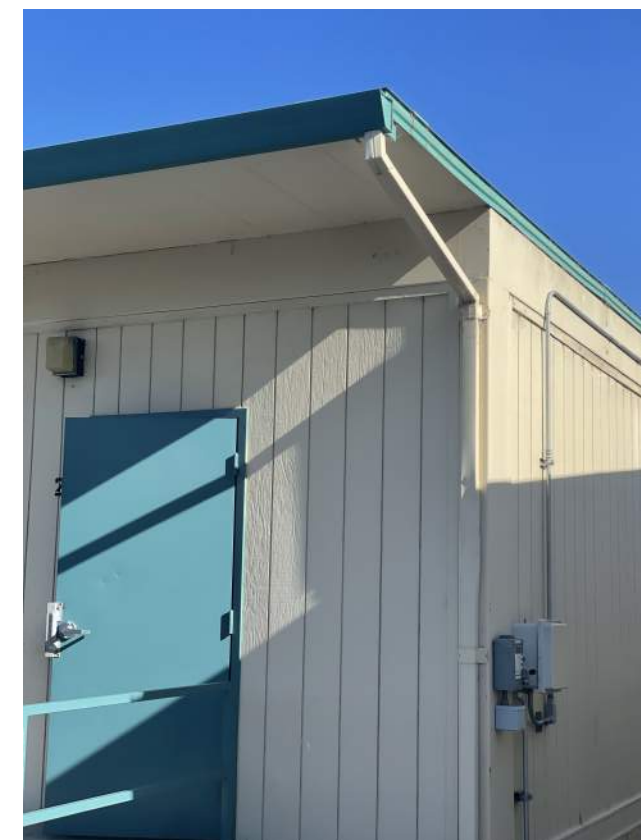
Image 2.2.5 Damaged gutter. Taken on 05/03/2022 by Belli Architectural Group.

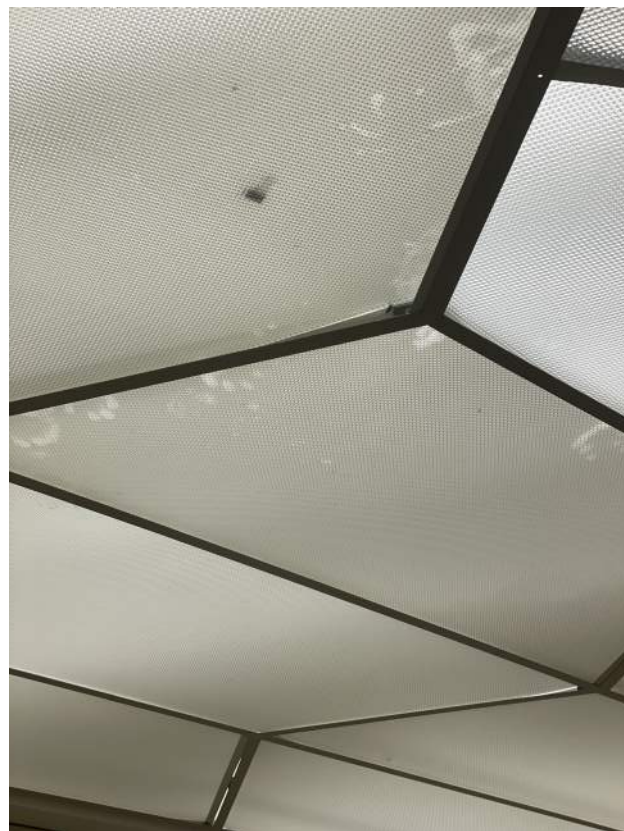
Image 2.3.1 MPR lighting. Taken on 05/03/2022 by Belli Architectural Group.

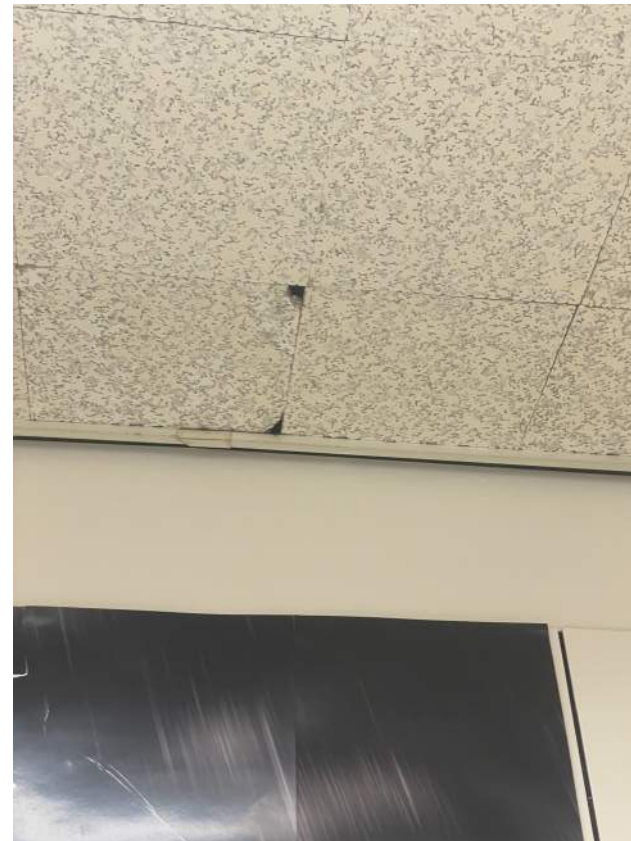
Image 2.3.2 Aging ceiling panels. Taken on 05/03/2022 by Belli Architectural Group.

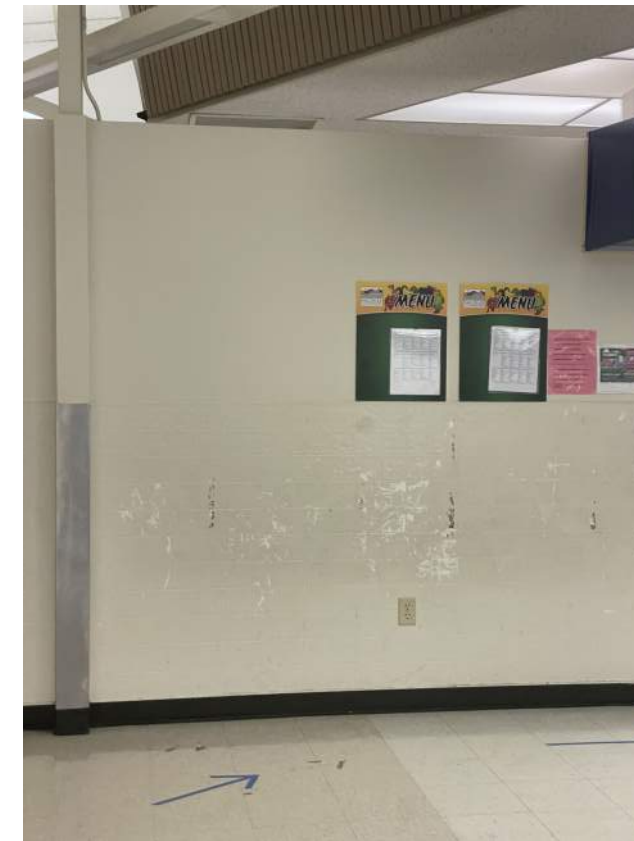
Image 2.3.4 Worn wall surfaces. Taken on 05/03/2022 by Belli Architectural Group.

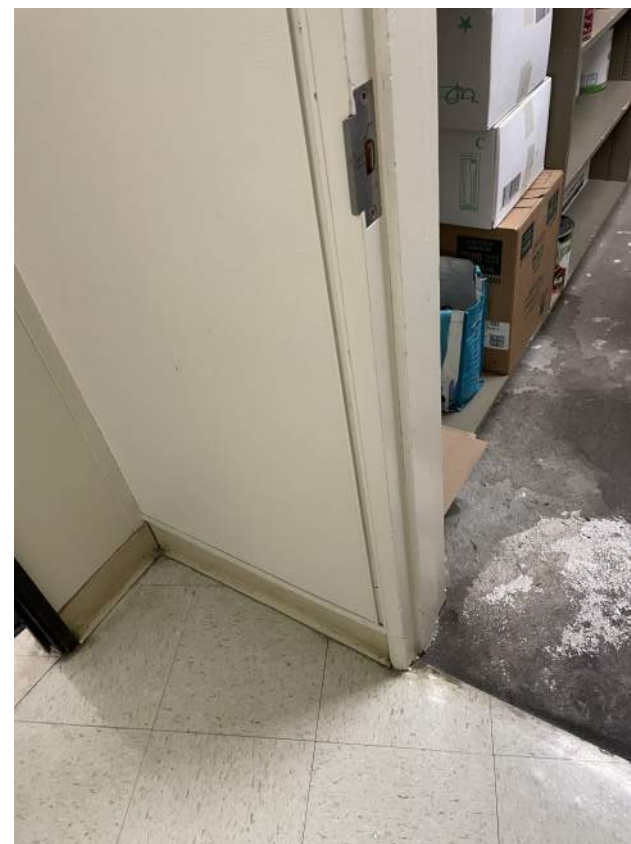
Image 2.3.3 Aging flooring. Taken on 05/03/2022 by Belli Architectural Group.

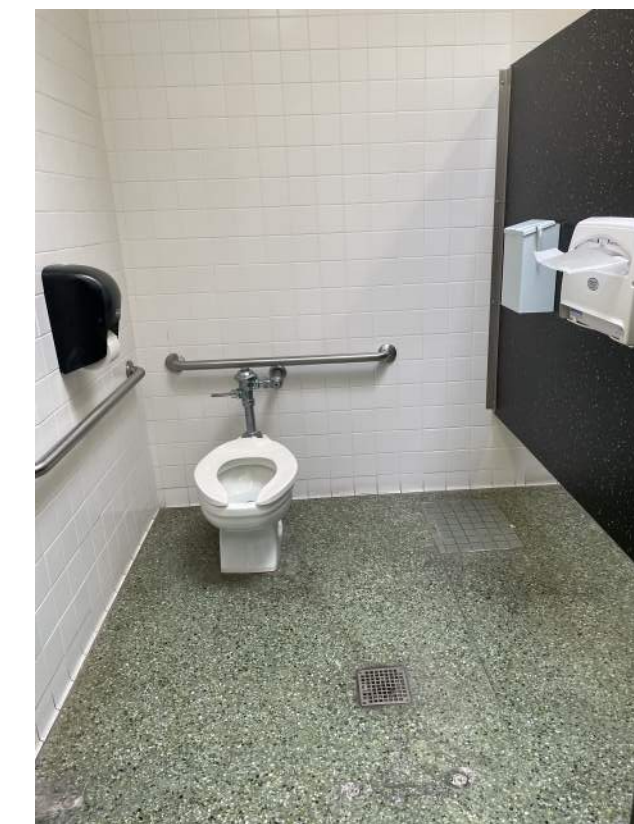
Image 2.3.5 Restroom flooring. Taken on 05/03/2022 by Belli Architectural Group.

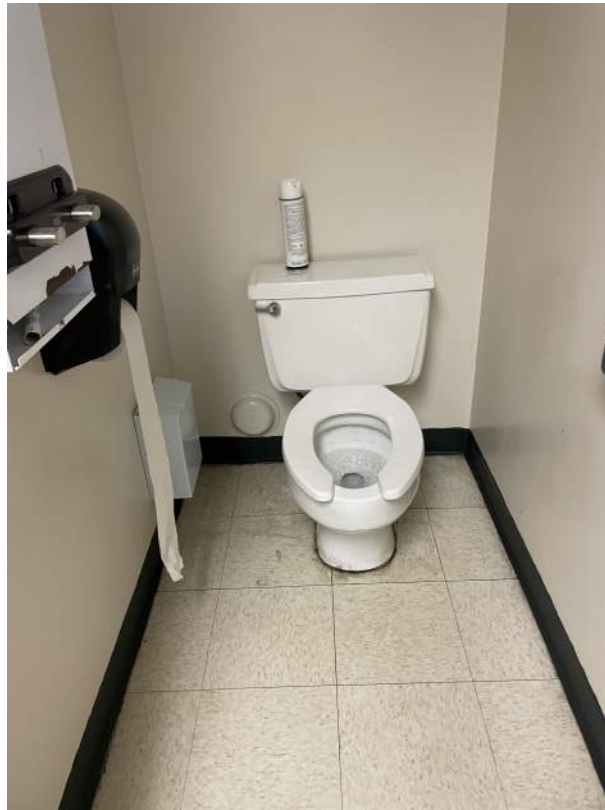
Image 2.3.6 Single occupancy non-accessible restroom. Taken on 05/03/2022 by Belli Architectural Group.

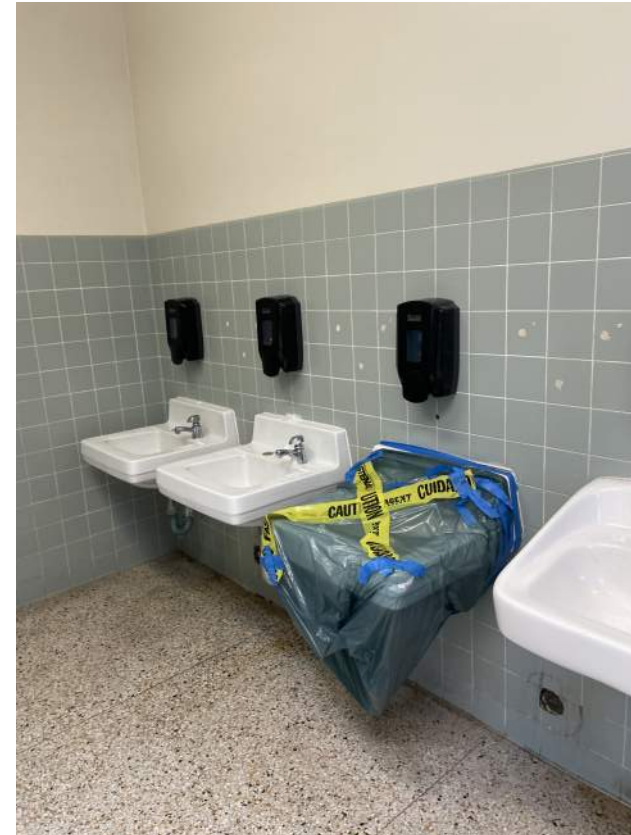
Image 2.3.8 Non-operational plumbing fixtures. Taken on 05/03/2022 by Belli Architectural Group.

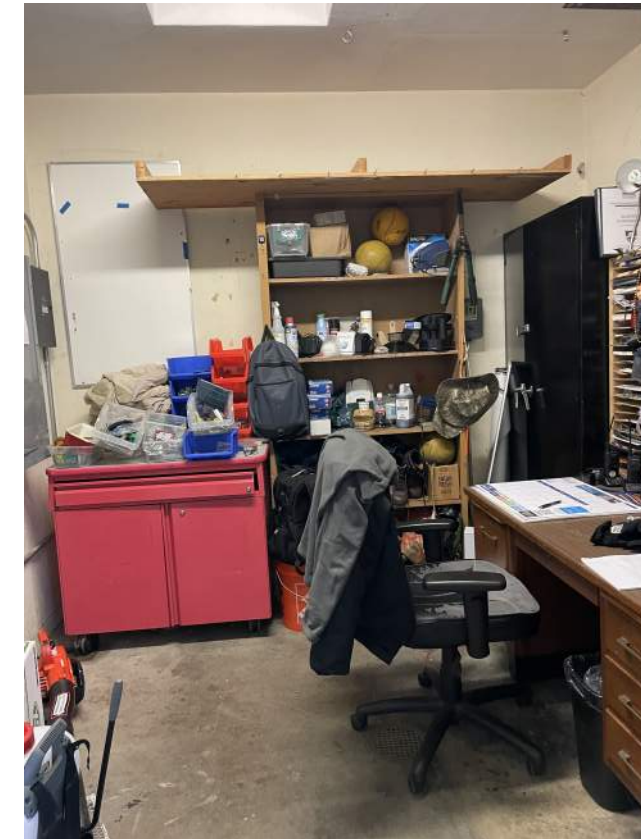
Image 2.3.10 Janitorial Room. Taken on 05/03/2022 by Belli Architectural Group.

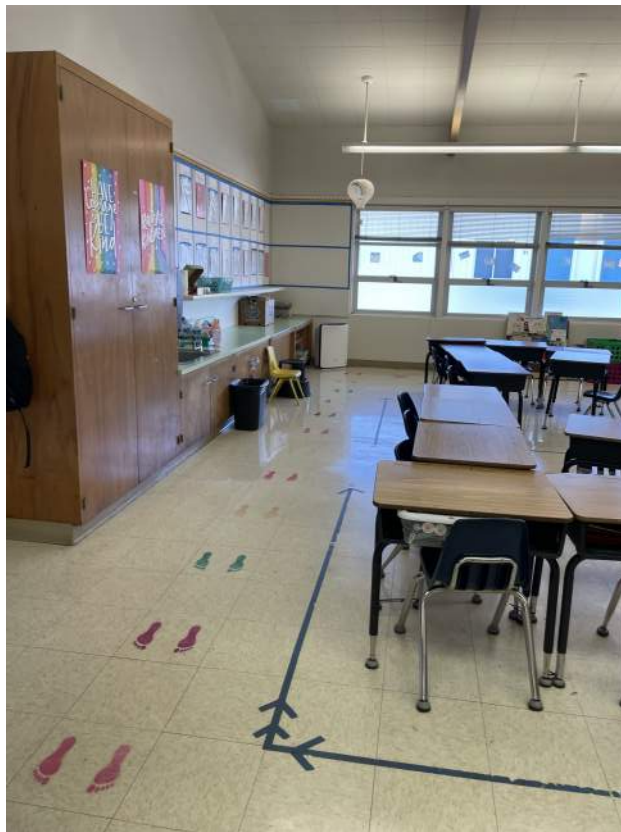
Image 2.3.7 Old classroom casework. Taken on 05/03/2022 by Belli Architectural Group.

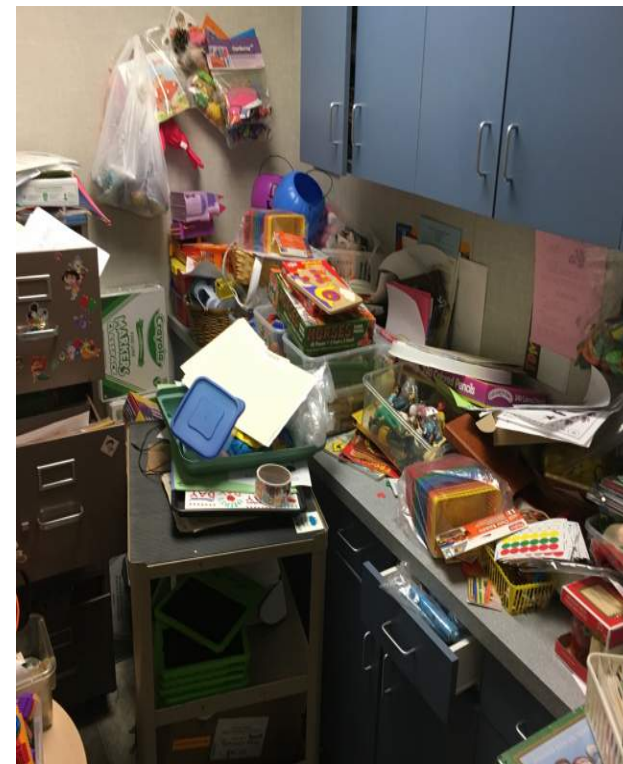
Image 2.3.9 Preschool. Small deteriorated spaces Taken on 05/03/2022 by Belli Architectural Group.

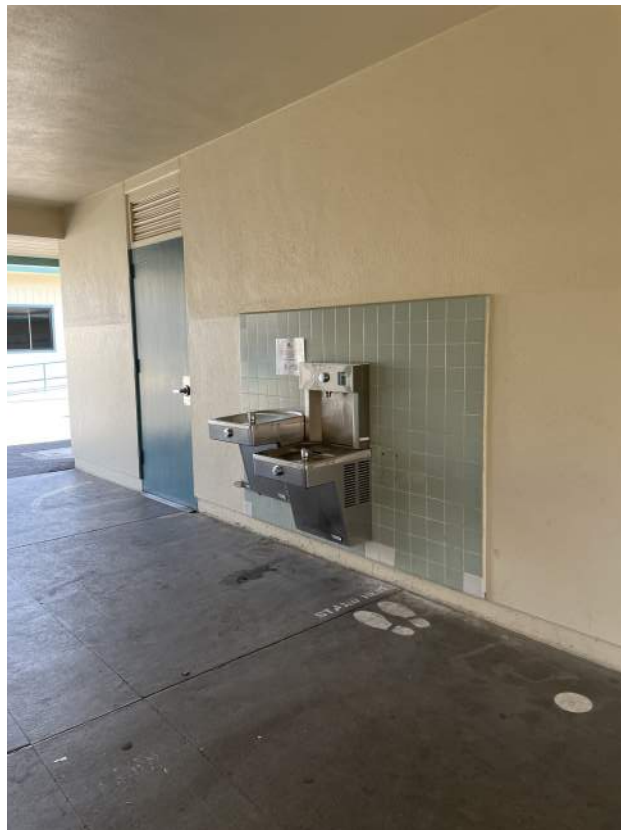
Image 2.4.1 Non-ADA compliant drinking fountain. Taken on 05/03/2022 by Belli Architectural Group.

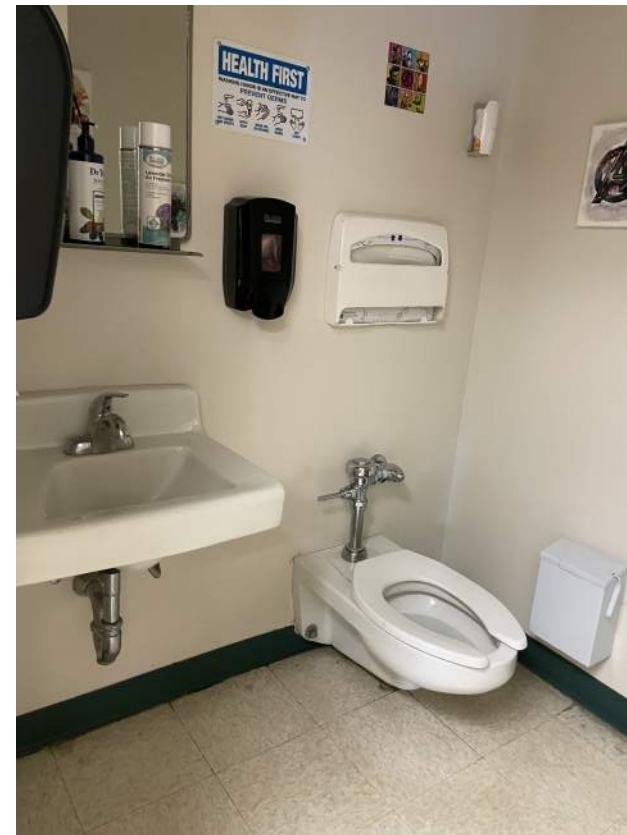
Image 2.4.2 Non-ADA compliant restroom and accessories. Taken on 05/03/2022 by Belli Architectural Group.

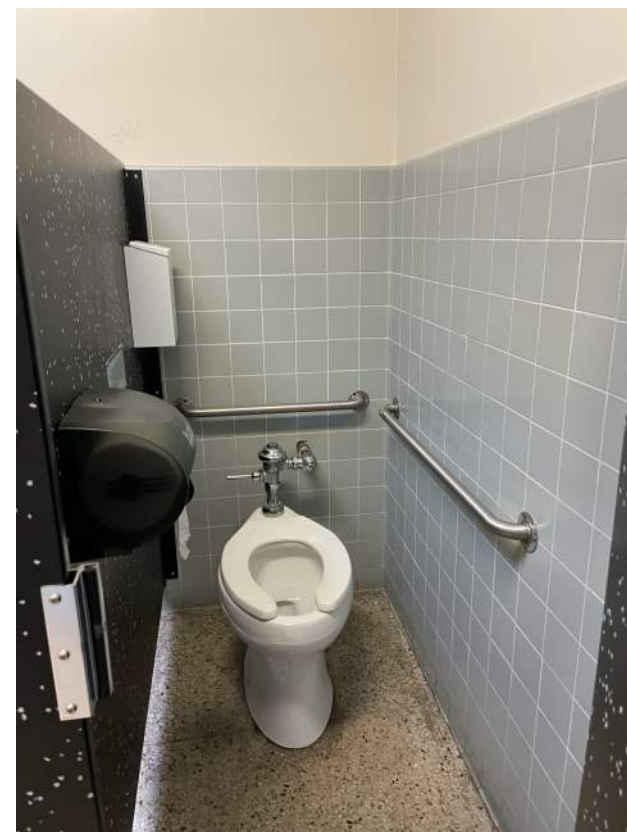
Image 2.4.3 Non-ADA compliant restroom. Taken on 05/03/2022 by Belli Architectural Group.

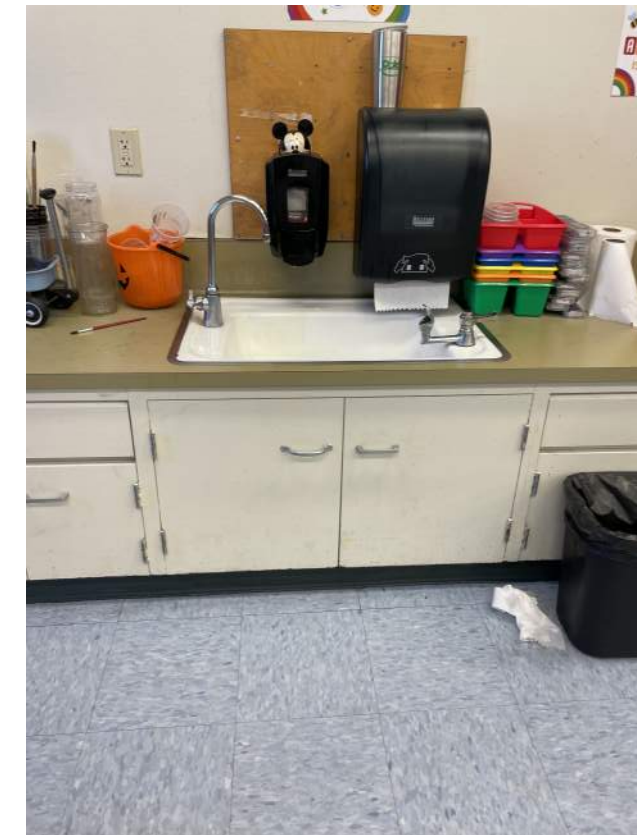
Image 2.4.4 Non-accessible sink. Taken on 05/03/2022 by Belli Architectural Group.

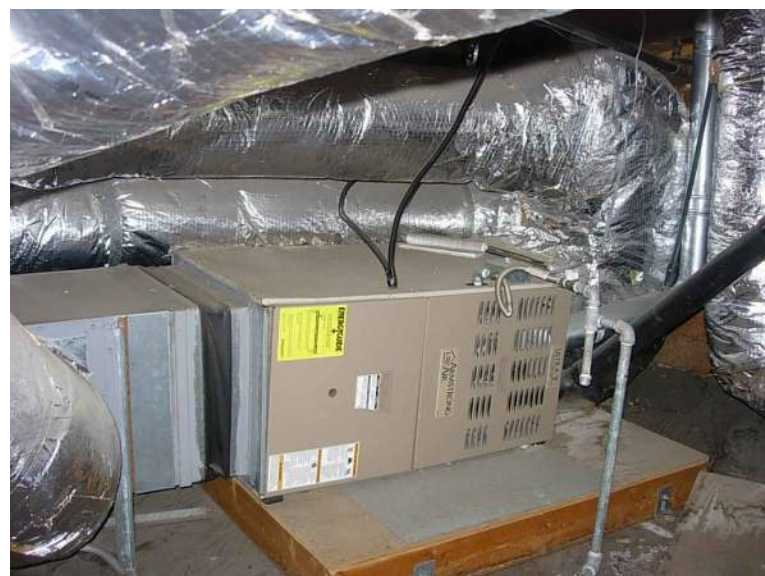
The heating system consist of a five (5) Armstrong horizontal gas-fired furnaces located in an attic mezzanine. These furnaces were installed during the 2002 modernization. The heating system appeared to be in fair condition and operating. These furnaces are now 20 years old and need replacing. Thermostats are programmable. Ceiling mounted exhaust fans throughout require replacing.

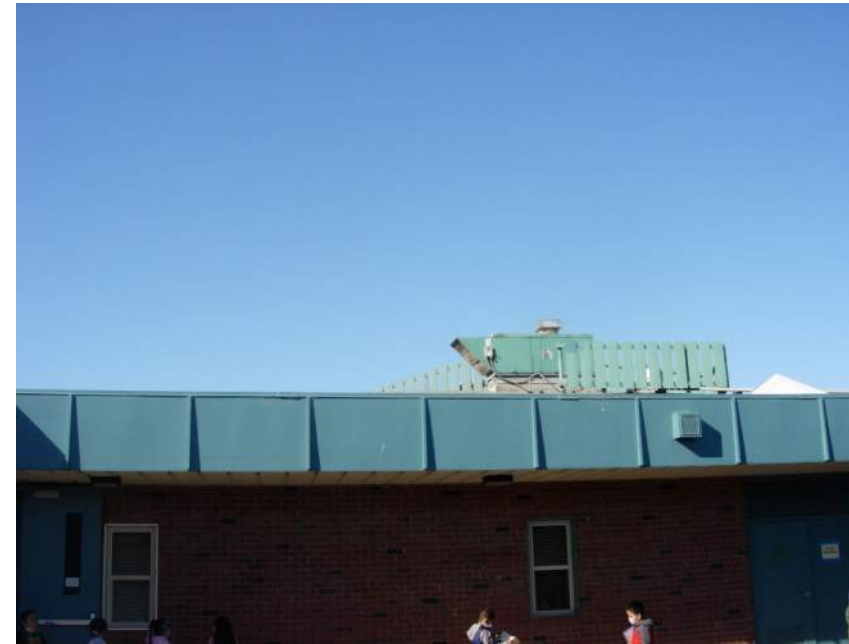
It appears as if the original rooftop HV unit has been abandoned on the roof. This should be removed.

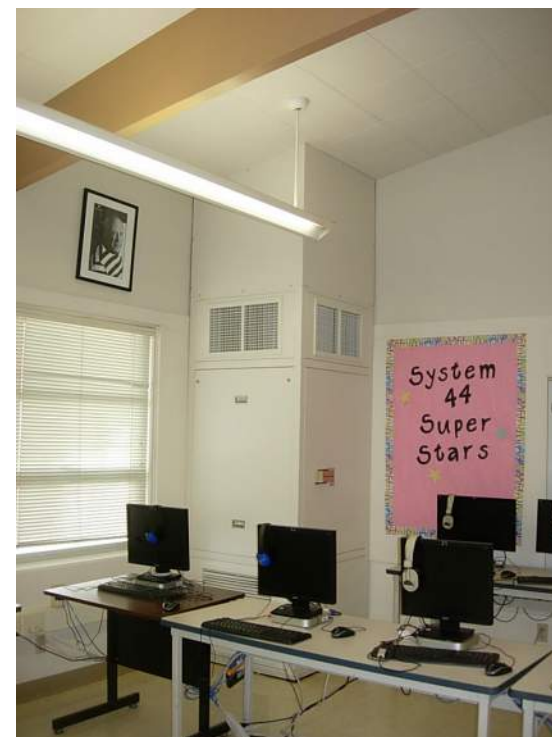
The heating system for these classrooms consist of Armstrong up-flow furnaces located inside a TEAM Mfg. metal enclosure. These were installed during the 2003 modernization. The heating system appeared to be in fair condition and operating. These furnaces inside the enclosures are 20 years old and should be replaced. Thermostats are non-programmable and operate from a 0 to 6 hour no-hold timer.

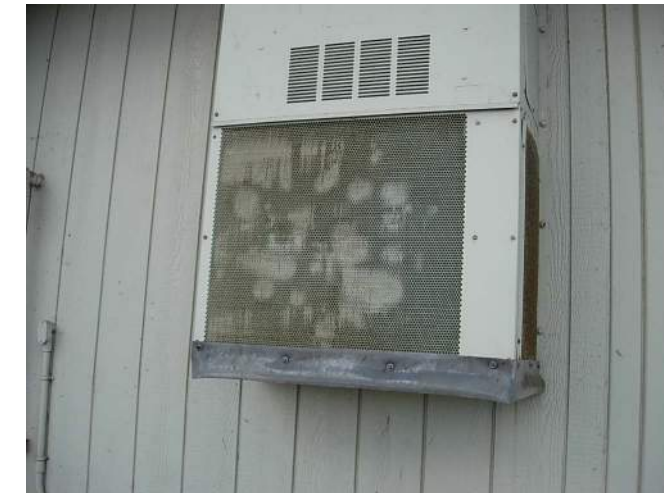
These are portable classroom consisting of the exterior wall mounted “Bard” type heat pump units. All portables utilize this type of equipment. These units throughout the campus appear to be original and are operating satisfactory. Older (20 years) units become a continual maintenance problem and should be replaced with new units. The photo below is of a unit that has been vandalized.

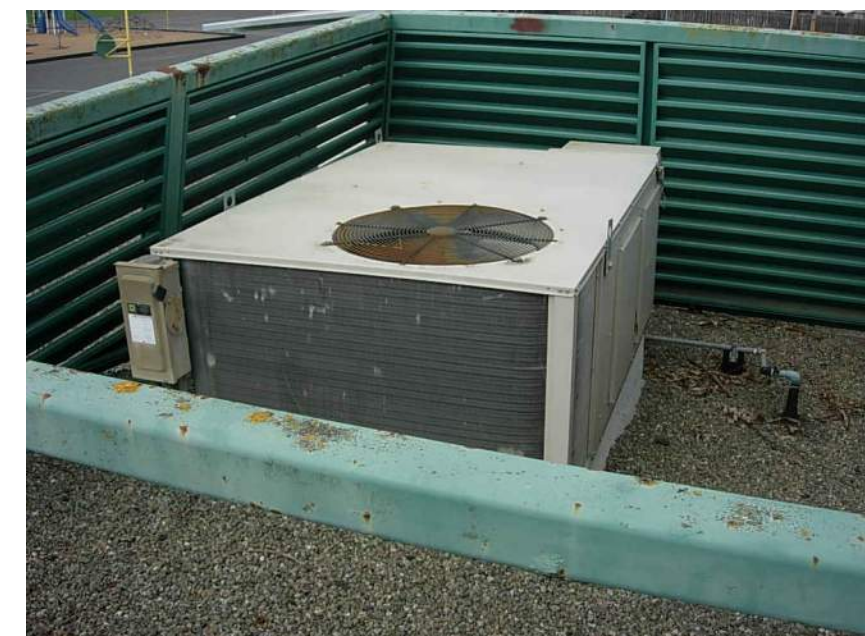
This heating system consist of four (4) Lennox, rooftop mounted, packaged, gas heat/electric cooling units. These units appear to be from the 2002 modernization and due to salt air exposure, need replacing. Supply and return ductwork serving these classrooms is overhead. This building recently had a new roof installed. The metal enclosure shown around the HVAC unit in the picture below has been removed.

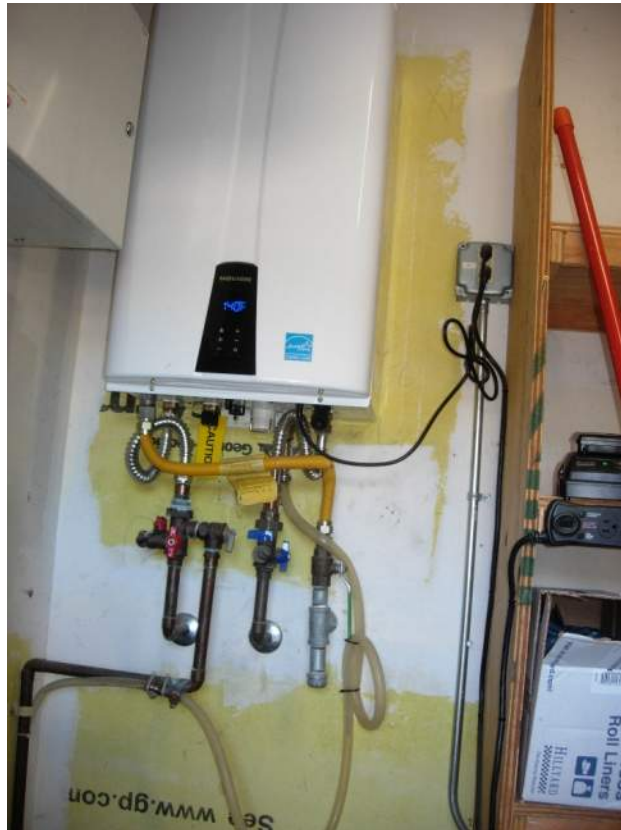
A minor modernization to the kitchen was performed in 2013. A new gas-fired tank-less water heater was installed, along with new kitchen sinks and a grease interceptor.

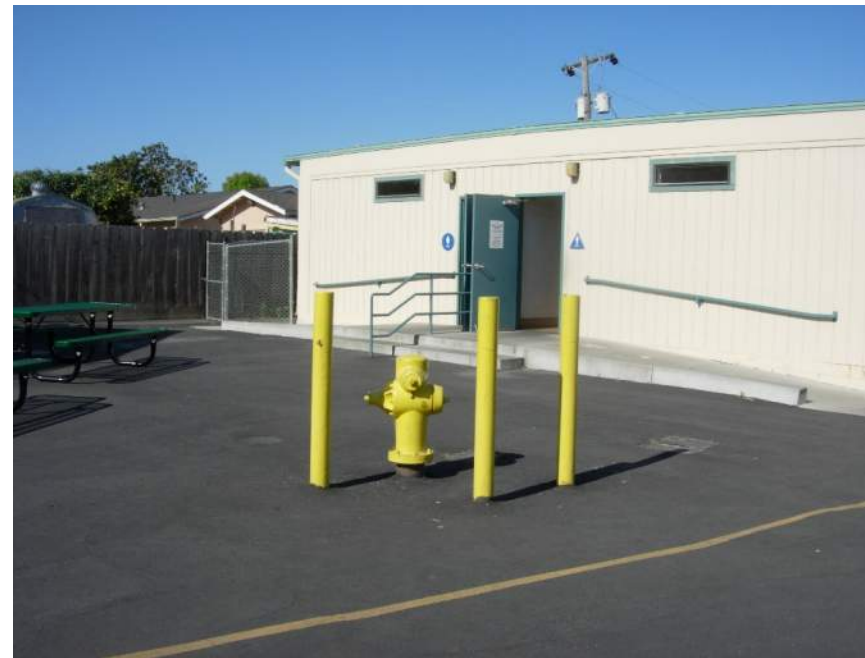
Note that there is a fire hydrant on site to provide fire protection for the portables.

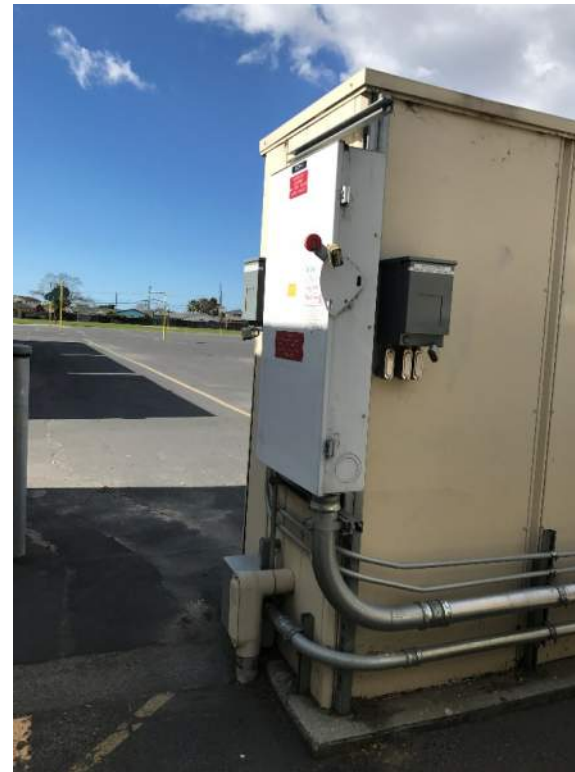
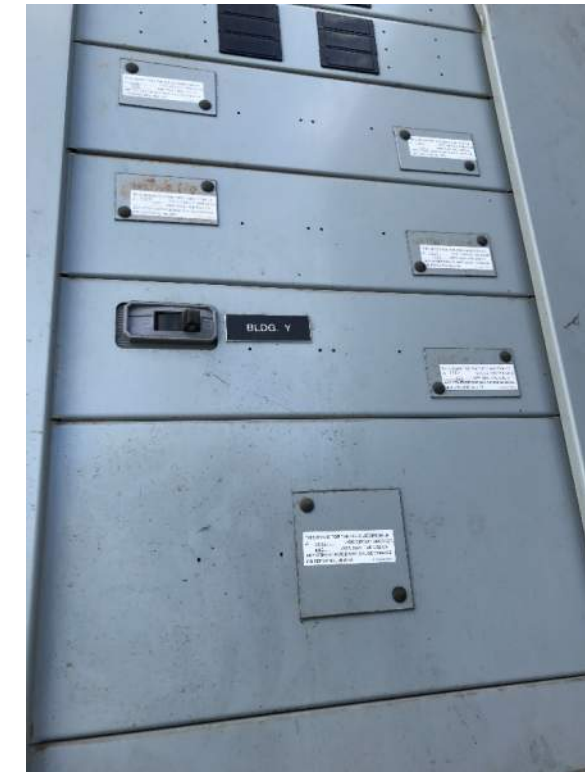
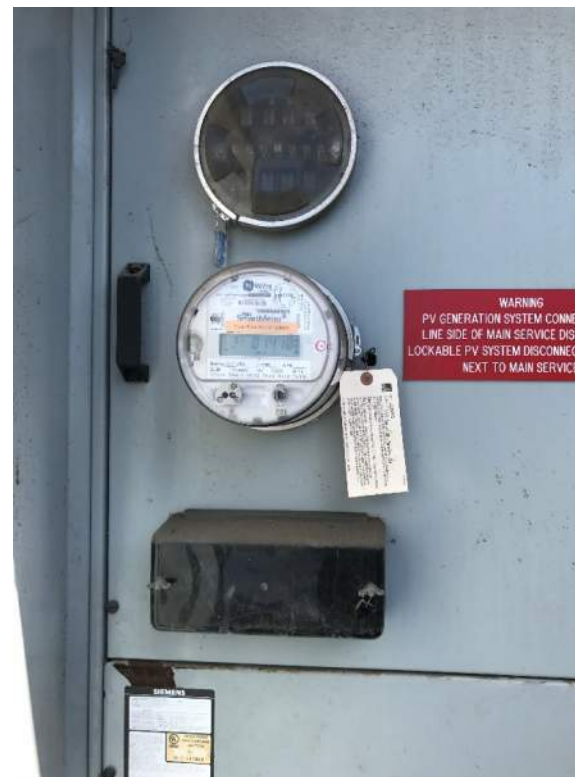
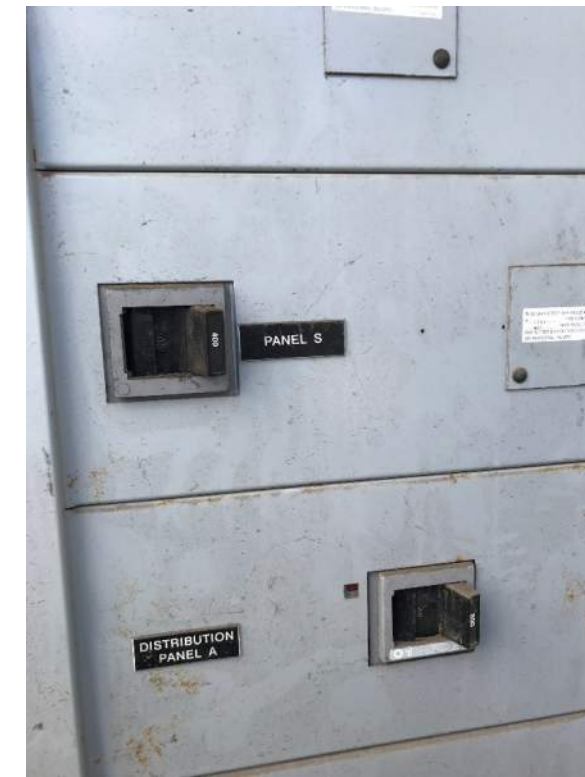
MSB1.

There are (2) Main “metered” electrical service switchboards (MSB1 and MSB2) at the site. MSB1 is a 1200 amp, 120/208 volt, 3 phase, NEMA 3R service located on the north side of the campus behind portable building #28. The MSB has a connection for an existing Solar PV system on site and this Solar PV System is connected to the MSB through a step-down voltage transformer (steps down 480V Solar PV system to 208V electrical distribution system) located adjacent to the MSB. The Solar PV is then connected ahead of the main breaker and the solar data collector panel is located on the back of portable building #28 which may require relocation should portable building #28 be removed from site. The MSB serves in large part, the main campus except for the western most string of portables consisting of Portables #20 through #27. MSB2 is a 600 amp, 120/240V, 1-phase, NEMA 3R service located behind portable #21 on the west side of campus. MSB3 serves the string of (8) portables and a restroom portable. The electrical service switchboard MSB1 seems to be relatively new and the additional electrical service MSB2 seems to have been added as buildings/modulars were added to the site. MSB1 expected life; approximately 15-20 yrs. MSB2 expected life; 10-15 yrs. The electrical services are used primarily for lighting and heating equipment, with minimal plug loads. Some of the electrical distribution system panels that are located around the site and are original to the buildings when the school was built, are old and manufactured by a company that no longer exists. The reliability of the older electrical panel system’s breakers to function correctly when necessary cannot be relied upon. It is recommended to replace the oldest panels within the central campus buildings that have panels “original” to the school construction “ZINSCO” (manufacturer) panels as soon as possible. Where the District plans to add HVAC to the site, the MSB2 may not be adequate and MSB1 will need further evaluation to confirm capacity for proposed new HVAC system. See attached photos MSB1 & MSB.

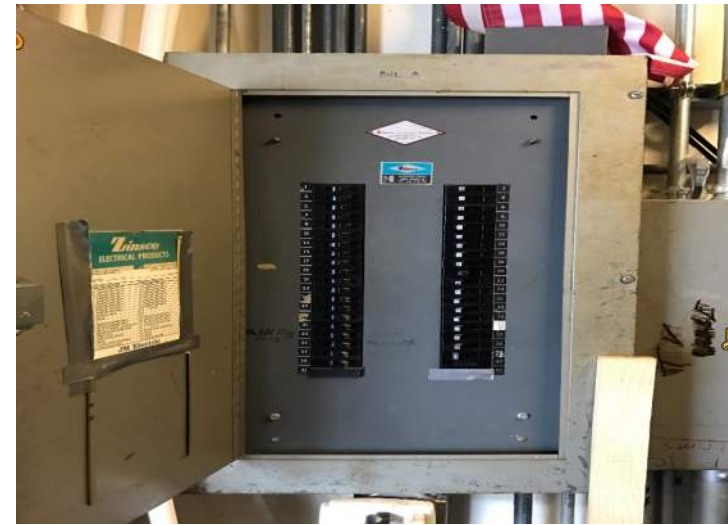
ZINCO PANEL.

The school electrical infrastructure is in fair condition, however, the older “ZINSCO” manufacturer panelboards (see attached photo “ZINSCO PANEL”) need to be replaced with new branch circuit panels to alleviate failing breakers and any possible overload conditions that may be present due to over extending existing circuits. The school interior lighting system and controls need to be upgraded in the near future where energy may be conserved with lower maintenance cost and higher lamp life LED technology. An increase in the classroom receptacle quantity and associated electrical loads will require electrical distribution upgrades to support future additional computer/technology loads as well as possible mechanical HVAC connections. The raceways associated with low voltage systems around the campus may need to be verified/inspected for re-use where additional fiber optic cables/network cabling for any low voltage system upgrades is deemed necessary in order to verify cost impact of new trench vs. existing underground conduit re-use. Where a new building may be proposed at this site, an electrical survey will need to be completed and it is likely that the new building will require an Electrical (PG&E) service upgrade to accommodate any new proposed building (should an equivalent number of buildings/rooms not be slated to be removed due to new building added). In addition, Site Telecom, Fire Alarm, and Low Voltage Systems will need upgrades to accommodate new connections with newer technology and EM Voice Evacuation Fire Alarm System.

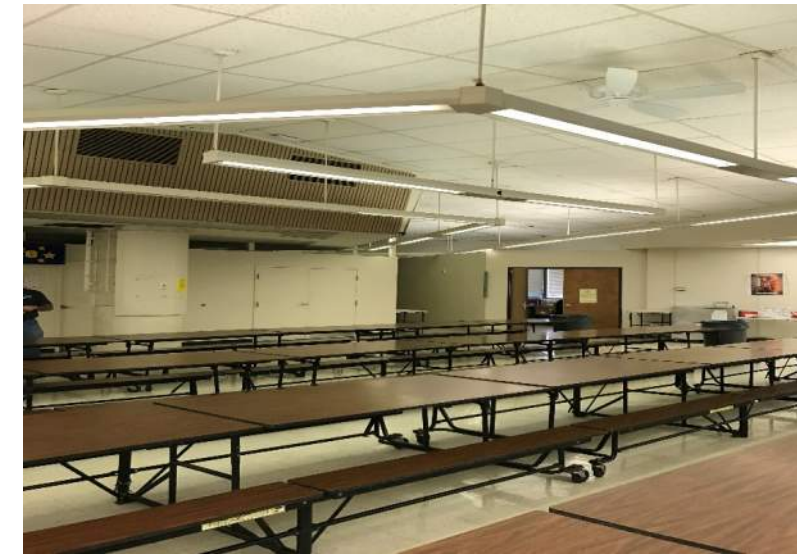
LTG1.

Interior Lighting is primarily fluorescent with T8 or T12 lamps at interior spaces. Most if not all the lighting throughout the school campus is old and although there was no mention of complete failure, some light fixtures seemed original to the spaces, so they are likely near their “end of life”, especially with regards to efficiency. Emergency lighting was not apparent at any classrooms, restrooms, exterior landings. However, in multi-use spaces, bug-eye type stand-alone emergency light fixtures were installed. Occupant sensors and multilevel switching necessary for energy conservation is almost non-existent. Expected life; Unknown. It is recommended to retrofit campus wide lighting system in the near future. This would be a good opportunity for reduction in energy use from more efficient lighting fixtures, improved classroom lighting, smart lighting controls and reduced maintenance. See attached LTG1 photo.
