FACILITIES NEEDS ASSESSMENT

LOS PADRES

PREPARED BY BELLI ARCHITECTURAL GROUP

2022

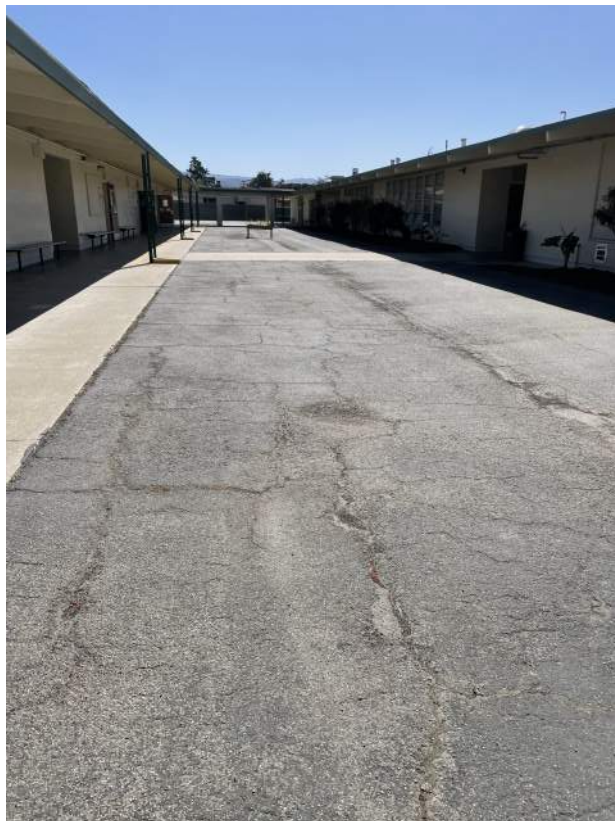
- Uneven surfaces and cracks in existing asphalt.
- Older, non-accessible Kindergarten playground.

Image 2.1.1 Cracked, weathered conditions in asphalt. Taken on 05/03/2022 by Belli Architectural Group.

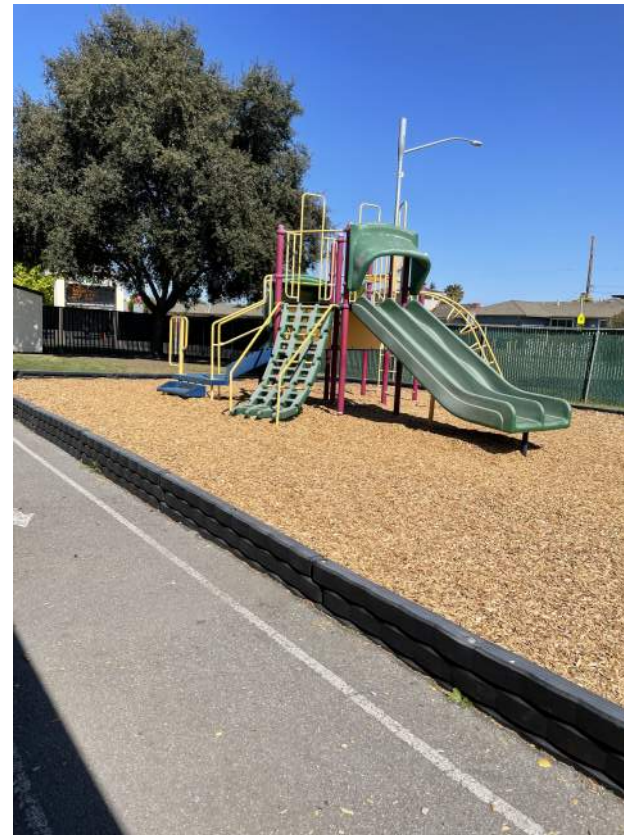
Image 2.1.2 Kindergarten playground. Taken on 05/03/2022 by Belli Architectural Group.

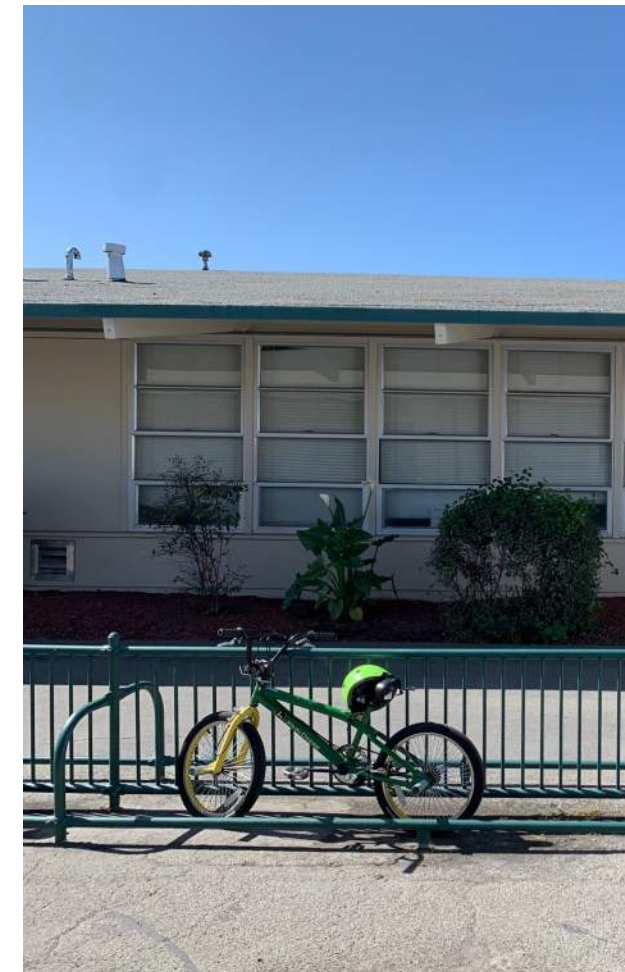
- Aging roofs in need of replacement.
- Weathered exterior paint.
- Non-compliant door thresholds.

Image 2.2.1 Permanent classroom roof. Taken on 05/03/2022 by Belli Architectural Group.

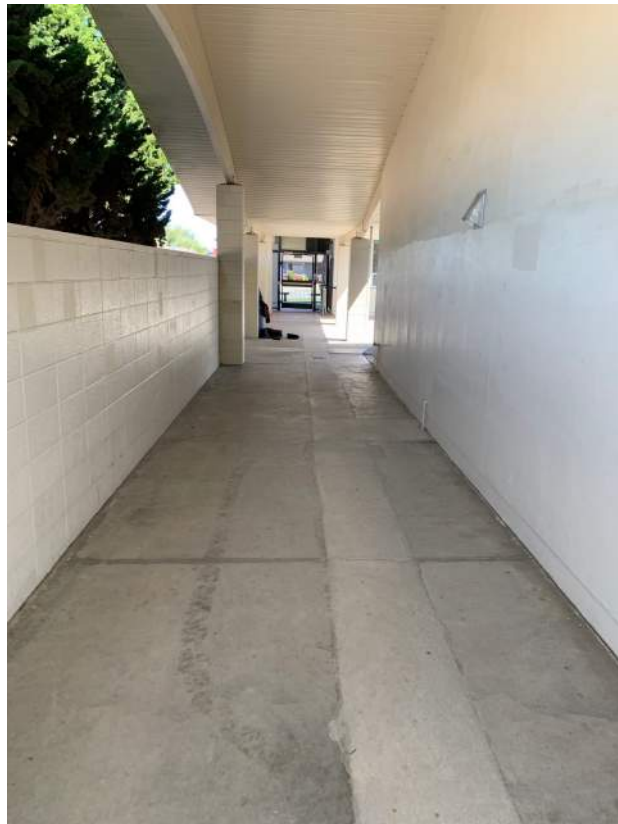
Image 2.2.2 Exterior paint. Taken on 05/03/2022 by Belli Architectural Group.

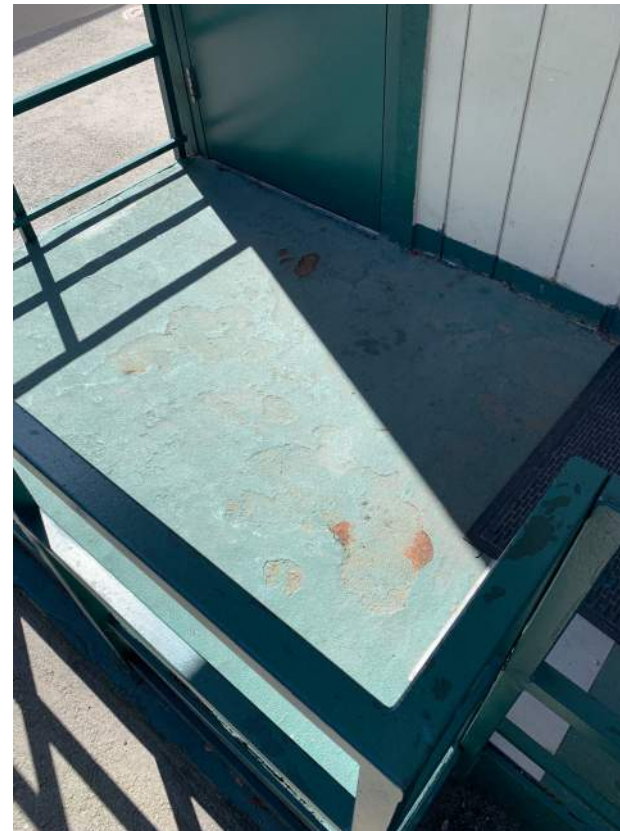
- Rust in access ramps.
- Rust in roofs.

Image 2.2.4 Relocatable classroom access ramp. Taken on 05/03/2022 by Belli Architectural Group.

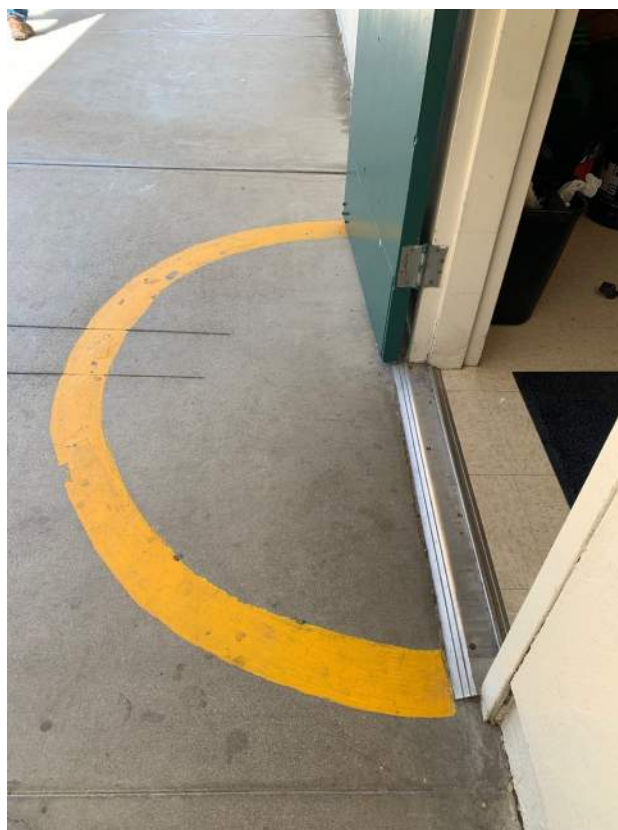
Image 2.2.3 Threshold. Taken on 05/03/2022 by Belli Architectural Group.

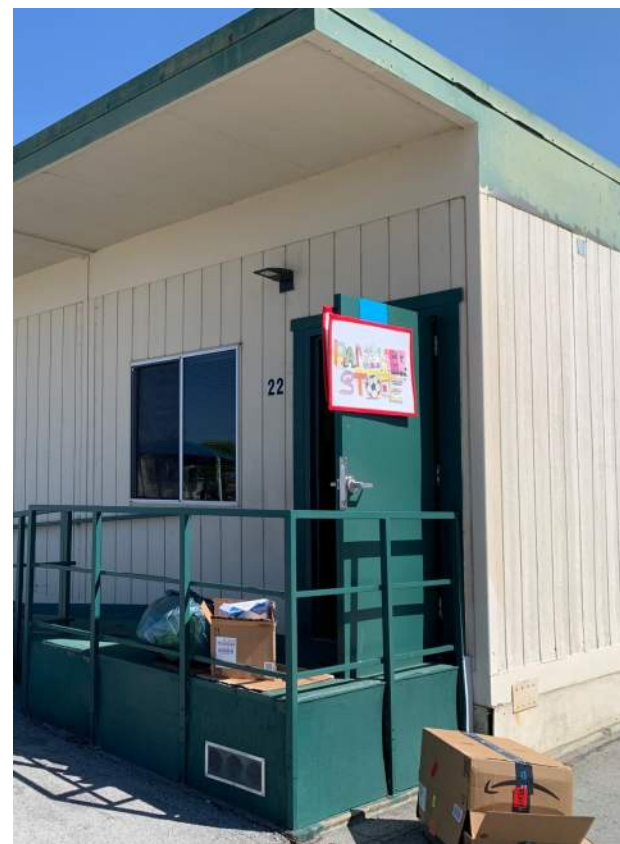
Image 2.2.5 Relocatable classroom exterior. Taken on 05/03/2022 by Belli Architectural Group.

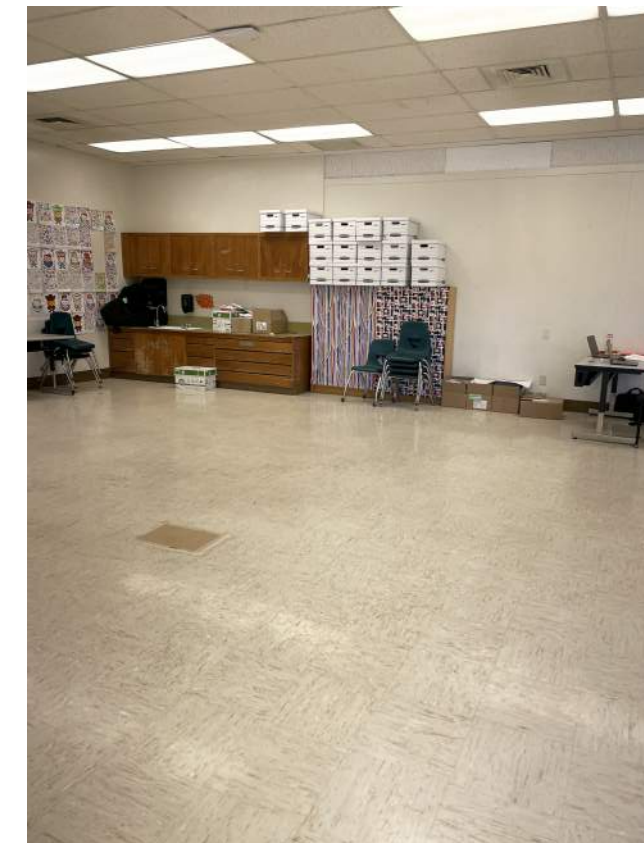
Image 2.3.1 Permanent classroom interior. Taken on 05/03/2022 by Belli Architectural Group.

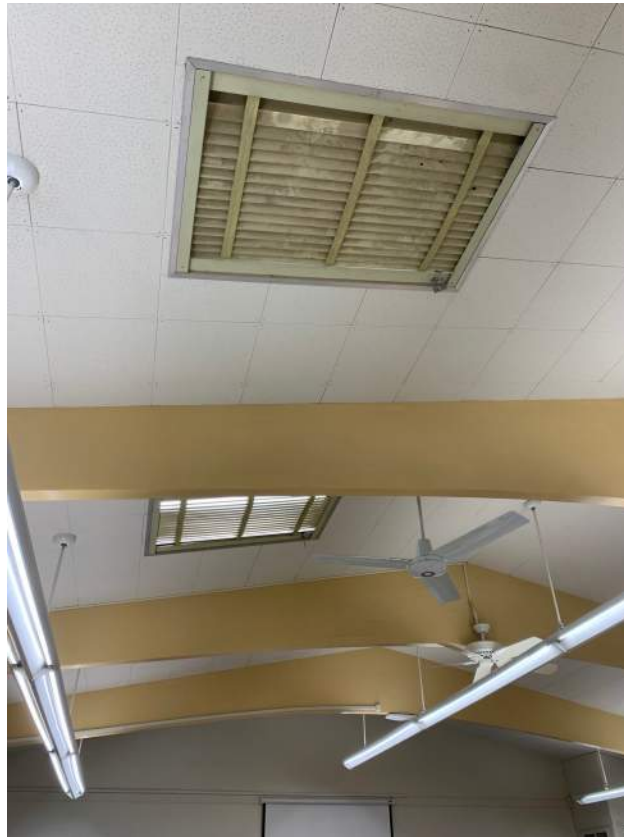
Image 2.3.1 Dirty louvers at aged skylights. Taken on 05/03/2022 by Belli Architectural Group.

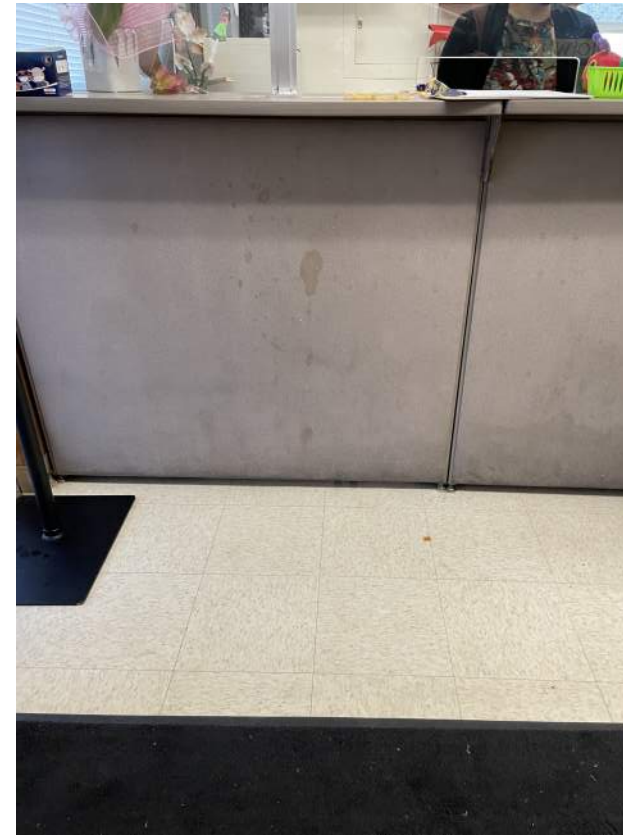
Image 2.3.1 Surface damage at reception desk. Taken on 05/03/2022 by Belli Architectural Group.

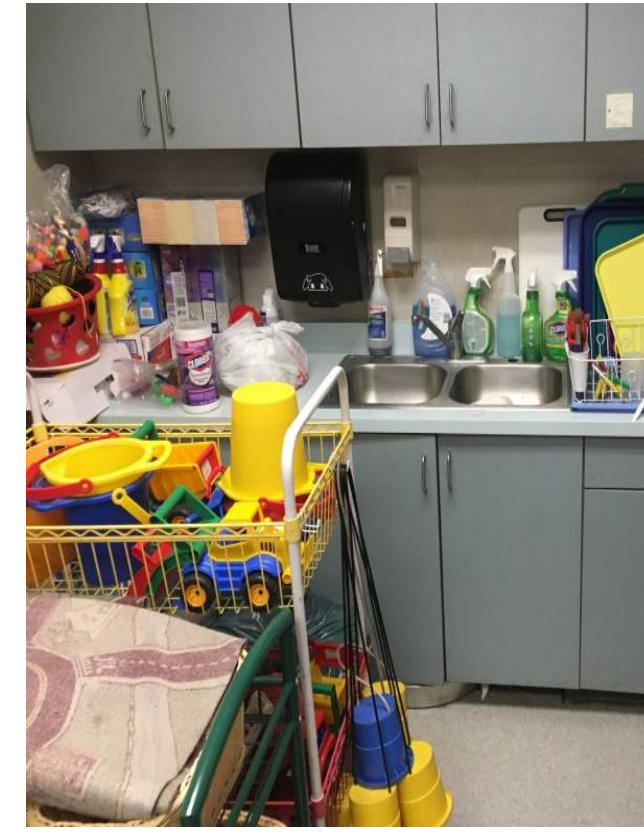
Image 2.3.6 Preschool. Taken on 05/03/2022 by Belli Architectural Group.

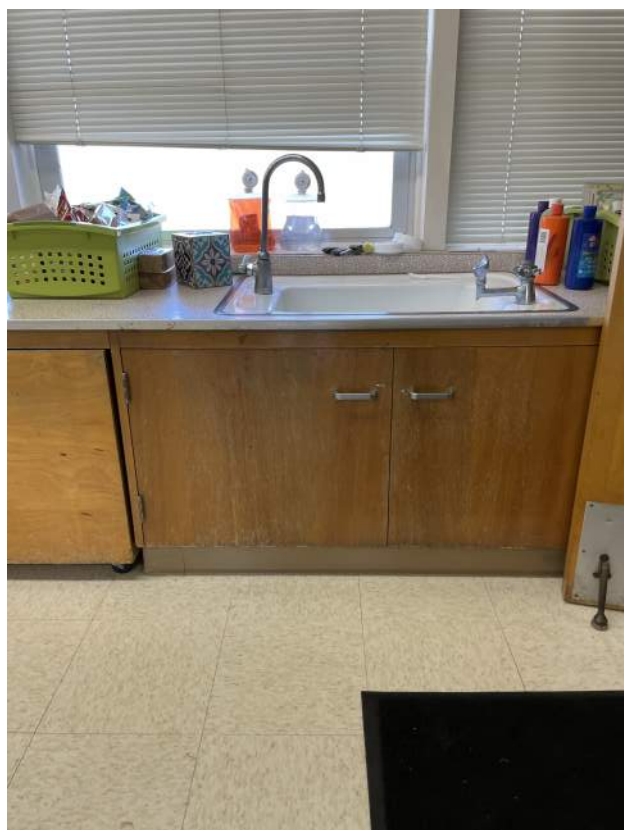
Image 2.3.3 Non-accessible sink at older casework. Taken on 05/03/2022 by Belli Architectural Group.

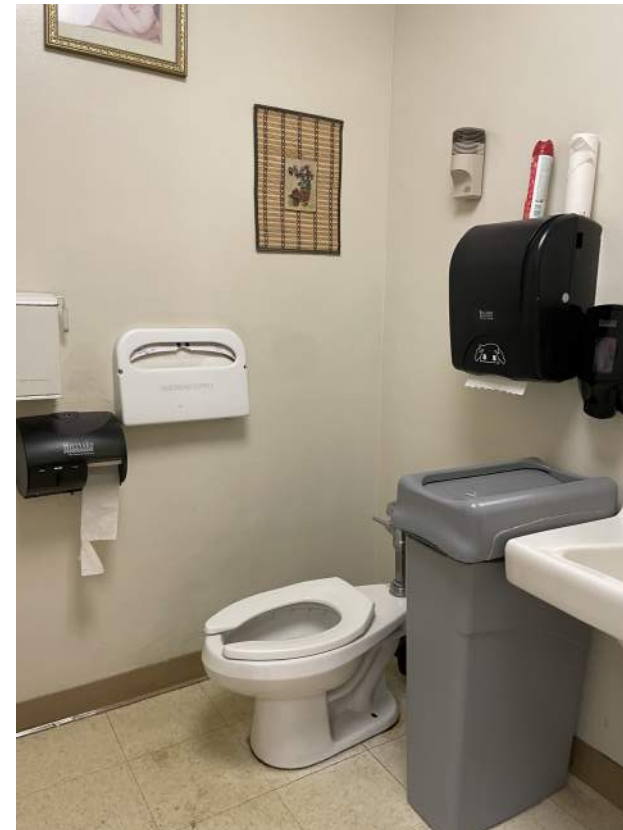
Image 2.3.5 Small, non-accessible staff restroom. Taken on 05/03/2022 by Belli Architectural Group.

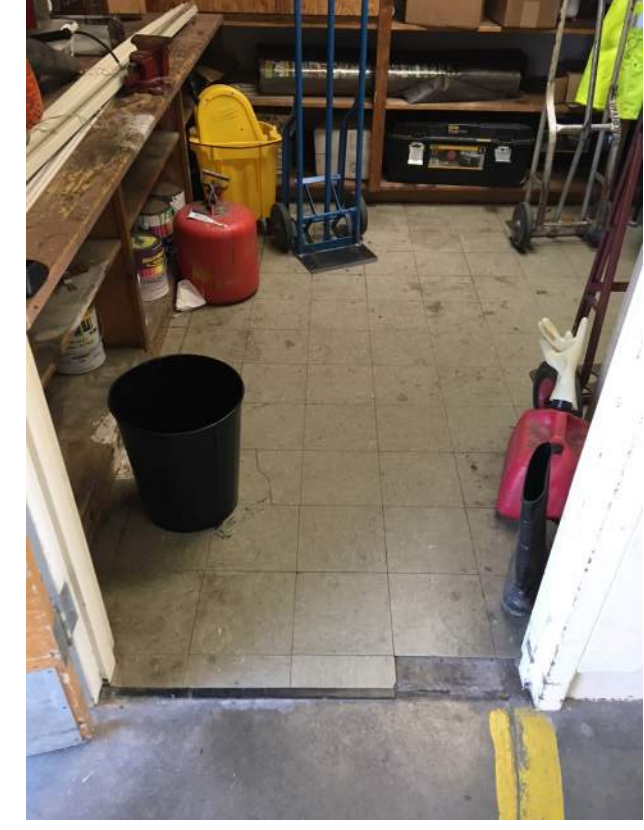
Image 2.3. Janitorial room. Taken on 05/03/2022 by Belli Architectural Group.

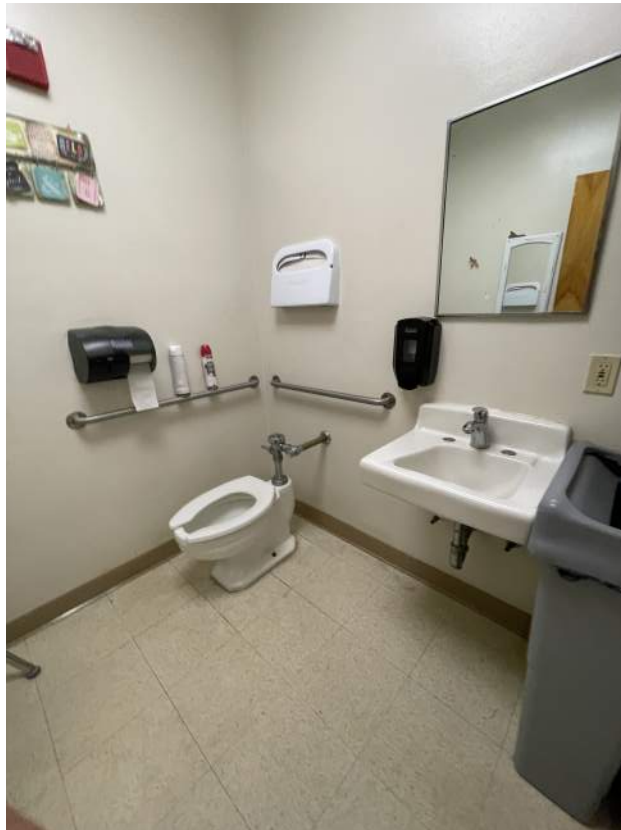
Image 2.4.1 Not fully ADA-compliant staff restroom. Taken on 05/03/2022 by Belli Architectural Group.

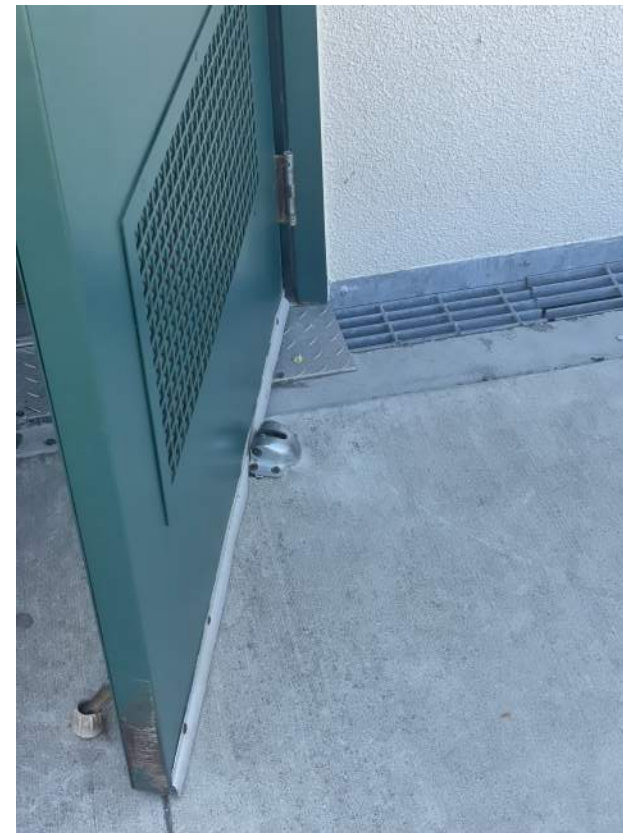
- Non-accessible Staff Restrooms at Amin. Office
- Non-accessible sinks in classrooms.
- Exterior door stop at pit-set modular restrooms prevents door from opening to a dull 90 degree open position.

Image 2.4.2 Door stop at pit-set modular restroom. Taken on 05/03/2022 by Belli Architectural Group.

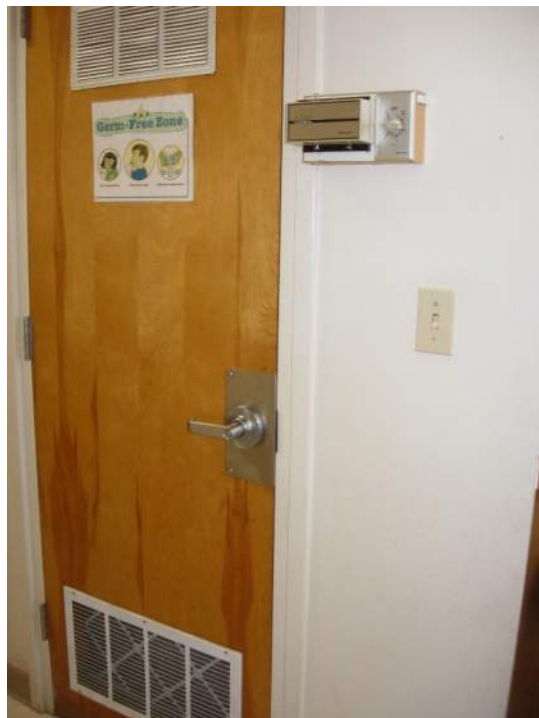
The heating system for this area consist of an Armstrong up-flow gas-fired furnace located in a closet off of the Lobby. This furnace is from the 2002 modernization and appears to be in fair condition and operating. This furnace is 20 years old and should be replaced.

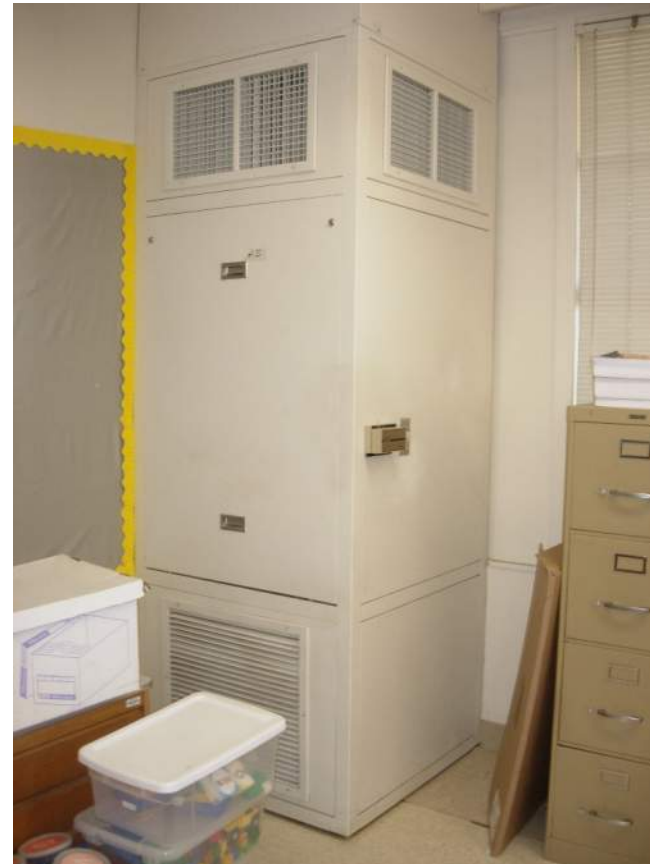
These classrooms are heated with Armstrong up-flow gas-fired furnaces located inside a TEAM Mfg. enclosure located in the room. These were installed during the 2002 modernization and appear to be in fair condition and operating. The furnaces inside the enclosures are 20 years old and should be replaced. The photo below is Classroom 1.

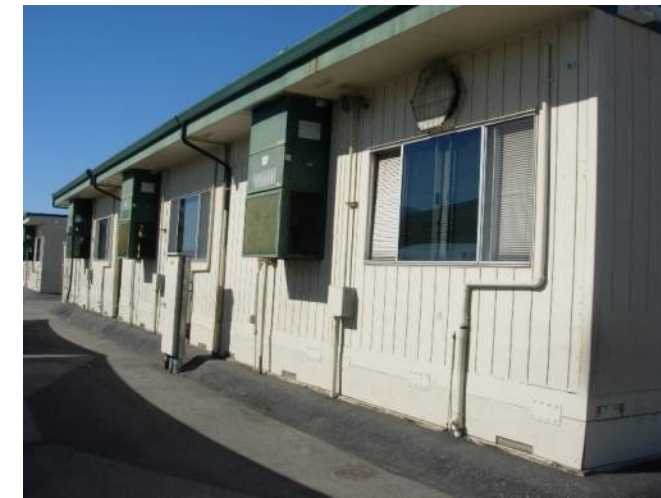
These are portable classroom consisting of the exterior wall mounted “Bard” type heat pump units. All portables utilize this type of equipment. A few of these units throughout the campus appear to be from the 2002 modernization and are operating. Older (20 years) units should be replaced with new units.

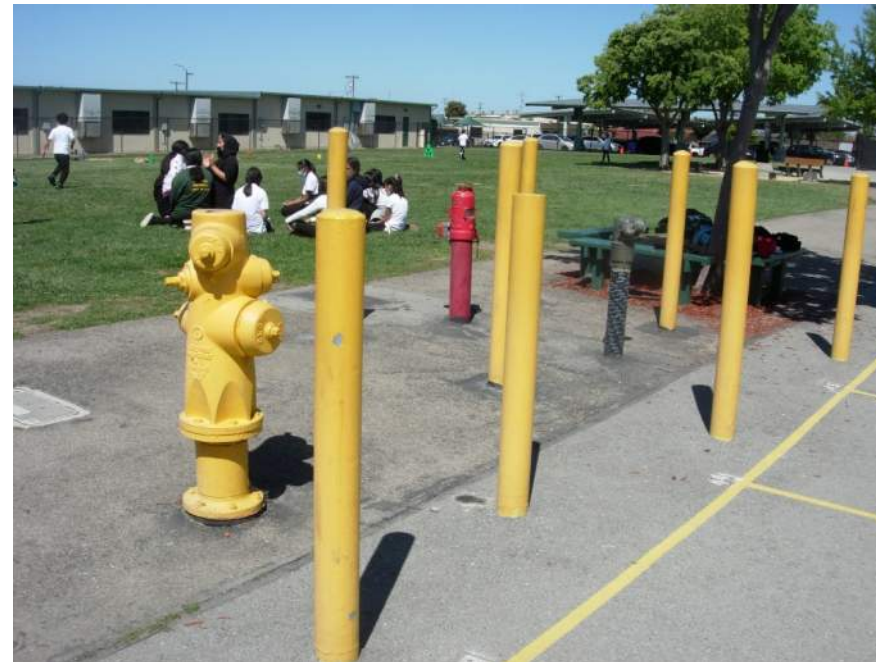
There is a fire hydrant located in the back of the site. The FDC and PIV shown in the picture below are for the new Multi-Purpose Building built in 2013.

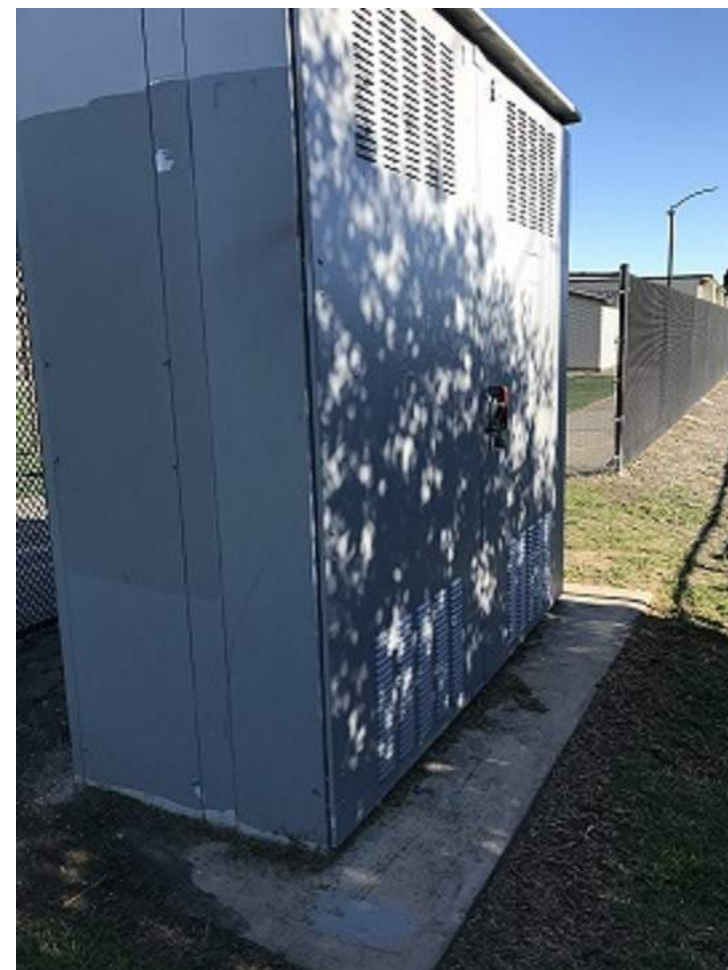
There are (2) existing main “metered” electrical service switchboards (MSB1 and MSB2). MSB1 is a 2000 amp, 120/208 volt, 3 phase, NEMA 3R, Square D, service located on the east side of school campus near the front parking lot. MSB1 has a connection for the existing Solar PV system. The Solar PV is connected ahead of the main breaker at MSB1. MSB1 serves in large part, the east side modular classrooms (approximately 27 total modular classrooms) and the new multi-purpose building. MSB1 expected life; 15 to 20 yrs. MSB2 is a 400 amp, 120/240V, 3-phase, NEMA 1, Square D, service located in the Administration building. The solar PV system is also connected at this switchboard. MSB2 feeds the permanent buildings and few portable classrooms located at the center of school campus. MSB2 expected life; 10 to 14 yrs. The electrical services are used primarily for lighting and heating equipment, with minimal plug loads. Some of the electrical distribution system panels that are located around the site and are original to the main campus buildings when the school was built, are old and manufactured by a company that no longer exists. The reliability of the system’s breakers to function correctly when necessary cannot be relied upon. It is recommended to replace the oldest panels within the classroom wings of the main campus building. Where the District plans to add HVAC to the site, the switchboards that are serving those locations may require an upgrade based on what type of system is recommended for HVAC upgrades. See attached photos MSB1 and MSB2.

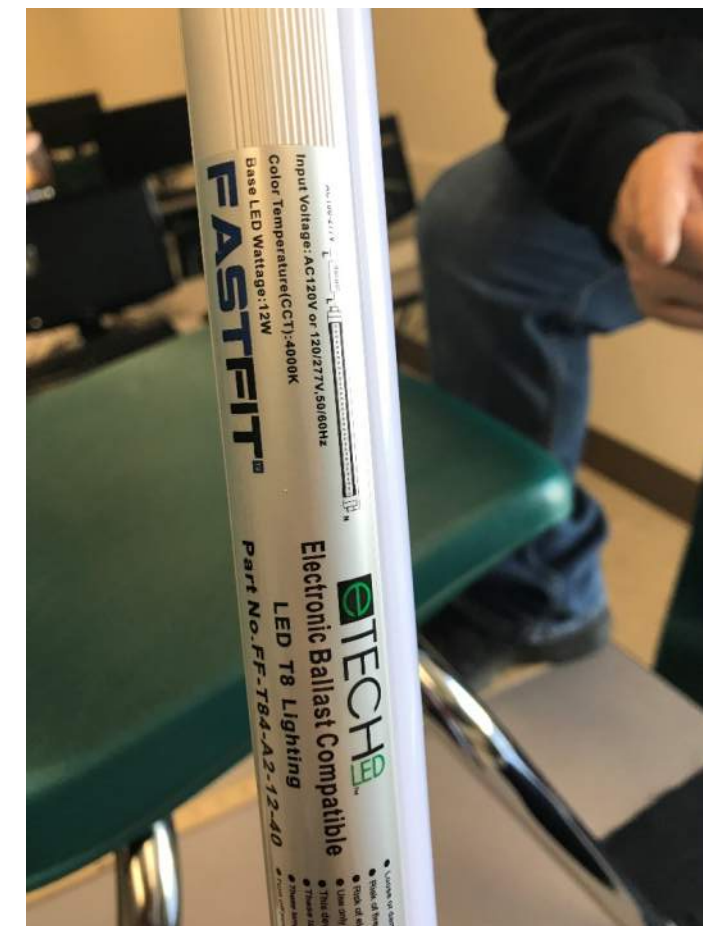
Interior Lighting is primarily LED T8 lamps. Several closets and utility rooms still have old fluorescent lights. Most, if not all classrooms fluorescent lights were retrofitted with LED T8 lamps manufactured by eTech LED, see attached photo LTG1. The District Staff stated that these LED lamps are made in China and are no longer available. The lighting lenses/diffusers throughout the school campus are old and although there was no mention of complete failure, some light fixture housing seemed original to the spaces, hence the old diffusers would not provide the adequate lighting distribution. There were also several light fixtures in the classrooms that don’t work. It appears that all classrooms and large areas have energy code compliant controls such as wired and wireless occupancy sensors. Emergency lighting was not apparent at any classrooms, restrooms, or exterior landings (except for new MPR building). However, in multi-use spaces and hallways, bug-eye type stand-alone emergency light fixtures were installed. Multi-level switching/dimming necessary for energy conservation is almost non-existent. Expected life; Unknown. It is recommended to retrofit or replace campus wide lighting system with new LED technology in the near future. This would be a good opportunity for reduction in energy use from more efficient lighting fixtures, improved classroom lighting, smart lighting controls, daylight harvesting and would also reduce maintenance costs.

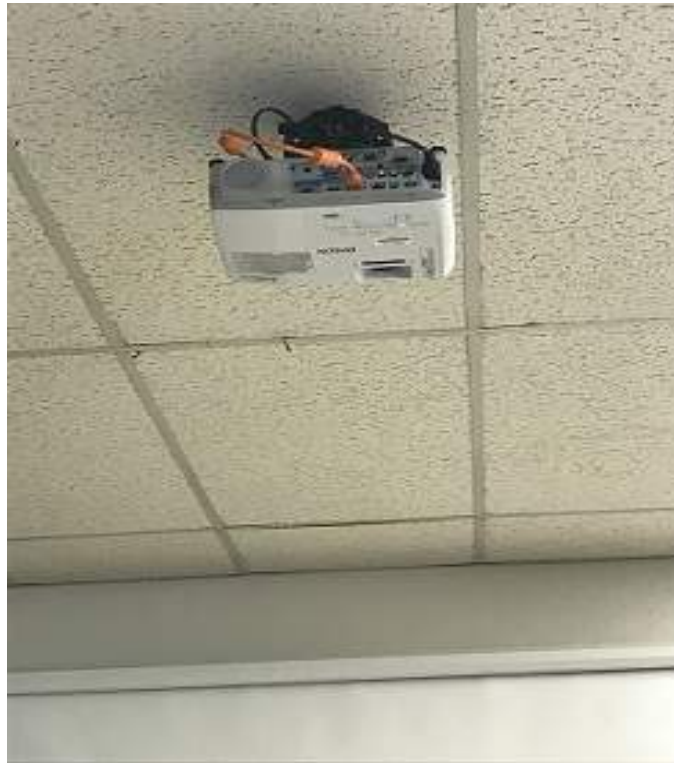
Most of the classrooms have ceiling mounted projectors with associated AV controls located near the teacher’s station. There are no ongoing problems. However, where projectors were installed on an accessible ceilings (T-BAR), the associated receptacles were installed above the ceiling with the cord passing through the T-BAR up to the receptacle. Current code does not allow this installation. Where classroom renovations occur, it is required to mount the receptacles exposed on the ceiling. See attached photo PROJECTOR1.
